Existing Condition of the Leadville Mine Drainage Tunnel

Leadville Mine and Drainage Tunnel Project, Colorado
Great Plains Region

U.S. Department of the Interior
Bureau of Reclamation

October 2008

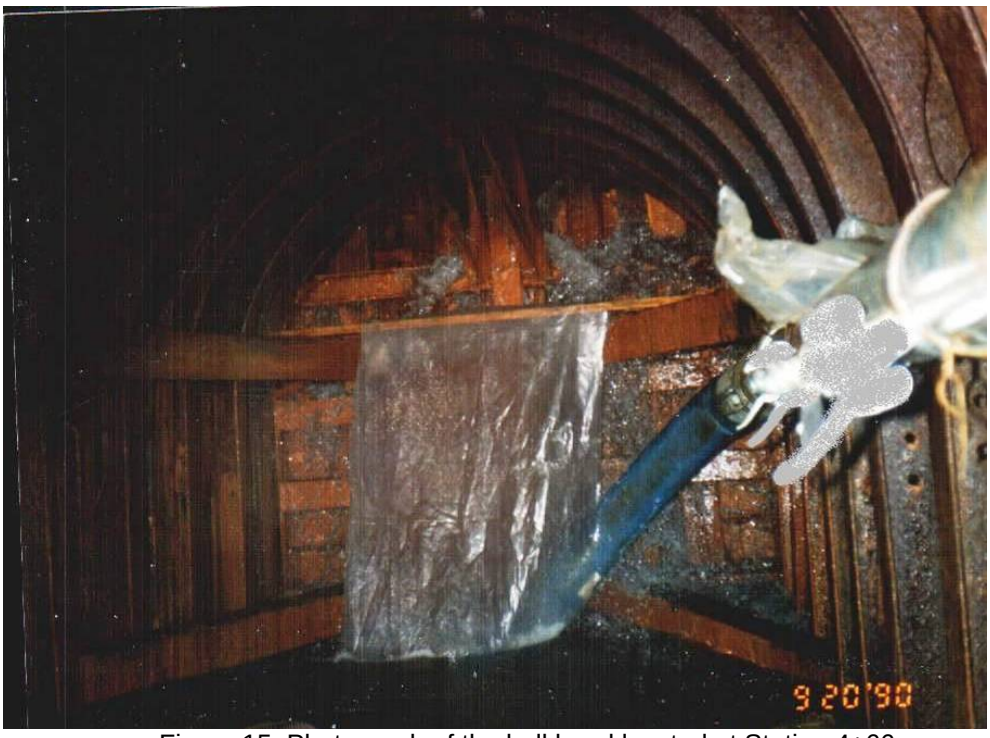
Figure 15. Photograph of the bulkhead located at Station 4+66.

On May 9, 1980, prior to completion of the bulkhead shown in Figure 15, Reclamation visually estimated flows from the vent pipe (250 gpm), cast iron air line (250 to 400 gpm), and there was seepage at the face, for a total of 600 to 800 gpm (Smirnoff and Allen, 1980). Figure 16 shows the locations of the vent pipe and air pipe.
