Tracy Fish Collection Facility

Hydraulic Performance Evaluation of the Replacement Primary Bypass Intakes and Transition Boxes at Tracy Fish Collection Facility

Volume 40

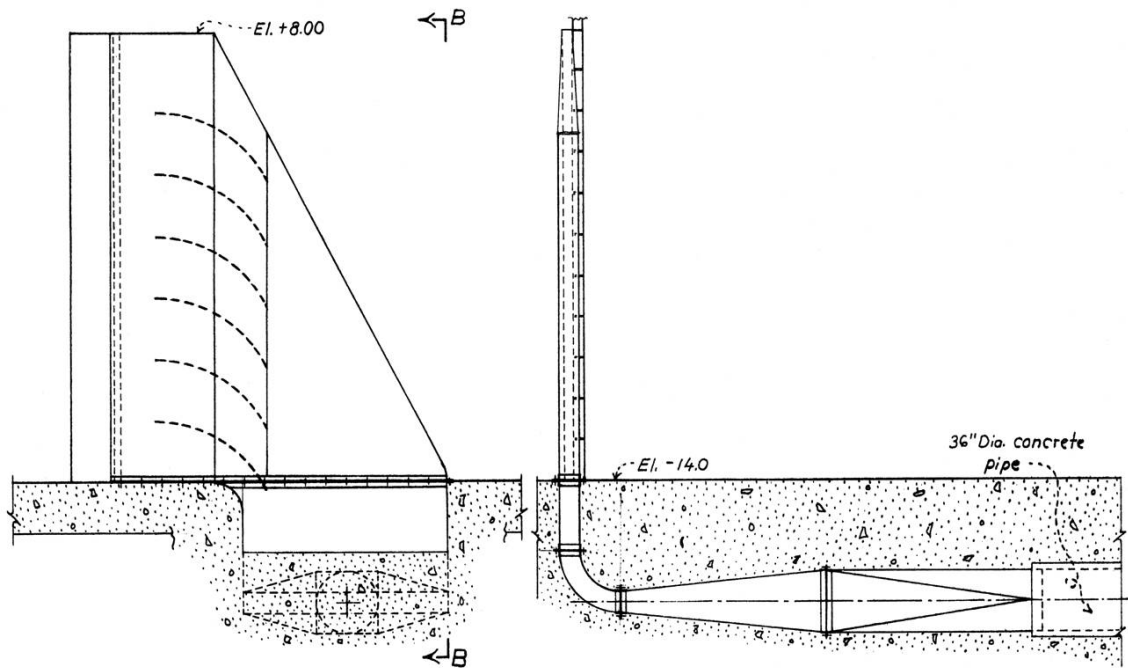
FIGURE 3.—Original bypass intake design using internal curved vanes from 1956.

Although the intakes were designed to generate near-uniform entrance velocity distributions, the vanes were not accessible for maintenance and cleaning. The vanes accumulated debris, causing flow blockages within the intake and degrading

the uniformity of the entrance velocity profiles. As the bypass intakes corroded and deteriorated with time, vane failure reduced velocity distribution control effectiveness and holes in the bypass transition boxes were observed.

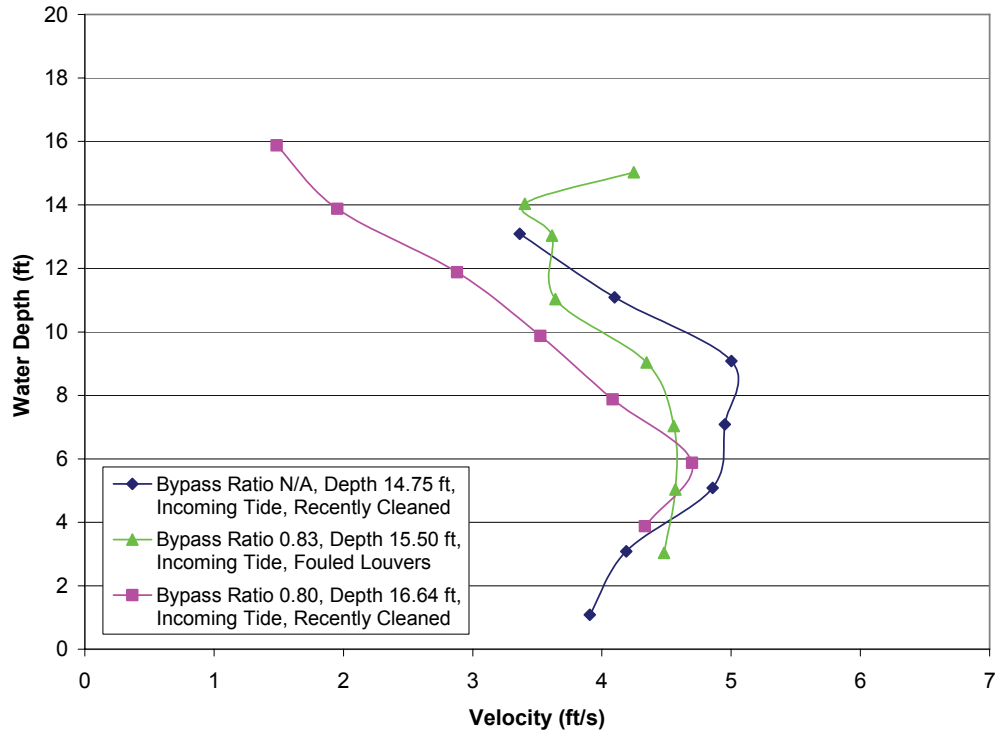
FIGURE 14.—Velocity profiles in the original primary bypass 1 intake entrance.

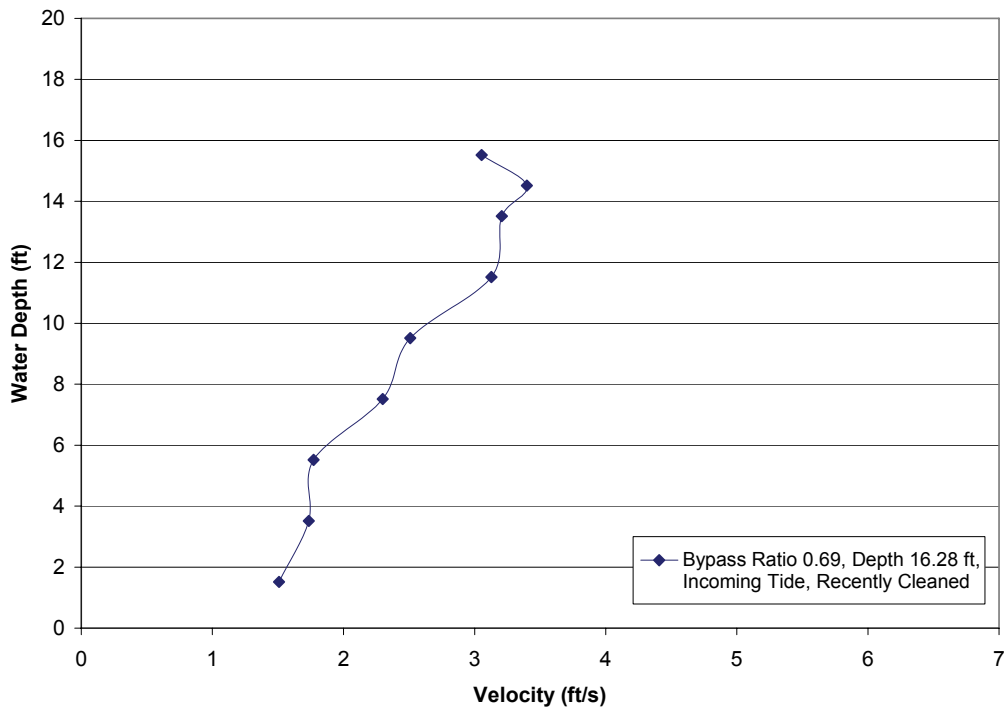
FIGURE 15.—Velocity profiles in the original primary bypass 4 intake entrance.

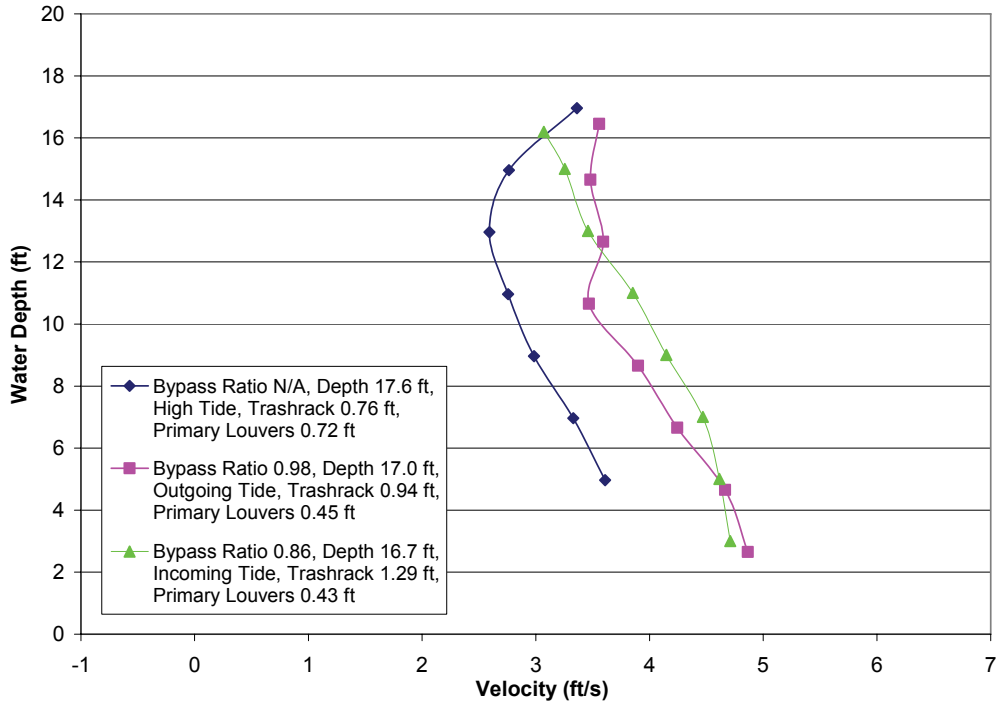
FIGURE 16.—Velocity profiles in the replacement primary bypass 1 intake entrance.

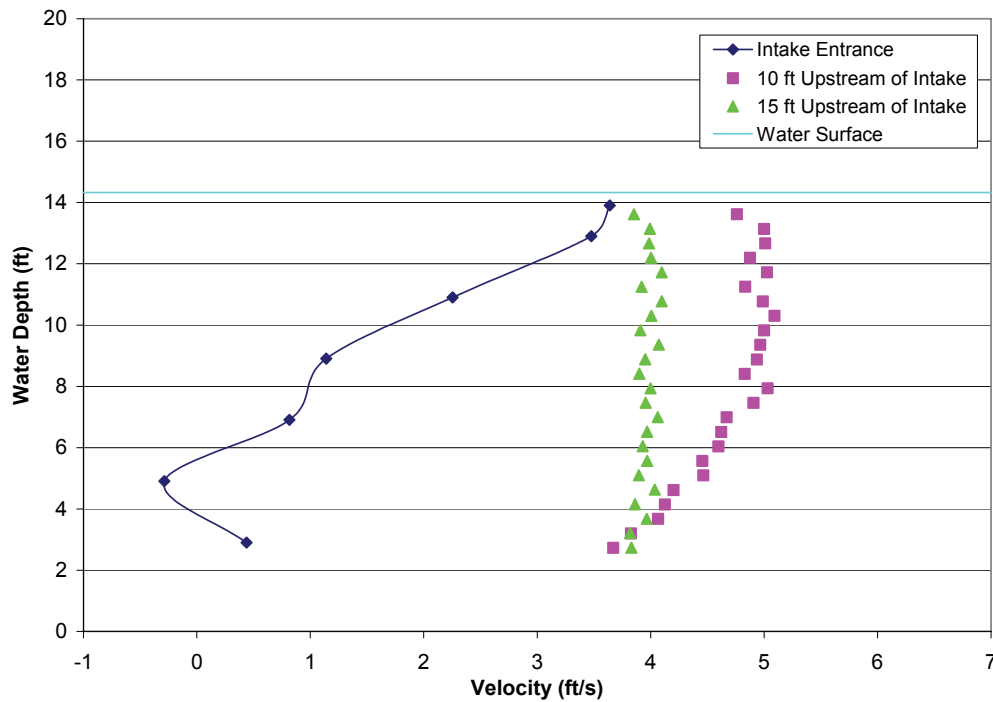
In the laboratory study, bypass ratios of 1.2 and 1.6 were tested due to their significance as TFCF operating criteria. In the field, bypass ratios greater than 1.0 can be difficult to achieve due to tidal conditions, debris influences, and facility limitations. When bypass ratios are well below 1.0, velocity profiles decelerate into the bypass intake (figure 20). This slowing trend negates the intended increase in velocity recommended for guiding fish into the bypass intake. Entrance profiles often show flow patterns that are not present in the approach velocities, indicating that secondary flow patterns and eddies are generated within the transition box due to flow restrictions. This causes non-uniform velocity fields at the bypass entrance and occasional reverse flows.

FIGURE 20.—Example of a profile collected with a bypass ratio of less than 1.0. Test 2-4, collected at bypass 4 with a measured bypass ratio of 0.37, shows significant slowing in the approach velocity fields and reverse flows at the intake entrance.

Minimizing the amount of debris on the trashrack and louvers will likely improve performance of the replacement intakes. Bypass ratios less than 1.0 appear to generate secondary flow patterns and eddies due to a restriction in flow. Flow decelerations and even reverse flows can occur on the approach to the bypass entrances. Bypass ratios of 1.0 or greater, had better sustain velocity fields entering the intake with little flow disruption. Bypass ratios well above 1.0 produce an efficient acceleration of flow into the intake. Therefore, the TFCF should be operated to maintain bypass ratios greater than 1.0 whenever possible.

Since increased bypass ratios improve the hydraulics at the intakes, when it is not possible to produce bypass ratios above 1.0 using standard four bypass operations, one or two of the bypasses may be closed to increase flow through the open bypasses. The bypass ratio of the open bypasses is increased while possibly maintaining an acceptable velocity in the secondary channel. A study to analyze closing bypasses as an alternative operational method is recommended. Sufficient field data was collected during the replacement bypass studies on TFCF system wide performance to establish the basis for these alternative operations. Other factors regarding fish behavior need to be considered: the majority of fish are collected through bypass 4 and the maximum fish exposure duration on the louver face is 60 seconds (National Marine Fisheries Service, 1995). Additional hydraulic and fisheries field evaluations may be needed to demonstrate recommended operations. It may be possible to estimate potential improvements in bypass operation with alternative operations by looking at the percent of time that bypass ratios are achievable considering TPP operations, tidal influences, and debris fouling. Operational changes can be enacted after agency approval with no associated capital cost.

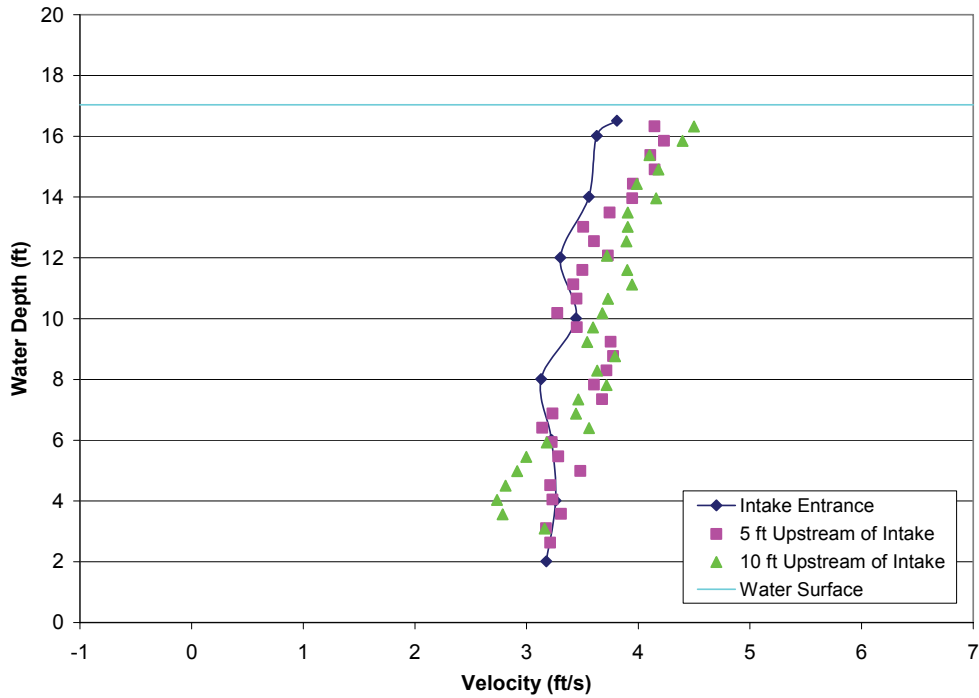
When bypass ratios are near 1.0, profiles measured in the intake are often similar in shape to near-field velocity profiles (figure 21). This similarity in flow distribution is consistent with scale physical model results (Johnson *et al.*, 2004). Flow accelerates or decelerates gradually into the intake with little flow disruption. When bypass ratios are well above 1.0, the flow consistently accelerates into the intake as is recommended for efficient fish collection (figure 22). Since bypass ratios greater than 1.0 are difficult to achieve in the field, one or two of the four bypasses were closed during the field evaluations to force more water to pass through the open bypasses. This alternative operating method raises the bypass ratio of the open bypasses while maintaining an acceptable velocity in the secondary channel.

FIGURE 21.—Example of a profile collected with a bypass ratio near 1.0. Test 3-2, collected at bypass 2 with a measured bypass ratio of 1.02, shows similarly shaped approach profiles with a slight deceleration of flow into the intake.

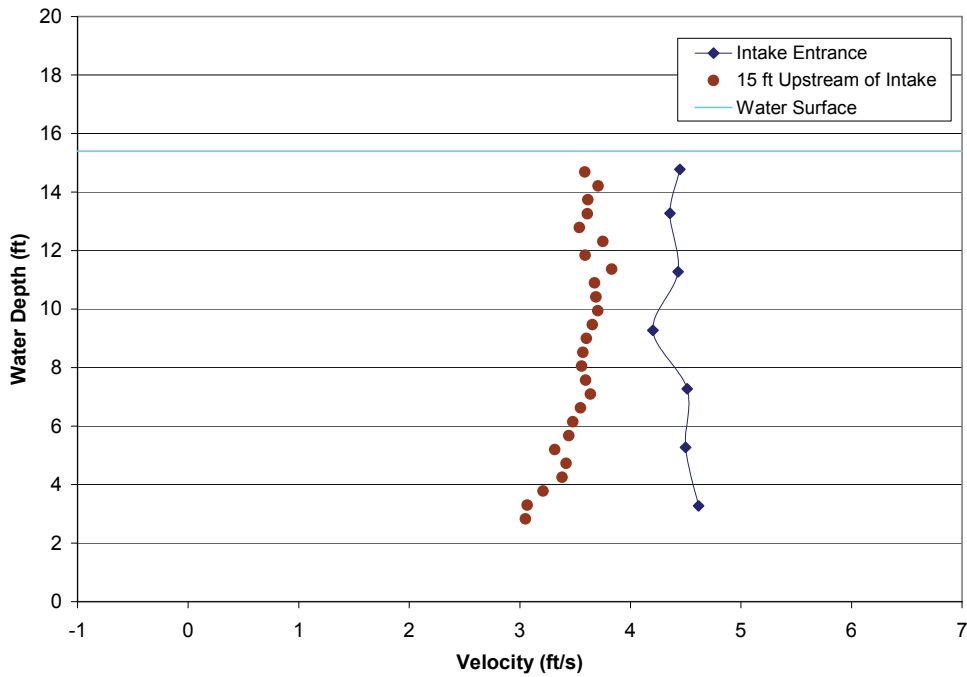
FIGURE 22.—Example of a profile collected with a bypass ratio greater than 1.0. Test 1D, collected at bypass 4 with a measured bypass ratio of 1.32, shows an acceleration of flow into the intake.

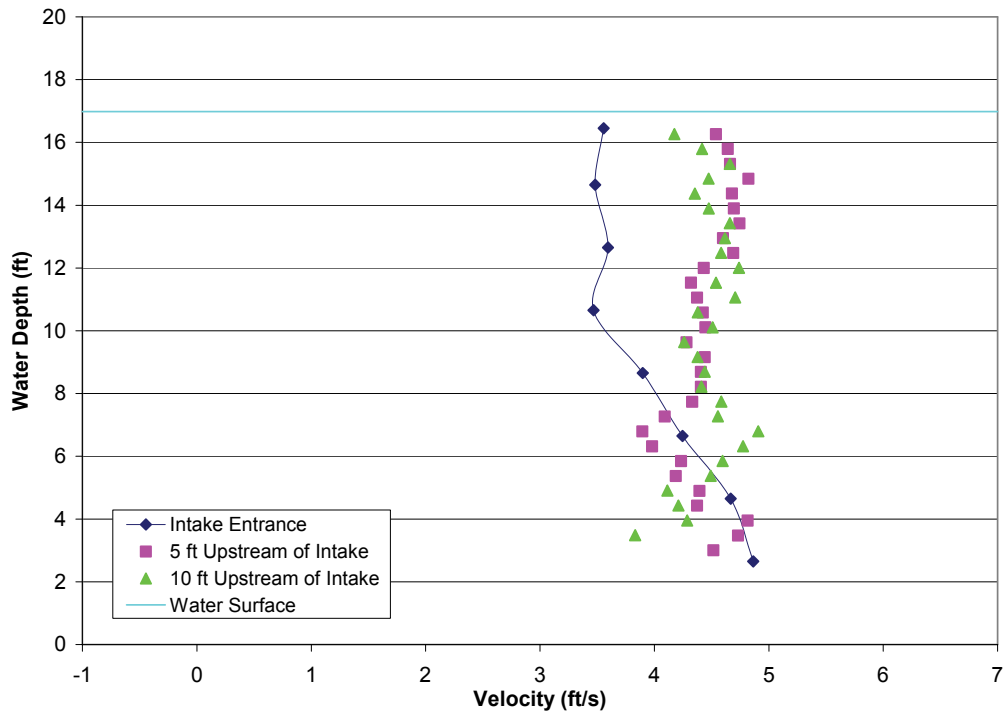
With the replacement intakes installed, the trashrack differential was above 2.0 ft during Tests 2-3 and 2-4. In both cases, the large differential produced enough air entrainment in the primary channel to fault the primary channel flowmeter. High louver differentials of 0.74 and 1.29 ft were also recorded for Tests 2-3 and 2-4, respectively. These were the only two tests with a negative downstream velocity component in the vertical profile, showing the presence of reverse flow out of the bypass intake. For both tests, the velocity profiles slowed down on the approach to the bypass entrance (Appendix 2, figures A2-5 and A2-7). Model testing has shown that velocity fields upstream from the bypass intake influence the distribution of flow into the intake (Johnson *et al.*, 2004). It is possible for strong vertical gradients in the channel approach velocities to generate flow distribution concentrations at the bypass entrances that overwhelm the characteristics of the intake to produce near-uniform velocities. Since trashrack and louver debris fouling influence approach flow velocities, it is likely that any type of bypass intake will perform best when debris fouling is minimized.

FIGURE A2-5.—Test 2-3, bypass 3 intake profile with all bypasses open, measured bypass ratio = 0.69, bypass ratio with facility instruments = N/A, outgoing tide, water depth = 14.86 ft, trashrack differential = 3.03 ft, louvers differential = 0.74 ft.

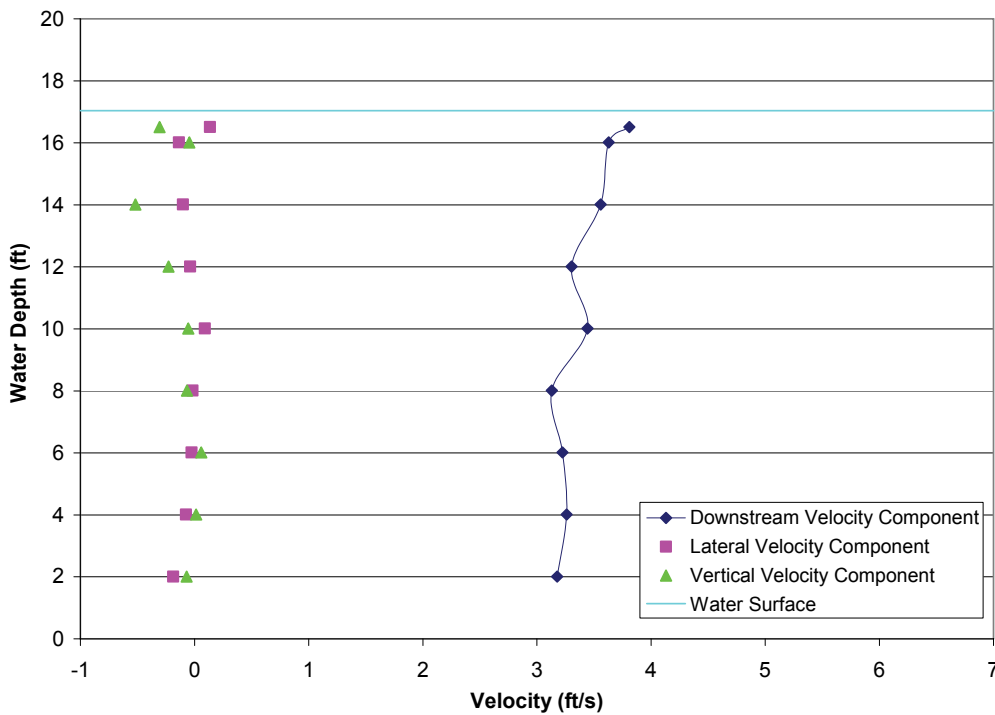
FIGURE A2-7.—Test 2-4, bypass 4 intake profile with all bypasses open, measured bypass ratio = 0.37, bypass ratio with facility instruments = N/A, outgoing tide, water depth = 14.33 ft, trashrack differential = 2.98 ft, louvers differential = 1.19 ft.
