R-99-06

CANAL-LINING DEMONSTRATION PROJECT
YEAR 7 DURABILITY REPORT

U.S. DEPARTMENT OF THE INTERIOR
Bureau of Reclamation

Pacific Northwest Region
Water Conservation Center

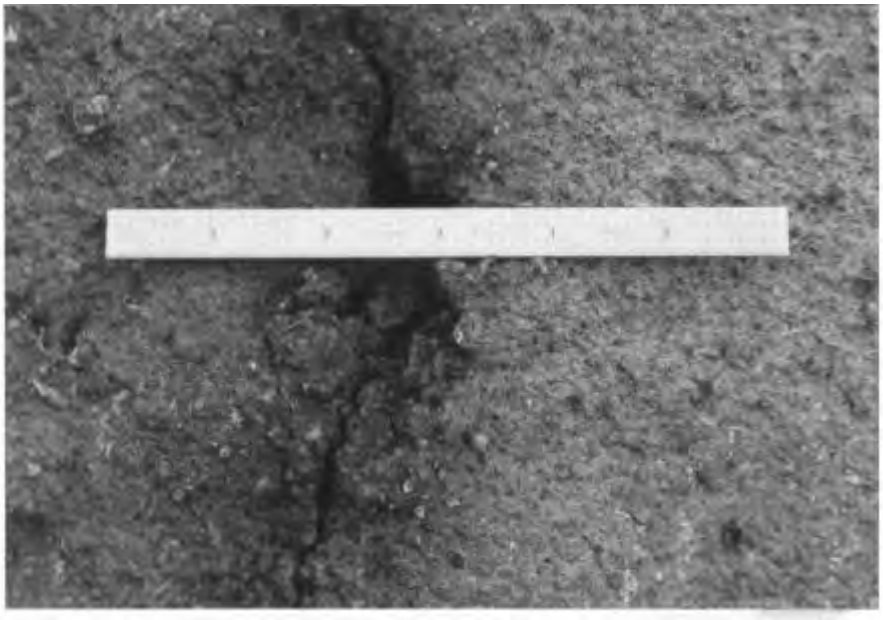
Arnold Canal - Test Section A-2
30-mil textured VLDPE with 16-oz Geotextile Cushion and Shotcrete Lining

Photograph 85.—Largest cracks measure up to 3/16 inch wide.

Photograph 86.—Thin shotcrete over anchor trench is less than 1 inch thick and severely cracked.

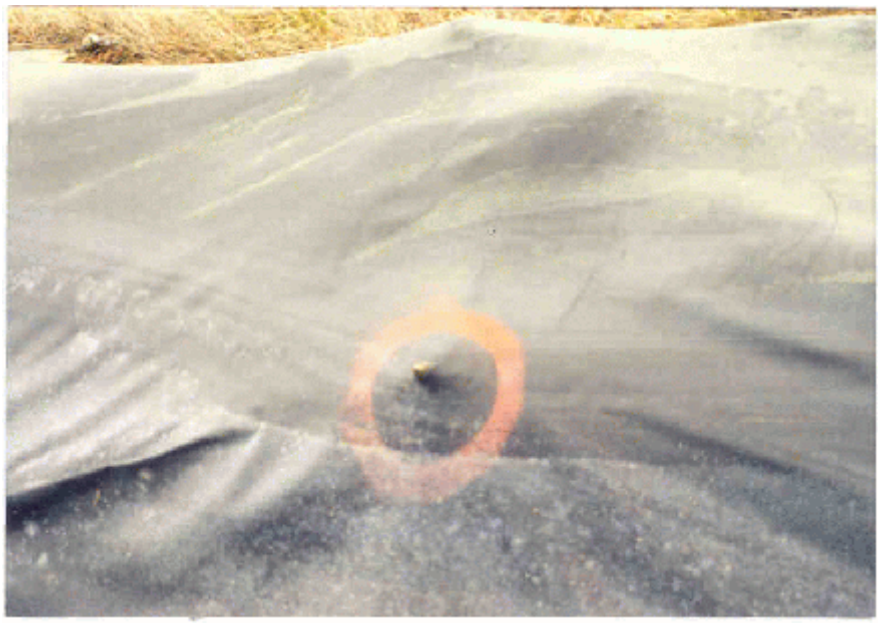
Arnold Canal - Test Section A-5
Exposed 45-mil Hypalon with 16-oz Geotextile Cushion

Photograph 96.—Sharp subgrade rock (or stick) has punctured the liner at station 33+20.
The puncture has not progressed over the last 4 years.

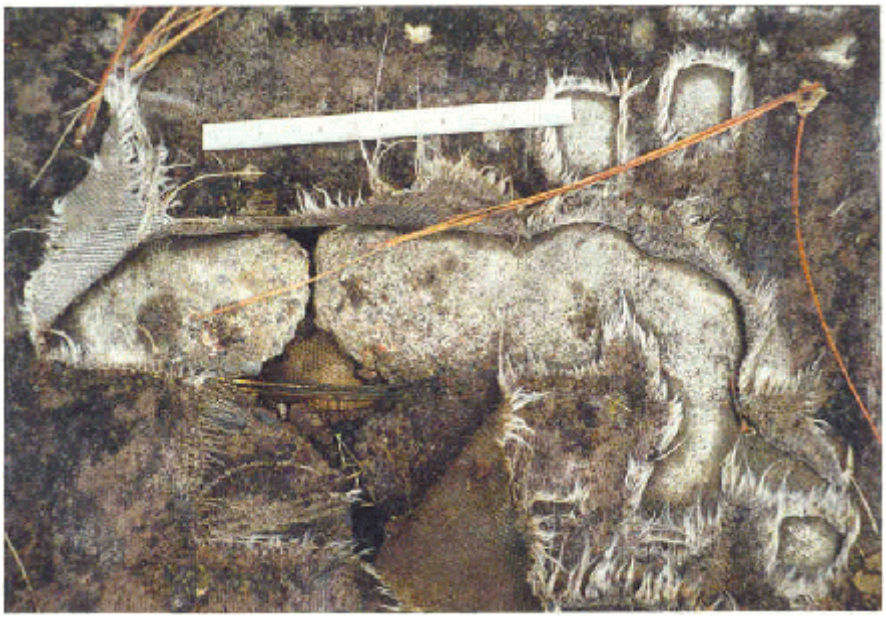
Arnold Canal - Test Section A-7
40-mil PVC with 3-inch Grout-filled Mattress

Photograph 103.—Closeup of area with deteriorated geotextile.
Note that some of the grout bricks are also missing in this area.

Photograph 104.—PVC membrane visible beneath grout mattress.
Grout was only about ½ inch thick in this location.

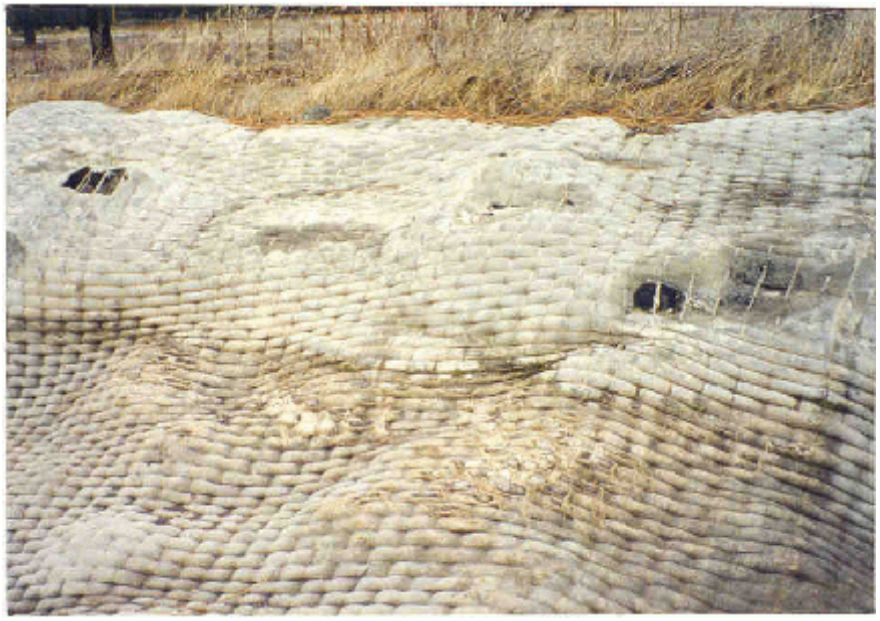
Arnold Canal - Test Section A-8
3-inch Grout-filled Mattress

Photograph 106.—The grout-filled mattress is missing several bricks at station 54+50.

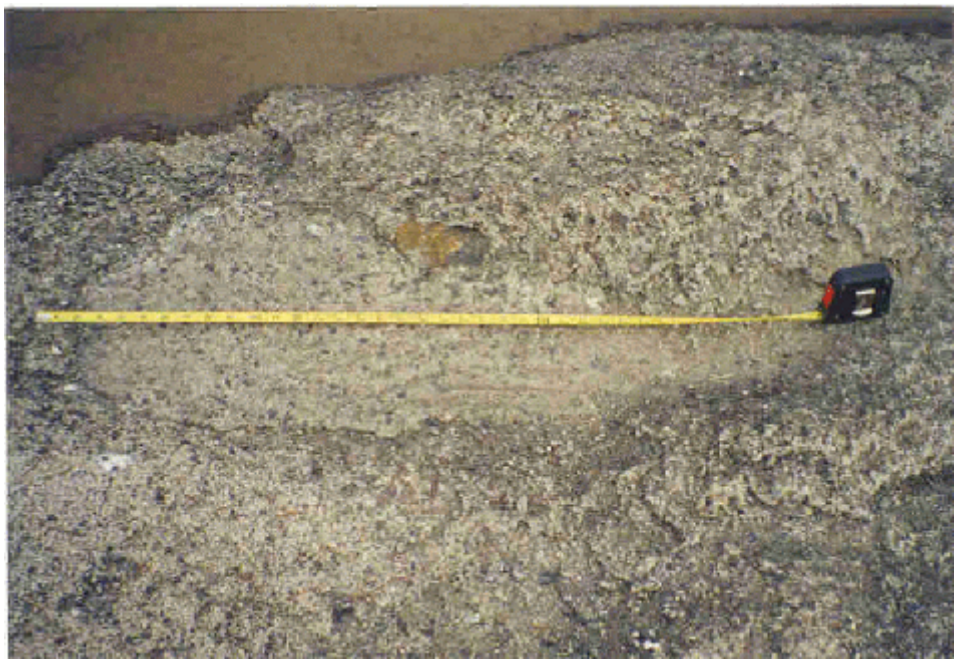
North Unit Canal - Test Section NU-6

Photograp h 112.—A previous 2-ft-diameter repair is still in good condition.

Photograph 113.—Elastomeric sealant has disbonded in many areas.

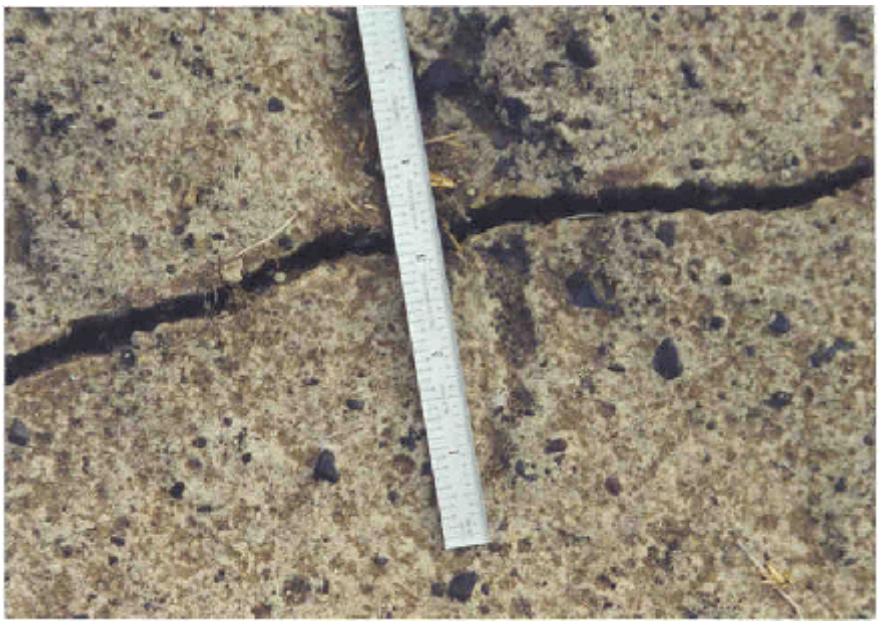
North Unit Canal - Test Section NU-8
Shotcrete Reinforced with Fibermesh Polyfibers

Photograph 119.—Largest crack measures about ¼ inch wide.

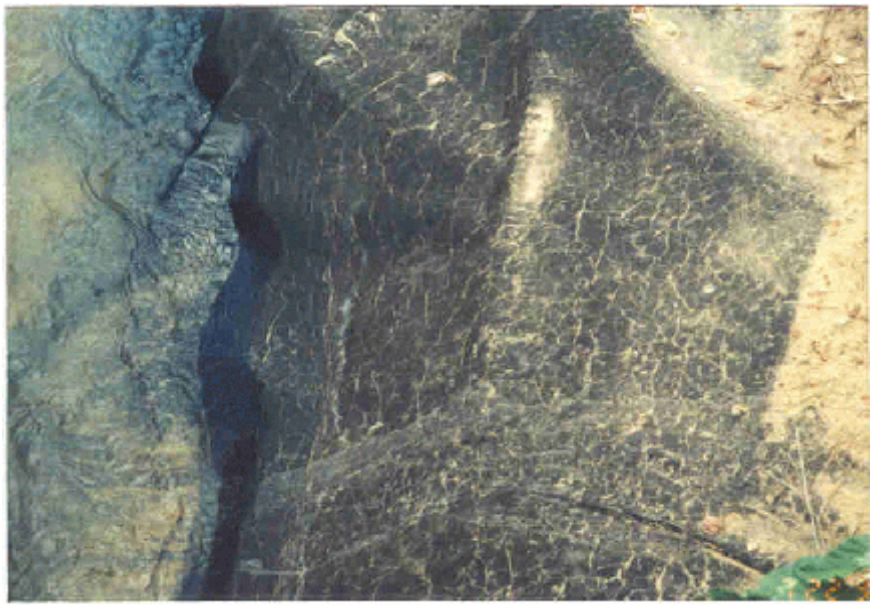
Lugert-Altus Irrigation District - Test Section L-1
Exposed 160-mil Teranap Geomembrane

Photograph 130.—After 5 years, the Teranap shows some surface cracking (alligator cracking), which is normal for this product.
(Photograph courtesy of Lugert-Altus Irrigation District).
