HYDRAULIC LABORATORY REPORT NO. 143

IMPROVEMENTS IN RIVER CHANNEL BELOW BOULDER DAM-- BOULDER CANYON PROJECT

J. N. BRADLEY

April 19, 1944

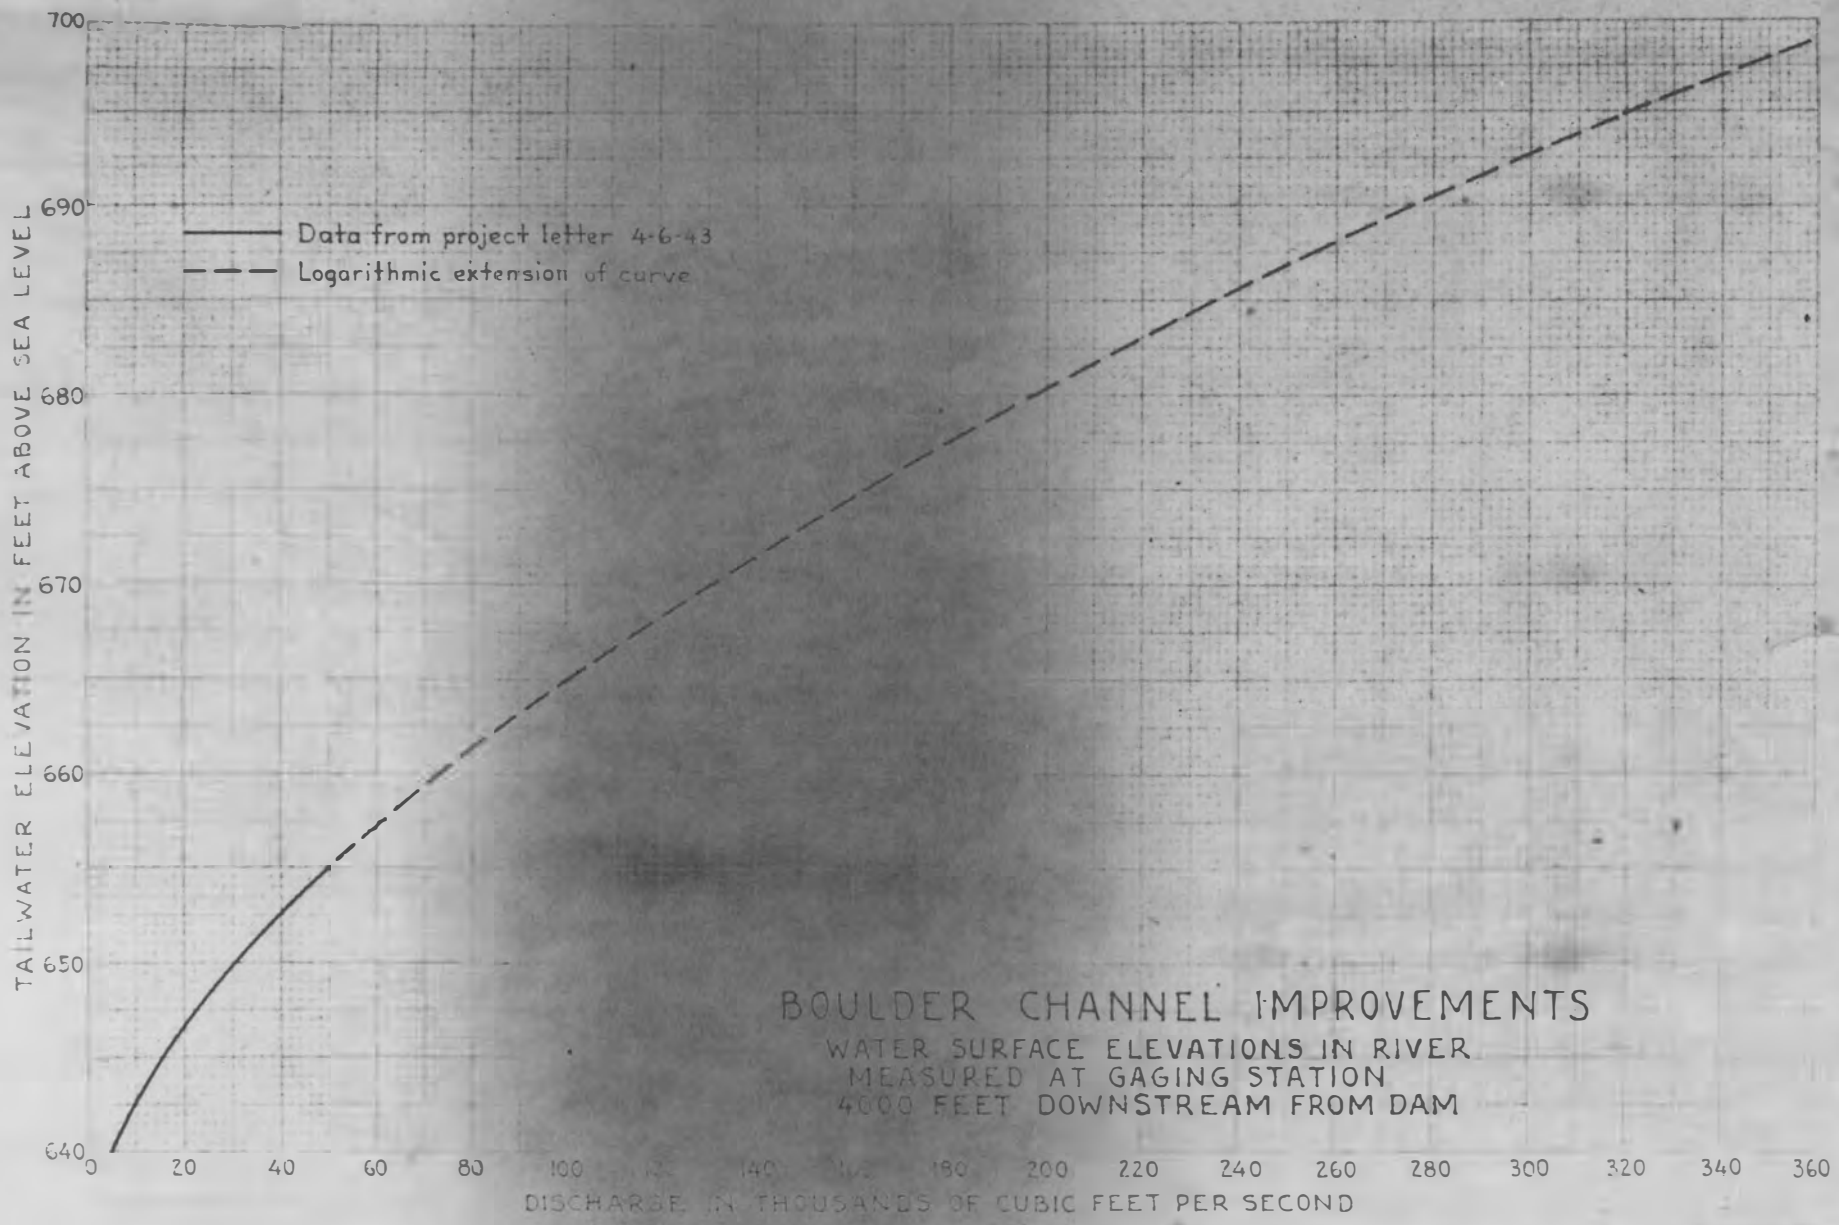
FIGURE 2

WATER SURFACE ELEVATIONS IN RIVER
MEASURED AT GAGING STATION
4000 FEET DOWNSTREAM FROM DAM

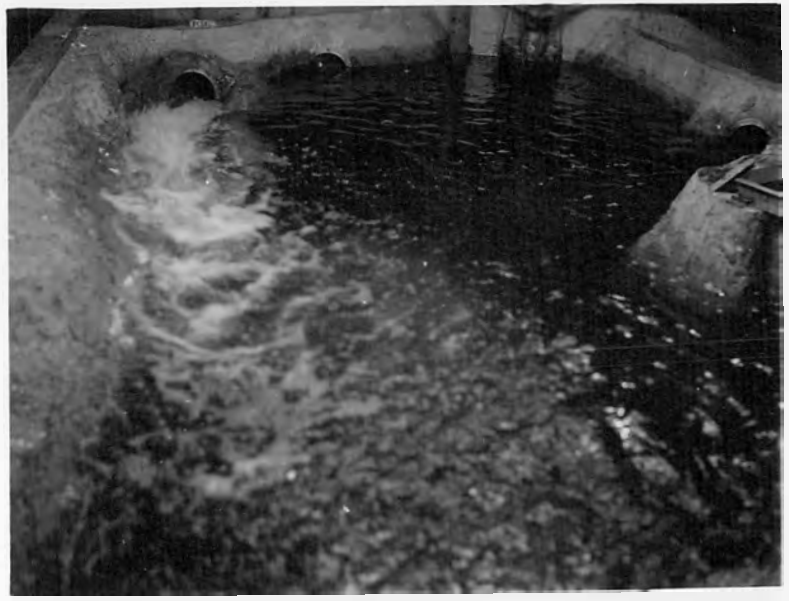
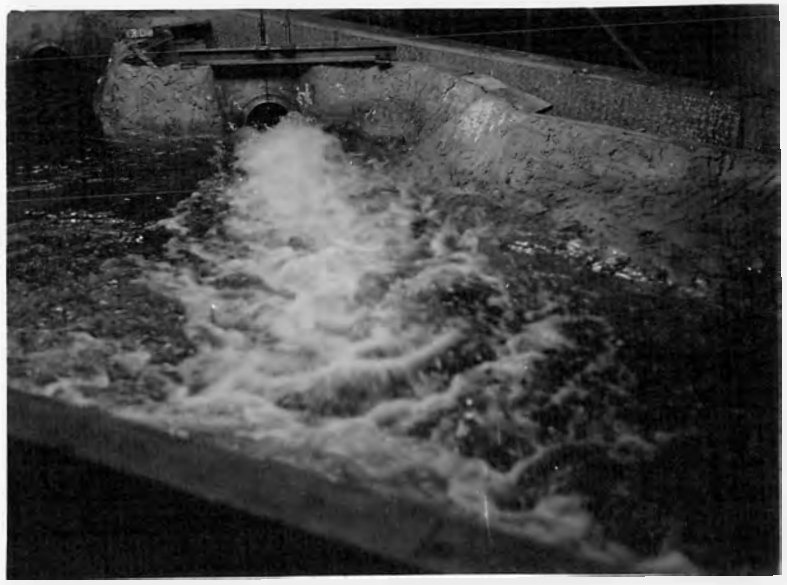
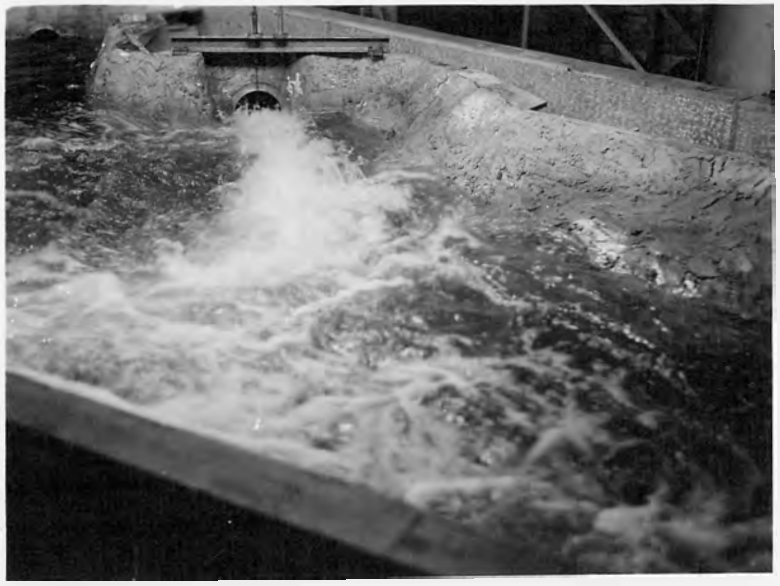
FIGURE 3

Figures 3C and D depict similar discharges from the Arizona Spillway Tunnel. This jet also threatened removal of the loose fill on the Nevada side of the river, while conditions on the Arizona side were favorable, except for a large eddy similar, but opposite in direction of rotation, to that described above. This is best shown in Figure 3D by the manner in which the inflowing water from the eddy forced the high-velocity jet toward the Arizona canyon wall. The photographs do not justly portray the eddies which would be tremendous in size and power in the prototype. It is these eddies which are responsible for the present damage of the portal structures.

PRESENT DESIGN - SPILLWAY TUNNELS 1 AND 4 OPERATING SEPARATELY

a. Extension of the Nevada Spillway Tunnel (Tunnel 1, Figure 1), a distance of 377 feet downstream on an 1,170-foot radius curve, to direct the flow downstream with minimum disturbance and to provide protection against slides from the canyon wall. The tunnel as it now exists guides the flow directly into a fault area in the canyon wall, in which large slides are active. Slides in this area can conceivably develop in magnitude sufficient to render the Nevada Spillway Tunnel inoperative. Should it become necessary to operate this spillway for any period of time, the slides, which are now a menace, would become a reality as undercutting of the fault area would be severe. For the above reasons, extension of Tunnel 1 is imperative and of first importance.

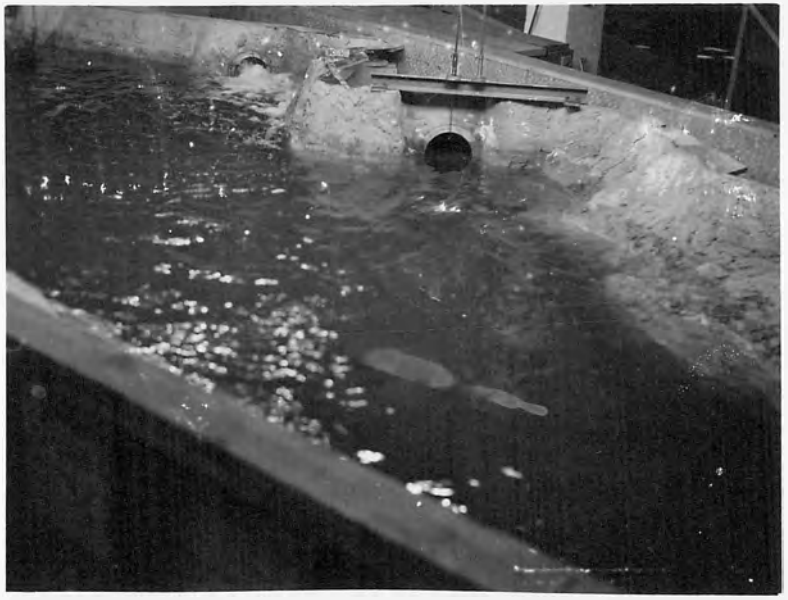
FIGURE 5

PRESENT DESIGN - OUTLET TUNNEL 3 IN OPERATION

Operation of the model of the present Arizona Tunnel plug outlet is shown for two, four, and six valves, at a head equivalent to a reservoir water surface of elevation 1205 in Figures 5B, C, and D. The photographs show the jet of water impinging on the Arizona canyon wall, which in this case projects out to approximately the centerline of the tunnel. Although not clearly visible in the picture, an eddy was present which tended to force the high-velocity jet toward the canyon wall.

The tunnel plug valve assembly on a 1:60 scale as used for the model is shown on Figure 5A. The valve passages could not be regulated, but flow through individual valves could be completely stopped by slide gates upstream. The same valve assembly was used for both the Arizona and Nevada outlets so these were not operated simultaneously.

b. Major repairs to the foundation of the Arizona Tunnel plug outlet portal (Tunnel 3), repair of the tunnel invert, and modification of the portal transition to prevent further damage to the portal foundation and canyon wall. Slides and erosion from a fault area immediately downstream from the tunnel portal have progressed to such an extent that they threaten to expose a portion of the Arizona Spillway Tunnel. Erosion results as spray from the outlet tunnel collects in small streams and returns to the river. It will be necessary to protect this area against spray. Flow from the tunnel also impinges on a portion of the canyon wall which protrudes out into its path. This can be avoided by deflecting the jet toward the center of the river.

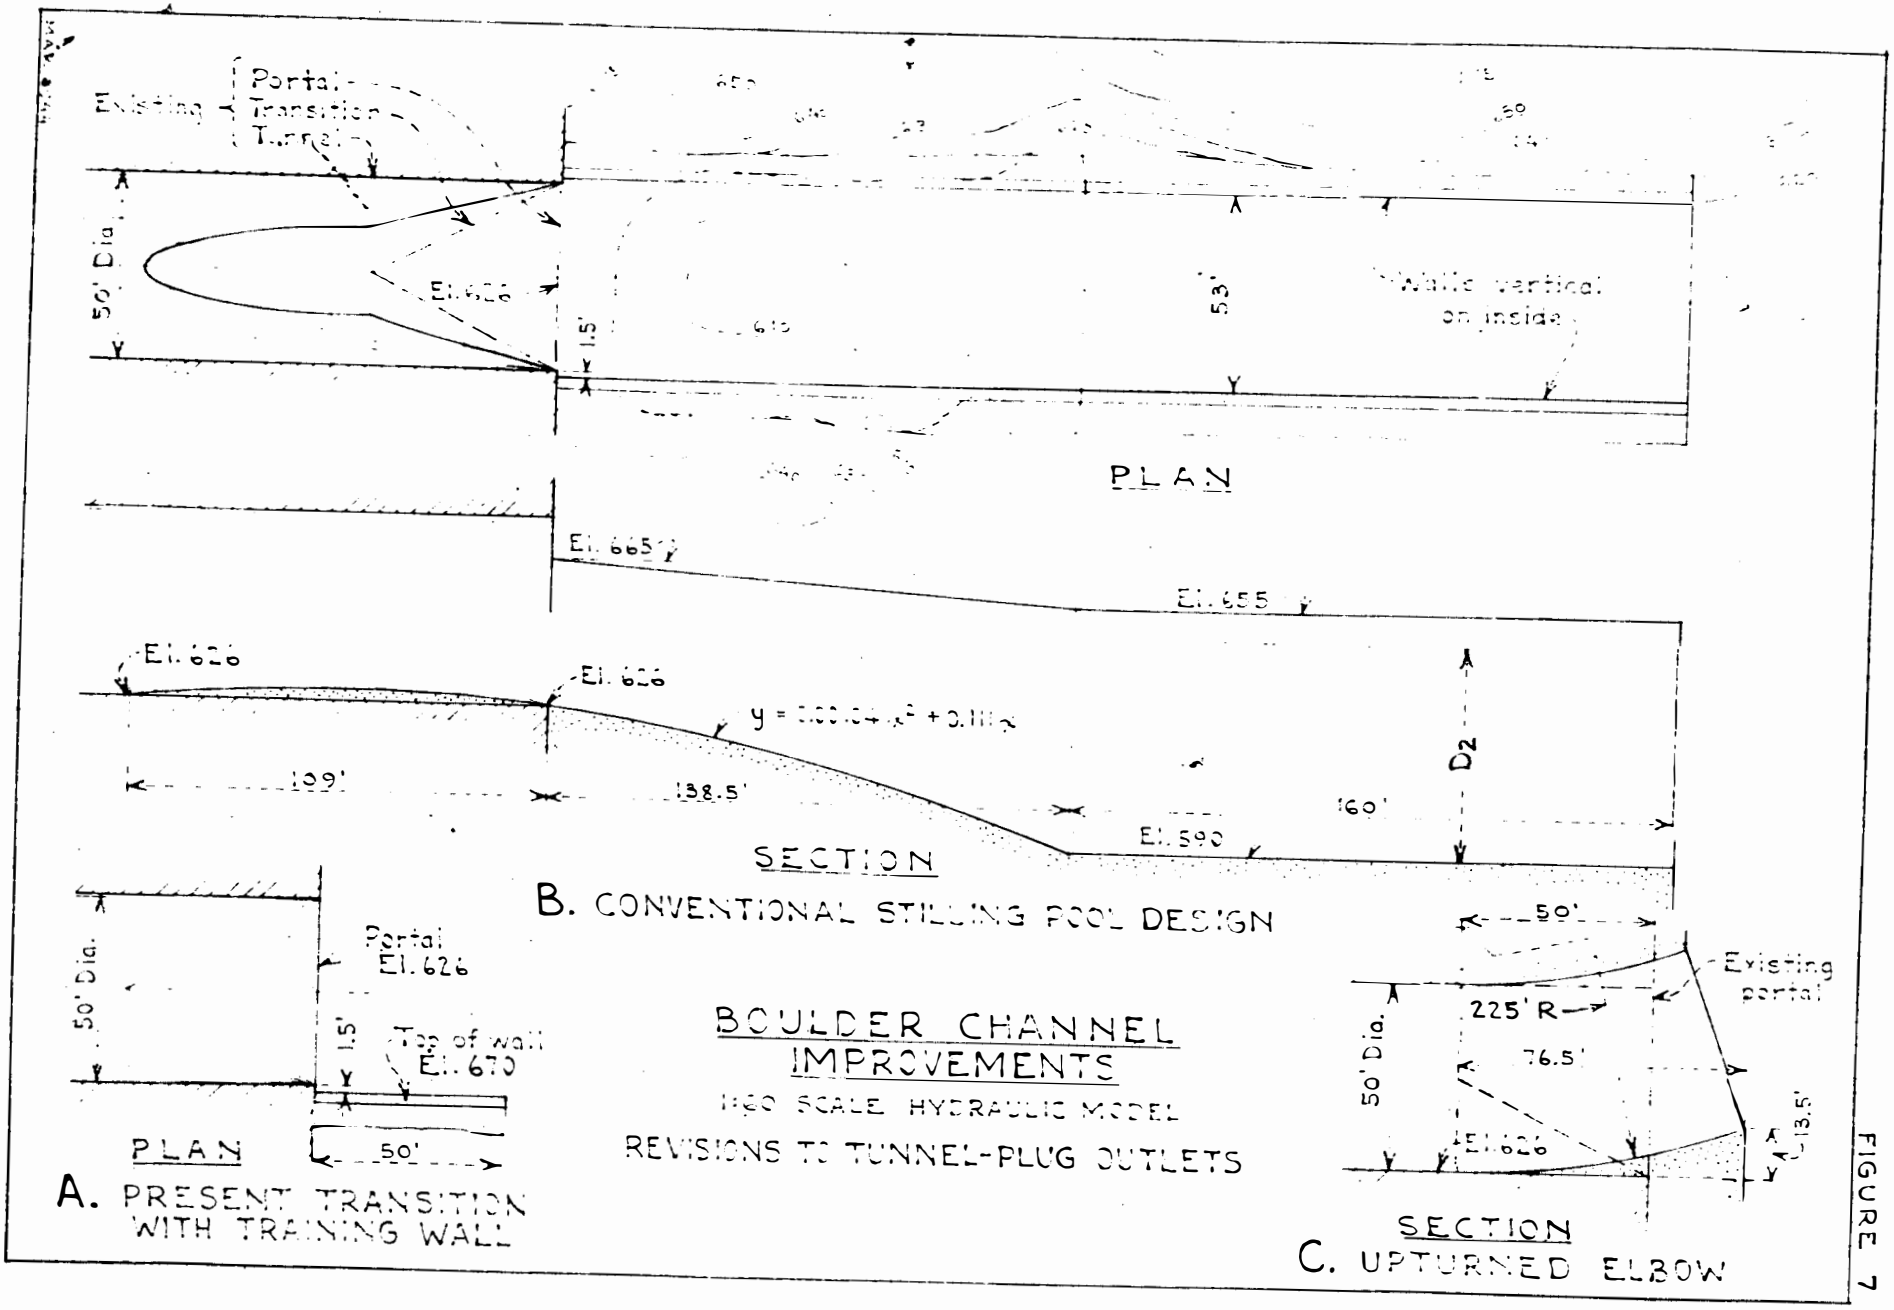
FIGURE 7

The cheapest solution appeared to involve repair of the Arizona portal foundation and construction of a short wall on the river side of the structure to block the side inflow to the high velocity stream, as shown on Figure 7A. It was intended that the concrete be placed by underwater methods. The short wall on the river side proved to be of little value. The same eroding action occurred at the end of the wall that prevailed previously at the corner of the gate structure, as the eddy merely moved downstream the length of the wall.

A second trial (Figure 7B) consisted of a conventional rectangular stilling-basin, 53 feet in width, designed for a maximum discharge of 24,000 second-feet. The basin consisted of a trajectory floor, designed for a velocity of 125 feet per second, which intersected a horizontal floor at the proper depth to obtain a good hydraulic jump at the maximum discharge. The original length of the horizontal floor was 4D2, but it was found that the basin operated satisfactorily with the floor cut back to half this length. It was necessary to excavate a sizable area from the canyon wall which interfered with construction of this structure. Excellent operation resulted for all but the very small discharges, in which case the tailwater was excessive. This difficulty could have been overcome by increasing the height of the rise in the tunnel (Figure 7B) but would have required a longer trajectory floor and consequently a longer structure. The main objection to this design was its cost. Portions of the stilling-basin walls were 65 feet high; consequently, a cofferdam would have been required to pour them.

A third trial, which was suggested by Engineer D. S. Walter, consisted of constructing a circular upward deflecting elbow beginning at the end of the present transition (Figure 7C). The elbow was on a radius of 225 feet with downstream lip at elevation 639.5. The purpose of the deflector was to discharge the high-velocity jet on the surface of the river. In all previous trials, the plan had been to force the high-velocity jet to dive quickly to eliminate as much spray and surface disturbance as possible. The upturned elbow was therefore a contradiction to the previous considerations; however, its ease of construction and low cost were much in its favor. Spray was excessive, but it was felt that this was offset by the more favorable factors. The former eddy in the river was eliminated. Beginning with this trial, some of the objectionable features of the deflector elbow were systematically corrected; thus, the final modified design was developed.

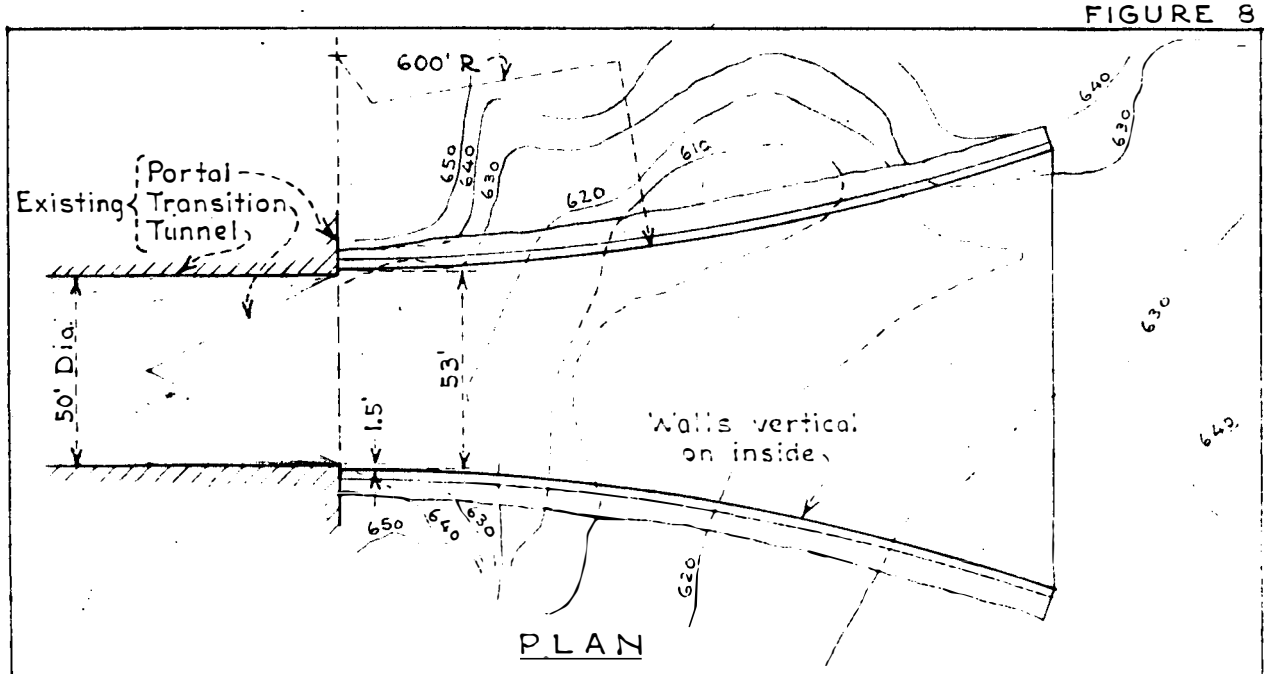
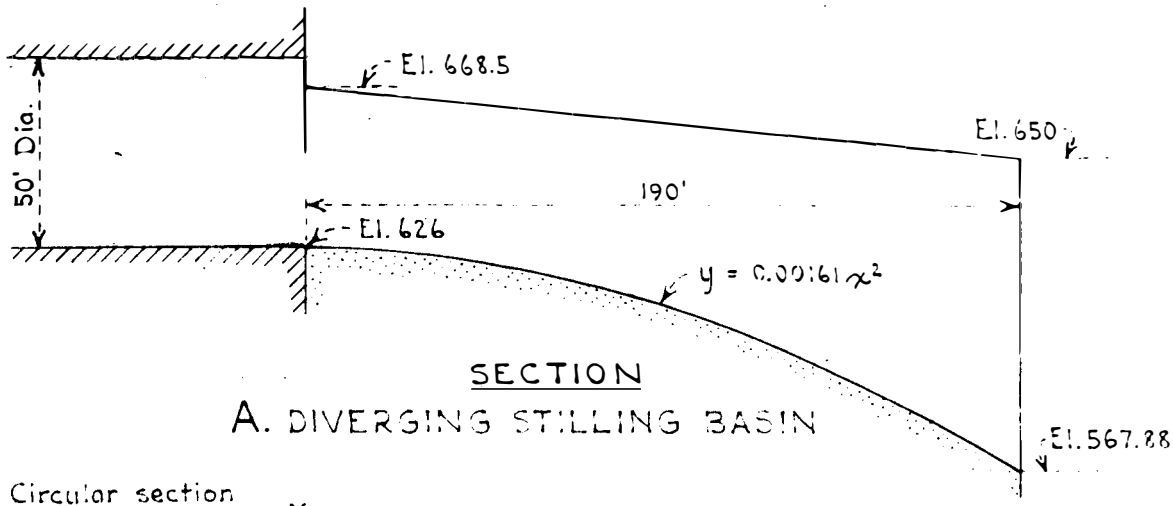
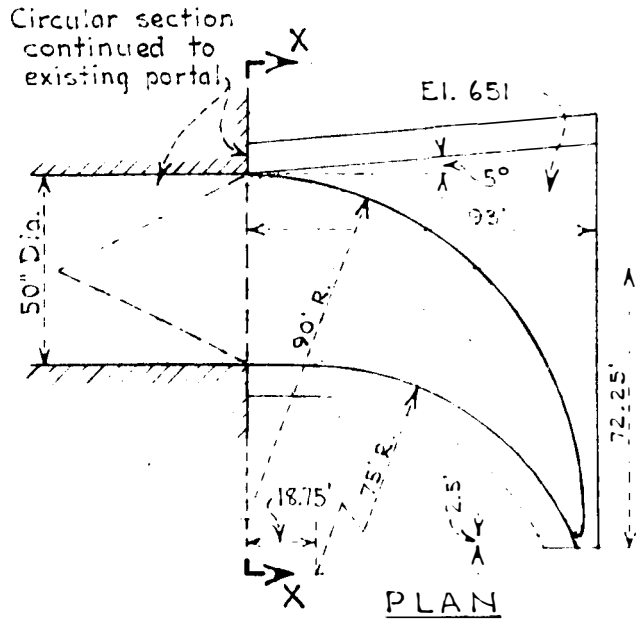
FIGURE 8

A. DIVERGING STILLING BASIN

B. FONTANA DEFLECTOR

the complexity of the spillway problem, especially on the Arizona side. The 100,000 second-feet is just one-half the capacity for which each spillway was originally designed. In other words, the portion of the river available is neither sufficient in area nor depth to properly dissipate the energy involved. The above design performed the best of any tried; however, the disadvantages were numerous. The structure would be very expensive as it would be necessary to place the concrete in the dry, requiring a large cofferdam; the wall on the river side would necessarily be massive to withstand full hydrostatic head; and future inspection and maintenance would be difficult as a portion of the basin would be under approximately 80 feet of water. Therefore, less expensive measures were sought.

A second scheme investigated was the installation of a deflector cone to the Arizona Spillway Tunnel similar to those used at Fontana Dam. The device is shown on Figure 8B. Numerous variations of the design were tested. The purpose of the cone reflector was to spread the high-velocity jet on the surface of a large area of the river. The device performed as expected but, with the area of the river limited, the surface disturbance was intense at the base of the fill on the Nevada side for discharges greater than 50,000 second-feet. The deflector cone has merit but requires a large body of water to operate properly.

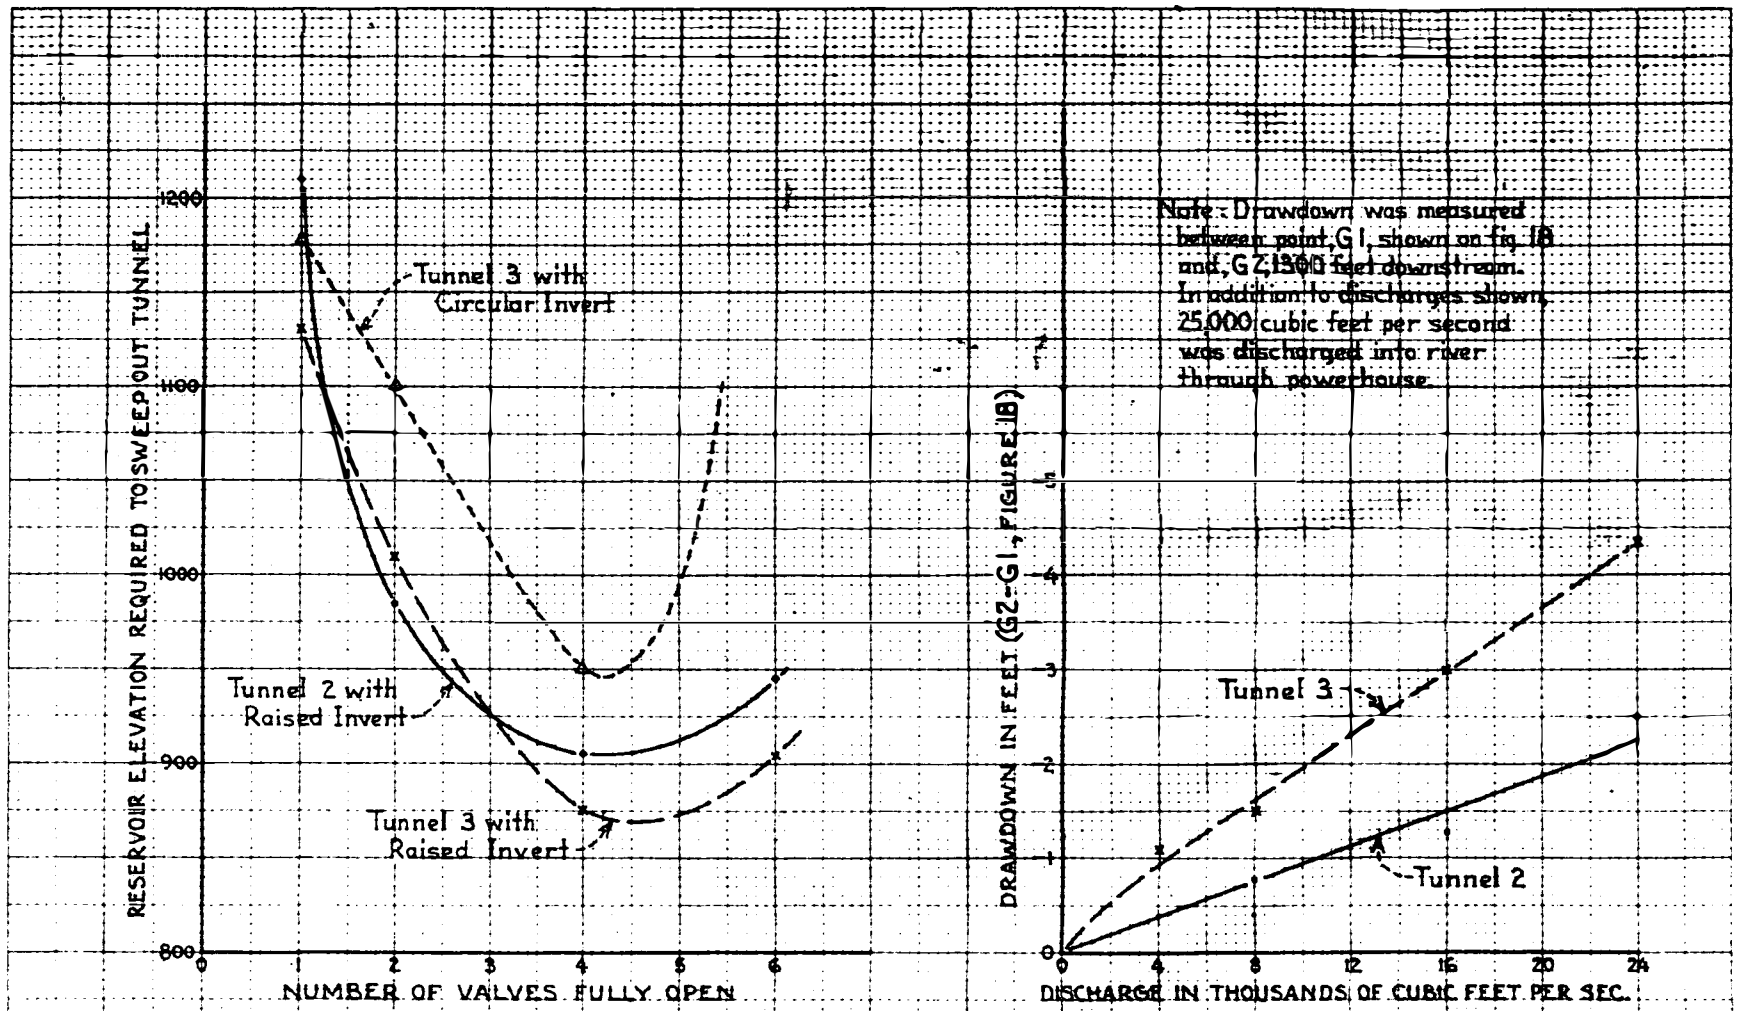
FIGURE 13

The sweep-out characteristics for Tunnel 3 with the present circular invert are shown by the dotted line on Figure 13A. In this case, it was not possible to move the hydraulic jump out of the tunnel when six valves were opened simultaneously. A comparison of the two curves for Tunnel 3 on Figure 13A indicates the hydraulic improvement gained by raising the tunnel invert.

A. RESERVOIR ELEVATION REQUIRED TO MOVE HYDRAULIC JUMP OUT OF OUTLET TUNNELS

B. DRAWDOWN AT POWERHOUSE PRODUCED BY DISCHARGE FROM OUTLETS

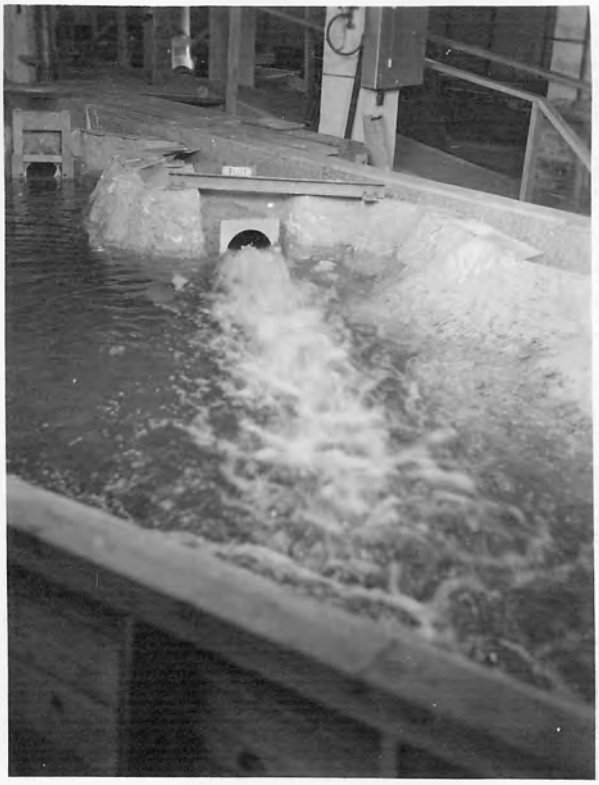
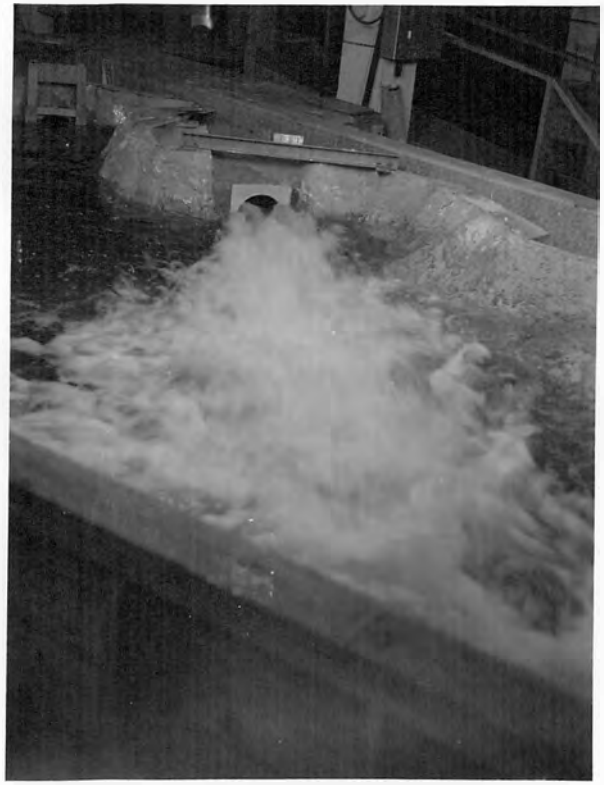
FIGURE 17

7. Recommended modified design for Arizona Spillway Tunnel. The recommended design for the Arizona Spillway Tunnel consists of another modification of the upturned deflector elbow, which is again confined to the present tunnel section, as shown on Figures 14A and 15. The latter figure consists of a working drawing for modification of this tunnel. The deflector was designed to lift and spread the jet as it emerged from the tunnel to eliminate the undesirable eddy in the river. For discharges greater than 50,000 second-feet, the jet from the Arizona Spillway impinged on the opposite bank of the river. For discharges above 70,000 second-feet, this action was severe; however, without a change in the present alinement of the tunnel, this was unavoidable. For discharges less than 10,000 second-feet, the hydraulic jump formed in the tunnel, which is to be avoided. Figure 16A shows the jump forming in the end of the tunnel for a discharge of 9,000 second-feet. Figures 16B, C, and D show the flow conditions for discharges of 25,000, 50,000, and 75,000 second-feet, respectively. Figures 17A and B depict the same tunnel discharging at 100,000 and 150,000 second-feet. A comparison of the above photographs with those of the present design, Figure 3 indicates the absence of the large river eddies in the modified design. Scour of the riverbed is shown to be negligible after a discharge of 150,000 second-feet, Figure 17C.

MODIFIED DESIGN - SPILLWAY TUNNEL 4 IN OPERATION

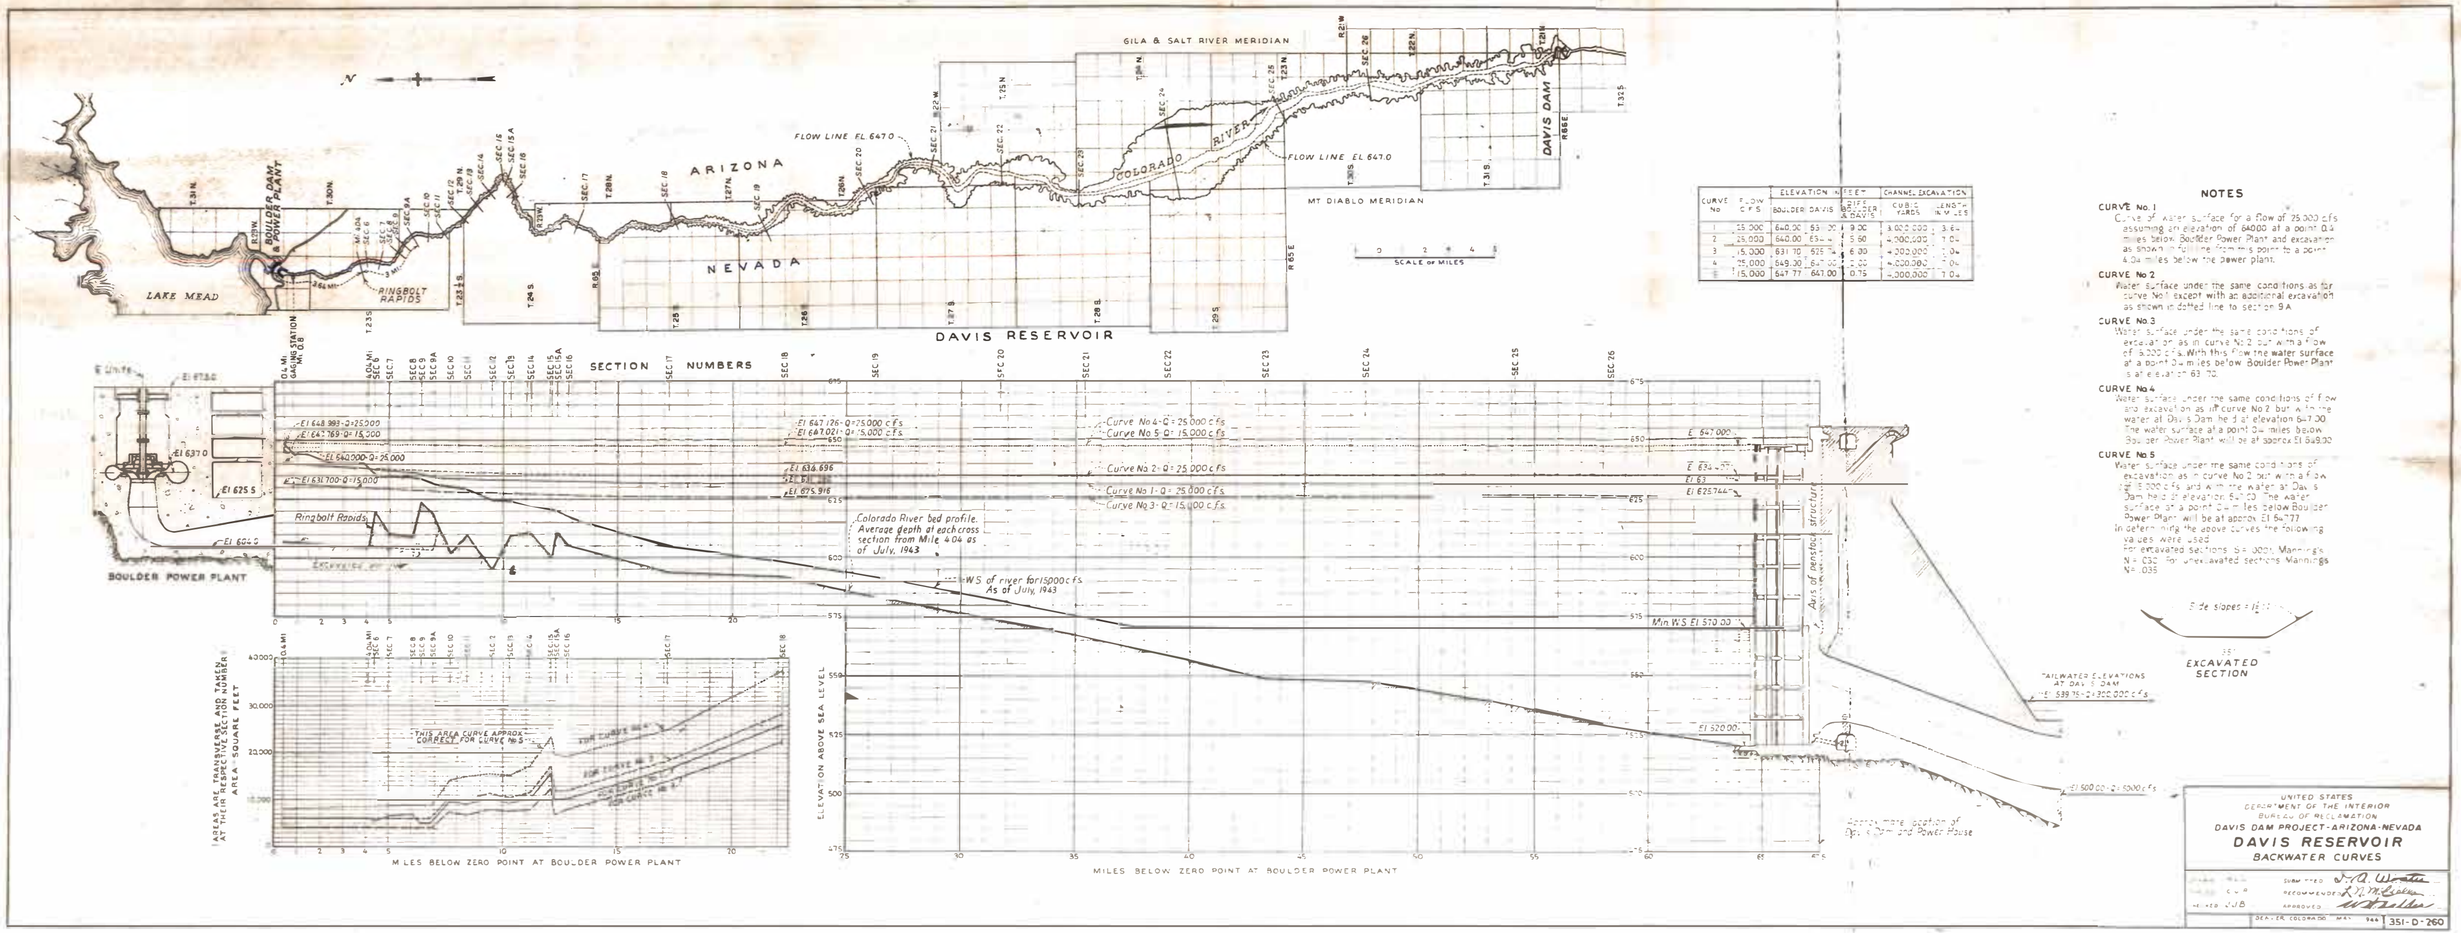
FIGURE 19

4. These studies show that with the river-channel improvements extending below Ringbolt Rapids and the forebay at Davis Dam held at 647, the effective head on the turbines at Boulder will be reduced only two feet for a flow of 25,000 c.f.s. and 3/4 of a foot for a flow of 15,000 c.f.s. It is not unreasonable to expect at least two percent higher over-all efficiency at Davis Dam, and it may be to the Government's best interests to obtain the greatest practicable operating head at Davis at a sacrifice of head at Boulder.

5. The backwater curves for 25,000 c.f.s. show a net gain in power head of 3.5 feet by holding the forebay at Davis Dam at elevation 647. This would indicate that the forebay at Davis should be held at the highest possible elevation at all times. This is the conclusion expressed in Mr. Debler's memorandum. For a flow of 15,000 c.f.s. under extreme drawdown conditions the tailwater at Boulder would reach approximately elevation 632, with Davis forebay at all points below elevation 626. Under these operating conditions, the turbines at Boulder would gain 16 feet in effective head, while the turbines at Davis would lose 21 feet. These comparisons illustrate the advantages to the Government to operate the Davis forebay at the highest possible elevation consistent with the requirements for reregulation of Boulder releases to suit downstream irrigation demands. The turbines at Boulder will operate satisfactorily either with the present elevation of tailwater or with the tailwater lowered by river dredging. From a power standpoint the dredging would result in an increase in energy production prior to completion of Davis Dam, due to increase of 12.5-foot effective head and also after Davis Dam is completed, when the increase in head would be reduced to four feet. Under present river channel conditions the backwater from Davis Dam would reduce the head on Boulder only ½-foot, for a flow of 25,000 c.f.s.

CURVE No. 2
Water surface under the same conditions as for curve No. 1 except with an additional excavation as shown in dotted line to section 9A.

CURVE No. 3
Water surface under the same conditions of excavation as in curve No. 2 but with a flow of 15,000 c.f.s. With this flow the water surface at a point 0.4 miles below Boulder Power Plant is at elevation 631.70.

CURVE No. 4
Water surface under the same conditions of flow and excavation as in curve No. 2 but with the water at Davis Dam held at elevation 647.00. The water surface at a point 0.4 miles below Boulder Power Plant will be at approx. El. 649.30.

CURVE No. 5
Water surface under the same conditions of excavation as in curve No. 2 but with a flow of 15,000 c.f.s. and with the water at Davis Dam held at elevation 647.00. The water surface at a point 0.4 miles below Boulder Power Plant will be at approx. El. 647.77.

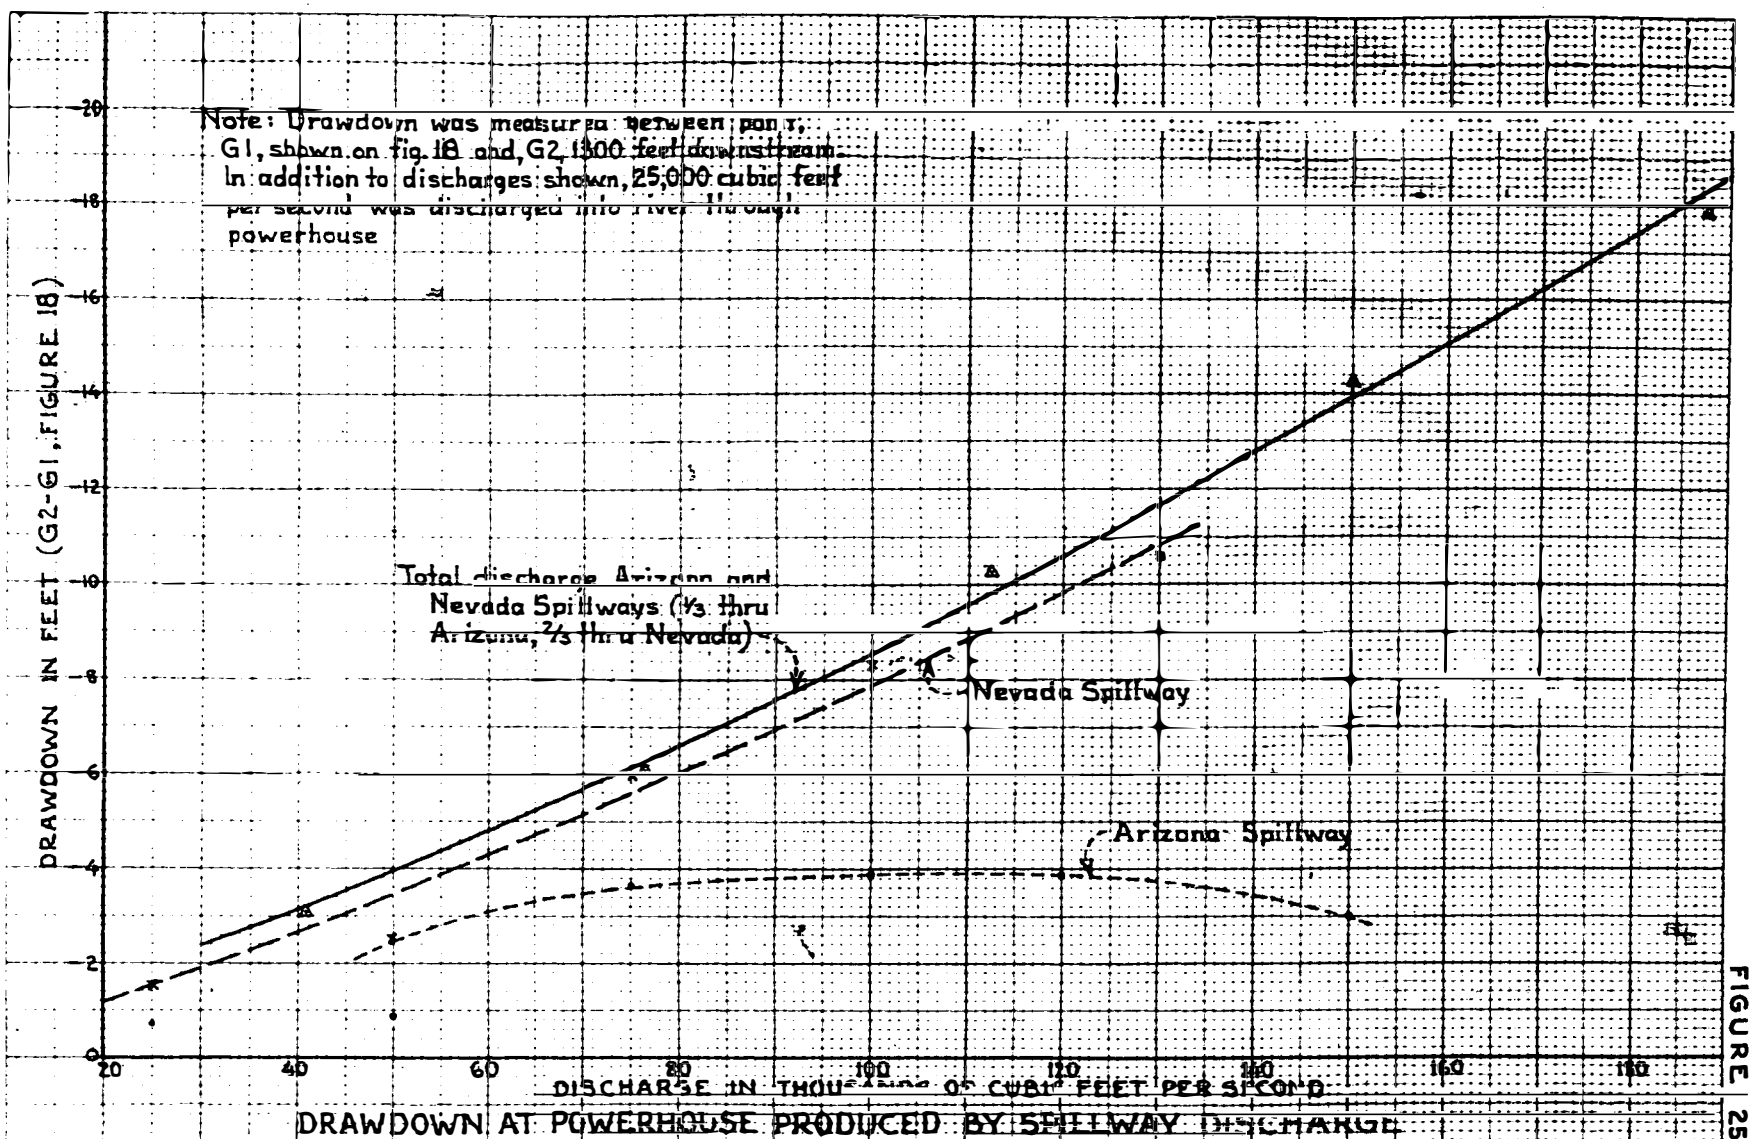
FIGURE 25

DRAWDOWN AT POWERHOUSE PRODUCED BY SPILLWAY DISCHARGE
