STUDY OF HEIGHT AND FREQUENCY OF WAVES ACTING ON TAILRACE SLOPES AND RIVERBANKS DURING 1949 FLOOD SEASON GRAND COULEE DAM COLUMBIA BASIN PROJECT

Hydraulic Laboratory Report No. 336

November 28, 1952

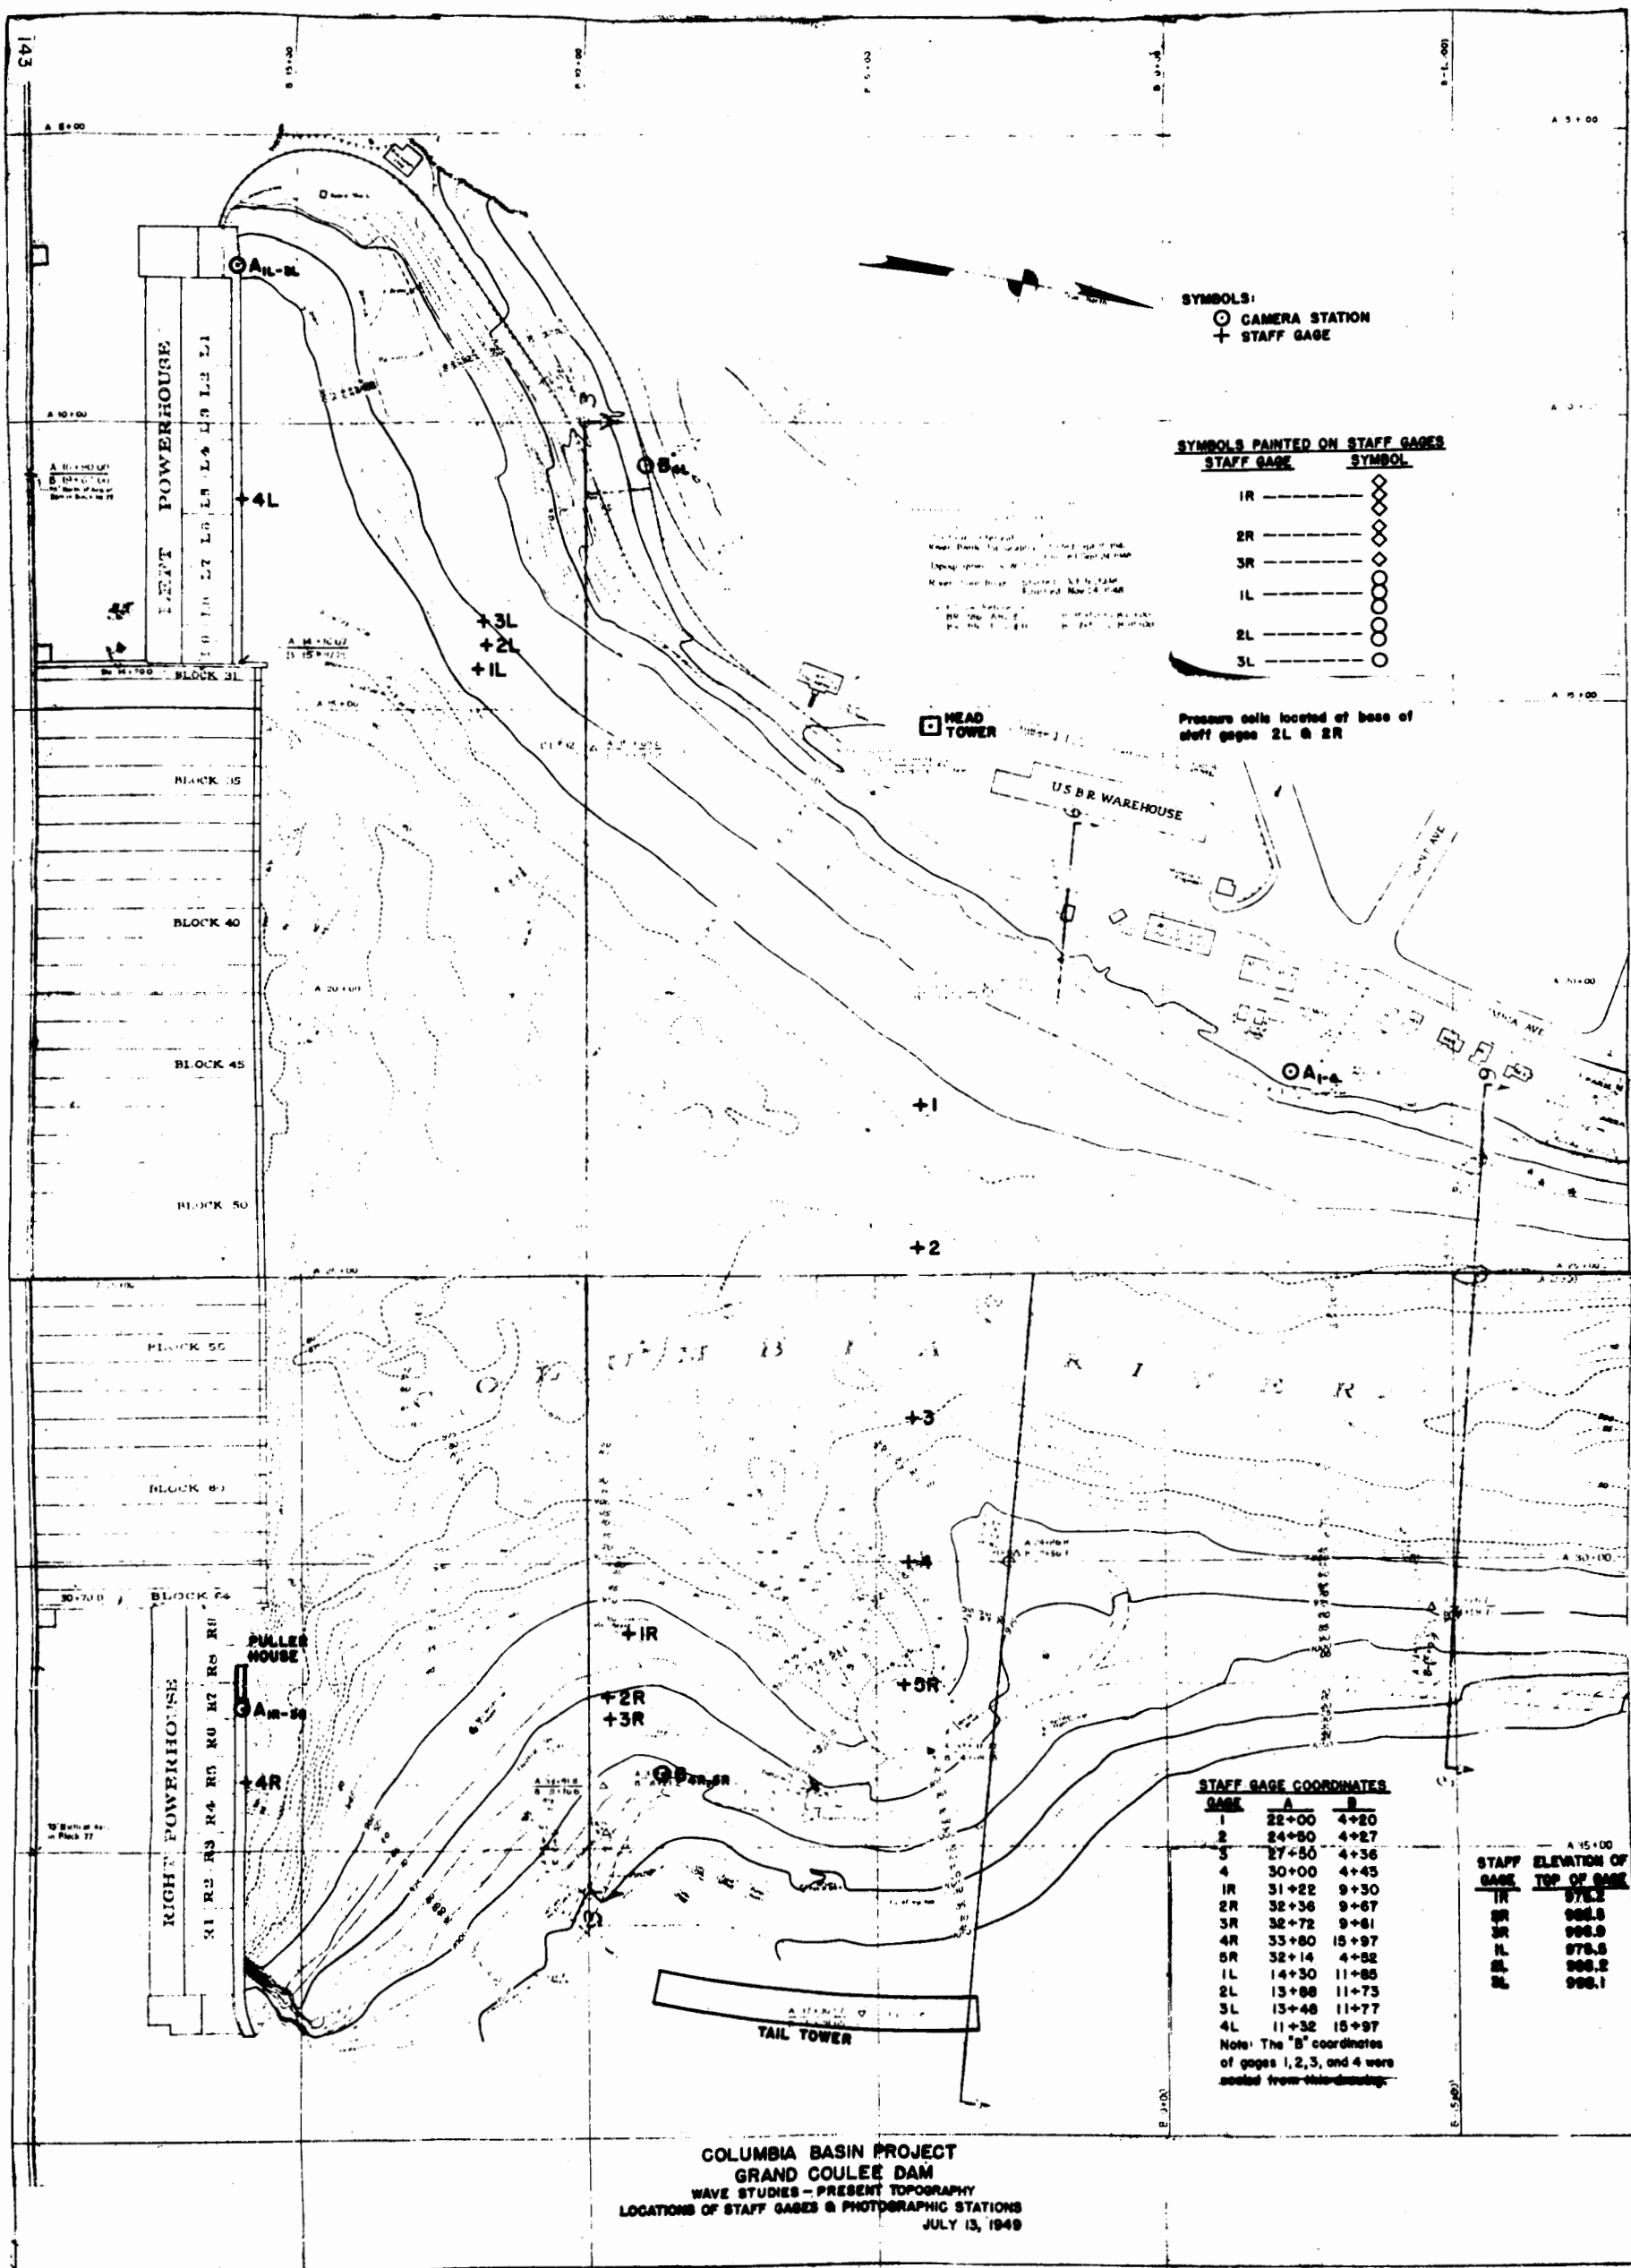
FIGURE I
REPORT HYD 336

COLUMBIA BASIN PROJECT
GRAND COULEE DAM
WAVE STUDIES — PRESENT TOPOGRAPHY
LOCATIONS OF STAFF GAGES & PHOTOGRAPHIC STATIONS
JULY 13, 1949

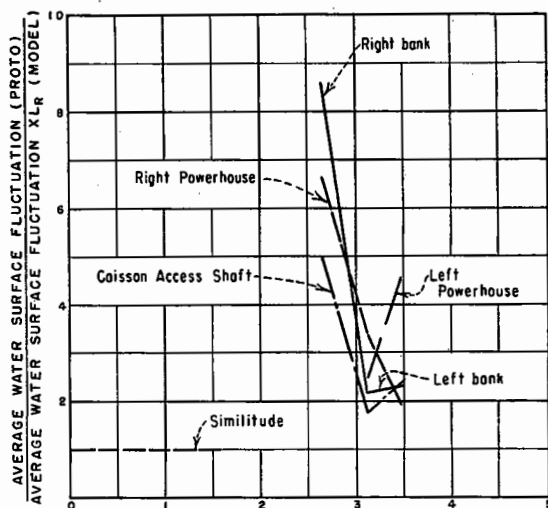
FIGURE 5
REPORT HYD.336

Wave Studies - Grand Coulee Dam

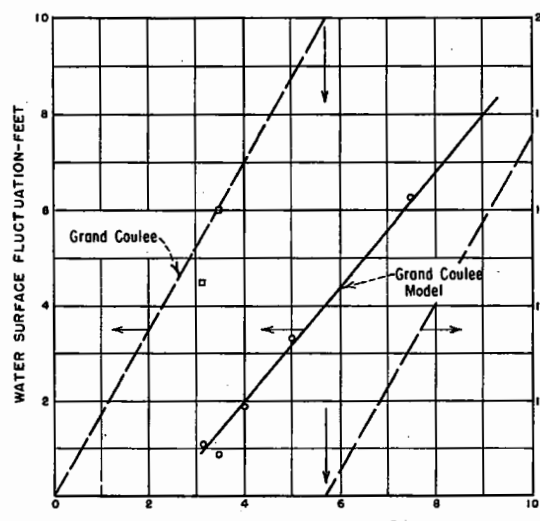
FIGURE 6
REPORT HYD. 336

A comparison of the height similitude of the wave action in the
Grand Coulee tail bay with that in the model was based on an average
fluctuation value (Figure 6A). Average values were used in the similitude
ratio to minimize the effect of a maximum value that occurred in tests on
either the model or the prototype. The maximum ratio of the average
prototype to model fluctuation was 8.6 to 1 at the right bank and the mini-
mum 1.8 to 1 at the caisson access shaft in the 1949 range of prototype
discharge. Comparisons based on the maximum fluctuation values at the
five measuring stations have ratios that varied from a maximum of 5.4
to a minimum of 2.5 for the 1949 flood (Figure 6B to 6F). A ratio of

The changes in flow conditions may be indicated by the decreasing values of the average prototype to model fluctuation, but the limited range of prototype discharge prohibited a definite conclusion (Figure 6A). The decreasing model to prototype ratio would indicate that scale effect decreases as the discharge increases although again limited discharge prohibited a definite conclusion (Figure 6B). It was concluded from the data that fluctuations on the banks in the vicinity of the staff gages were likely to be in the order of 15 to 20 feet for the design discharge of 1,000,000 cfs.

A. MODEL AND PROTOTYPE CONFORMITY

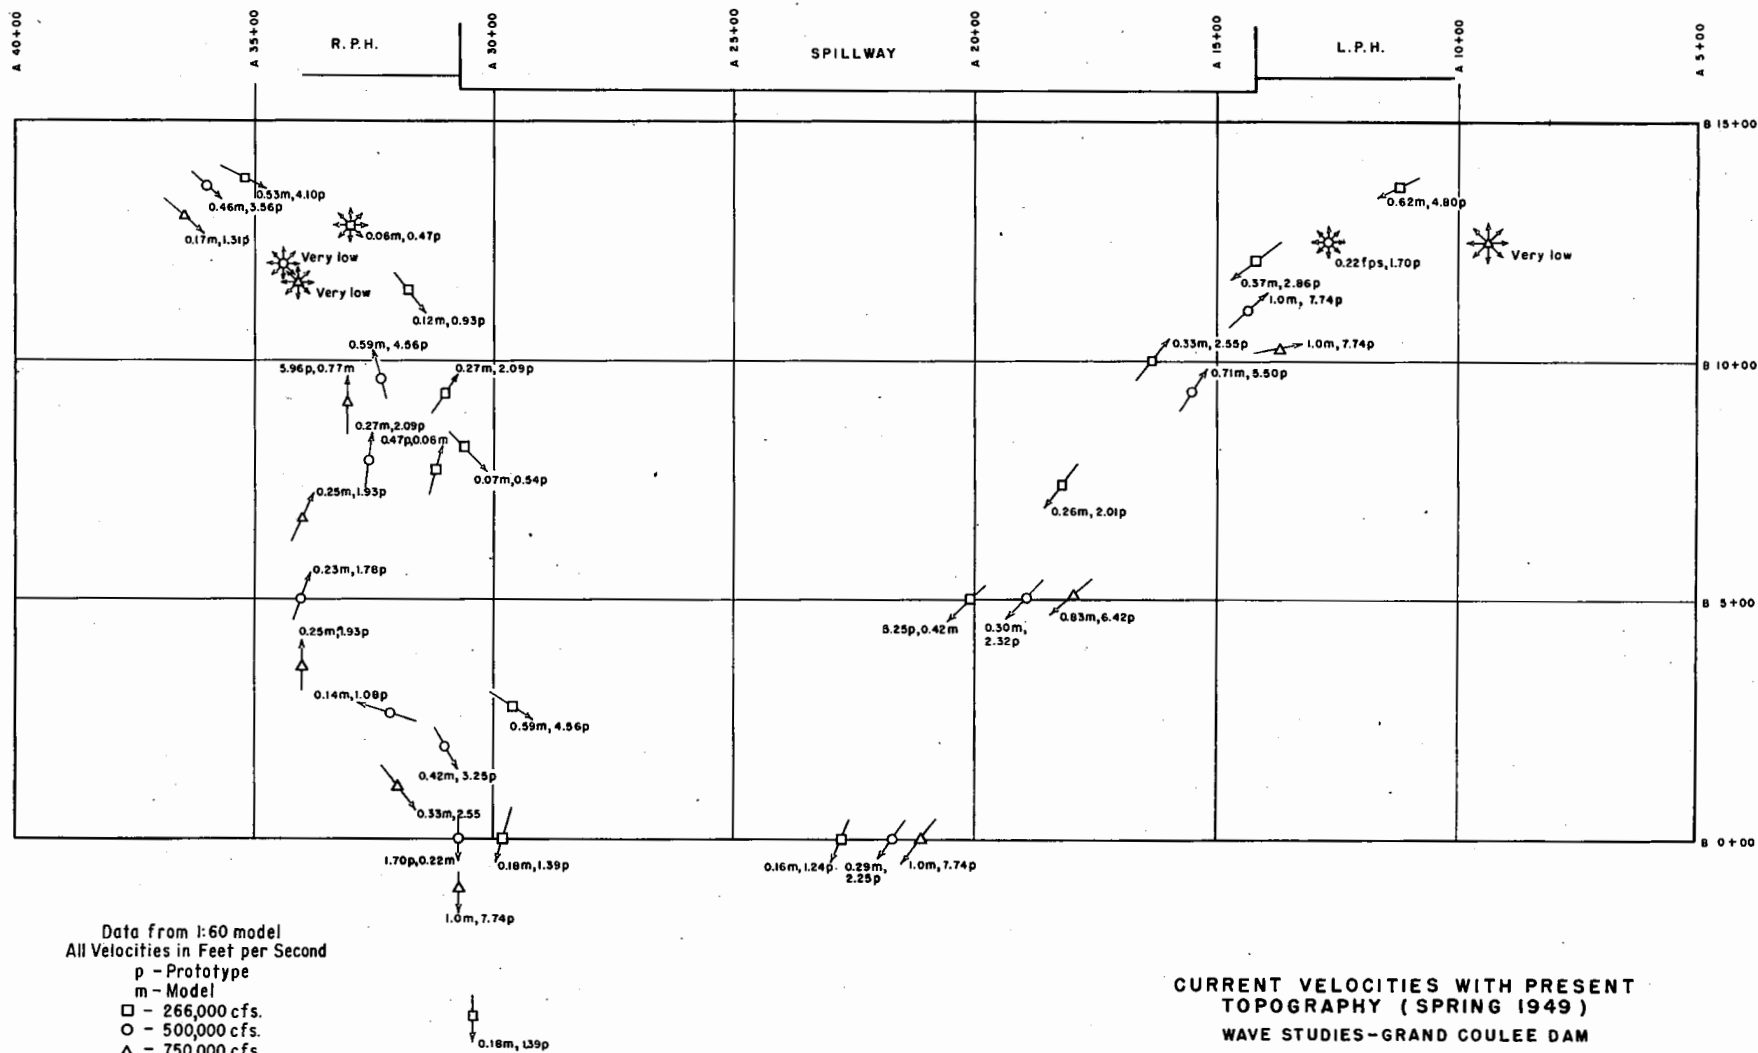
Water surface velocities along the tail bay riverbanks in the 1:60 model were obtained for river flows representing 266,000, 500,000, and 750,000 cfs. These discharges were used for both the present and ultimate topography plans with the resulting velocities shown in Figures 9 and 10. The maximum prototype velocity in the tail bay indicated by these data was 7.7 feet per second at a discharge of 750,000 cfs. This velocity occurred for both topography plans on the riverbank immediately downstream of the left powerhouse and near Station B, 0+00 on both riverbanks for the present plan. With the flattened slopes in the ultimate topography plan, the increase in cross-sectional areas will result in a general reduction in the velocities throughout the tail bay.

CURRENT VELOCITIES WITH PRESENT
TOPOGRAPHY (SPRING 1949)

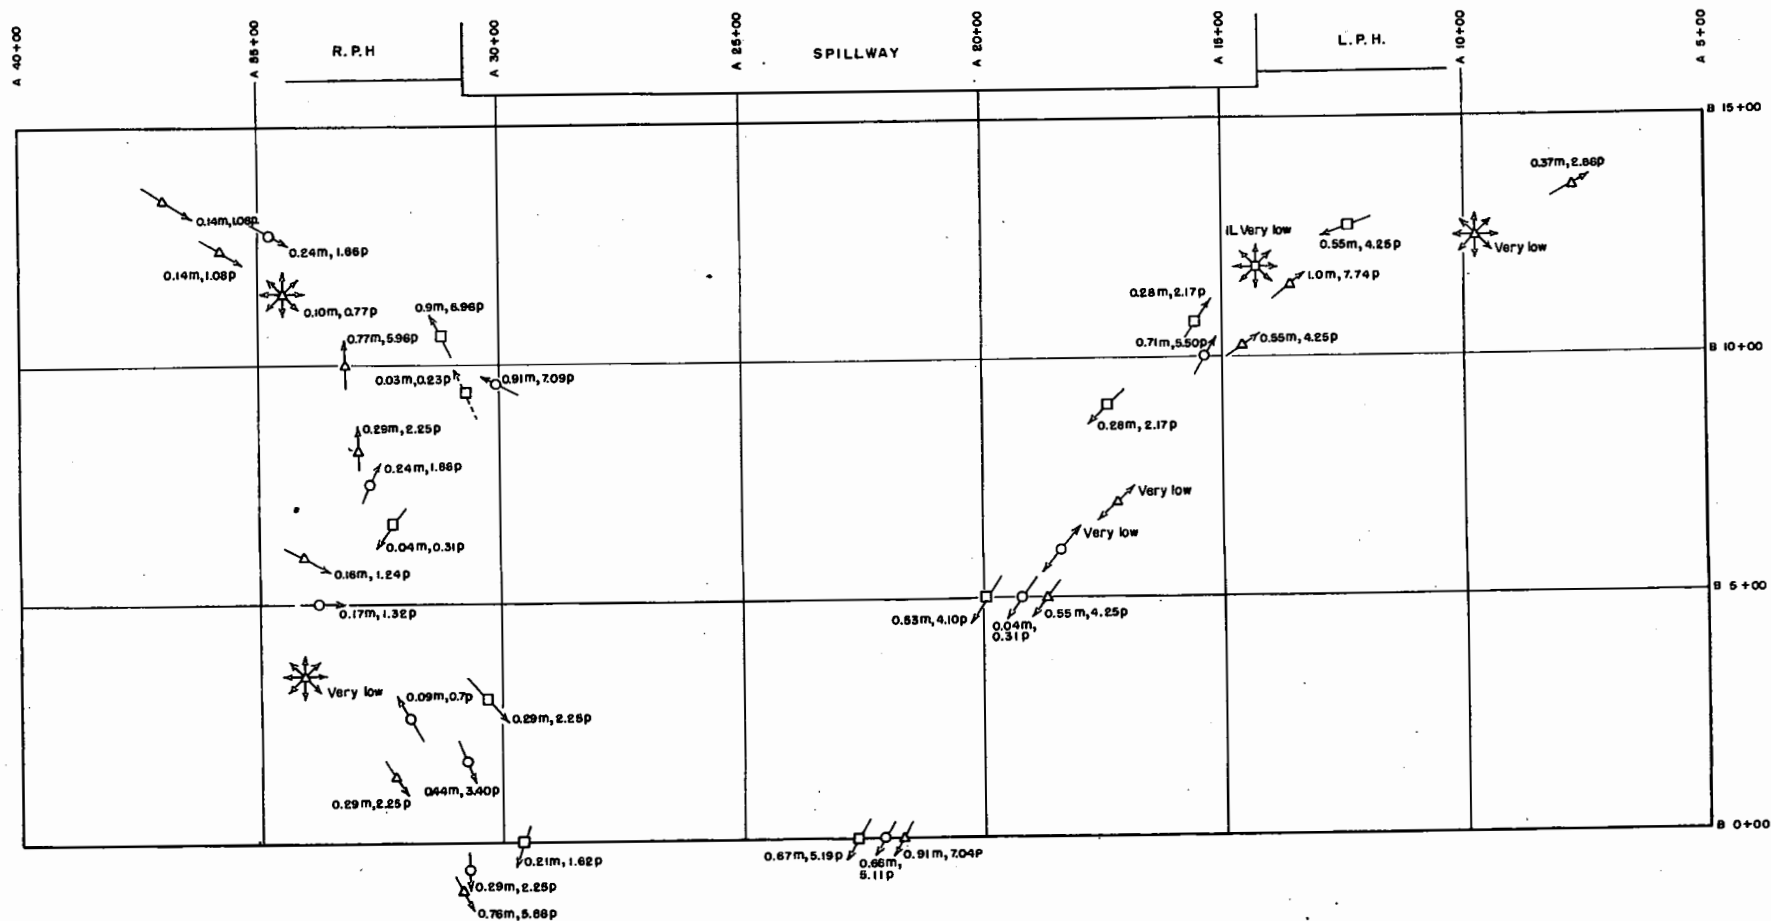
FIGURE 10
REPORT HYD. 336

CURRENT VELOCITIES WITH
ULTIMATE TOPOGRAPHY
