HEART BUTTE SPILLWAY AND OUTLET WORKS

A paper for the
Summer Convention, ASCE,
Denver, Colorado, June 1952

Performance Tests on the Prototype and Model

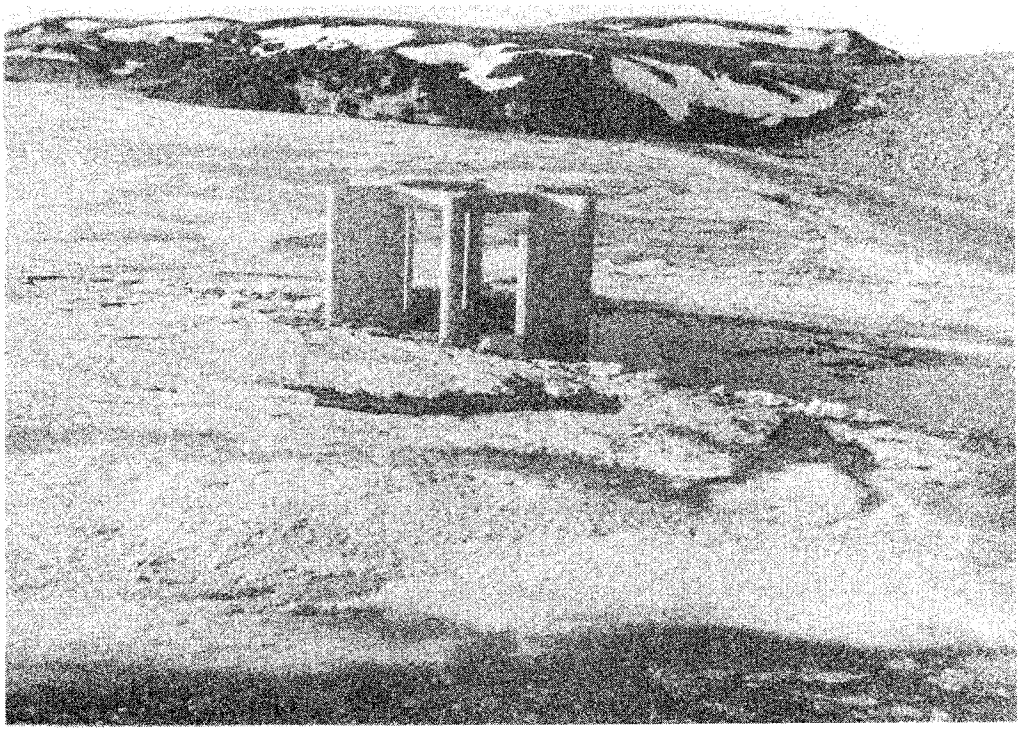
A--On April 16, 1950, the reservoir had risen to the spillway crest, elevation 2064.5. The riprapped upstream face of the dam is at right.

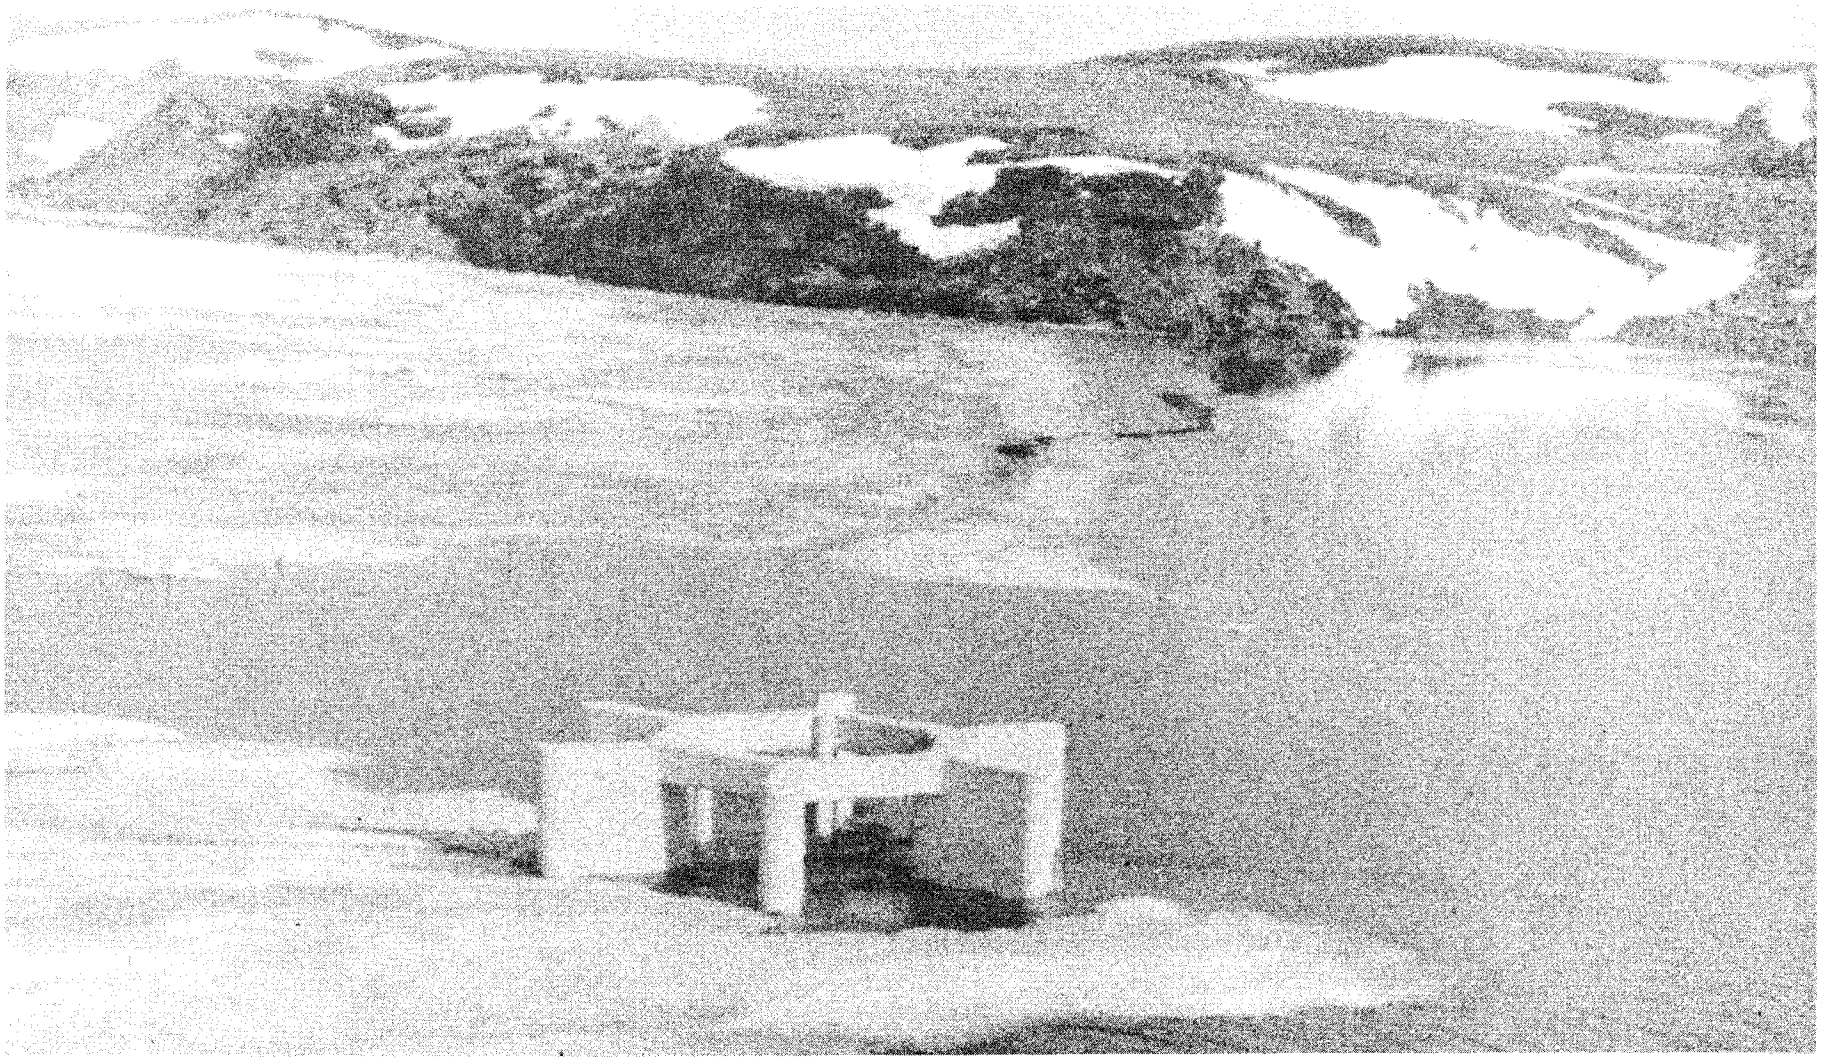
Figure 15

On April 17 the reservoir had risen sufficiently to submerge the spillway crest. Some of the ice was discharged through the spillway but the wind had moved some of the ice upstream. Reservoir elevation 2073.8, head on crest 9.3 feet.

HEART BUTTE DAM
Spillway Operation--Discharge 3,250 cfs

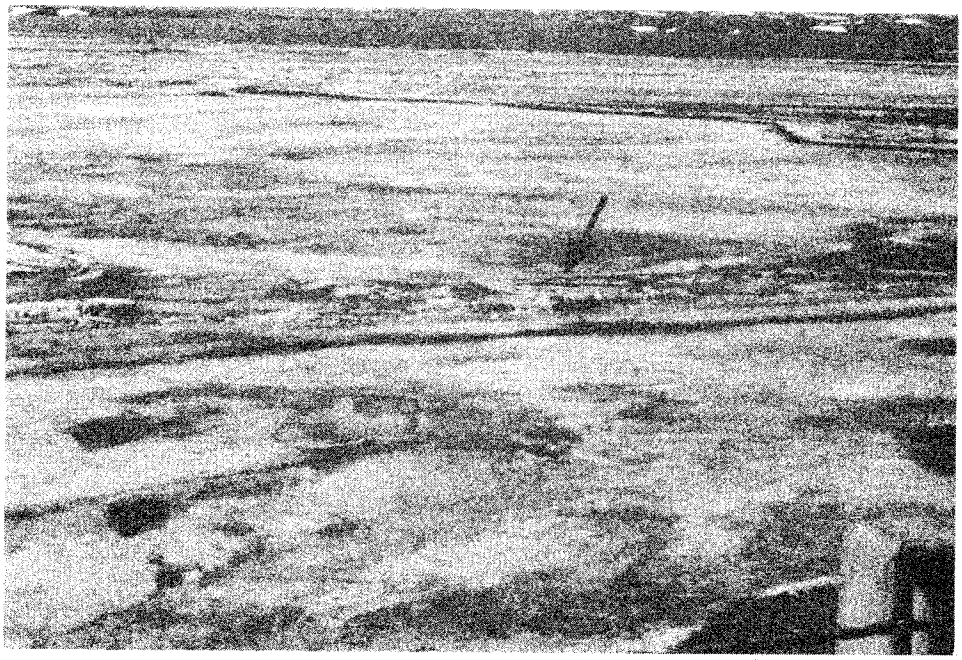
A--On April 18 the spillway piers were submerged. Arrow indicated spillway location. Very slight motion on water surface beneath the arrow was noted. Reservoir elevation 2080.2, head on crest 15.7 feet, piers submerged 1.7 feet, discharge 3,650 cfs.

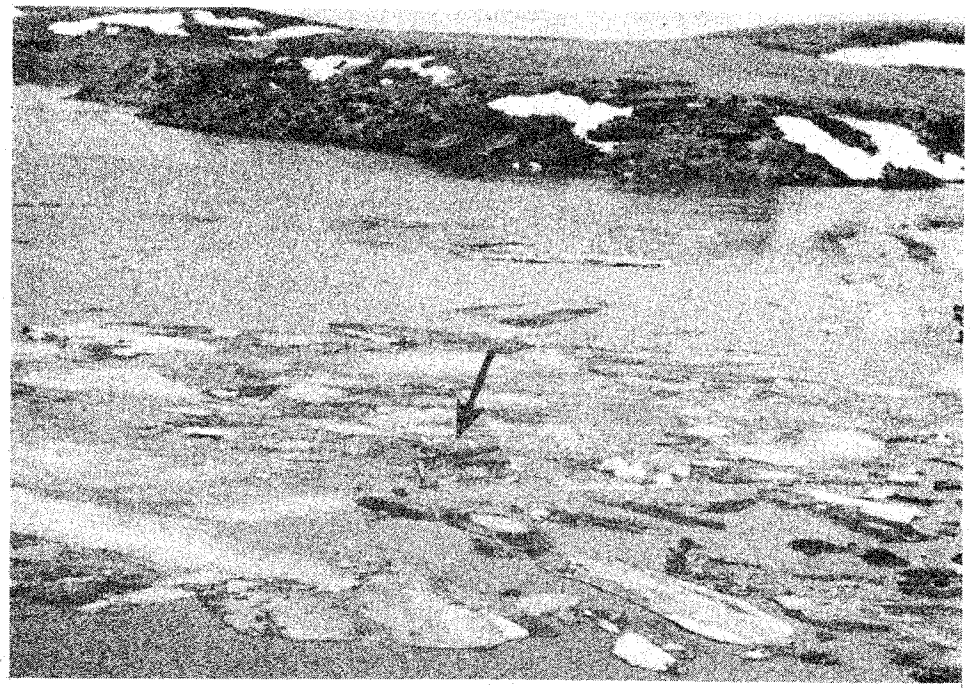
B--On April 21 the reservoir had receded slightly but was still 1 foot over the tops of the piers. A close inspection was necessary to determine where the spillway was located.

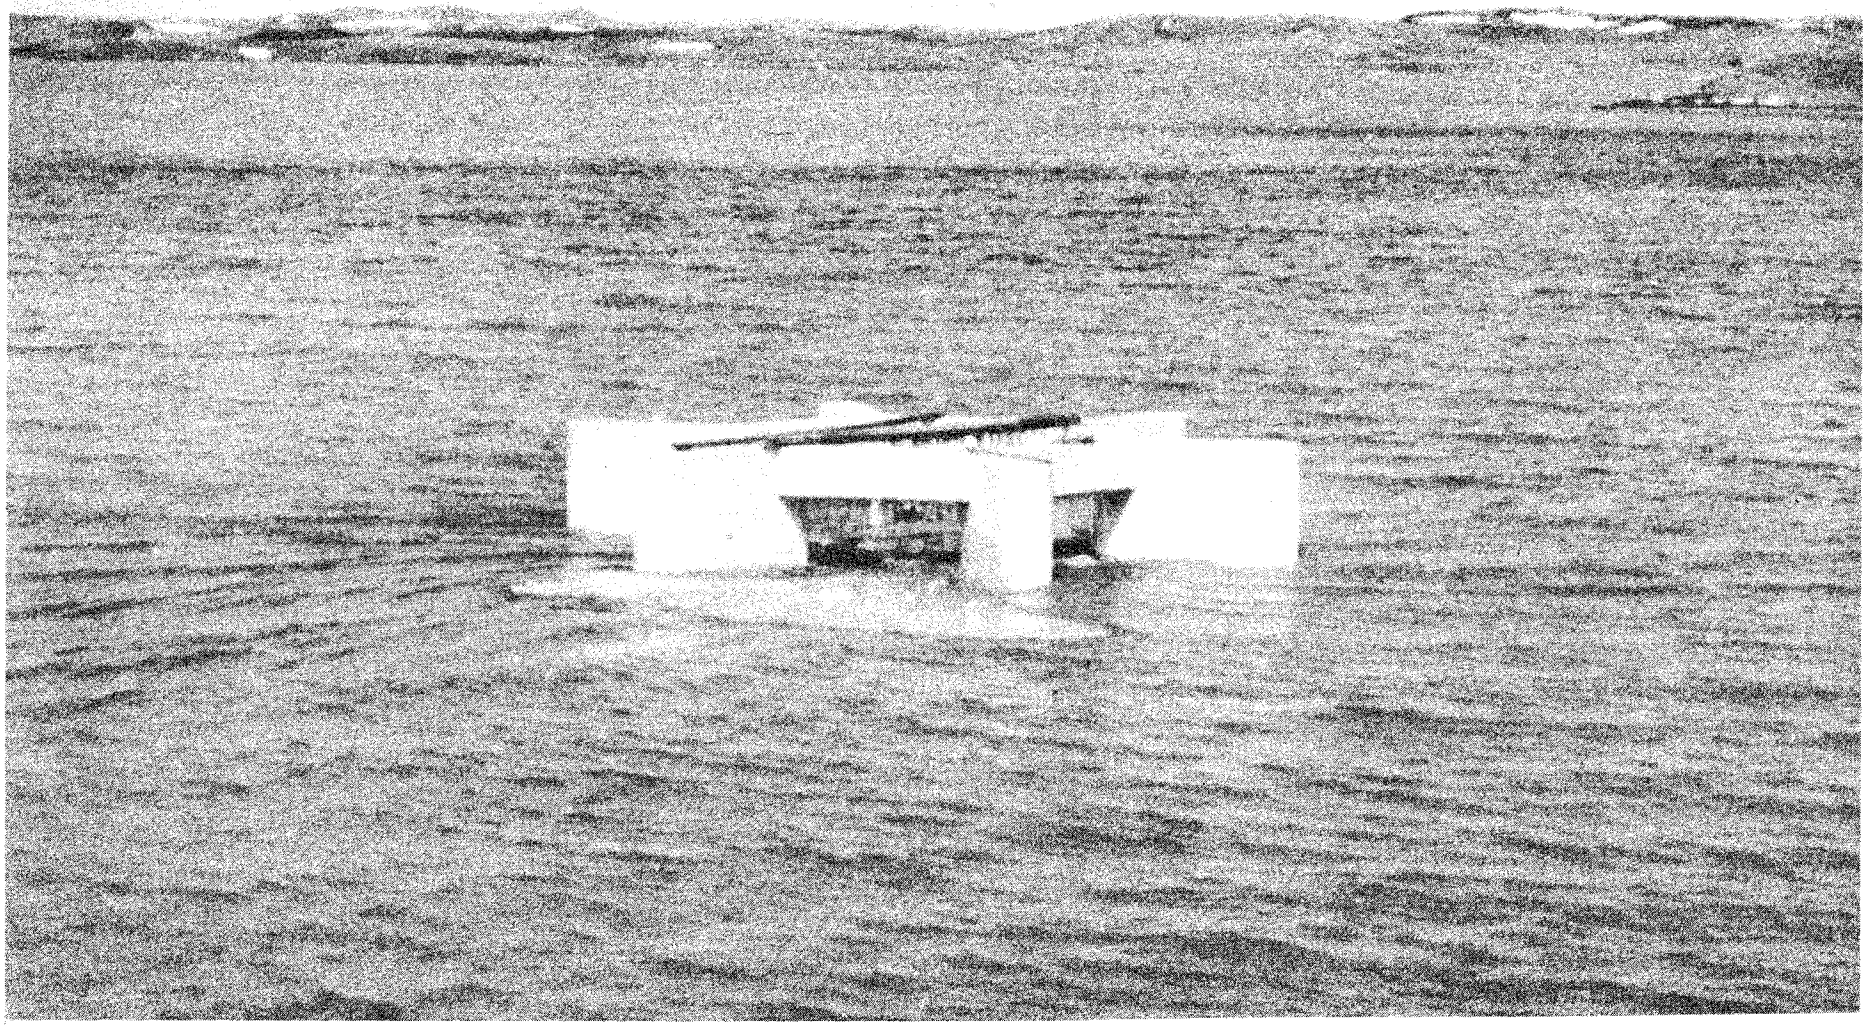
Continuous outflow reduced the reservoir to elevation 2074.0 on April 26, 1950. Ice hides the slight disturbance over the glory hole. Construction timbers lodged on tops of piers.

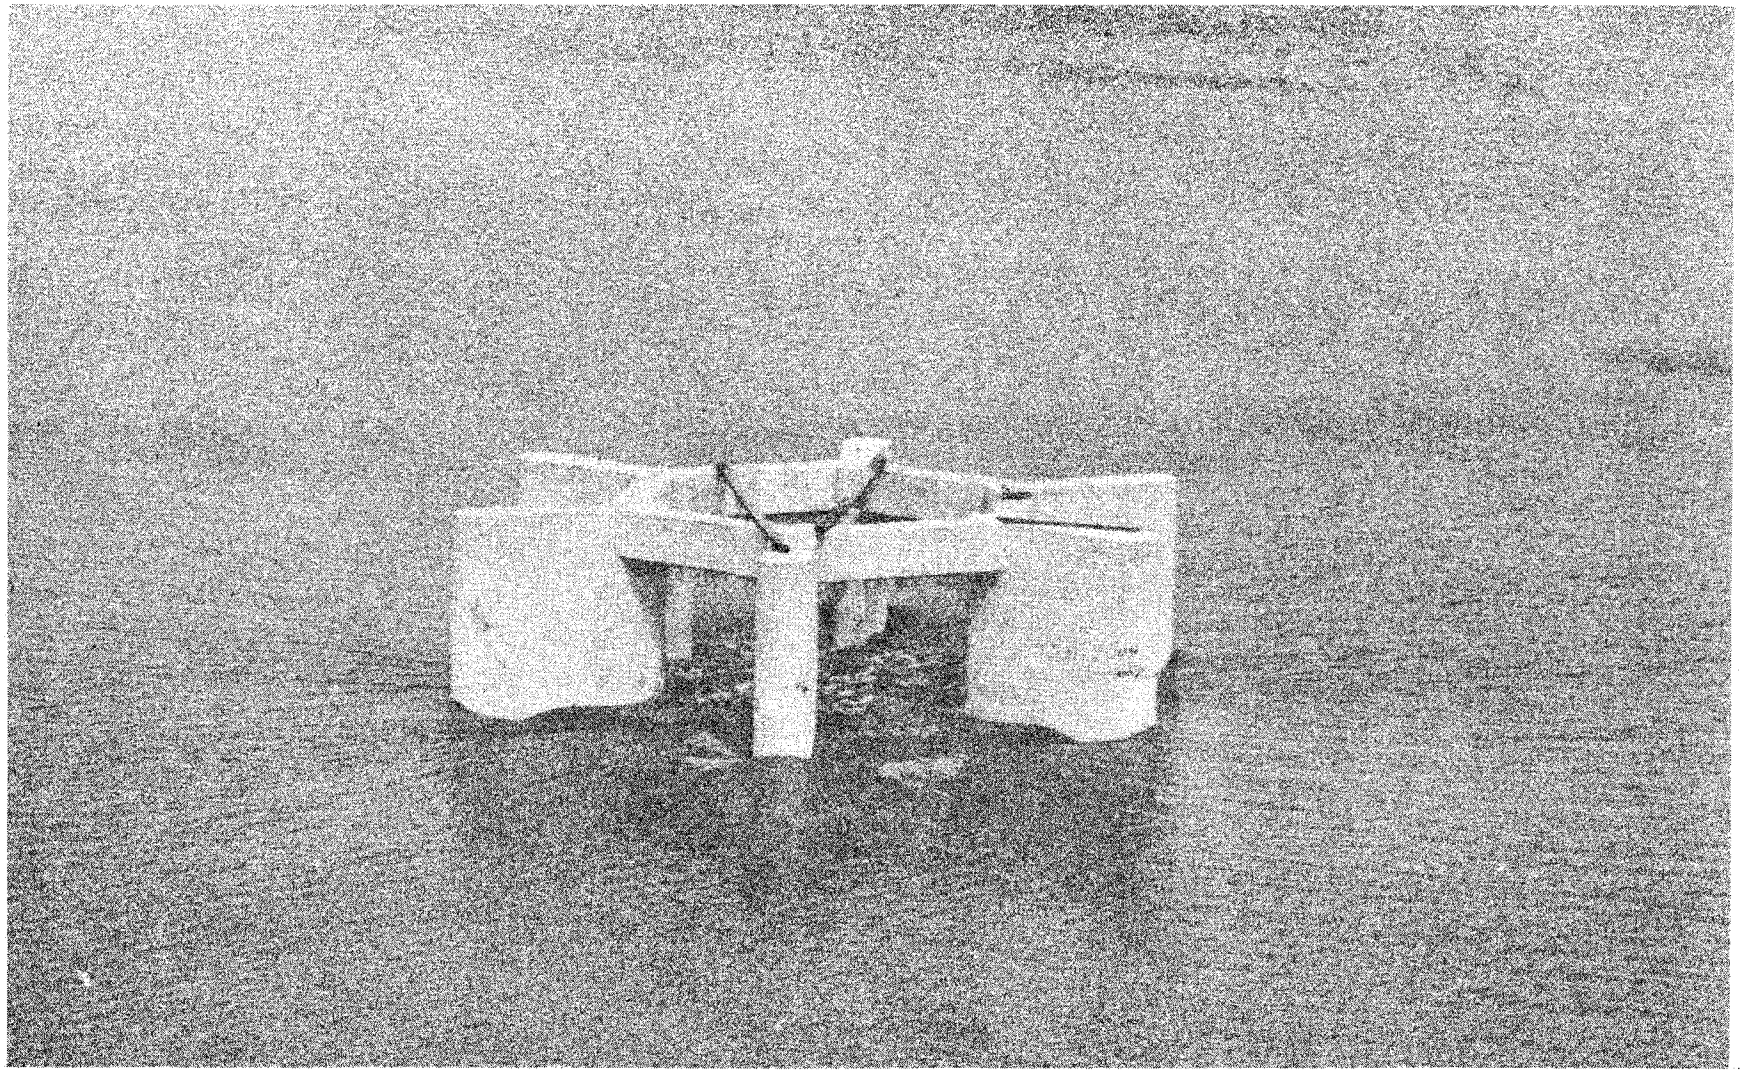
On April 28, 1950, the reservoir was at elevation 2071, or about 0.7 foot above the point where the flow changes from free to submerged. Action inside the morning-glory is very mild. Note flow lines visible on water surface.

HEART BUTTE DAM
Spillway Operation--Discharge 3,090 cfs

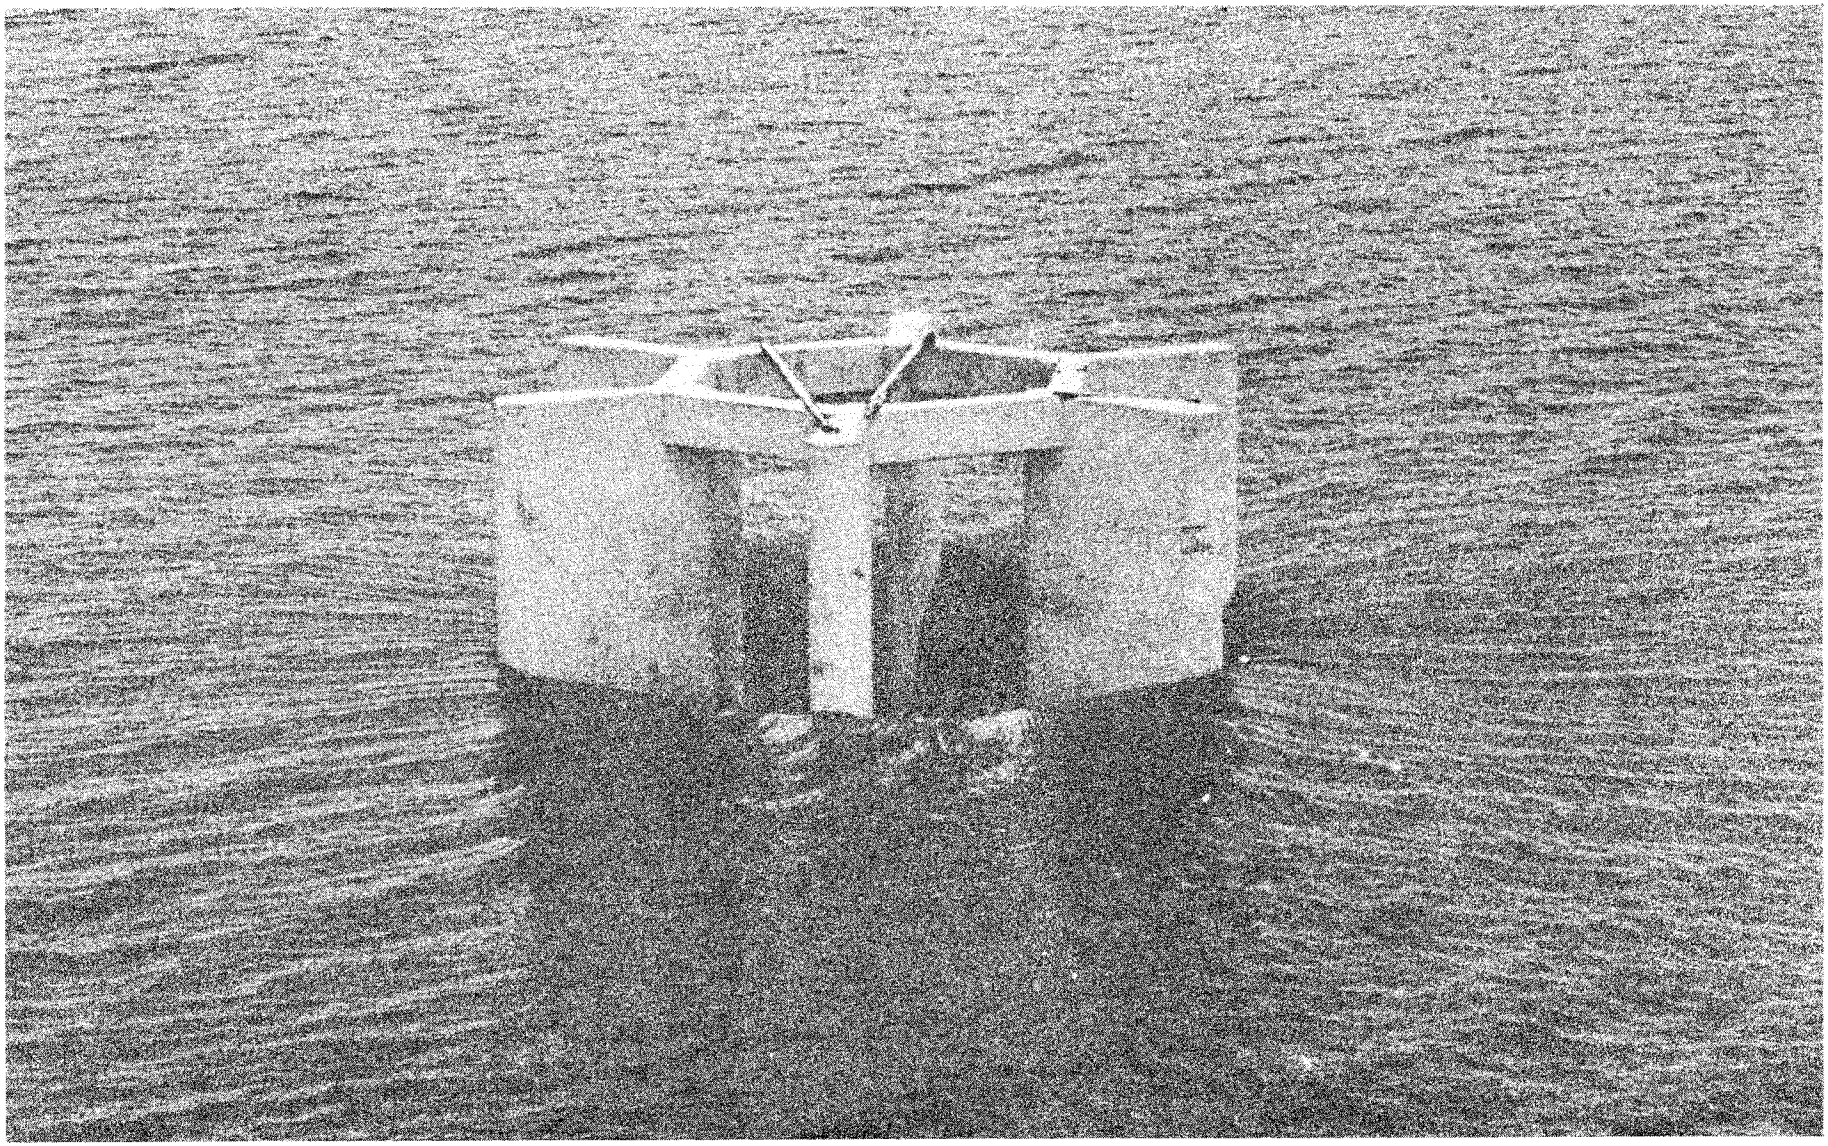
Figure 19

On April 30, the spillway was discharging freely (1,600 cfs) with reservoir elevation 2068.6, see Figure 19. No spray emerged from the glory hole at this or lower heads as has occurred on some other glory hole spillways.

The spillway was discharging freely on April 30, 1950, with reservoir elevation 2068.6.

HEART BUTTE DAM
Spillway Operation--Discharge 1,600 cfs

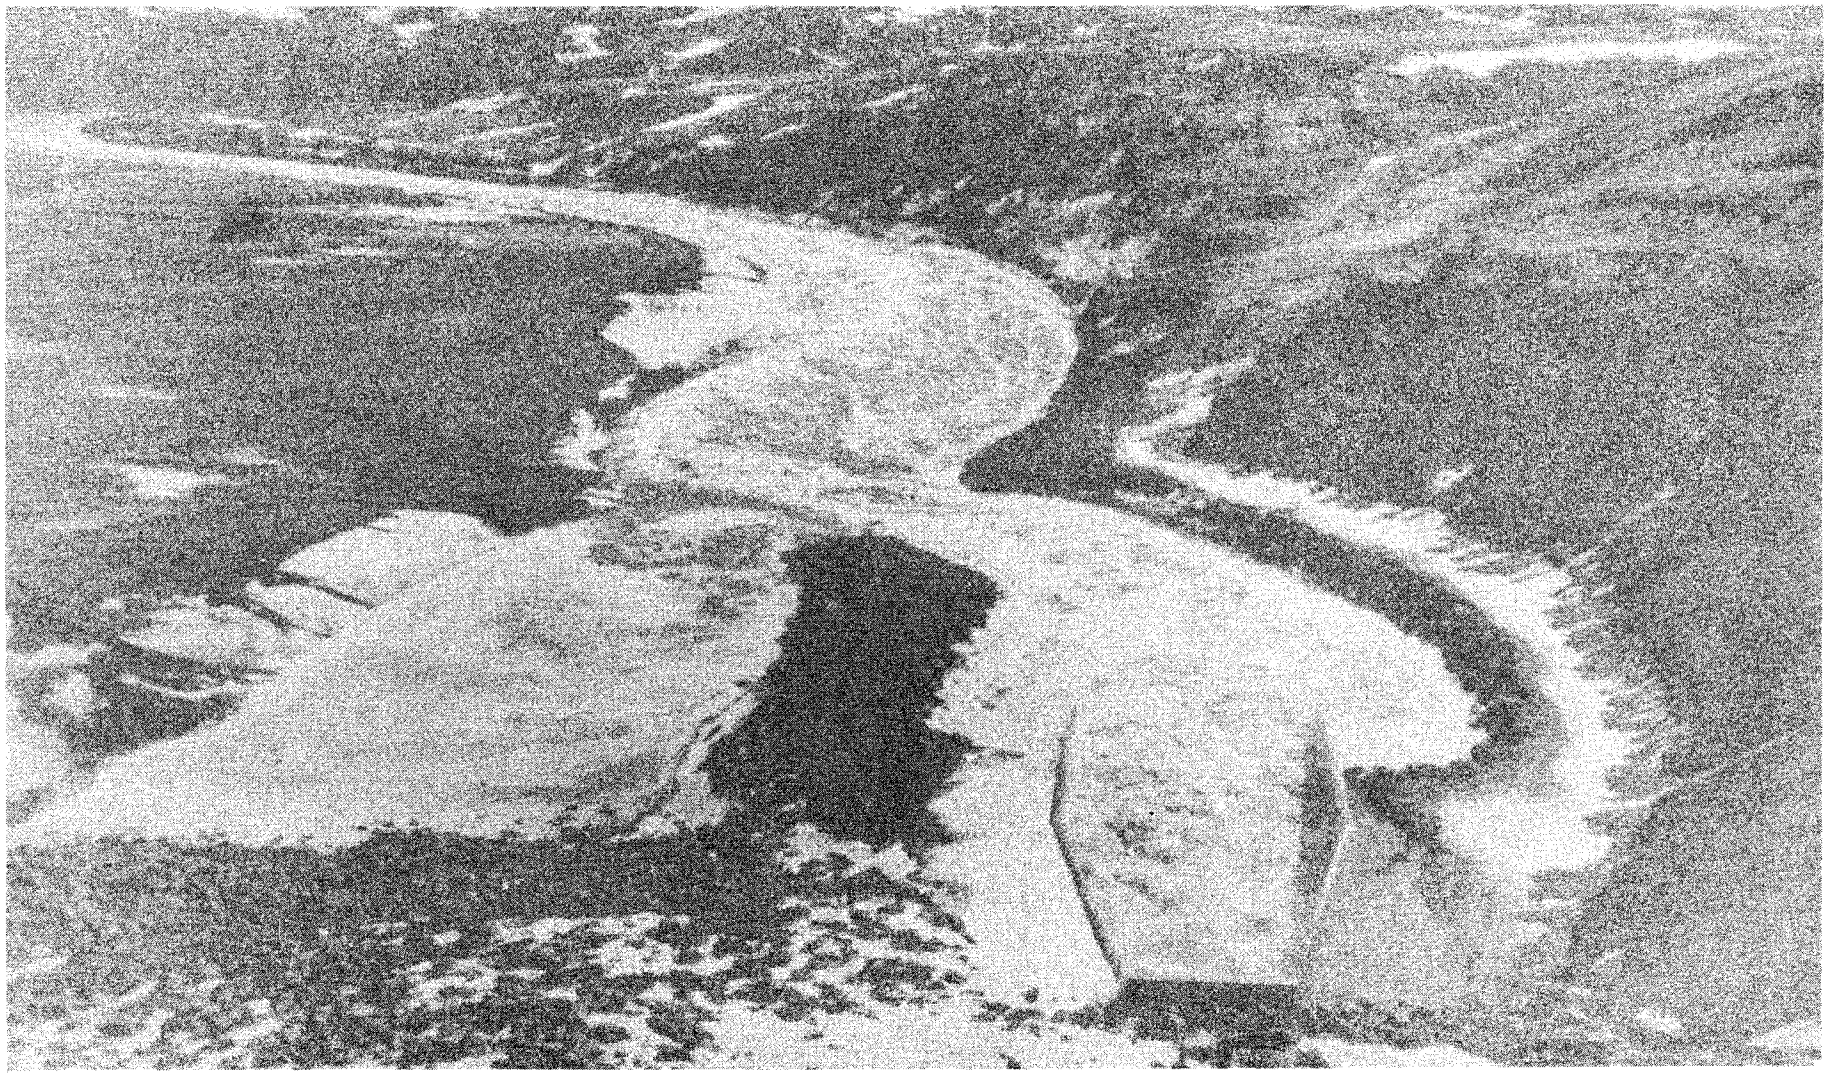
Figure 23

The performance of the stilling basin was satisfactory in every respect and, futhermore, it performed according to the predictions made from the model tests. A general view of the basin and surrounding area is shown in Figure 23.

Stilling basin, excavated channel, and Heart River as seen from the top of the dam. Basin was very effective in dissipating energy. Outflow is about 58 percent of capacity. April 17, 1950.

HEART BUTTE DAM
Stilling Basin Performance--Discharge 3,250 cfs

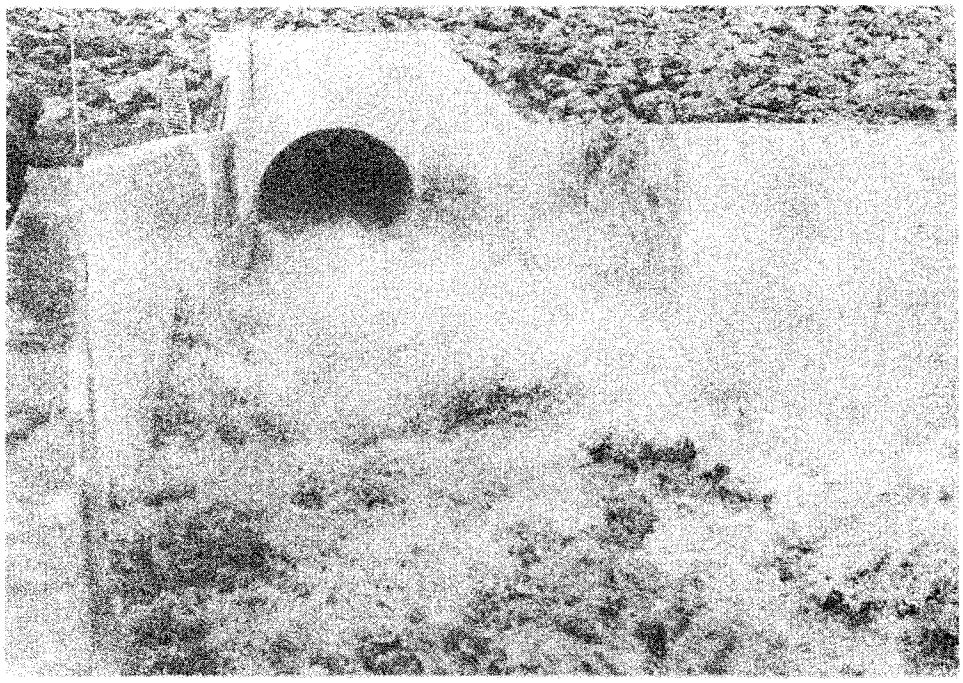
Water leaving the tunnel appeared to be fully aerated and at the approximate depth indicated in the model studies, see Figure 24A. The entire basin contained extremely turbulent water, see Figure 24B, and was long enough to obtain the full jump height before the flow entered the excavated

A--Flow entering the basin was well aerated and well distributed across the basin width.

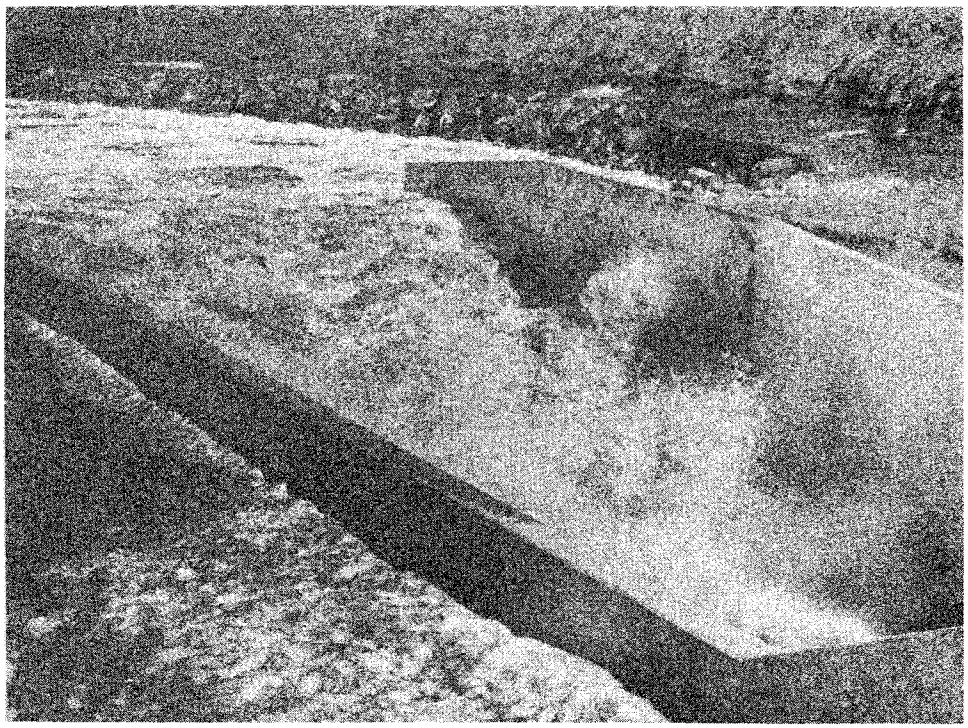
B--The profile of the hydraulic jump is indicated along the stilling basin wall. Flow leaving the basin is smooth and uniform.

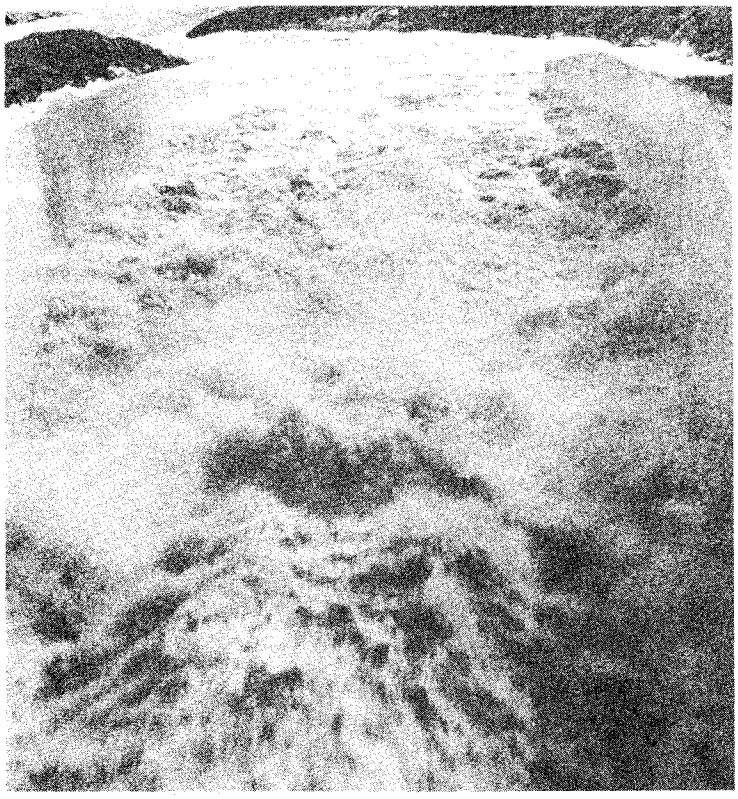
channel, see Figures 25A and 25B. A considerable amount of spray was thrown into the air, at times, where the outflow from the tunnel plunged beneath the tail water, but most of the spray fell back into the basin. The small amount of spray which fell adjacent to the basin caused no difficulty. Much of the time the flow entered the basin smoothly as shown in Figure 25A. Flow leaving the basin had a relatively quiet water surface with few measurable waves, Figure 25B. There were long-period swells, however, with a maximum height of 12 to 18 inches which were caused by pulsation set up in the stilling basin. The disturbances below the stilling basin were similar to those noted during the model tests.

A--Flow from the tunnel was spread to the entire basin width by the dividing walls, which, for this discharge, are submerged.

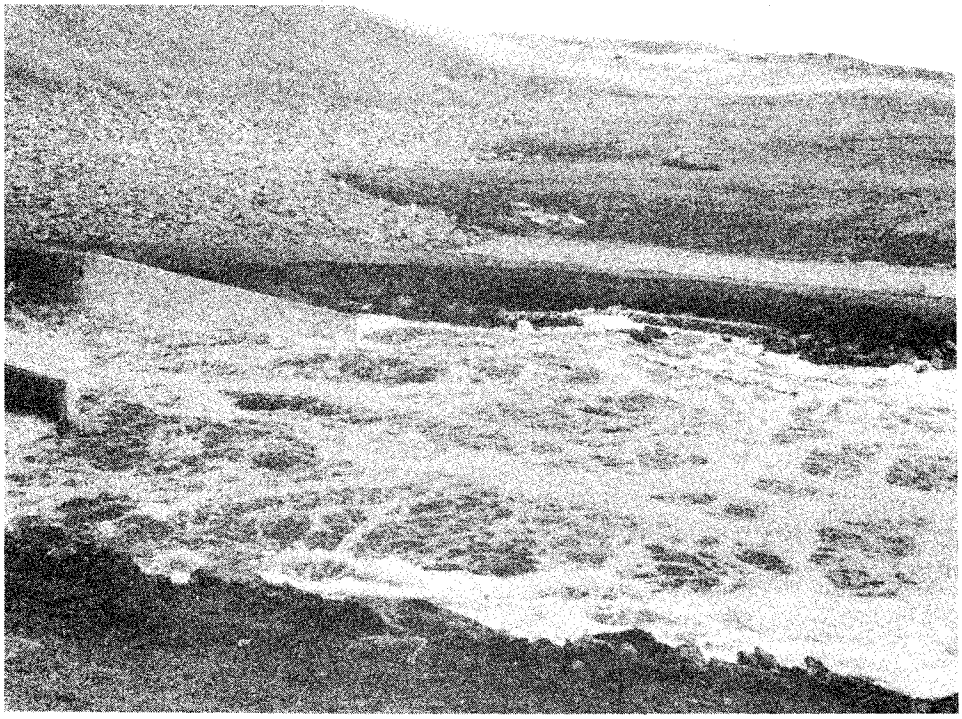
The difference in water levels between the excavated channel and the river was the cause of the high-velocity flow entering the Heart River. Water leaving the stilling basin was of relatively low velocity and would not have caused ill effects as it entered the river, see Figure 25B. The 4-foot difference in elevation, however, caused an increase in velocity which proved to be sufficient to cause considerable damage to the unprotected riverbank downstream, see Figure 32B. Some of the damage was caused by the direct effects of the current flowing diagonally across the river and cutting into the far or left bank. A great share of the damage, however, was caused by a large induced eddy in the river, see Figure 32B. This eddy caused an upstream current along the left bank which removed large volumes of material from areas considerably upstream from the point where the main flow impinged on the bank. Although the damage was considerable in extent, it had no ill effects on the structure or its operation. Riprap placed in the eroded area will prove of value, however, since the damage will become greater with each successive run-off and the end result is difficult to predict. The bank damage is illustrated in Figure 33. A comparison of Figures 23 and 34 shows the extent of the bank damage which occurred between the start of the run-off and May 5, 1950.

B--Flow leaving the basin had no choppy waves but did have mild swells and boils.

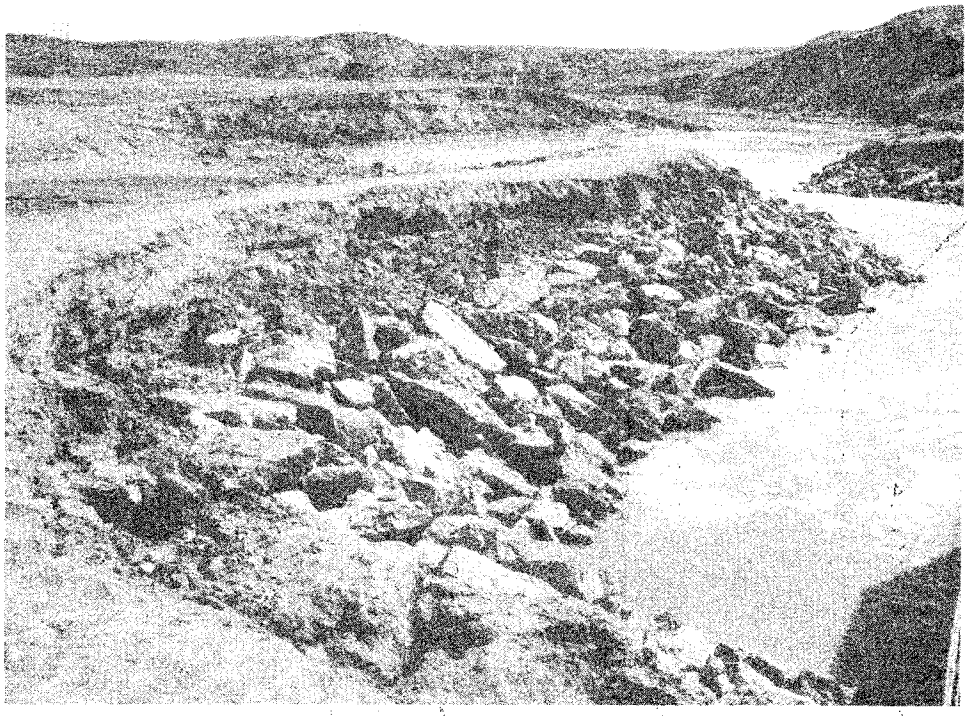
Figure 30

Conversely, the channel banks, despite their riprap cover, were eroded to a greater degree. The riprap, however, had been placed in a thin layer, was not well graded as to size, and in places the earth banks could be seen between the individual rocks. Swells were observed to rise over local areas and penetrate very easily into the large voids. When the water receded some of the earth was removed from behind the riprap. This was evidenced by the darker, earth-colored water which could be seen

adjacent to the riprap. After several days of operation the riprap had slumped and the earth banks had caved as shown in Figure 30. In spite of the apparent damage to the banks the riprap still continued to provide a good measure of protection against further cutting.

The bank damage was not caused primarily by waves of the ordinary variety, since these were only a matter of inches in over-all height, but rather by swells caused by surges in the hydraulic jump. The model stilling basin had been equipped with baffle piers and chute blocks to reduce the over-all length of the stilling basin and decrease its cost. It had been noted during these and other model tests that when a hydraulic jump is reduced in length by the use of artificial devices such as baffle piers that the jump becomes more stable in most respects, but does exhibit a tendency to produce the swells discussed above. The swells are considered the lesser of the evils, however, and are not impossible to cope with. With a thicker application of riprap, containing rock well graded as to size, there probably would have been no damage.

A--Loss of bank material was caused by swells removing fine material from behind the coarse riprap. Note man standing on the riprap.

B--Loss of bank material also occurred along the right bank, particularly near the junction of excavated channel and river.

HEART BUTTE DAM
Erosion of Excavated Channel Banks

Inspection of the riprap downstream from the stilling basin, following the 1950 flood, indicated that repairs would be advisable. The slumped riprap in the channel immediately downstream from the stilling basin structure was repaired in May and June 1950. Gravel backfill was placed on the slopes to bring them to grade and rock replaced over the gravel. The erosion of the riverbank just downstream from the end of the riprapped channel was sloped and covered with gravel and rock.

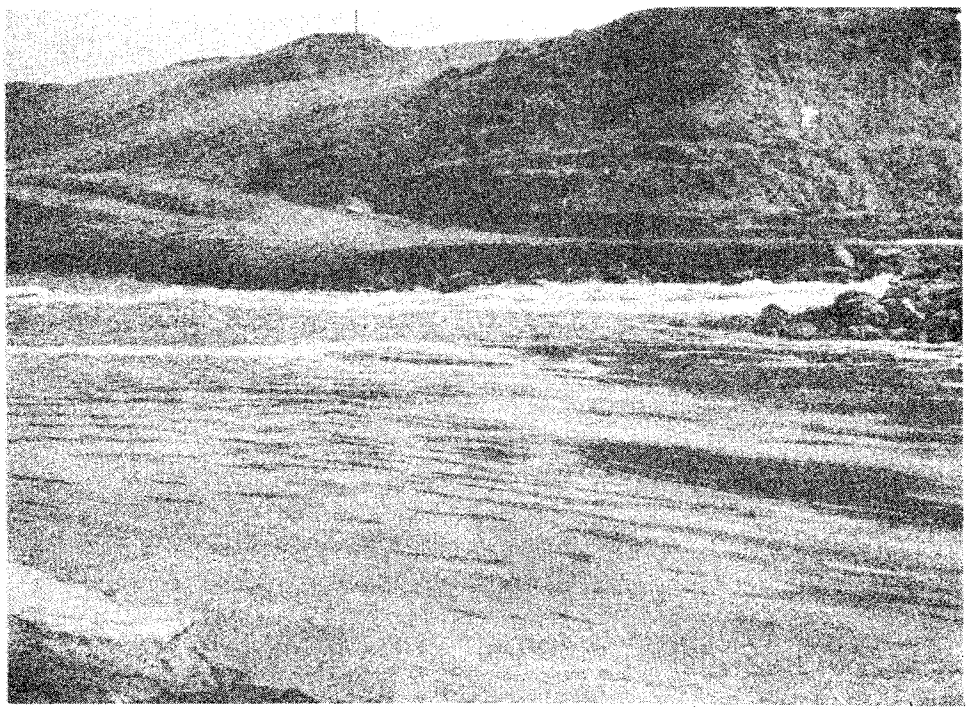
A--Flow entering the river from the excavated river channel was accelerated by the difference in elevation apparent in the photograph. At 3,700 cfs the difference was about 4 feet.

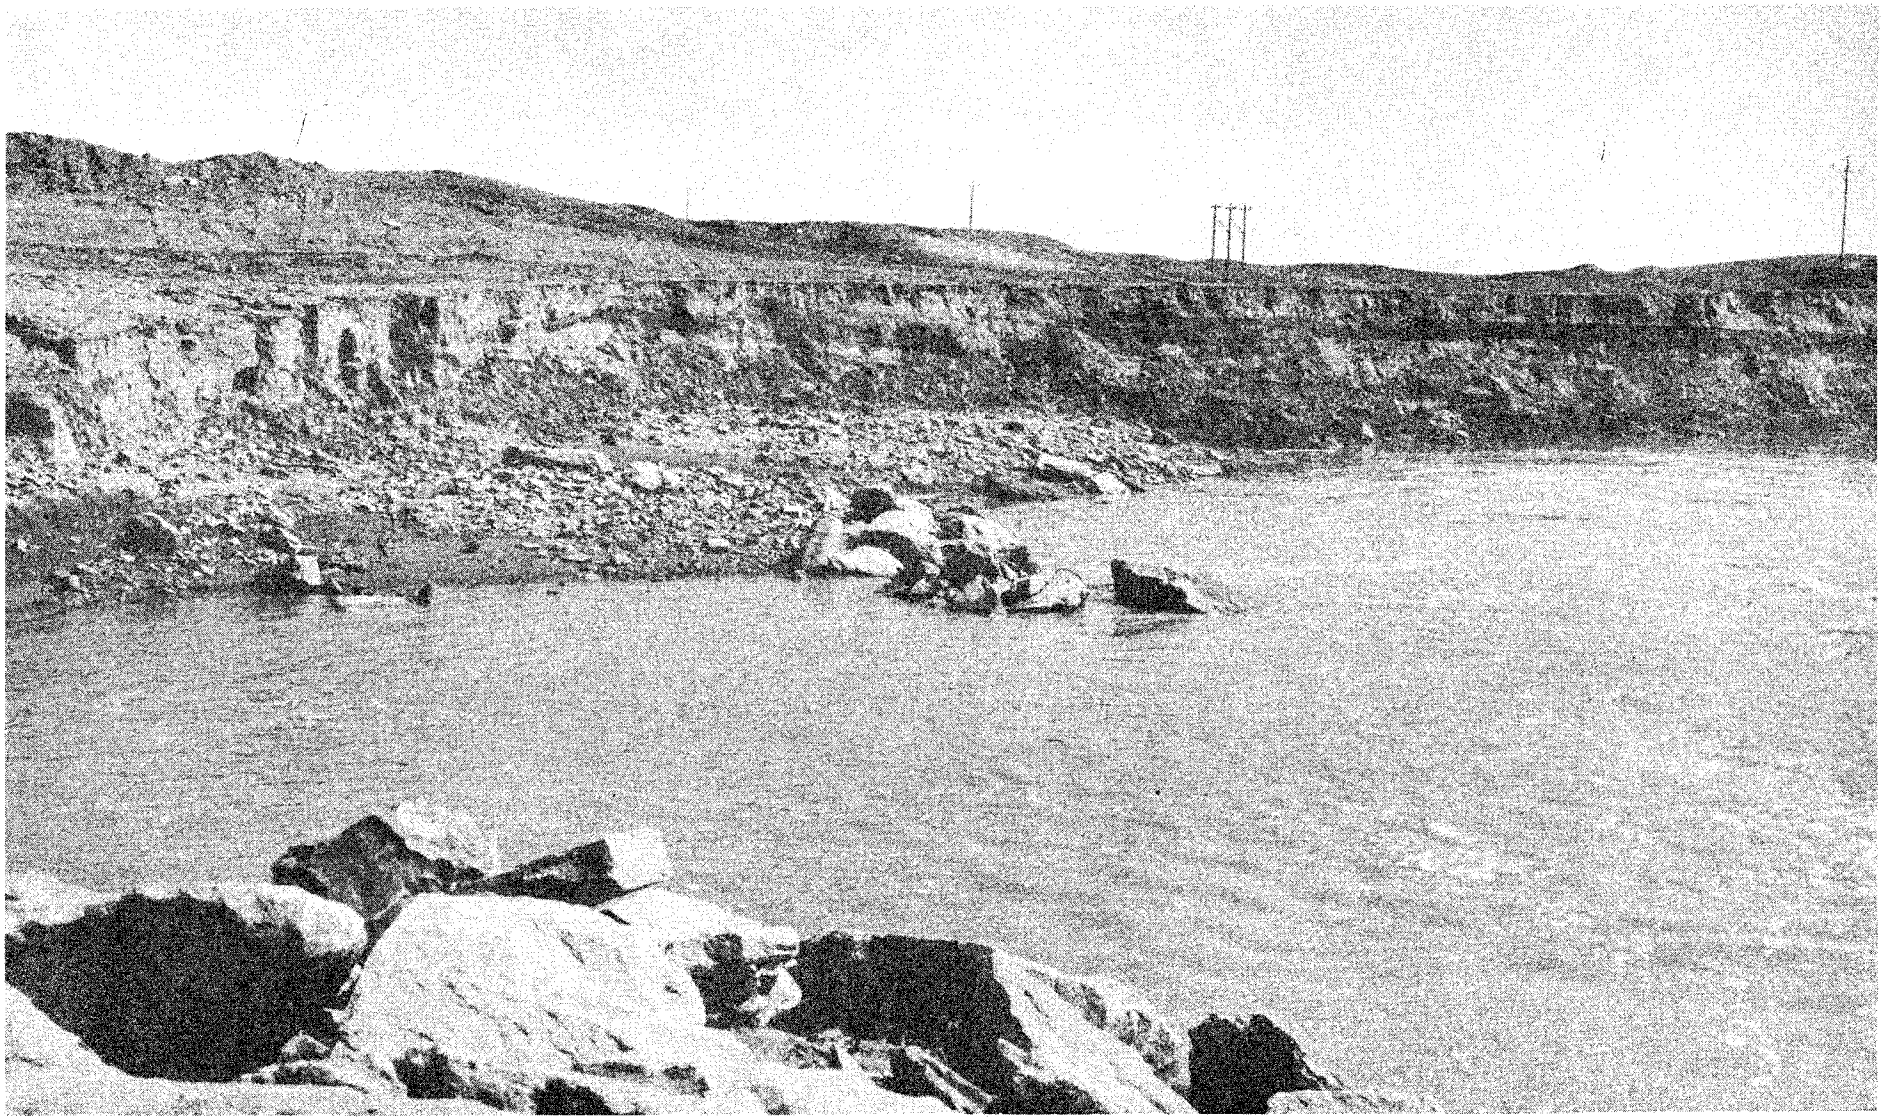
Figure 33

After flood had receded the loss of bank material opposite the excavated channel was readily apparent.

HEART BUTTE DAM
Riverbank Erosion

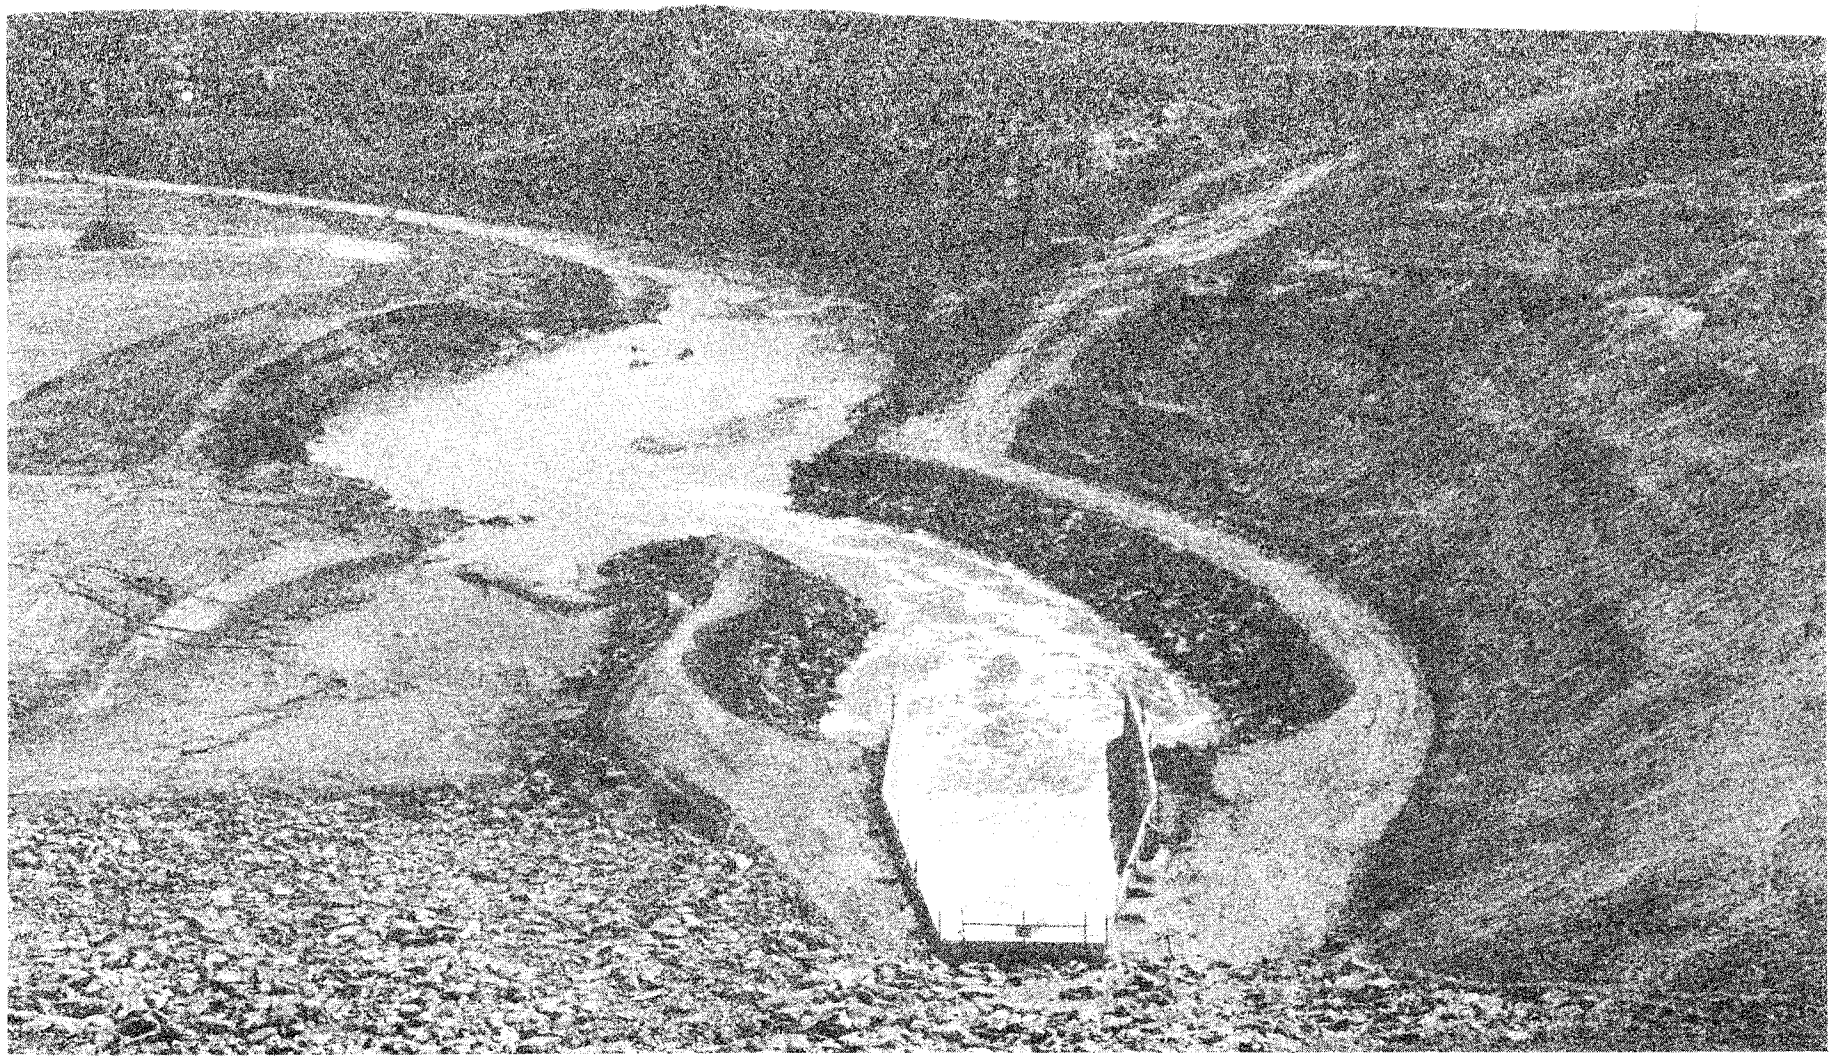
Over-all view after flood had passed shows extent of downstream bank erosion on May 5, 1950. Note bars formed from eroded material. Compare with Figure 23.

HEART BUTTE DAM
Downstream Bank Erosion
