HEART BUTTE SPILLWAY AND OUTLET WORKS

A paper for the
Summer Convention, ASCE,
Denver, Colorado, June 1952

Performance Tests on the Prototype and Model

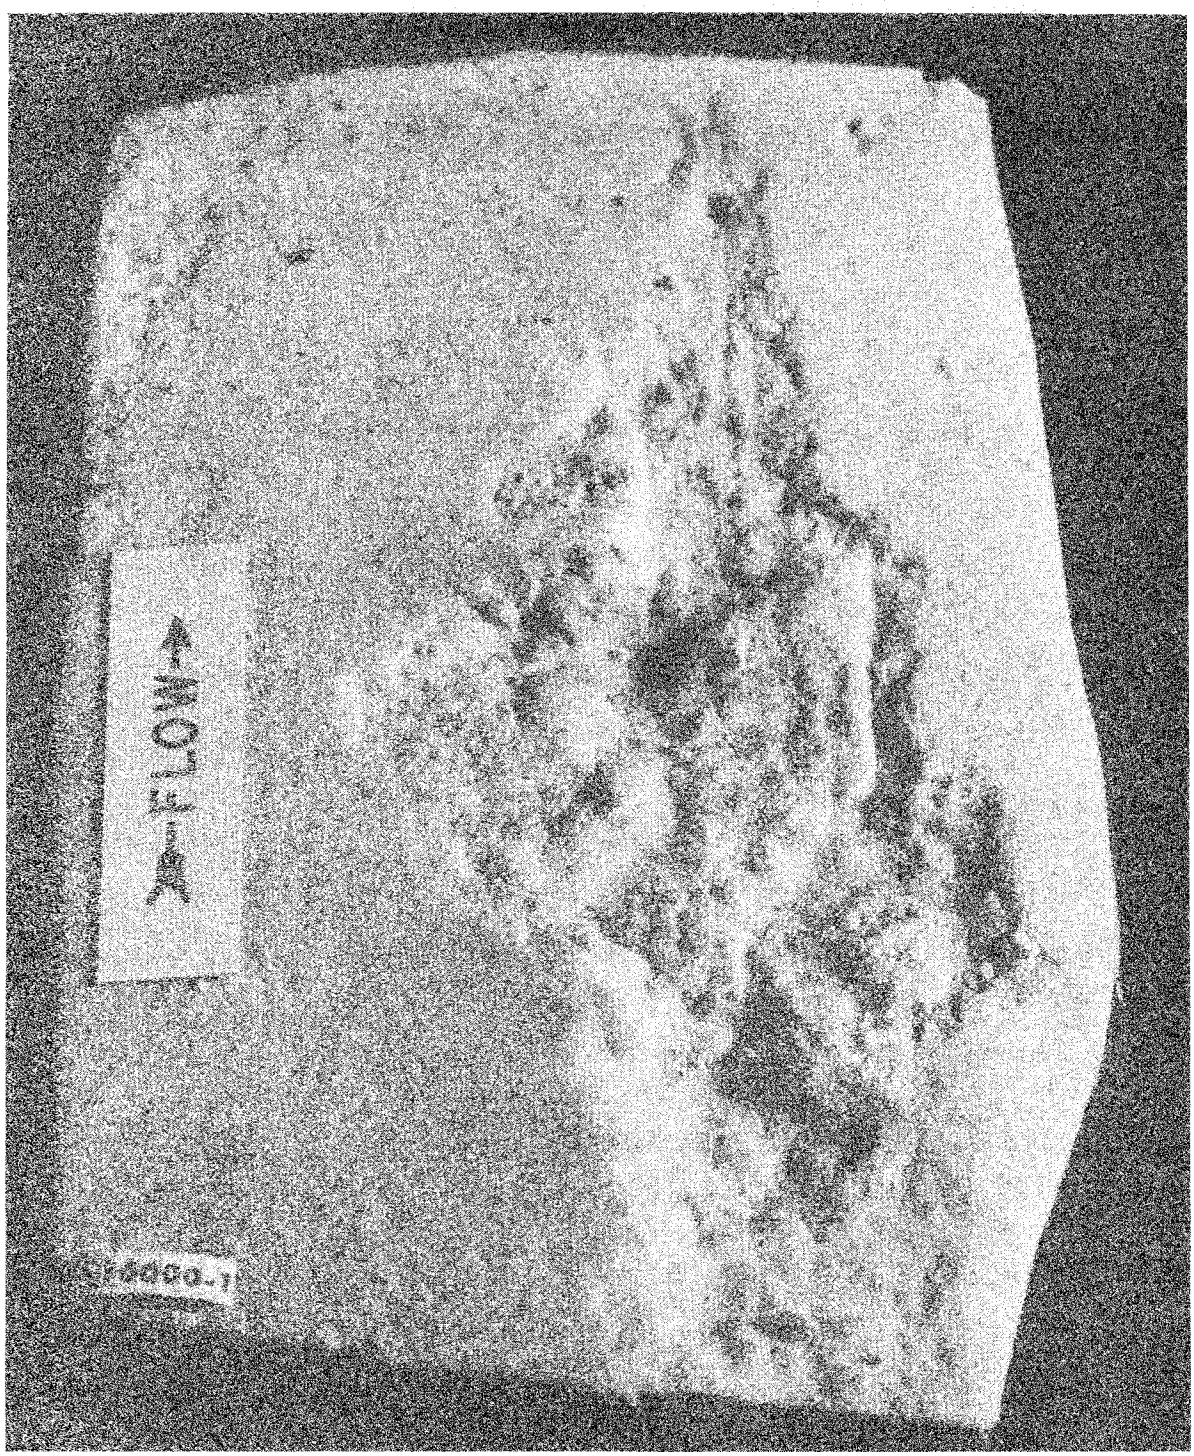
Figure 36

The conduit inspection, in both instances, revealed that the concrete was in excellent condition with the exception of four small eroded areas located in the 90° bend. Following the 1950 flood, plaster casts were made of the two most prominent areas. These are shown about full size in Figures 35 and 36. The largest area is about the size of a man's hand and by actual measurement has a maximum depth of erosion of 3/4 inch. The smaller area shows a maximum depth of 1/2 inch. The surfaces shown in Figures 35 and 36 were molded in sponge rubber against the plaster casts made in the field and are therefore an exact replica of the tunnel surface following the 1950 flood.

the 90° bend. Construction timbers or ice falling into the shaft could have, by impact, caused the surface damage shown. Persons who have viewed the rubber casts have been of the unanimous opinion that the damage was not started by cavitation.

Another eroded area in 90° bend, shown full size. This area, the largest of the four found, has a maximum erosion depth of 1/2 inch. 1951 flood did not cause measurable increase in area or depth.

HEART BUTTE DAM
Eroded Area in 90° Bend--"Lower Right"

Following the 1951 flood, these areas were again noted. "There did not appear to have been any marked change in these areas as a result of the 1951 spring floods." "No repairs were believed necessary."
