Trinity Dam Auxiliary Outlet Works Hydraulic Laboratory Model Results

Subject: Trinity Dam Auxiliary Outlet Works - Hydraulic Laboratory Model Results

TRINITY DAM AUXILIARY OUTLET WORKS LABORATORY MODEL EVALUATION OF THE OPERATING CHARACTERISTICS

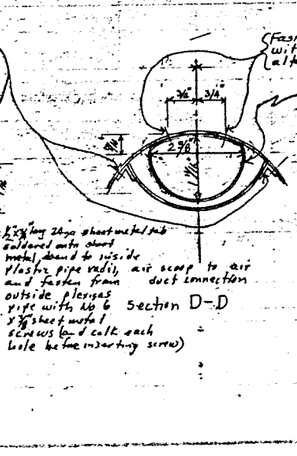
Section D-D

3. At 70 percent gate opening, air and water entered into the air scoop at the downstream end at the junction with the aluminum air duct (refer to Section D-D, figure 3) which had been left open in the construction of the new air duct system. This opening, with air and water being drawn through it, could have been the primary cause of the high pressure fluctuations that occurred at the 70 percent gate opening.

1. Install a sealed bulkhead at the downstream end of the air scoop at the junction of the aluminum air duct (section D-D, figure 3).

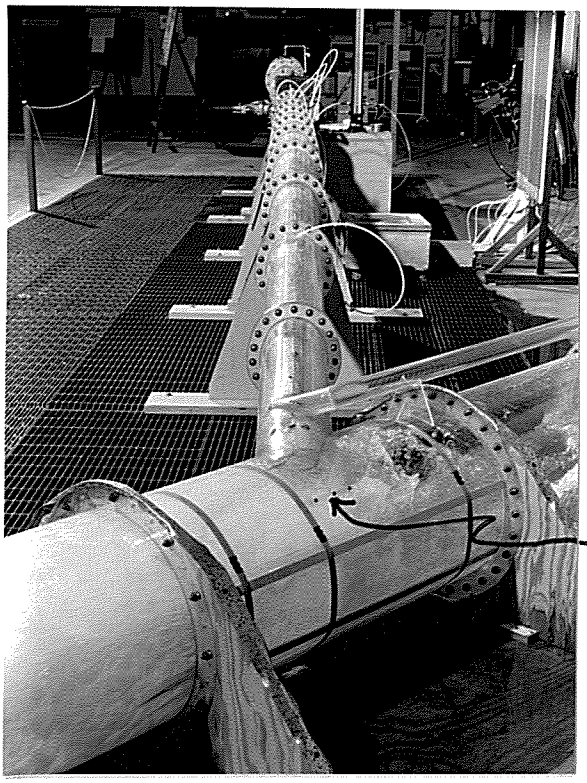
conduit (perpendicular to the centerline) 6 ft downstream from the end of the aluminum air duct and was 2 ft (prototype) in depth at the centerline. The deflector plate at this location was not completely satisfactory. The deflector plate combined with the bulkhead seal reduced the pressure fluctuations by about 60 percent at the 70 percent gate opening. However, some return flow on top of the main flow prism at the end of the auxiliary outlet conduit still occurred. Actually, it appeared to have increased because the reversed flow from the spillway tunnel was being deflected downwards into the roller area. The upstream edge of the deflector plate was catching the top of the roller on a random basis. The roller would then advance upstream. Twice during the 70 percent gate opening steady-state test run (No. 7), the roller submerged the downstream end of the aluminum air duct and primed the entire auxiliary outlet conduit and the air duct system, causing extremely high negative pressures. The high negative pressures were beyond the range of the manometers and could not be measured. The vertical deflector plate was moved down the opposite side of the spillway tunnel as shown in figure 7. The first deflector plate tested at this lcoation was 15 in deep by 6 ft, 10 in long (prototype). It was later modified by increasing the length to 8 ft (in the downstream direction). A general view of the return flow being deflected away from the entrance of the auxiliary outlet works conduit can be observed in figure 8.

Figure 8. - General view of the vertical deflector plate installed inside the Trinity Dam spillway tunnel opposite the auxiliary outlet conduit entrance with the flow at 100 percent gate opening.

2. The entire length of the air duct system must be sealed (except at the ends and at the air slot) and a perpendicular deflector plate installed as shown in figures 7 and 8 to reduce the air demand and the negative pressure fluctuations on the conduit side walls.

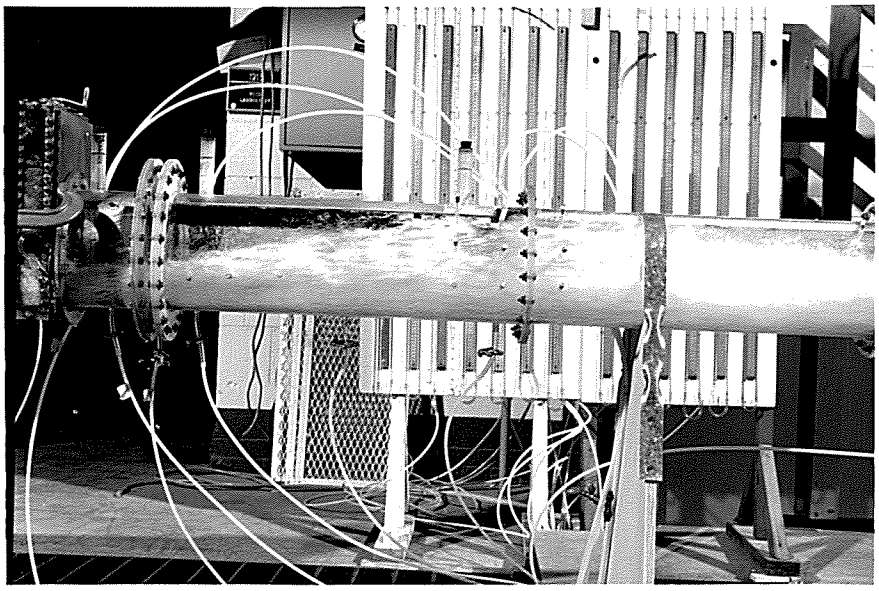
1. At partial gate openings from 0 to 80 percent, the jet from the gate deflected upward from the air slot orifice ring onto the bottom of the air duct system. The area of flow impingement on the bottom of the air duct system began about 6 ft (prototype) downstream of the air slot and continued downstream about 50 to 60 ft (prototype). The flow impingement area extended onto the aluminum air duct and would explain the partial failure observed after the January 10, 1985 field test (memorandum dated January 17, 1985, from Richard C. Kristof to Chief, Water O&M Branch, Mid-Pacific Regional Office).

Figure 9. - General view of the flow impingement onto the bottom of the air duct system at 40 percent gate opening flow with the 1/2-in-high offset ring orifice installed.

3. The structural integrity of the aluminum air duct must be increased to withstand (a) flow impingement that occurs at partial gate openings and (b) wave action that normally occurs at the 100 percent gate opening.

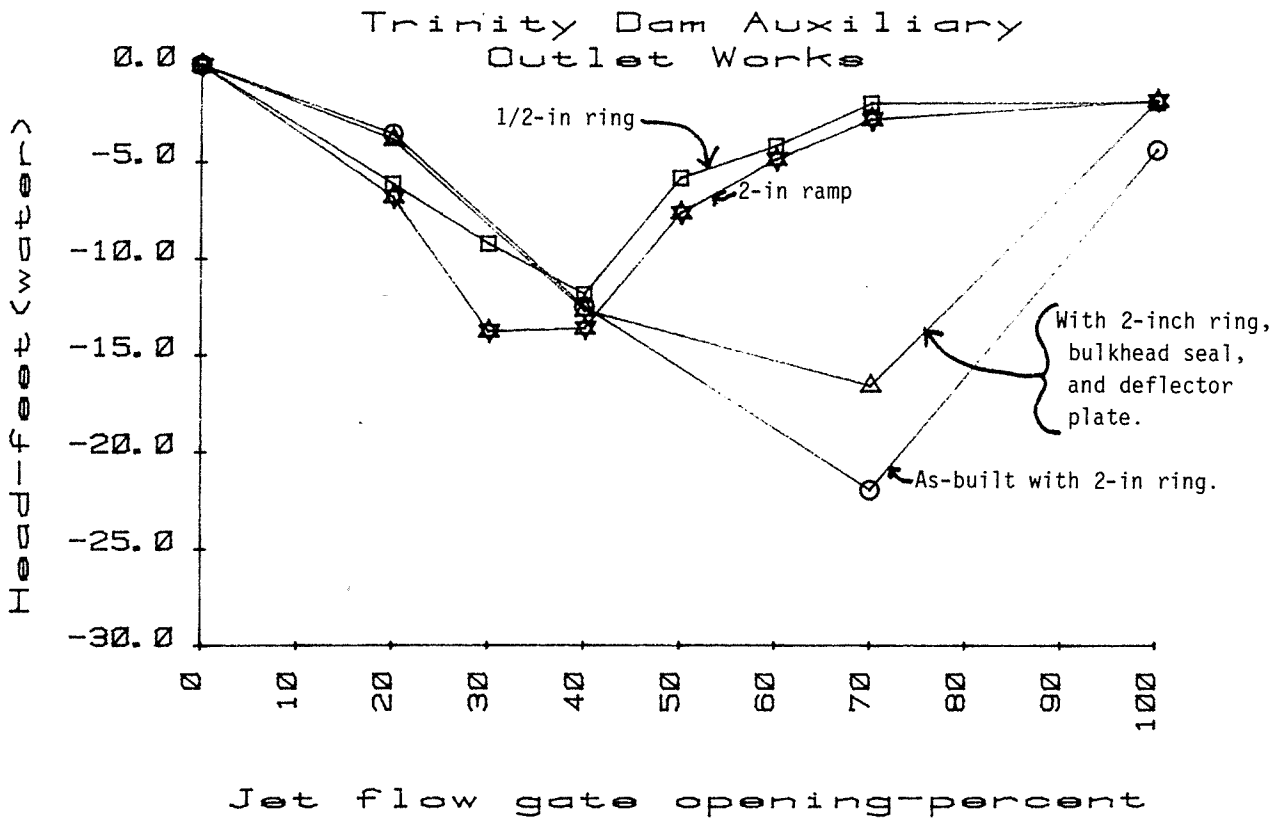
The overall review of the test results of the as-built and the three modifications to the Trinity model can best be observed in figure 10. Figure 10 is a plot of the average static pressure head at the upstream end of the aluminum air duct (P13) versus the gate opening. The average static pressure head at P13 provides a good indication of the air demand requirements which can be used to evaluate the modifications. As illustrated, the maximum air demand for the as-built configuration occurred at the 70 percent gate opening.

Installing the sealed bulkhead and the downstream deflector plate, reduced the air demand requirements for gate openings greater than 40 percent gate. The 1/2-in orifice ring offset modification reduced the air demand significantly for gate openings above 40 percent. However, the air demand below 40 percent gate opening increased slightly. The air demand requirements for the 2-in ramp were similar to, but slightly greater than, the 1/2-in ring. The maximum air demand with the 1/2-in ring or 2-in ramp modification occurred at the 30 to 40 percent gate opening range.

Figure 10. - Average static air pressure head inside upstream end of aluminum air duct (P13) vs. gate opening.

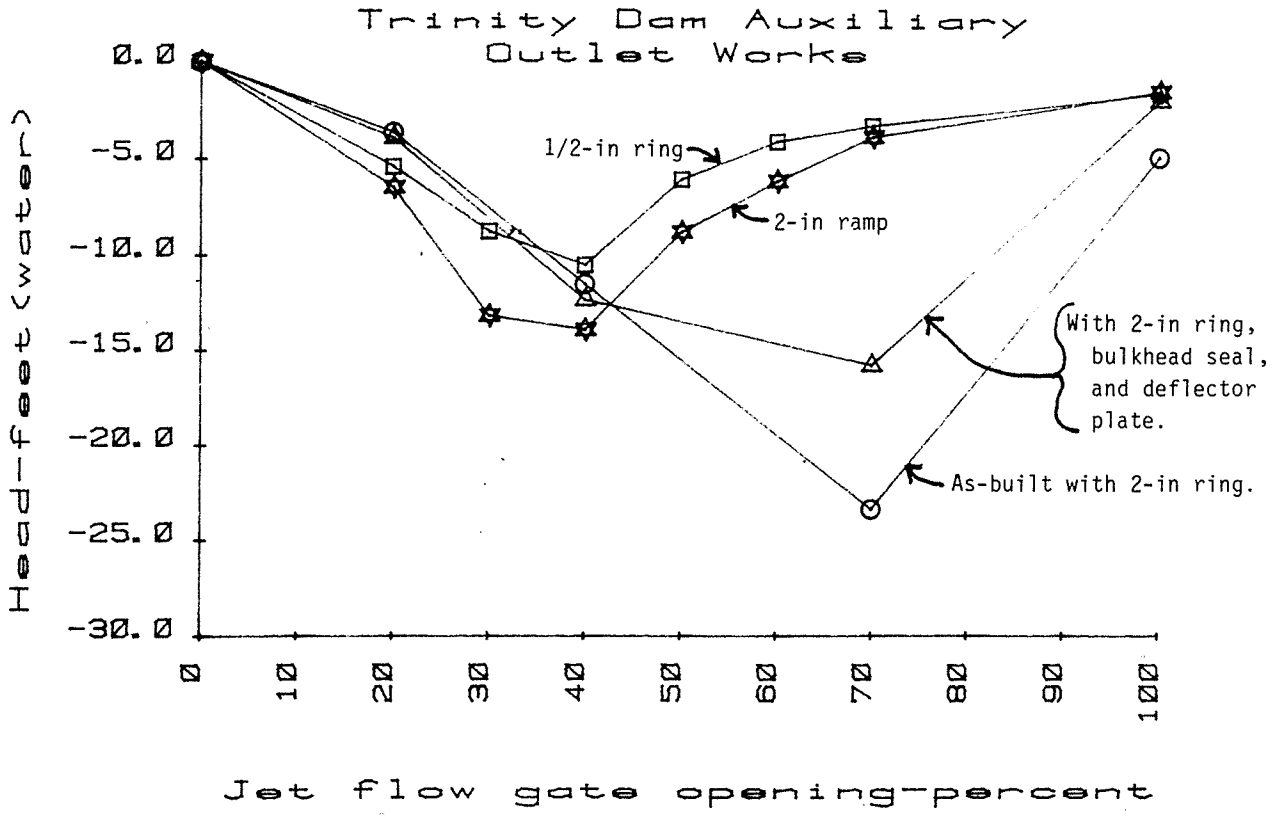
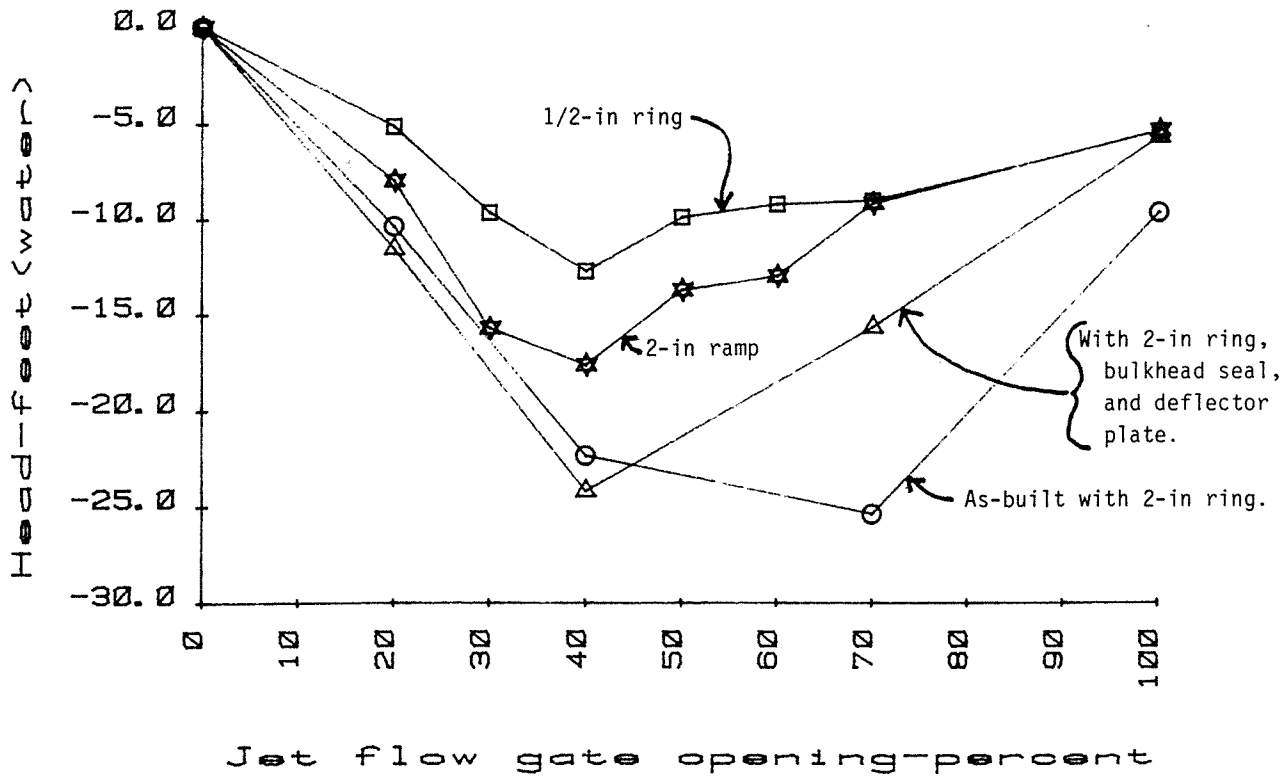
Figure 11 shows the maximum average subatmospheric pressures that occurred on the side wall immediately downstream of the air slot and at the downstream end of the air scoop (P9's and P10's, figure 5). As illustrated, the largest negative pressure for the as-built configuration occurred at the 70 percent gate opening. It was at this point where the maximum pressure fluctuations of -3.3 ft (model) occurred (P10b, figure 5). At the 1:14.87 model scale, vapor pressures would have occurred in the prototype at this location. The sealed bulkhead and deflector plate reduced the maximum average negative pressure from -25.5 to -15.5 ft (prototype), a reduction of about 40 percent, at the 70 percent gate opening. The maximum pressure fluctuations also reduced to -1.2 ft (model), a reduction of about 60 percent compared to the -3.3 ft (model) for the as-built configuration.

The 1/2-in orifice ring offset modification reduced the side wall negative pressure significantly with the maximum average negative pressure of -12.7 ft (prototype) occurring at the 40 percent gate opening at P10f (figure 5). The maximum pressure fluctuation occurred at P10i and was -1.25 ft (model). The prototype maximum pressure fluctuation at this point would be -18.6 ft which is well above vapor pressure.

The maximum negative pressure occurred at the end of the air scoop which is also the end of the existing prototype steel liner. The vertical row of piezometer taps P10b, P10f, and P10i, figure 5, are located at the end of the steel liner. The vertical row downstream, piezometer taps P10c, P10g, and P10j, are 5 ft (prototype) downstream in the concrete-lined section of the egg shaped conduit. Figure 12 is a plot of the maximum average pressure at P10b, P10f, and P10i compared to the maximum at P10c, P10g, and P10j versus the percent gate opening, using the data from the 1/2-in ring modification test runs. The negative pressure is less in the concrete section with a maximum of -9.0 ft (prototype) occurring at the 40 percent gate opening. The relatively moderate negative pressures do not warrant the extension of the steel liner downstream for the protection against cavitation damage.

Figure 11. - Average side wall pressure head at (a) immediately downstream of air slot and (b) at end of steel liner vs. gate opening.

1. The existing 2-in-high orifice ring offset at the upstream edge of the air slot should be reduced to a 1/2-in offset (to a height 8 ft above the conduit invert) to reduce flow impingement onto the bottom of the air duct system, thereby reducing the air demand and negative pressures on the conduit side wall.
