PAP-725

Review of Facilities for Automation
Glenn-Colusa Irrigation District
Willows, California

U.S. Department of the Interior
Bureau of Reclamation

April 2, 1996

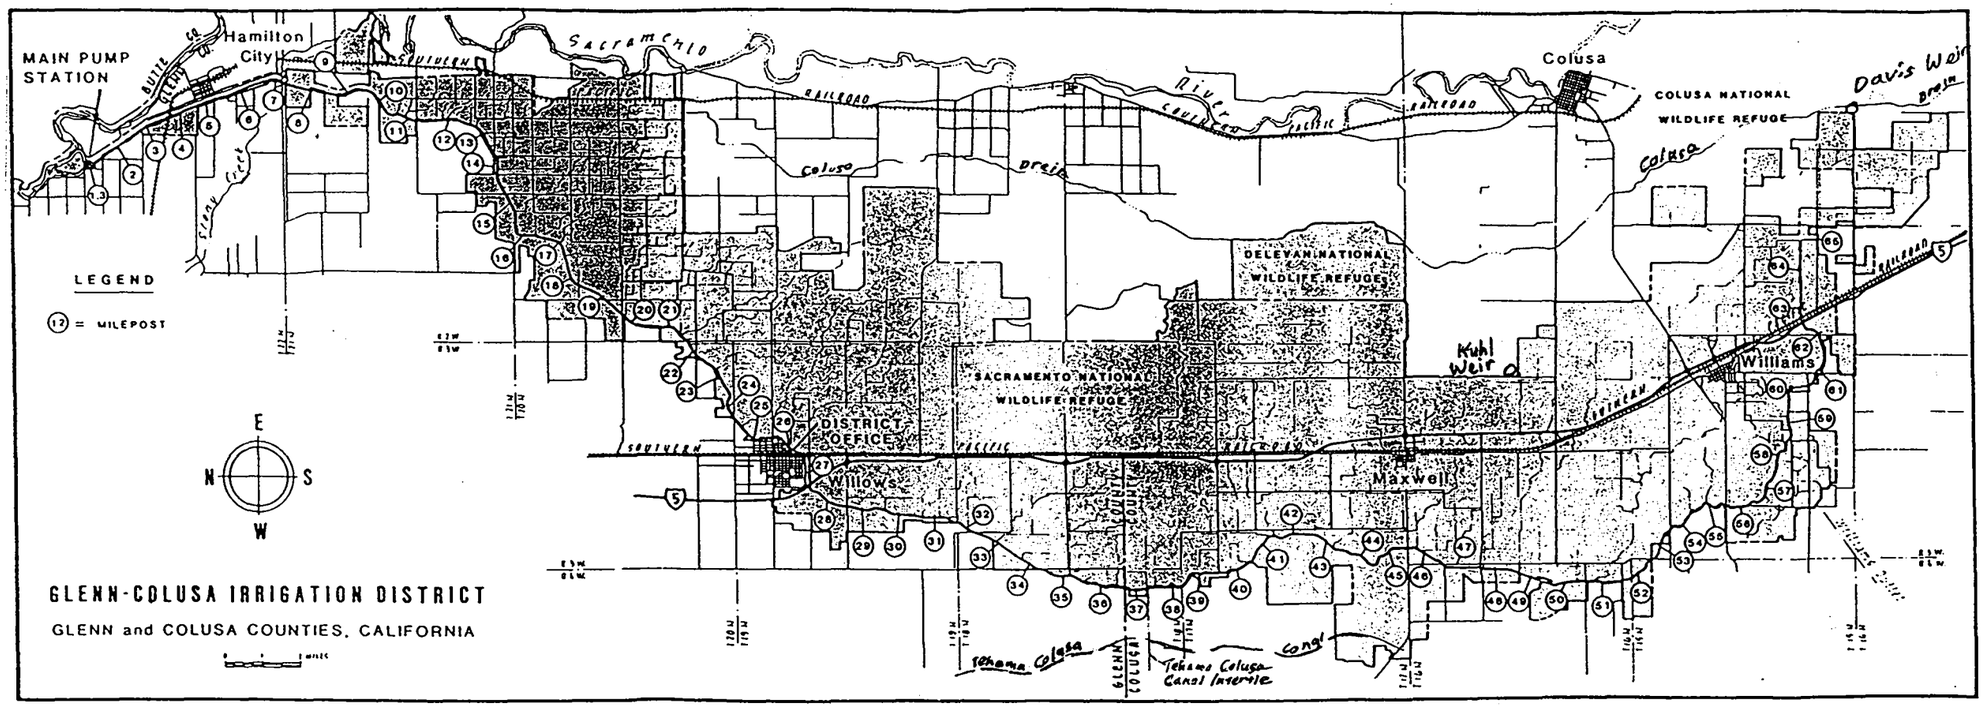
Figure 2

Main Canal Structures by Mile Post

MI	Structure
1.39	Sacramento River Main Pump Station
7.23	Stony Creek Gates (P/S/M)
13.75	Jacinto Check (P/R)
17.68	Willard Check (P/S/B/C/UC)
21.75	Tuttle Check (P/S)
24.00	Walker Check (P/R/C/UC)
26.21	Willows Check (P/R/C)
26.60	Railroad Siphon (M)
31.71	Spooner Check (P/R/C)
35.?	Baker Creek Siphon
36.63	Norman Check (P/R/C)

MI	Structure
41.30	Funks Check (P/R/C)
43.?	Sheehy Bridge (M)
44.95	Stone Corral Siphon
45.48	Stone Corral Check (P/S)
48.74	Abel Check (P/S)
49.95	Lurline Siphon/Check (S/P/M/C)
52.42	(Freshwater Check) (A/R) Siphon
53.93	Terkildsen Siphon
56.45	Salt Creek Siphon and Check (P/R/C/UC)
57.?	Stovall Check (B)
58.?	Spring Creek Siphon (M)

MI	Structure
60.87	Zumwalt Check (P/R/C)
62.04	Husted Check (P/R)
62.60	I-5 Check & Freeway/Railroad Siphon (P/R)
62.72	I-5 Check & Railroad Siphon (Weir) Fixed weir with slide gate in center
62.89	Check (R)
63.35	Check (R)
63.67	Check (R)
64.11	Check (R)
64.36	Check (R)
64.59	Check (R)
64.95	Check (R)

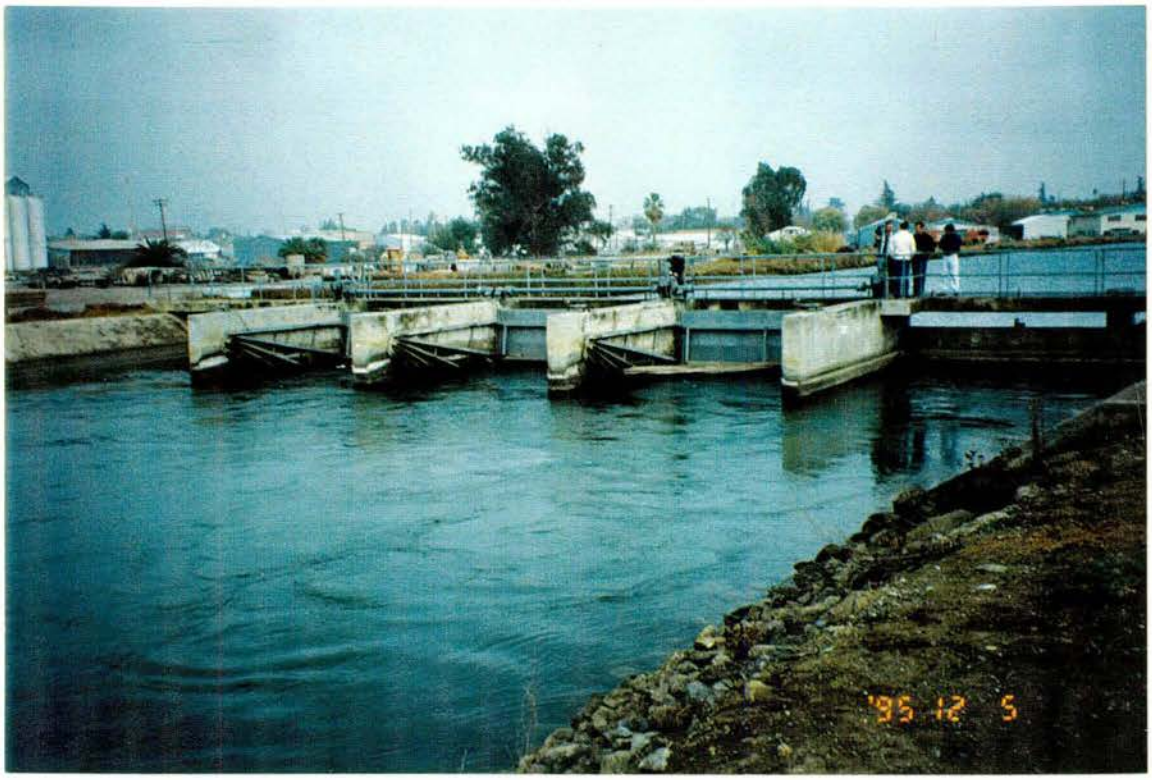
- The Willows check structure is a typical radial gate structure. Because of its proximity to the District's office, it would be an excellent site for first phase modernization activities.

Photograph 1. - Willows check - typical radial gate check structure on Glenn Colusa canal.

Photograph 2. - Willows check.

The district would like to pursue automating some sites prior to the 1996 irrigation season. The first stage of automation at these sites would be remote monitoring and control. Automatic control at the Willows check structure could be accomplished first since it is close to the GCID headquarters and most of the equipment is currently in place. Some of the main check structures along the canal and solar powered sites at the key turnouts and laterals could be added. One of the District's highest priorities is to better control and monitor the relift and reuse stations at the major drainage weirs where drain water leaves the irrigation district. Installing computer hardware and software at the master station and establishing a communications system that will monitor and control the remote sites are a major priority.

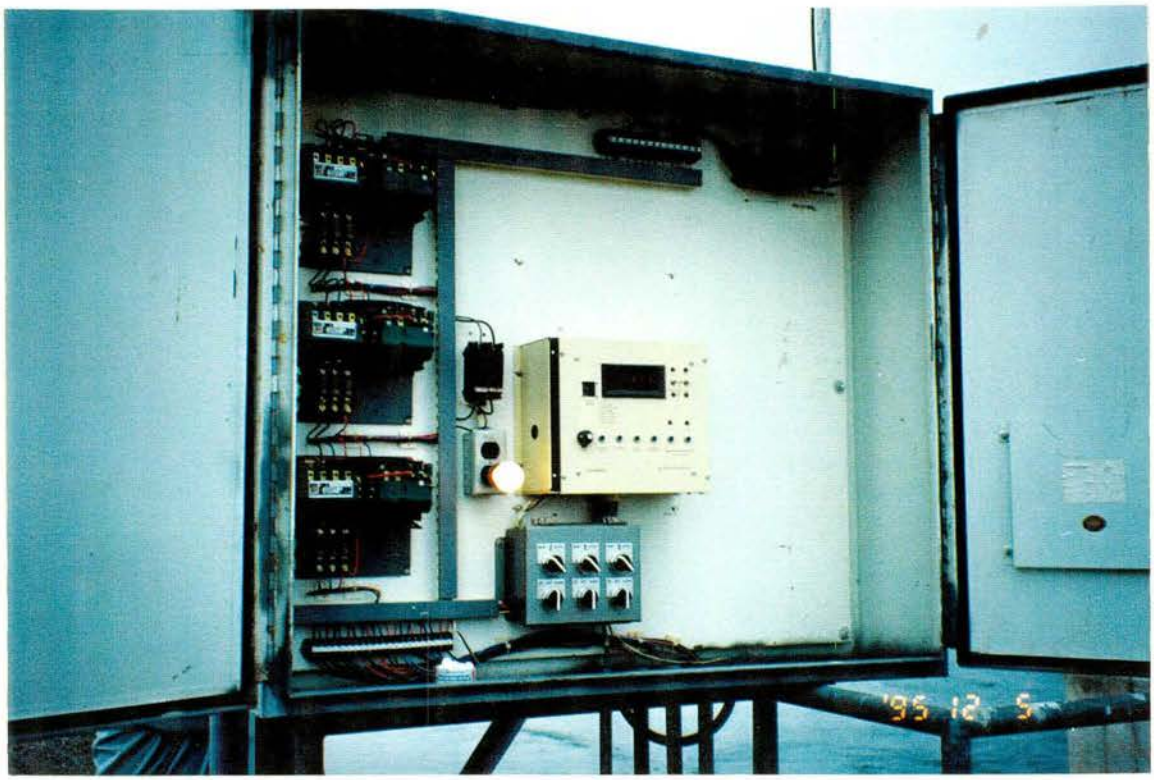
- The turnout to the Sacramento Wildlife Refuge at mile post 26.2 (photograph 4) with a flowmeter would be another good site to add to the telemetry network in the early phases. The turnout flows could be continuously controlled and recorded by adding a solar powered RTU, motorizing the gates in photograph 4, and adding a current output to the flowmeter to telemeter the flow data to the master (photograph 5.)

Photograph 3. - Willows check - controller by Sierra Controls. (Not used in automation mode in 10 years.)

Photograph 4. - Lateral 26.2 - to Sacramento National Wildlife Refuge, 80-100 ft^3/s in winter.

Photograph 5. - Lateral 26.2 - Micrometer propeller flowmeter. Flow measured in one of two outlets to FWS refuge and lateral.

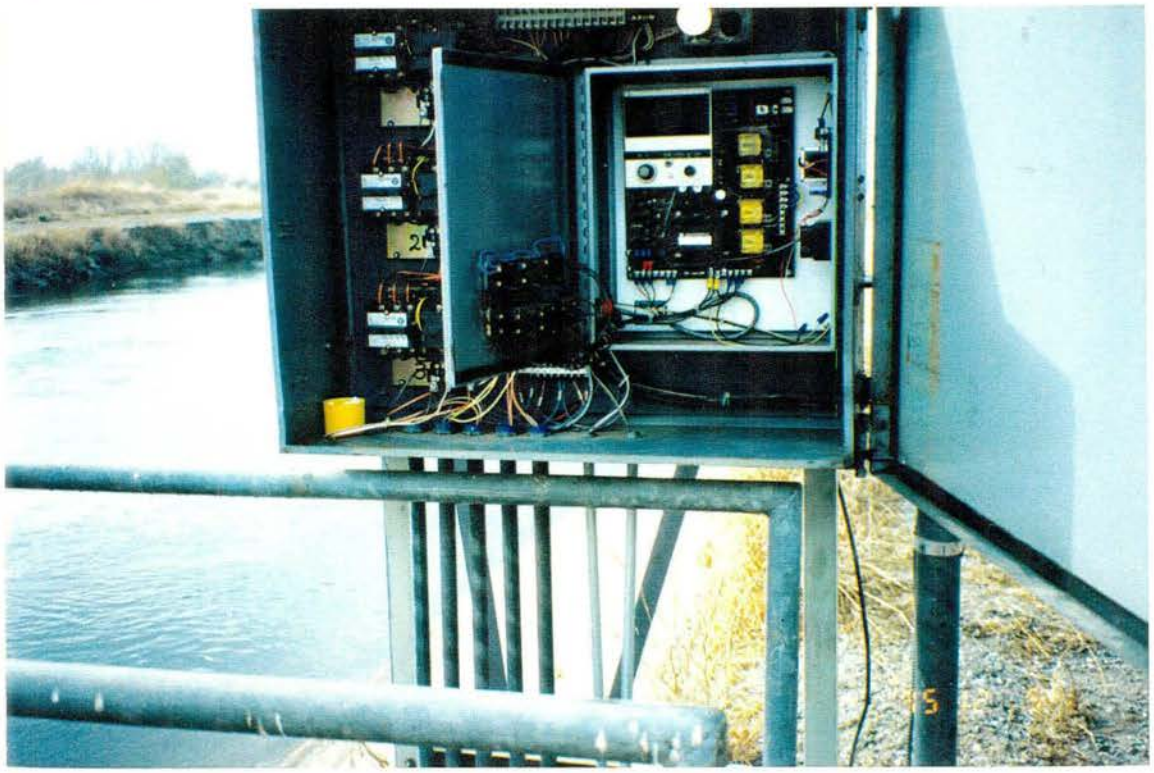
- The control unit at Walker check (photograph 6) should be replaced since it is a key control site on the canal.

- Tuttle check and Willard check (photographs 7, 8, and 9) have vertical slide gates. Some of these gates have problems with binding. Simultaneous operation of all of the gates may be helpful in alleviating this problem. When an additional gate is opened from a fully closed position under a large head differential to increase flow, binding occurs. Automatic control of several gates operating in unison would avoid the need to open additional gates from fully closed positions.

- Clint lateral turnout (photograph 10) would be a excellent site for automation of a lateral turnout structure. The canal water surface elevation experiences quite a bit of fluctuation at this point and the ditchriders try to keep a constant water

surface elevation in the pool just downstream of the turnout structure. An automated algorithm could do this job continuously and make more consistent deliveries.

Photograph 6. - Control unit (Sierra Controls) at Walker check. Still automatically controls upstream water level.

Photograph 7. - Tuttle check.

Photograph 8. - Willard check - vertical slide gates in bulkhead slots. Some problems are encountered with binding gates.

Photograph 9. - Willard check.

Photograph 10. - Clint lateral - bifurcates into two lateral canals downstream.

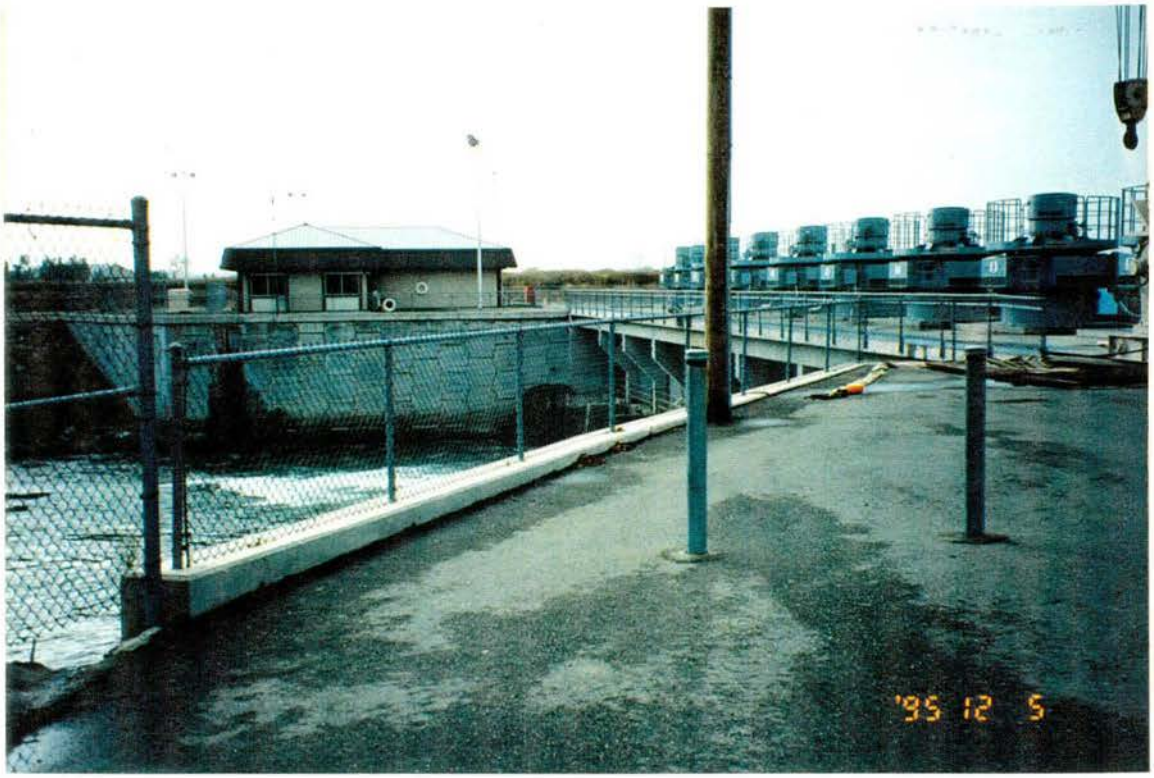
- Photograph 11 shows the main pumping plant. The plant is controlled by Allen-Bradley controllers. These controllers are well suited to plant operations; however, they need to be updated. If newer generation Allen-Bradley controllers are chosen, the data could be interpreted by an Allen-Bradley driver for the Genesis or Wonderware software at the master site or at the alternate master site (the pumping plant). The data from the canal control system can then be used in a supervisory control mode to make flow changes at the pumping plant.

Photograph 11. - Glenn Colusa canal - main pumping plant on the Sacramento River.

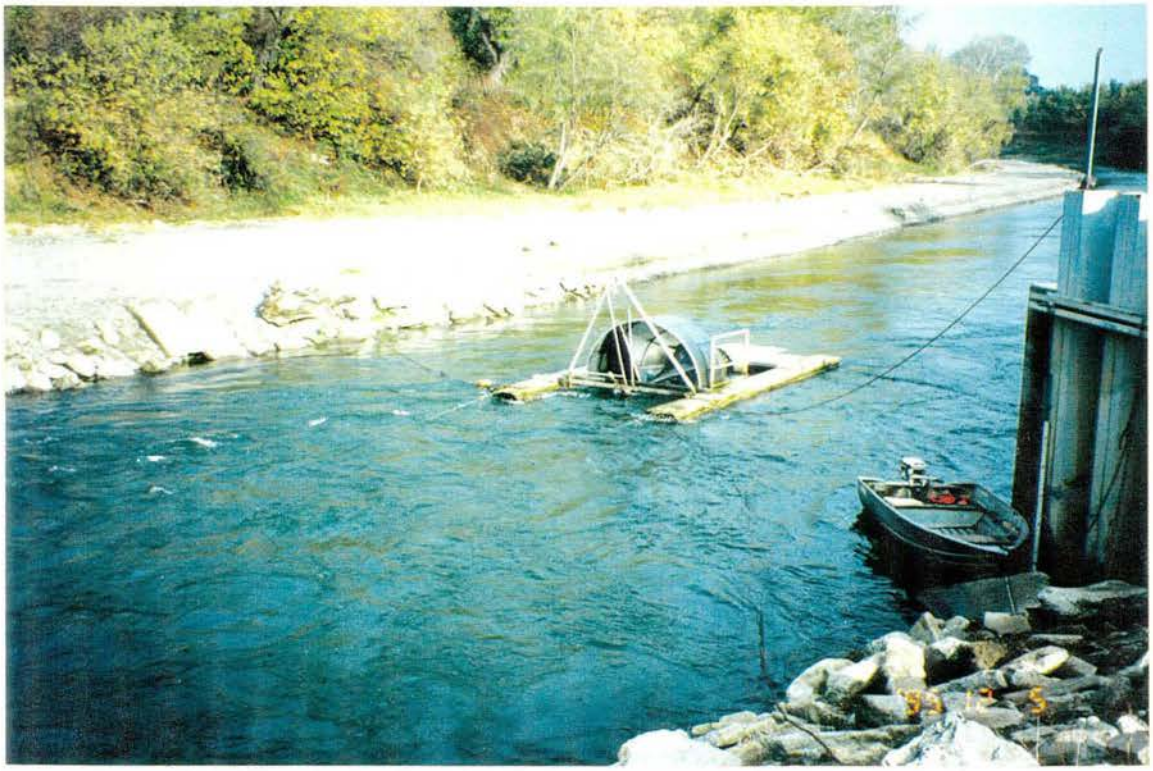
- The powerplant operation at the Tehama-Colusa Canal inflow (photograph 13) could also be automated or remotely controlled from the master station.

- Many of the lateral/sub-lateral branches of the system (photograph 14) could eventually be automated if some simple motorized gates and solar power are installed at key delivery points in the lateral system.

Photograph 12. - Glenn Colusa pumping plant bypass flow (note fish trap).

Photograph 13. - Powerplant on Tehama Colusa intertie. A 19-ft head drop and 150 ft^3/s generate electricity with two turbines.

Photograph 14. - Turnout site from a lateral canal to a sublateral. Possible site for a motorized gate to control flow distribution in a lateral/sublateral distribution system.
