GR-86-1

PROPERTIES OF CONCRETE IN AMERICAN FALLS REPLACEMENT DAM: 1- AND 5-YEAR CORE REPORT

December 1985
Engineering and Research Center

U.S. Department of the Interior
Bureau of Reclamation
Division of Research and
Laboratory Services
Concrete and Structural Branch

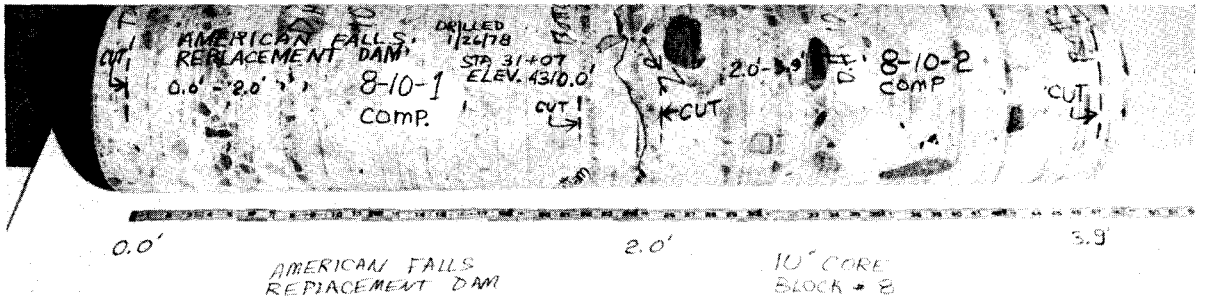
Figure 1. – Typical 10-in-diameter concrete core, American Falls Replacement Dam.

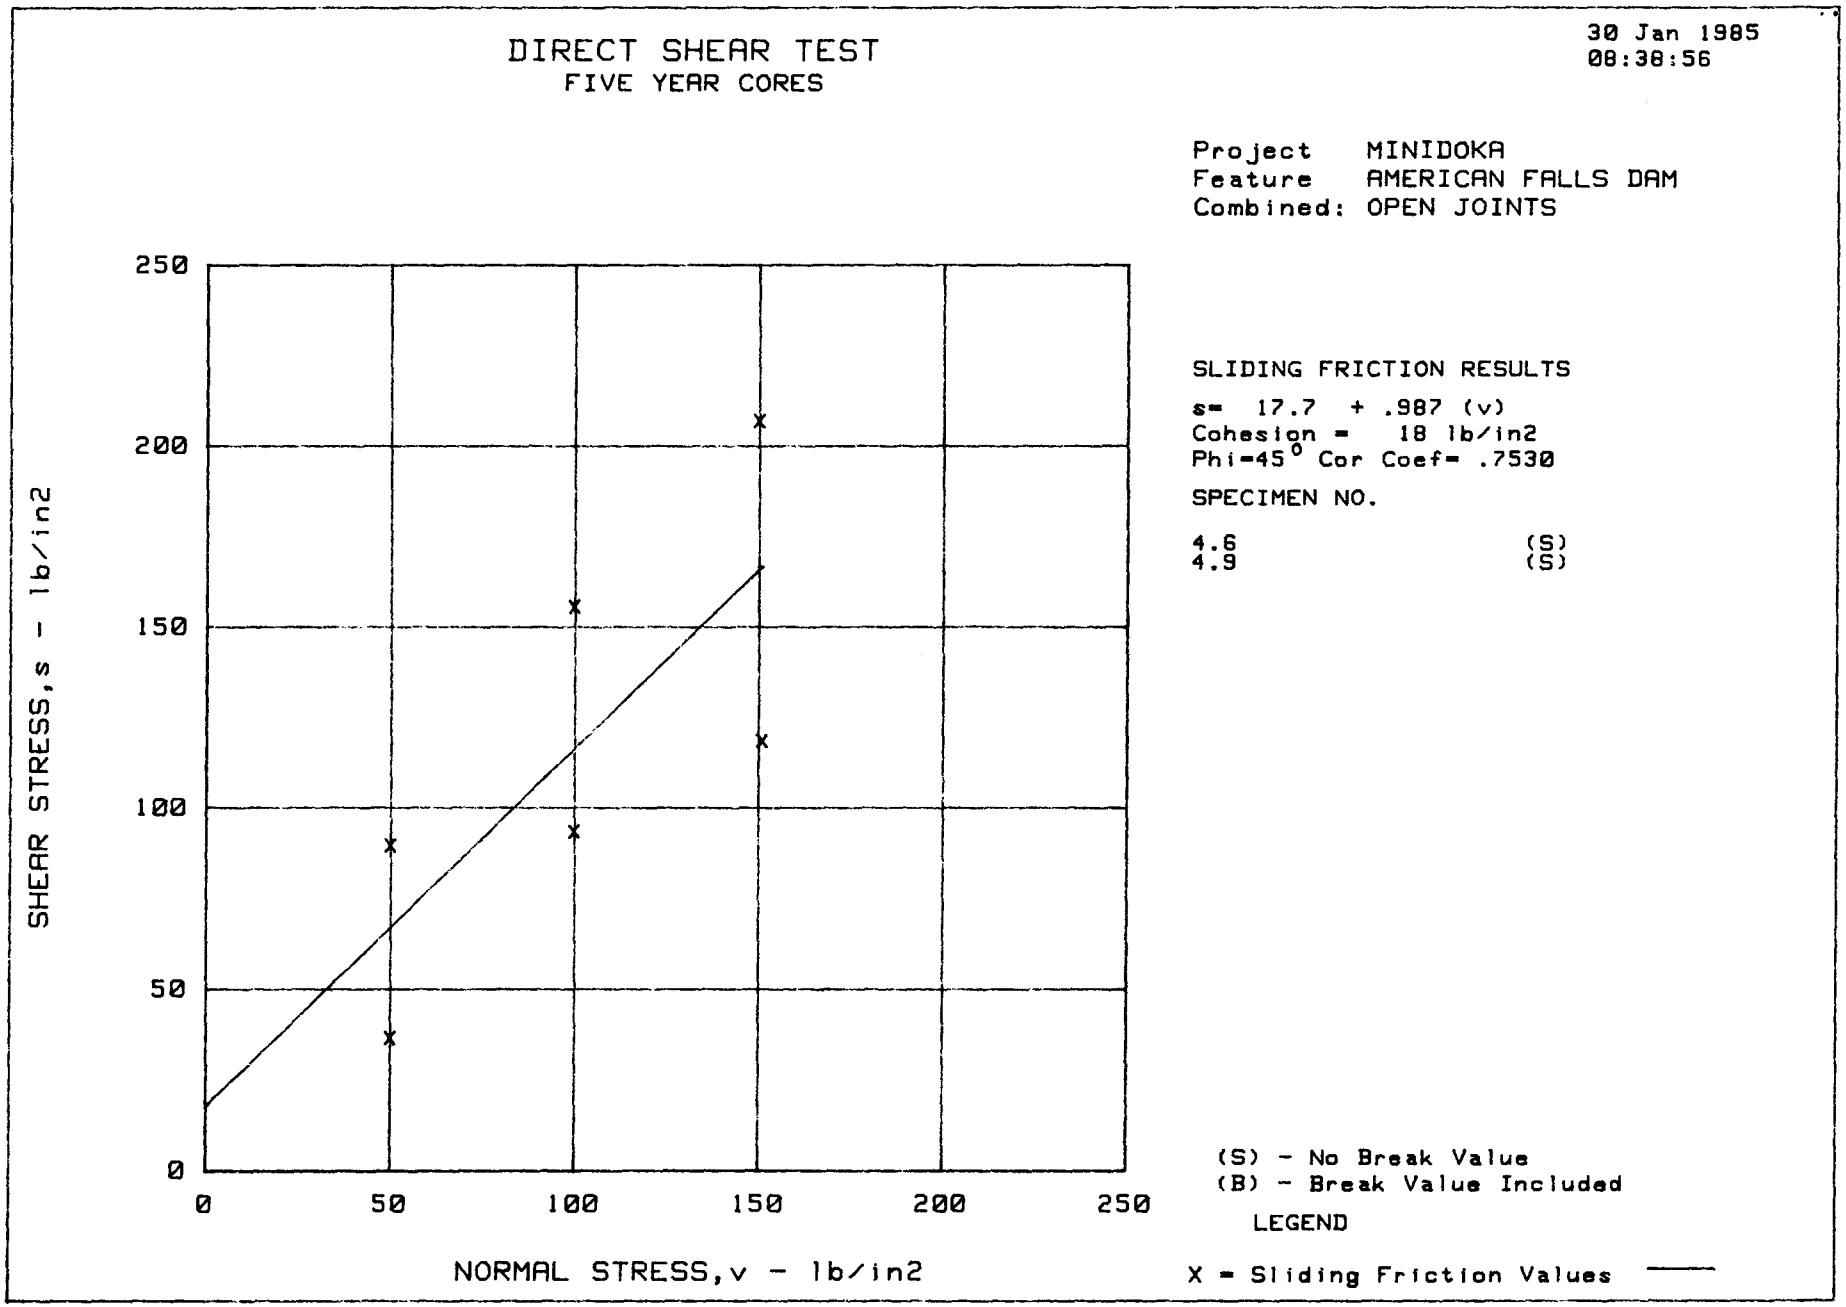
Figure 1

Results of linear regression analyses of test data are summarized in table 1. Before and after testing photographs of the specimens, shear stress versus displacement plots, and a linear regression analysis summary sheet and plot for each specimen are shown in the appendix. A combined linear regression analysis of the sliding friction data from both specimens is summarized in table 2 and shown graphically on figure 1.

DIRECT SHEAR TEST
FIVE YEAR CORES
30 Jan 1985
08:38:56
Project MINIDOKA
Feature AMERICAN FALLS DAM
Combined: OPEN JOINTS
SLIDING FRICTION RESULTS
s= 17.7 + .987 (v)
Cohesion = 18 lb/in2
Phi=45° Cor Coef= .7530
SPECIMEN NO.
4.6 (S)
4.9 (S)
(S) - No Break Value
(B) - Break Value Included
LEGEND
X = Sliding Friction Values
SHEAR STRESS,s - lb/in2
NORMAL STRESS,v - lb/in2
0
50
100
150
200
250

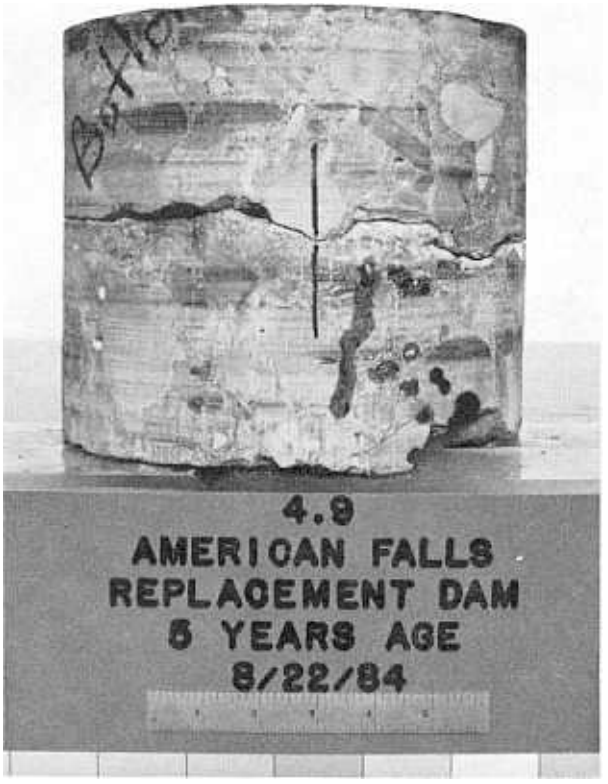
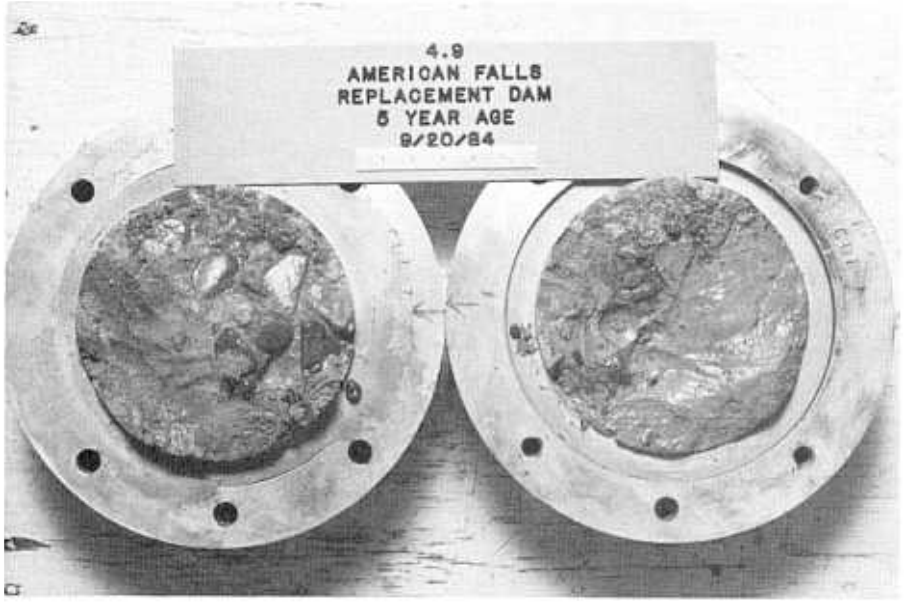
The test specimens contained dry, open construction joints with no sign of water staining or deterioration of the aggregate or cement.

Specimen before testing
(Parallel to sliding direction)

Specimen before testing
(Plan view of sliding surface)

Specimen after testing
