BUREAU OF RECLAMATION

Technical Report No. ENV-2020-019

Elephant Butte Reservoir 2017 and 2019 Sedimentation Survey

Rio Grande Project, New Mexico
Upper Colorado Region

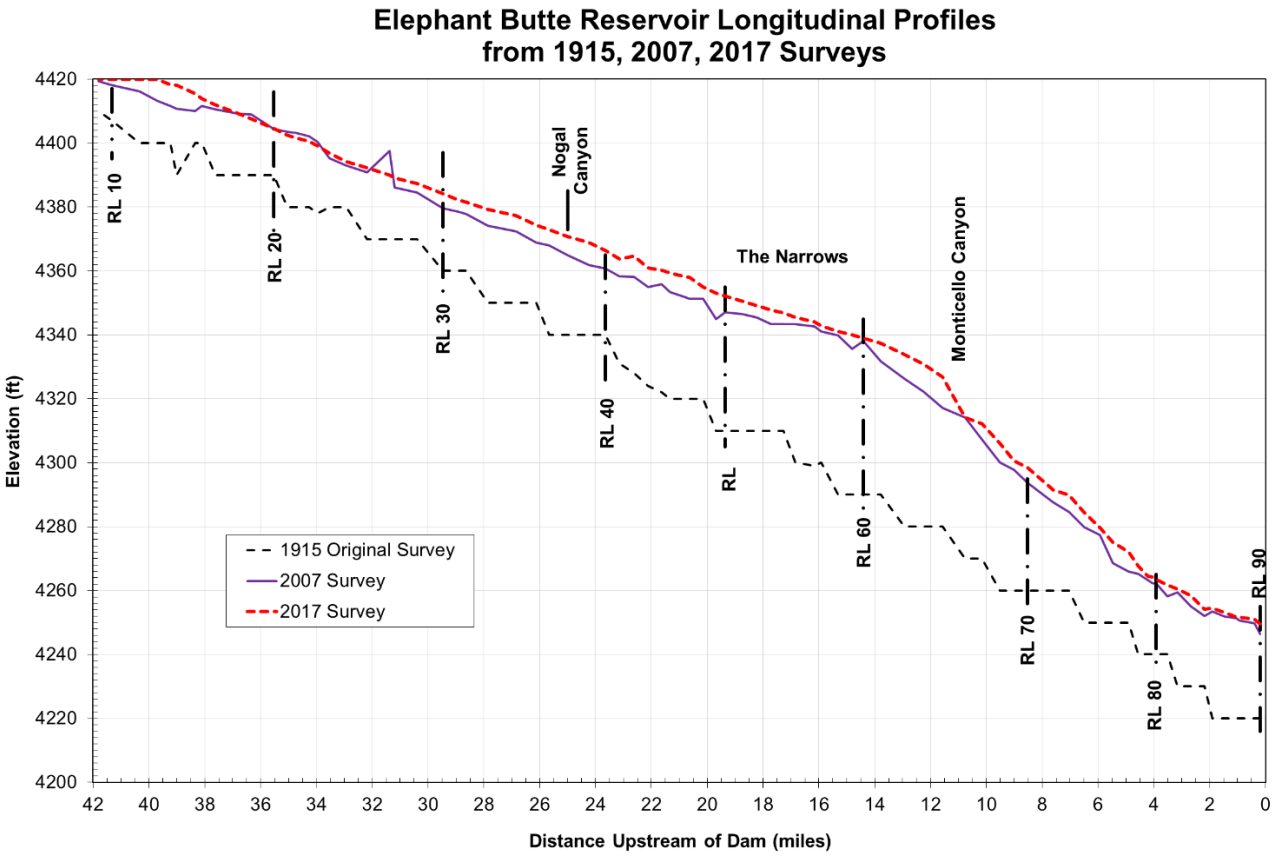
A longitudinal profile and representative cross sections of the 2017 and 2019 reservoir bottom were developed in GIS. The longitudinal profile (Figure 8) indicates a break in slope at about 12 miles upstream from Elephant Butte Dam (near Monticello Canyon). This is also where the sediment deposition profile is thickest. A break in profile slope is common where the delta topset slope may be about one-half the upstream river slope and the downstream foreset slope may be about six times the river slope (Stand and Pemberton, 1982; Morris and Fan, 1998; and Randle et al., 2006). The 2017 and 2019 longitudinal profiles were digitized along the thalweg which meanders along the reservoir alignment for a total length of 50 miles. For comparison with previous reservoir sediment profiles, the longitudinal stationing of the 2017 and 2019 profile was adjusted to the stationing of straight-line segments between established range lines for a total length of 42 miles (Figure 9).

Figure 8. Longitudinal profiles of the Elephant Butte Reservoir bottom between upstream river range line 9 and Elephant Butte Dam (near range line 90).

Sedimentation accumulates along the entire reservoir length, at all reservoir elevations, and against Elephant Butte Dam (Figure 8). The early range-line surveys showed about 12 feet of variation in the lowest reservoir elevation (Figure 16). By the 1969 survey, sedimentation near the dam significantly increased the lowest reservoir bottom elevation and effectively eliminated the dead storage. The reservoir storage capacity below the power penstock invert has been decreasing over time (Figure 17). In the absence of reservoir sediment management, non-linear extrapolation of the trend line suggests that the storage capacity below the power penstock will be eliminated within the next two centuries. The reservoir dead storage has already been filled with sediment, so future sedimentation may reduce the reliability of the outlet works as large wood and sediment accumulate around the trash rack. This occurred at Paonia Reservoir near Paonia, CO (Collins and Kimbrel, 2015). Once sedimentation has reached the invert of the power penstock, additional sedimentation and large wood may reduce the reliability of the penstocks.

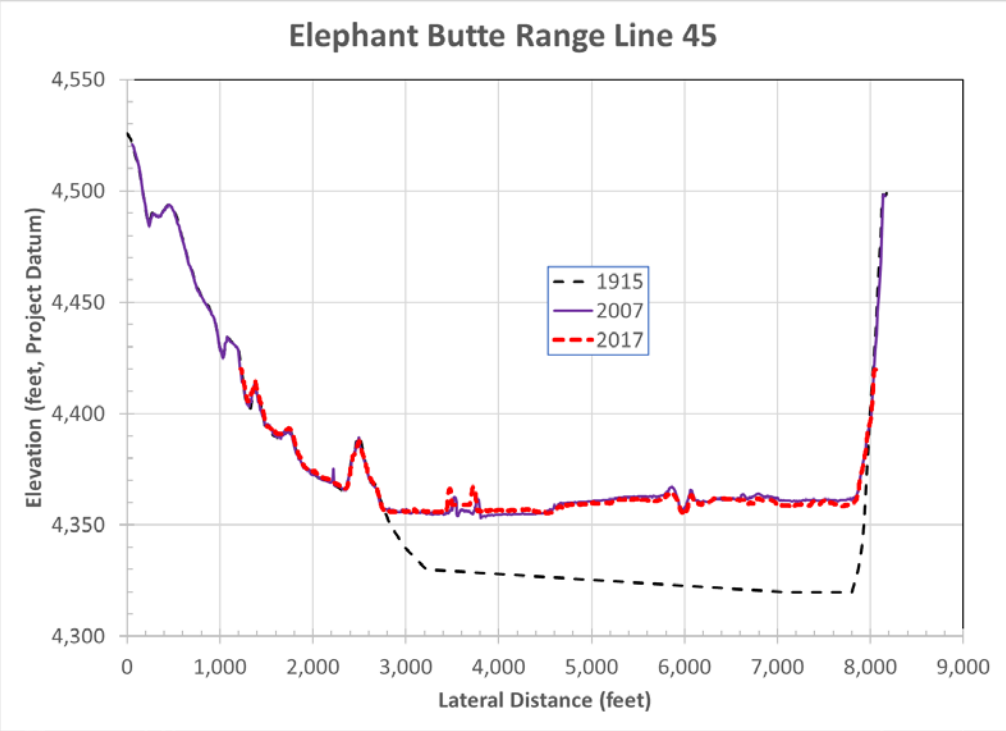
Reservoir cross section plots (Figure 10, Figure 11, Figure 12, and Figure 13) show the lateral distribution of sediment deposits. In general, reservoir sedimentation tends to be flat across the reservoir. However, the delivery of sediment from tributary arroyos can produce a cross slope where tributary deltas intersect the main delta (Figure 10 and Figure 11). Along most of the exposed delta, the Rio Grande flows through a single channel with levees on both sides (Figure 10, Figure 11). Distributary delta channels are evident where the Rio Grande intersects the drawn down reservoir pool.

Figure 10. Cross section of the reservoir delta at range line 45 (looking upstream), 21.3 miles upstream from the Elephant Butte Dam.

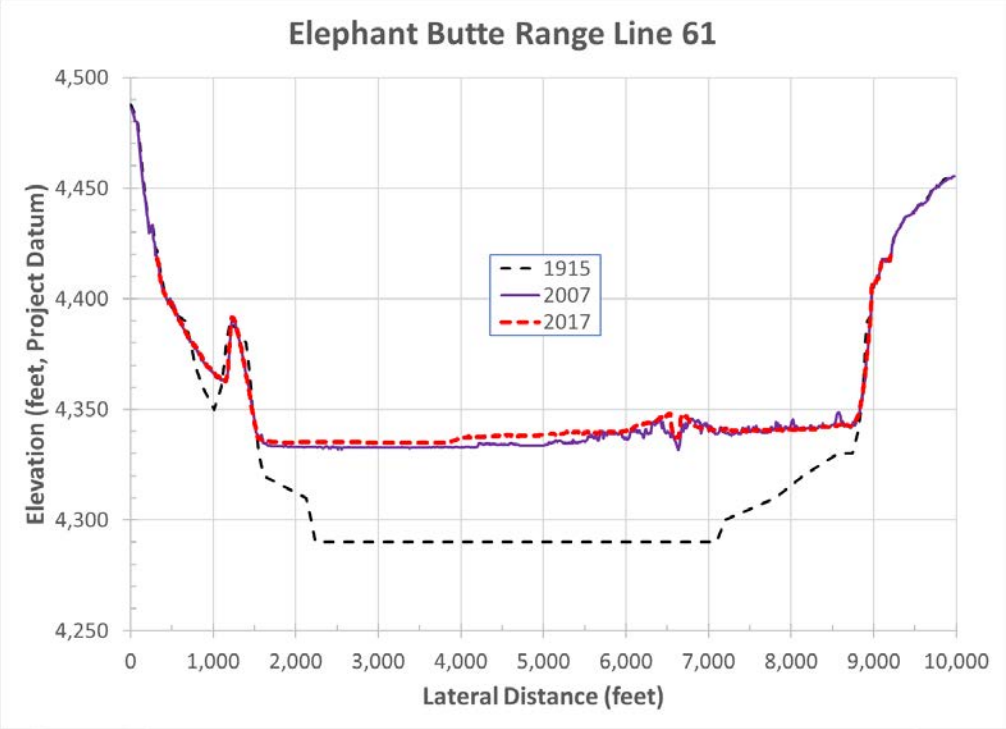
Figure 11. Cross section of the reservoir delta at range line 61 (looking upstream), 13.8 miles upstream from the Elephant Butte Dam. Sediment contributions from Monticello Canyon from the right (west) side are likely responsible for the cross slope between lateral stations 5,200 and 8,800 feet.

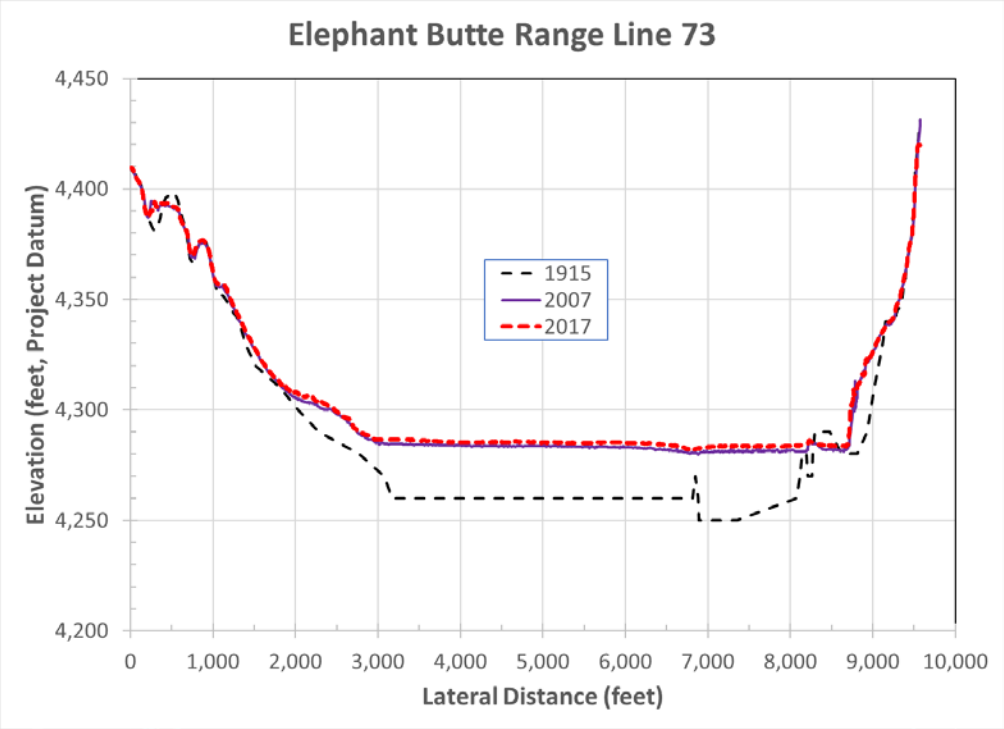
Figure 12. Cross section of the reservoir delta at range line 73 (looking upstream), 6.5 miles upstream from the Elephant Butte Dam.

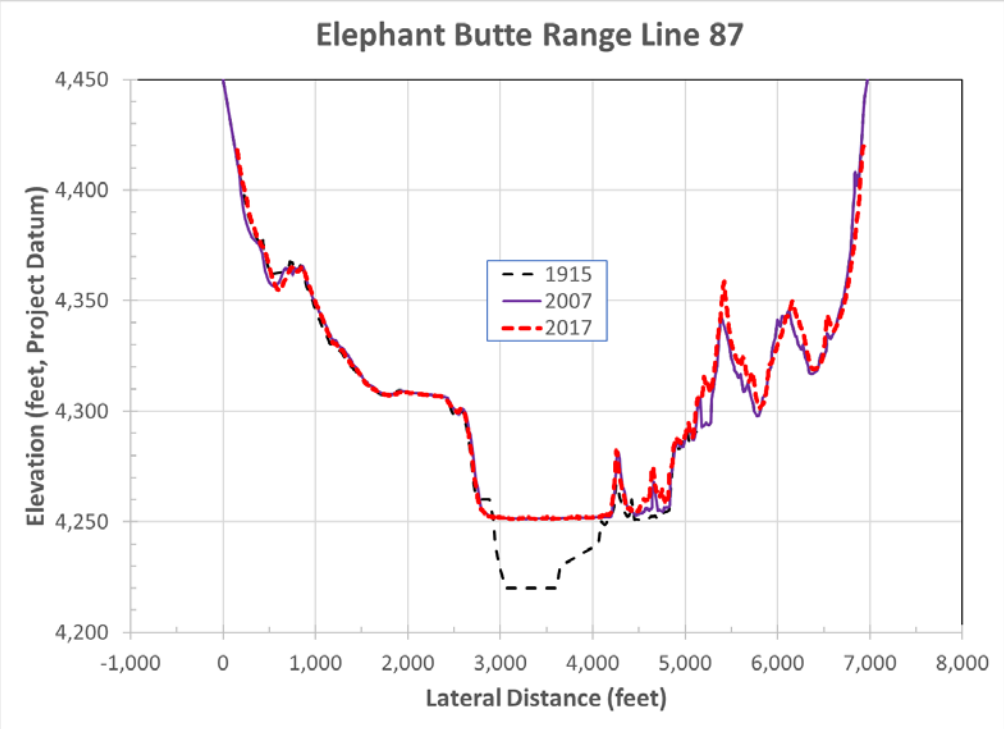
Figure 13. Cross section of the reservoir delta at range line 87 (looking upstream), 1.0 mile upstream from the Elephant Butte Dam.

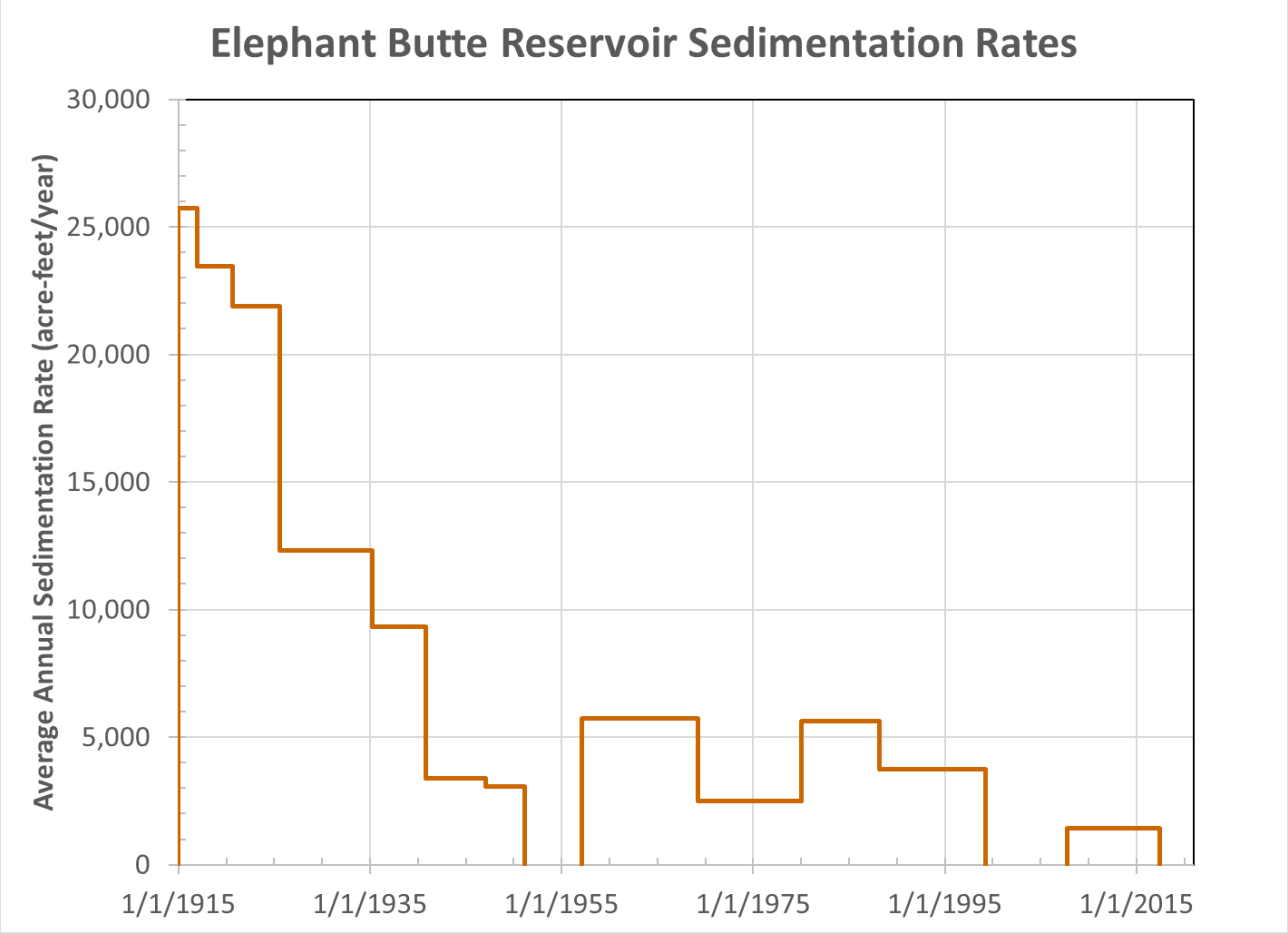
Graphs of the historic reservoir sedimentation rates over time (Figure 14) and cumulative reservoir sedimentation volume over time (Figure 15) indicate initially high sedimentation rates that decreased from 1915 through the mid 1950's. Sedimentation rates were more consistent between 1957 and 1999. Sedimentation rates could not be determined when there was a change in the range line survey method in 1957 and when multibeam survey was introduced in 2007. Sedimentation rates have been low (1,400 acre-feet/year) between 2007 and 2017, which is likely due to below average water years from 2010 through 2016 (Figure 3). The low reservoir sedimentation rate corresponds to a very low sediment yield rate of 0.1 acre-feet/mi^2/year from the upstream watershed. Future sedimentation rates are expected to increase during periods of above average Rio Grande flows.

Figure 14. Average Elephant Butte Reservoir sedimentation rates over time. Data are based on Reclamation (1960) and Ferrari (2008).

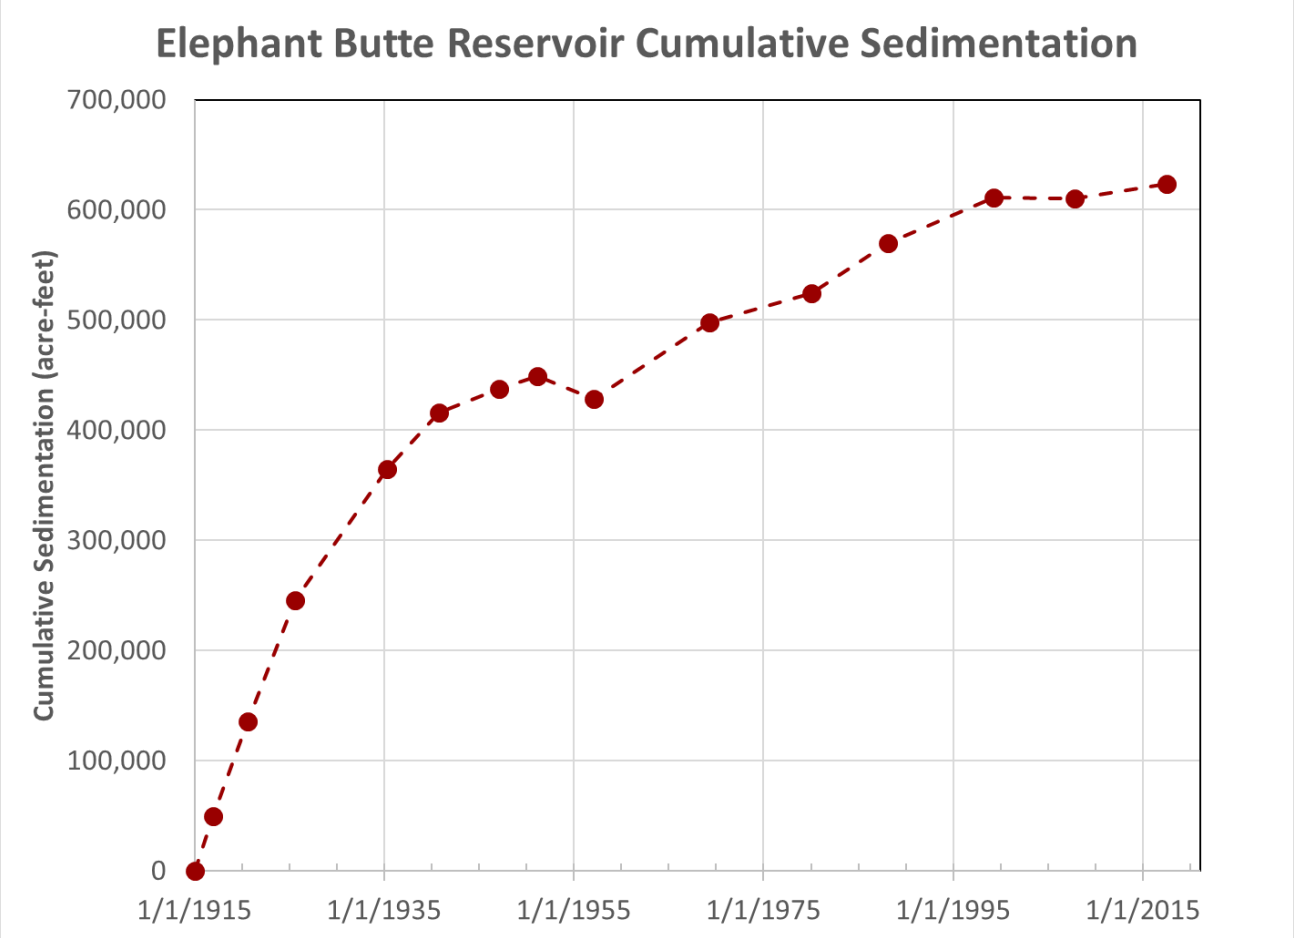
As of the 2017 and 2019 survey, the total sedimentation in Elephant Butte Reservoir was 624,000 acre-feet (1.0 billion yd^3), which is 24 percent of the original storage capacity. This sedimentation volume is more than six times the storage capacity of a median-sized Reclamation reservoir (100,000 acre-feet).

Figure 15. Cumulative sedimentation in Elephant Butte Reservoir over time.

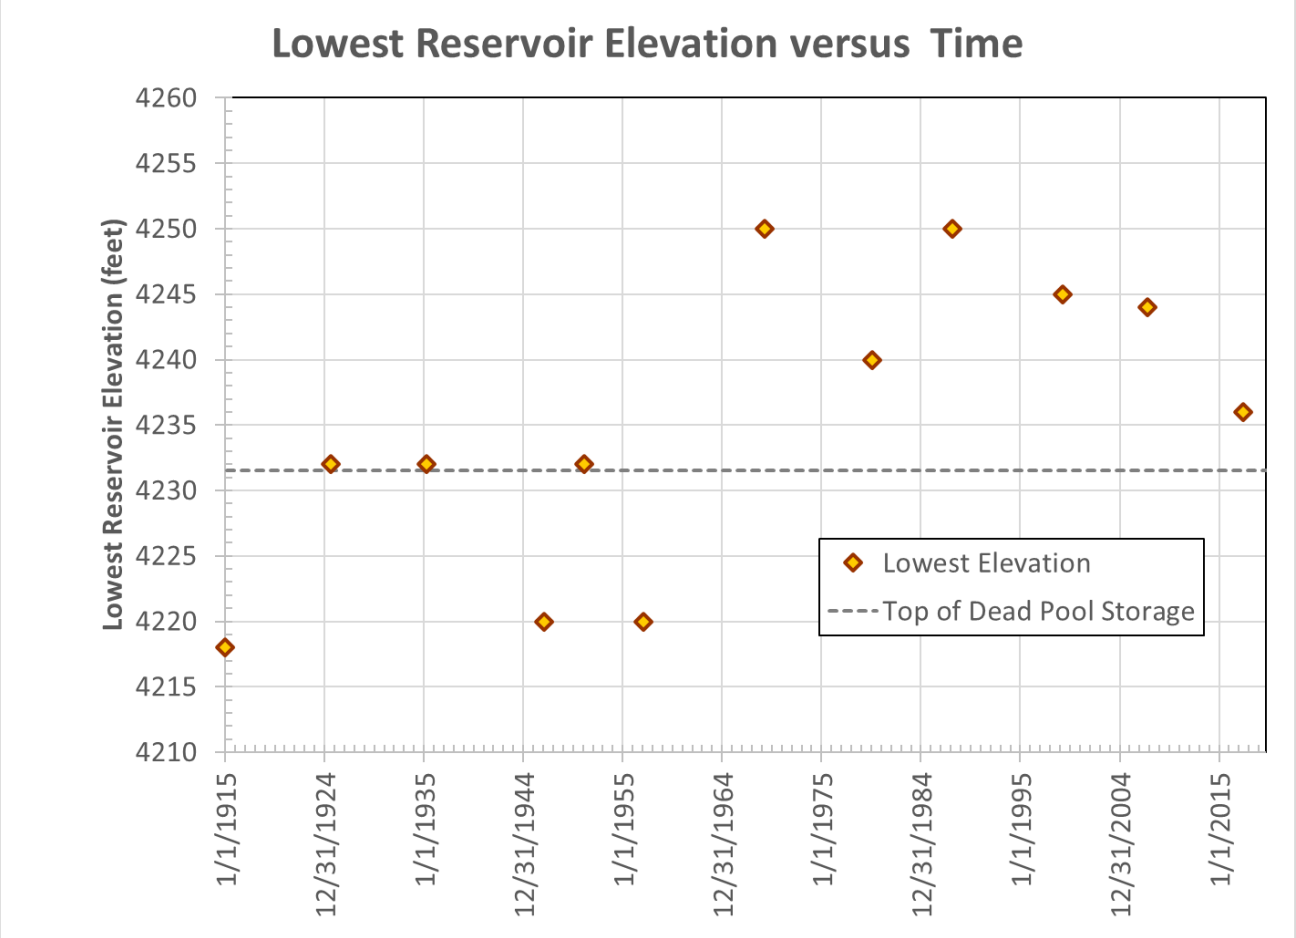
Figure 16. Sedimentation near the dam increase the lowest reservoir elevation over time.

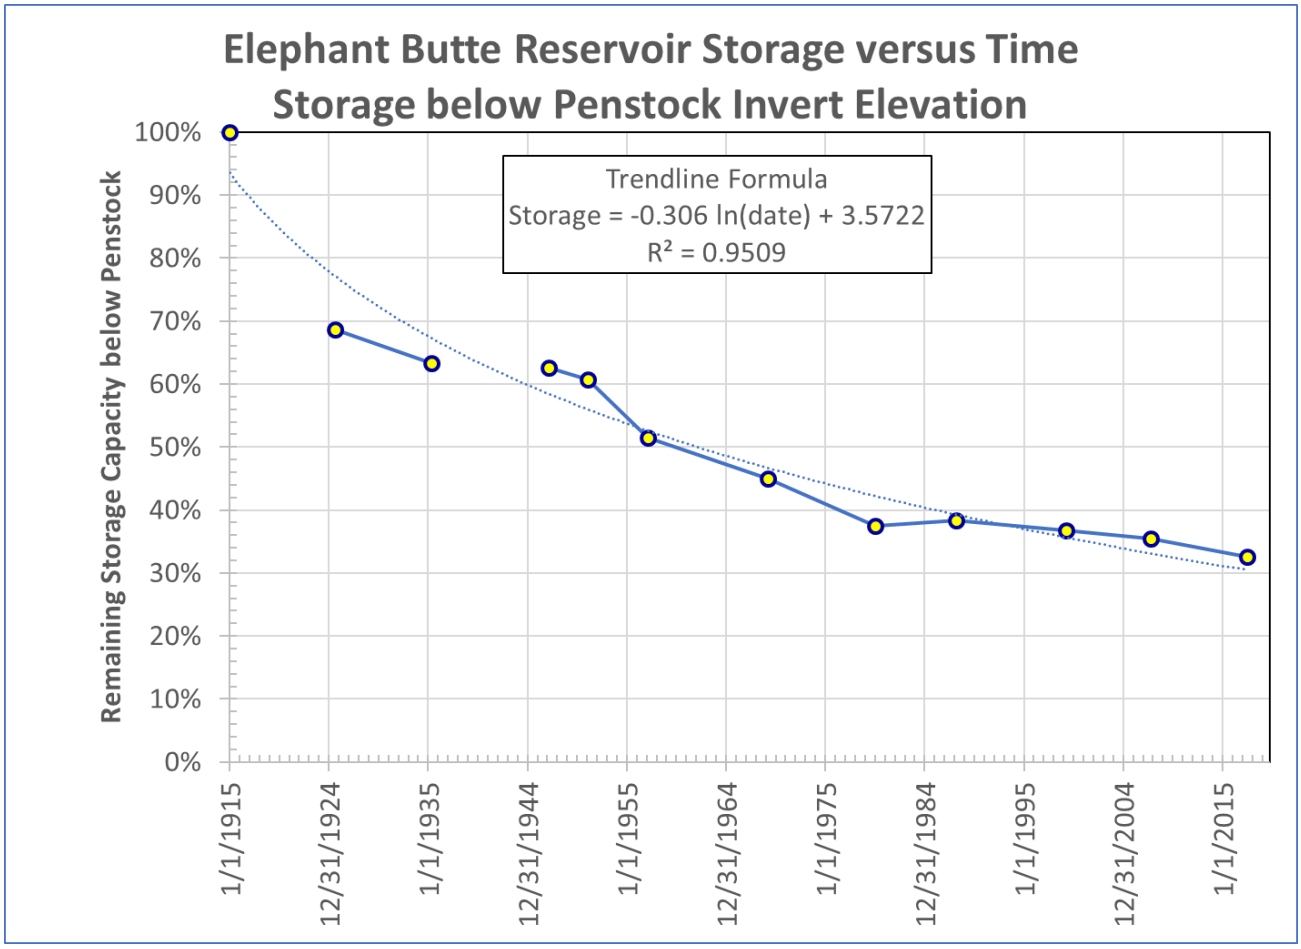
- The dead storage pool volume was filled with sediment by the late 1960's. The reservoir pool below the invert of the power penstock valve has been reduced to 33 percent of the original penstock storage volume, a loss of 67 percent. The sedimentation level at the dam is 4236 feet (project vertical datum), which is about 4 feet higher than the invert of the outlet works valve.

Figure 17. Sedimentation is reducing the reservoir storage capacity below the elevation of the power penstock over time. Extrapolation of the trendline suggests the storage capacity below the power penstock will be filled with sediment within the next two centuries.

Based on the past rates of sedimentation, the next survey of Elephant Butte Reservoir is recommended within the next decade (by 2029), after a 10-year flood peak on the Rio Grande, or after a large wildfire in the sediment-contributing watershed. The next reservoir survey should again employ a multibeam depth sounder for the bathymetric survey and LiDAR for the above-water topography. The bathymetric and LiDAR surveys should be conducted in the same water year if possible.
