New York Canal

Canal Assessment Session – Denver, Colorado

May 14, 2008

New York Canal Special Review

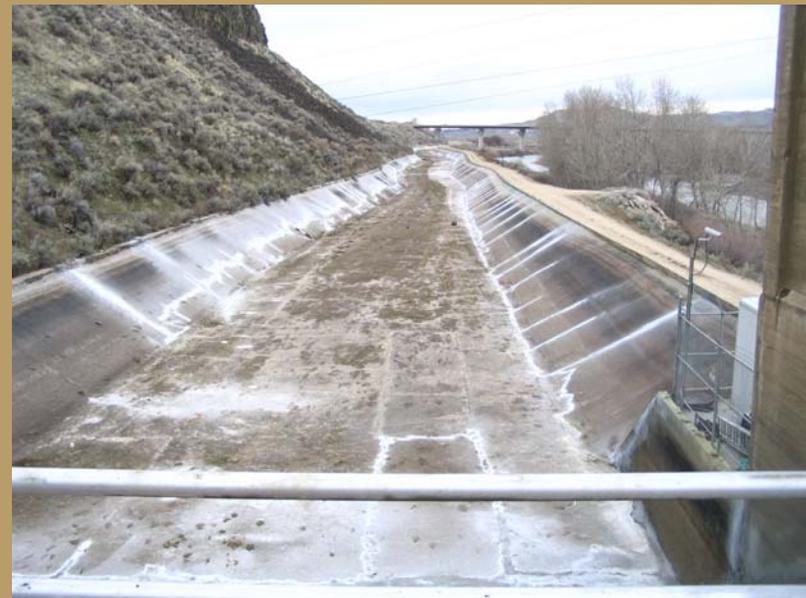
View from Boise River Diversion Dam

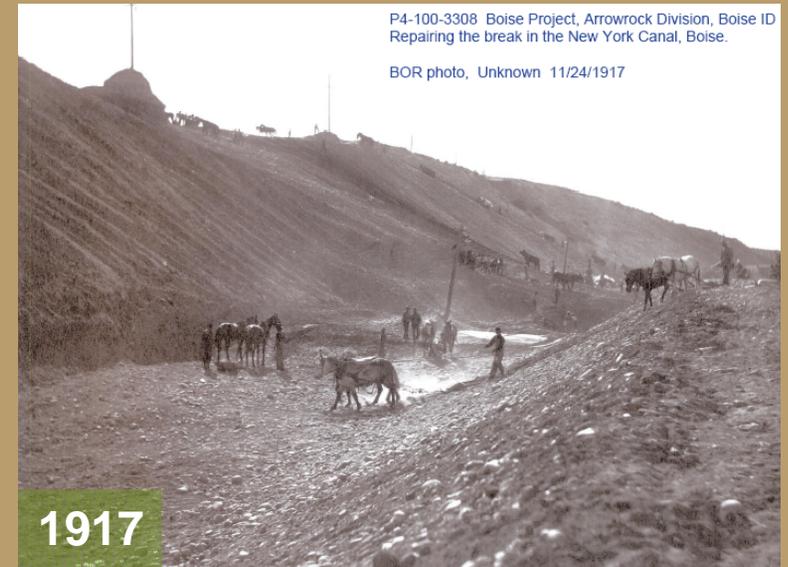
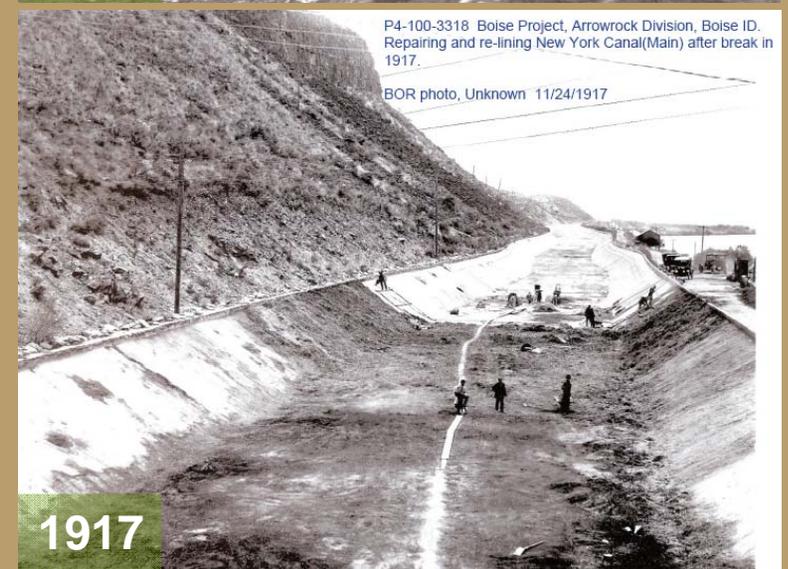
- Features – 40 miles, 2,800 cfs, 8 feet deep, 40' bottom width
- Has operated for a hundred years – (1906-08, enlarged 1909-12)
- Construction practices – horsepower!
- Past Failures
 - 1917, 1955
- Current condition
- Recent scares

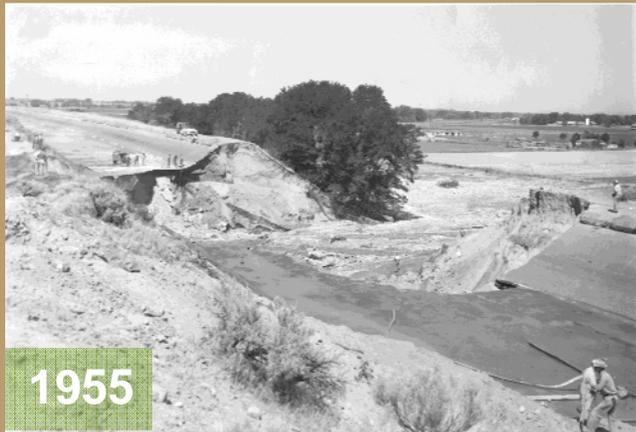
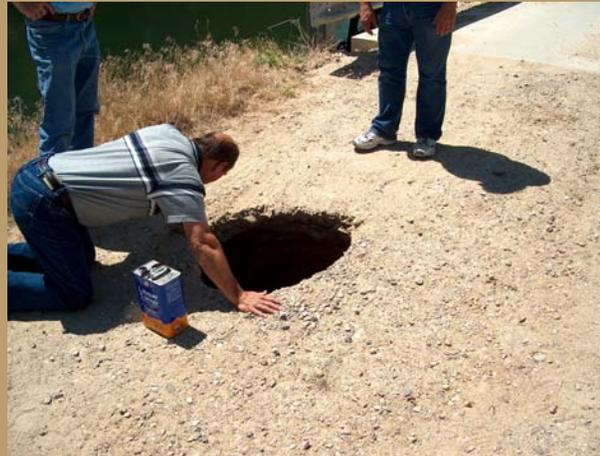
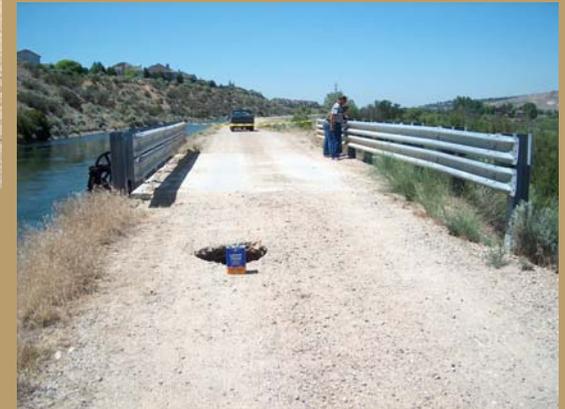
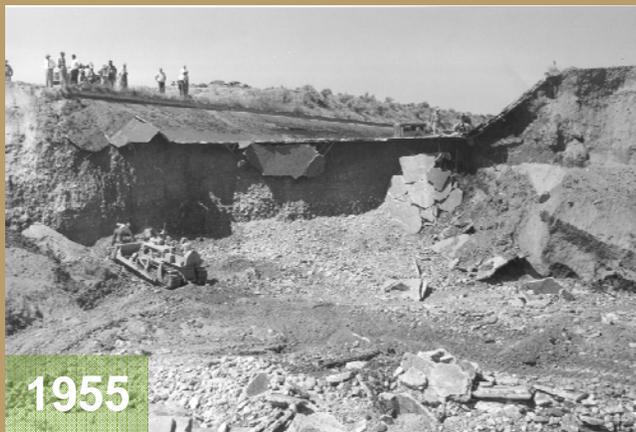
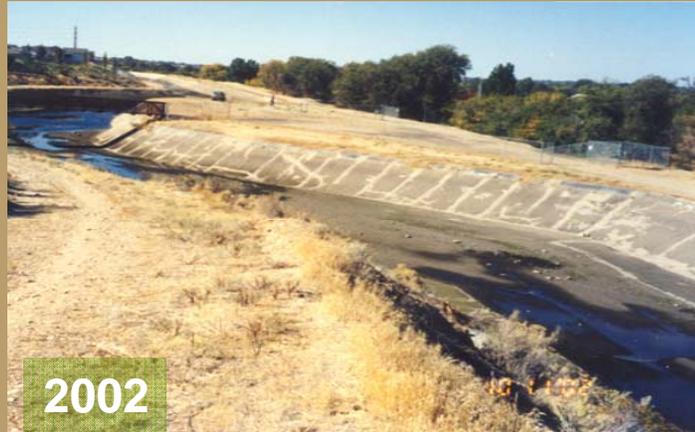
New York Canal Past Performance (cont.)

Canal history (failures, seepage, flooding, overtopping, past problem Canal Break 1955 (seepage), Several near failures since 1955: TS17, large failure 1917)

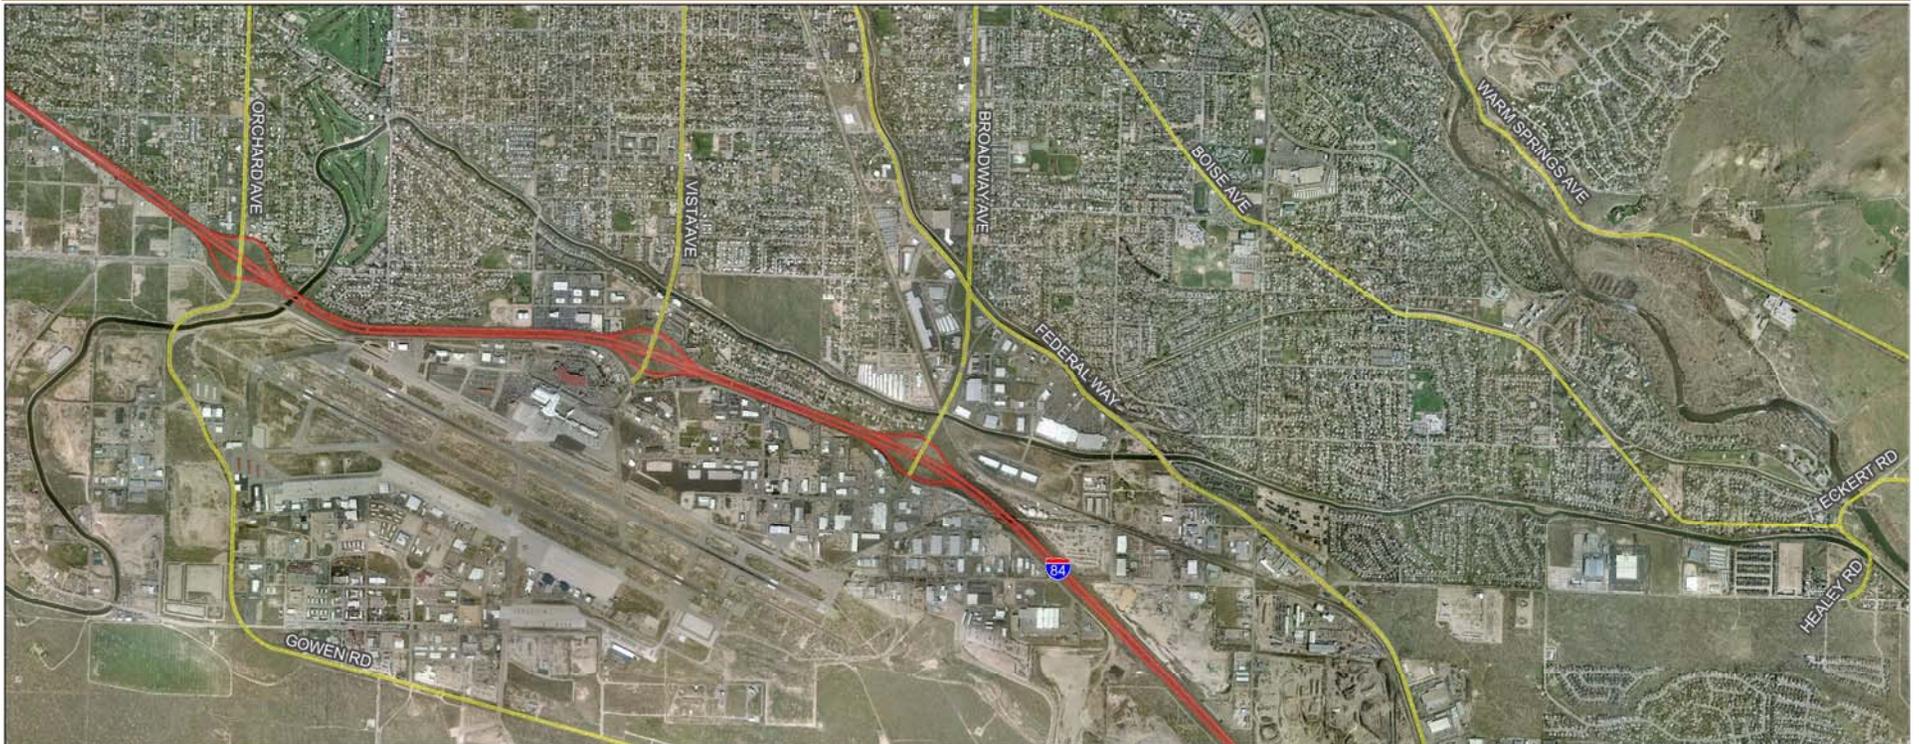
- **Mile post 2.5 to Mile Post 10.8**
 - **3-25-08**
 - Healey Rd. to Vista Ave. then I-84 to Gowen Rd. (no water in canal)
 - **5-2-08**
 - Vista Ave. to Gowen Rd. ($\approx 2,350$ ft³/s in canal)
