HYDRAULIC LABORATORY REPORT NO. 189
TESTS ON 24-INCH
HOLLOW-JET VALVE AT BOULDER
DAI

Denver, Colorado,
Nov. 29, 1945

Subject: Tests on 24-inch hollow-jet valve at Boulder Dam.

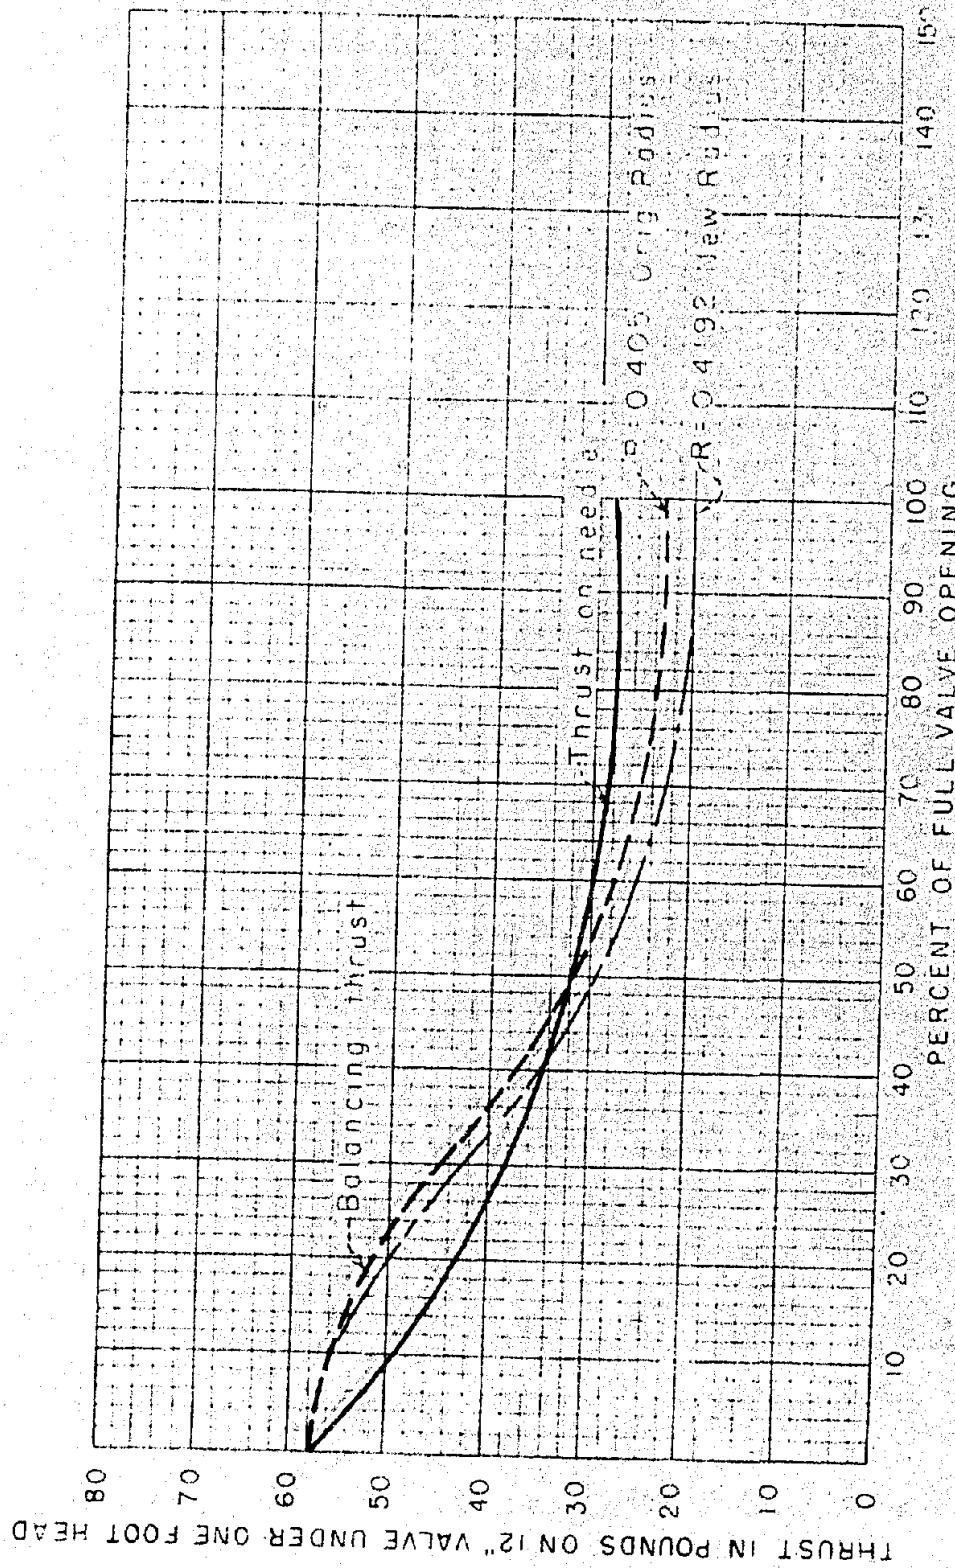
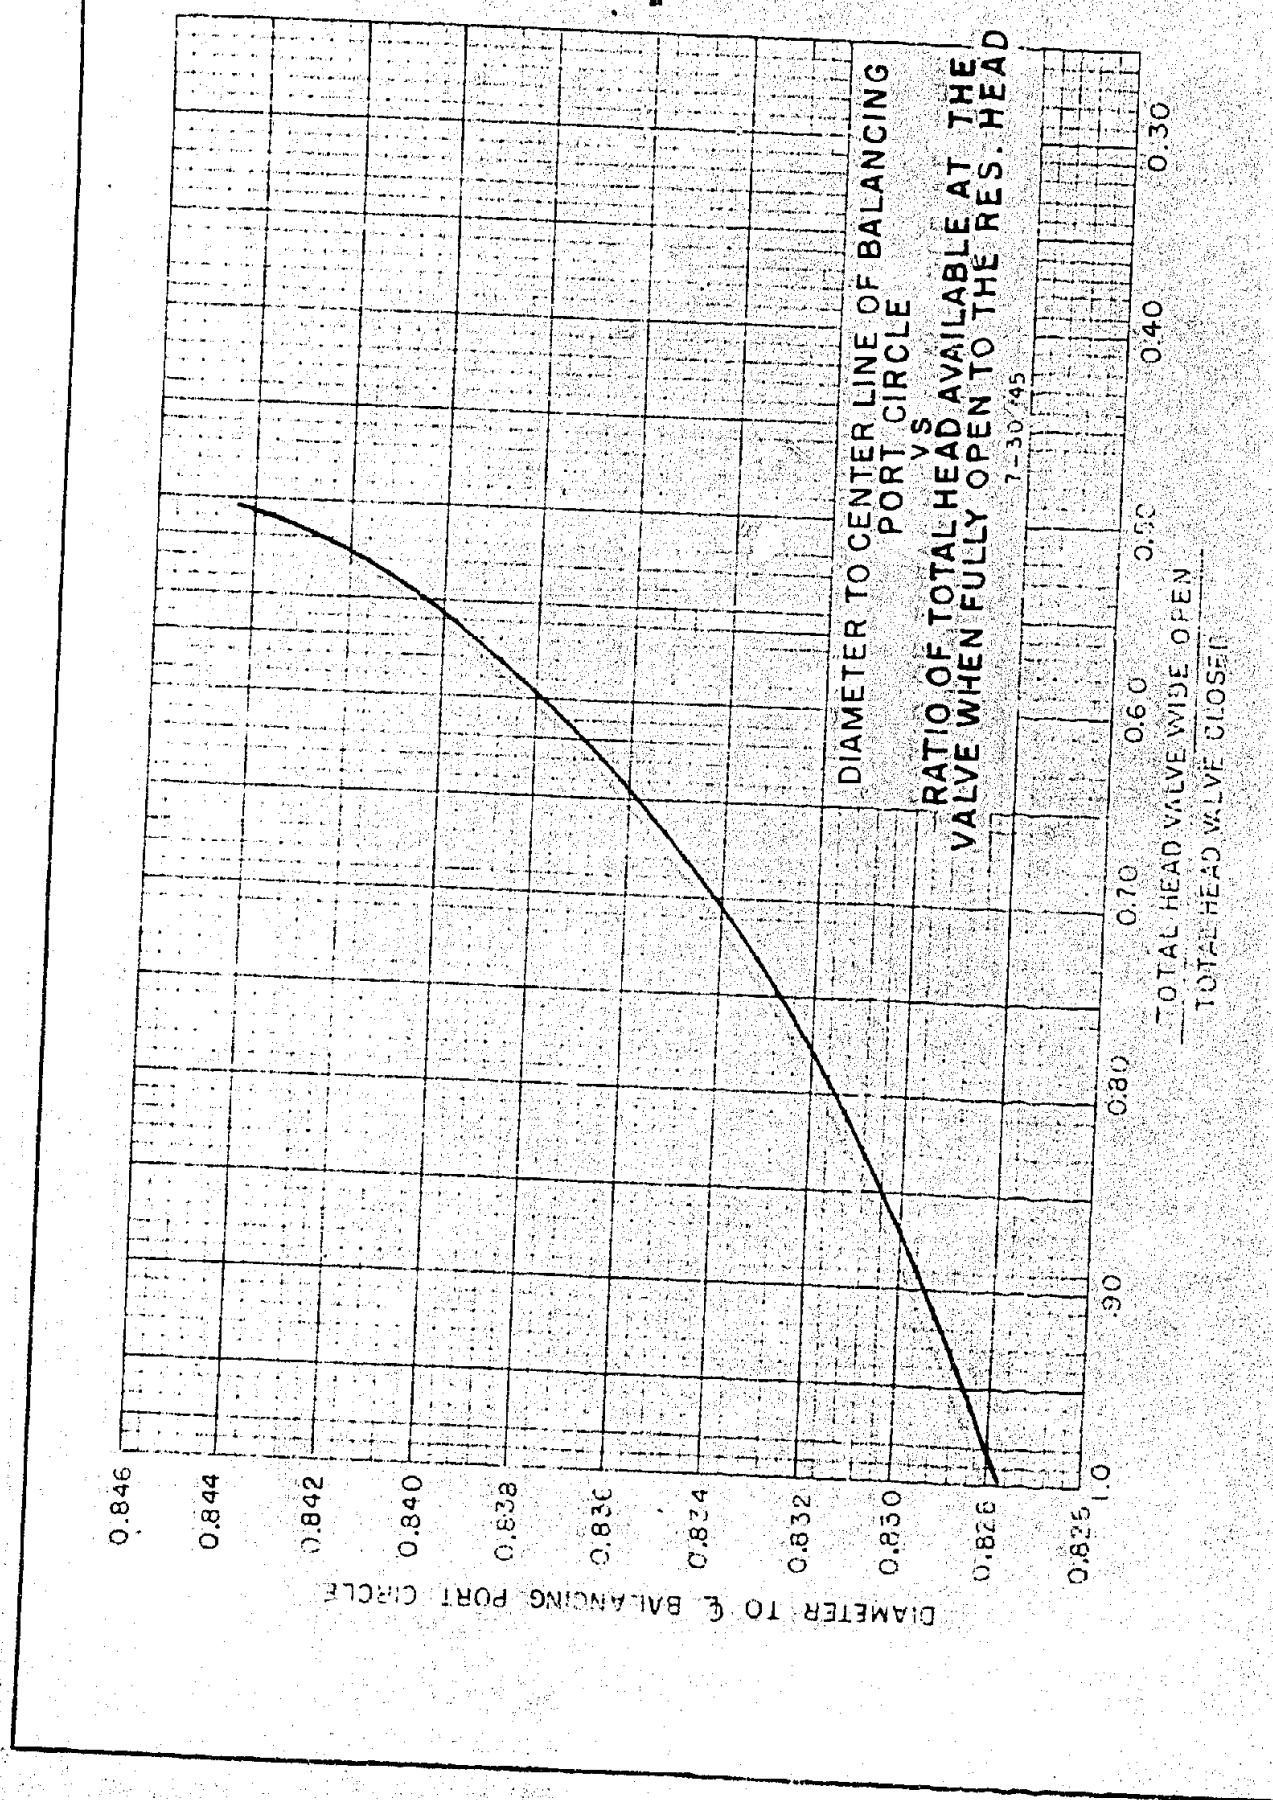
FIGURE 10

4. Pressure measurements on the valve. Piezometers were installed on the valve body and needle as shown on figures 10 and 11. Additional piezometers were placed on the large vanes, and one was located in the air chamber downstream of the needle. Pressures were taken at each ten percent of valve opening. The results for the needle and the valve body are shown on figures 10 and 11 along with pressures obtained from the six-inch model with piezometers in homologous locations.

a. While it is generally accepted that model and prototype pressures should agree very closely, the results of the pressure measurements on the valve have served to establish further proof of this concept. This relationship will exist if careful measurements are made in both the model and the prototype and if the two structures are exactly similar. Under certain conditions, a variation of a few thousandths of an inch in the contour of the water passage will cause a noticeable difference in pressure.

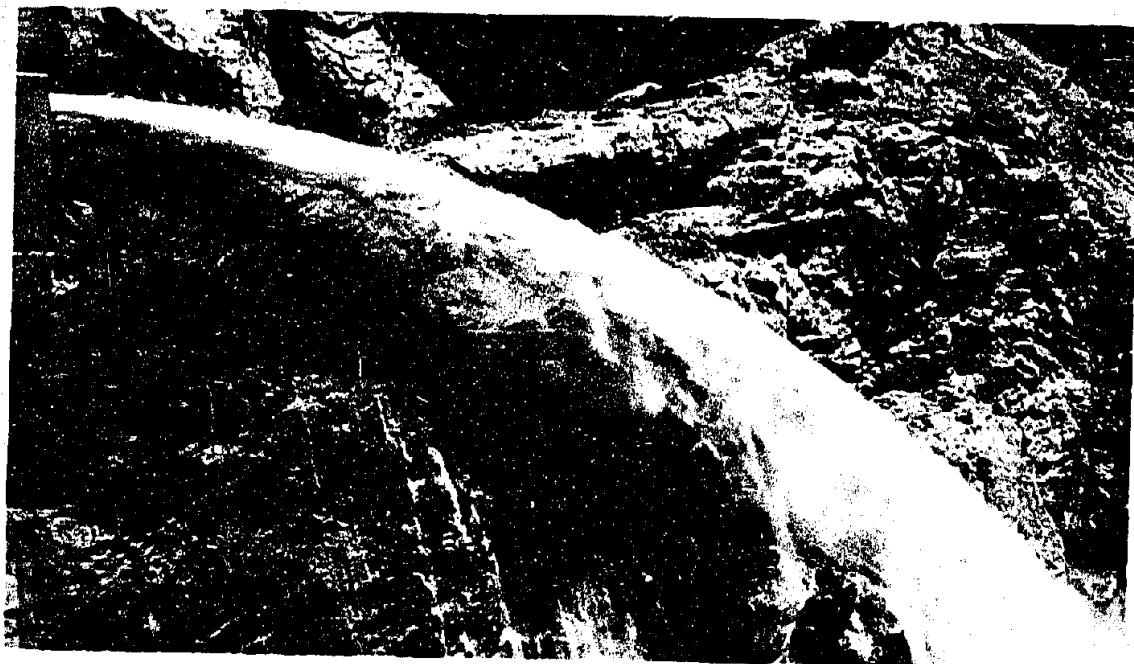
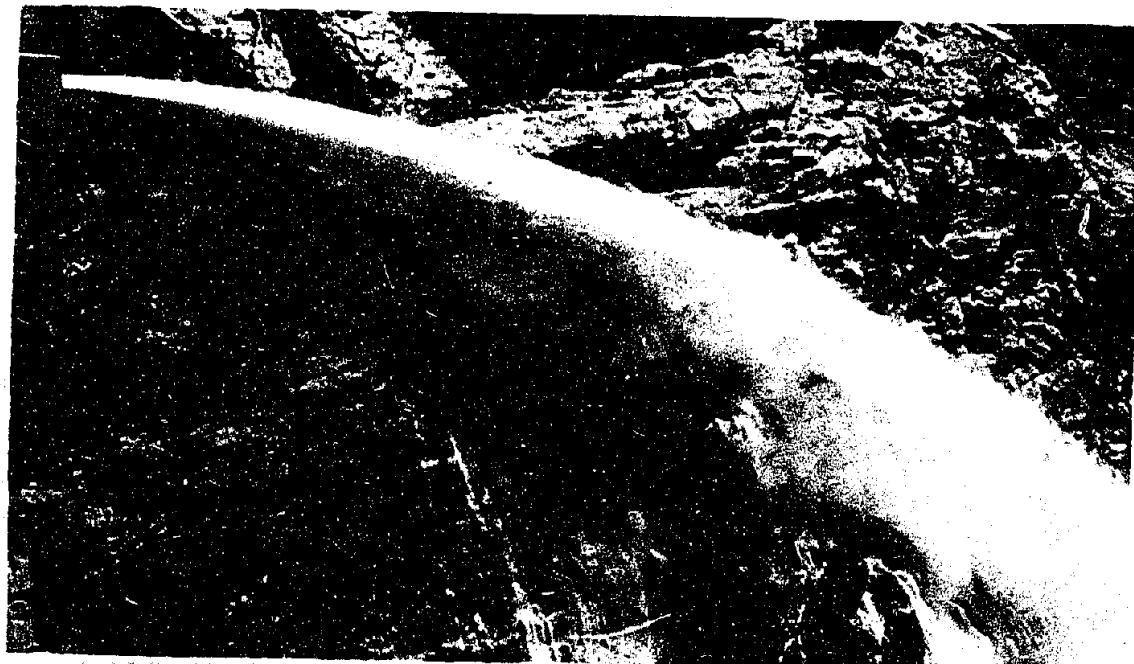
JET FROM 24-INCH HOLLOW-JET VALVE
