HYDRAULIC LABORATORY REPORT NO. 190

**HYDRAULIC MODEL STUDIES ON
REPAIRS TO THE CALIFORNIA WASTEWAY
YUMA PROJECT
ARIZONA-CALIFORNIA**

Subject: Hydraulic model studies on repairs to the California
Wasteway - Yuma Project, Arizona-California.

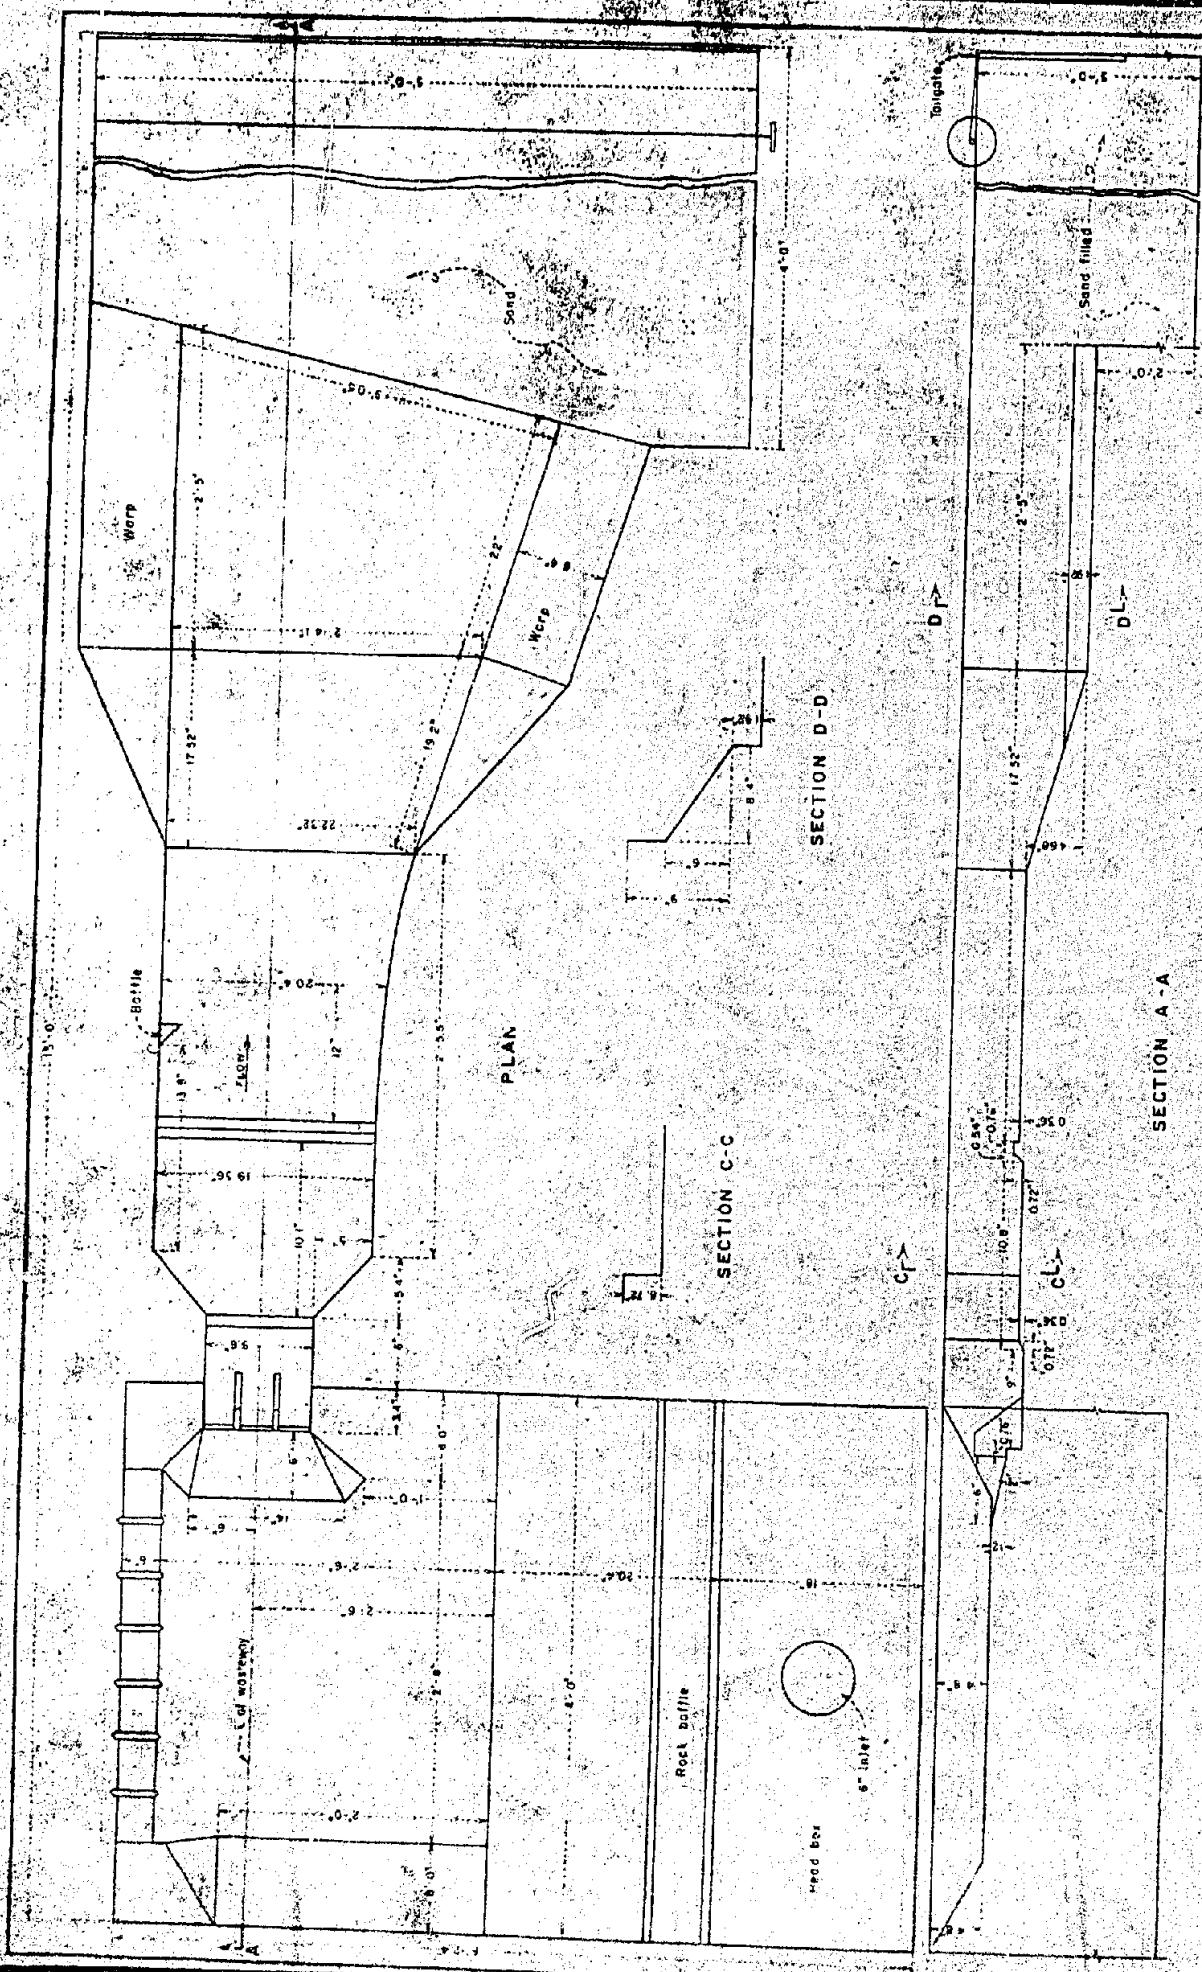
FIGURE 2

3. Description of the model. The model of the California Wasteway as constructed on a 1:30 scale is shown on figure 2. The model included the wasteway and check structures and a section of the canal upstream from the wasteway gates. The headbox and main canal were constructed of wood and lined with sheet metal. The wasteway was constructed of plywood with the joints sealed with white lead. The warps were a mixture of Plaster of Paris and cement. The downstream section of the canal leading from the wasteway to the river was lined with fine sand to study the scouring action. Although the grain size was not to scale, this was not important as only general scour patterns were of interest.

From figure 2 it can be observed that the present wasteway contains a deflector baffle on the left wall. Throughout the tests the model was operated with and without the use of the baffle. In no case did it improve the flow conditions decisively. It is, therefore, recommended that this baffle be removed from the final design.

PRESENT PROTOTYPE STRUCTURE
