IMPORTANCE OF SMOOTH SURFACES ON FLOW  
BOUNDARIES DOWNSTREAM FROM OUTLET  
WORKS CONTROL GATES

Hydraulic Laboratory Report No. Hyd-448

July 15, 1958

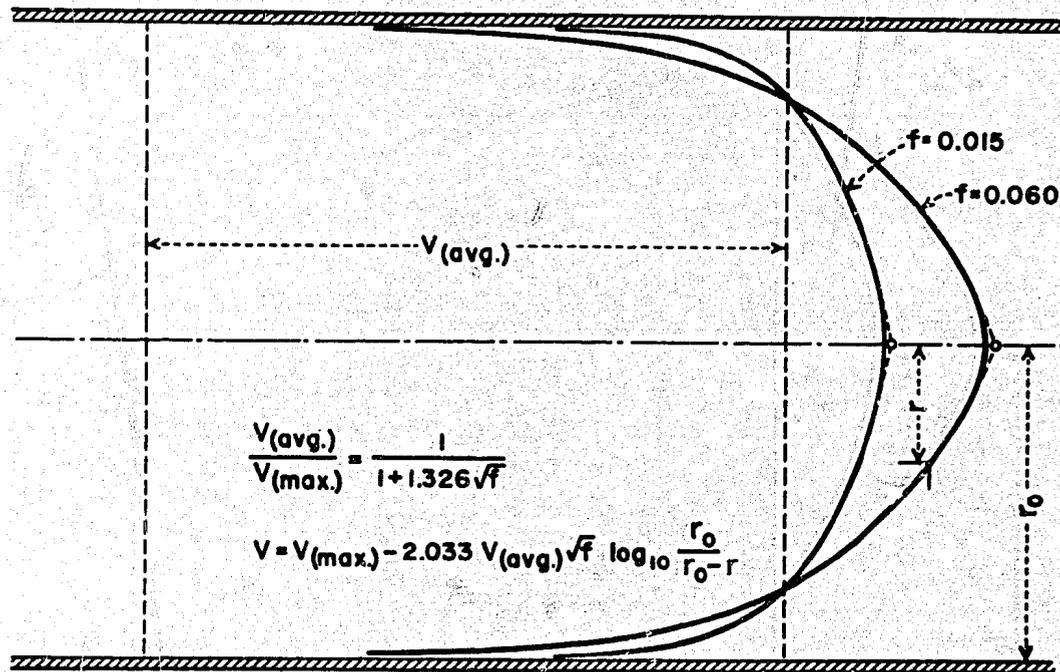
Figure 1

When a turbulent boundary layer is nearly destroyed, the flow velocities close to the boundary become about the same as that of the main stream and much higher than when the boundary layer is fully developed (Figure 1). These higher velocities at the boundaries below gates make a rough boundary more conducive to cavitation than the same roughness on a spillway or other surface where the head or the amount of fall are the same. It is in this region where the boundary layer is being reestablished below a gate that small surface irregularities, particularly abrupt offsets, are troublesome.

**COMPUTED VELOCITY PROFILES IN TURBULENT FLOW**

Computed velocity profiles for smooth and rough surfaces in turbulent flow.

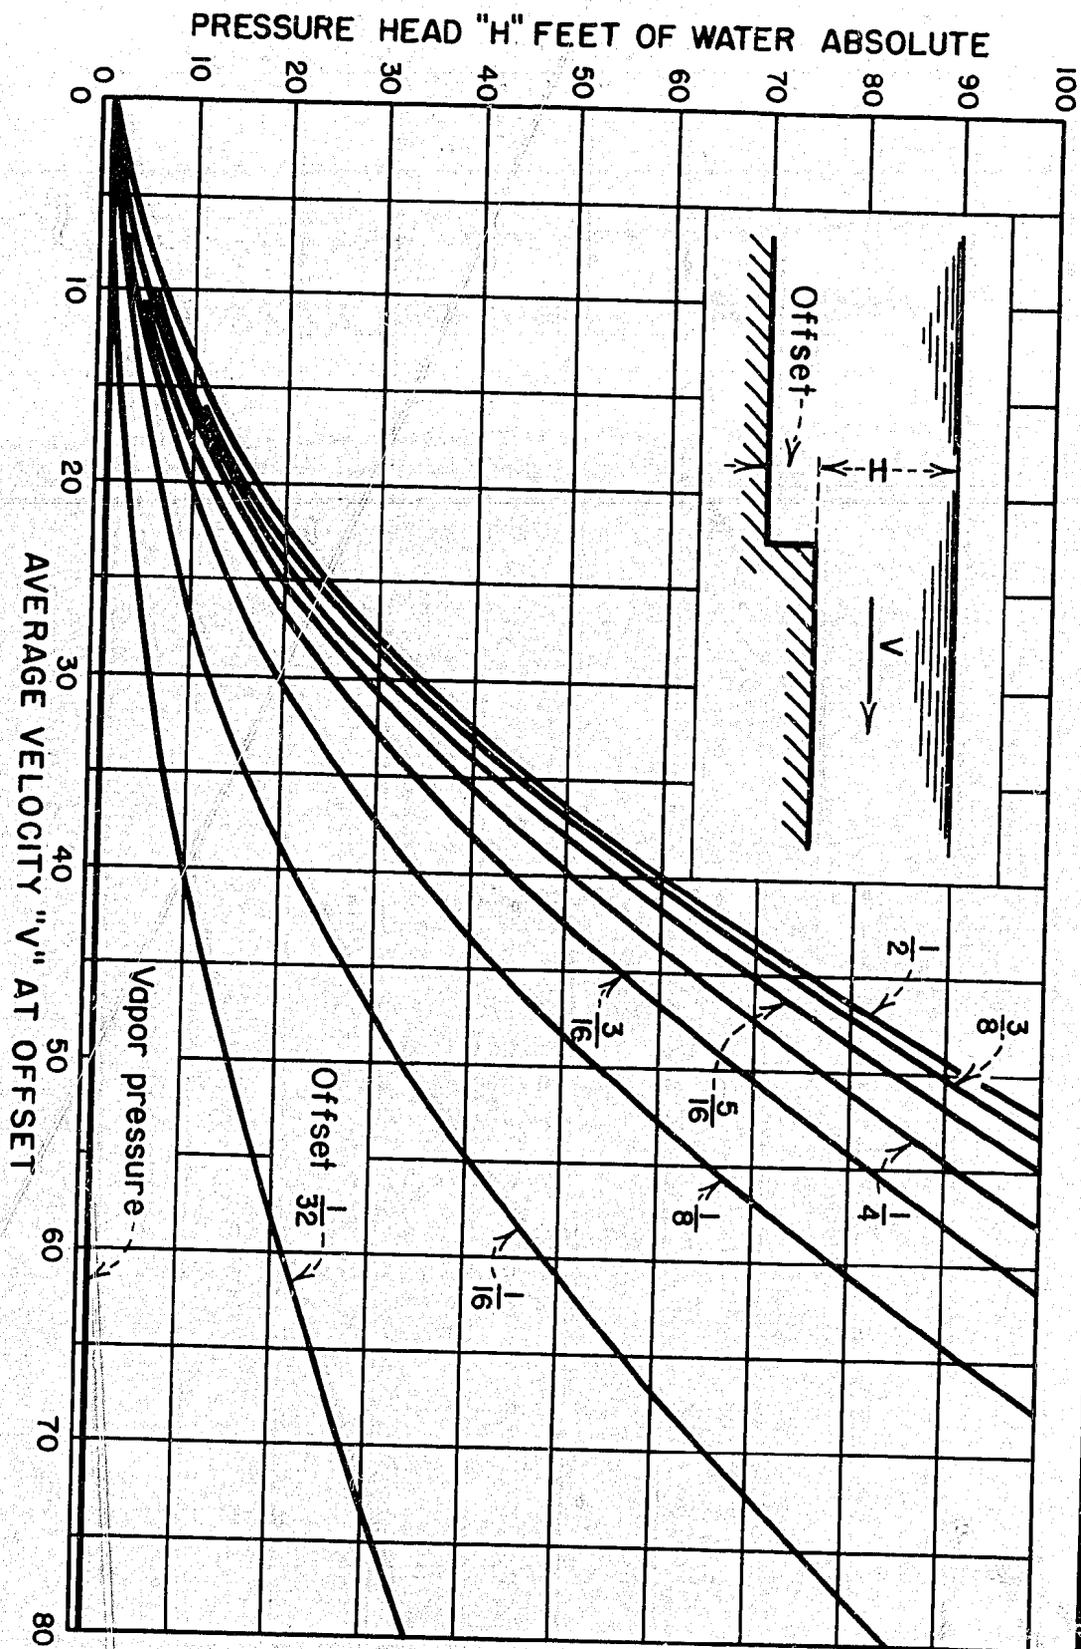
Laboratory tests on small abrupt 90°, sharp-cornered offsets into and perpendicular to the stream show that cavitation may occur downstream from a 5/16-inch offset at stream velocities of 29 feet per second when the pressure at the offset is approximately atmospheric or 30 feet of water absolute (Figure 2). The velocities below outlet works gates are usually much higher than those shown in the figure for incipient cavitation. This means that cavitation and destructive erosion of the surfaces will occur if surface irregularities of the offset-into-the-flow type are of any appreciable magnitude. Such erosion took

FIGURE 2.- HEAD-VELOCITY RELATIONSHIP FOR INCIPIENT CAVITATION-ABRUPT, INTO-THE-FLOW OFFSETS

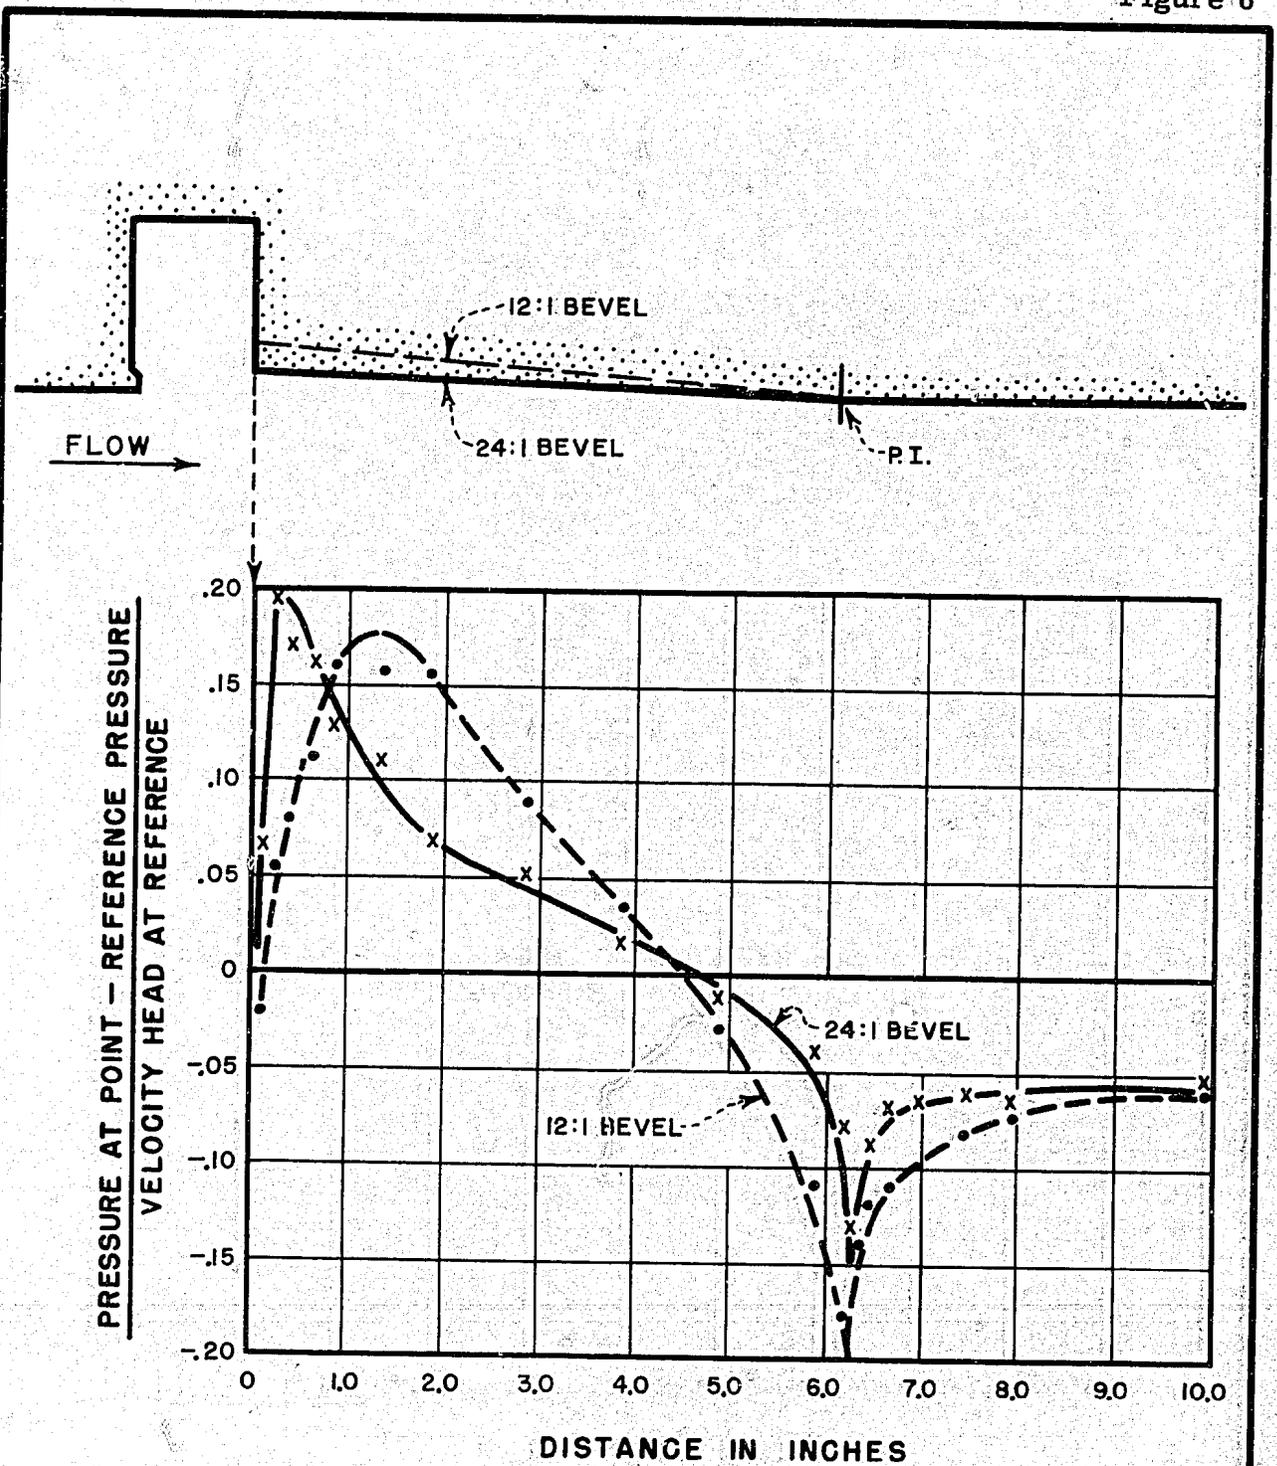
Pitting was also noted at the downstream end of a bevel of about 10:1 which had been formed by grinding an into-the-flow offset at the end of the Palisades gate frame (Figure 5). The probability of this damage has been indicated in model tests which show that low pressures form downstream of lines of intersection for bevels of 12:1 and 24:1 (Figure 6). When high velocity flows pass the abrupt changes in alignment of these surfaces, the pressures are reduced to vapor pressure and cavitation and cavitation pitting takes place. Typical pitting downstream of a 12:1 bevel at a stop log slot is shown in Figure 7.

STUDIES OF SURFACE IRREGULARITIES  
 PRESSURE REDUCTION DOWNSTREAM  
 FROM 12:1 AND 24:1 BEVELS
