UNITED STATES  
DEPARTMENT OF THE INTERIOR  
BUREAU OF RECLAMATION

Laboratory Report No. HM-12  
Glendive Pumping Plant  
Buffalo Rapids Project  
Test Conducted by: G. J. Hornsby  
Checked by: D. J. Hebert  
Submitted by: G. J. Hornsby

Subject: Field acceptance test on pumping units Nos. 1 and 2 of the Glendive pumping plant - Buffalo Rapids project, Glendive, Montana - Specifications No. 1018-D.

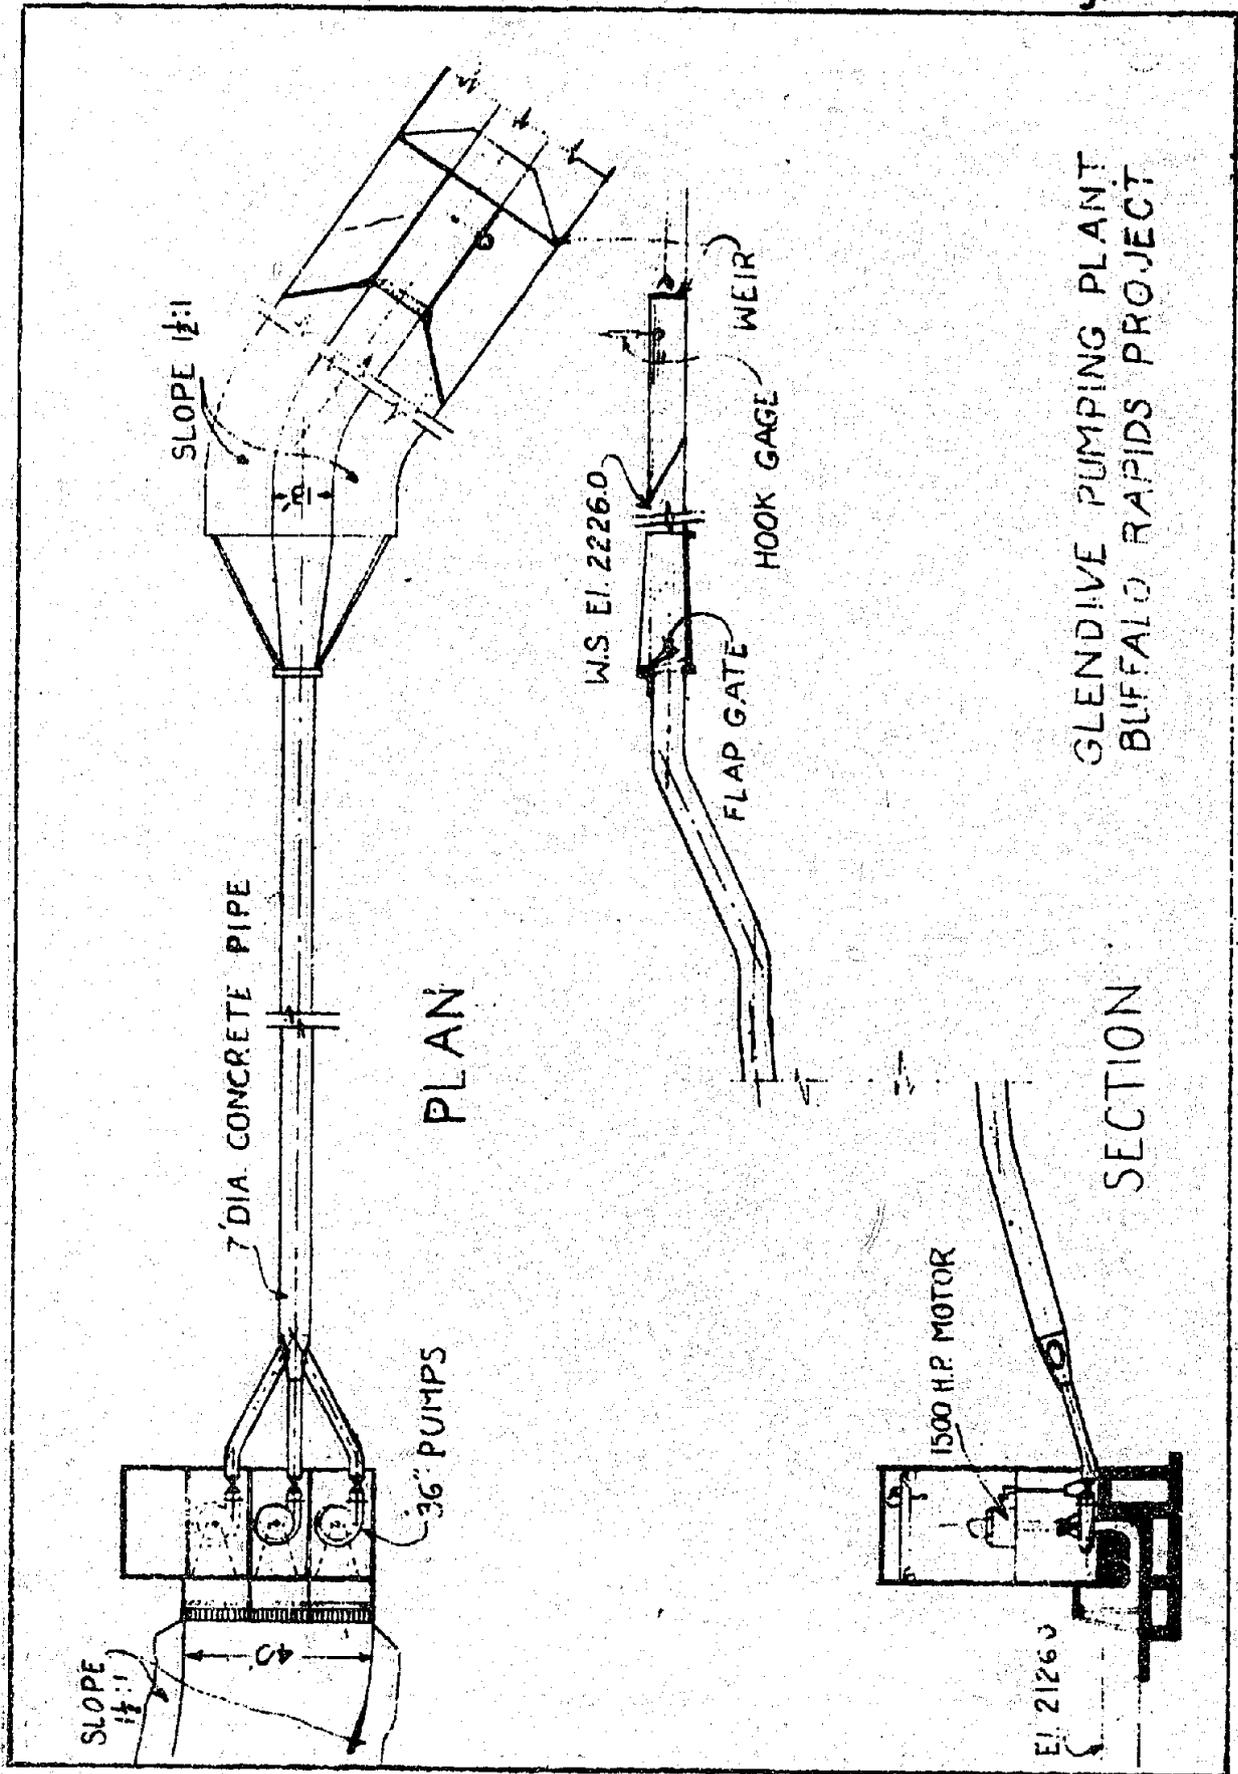
Fig. 1

The pumps each have individual suctions drawing through rack structures from a common inlet canal. The discharge of each pump is through a 36-inch gate valve, a short length of 36-inch steel pipe into the legs of a 3-way connection to a 7-foot diameter, concrete, common delivery pipe leading to the canal at the top of the hill. At the point where the delivery pipe discharges into the warped-wing transition to the canal, there is an 84-inch swing check, or flap valve, to prevent reversal of flow in case of emergency. The complete arrangement is shown on figure 1.

GLENDIVE PUMPING PLANT  
BUFFALO RAPIDS PROJECT

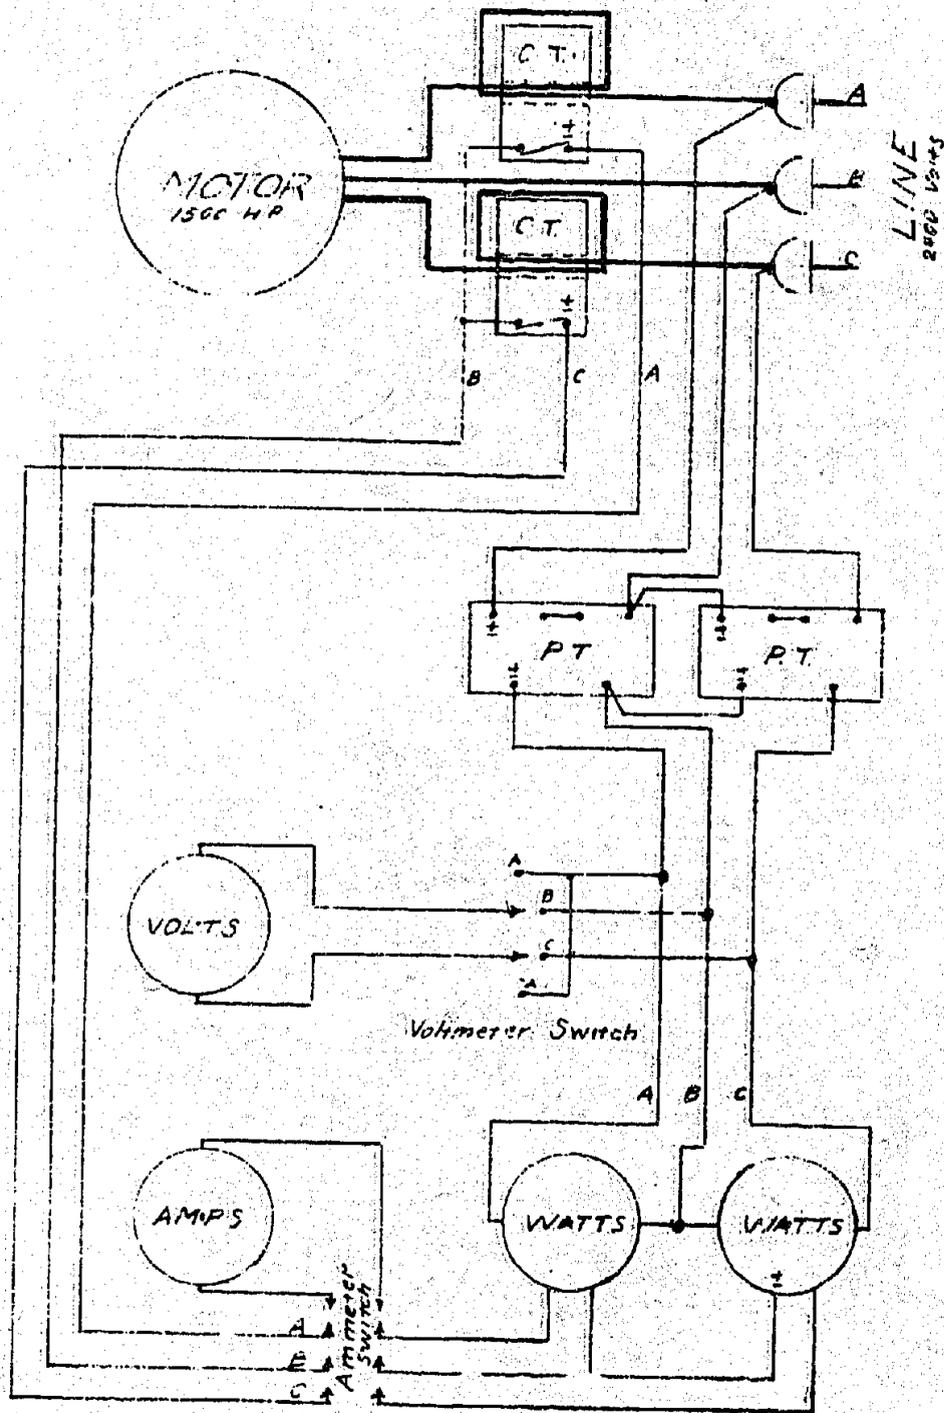
Fig. 2

3. Test procedure. The horsepower input to the pump was measured by means of electrical test instruments connected as shown in the wiring diagram, figure 2. The motor field rheostat was adjusted so as to bring the power factor up to 100 percent as indicated by balanced readings on the two wattmeters and by the power factor meter on the switchboard. The power input as

WIRING DIAGRAM  
Glenide Pumping Plant  
Buffalo Rapids Project

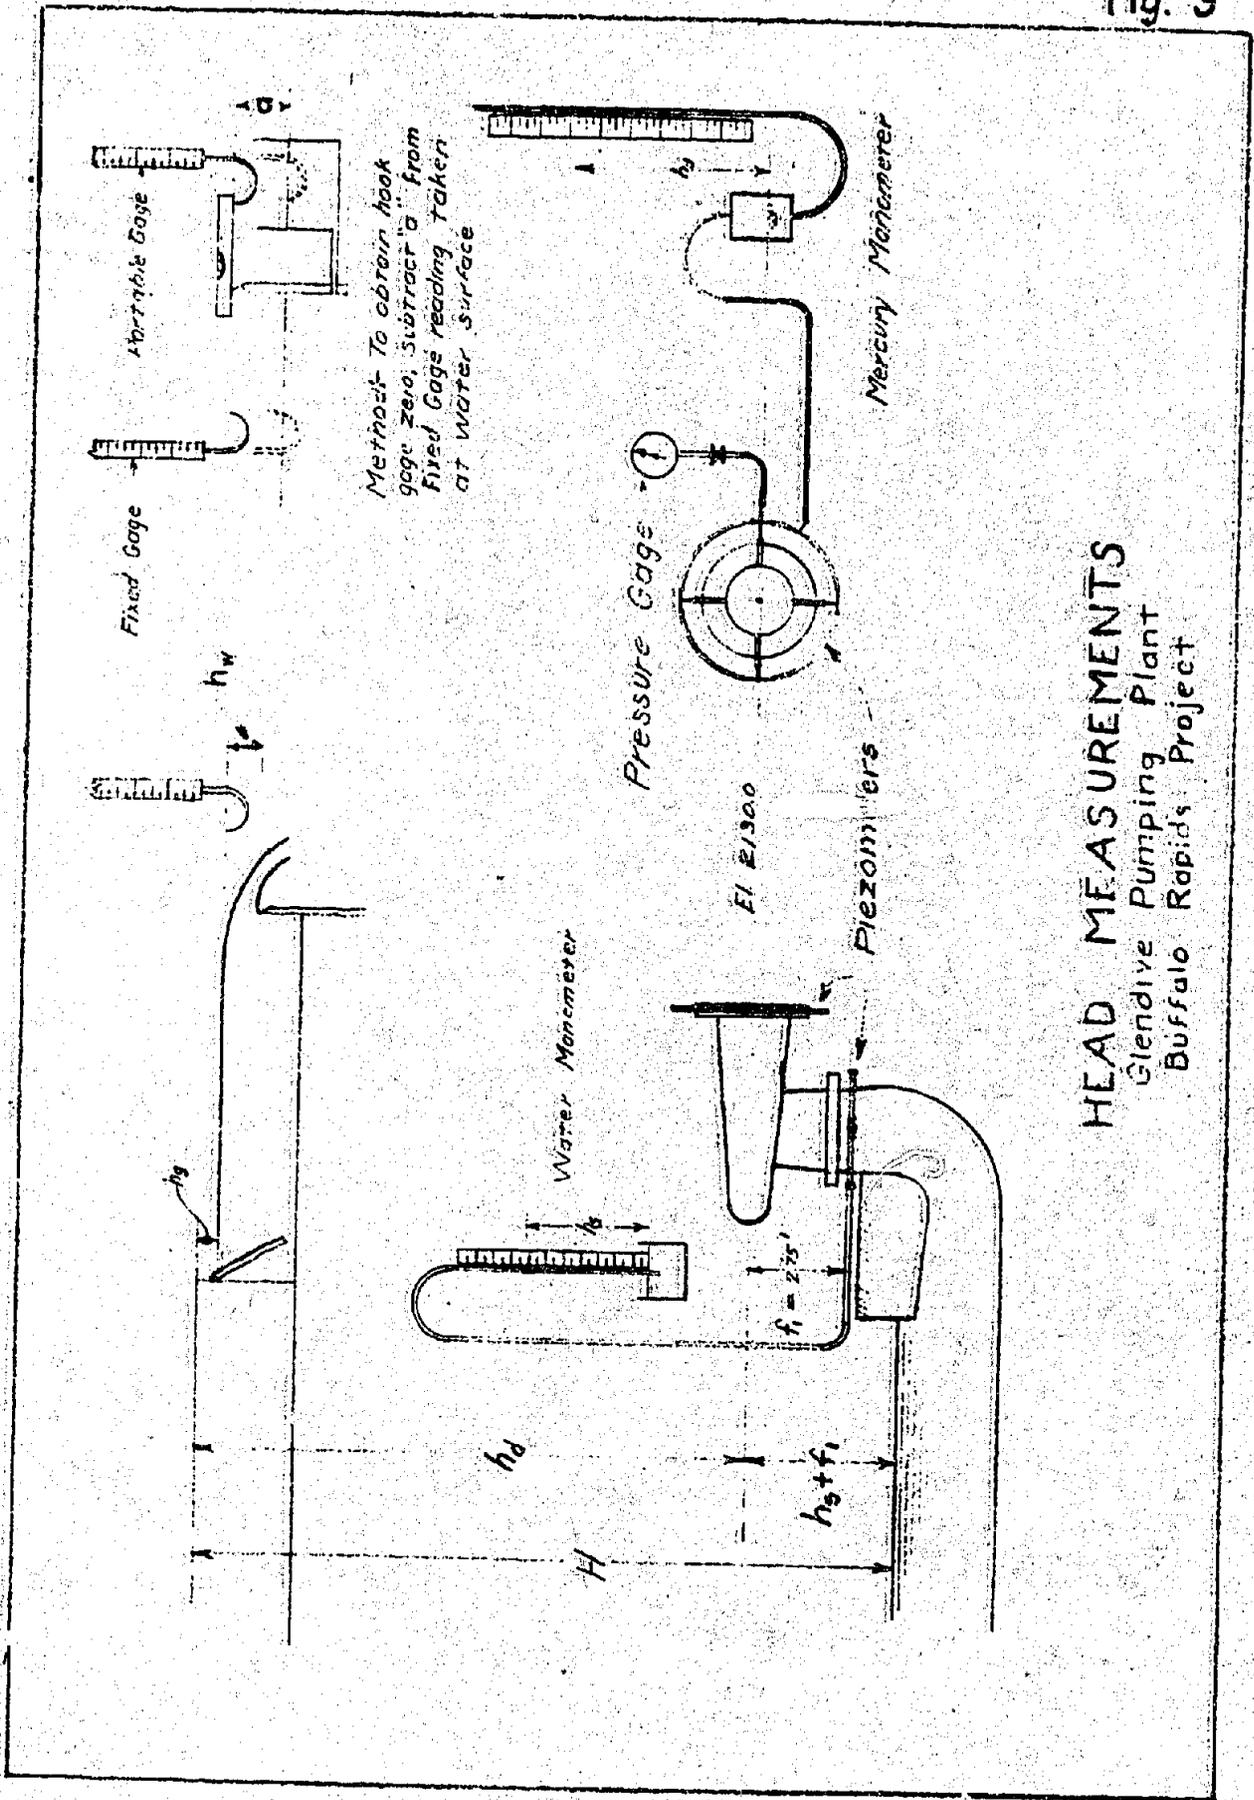
Fig. 3

Of course the pipe areas in the plane of the piezometers at both the suction and discharge were carefully measured. The set-up is shown diagrammatically in figure 3.

The discharge was measured over a weir designed in strict accordance with Standards of Hydraulic Institute Code. The head over the weir was measured by means of a hook gage reading to thousandths of a foot. The hook gage zero was determined before and after each test by the method shown in figure 3. A head discharge curve, figure 4, was plotted according to the Hamilton Smith formula as shown on the curve sheet. The photograph, plate I, shows the measuring weir in operation.

HEAD MEASUREMENTS  
Glendive Pumping Plant  
Buffalo Rapids Project

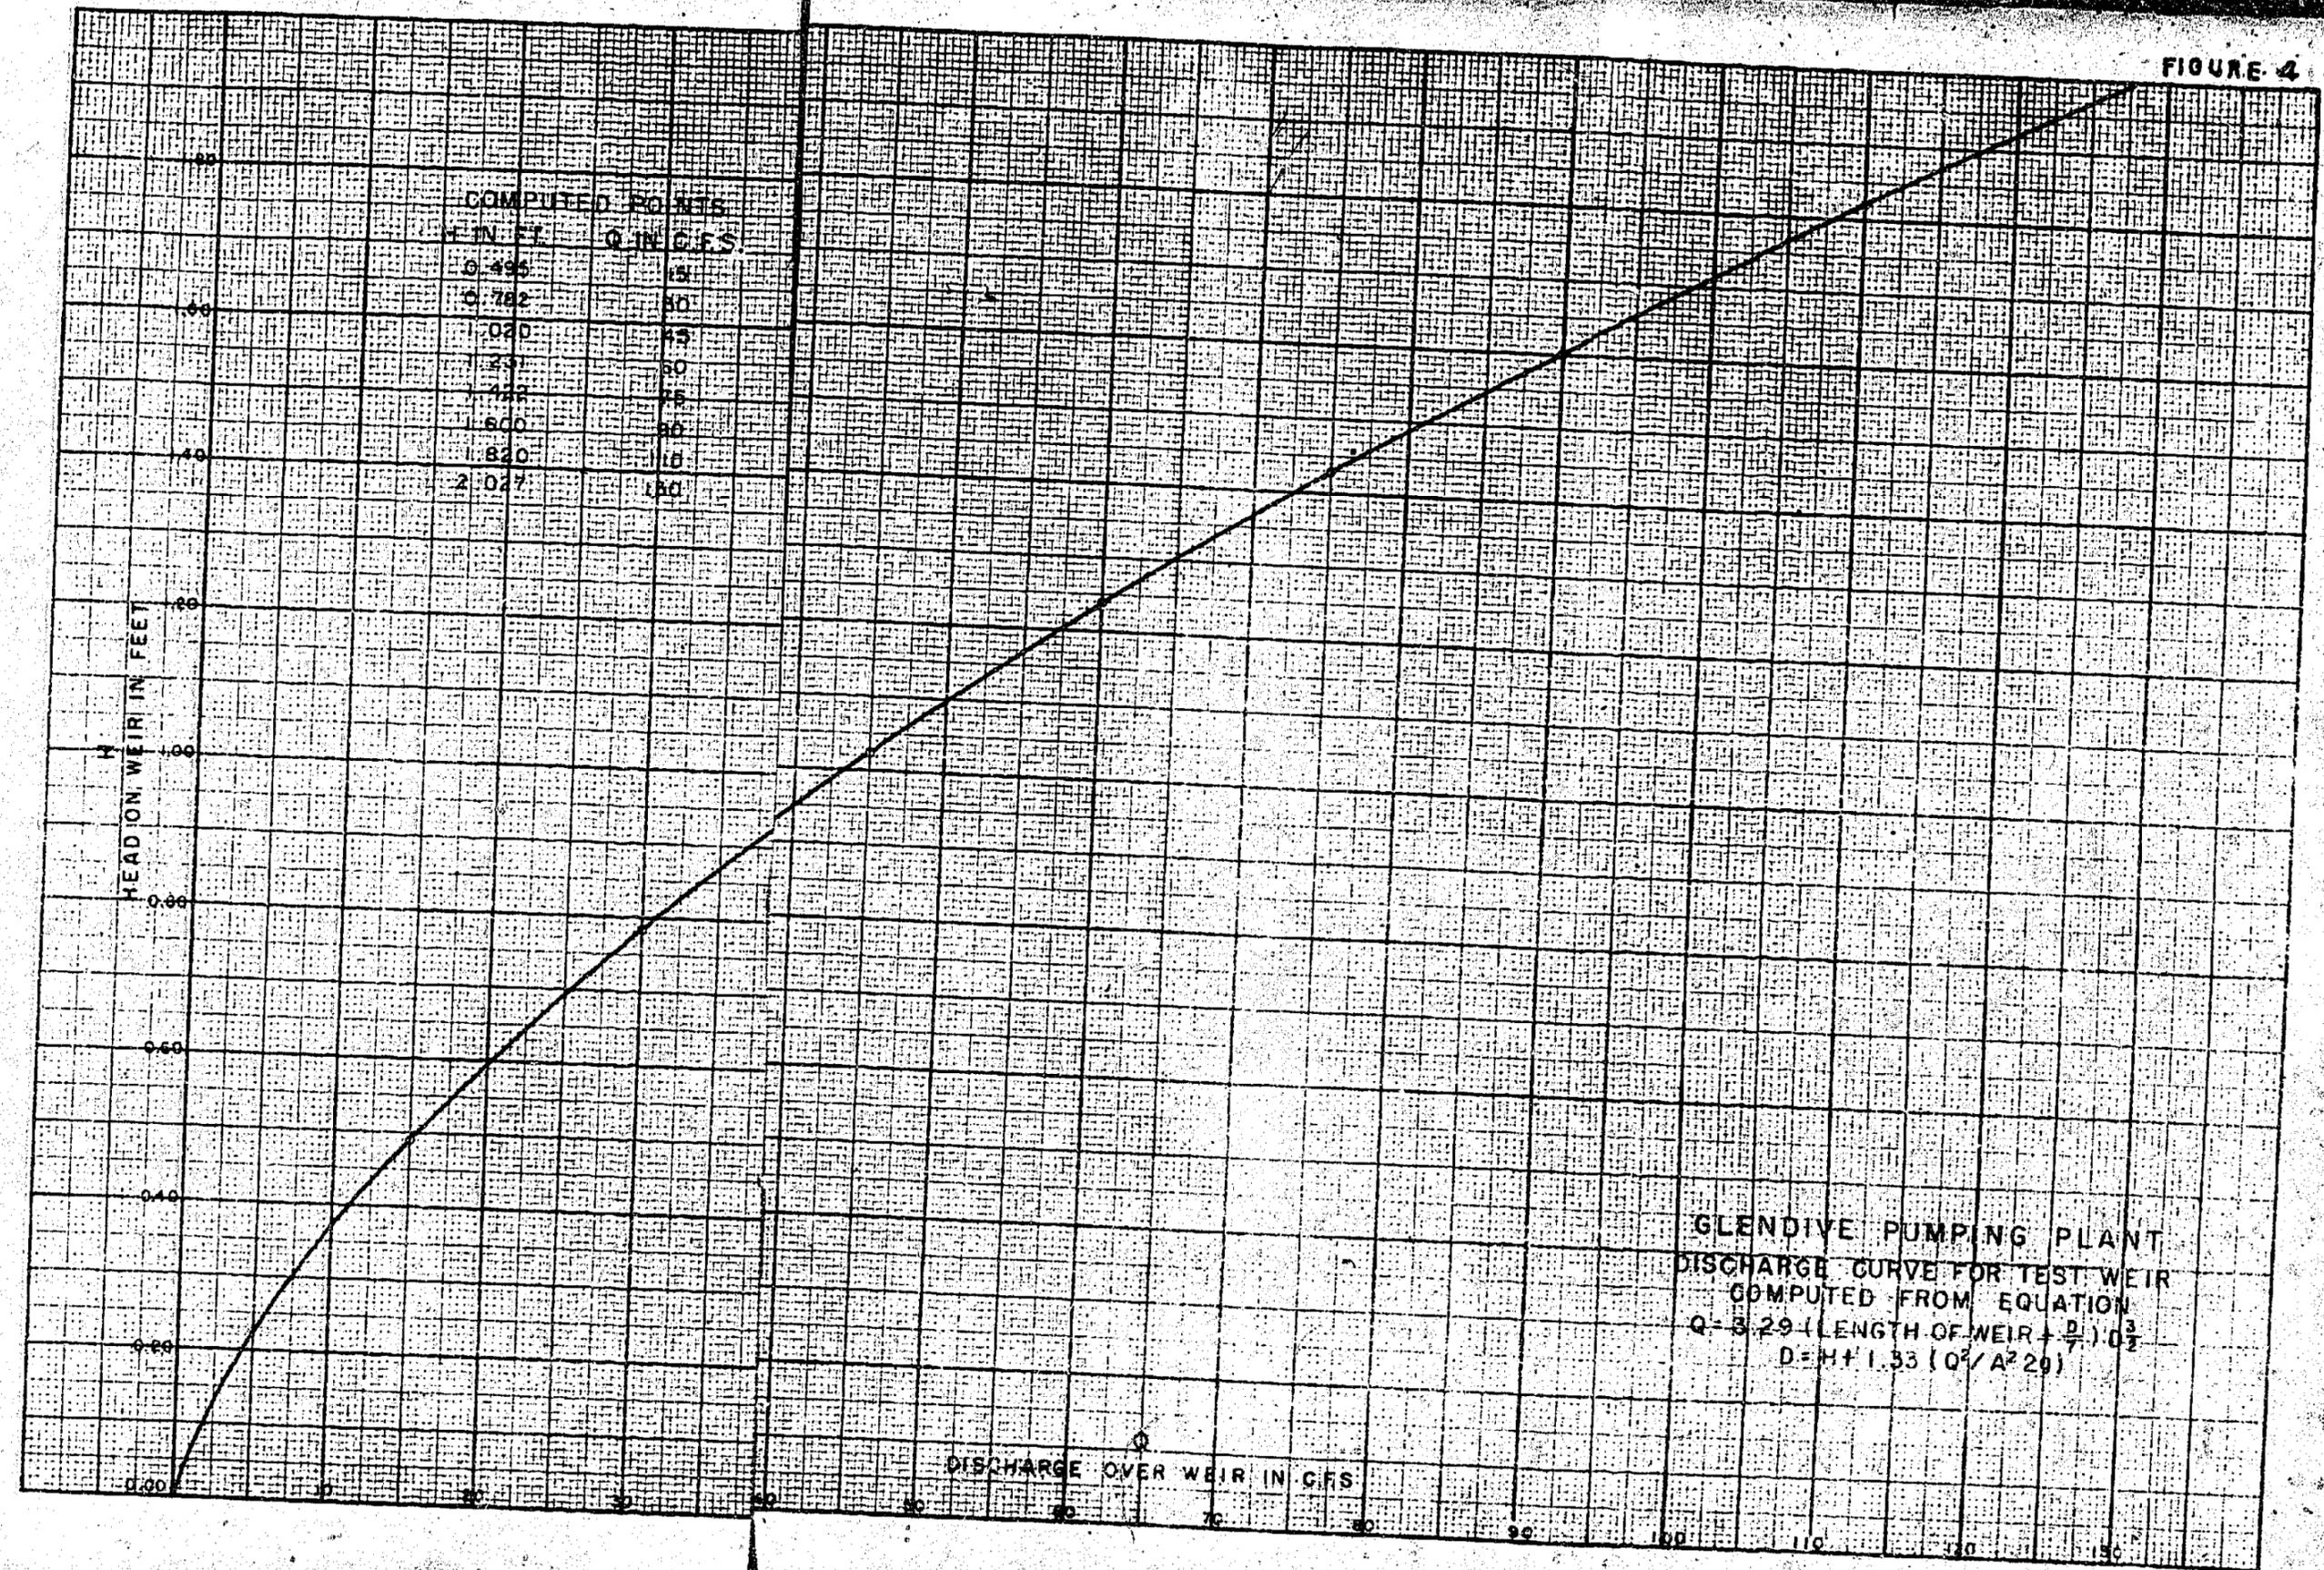
FIGURE 4

GLENDIVE PUMPING PLANT  
 DISCHARGE CURVE FOR TEST WEIR  
 COMPUTED FROM EQUATION  
 $Q = 3.29 (\text{LENGTH OF WEIR} + \frac{D}{7}) H^{3/2}$   
 $D = H + 1.33 (Q^2 / A^2 29)$
