# DOCUMENTATION OF OPERATION, DAMAGE, REPAIR, AND TESTING OF YELLOWTAIL DAM SPILLWAY

R. C. Borden  
D. Colgate  
James Legas  
C. E. Selander  
Engineering and Research Center  
Bureau of Reclamation

May 1971

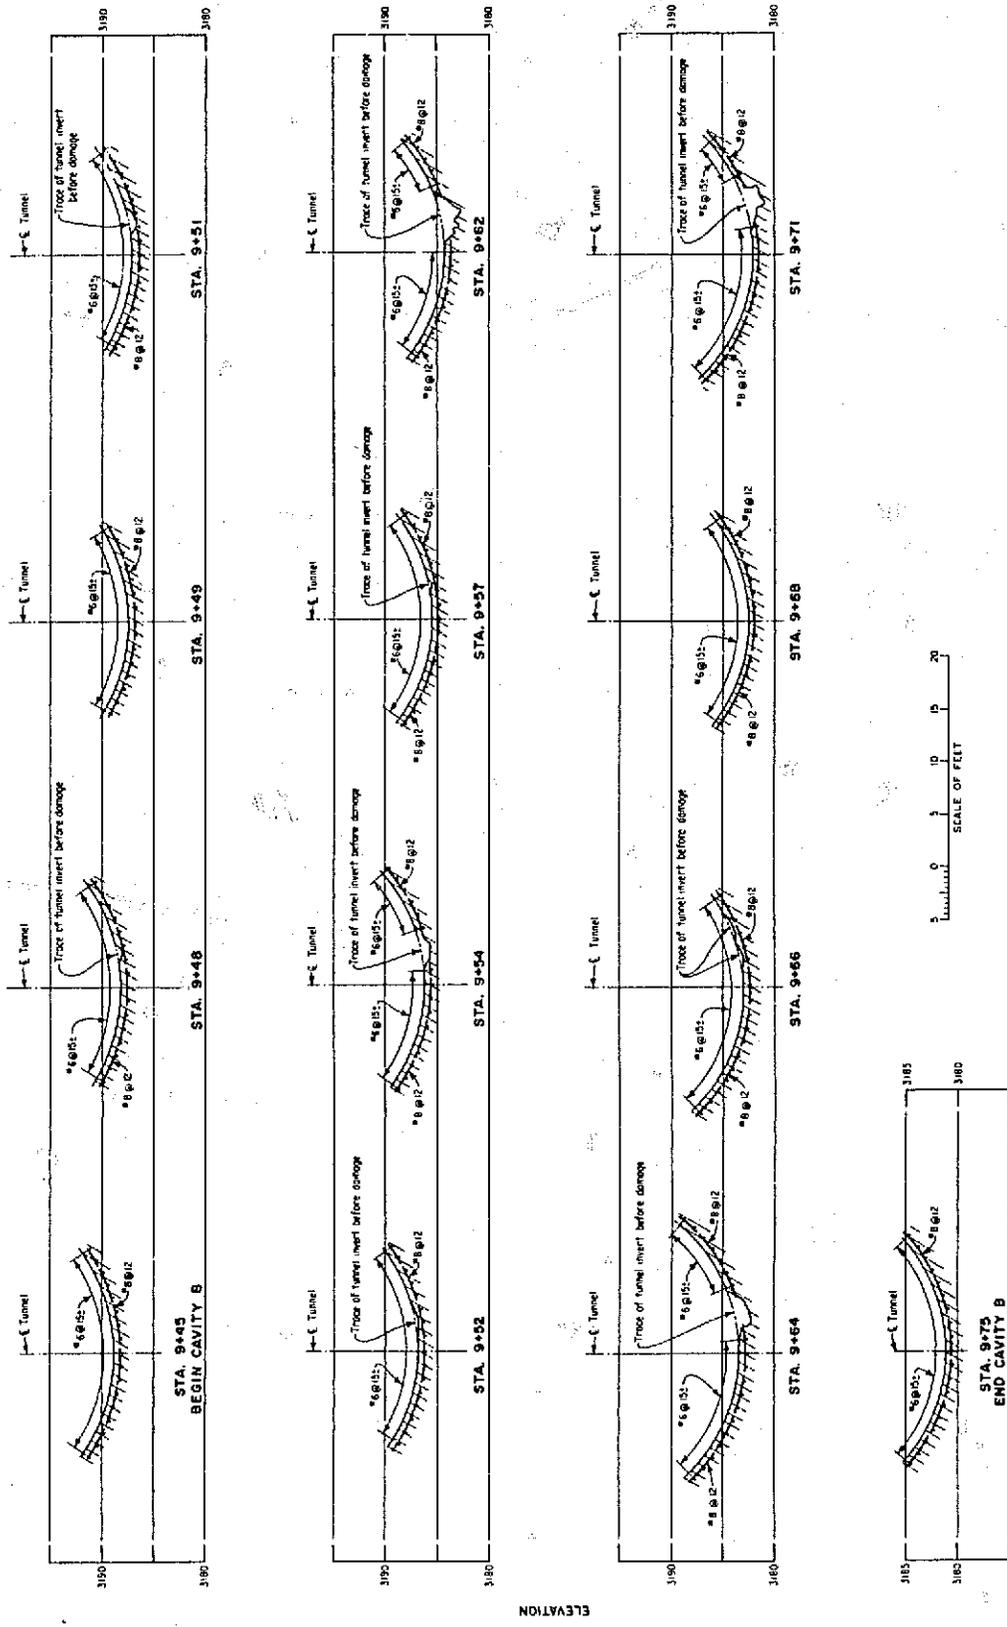
Figure 2-2. Sections through damaged Area B.

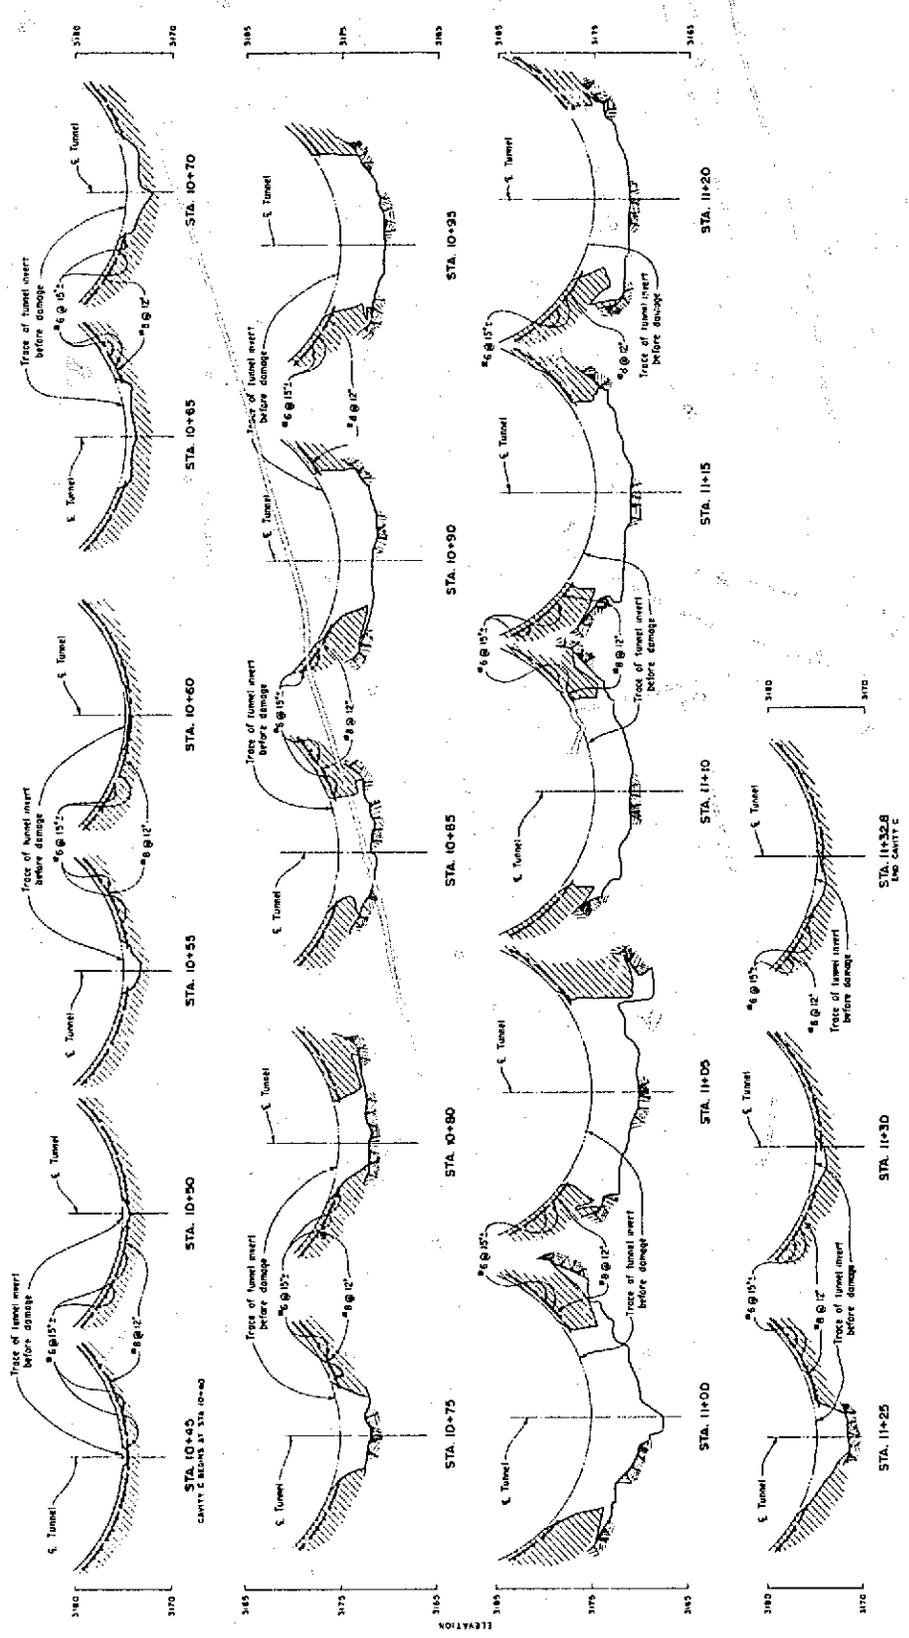
Figure 2-3. Sections through damaged Area C.

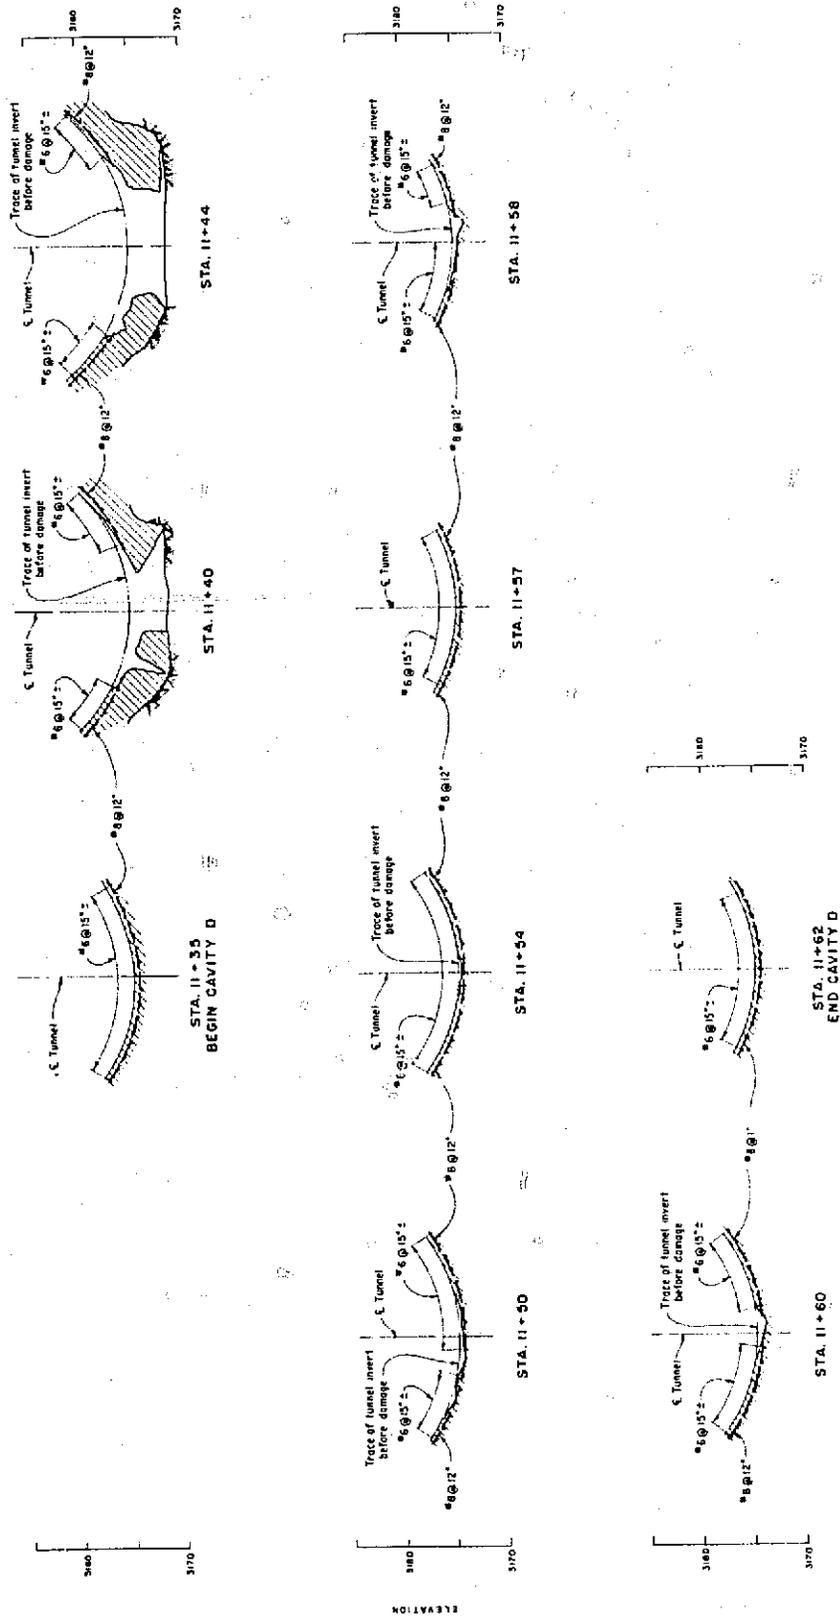
Figure 2-4. Sections through damaged Area D.

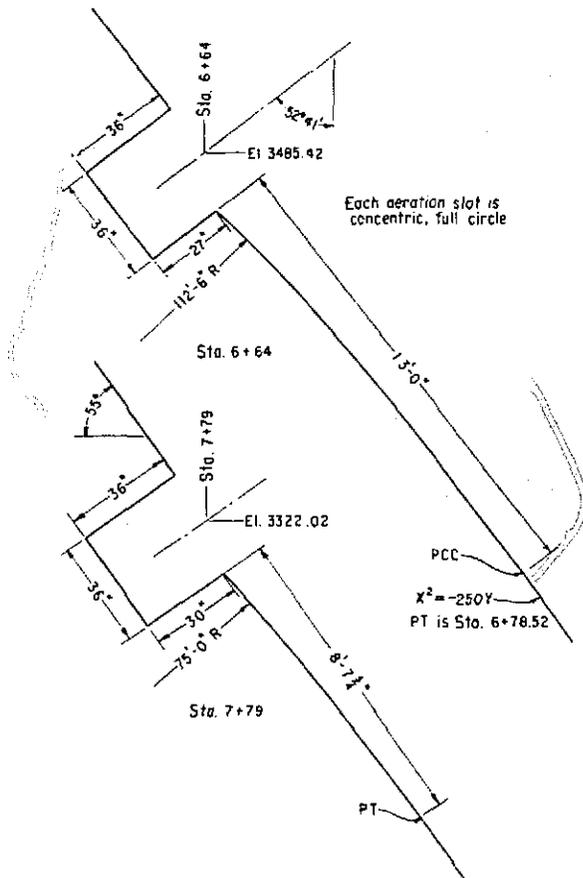
An aeration slot with the preliminary shape, shown in Figure 2-7, was installed at Station 7+79. The slot was uniform in cross section for the entire circumference of the tunnel. Although air was entrained in the flowing water for low flows, the edges of the jet near the water surface impinged on the downstream edge of the slot for discharges greater than about 5,000 cfs. As the discharge increased more of the jet impinged on the downstream edge of the slot and greater amounts of water entered the slot. As more water entered the slot the amount of air entrained in the flowing water decreased and stopped entirely at about 50,000 cfs.

Figure 2-7. Preliminary aeration slots.

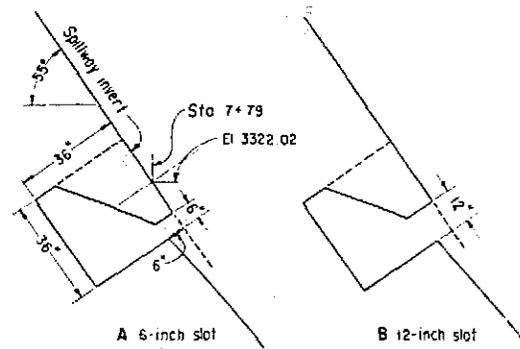
The slot was narrowed to 6 inches, with a 6-inch away-from-the-flow offset downstream, in an attempt to prevent water from entering and filling the slot. (Figure 2-9A). Although some air was entrained in the jet at low discharges, water entered the slot near the water surface for all spillway discharges. For discharges less than 20,000 cfs water drained down the slot and flowed out into the jet at the tunnel invert, reducing the amount of entrained air as the spillway discharge increased. At a spillway discharge of 20,000 cfs the water surface in the slot was at the same elevation as the spillway water surface, and no air entered the jet. For spillway discharges greater than 20,000 cfs the water was forced into the slot at a sufficiently high head to cause it to boil up the slot above the spillway water surface and spill out onto the surface of the jet.

Figure 2-9. Narrow aeration slots.

The slot was opened up to 12 inches wide (Figure 2-9B). The flow with this configuration was similar to that with the 6-inch slot. The discharge at which the water surface in the slot was equal to that of the spillway water surface was 30,000 cfs.

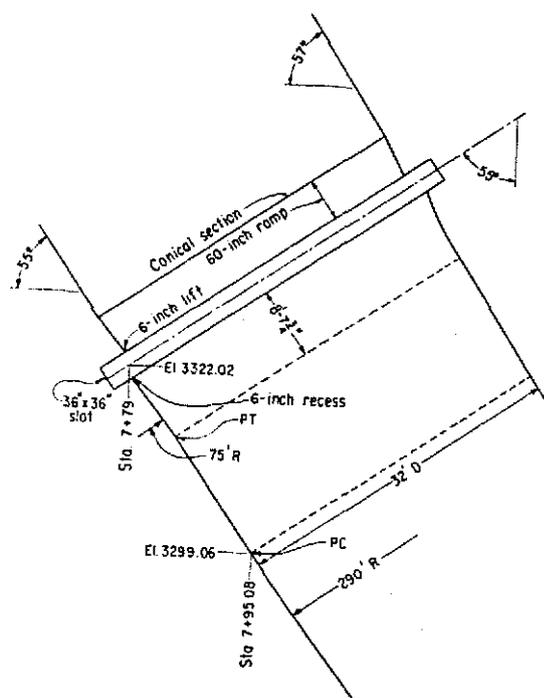
A conical nozzle was installed in the tunnel at the upstream face of a 3- by 3-foot aeration slot at Station 7+79. The nozzle exit was 32 feet in diameter, and the cone extended 5 feet upstream from the slot (Figure 2-10). Air was entrained in the jet, and the slot remained free of water, for all discharges. A large fin of water formed on either side of the tunnel where the jet from the nozzle impinged in the bend. The fins became progressively larger and arched higher with increasing discharge until, at a discharge of 6,000 cfs, the side fins extended to the crown of the tunnel. For discharges greater than 40,000 cfs, the water folded over the top of the jet and choked the tunnel. The above test indicated that the nozzle shape, or a ramp type of lift, upstream from an air slot would permit the jet to entrain air for all discharges, but modifications were needed to prevent side fins from choking the tunnel at the higher discharges. Several transitional ramp shapes were evaluated in the model before a configuration was perfected which would operate satisfactorily for all discharges up to the design maximum of 92,000 cfs.

Figure 2-10. Conical nozzle—6-inch lift, 60-inch ramp.

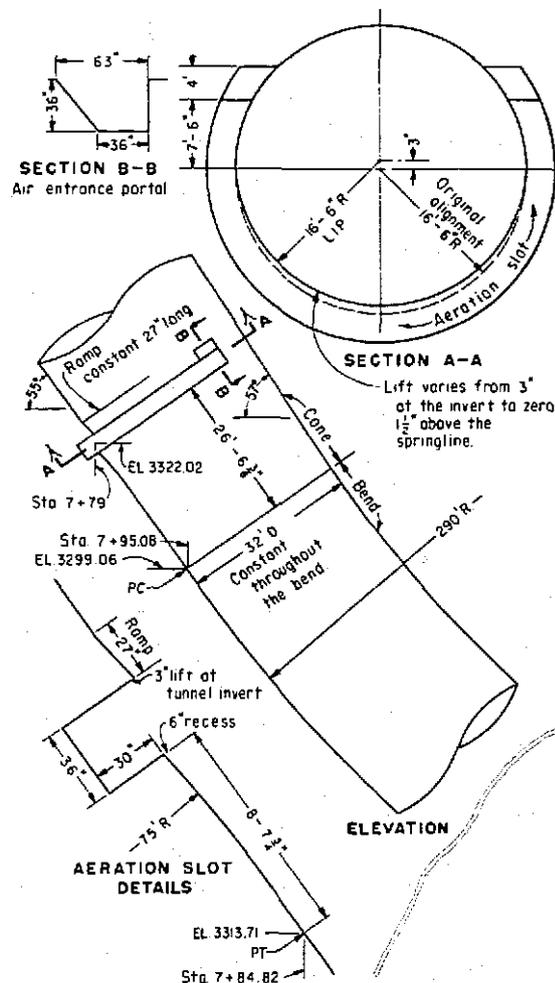
Figure 2-11. Recommended aeration slot.

The recommended design consisted of a 3- by 3-foot aeration slot at Station 7+79. A ramp, 27 inches long in the direction of flow, raised the upstream face of the slot 3 inches at the tunnel invert. The trace of the spring point of the raised lip was the

same diameter as the tunnel, with a 3-inch eccentricity in a plane perpendicular to the tunnel centerline. Thus the lift varied from 3 inches at the tunnel invert to zero at a point 1-1/2 inches above the tunnel spring line. The ramp upstream from the spring point was a constant 27 inches long (Figure 2-11).

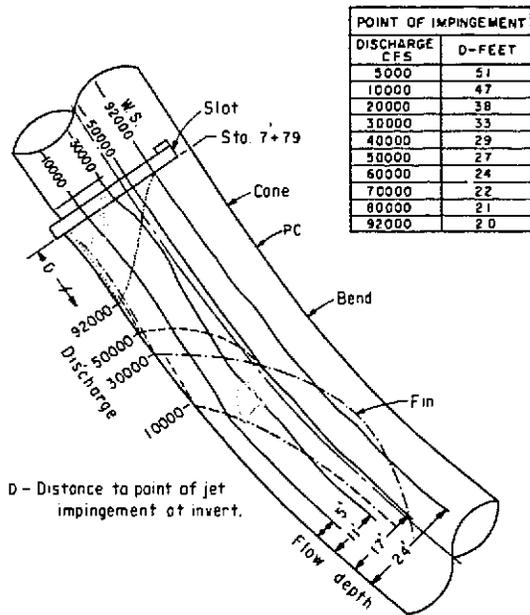
The lift, or ramp, forced the bottom of the jet away from the tunnel flow surface, over the aeration slot, and the jet remained free for a considerable distance downstream before it impinged on the tunnel invert. The distance to the point of jet impingement on the tunnel invert reached a maximum of 52 feet downstream from the aeration slot at a discharge of 4,000 cfs. This distance decreased as the flow depth and discharge increased, and was 20 feet for a discharge of 92,000 cfs (Figure 2-12). This type of impingement will not damage smooth concrete surfaces.

Figure 2-12. Trace of jet impingement and side fins—Recommended aeration slot.

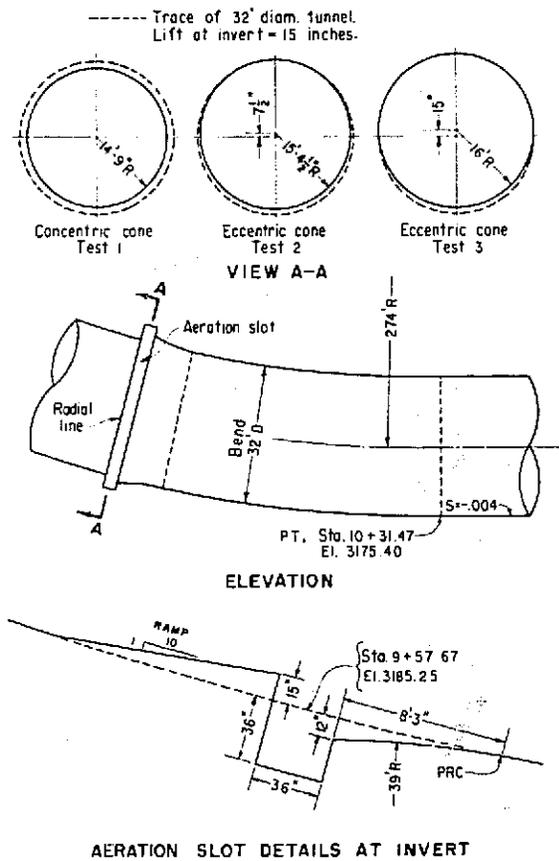
Various ramps and lifts were installed in the tunnel upstream from the slot. Each design tested produced satisfactory air entrainment and hydraulic operation for a limited range of discharges; however, none would operate satisfactorily over the full range of discharges (Figure 2-17).

These limited tests indicated that, for a satisfactory aeration device to be installed in the vertical bend of an existing structure, the necessary repairs and modifications appear to be too extensive to be practical. An aeration device to be installed in a bend during initial construction of a spillway tunnel could probably be developed.

Figure 2-16. Aeration slot in the bend—Station 9+57.67 (Not recommended).

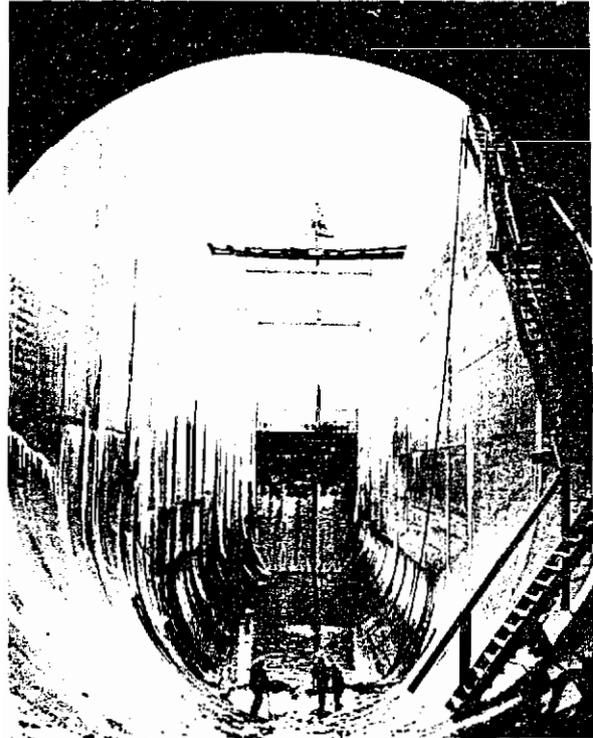
Figure 3-2. View of spillway tunnel stilling basin showing access to downstream spillway tunnel portal by stairway. Photo P459-640-4429 NA

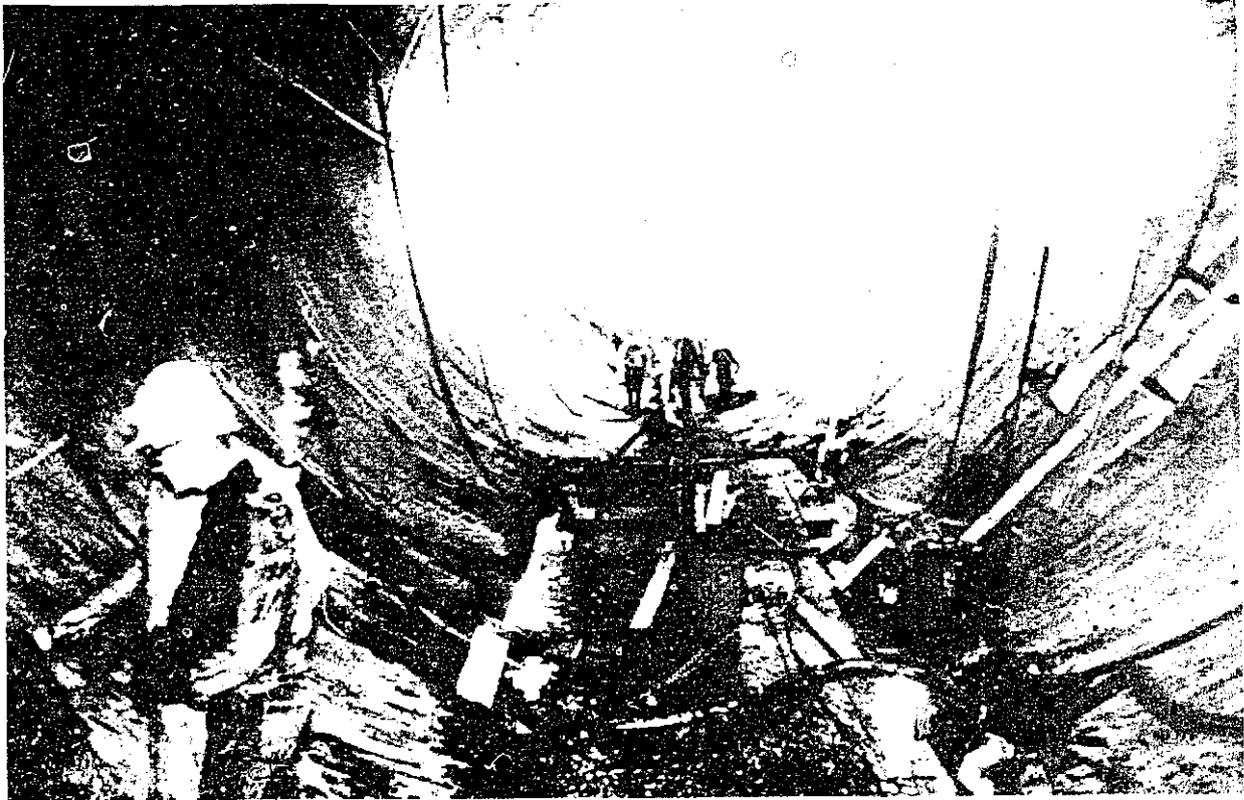
Figure 3-7. Overall view is shown of work area in spillway tunnel looking downstream from approximately the P.T. station of the elbow. Bonded concrete repairs have been completed; epoxy repairs are underway. Photo P459-D-68814

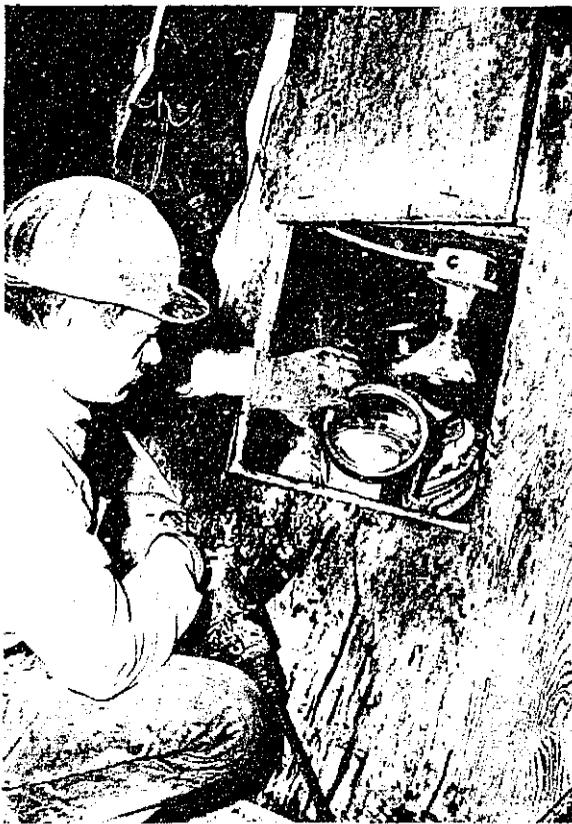
Figure 3-9. Wooden storage compartment for warm storage of epoxy components. Material temperatures of 75° to 80° F were maintained in this simple setup. Photo P459-640-1004 NA

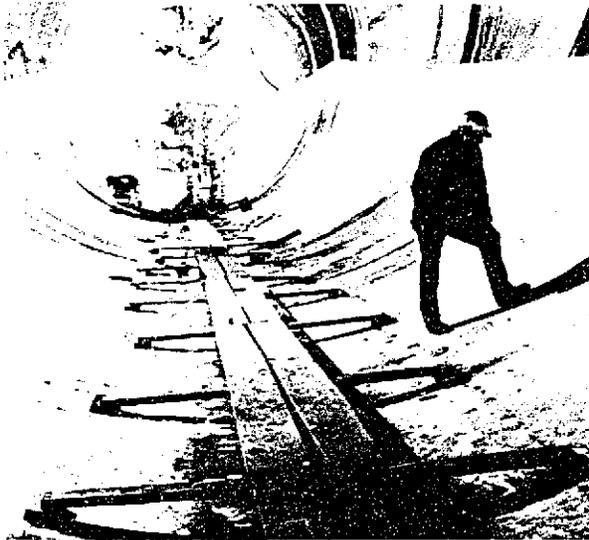
replaced. Although most of the carbonate deposits had been removed, additional removal was required at random locations. Several holes, up to 3 inches in diameter and with varying depths, were noted and were to be repaired.

Figure 3-11: Appearance of the spillway tunnel near the end of construction is shown. Note the excellent inspection potential with the white epoxy-phenolic paint coat. Smoothness of the total lining is also apparent. Photo P459-640-998

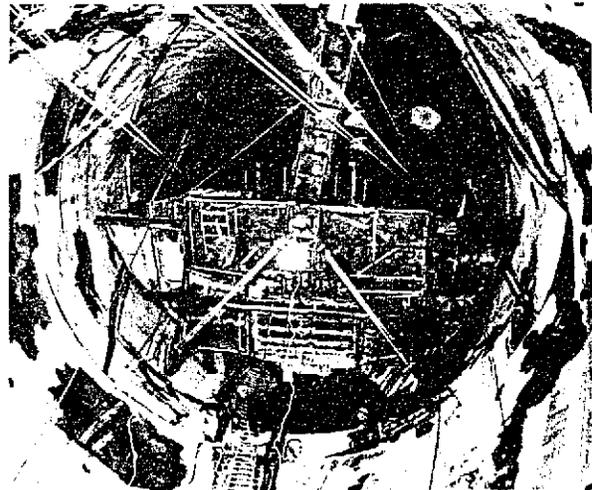
Figure 3-12: View of upper jumbo and nearly completed aeration slot. Dark areas below aeration slot are epoxy-bonded epoxy-mortar repair areas. Photo P459-640-4432 A

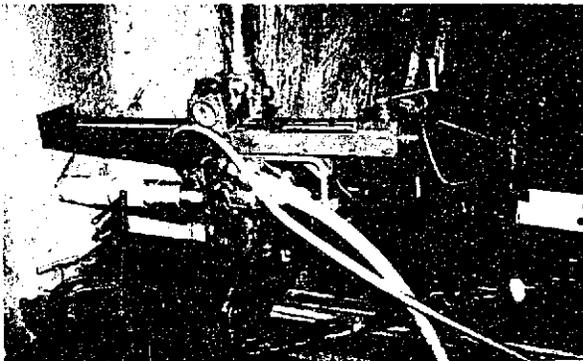
Figure 3-14. Diamond drill working off the upper jumbo and drilling reinforcement steel on periphery of the aeration slot excavation. This tool was later abandoned because it was too slow and impeded progress. Photo P459-D-68569

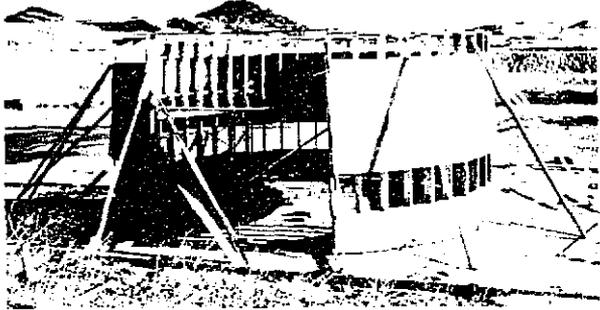
Figure 3-15. Prototype of the aeration slot forms. The assembled form at this stage is ready for disassembly and final installation at the excavated slot area of the lining in the spillway tunnel, Photo P459-D-68570

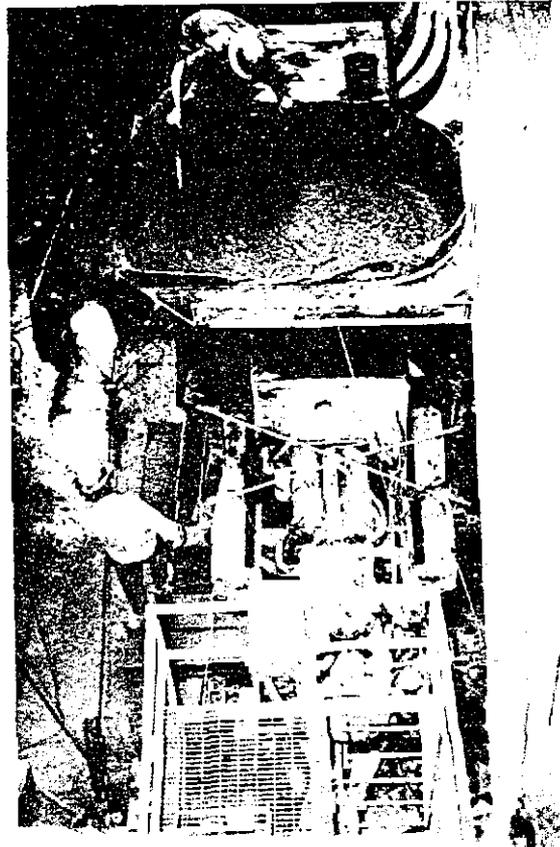
The location of the pump above the point of placement was contrary to good concrete placement practices because of the difficulty of pumping concrete downhill. However, pumping concrete from below the aeration slot into the slot forms presented difficult problems of supplying concrete to the pump from the

Figure 3-17. Case-McCarr hydraulically operated concrete pump used to place the concrete in the aeration slot. Photo P459-D-68571

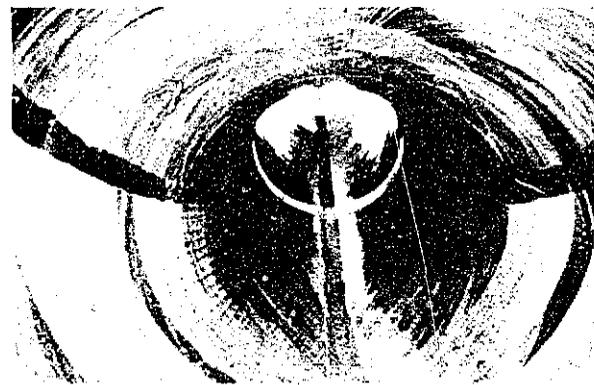
The work in repairing the major damaged areas, applying the epoxy-mortar veneer, construction of the aeration slot, and application of the epoxy-phenolic paint was accomplished by working two 10-hour shifts per working day. The work was among the most difficult repair jobs contracted by the Bureau. Figure 3-19 shows the completed tunnel repair.

Figure 3-19. Completed repair work. View looking upstream into bend of tunnel. White slash in center of photograph is the completed aeration slot. Photo P459-D-68573
