Oxbow Conservation Area Reach Assessment Middle Fork John Day River

Grant County, Oregon

U.S. Department of the Interior
Bureau of Reclamation
Pacific Northwest Region
Pacific Northwest Regional Office, Boise, Idaho

March 2010

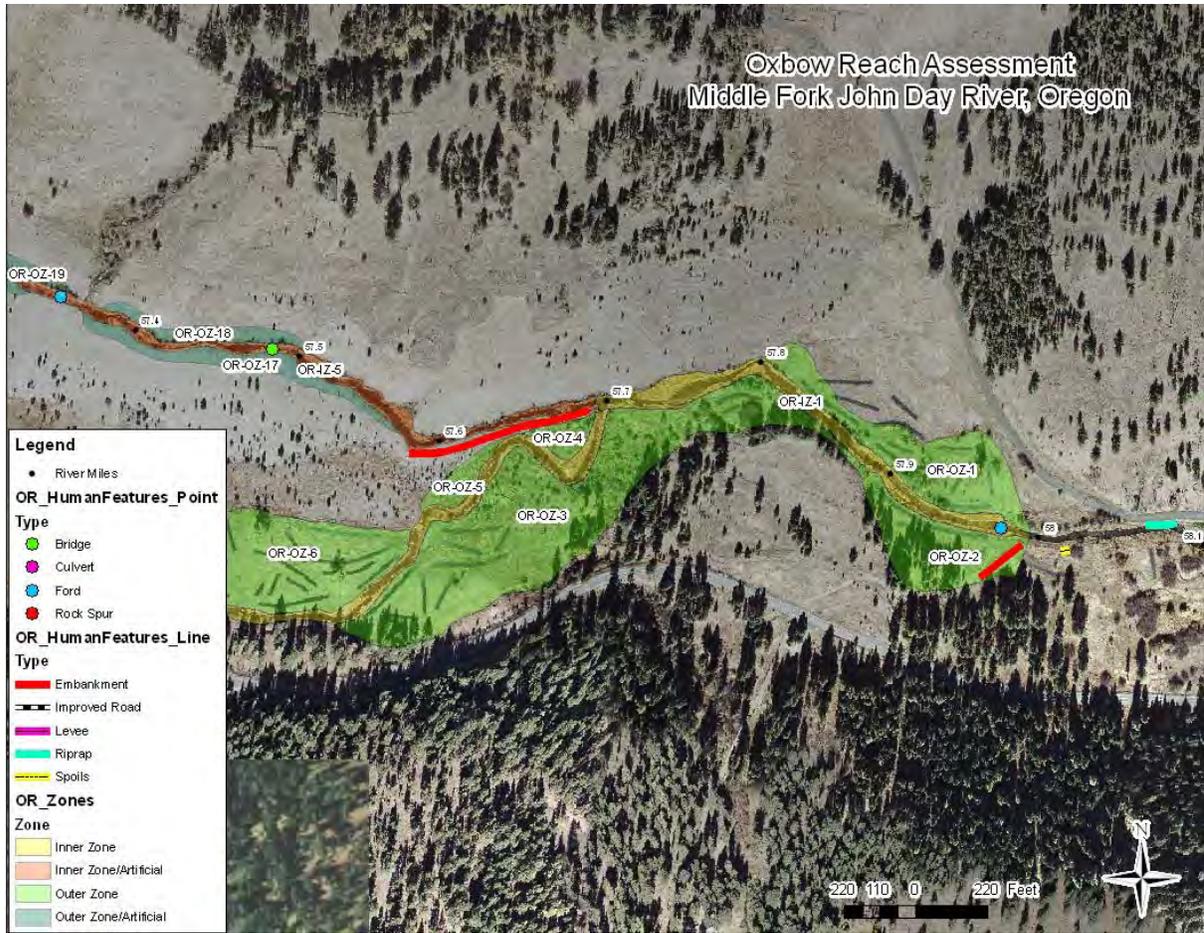
Figure 8. Location map from RM 58.00 to RM 57.70 showing inner and outer zone subreaches and anthropogenic features.

Between RM 58.00 and RM 57.70 (Figure 8), the river is in a transition condition (transport-limited) as it accesses a moderately wide floodplain (Figure 9 and Figure 10, also see Appendix C). The upstream valley constriction is near RM 58.00 where the floodplain is confined between bedrock (Tc) and an older terrace (Qa2), and the downstream valley constriction near RM 57.70 where the floodplain is confined by the Granite Boulder Creek alluvial fan (Qafs) and the Butte Creek alluvial fan (Qafd). The average channel slope is about 0.51 percent. The predominant channel units are pools and riffles and the dominate substrate consists of cobbles and gravel.

There is one human feature (embankment) in OR-OZ-2 that negatively impacts floodplain processes. A ford crossing occurs in OR-IZ-1 that has minimal impact to processes, but could be contributing fine sediment to the river if its use as a crossing continues. The most notable impacts to this area include the (1) lack of a riparian buffer zone, (2) lack of instream large wood, and (3) lack of large wood recruitment potential (Table 6).

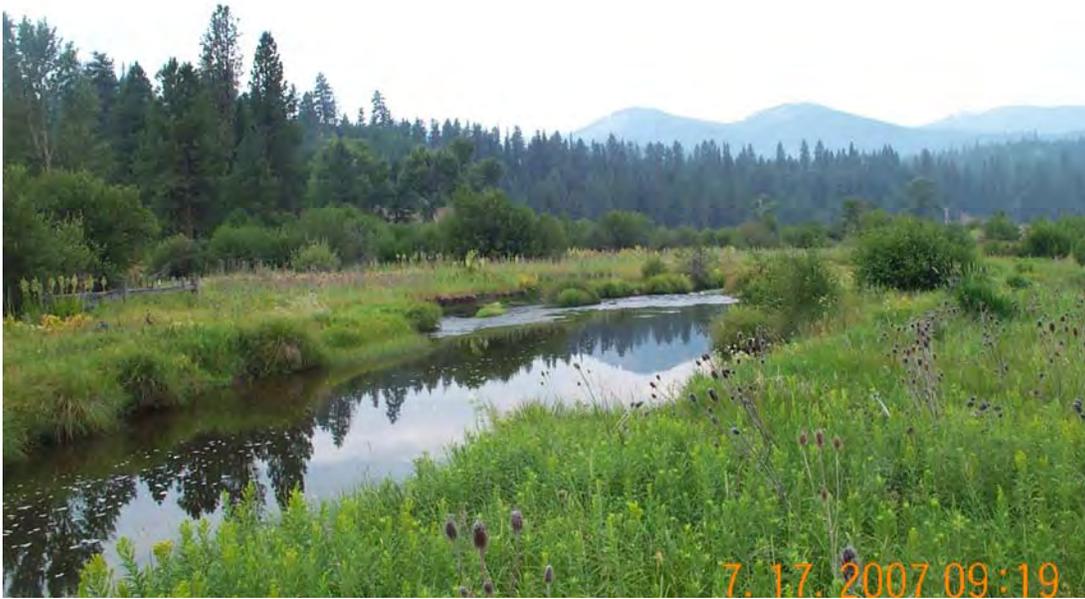
Figure 9. View is to the southwest looking downstream at bank erosion along river left. Oxbow Reach – Middle Fork John Day River, Oregon – Bureau of Reclamation photograph by E. Lyon, July 17, 2007.

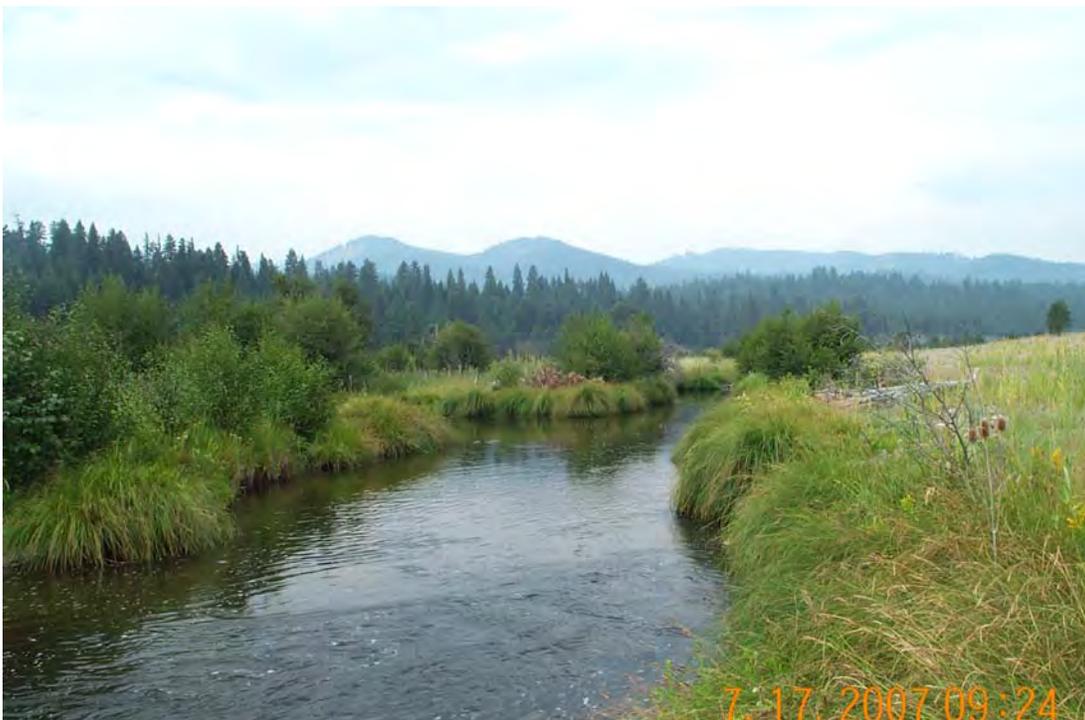
Figure 10. View is to the southwest looking downstream at flow split to the North and South Channels. Oxbow Reach – Middle Fork John Day River, Oregon – Bureau of Reclamation photograph by E. Lyon, July 17, 2007.

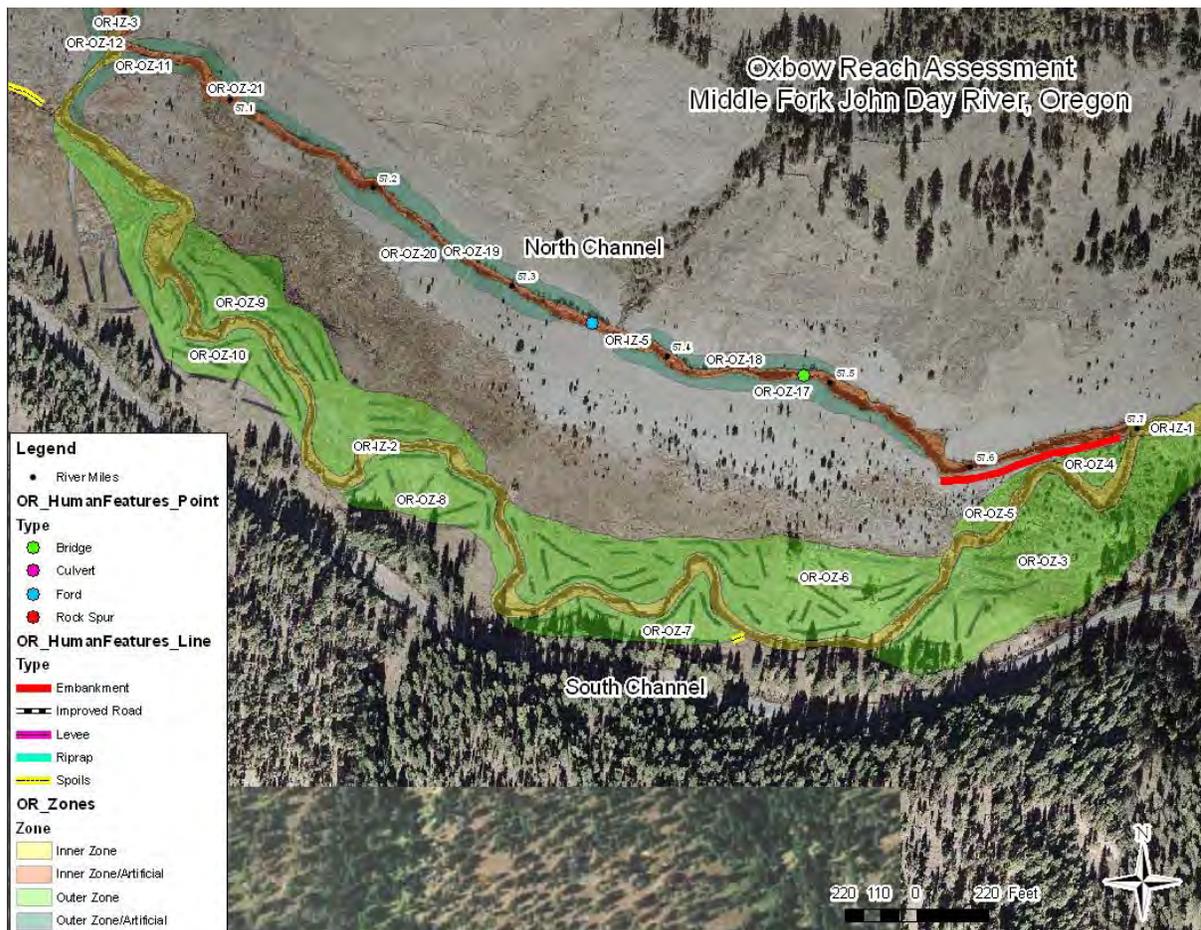
Figure 11. Location map from RM 57.70 to RM 57.00 (South Channel) showing inner and outer zone subreaches and anthropogenic features.

At RM 57.70, the channel bifurcates into two separate flow paths: the South Channel and the North Channel. Along the South Channel between RM 57.70 and RM 57.00 (Figure 11, also see Appendix C), the river is in a transition condition (supply-limited condition) as it accesses a relatively wide floodplain, but a significant portion of flows and sediment are conveyed through the North Channel. The average channel slope is about 0.41 percent and the predominant channel units are runs, but also include pools and riffles. The dominate substrate consists of gravel and cobbles.

There is one human feature (spoil pile) in OR-OZ-7 that has minimal impact to floodplain processes. Overall, this area is most notably impacted by (1) lack of riparian buffer zone, (2) lack of instream large wood, and (3) lack of large wood recruitment potential (Table 7).

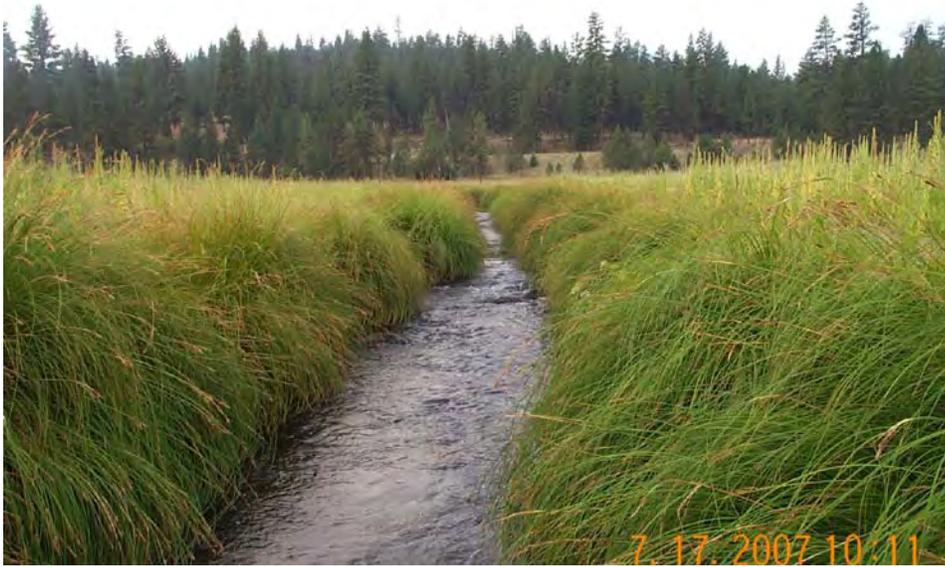
There appears to be localized incision near the head of the South Channel (Figure 12, also see Appendix C). Where the South Channel flows against the valley wall, there is “pocket-pool” habitat created by boulders (Figure 13). Near the downstream end of the South Channel, the river appears to have been straightened as it flows toward the North Channel (Figure 14) and some of the flow is diverted into the Ruby Creek irrigation system (Figure 15).

Figure 14. View is to the northeast looking downstream where the South Channel appears to have been straightened. Oxbow Reach – Middle Fork John Day River, Oregon – Bureau of Reclamation photograph by E. Lyon, July 17, 2007.

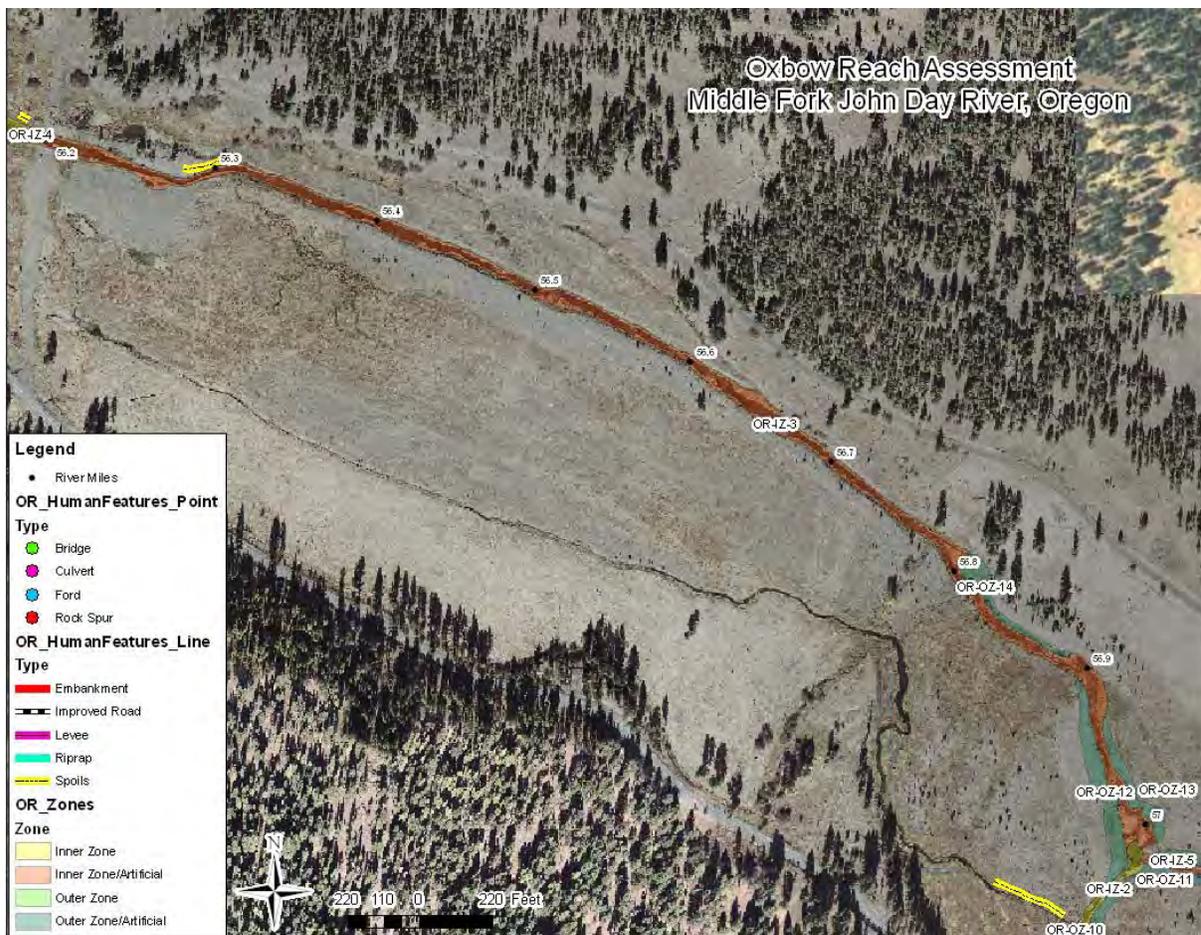
Figure 16. Location map of subreaches between RM 57.00 and RM 56.20 and the anthropogenic features.

Between RM 57.00 and RM 56.20 (Figure 16; also see Appendix C), the river is in a transport condition (morphologically resilient and supply-limited) due to channelization through mine tailings (Figure 17 and Figure 18). The upstream valley constriction is near RM 56.80 where the floodplain is confined by Ruby Creek alluvial fan (Qafd) and a landslide (Qls). The downstream valley constriction near RM 56.20 is where the floodplain is confined by Beaver Creek alluvial fan (Qafs) and an older terrace (Qa3). There is minimal activated floodplain area for flows of up to a 100-year discharge due to stream channelization. Average channel slope is about 0.60 percent. Rapids are present along this stream segment, but the predominant channel unit is a run and the dominate substrate consists of cobbles and gravel.

The primary human features are the mine tailings and the channelization of the river through the tailings. Overall, this area is most notably impacted by (1) lack of floodplain connectivity, (2) lack of channel migration, (3) lack of instream large wood, (4) lack of riparian buffer zone, and (5) lack of large wood recruitment potential (Table 8).

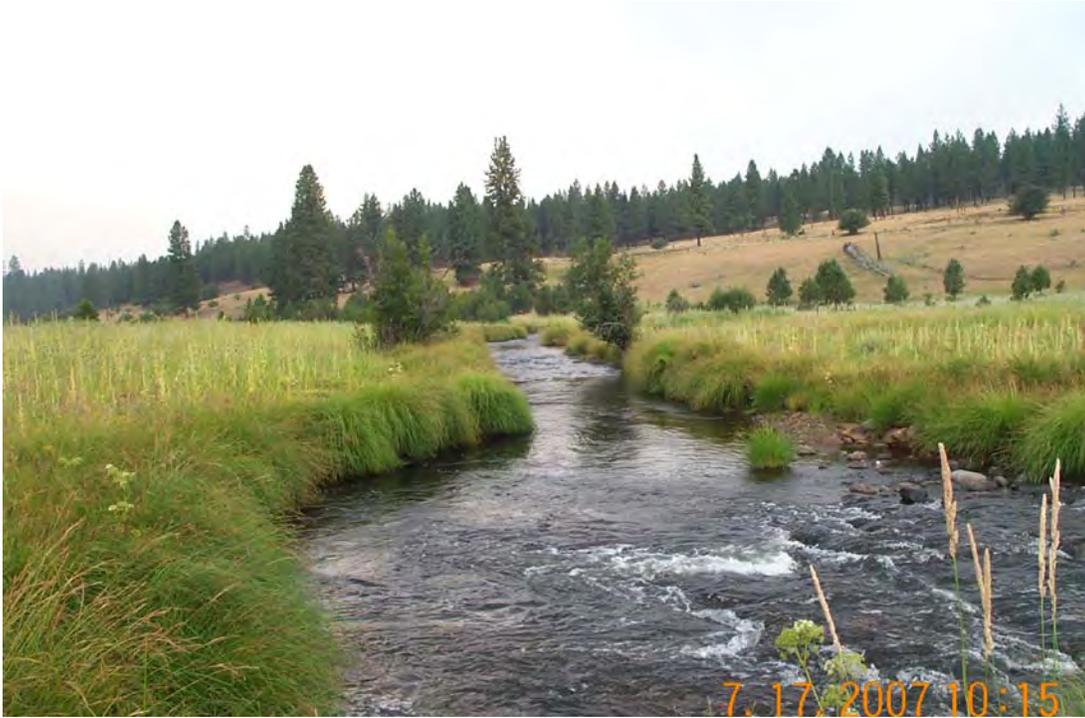
Figure 17. View is to the northwest looking downstream below the confluence of the North and South Channels. Oxbow Reach – Middle Fork John Day River, Oregon – Bureau of Reclamation photograph by E. Lyon, July 17, 2007.

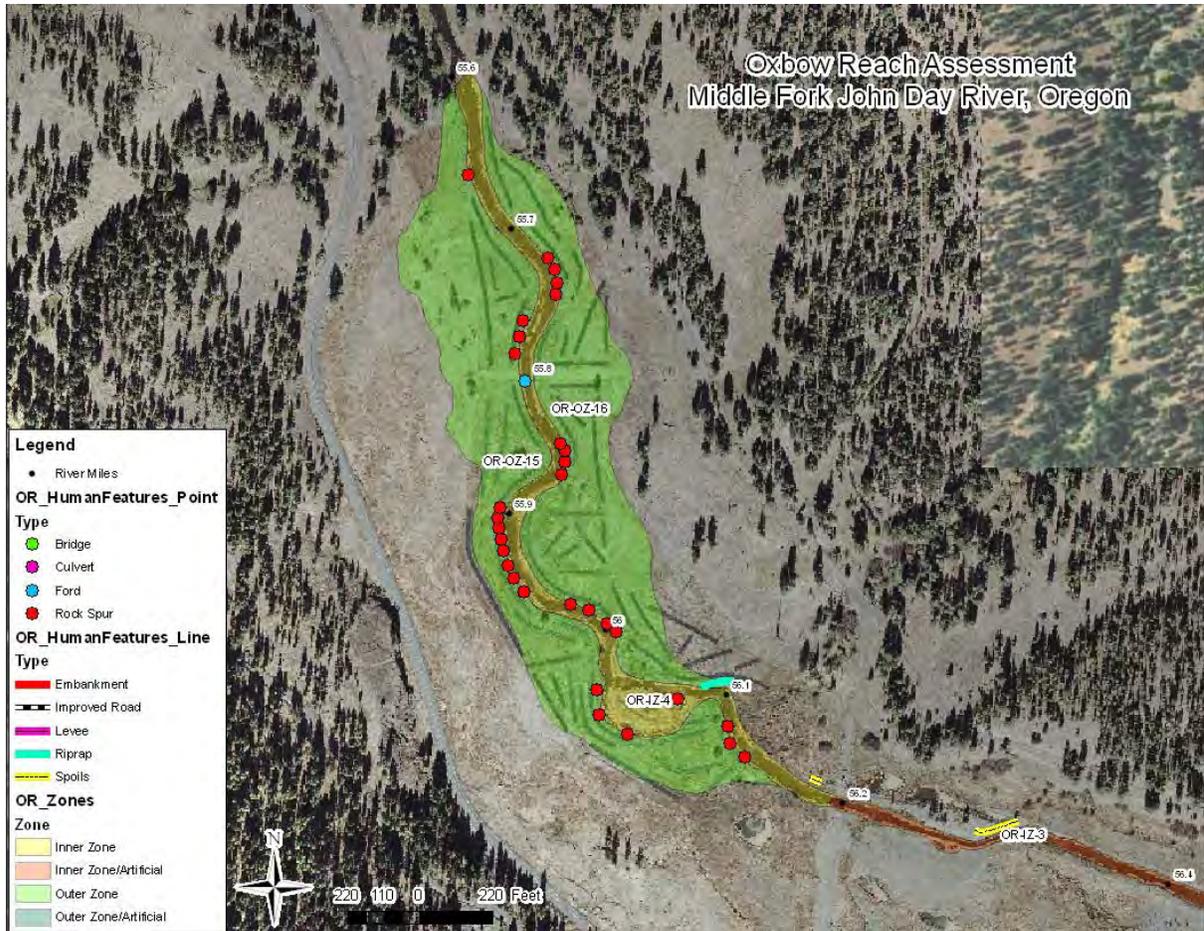
Figure 19. Location map from RM 56.20 to RM 55.60 showing inner and outer zone subreaches and anthropogenic features.

Between RM 56.20 and RM 55.60 (Figure 19; also see Appendix C), the river is in a transition condition (transport-limited) as it accesses a relatively wide floodplain (Figure 20). The upstream valley constriction is near RM 56.20 where the floodplain is confined between Beaver Creek alluvial fan (Qafs) and an older terrace (Qa3). Average channel slope is about 0.59 percent. Predominant channel units are runs and riffles, and a few pools are also present. The dominate substrate consists of gravel and cobbles.

The human features along OR-IZ-4 include riprap and rock spurs (Figure 20 and Figure 21) that negatively impact lateral channel migration. The river has scoured around some of the rock spurs so that the rock provides “pocket-pool” habitat, but these pools do not provide sufficient fish cover or biomass. Overall, this area is most notably impacted by (1) lack of riparian buffer zone, (2) lack of instream large wood, and (3) lack of large wood recruitment potential (Table 9).

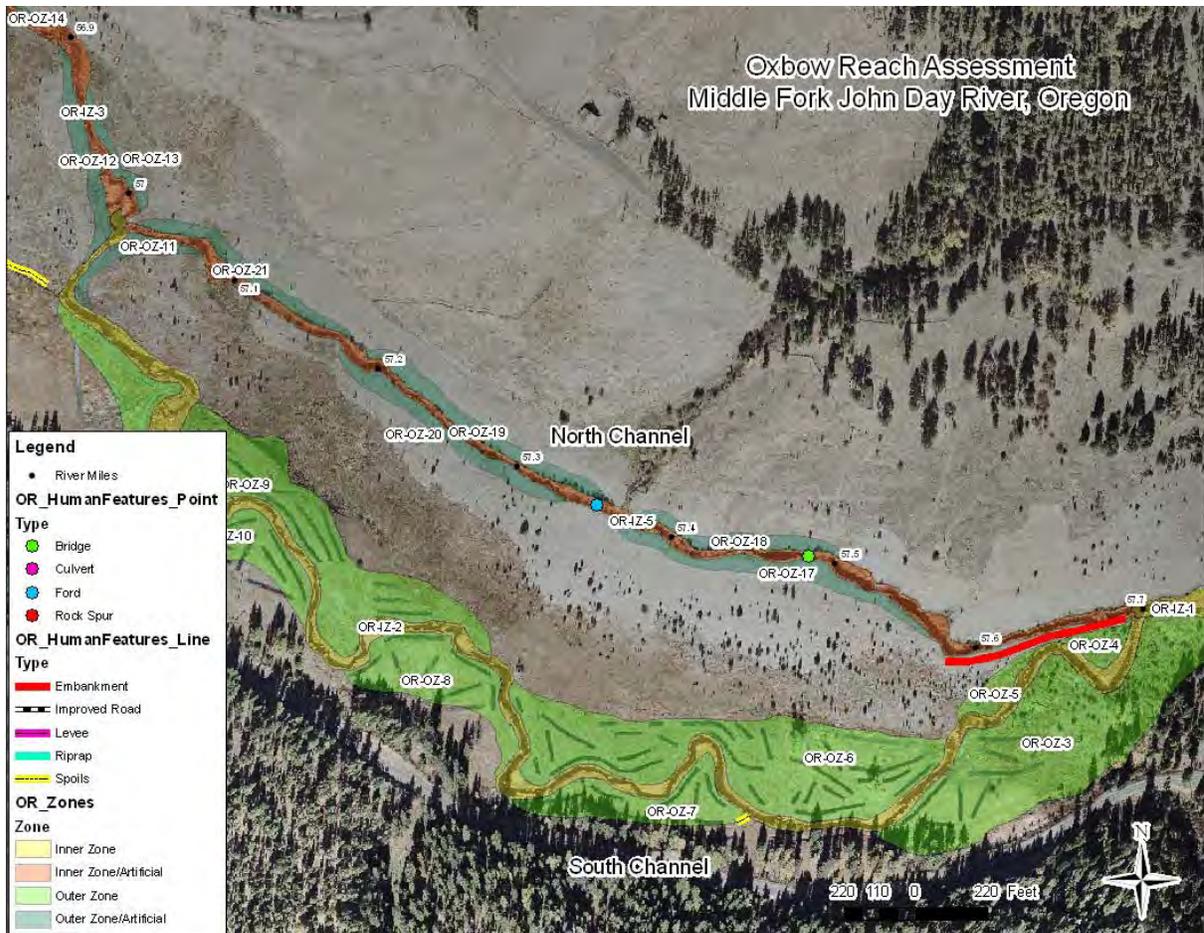
Figure 22. Location map from RM 57.70 to RM 57.00 (North Channel) showing inner and outer zone subreaches and anthropogenic features.

Between RM 57.70 and RM 57.00 (Figure 22; also see Appendix C), the river is in a transport condition (supply-limited) as it accesses a narrow, constructed floodplain through the mine tailings along a channelized stream segment (Figure 23). Average channel slope is 0.65 percent. Predominant channel units are riffles, pools, and runs with the highest concentration of rapids in the Oxbow reach. The dominate substrate is gravel and cobbles.

Primary anthropogenic features include mine tailings, stream channelization through the mine tailings, and an artificial flow bifurcation between the North and South Channels (Figure 24). The capacity of the North Channel to convey flows and sediment is limited due to the channel size and the entrance conditions at the bifurcation. Under high flow conditions, the majority of flows are routed through the South Channel with a lesser amount being routed through the North Channel. Conversely, under low flow conditions, the majority of the flows are routed through the North Channel (Reclamation 2009). An embankment that is 565 feet long also impacts the floodplain connectivity (Figure 25). Overall, this area is most notably impacted by (1) lack of floodplain connectivity, (2) lack of channel migration, (3) instream large wood, (4) lack of riparian buffer zone, and (5) lack of large wood recruitment potential (Table 10).

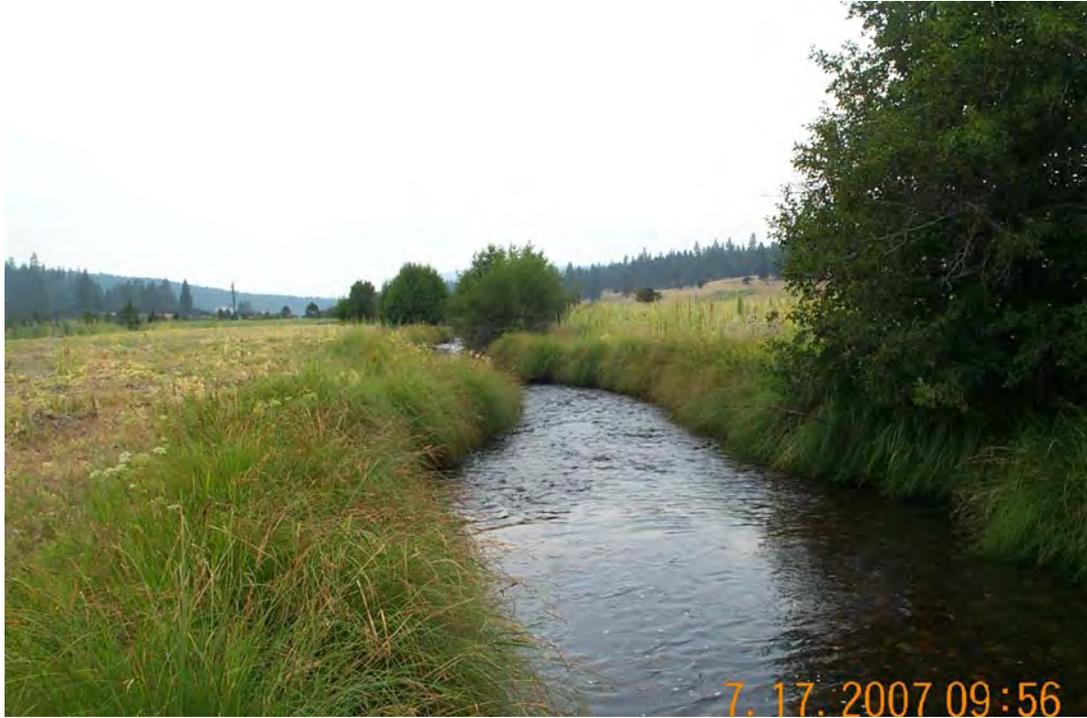
Figure 23. View is to the northwest looking downstream along the North Channel. Oxbow Reach – Middle Fork John Day River, Oregon – Bureau of Reclamation photograph by E. Lyon, July 17, 2007.

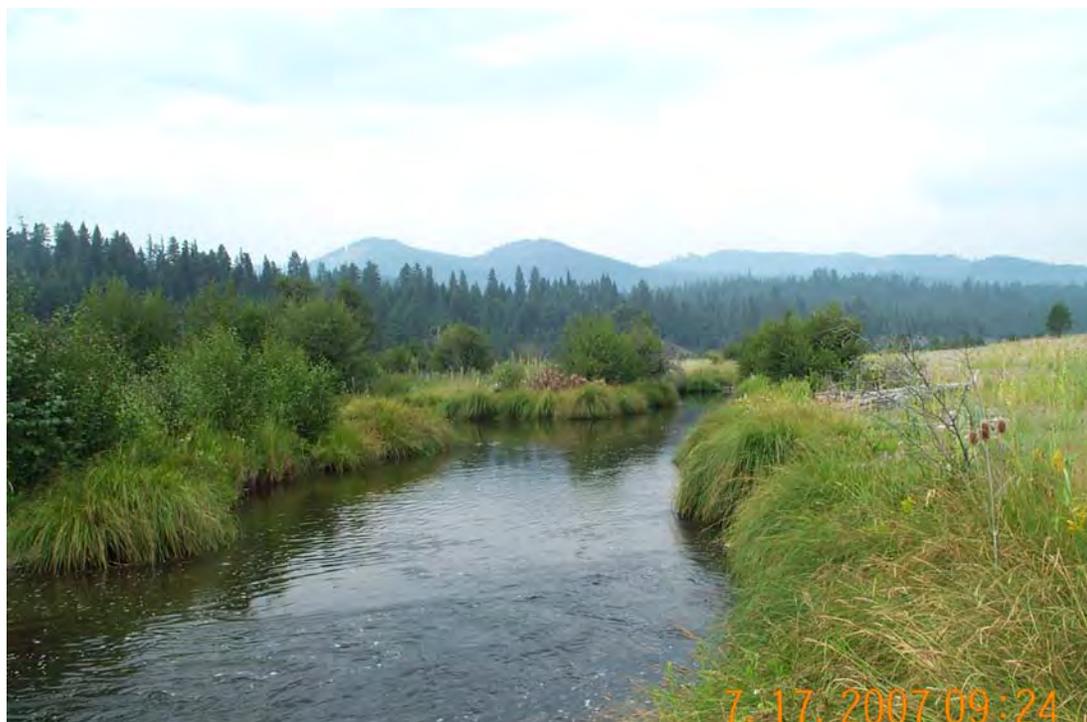
Figure 24. View is to the southwest looking downstream at flow split to the North (right) and South (left) Channels. Oxbow Reach – Middle Fork John Day River, Oregon – Bureau of Reclamation photograph by E. Lyon, July 17, 2007.

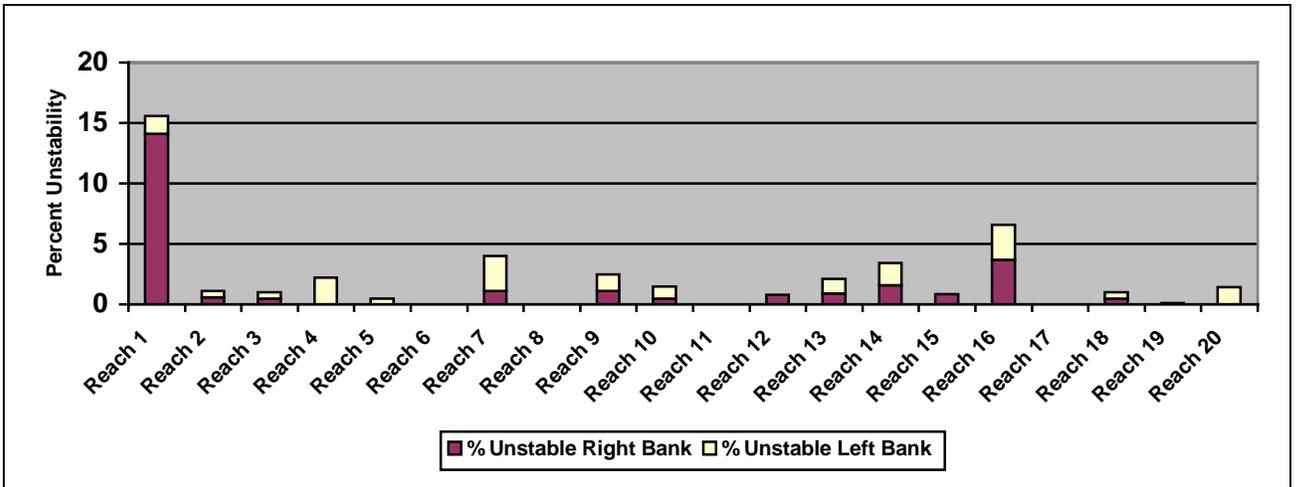
- The banks on Middle Fork John Day met the RMOs for bank stability, being more than 80% stable (Graph 1.4).
- For more detailed information by reach see the Unstable and Undercut Bank Summary in Chapter 2.

Graph 1.4. Percent of unstable banks observed by reach.

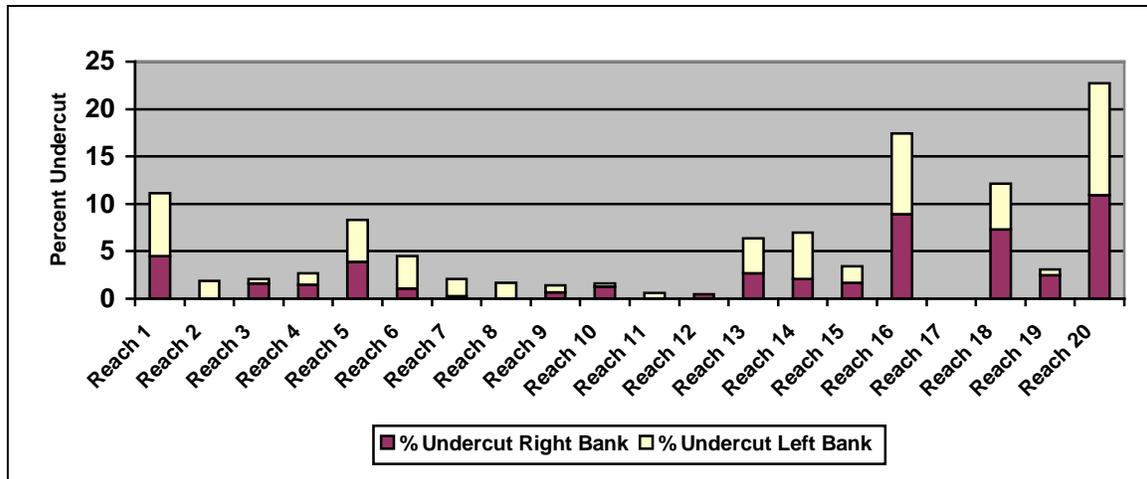
- The RMOs were met for undercut banks (lower bank angle) being greater than 75% stable (Graph 1.5).

Graph 1.5. Percent of undercut banks found on Middle Fork John Day River.

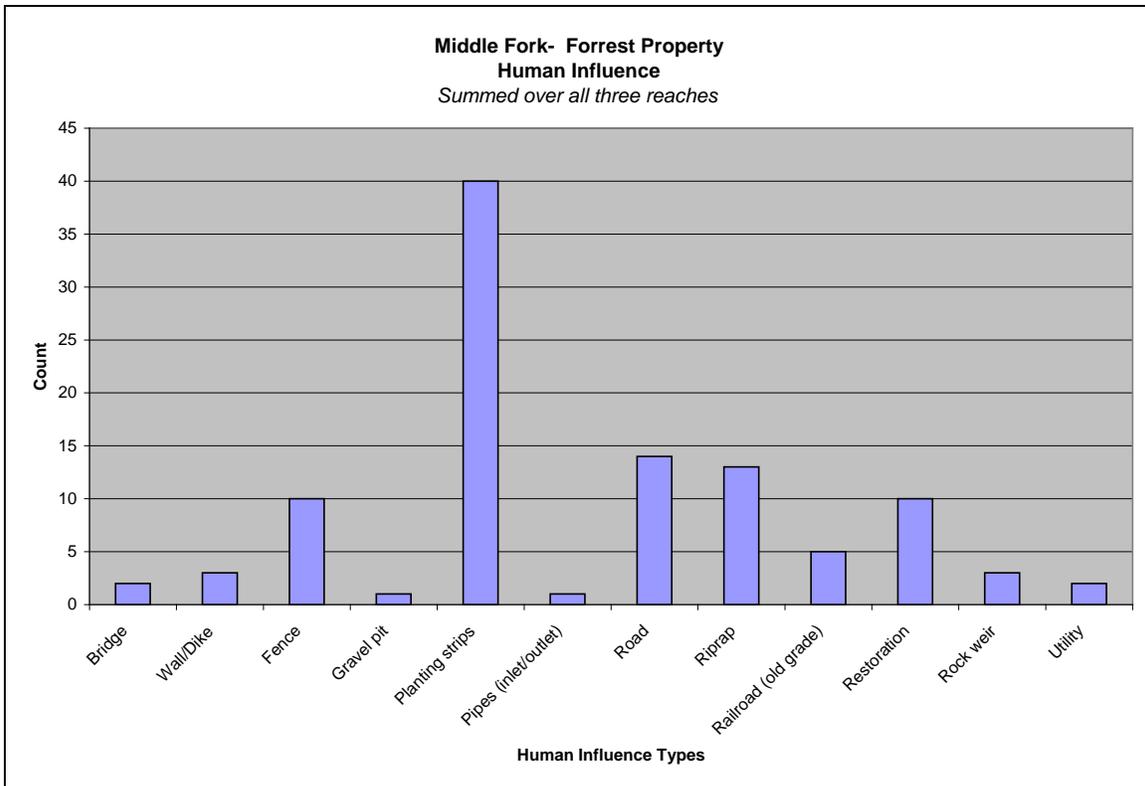
Human influence within the riparian zone was determined by visual assessment of presence, type, and proximity to the stream channel. Planting strips had the highest occurrence within the vegetation transects, followed by road and riprap disturbances (Graph 3.6). The road influences were only present in Reach 1 and Reach 2, while riprap was present in Reach 2 and Reach 3 (Appendix D). Rock weirs and riprap were human influences to the bank, while other influences were close (within the 10 x 10m plot) or were present (outside plot area).

Planting strips created a disturbance to the riparian area, first restricting of vegetation under the black mats, and second disturbing the soil, where early seral vegetation species were observed to establish in failed plantings. The paved road was a disturbance to the riparian area, by constraining the active channel and effective riparian zone. Both the rock weirs and riprap are often considered a human disturbances present to ameliorate bank degradation and create stream habitat.

Graph 3.6: Human influence counts on Middle Fork John Day- Forrest Property, summarized over all three reaches.

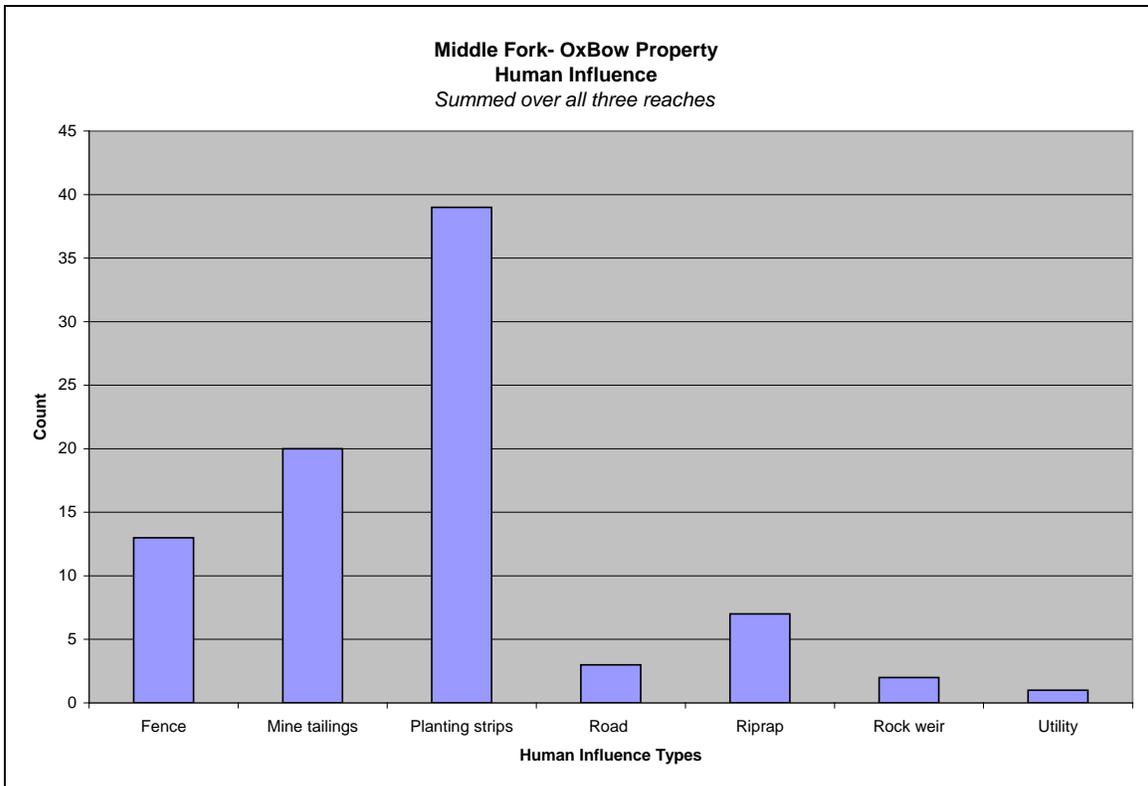
Planting strips had the highest occurrence within the vegetation transects, followed by mine tailings and fence disturbances (Graph 3.7). The mine tailing influences were only present in Reach 2 and Reach 3, while riprap and planting strips were present throughout (Appendix D). Riprap was the human influences to the bank, while other influences were close (within the 10 x 10m plot) or were present (outside plot area).

Planting strips created a disturbance to the riparian area, first restricting of vegetation under the black mats, and second disturbing the soil, where early seral vegetation species were observed to establish in failed plantings. The mine tailings were a disturbance to the riparian area and stream, constraining the active channel and effective riparian zone, while restricting vegetation growth. Riprap is often a human disturbances present to ameliorate bank degradation and create stream habitat, while the fence is often present to restrict cattle from the riparian area.

Graph 3.7: Human influence counts on Middle Fork John Day- Forrest Property, summarized over all three reaches.

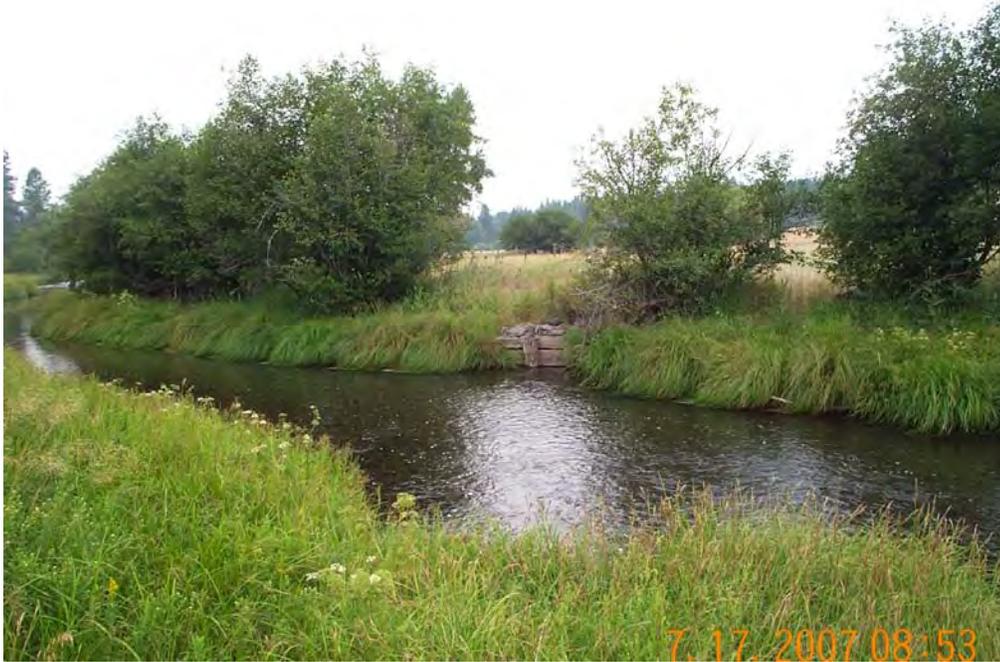
Photograph No. 1. View is to the west looking across the river at historic bridge abutment along river right that restricts lateral migration of the river. Oxbow Reach – Middle Fork John Day River – John Day Subbasin, Oregon – Bureau of Reclamation Photograph by E. Lyon, July 17, 2007.

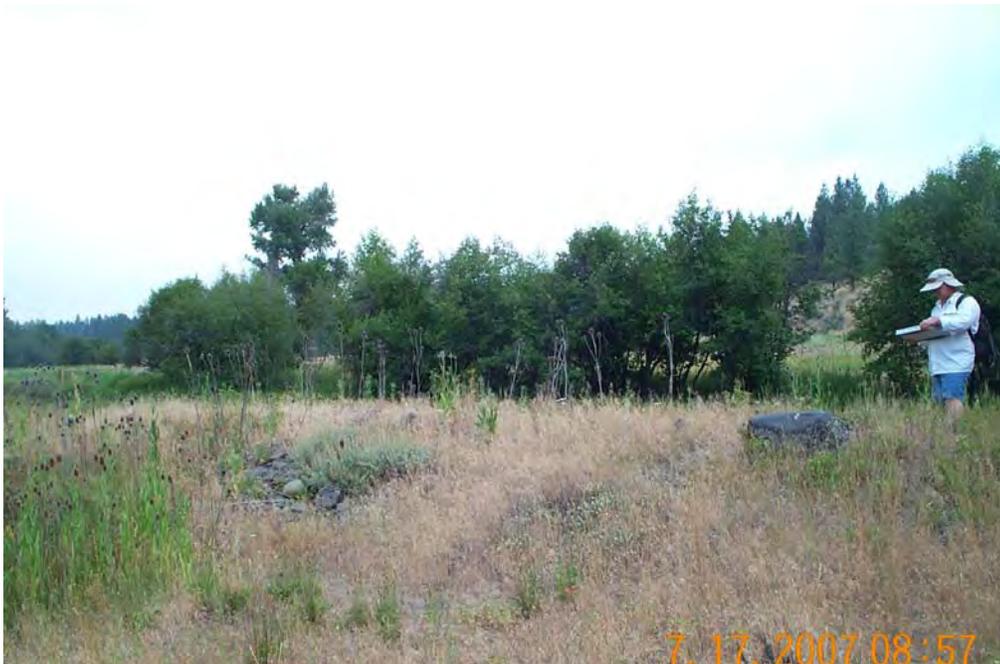
Photograph No. 2. View is to the north looking at levee placed along river left that restricts floodplain connectivity. Oxbow Reach – Middle Fork John Day River – John Day Subbasin, Oregon – Bureau of Reclamation Photograph by E. Lyon, July 17, 2007.

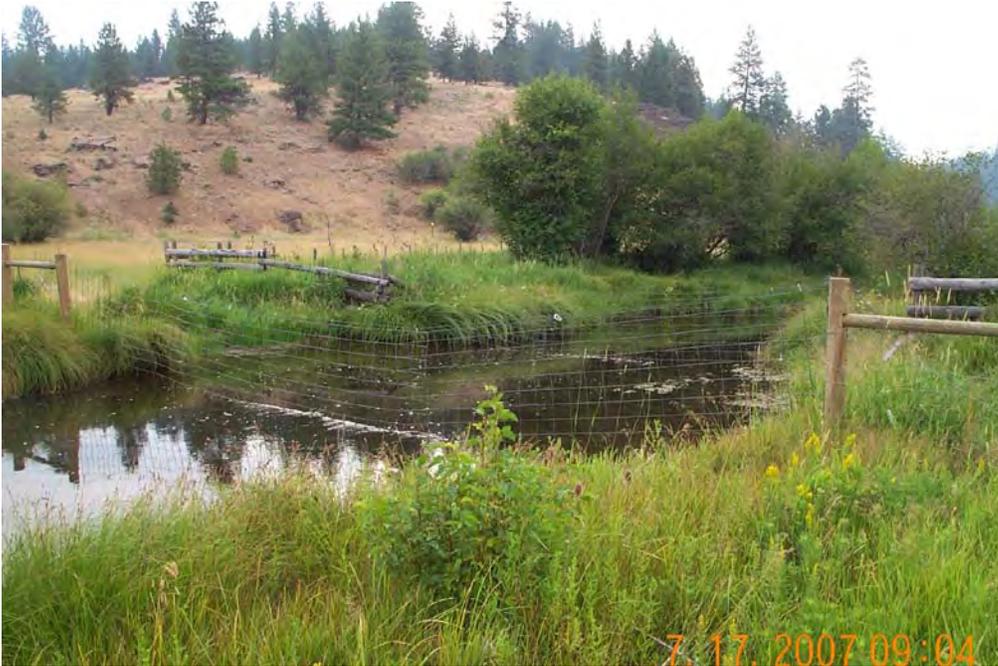
Photograph No. 3. View is to the northeast looking upstream at cattle crossing. Oxbow Reach – Middle Fork John Day River – John Day Subbasin, Oregon – Bureau of Reclamation Photograph by E. Lyon, July 17, 2007.

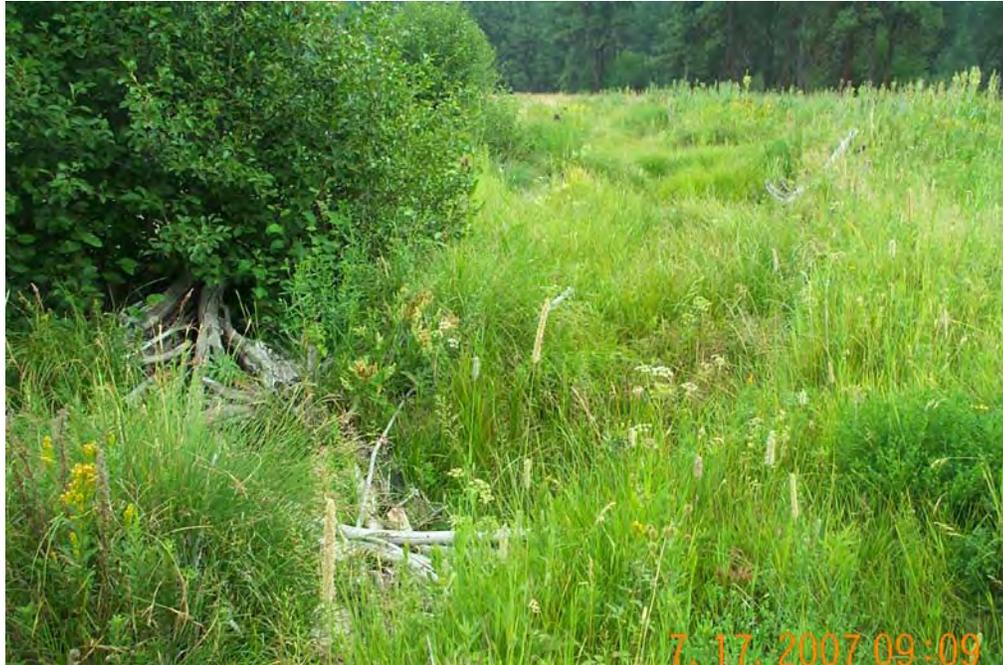
Photograph No. 5. View is to the northeast looking at the mouth of an overflow channel that is blocked due to small woody debris accumulation and sediment. Oxbow Reach – Middle Fork John Day River – John Day Subbasin, Oregon – Bureau of Reclamation Photograph by E. Lyon, July 17, 2007.

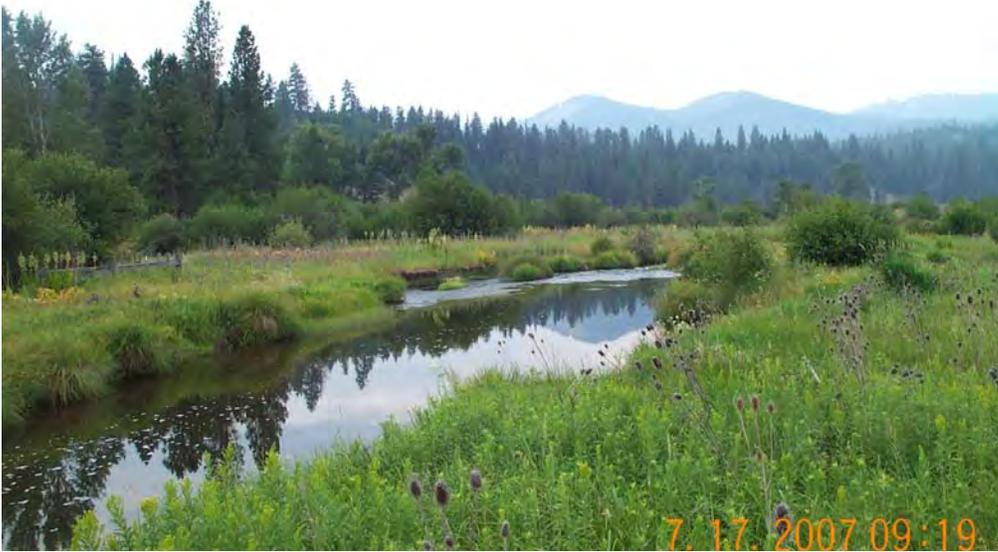
Photograph No. 7. View is to the southwest looking downstream at bank erosion along river left. Oxbow Reach – Middle Fork John Day River – John Day Subbasin, Oregon – Bureau of Reclamation
Photograph by E. Lyon, July 17, 2007.

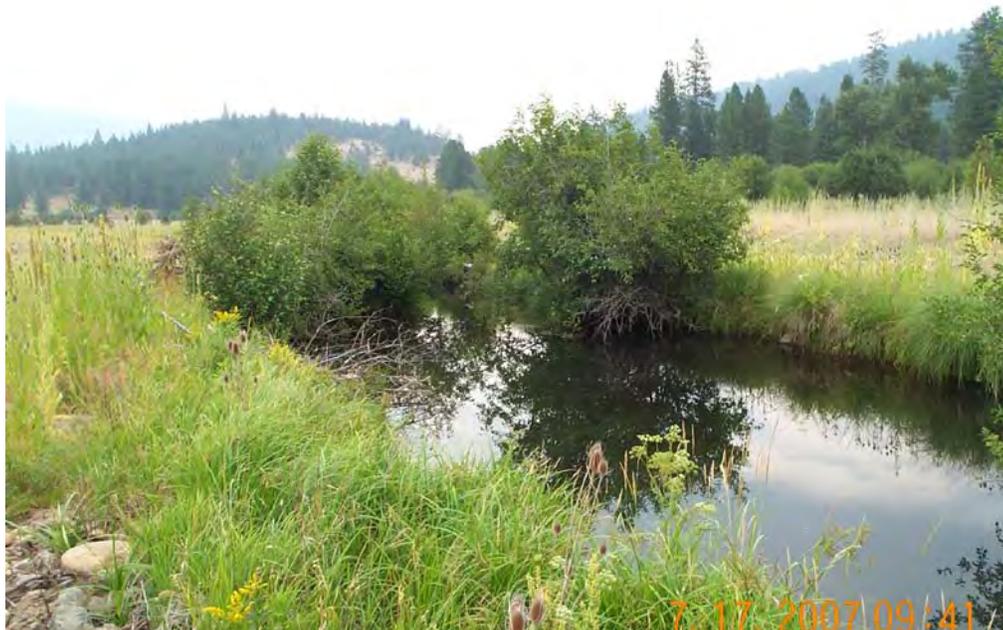
Photograph No. 10. View is to the east looking upstream from river right at road grade (right of center in tan grass). Oxbow Reach – Middle Fork John Day River – John Day Subbasin, Oregon – Bureau of Reclamation Photograph by E. Lyon, July 17, 2007.

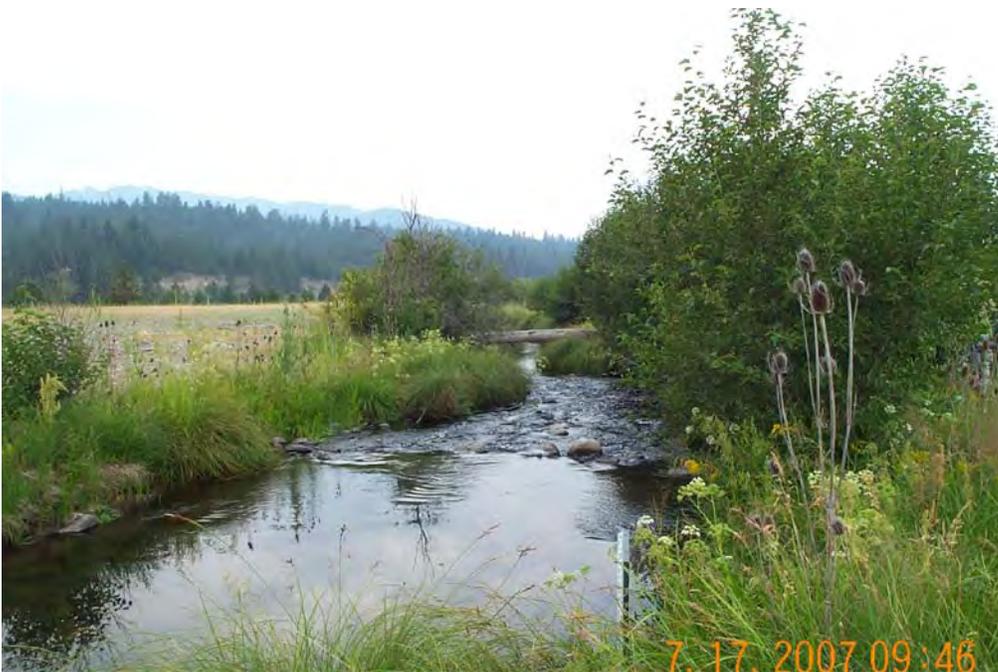
Photograph No. 12. View is to the northwest looking downstream along the North Channel at foot-bridge. Oxbow Reach – Middle Fork John Day River – John Day Subbasin, Oregon – Bureau of Reclamation Photograph by E. Lyon, July 17, 2007.

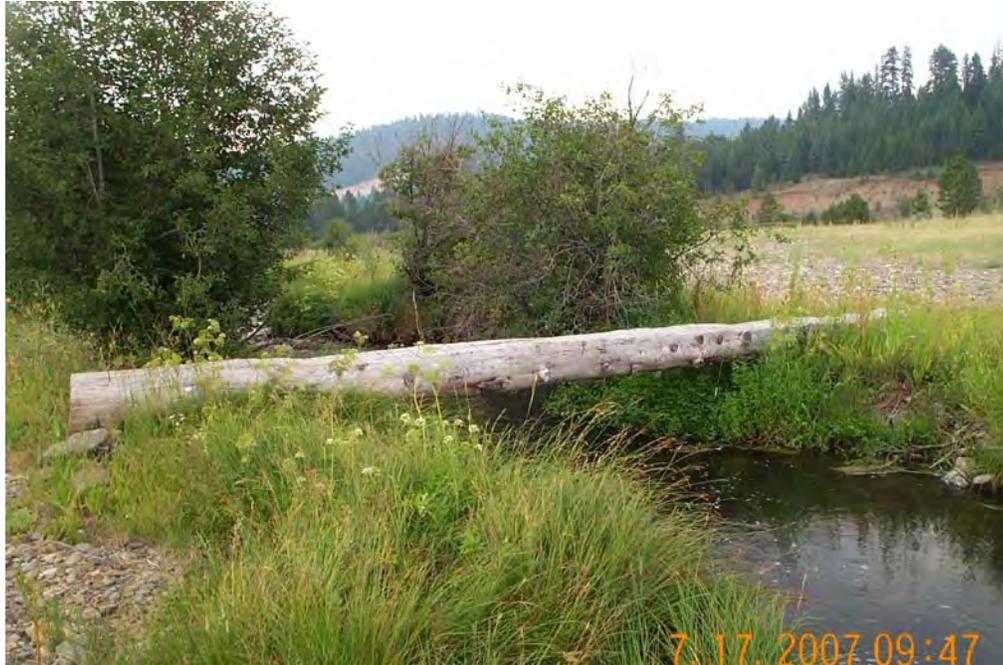
Photograph No. 13. View is to the southeast looking at foot-bridge crossing the North Channel. Oxbow Reach – Middle Fork John Day River – John Day Subbasin, Oregon – Bureau of Reclamation Photograph by E. Lyon, July 17, 2007.

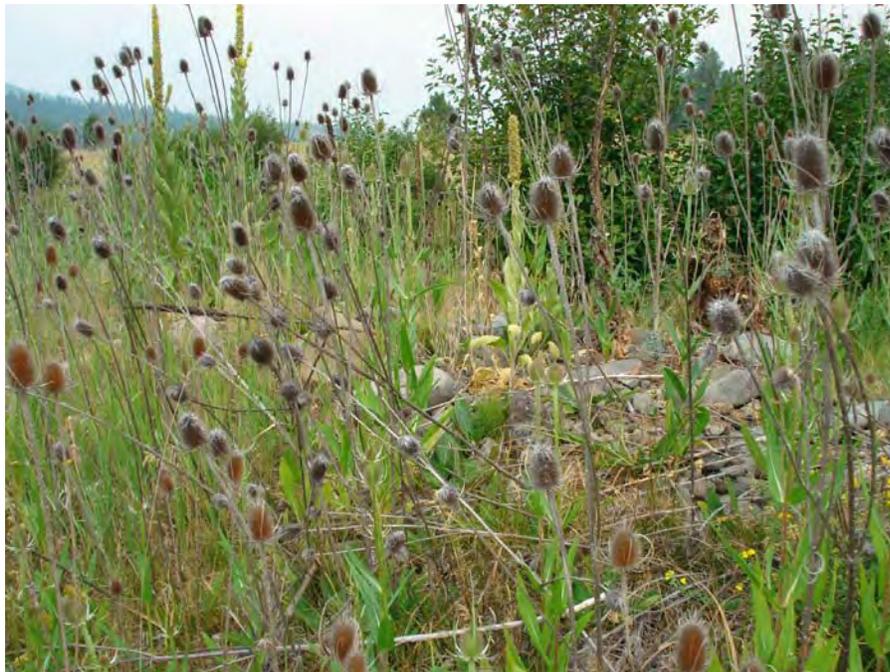
Photograph No. 22. View is to the west looking at a small push-up levee along river left. Oxbow Reach – Middle Fork John Day River – John Day Subbasin, Oregon – Bureau of Reclamation Photograph by R. McAfee, July 17, 2007.

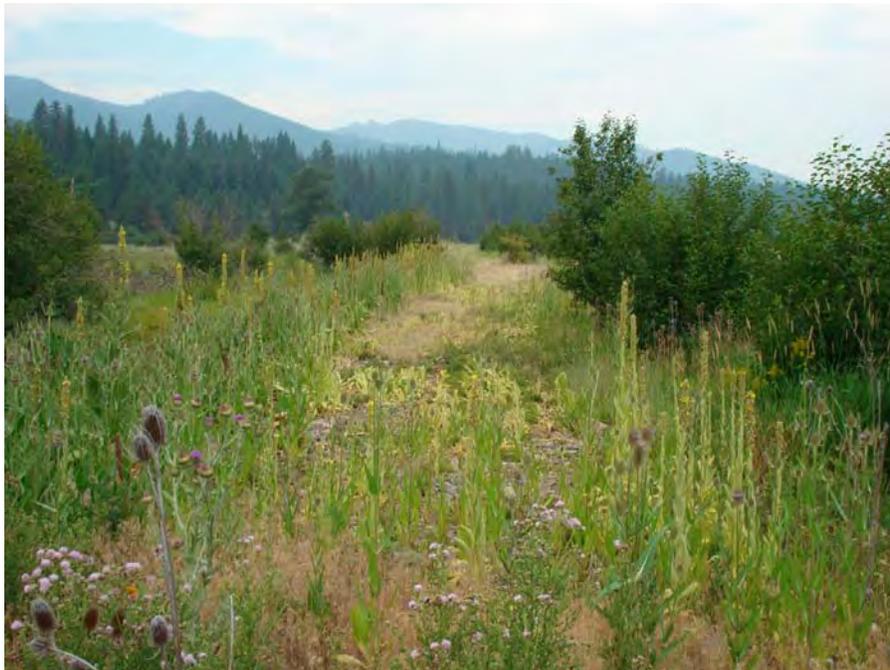
Photograph No. 24. View is to the west looking at an embankment that bisects the floodplain between the North and South Channels. Oxbow Reach – Middle Fork John Day River – John Day Subbasin, Oregon – Bureau of Reclamation Photograph by R. McAfee, July 17, 2007.
