Oxbow Conservation Area Reach Assessment Middle Fork John Day River

Grant County, Oregon

U.S. Department of the Interior
Bureau of Reclamation
Pacific Northwest Region
Pacific Northwest Regional Office, Boise, Idaho

March 2010

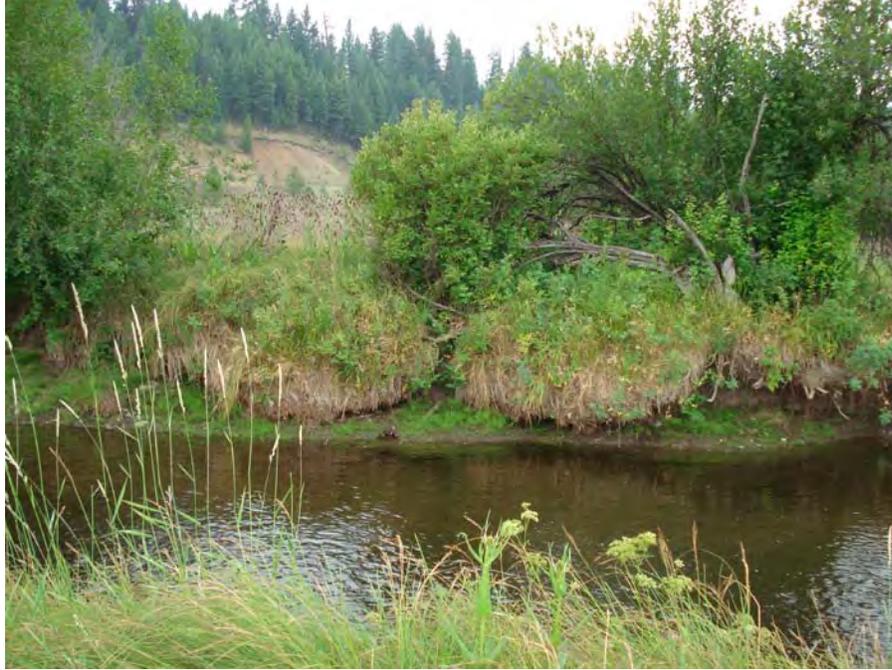
Photograph No. 28. View is to the west looking downstream at bank erosion along river left. Oxbow Reach – Middle Fork John Day River – John Day Subbasin, Oregon – Reclamation Photograph by R. McAfee, July 17, 2007.

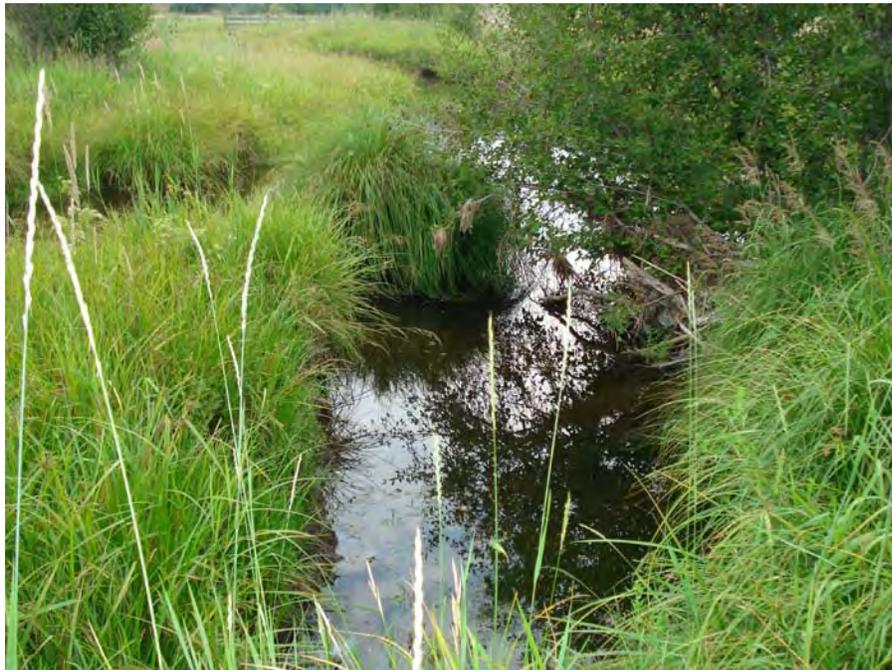
Photograph No. 29. View is to the west looking at bank erosion along river left. Oxbow Reach – Middle Fork John Day River – John Day Subbasin, Oregon – Bureau of Reclamation Photograph by R. McAfee, July 17, 2007.

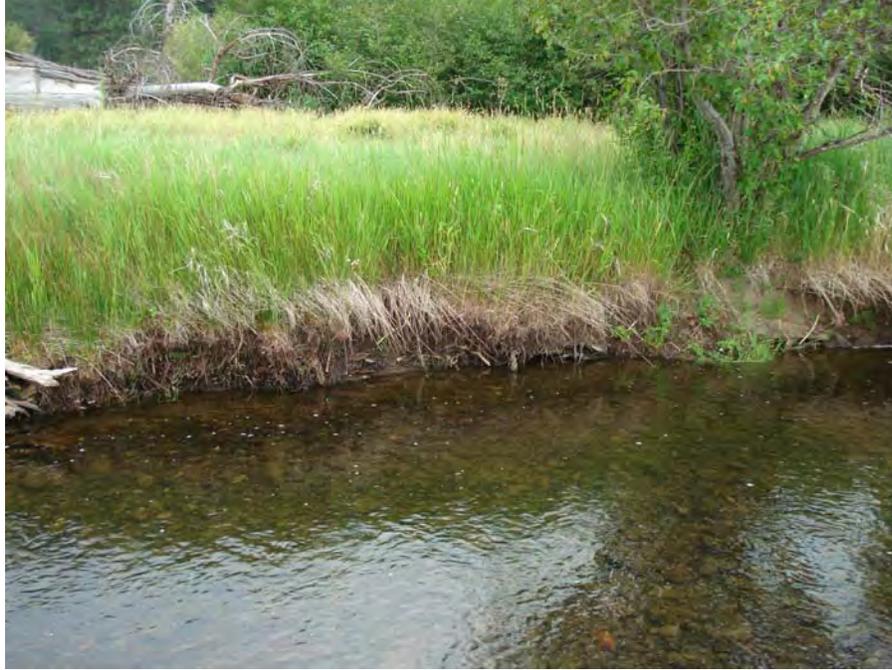
Photograph No. 33. View is to the south looking at erosion along river left. Oxbow Reach – Middle Fork John Day River – John Day Subbasin, Oregon – Bureau of Reclamation Photograph by R. McAfee, July 17, 2007.

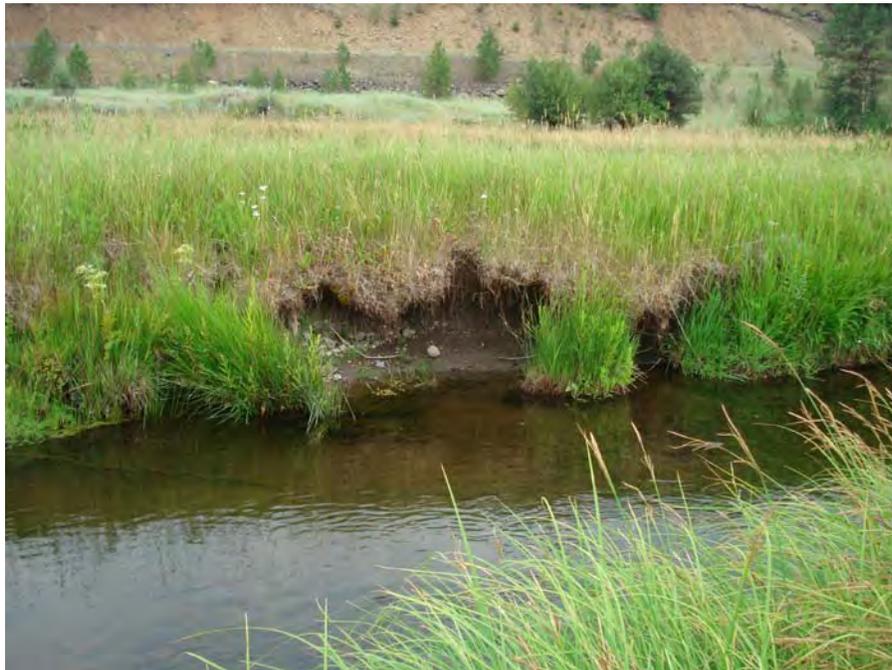
Photograph No. 34. View is to the south looking at bank erosion along river left. Oxbow Reach – Middle Fork John Day River – John Day Subbasin, Oregon – Bureau of Reclamation Photograph by R. McAfee, July 17, 2007.

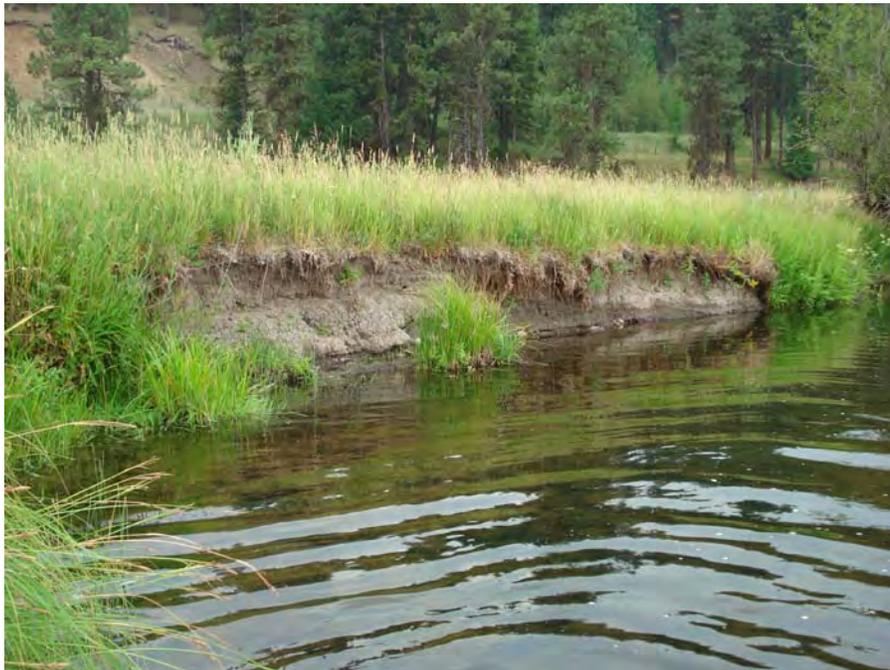
Photograph No. 36. View is to the south looking at bank erosion along river left. Oxbow Reach – Middle Fork John Day River – John Day Subbasin, Oregon – Bureau of Reclamation Photograph by R. McAfee, July 17, 2007.

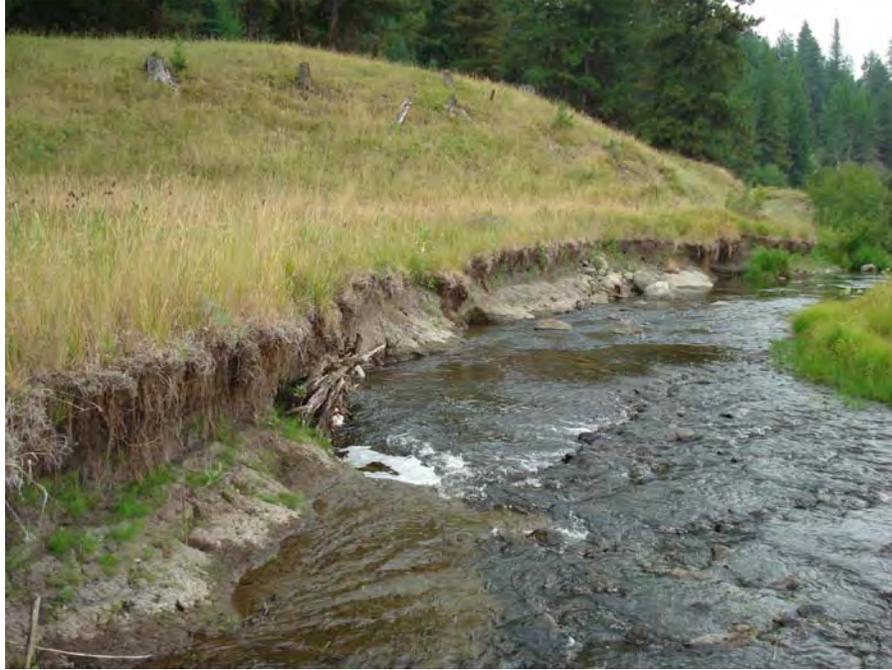
Photograph No. 37. View is to the southwest looking at bank erosion along river left where a silty-clay crops out. Oxbow Reach – Middle Fork John Day River – John Day Subbasin, Oregon – Bureau of Reclamation Photograph by R. McAfee, July 17, 2007.

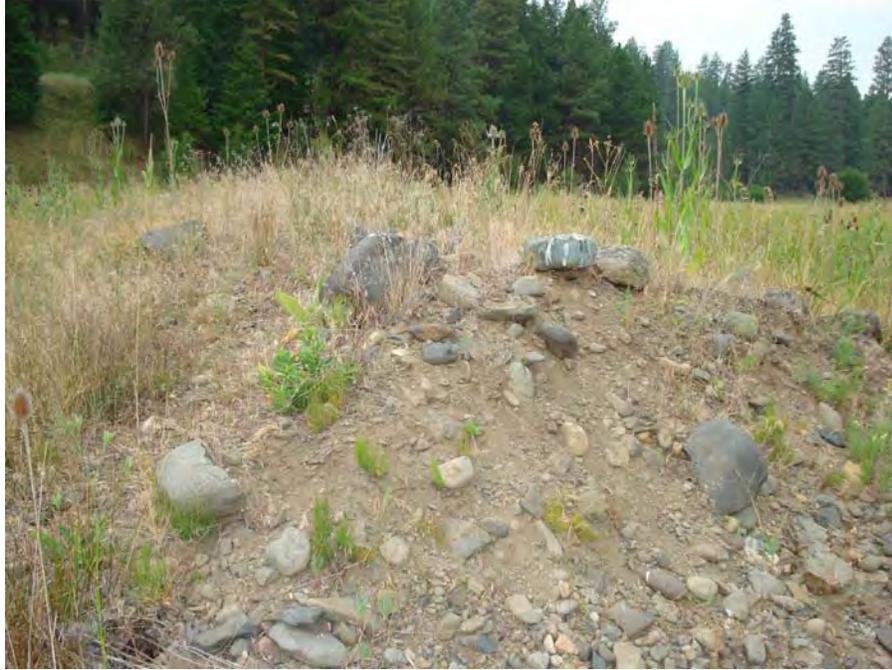
Photograph No. 41. View is to the southwest looking at a spoil pile along river left. Oxbow Reach – Middle Fork John Day River – John Day Subbasin, Oregon – Bureau of Reclamation Photograph by R. McAfee, July 17, 2007.

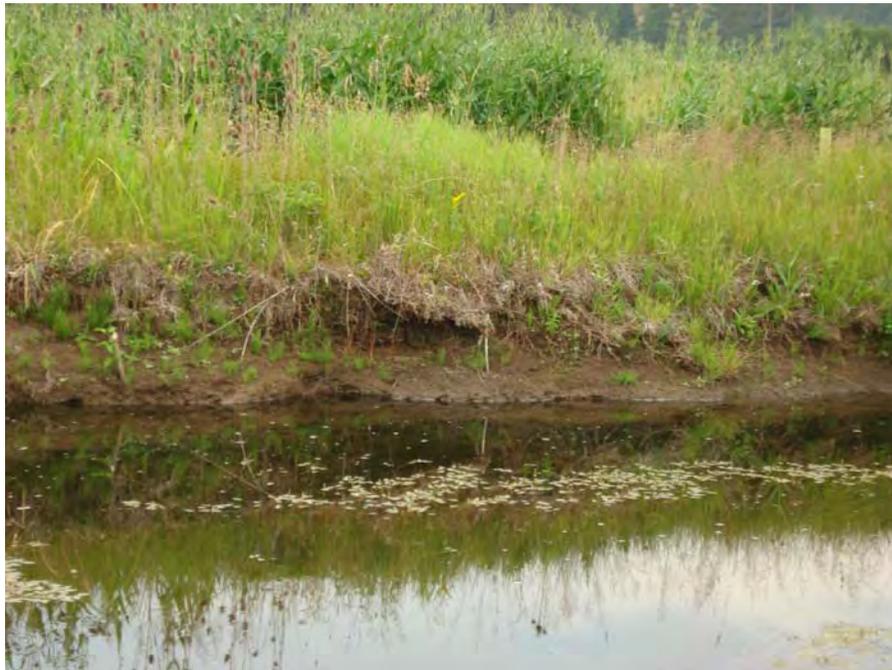
Photograph No. 42. View is to the southwest looking at bank erosion along river left. The bank is comprised of a clayey material. Oxbow Reach – Middle Fork John Day River – John Day Subbasin, Oregon – Bureau of Reclamation Photograph by R. McAfee, July 17, 2007.

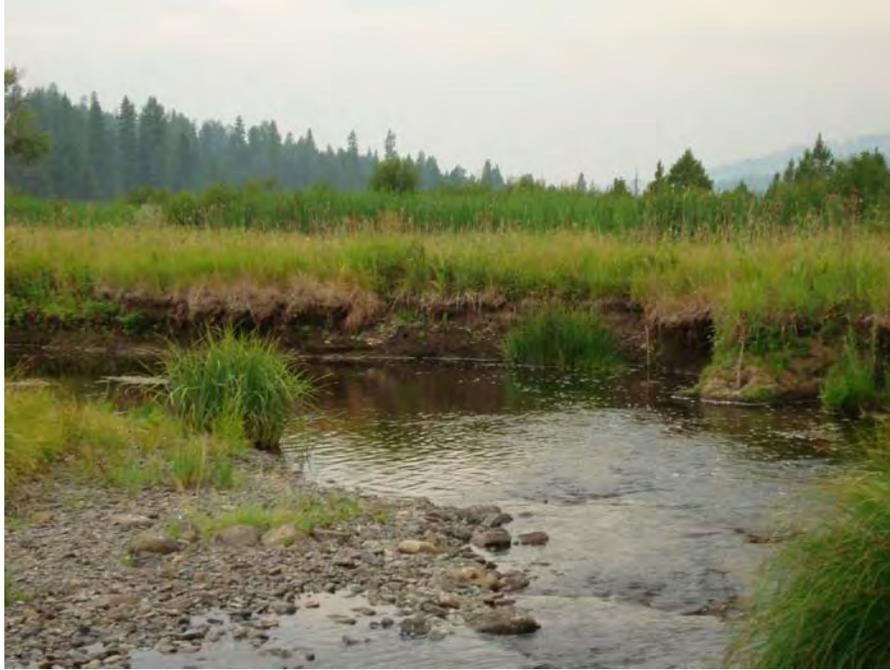
Photograph No. 43. View is to the west looking at bank erosion along river right. Oxbow Reach – Middle Fork John Day River – John Day Subbasin, Oregon – Bureau of Reclamation Photograph by R. McAfee, July 17, 2007.

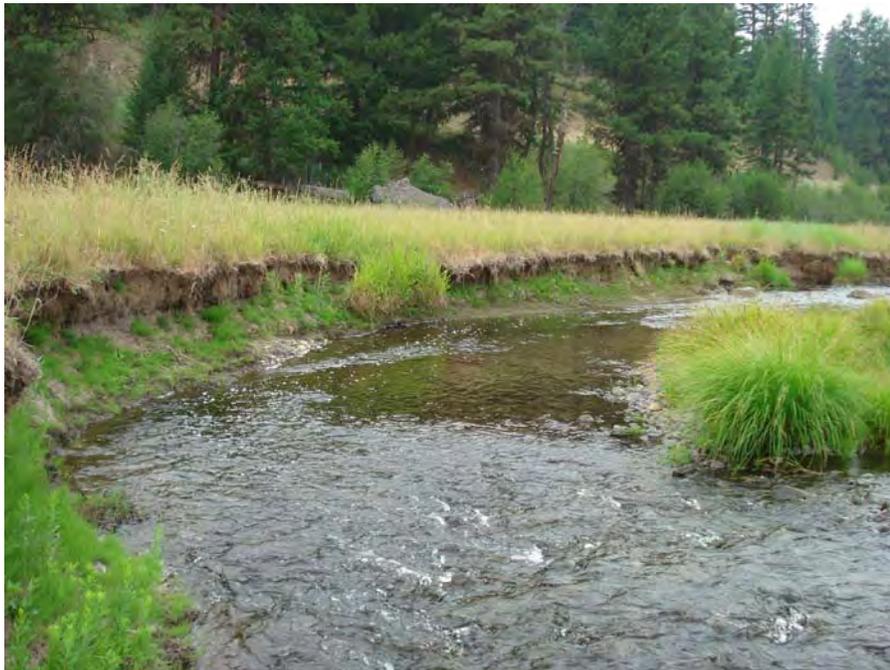
Photograph No. 44. View is to the south looking at bank erosion along river left. Oxbow Reach – Middle Fork John Day River – John Day Subbasin, Oregon – Bureau of Reclamation Photograph by R. McAfee, July 17, 2007.

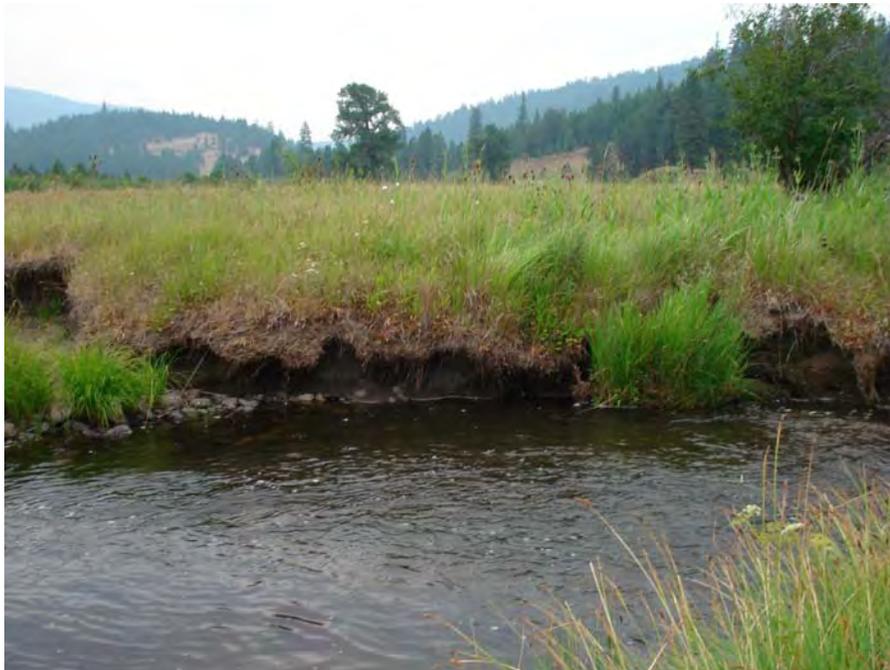
Photograph No. 48. View is to the east looking at bank erosion along river right. Oxbow Reach – Middle Fork John Day River – John Day Subbasin, Oregon – Bureau of Reclamation Photograph by R. McAfee, July 17, 2007.

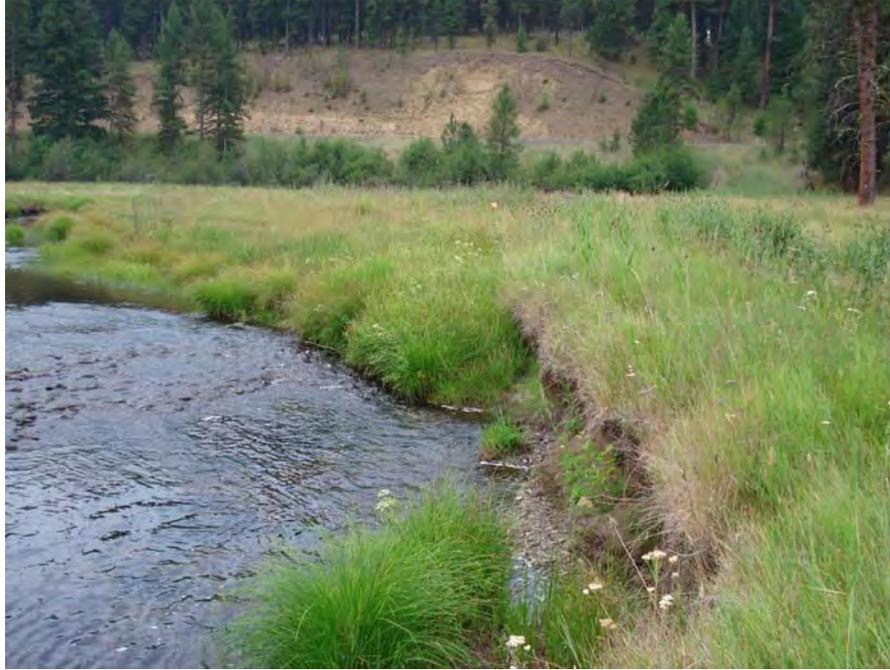
Photograph No. 49. View is to the south looking upstream at bank erosion along river left. Oxbow Reach – Middle Fork John Day River – John Day Subbasin, Oregon – Bureau of Reclamation Photograph by R. McAfee, July 17, 2007.

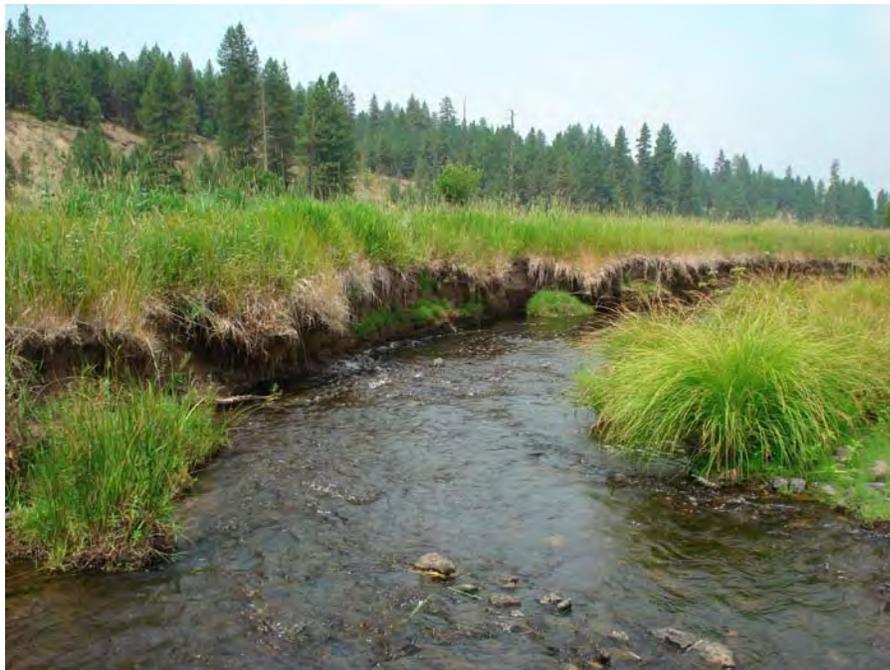
Photograph No. 50. View is to the west looking at bank erosion along river left. Oxbow Reach – Middle Fork John Day River – John Day Subbasin, Oregon – Bureau of Reclamation Photograph by R. McAfee, July 17, 2007.

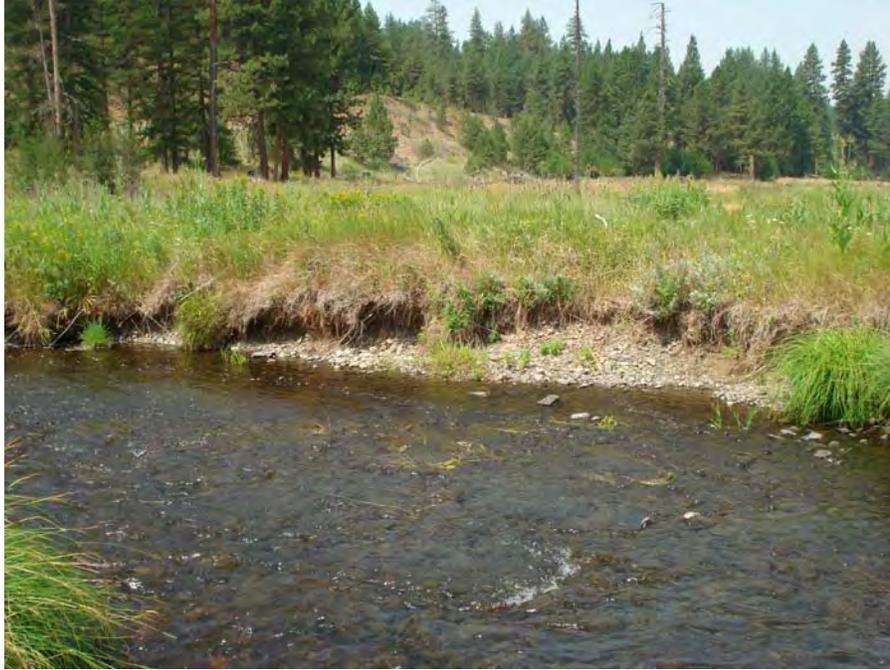
Photograph No. 51. View is to the north looking at bank erosion along river right. Oxbow Reach – Middle Fork John Day River – John Day Subbasin, Oregon – Bureau of Reclamation Photograph by R. McAfee, July 17, 2007.

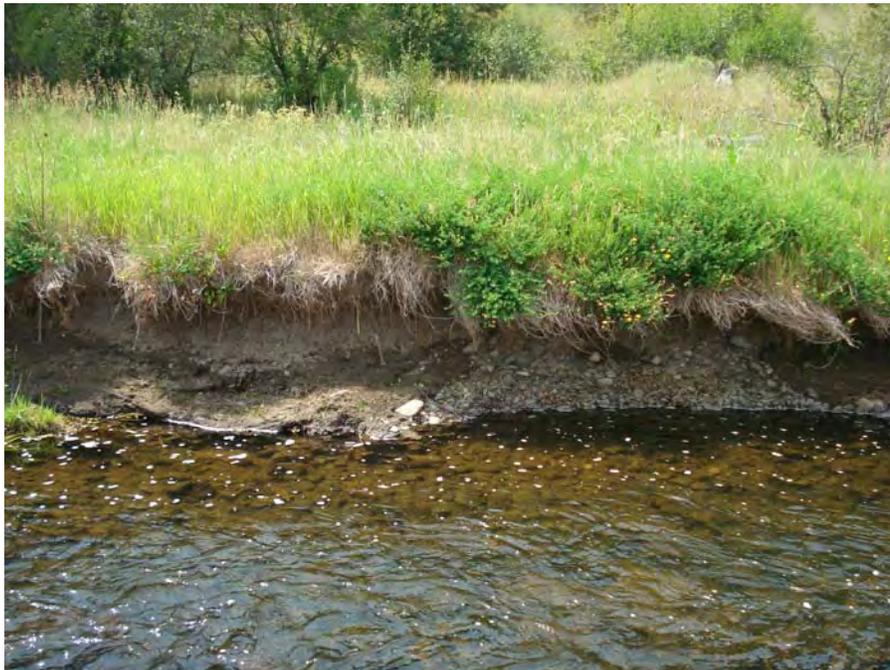
Photograph No. 52. View is to the south looking at bank erosion along river left. Oxbow Reach – Middle Fork John Day River – John Day Subbasin, Oregon – Bureau of Reclamation Photograph by R. McAfee, July 17, 2007.

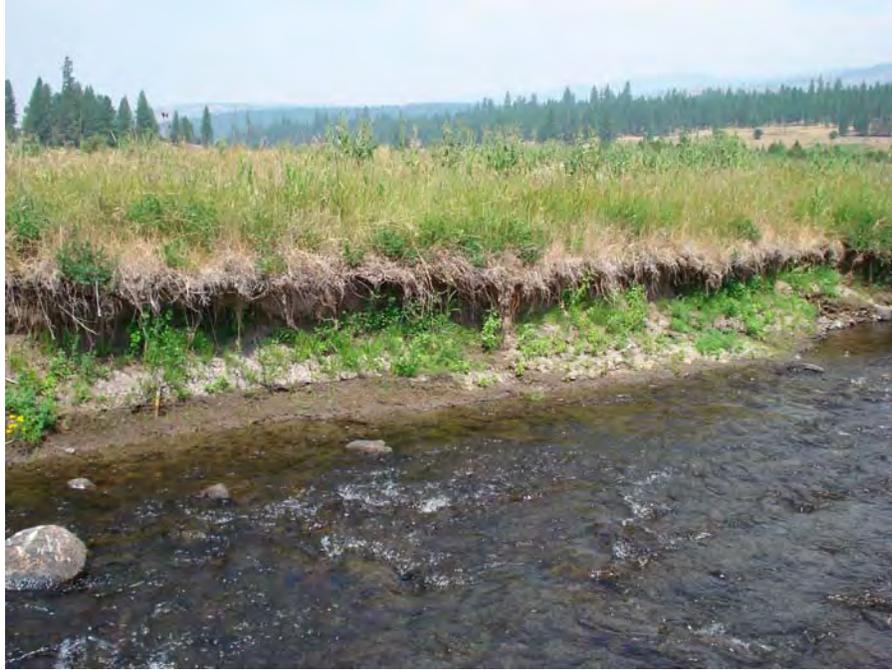
Photograph No. 53. View is to the west looking at bank erosion along river left. Oxbow Reach – Middle Fork John Day River – John Day Subbasin, Oregon – Bureau of Reclamation Photograph by R. McAfee, July 17, 2007.

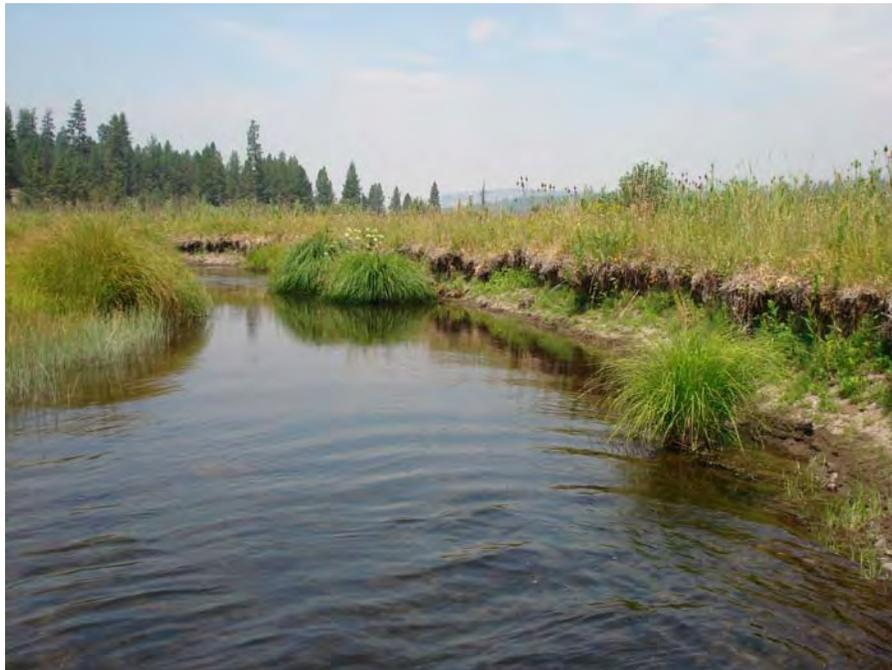
Photograph No. 54. View is to the west looking at bank erosion along river right. Oxbow Reach – Middle Fork John Day River – John Day Subbasin, Oregon – Bureau of Reclamation Photograph by R. McAfee, July 17, 2007.

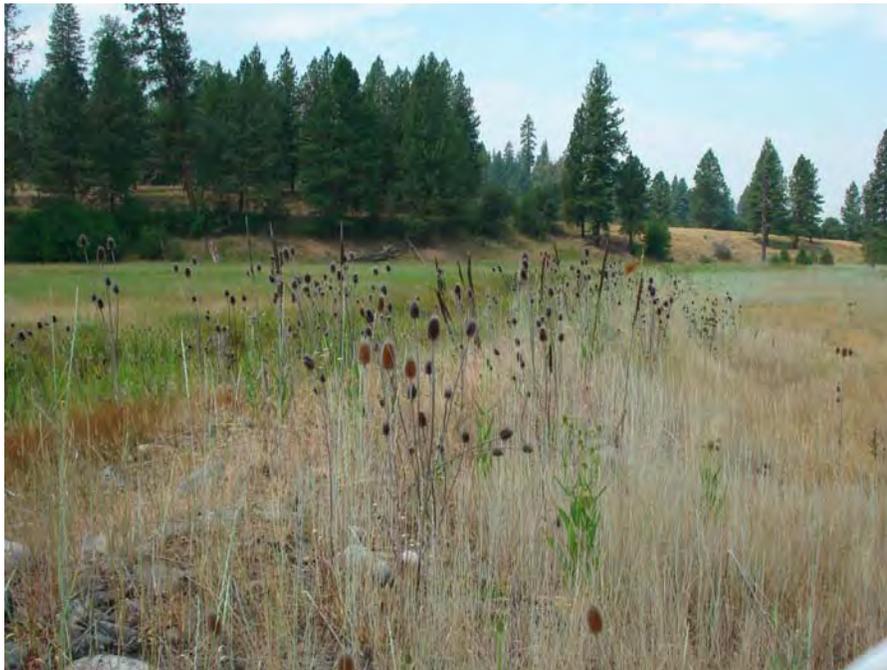
Photograph No. 60. View is to the west looking at a spoil pile that runs along river right. Oxbow Reach – Middle Fork John Day River – John Day Subbasin, Oregon – Bureau of Reclamation Photograph by R. McAfee, July 17, 2007.

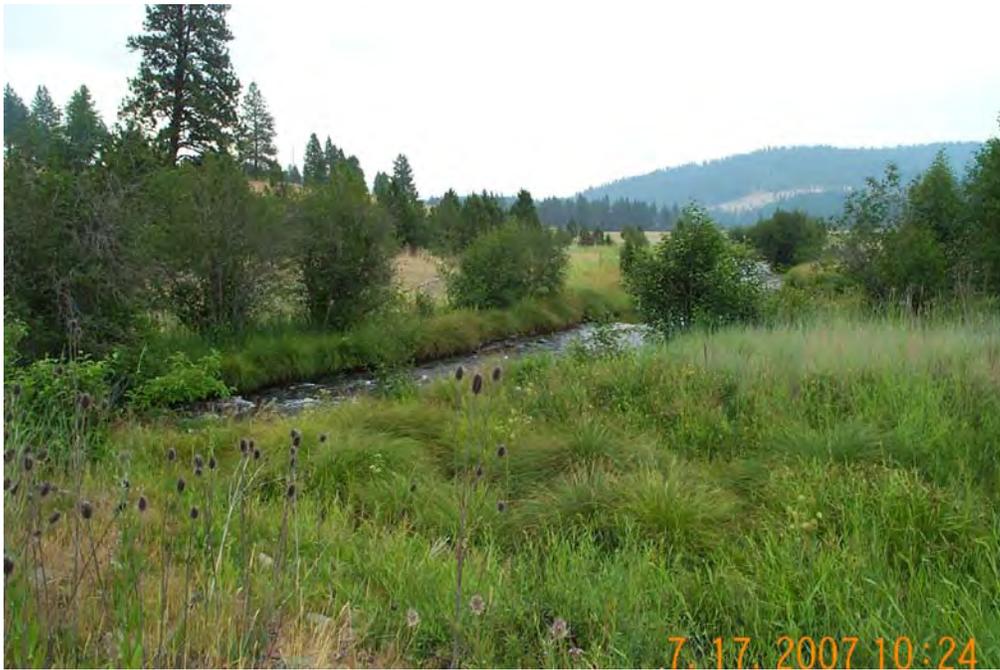
Photograph No. 64. View is to the southeast looking at a historical channel path on the Ruby Creek alluvial fan along river left. Oxbow Reach – Middle Fork John Day River – John Day Subbasin, Oregon – Bureau of Reclamation Photograph by E. Lyon, July 17, 2007.

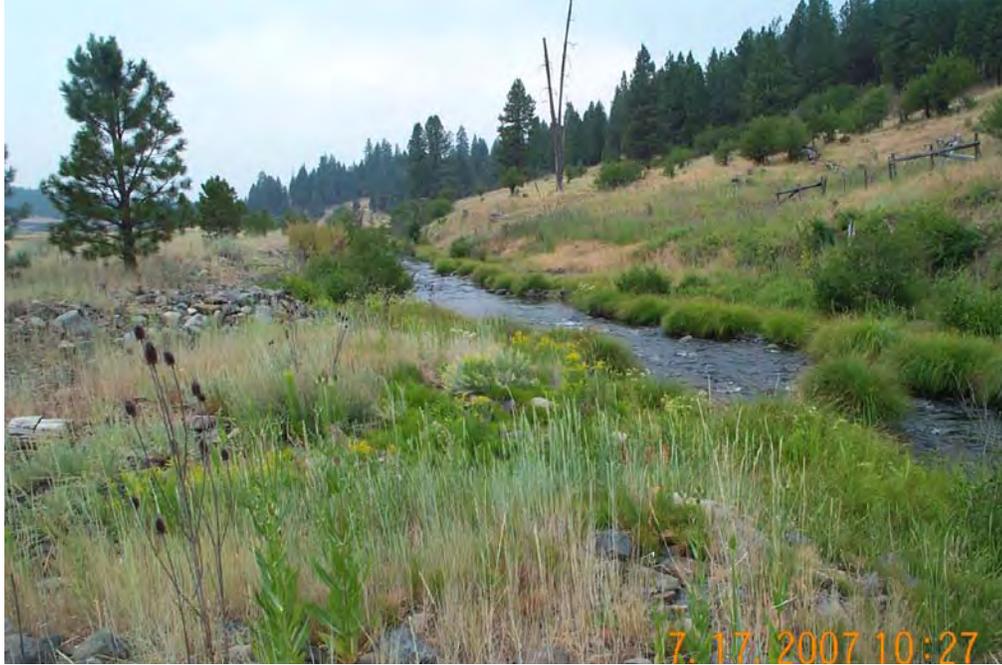
Photograph No. 65. View is to the northwest looking at historical channel path (primary) on the Ruby Creek alluvial fan along river left. Oxbow Reach – Middle Fork John Day River – John Day Subbasin, Oregon – Bureau of Reclamation Photograph by E. Lyon, July 17, 2007.

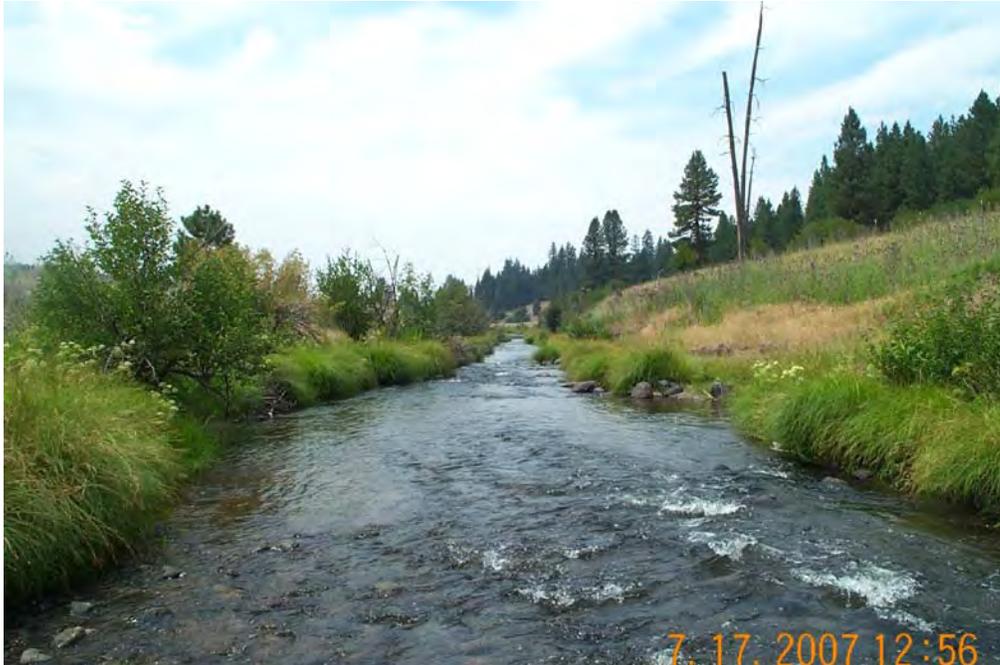
Photograph No. 67. View is to the northwest looking downstream along the main channel. Oxbow Reach – Middle Fork John Day River – John Day Subbasin, Oregon – Bureau of Reclamation Photograph by E. Lyon, July 17, 2007.

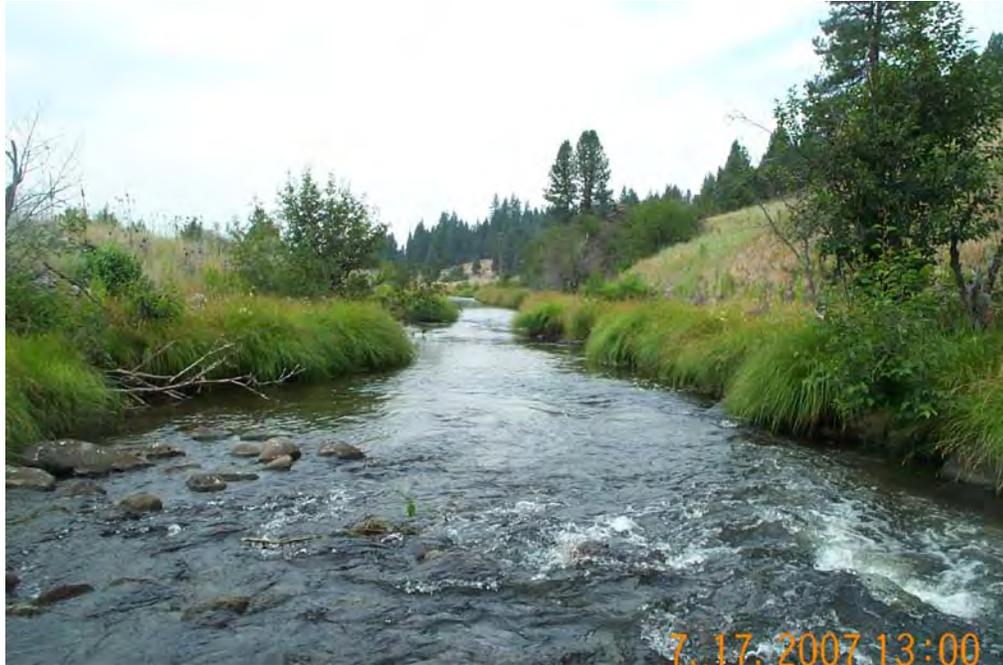
Photograph No. 69. View is to the west looking at the mine tailings (about 12-feet in height) along river left where the river has been channelized. Oxbow Reach – Middle Fork John Day River – John Day Subbasin, Oregon – Bureau of Reclamation Photograph by E. Lyon, July 17, 2007.

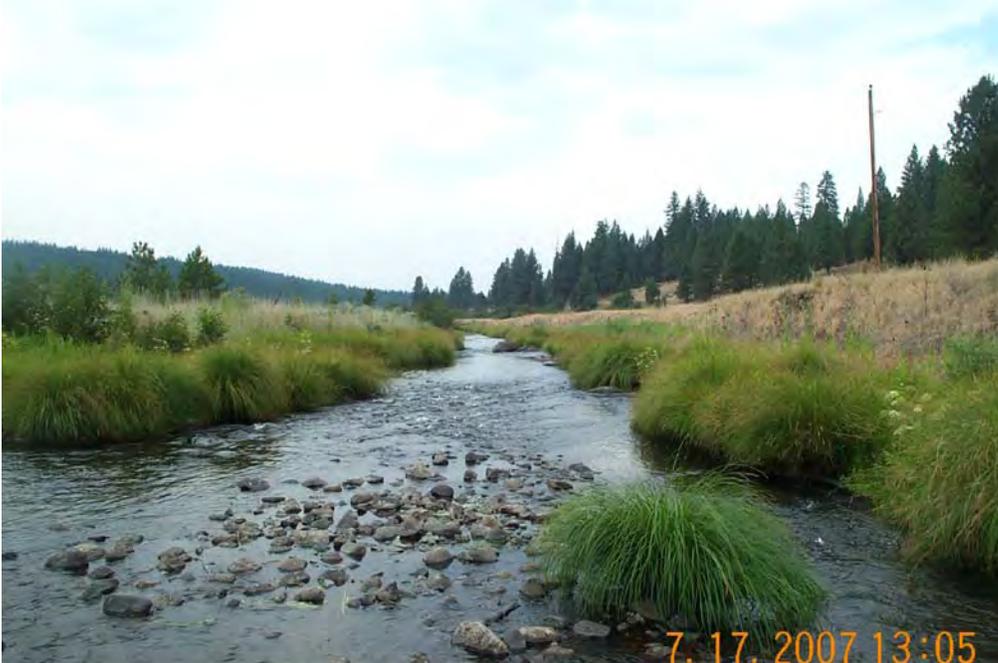
Photograph No. 71. View is to the west looking at the mine tailings along river left where the river has been channelized. Oxbow Reach – Middle Fork John Day River – John Day Subbasin, Oregon – Bureau of Reclamation Photograph by E. Lyon, July 17, 2007.

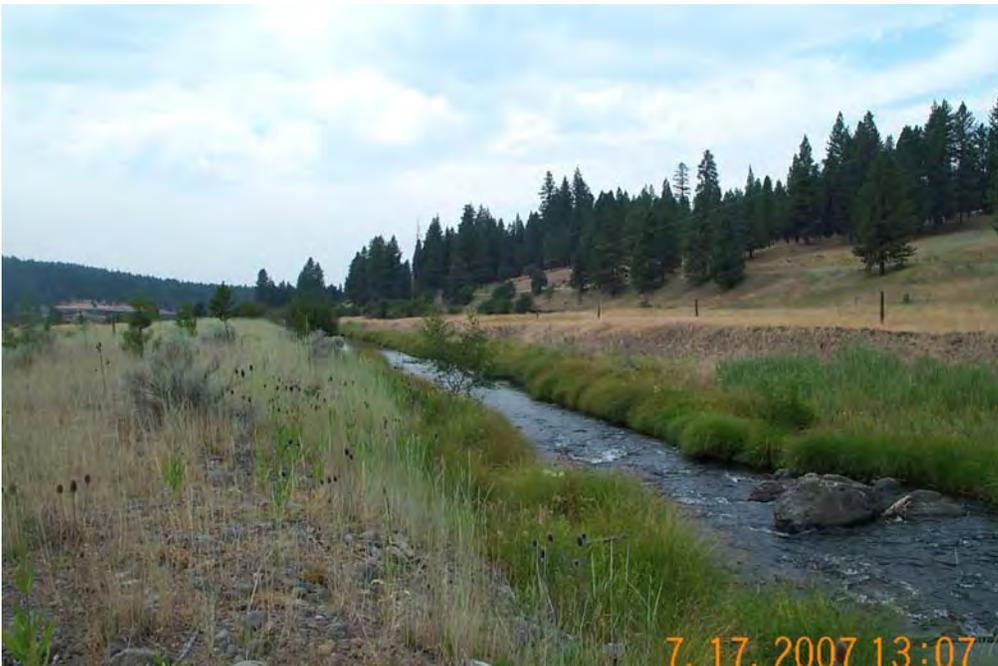
Photograph No. 72. View is to the west looking at the mine tailings along river left where the river has been channelized. Oxbow Reach – Middle Fork John Day River – John Day Subbasin, Oregon – Bureau of Reclamation Photograph by E. Lyon, July 17, 2007.

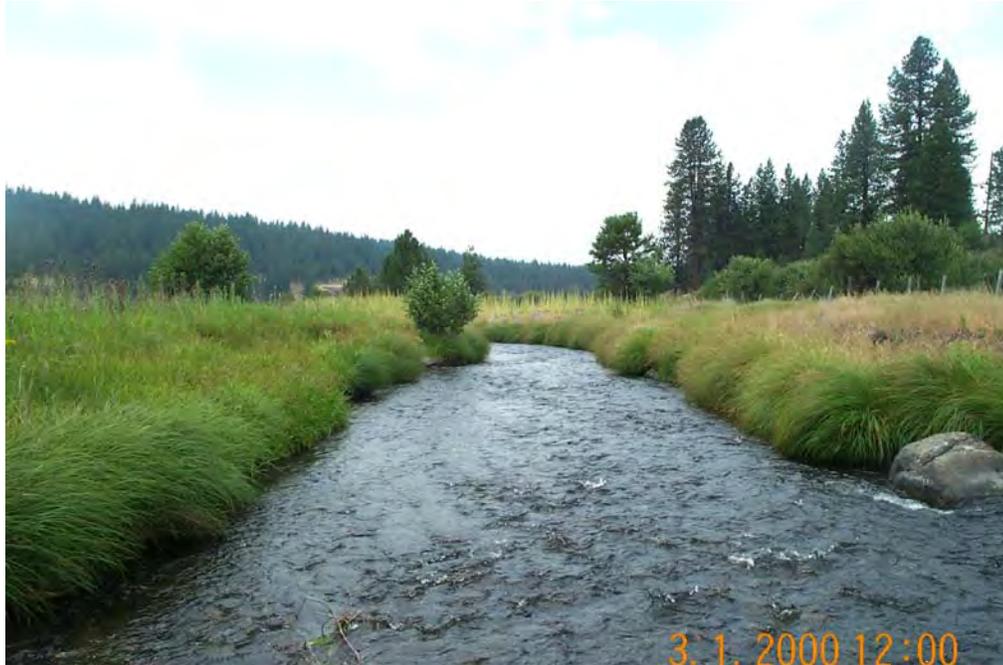
Photograph No. 73. View is to the west looking at the mine tailings (about 12-feet in height) along river left where the river has been channelized. Oxbow Reach – Middle Fork John Day River – John Day Subbasin, Oregon – Bureau of Reclamation Photograph by E. Lyon, July 17, 2007.

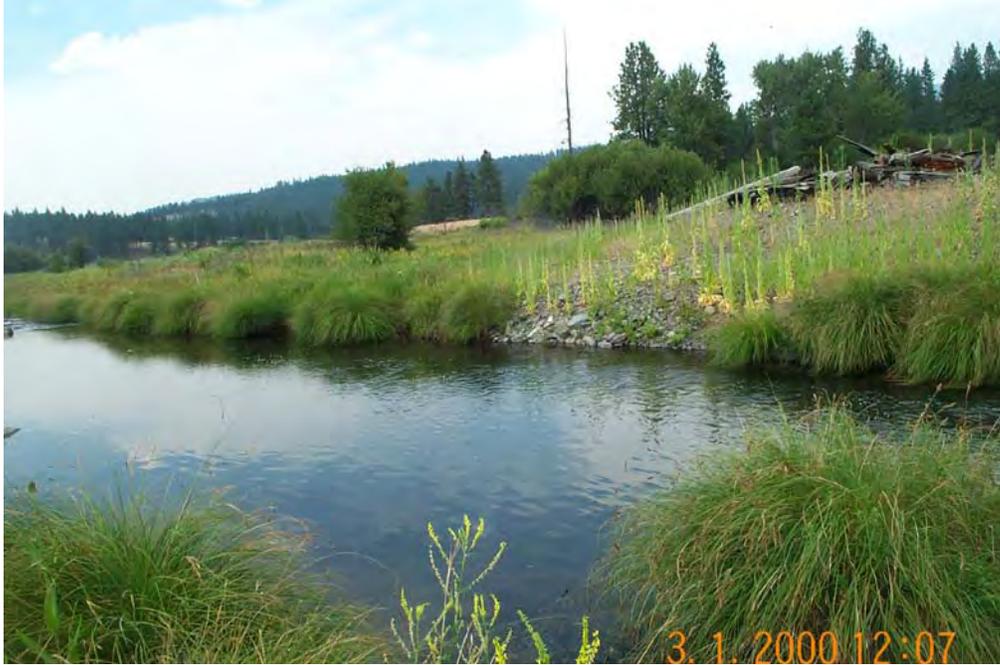
Photograph No. 75. View is to the northwest looking at the bridge abutment along river right. Oxbow Reach – Middle Fork John Day River – John Day Subbasin, Oregon – Bureau of Reclamation
Photograph by E. Lyon, July 17, 2007.

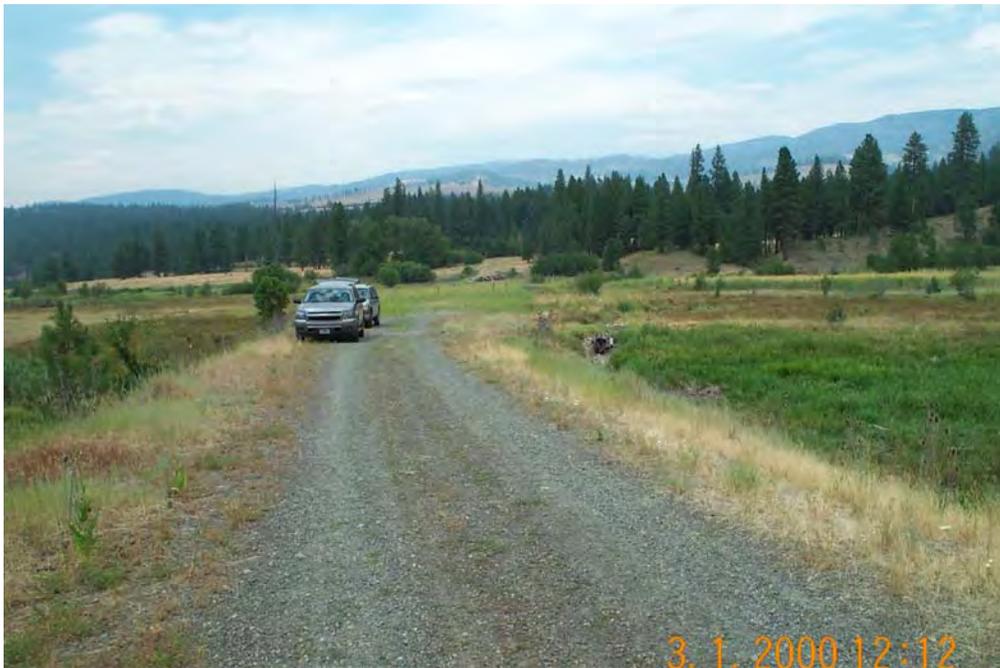
Photograph No. 76. View is to the north looking at the road embankment that bisects the floodplain. Oxbow Reach – Middle Fork John Day River – John Day Subbasin, Oregon – Bureau of Reclamation
Photograph by E. Lyon, July 17, 2007.

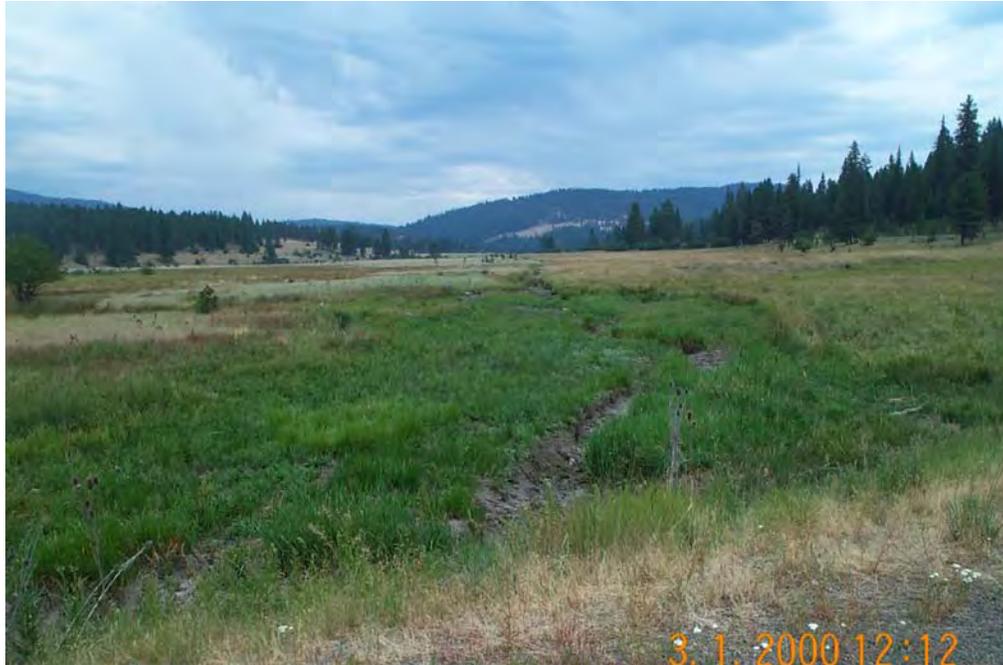
Photograph No. 77. View is to the southeast looking at the Ruby Creek channel path(?) or historical channel swale upstream of road embankment. Oxbow Reach – Middle Fork John Day River – John Day Subbasin, Oregon – Bureau of Reclamation Photograph by E. Lyon, July 17, 2007.

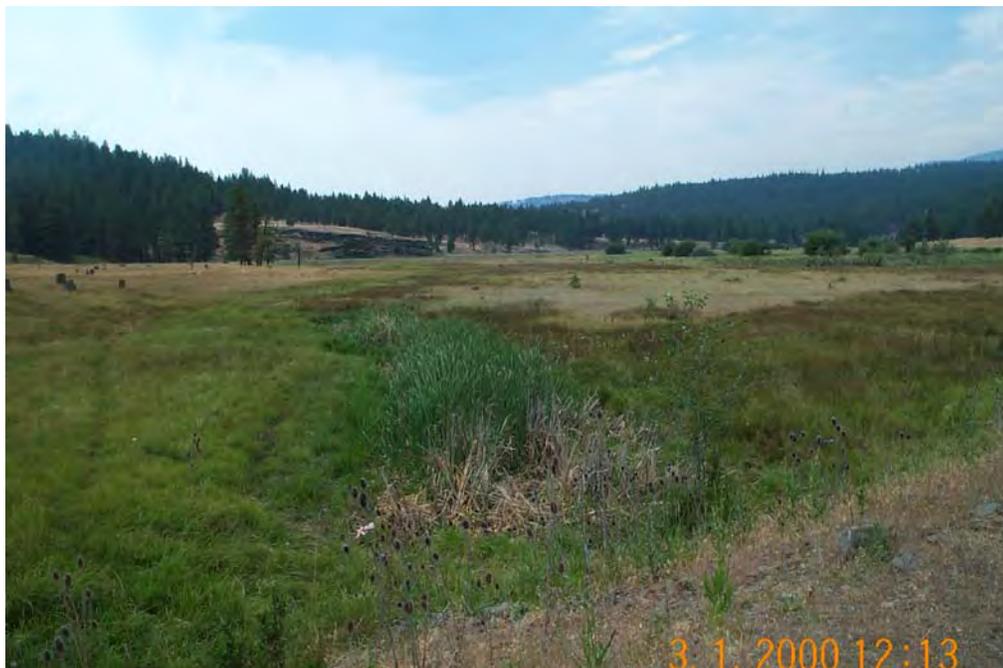
Photograph No. 78. View is to the northwest looking at the Ruby Creek channel path(?) or channel swale downstream of road embankment. Oxbow Reach – Middle Fork John Day River – John Day Subbasin, Oregon – Bureau of Reclamation Photograph by E. Lyon, July 17, 2007.

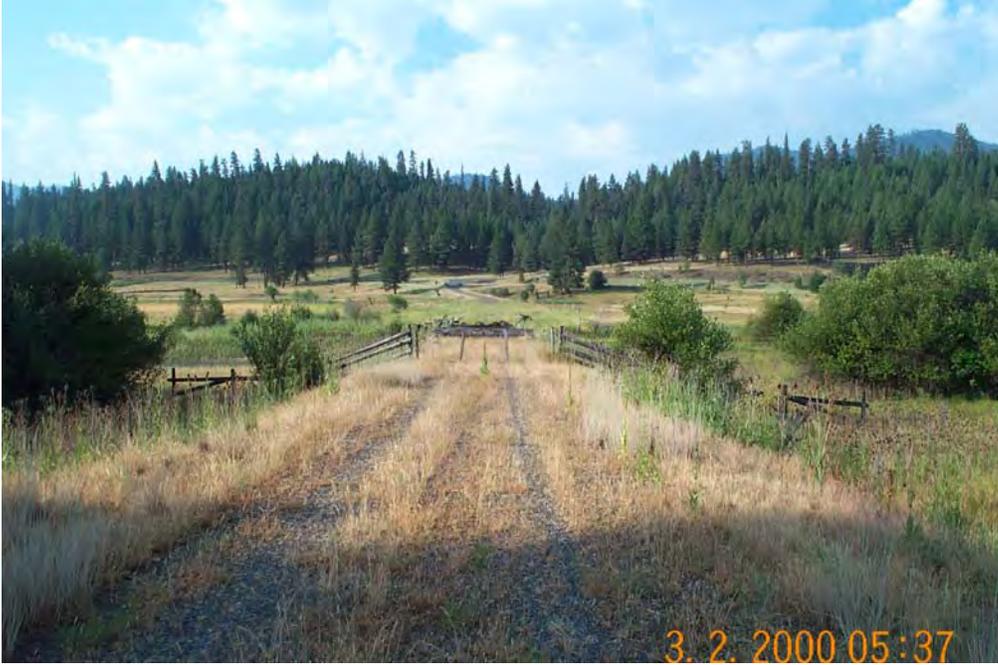
Photograph No. 79. View is to the south looking at road embankment that bisects the floodplain. Oxbow Reach – Middle Fork John Day River – John Day Subbasin, Oregon – Bureau of Reclamation Photograph by E. Lyon, July 18, 2007.

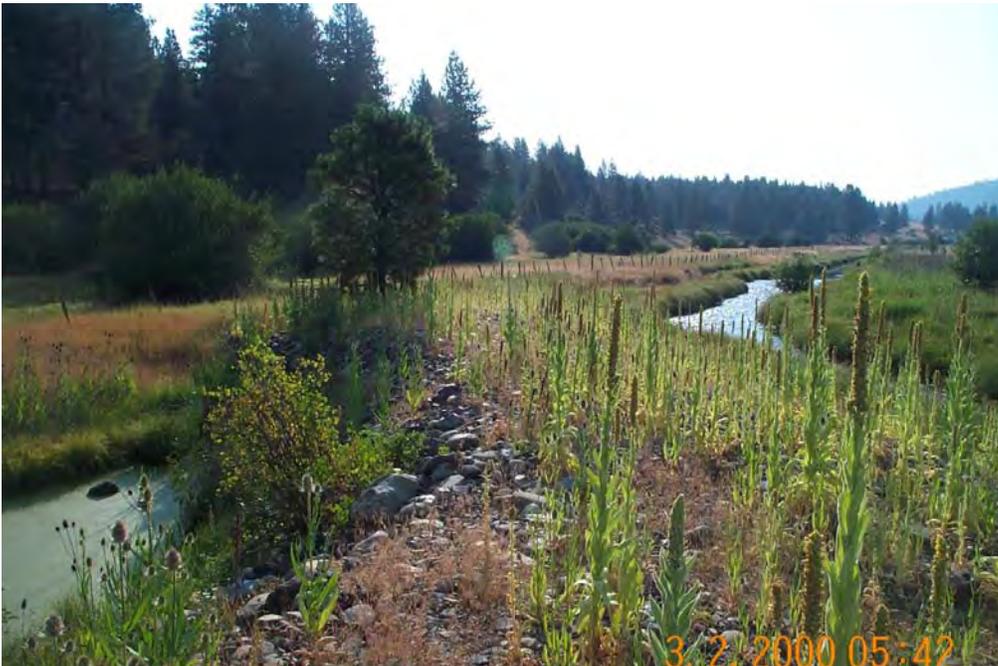
Photograph No. 80. View is to the west looking at mine tailings that separate the river from wetland area along river right. Oxbow Reach – Middle Fork John Day River – John Day Subbasin, Oregon – Bureau of Reclamation Photograph by E. Lyon, July 18, 2007.

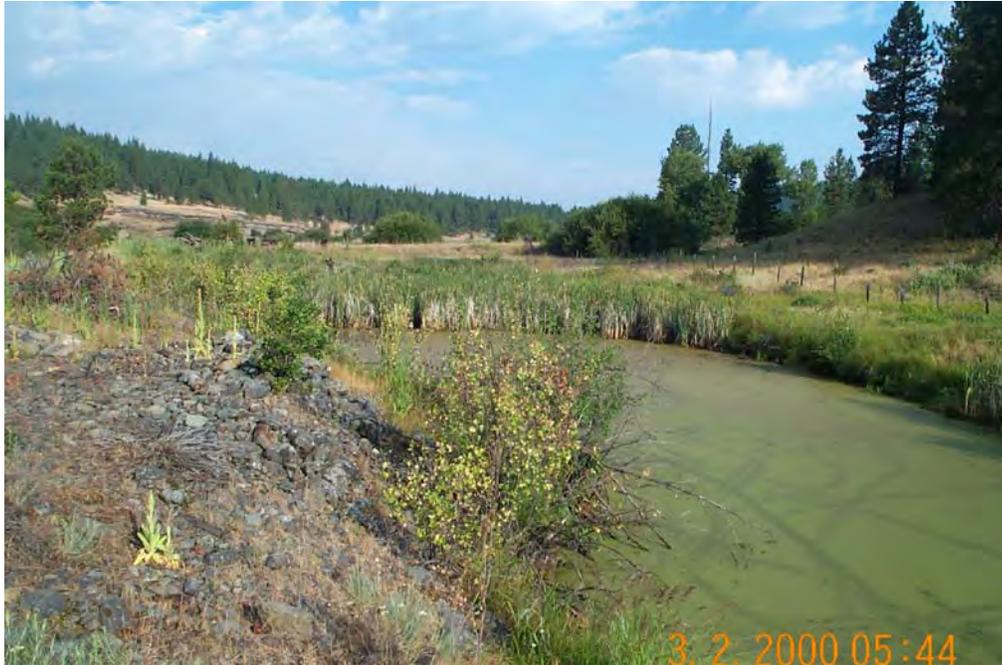
Photograph No. 81. View is to the northwest looking at wetland area disconnected from river by mine tailings. Oxbow Reach – Middle Fork John Day River – John Day Subbasin, Oregon – Bureau of Reclamation Photograph by E. Lyon, July 18, 2007.

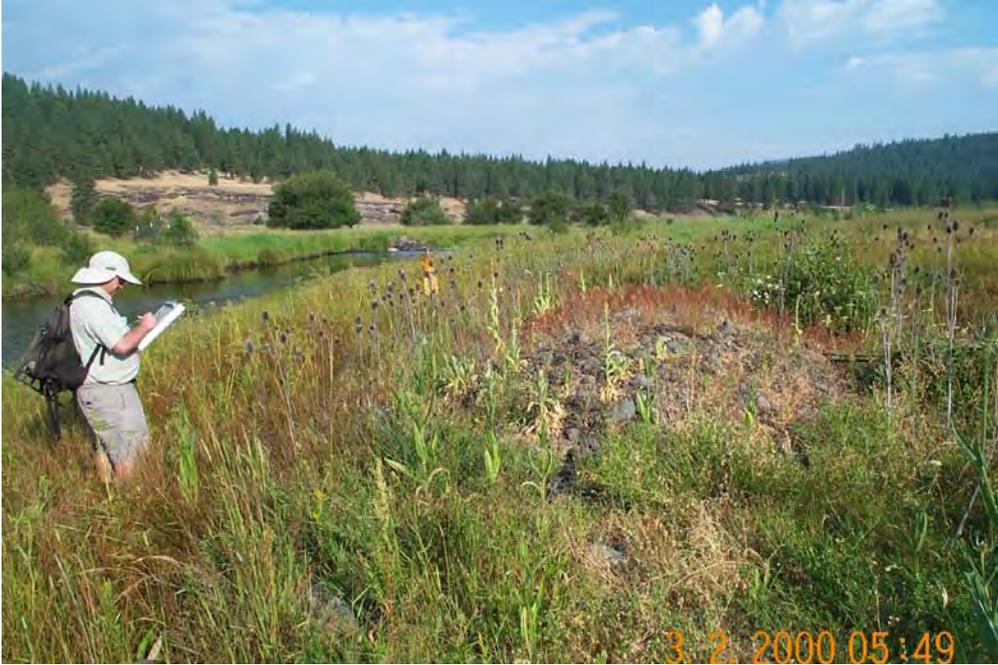
Photograph No. 83. View is to the northwest looking at spoil pile along river right. Oxbow Reach – Middle Fork John Day River – John Day Subbasin, Oregon – Bureau of Reclamation Photograph by E. Lyon, July 18, 2007.
