Oxbow Conservation Area Reach Assessment Middle Fork John Day River

Grant County, Oregon

U.S. Department of the Interior
Bureau of Reclamation
Pacific Northwest Region
Pacific Northwest Regional Office, Boise, Idaho

March 2010

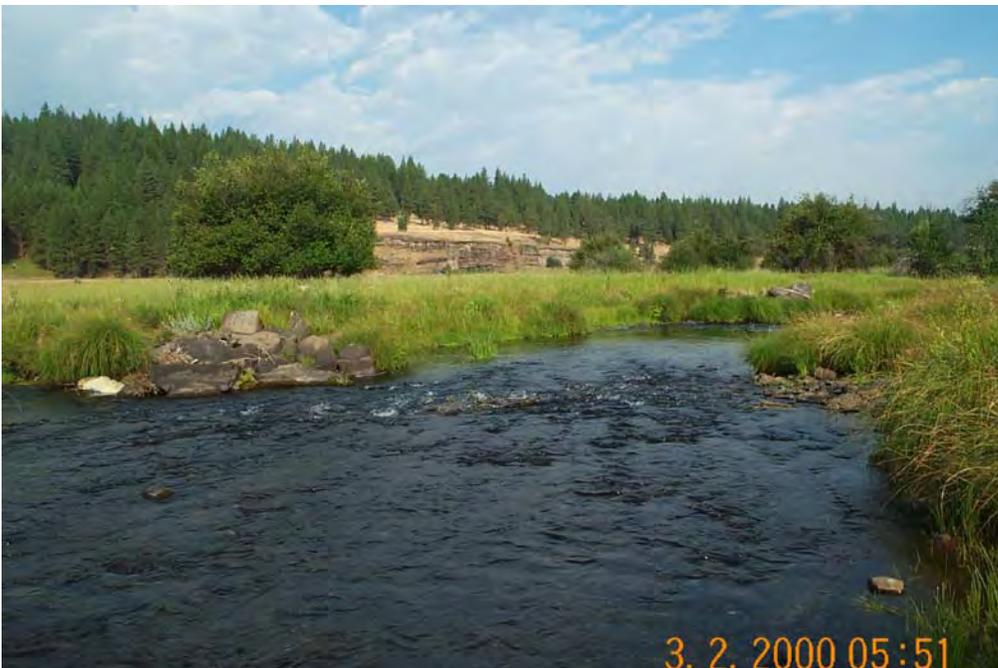
Photograph No. 84. View is to the west looking downstream at rock spurs placed along river left. Oxbow Reach – Middle Fork John Day River – John Day Subbasin, Oregon – Bureau of Reclamation Photograph by E. Lyon, July 18, 2007.

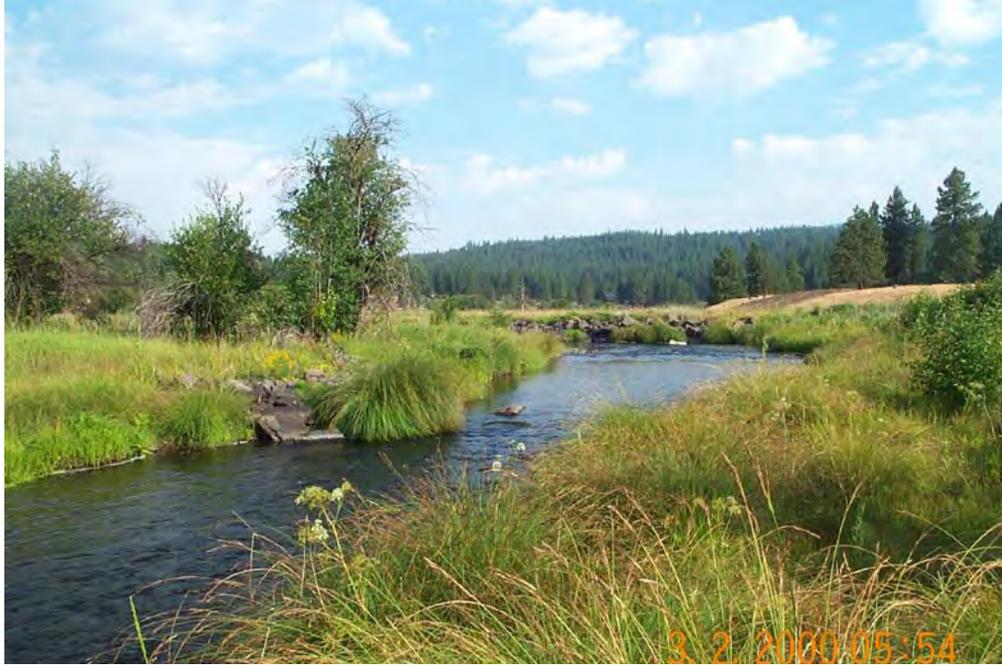
Photograph No. 85. View is to the northwest looking downstream at a rock spur on river left and riprap along river right. Oxbow Reach – Middle Fork John Day River – John Day Subbasin, Oregon – Bureau of Reclamation Photograph by E. Lyon, July 18, 2007.

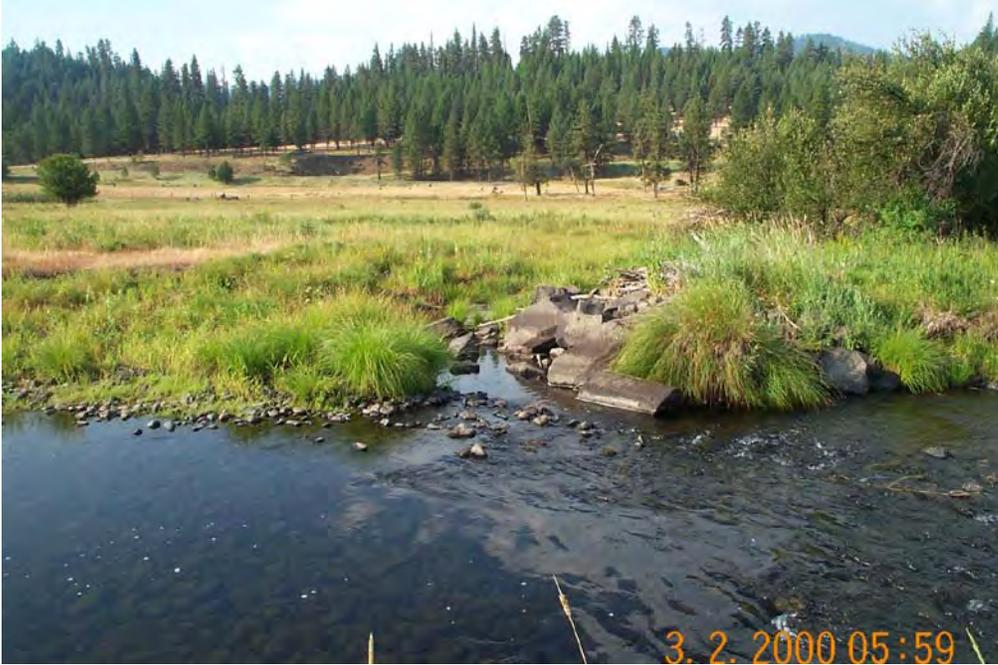
Photograph No. 87. View is to the south looking across the river at a side-channel with a rock spur at its entrance along river left. Oxbow Reach – Middle Fork John Day River – John Day Subbasin, Oregon – Bureau of Reclamation Photograph by E. Lyon, July 18, 2007.

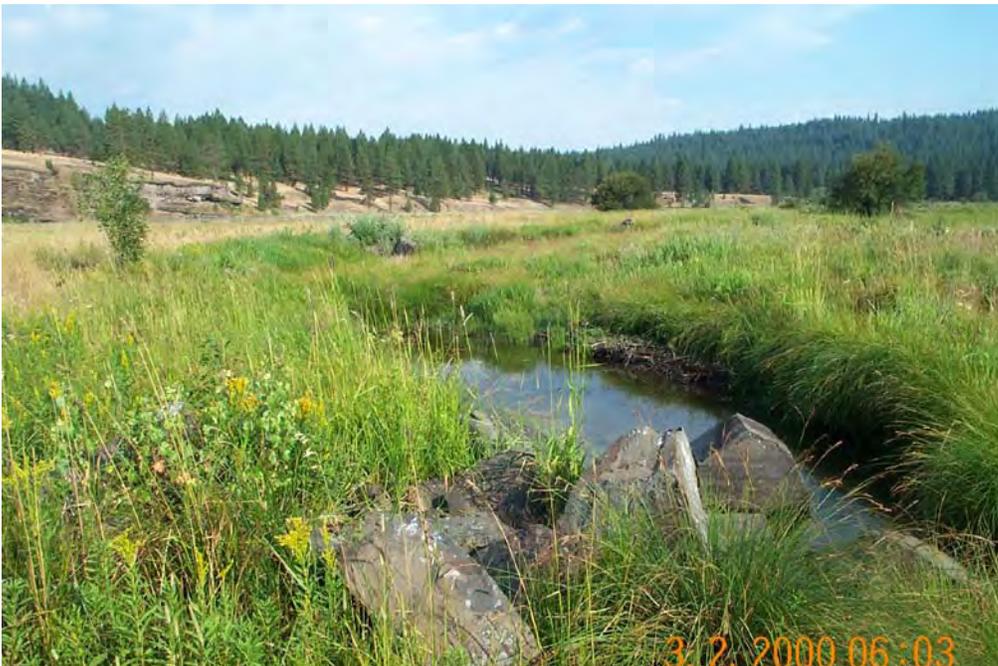
Photograph No. 88. View is to the northwest looking downstream at rock spurs placed along the left bank of the side-channel. Oxbow Reach – Middle Fork John Day River – John Day Subbasin, Oregon – Bureau of Reclamation Photograph by E. Lyon, July 18, 2007.

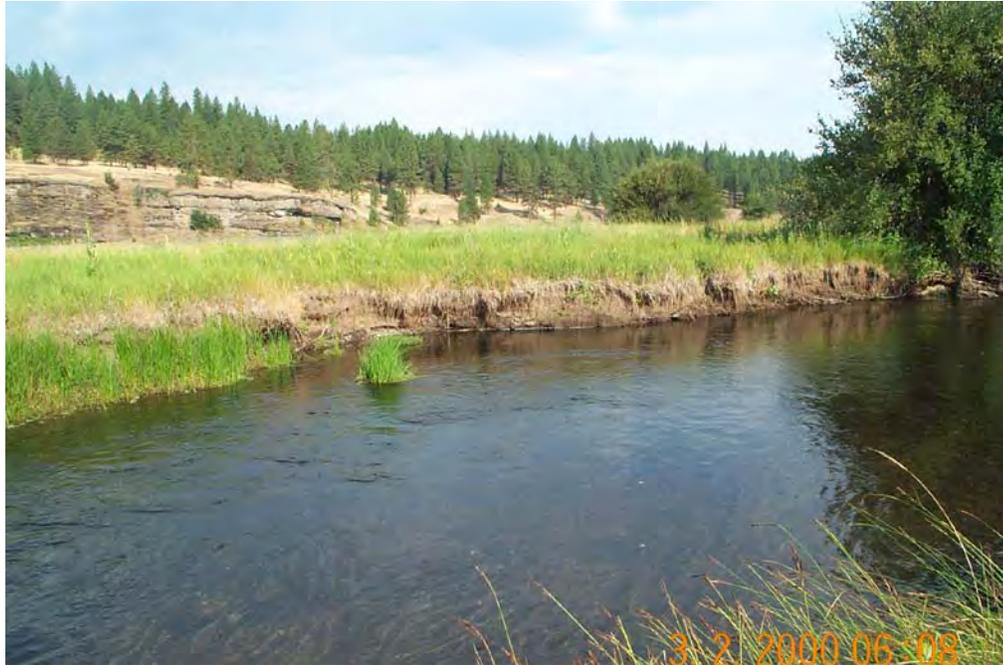
Photograph No. 89. View is to the west looking downstream at bank erosion along river left. Oxbow Reach – Middle Fork John Day River – John Day Subbasin, Oregon – Bureau of Reclamation Photograph by E. Lyon, July 18, 2007.

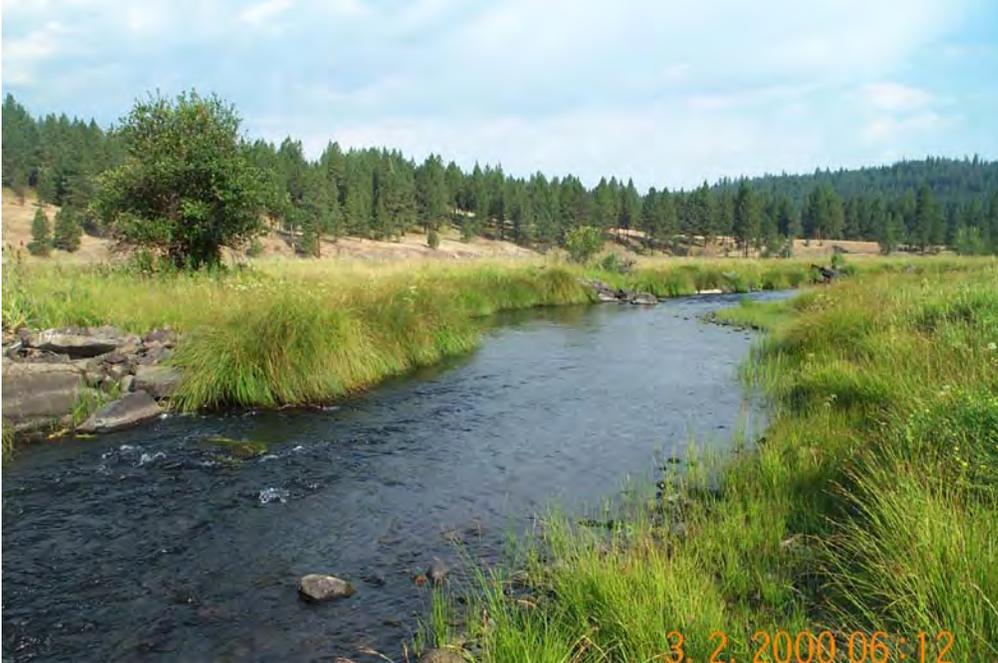
Photograph No. 91. View is to the northwest looking downstream at rock spurs placed along river left. Oxbow Reach – Middle Fork John Day River – John Day Subbasin, Oregon – Bureau of Reclamation Photograph by E. Lyon, July 18, 2007.

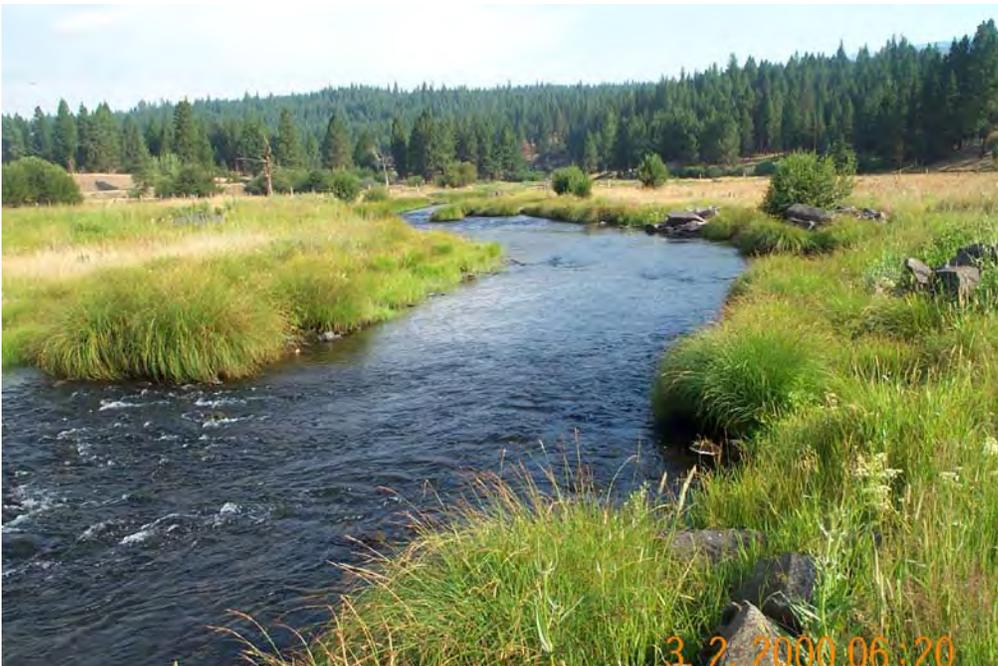
Photograph No. 92. View is to the north looking downstream at rock spurs placed along river right. Oxbow Reach – Middle Fork John Day River – John Day Subbasin, Oregon – Bureau of Reclamation Photograph by E. Lyon, July 18, 2007.

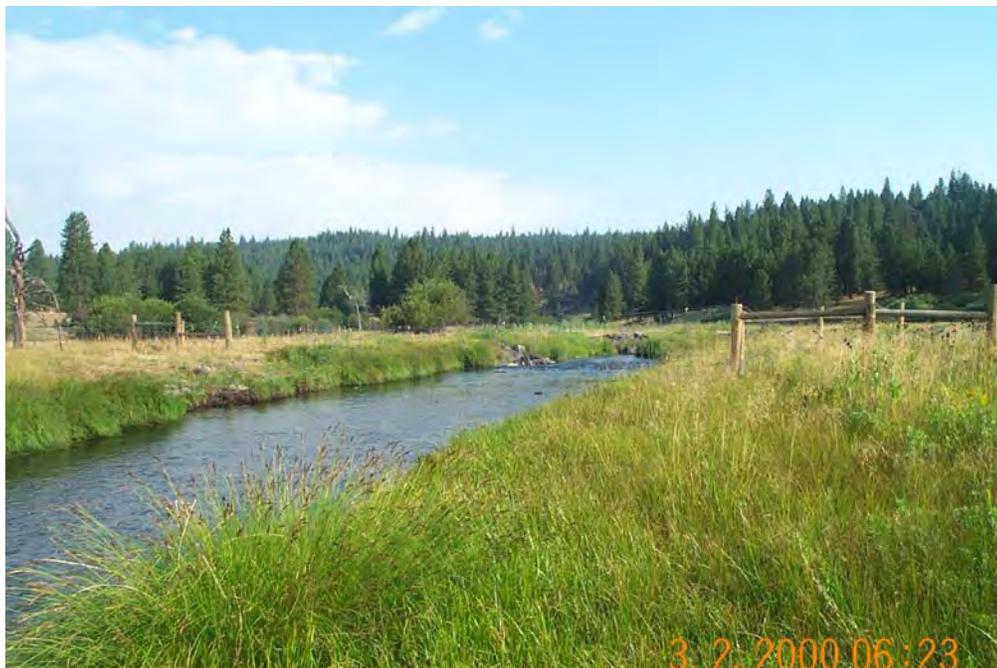
Photograph No. 93. View is to the north looking at cattle crossing across river. Oxbow Reach – Middle Fork John Day River – John Day Subbasin, Oregon – Bureau of Reclamation Photograph by E. Lyon, July 18, 2007.

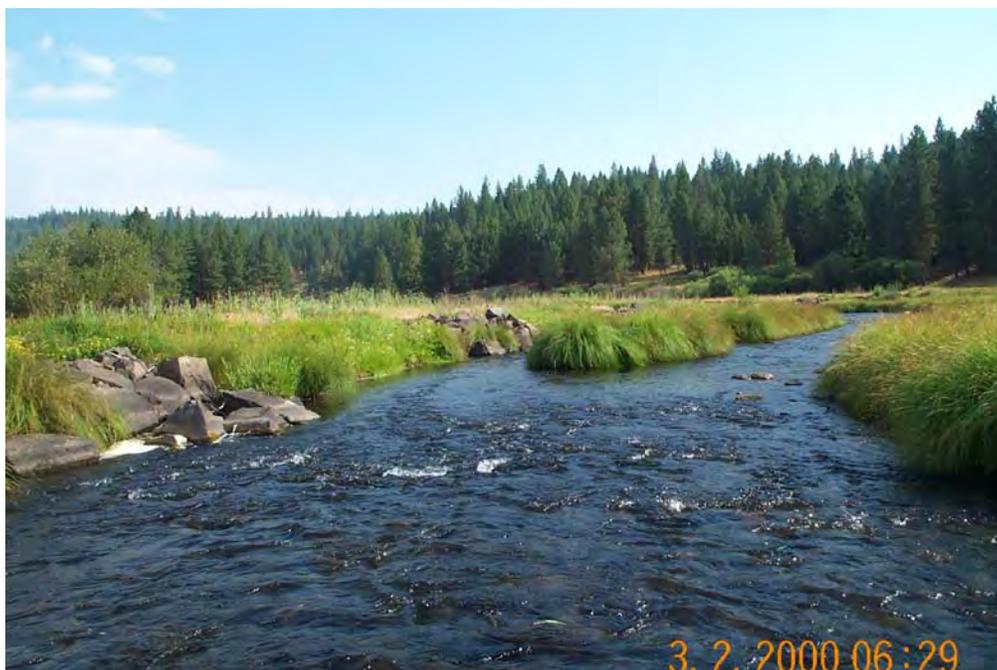
Photograph No. 94. View is to the north looking downstream at rock spurs placed along river left. Oxbow Reach – Middle Fork John Day River – John Day Subbasin, Oregon – Bureau of Reclamation Photograph by E. Lyon, July 18, 2007.

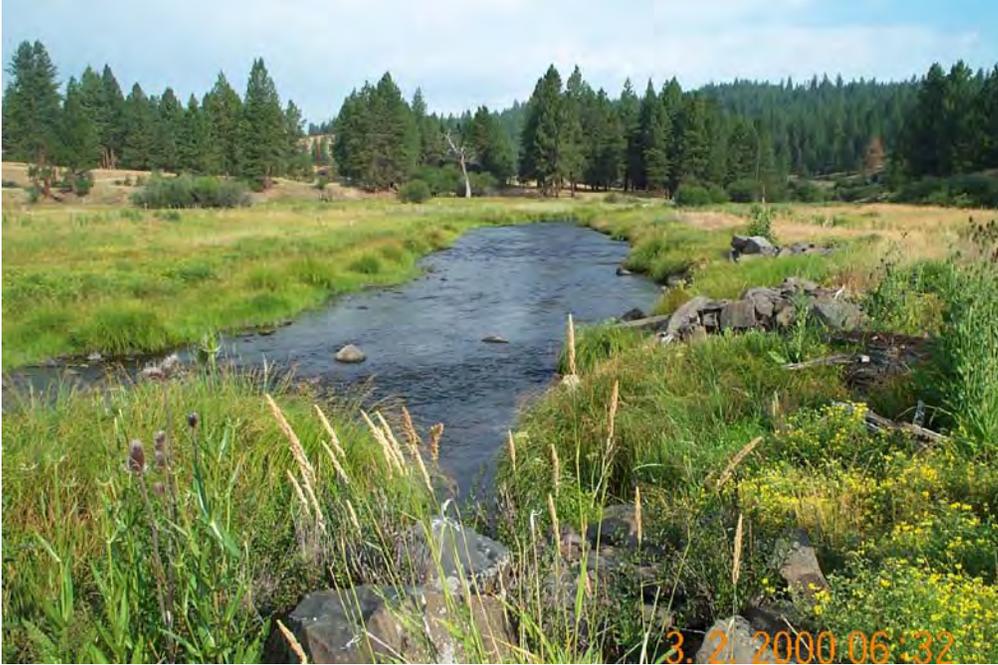
Photograph No. 95. View is to the north looking downstream at rock spurs placed along river right. Oxbow Reach – Middle Fork John Day River – John Day Subbasin, Oregon – Bureau of Reclamation Photograph by E. Lyon, July 18, 2007.

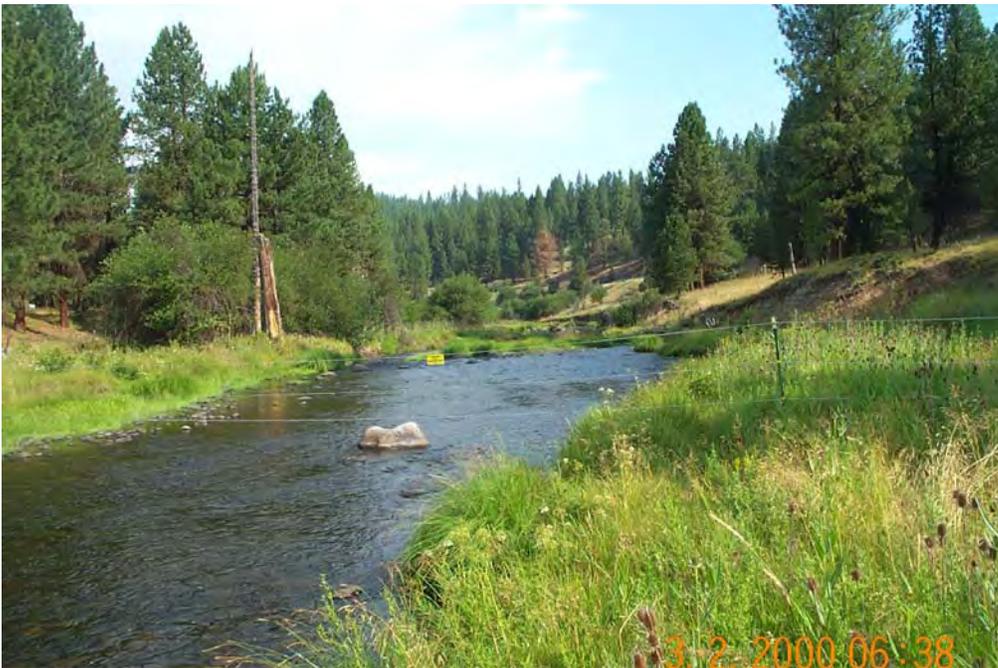
Photograph No. 96. View is to the north looking downstream along the river. Oxbow Reach – Middle Fork John Day River – John Day Subbasin, Oregon – Bureau of Reclamation Photograph by E. Lyon, July 18, 2007.
