WATER OPERATION AND MAINTENANCE

BULLETIN NO. 153

September 1990

**UNITED STATES DEPARTMENT OF THE INTERIOR
Bureau of Reclamation**

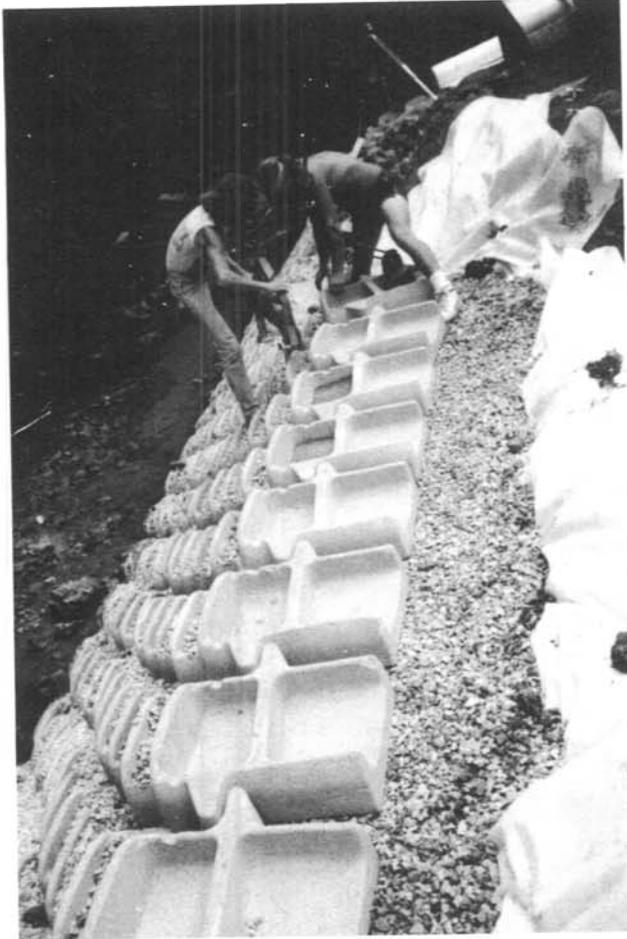
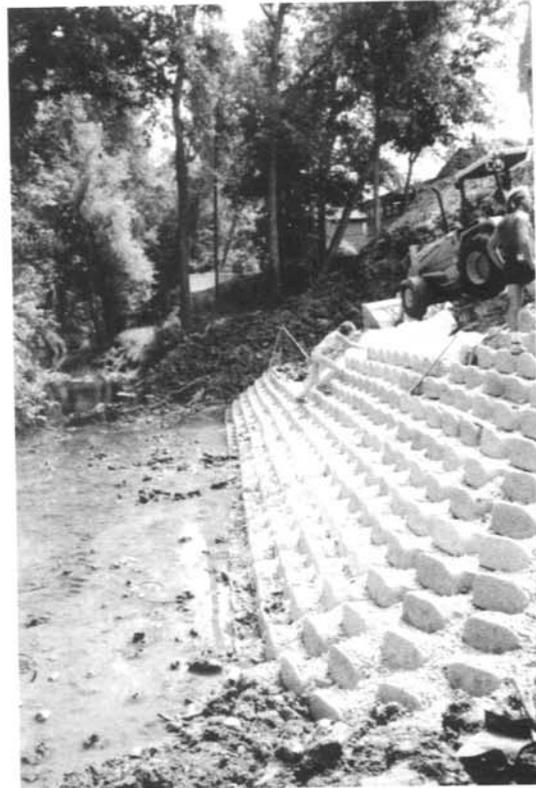
Creek bank stabilization system is built by placing layers of trough shaped modules on the steep slope. Interlocking wings tie units together, as shown in detail at left. Later a scour protection system was placed at the toe.

To ensure positive drainage through the wall, a 1-foot-thick layer of clean rock was placed behind the wall and the troughs of the modules were filled with clean rock. A filter fabric was placed between the rock layer and the excavated creek bank to reduce contamination of the clean rock.

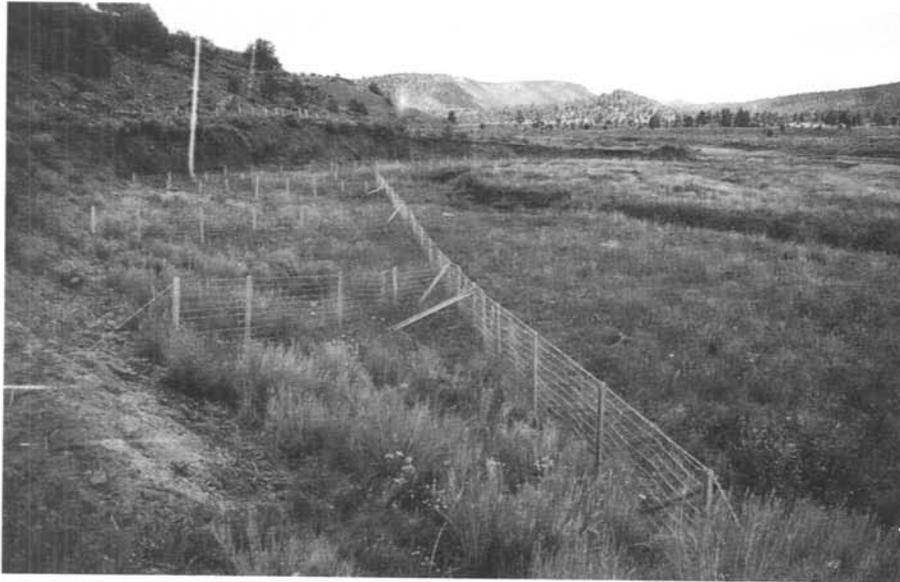
Excellent cover was established less than a year after revetment installation.

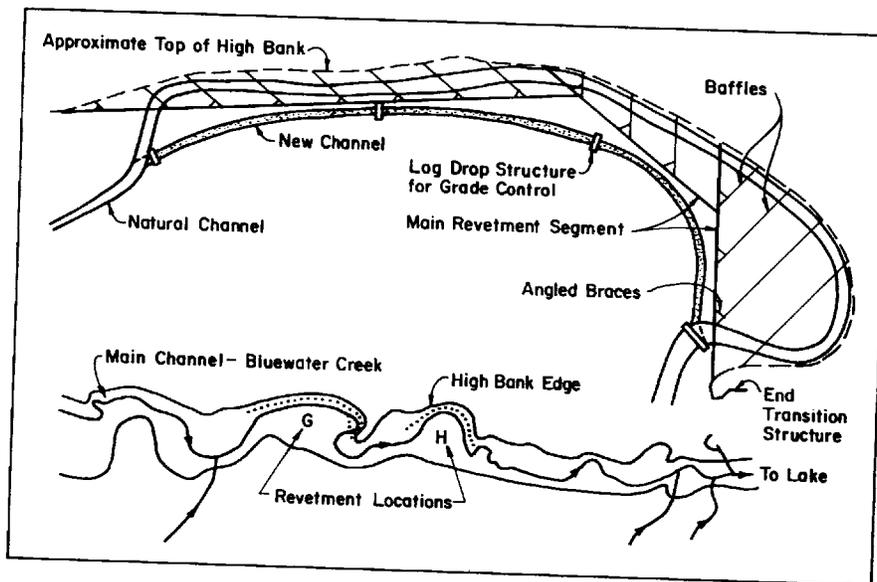
Two streams meanders were chosen to apply the porous fence revetment system. Designated in an earlier examination of meanders as sites G and H, the two locations had a combined streambank length of 1,400 feet. Eroding meander scarps measured up to 18 feet vertically. Based on three USGS streamflow gauges around the Zuni Mountains, design flows for the 100- and 50-year recurrence interval floods were 1,420 ft³/s and 890 ft³/s, respectively, from the 39,000-acre watershed above the sites (figure 1).

Figure 1. - Revetment locations on the creek and details of revetment G design.

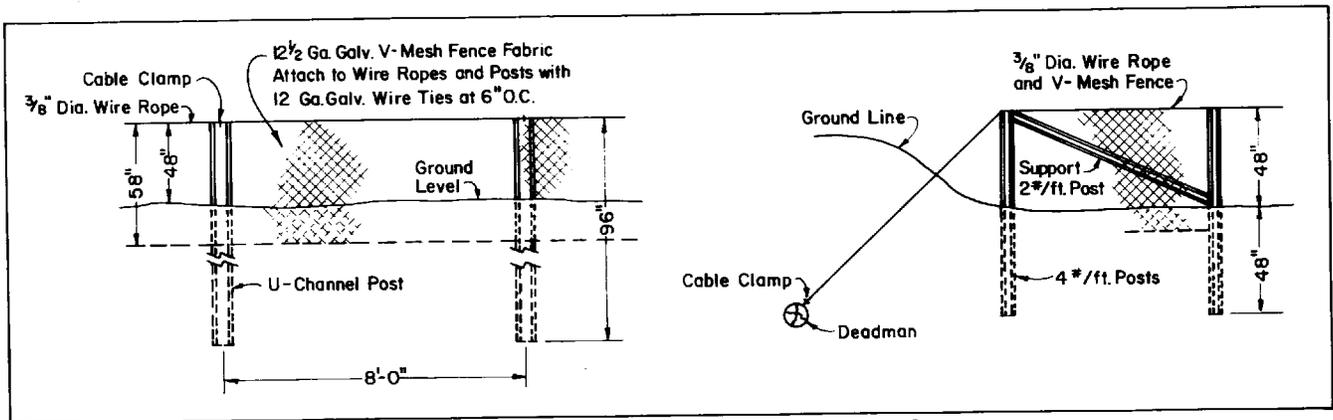
Figure 2. – Details of main revetment and baffle sections and the deadman and support assembly.

The design at Bluewater Creek uses pre-drilled galvanized steel U-channel sign posts commonly used to erect highway signs (figure 2). Posts can be bought in various lengths in 2-foot increments, in weights from 2-1/2 to 4 lb/ft. Two or more posts can be bolted

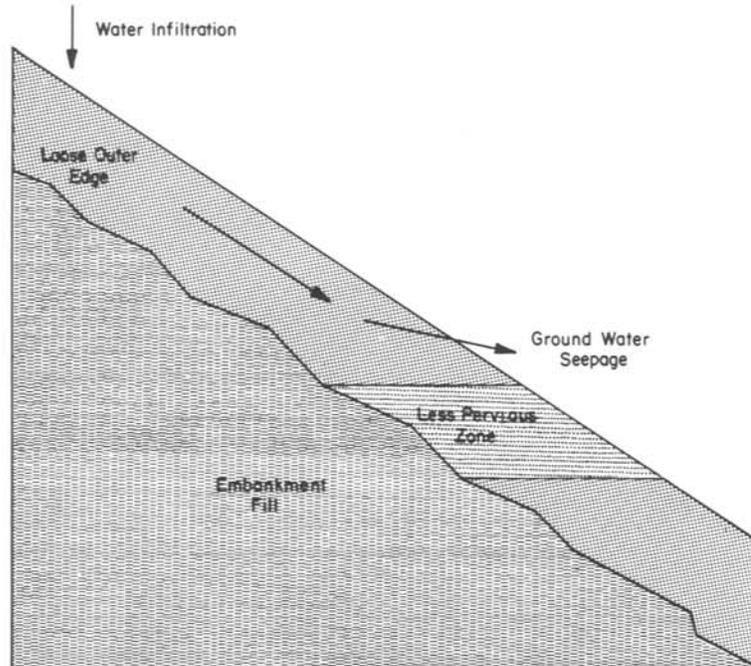
Factor of safety.—The relative security or factor of safety of an earthen slope is normally expressed as the ratio of the shear strength to the shear stress along a critical surface. A slope fails when the shear stress on this critical surface equals the shear strength (i.e., when the safety factor approaches unity). Different types of mass stability analyses or models have been developed to predict the factor of safety.[3] The so-called infinite slope model is appropriate for analyzing transitional slides in which the failure surface is planar and parallel to the slope over most of its length. An infinite slope analysis is suitable for evaluating the stability of a compacted fill when failure occurs primarily by shallow sloughing along a surface roughly parallel to the face of the slope. The failure surface tends to be located in the looser, less compacted soil near the outer edge of the fill, as depicted in Figure 1. Water infiltrating into the slope from the top flows along this looser, more permeable layer parallel to the slope. Less permeable zones along the way or at the bottom of the slope tend to divert this seepage laterally outward and cause it to emerge at the face as shown schematically in Figure 1. This condition not only decreases mass stability, it can lead to piping and seepage erosion as well.

Figure 1. – Schematic illustrates variables controlling shallow slope failures in compacted fill slope.

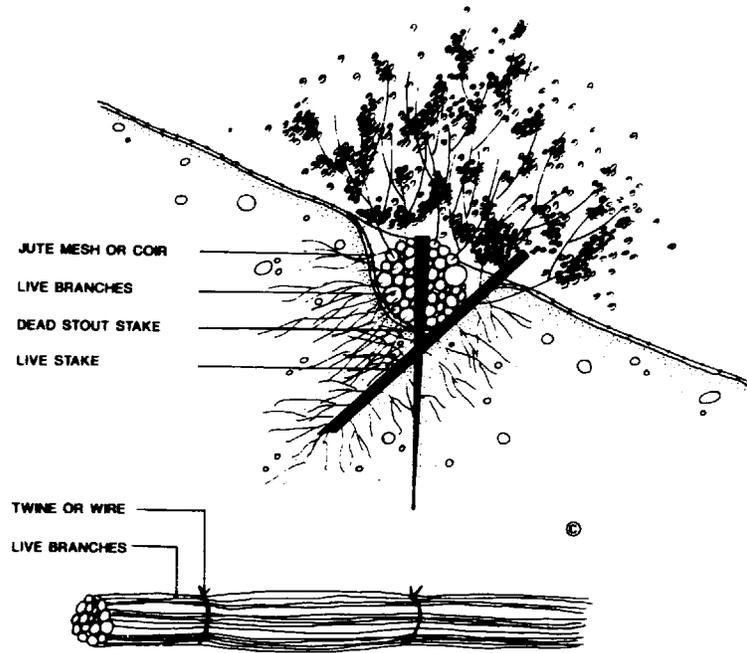
Figure 2. - Live fascine with jute or coir. Rooted/leaved condition of the living plant material is not representative at time of installation.

Soil bioengineering systems installed included live staking, live cribwall, cut brushlayers, and live fascines (figure 2).
- **Area 2.**—The slope was 1.5:1 with some vertical sections and had a maximum height of about 60 feet. It was heavily eroded with raveled and sliding sections.

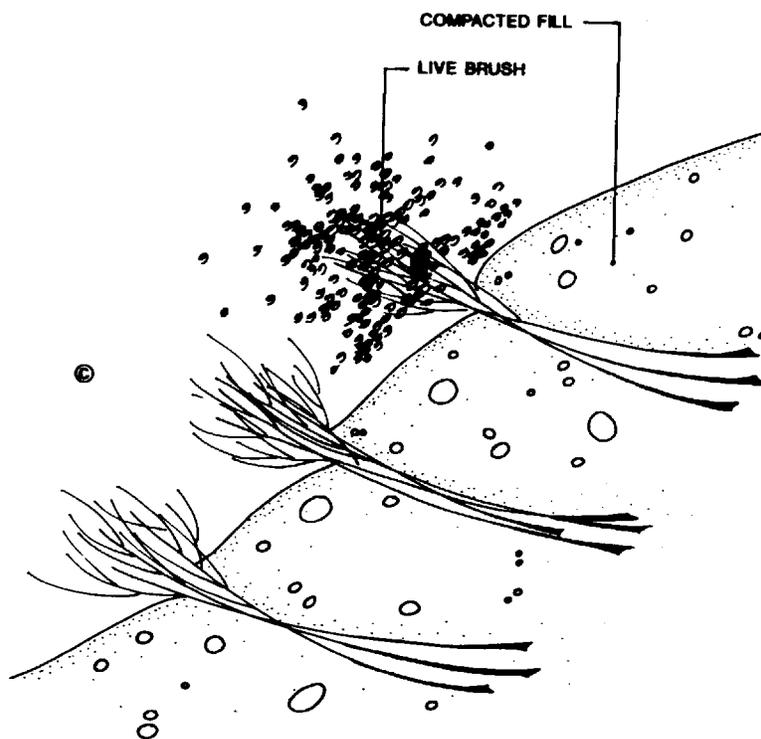
Figure 3. - Schematic representation of a brush-layer fill installation.

Soil bioengineering systems installed were fill brushlayers (figure 3), reinforced brushlayers, live staking, and rooted plants.

Brushlayering system.—This system (figure 3) includes brushlayers cut into a slope and those used in a new or repair fill that abuts the slope face. The branches are placed as the fill is raised in the latter case. This system works very well as porous filter units to control surface erosion from heavy rains during and after construction. This filtering action was observed during construction when 4.5 inches of rain fell in a 3-day period. The brushlayers prevented erosion of the outer edge of the loosely compacted fill material placed in the fill brushlayer system in Area 2. Those areas of the slope where such systems had not been installed experienced large soil flows and earth failures.

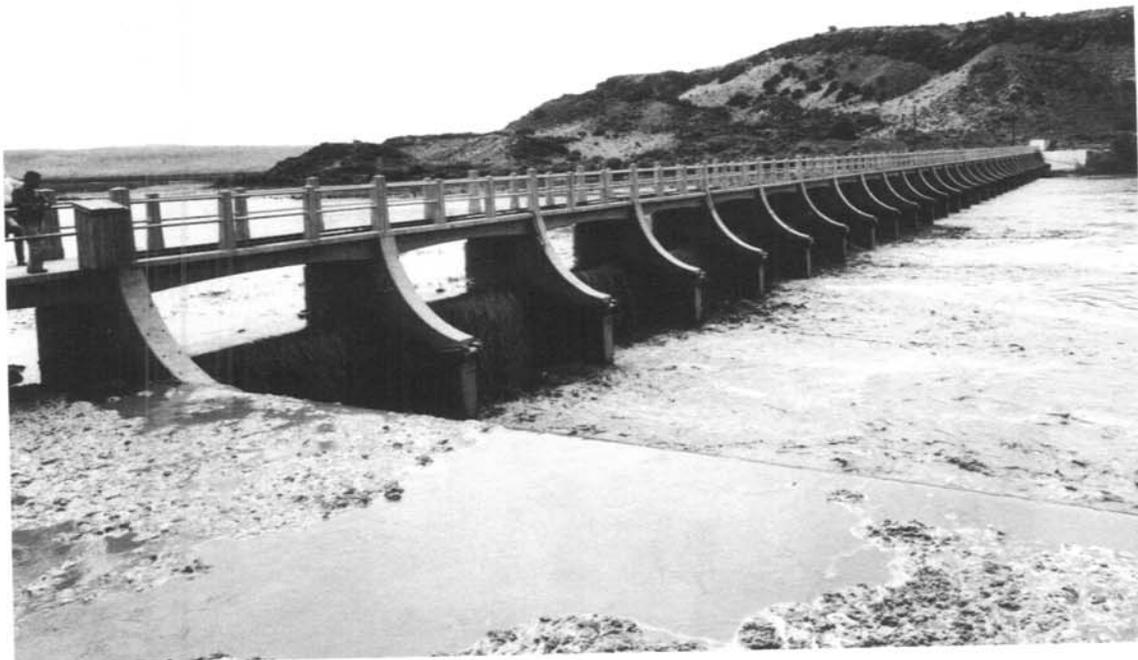
Figure 1. - Downstream view of San Acacia Diversion Dam from canal headworks. 6/30/66

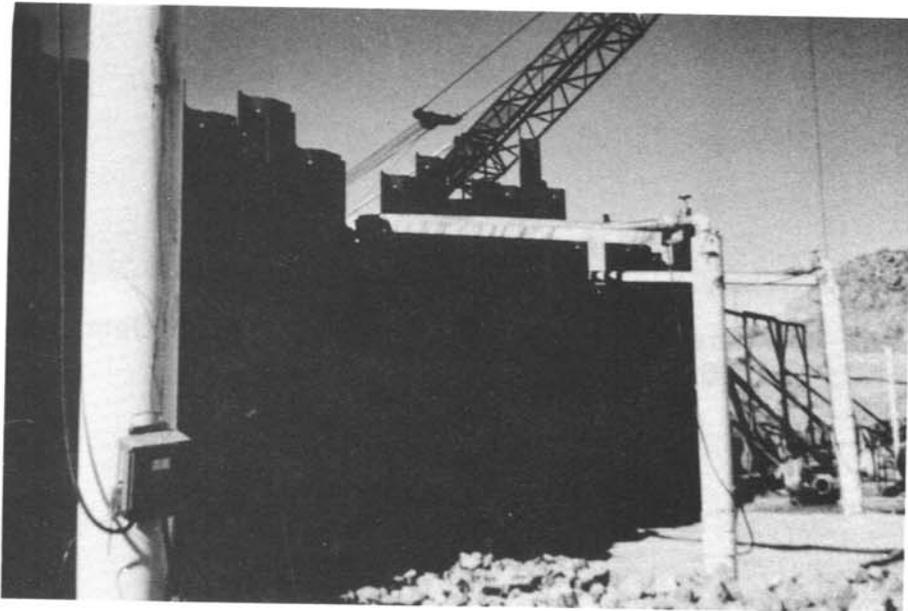
Figure 3. - Work area showing the dewatering wells just upstream of the steel sheet piling. 7/27/89

contractors failed mainly due to dewatering problems. This time, the work was accomplished by the Bureau of Reclamation's operation and maintenance crews from the Socorro Field Division of the Albuquerque Projects Office.

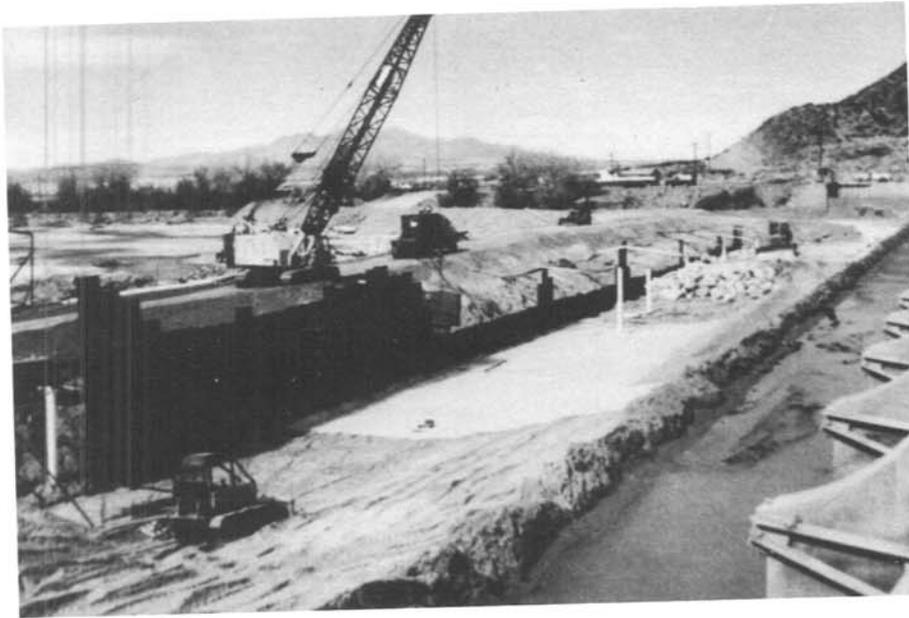
Figure 4. – Work area as viewed from the diversion dam. Some dewatering wells have been relocated to allow for geotextile placement and bedding material (center of photograph). 7/27/89

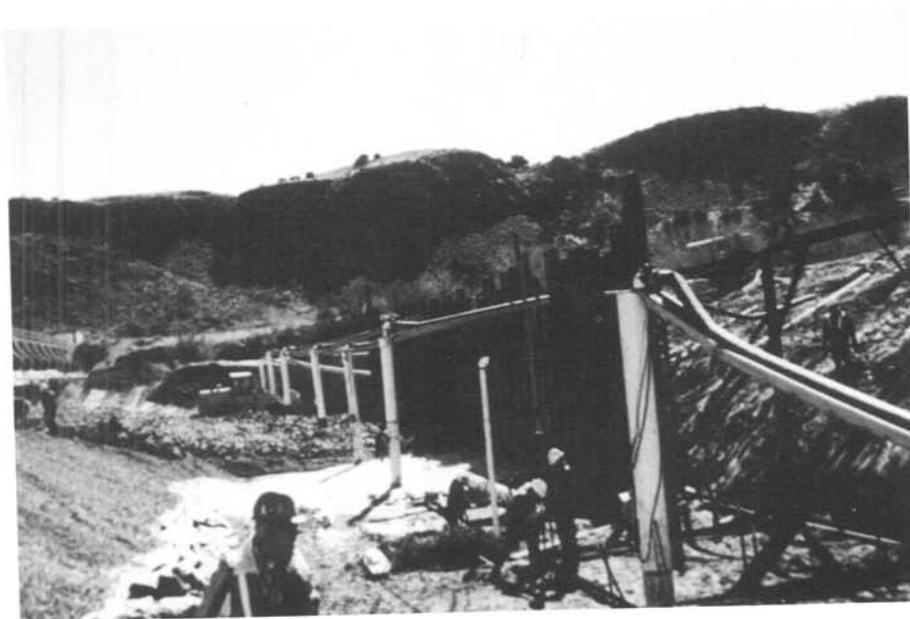
Figure 5. – Work area showing sheet piling dewatering wells, geotextile, bedding, and riprap placement. 7/27/89
