# WATER OPERATION AND MAINTENANCE BULLETIN

No. 198

December 2001

## LIQUEFACTION MITIGATION OF A SILTY DAM FOUNDATION USING VIBRO-STONE COLUMNS AND DRAINAGE WICKS: A CASE HISTORY AT SALMON LAKE DAM

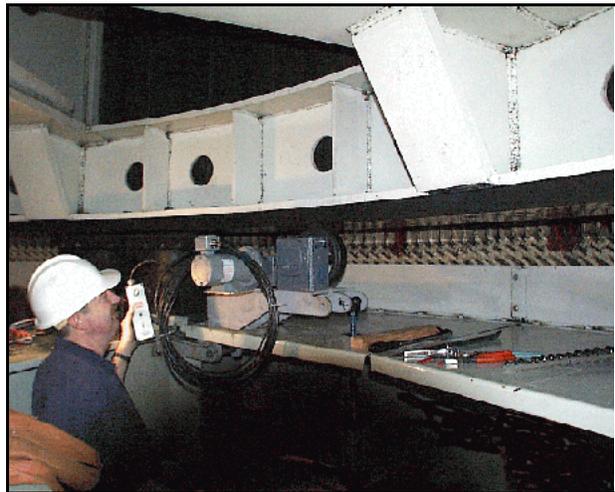
A potential safety hazard occurs when large, synchronous generator rotors must be turned slowly and stopped at precise positions for certain operations such as maintenance, inspection, mechanical alignment, and testing. Until now, rotors at Reclamation plants have generally been turned "by hand" or sometimes by using winches. These methods are difficult, cumbersome, and potentially dangerous. The rotor is made of steel, and its surface can be very slippery if any oil is present. Also, there are many projections on top of the rotor, such as fan blades, bolts, and nuts. When a generator rotor is turned by hand, several workers stand on the top of the rotor, brace their backs against some stationary structural component, and push with their feet on the projections, as if they were pushing a 110,000-pound stalled car. As the rotor begins to turn, the workers must reposition their feet to get a new purchase on the rotor and continue pushing.

Once turning, the inertia of the massive rotor tends to keep it in motion. It is not possible for a worker or even several workers to quickly stop the rotation of the rotor. Depending on its speed, the rotor may turn several times before it coasts to a stop. While moving, the rotor is a source of hazardous energy.

*Glen Canyon Plant Mechanic Rick Benzel demonstrates operation of the rotor turning gear. The rim of the generator rotor is overhead.*

The hazard is that a worker may be trapped or entangled with components of the turning rotor. The worker could slip or get into a position to be pinched or dragged by the rotor as it continues to turn. A worker at another utility died a few years ago in such an incident. Installation of the rotor turning gear eliminates this hazard.

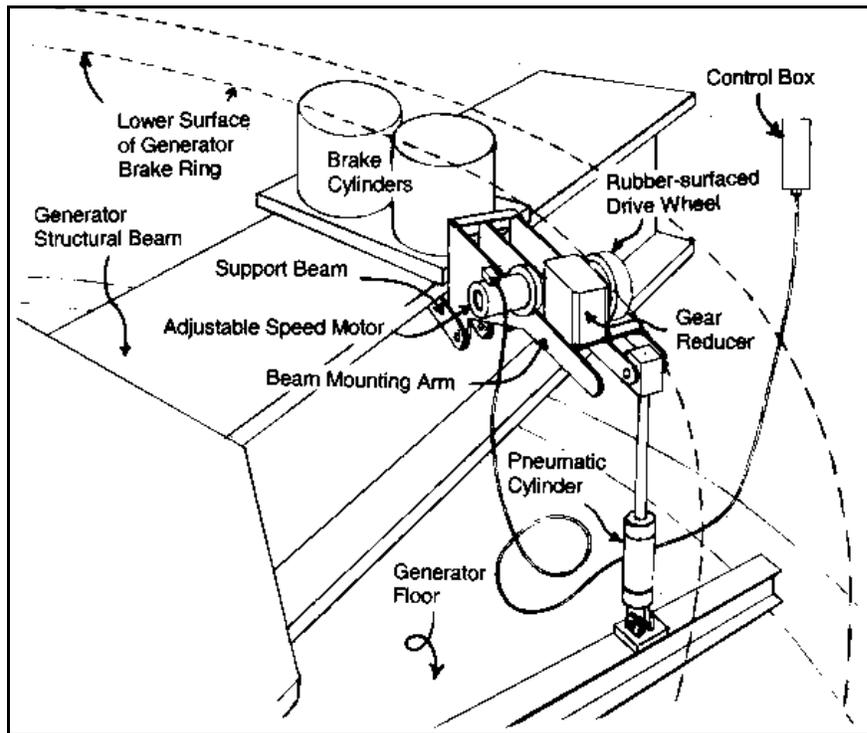
Diagram of the rotor turning gear.
