Technical Memorandum No. MERL-2011-41

## **Investigation of Overcoating Coal Tar Enamel with Foul Release Coatings**

**Materials Engineering and Research Laboratory,  
Technical Service Center**

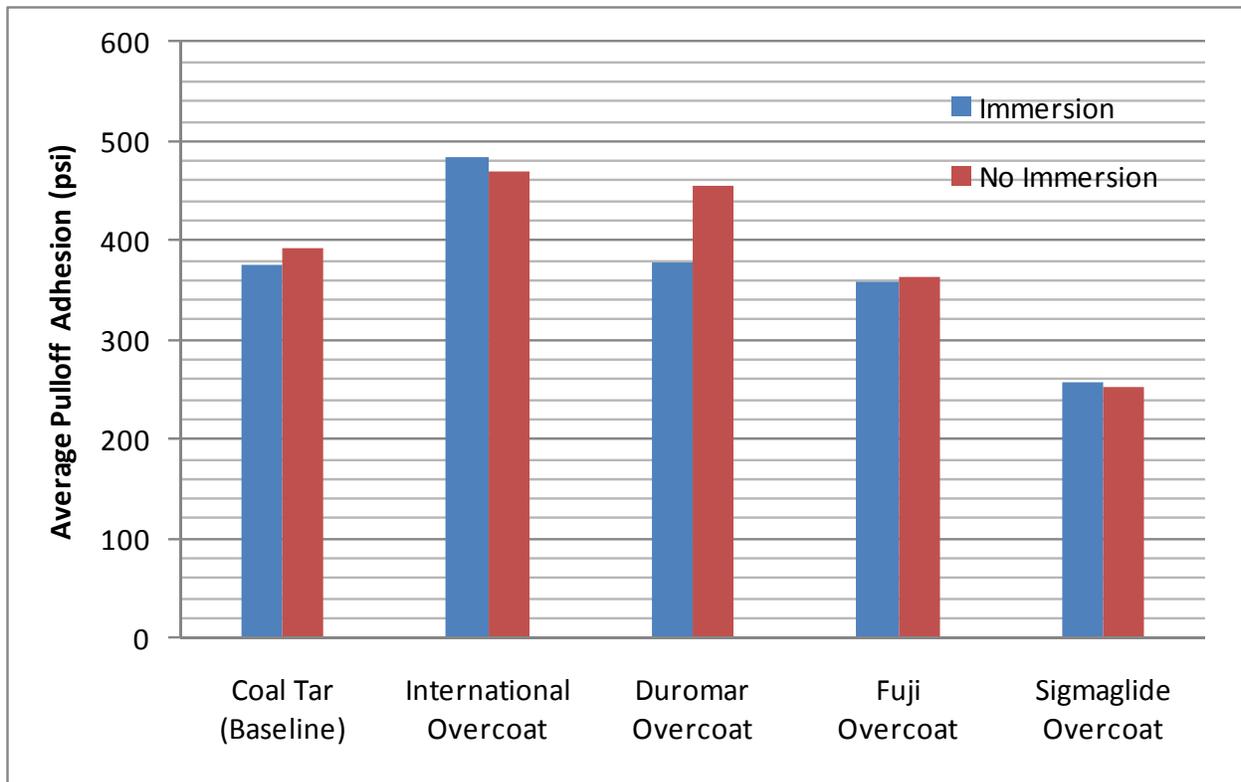
**Figure 17: Average pulloff adhesion strength**

The adhesion test results are given in Table 5 and summarized in Figure 17. Note that in all of the systems, the test failed within the coal tar enamel. In most systems, immersion did not appear to lower the coal tar strength significantly. The results show no significant decrease in adhesion for the two coating systems that used a 100% solids epoxy primer and actually may be slightly higher. The solvent borne epoxy primers used with Sigmaglride and Fuji caused slight decreases in adhesion due to the solvents dissolving the coal tar enamel. The effect was greater in the Sigmaglride sample which contained a higher amount of solvent (13% vs 3%). There was no significant change between the exposed samples and the controls that were in the refrigerator for the entire testing period.
