Department of the Interior
Bureau of Reclamation

OPERATION AND MAINTENANCE EQUIPMENT AND PROCEDURES

RELEASE NO. 18

RESURFACING DETERIORATED CONCRETE LININGS

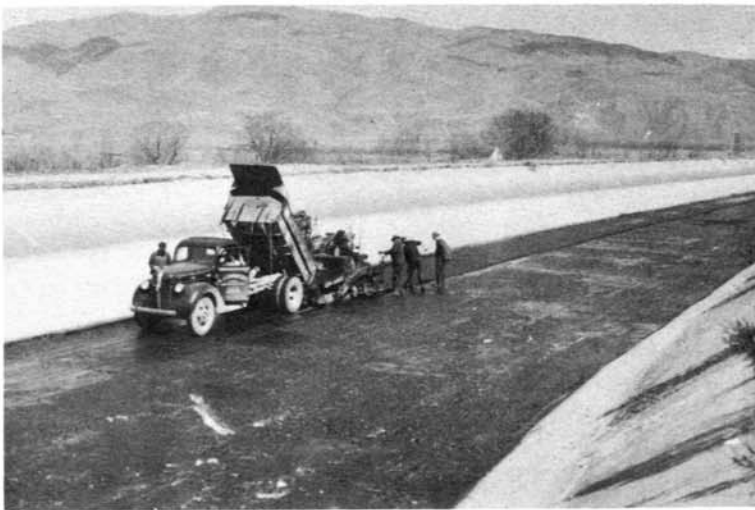
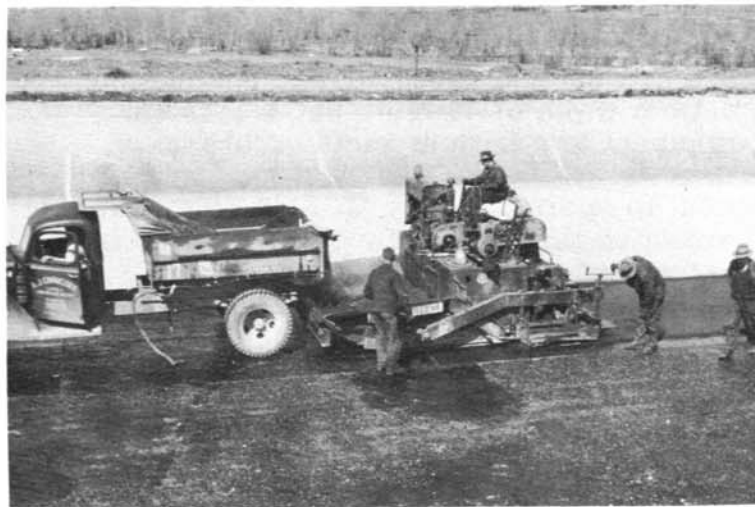
The resurfacing material consisting of 10-percent asphalt of 50-60 penetration and aggregate was hot mixed in the contractor's plant in Boise. The hot mix was transported by truck to the site of placement where it was dumped on the old concrete lining ahead of and spread by a paver, photographs at left.

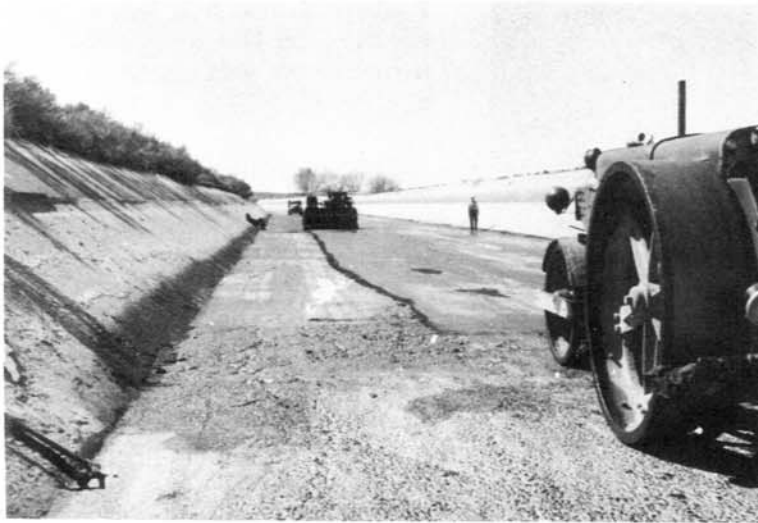
As shown in the photograph at the top of the following page, the lining was rolled with a 12-ton standard roller, no particular trouble being experienced, other than that it was usually necessary

to wait for some cooling before rolling.

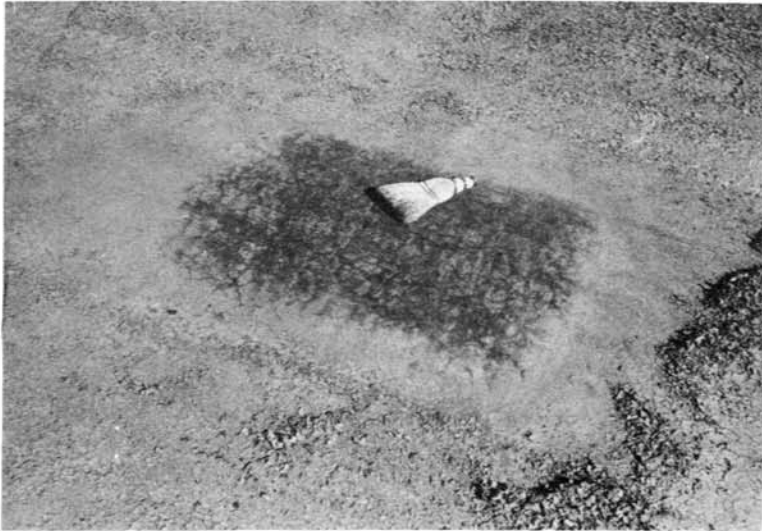
below, revealed little change in the general condition of the lining. Close examination of several representative areas, photograph at top of the following page, showed little, if any, erosion and no deleterious effects from mud curling. Bond between the portland cement concrete and the asphaltic concrete appeared to be excellent throughout the length of the repaired sections. The Manager of the Board of Control reported in 1952 that no

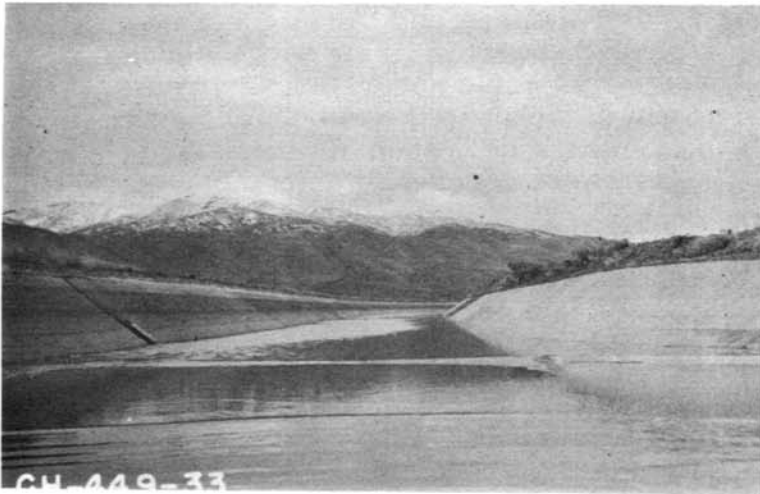
The middle photograph on this page is a general view of the Main Canal looking upstream from approximately Mile 1.

Although there was a thin sheet of water over much of the lining the asphalt mat was discernible and there did not appear to be any evidence of cracks in the older concrete lining being reflected or transmitted through the asphaltic concrete mat.

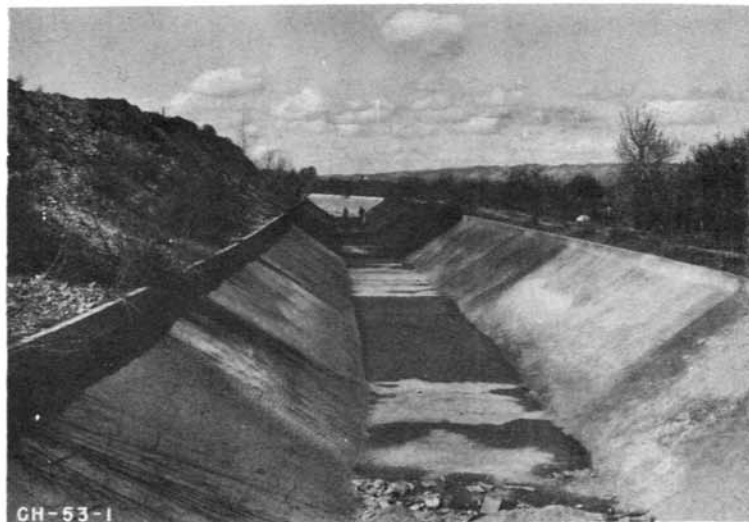
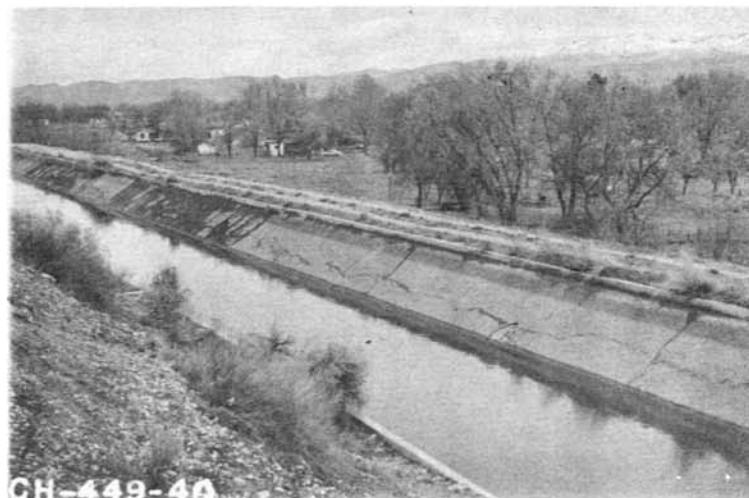
A typical view of a portion of the canal at the time some of the linings had been placed in 1947 is shown in the first photograph below. The old concrete lining in the foreground has been resurfaced with pneumatically applied portland cement mortar. Other resurfacing materials are being applied to the old concrete lining in the background. The lower photograph is a view of a portion of the resurfaced concrete lining after it has been in service for 8 years. Again the pneumatically applied portland cement mortar is shown in the immediate foreground, extending from right to left, with the other resurfacing materials toward the left. Practically all of the experimental resurfacing materials showed some signs of deterioration, with several being so badly weathered or eroded as to be no longer serviceable.

The 1½-inch thick pneumatically applied portland cement mortar or shotcrete resurfacing had a very good appearance at the time it was placed, as shown in the upper photograph on the previous page. After 8 years, in addition to the spalling and cracking apparent in the lower photo-

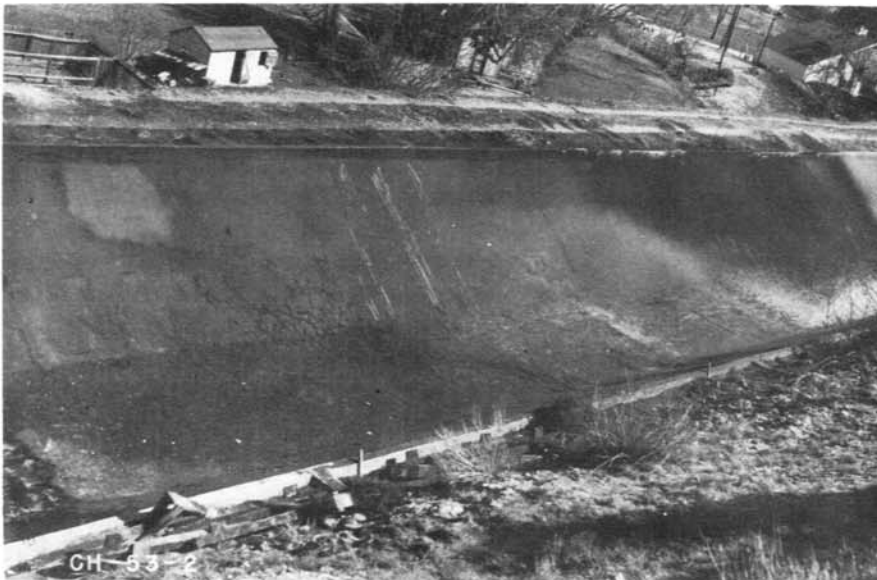
asphalt-sand mixtures, also placed pneumatically. The resurfacing material at the left in the photograph is a mixture of asphalt emulsion and sand and that toward the right is a mixture of RC-O cutback asphalt and sand.

In the photograph at the bottom of this page are shown two types of (The light colored surfacing material at the extreme right in the photograph is a portion of the pneumatically applied portland cement mortar described previously.)

The RC-O asphalt and sand was placed to a minimum thickness of 1/2-inch. It was soft and appeared to have a permeable structure. The softness was considered to be due to the inability of

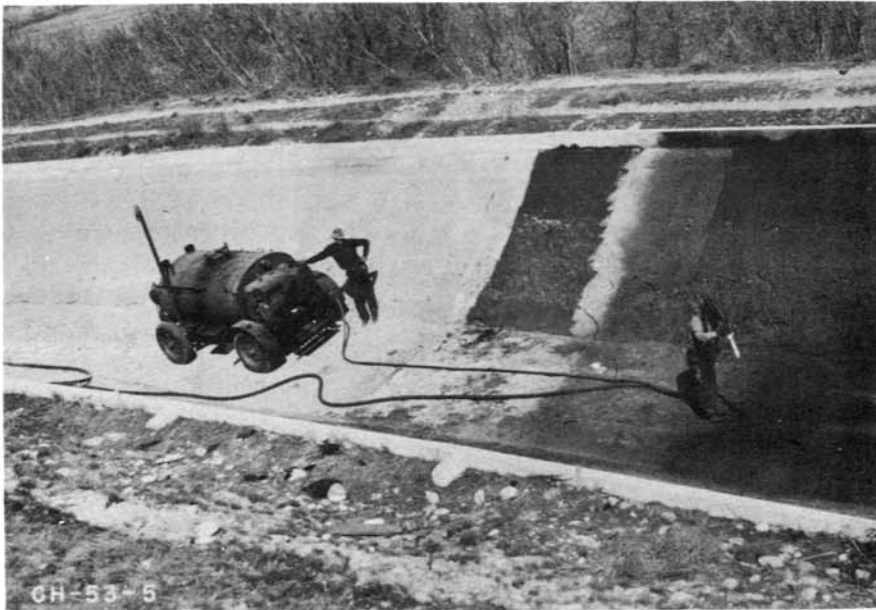
The resurfacing, photograph below had a fair appearance at the time of placement except for an exceptionally heavy rebound of sand particles.

The rebound was largely uncoated, indicating that the emulsion was not coming into proper contact with the sand in the pneumatic nozzle. Completed sections, when swept clear of the rebound, appeared firm and quite tight, with a fairly smooth surface. The first part of the emulsion-sand was constructed with an RRW asphalt emulsion, using the pneumatic gun shown above. An attempt was made to use an NX, quick breaking

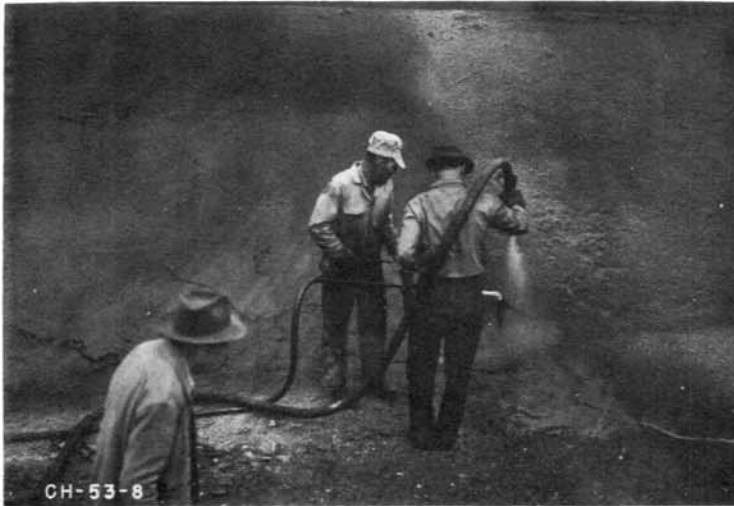
emulsion but the emulsion broke in the gun and the material could not be applied. In order to secure a test application of the NX emulsion, it was applied by a spray bar attached to a distributor truck, while the sand was applied with the pneumatic gun, photograph at top of the following page. One man operated the hand spray bar and applied the asphalt, while a second man operated the gun. No difficulty was encountered using this method. The sand, upon striking the emulsion film, broke the emulsion rapidly and there was very little rebound.

A firm, smooth surface with a good buildup of material over the concrete lining was obtained. Previously tried in the laboratory, with RC-cut-back asphalt and with hot asphalt cement this method produced negative results. The emulsion as used in the canal resurfacing work was very satisfactory.

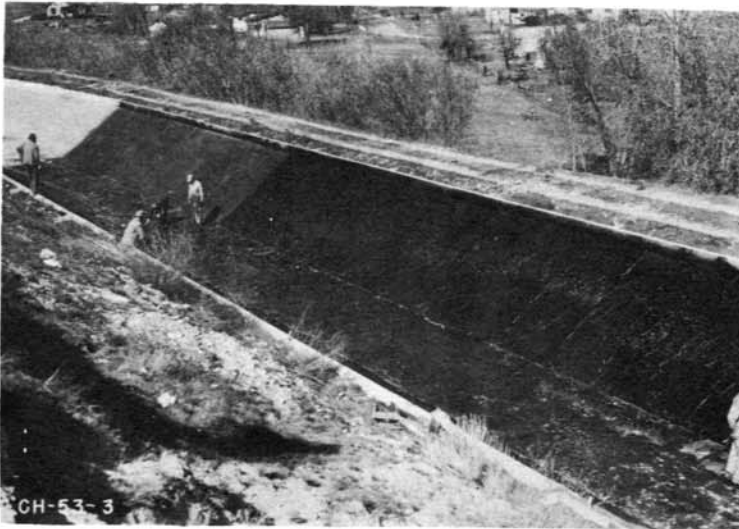
In the photograph immediately below, a section of the old portland cement concrete lining was resurfaced with a mineral filled asphaltic cement. It was applied as a relatively thin membrane by spray.

The resurfacing was primarily a seal coat and consisted of 23 per cent diatomaceous earth and 77 per cent, 85-100 penetration asphaltic cement.

The material applied, thoroughly coated and water-proofed the concrete lining, resulting in a slick, tough surface. A part of the section

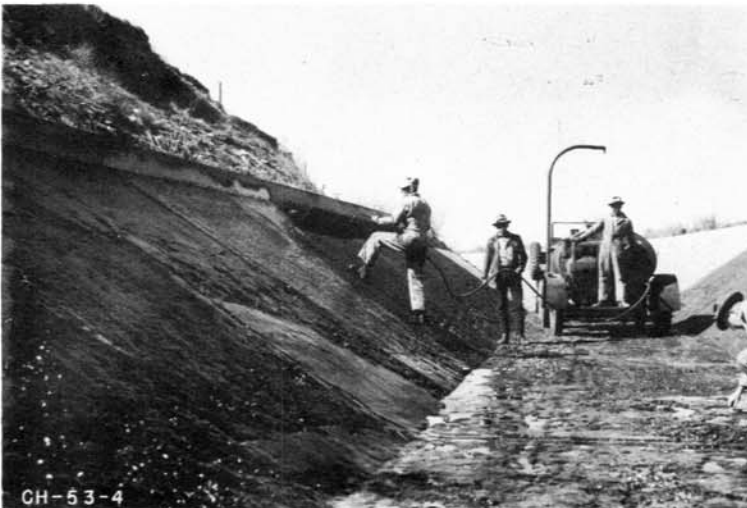
An application procedure, similar to that previously described, was followed in resurfacing a section of concrete lining with a mineral filled asphalt-emulsion, as shown in the middle photograph. The thin seal coat was applied with and without an RC-O cutback asphalt tack coat, and consisted of a soft, 200-penetration, asphalt cement having a 23 percent filler of diatomaceous earth applied at a temperature of 140 degrees F.

A good spray was obtained at the application temperature, and the resulting surface was fairly satisfactory.

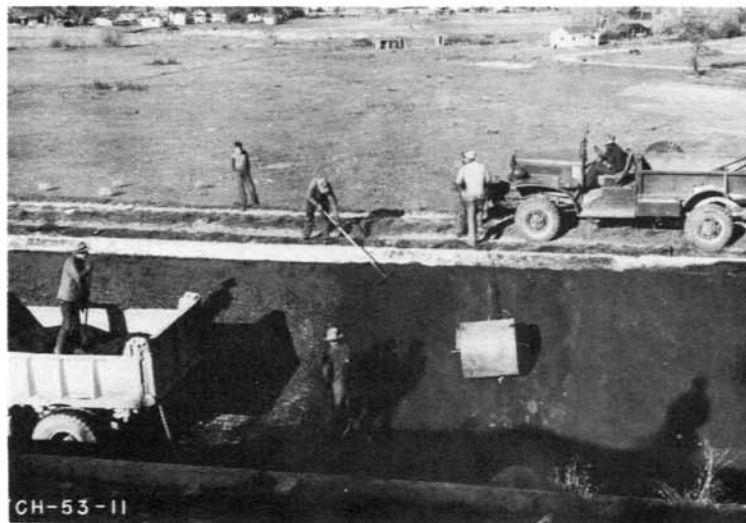
The "hot-mix" asphalt-emulsion, shown in the photograph below, was composed of an RX emulsion and a graded aggregate. The aggregate was heated to about 225 degrees F, before adding the emulsion. Eleven percent of emulsion was added, giving the mix an asphalt content of approximately 5.5 percent. Placement and rolling of the asphaltic-emulsion as shown was preceded by the application of a tack coat of RC-O cutback asphalt to the old portland cement concrete lining and hand raking to assure a minimum resurfacing material thickness of 1/2-inch after compaction.

Due either, possibly, to too low an aggregate temperature or to too lean a mix, the in-place asphaltic-emulsion concrete lining was brown in color and lacked cohesiveness, the completed surface being easily

abraded. Approximately a 30-foot length of this material was sealed with an application of 0.25 gallon of RC-O cutback asphalt per square yard of surface.

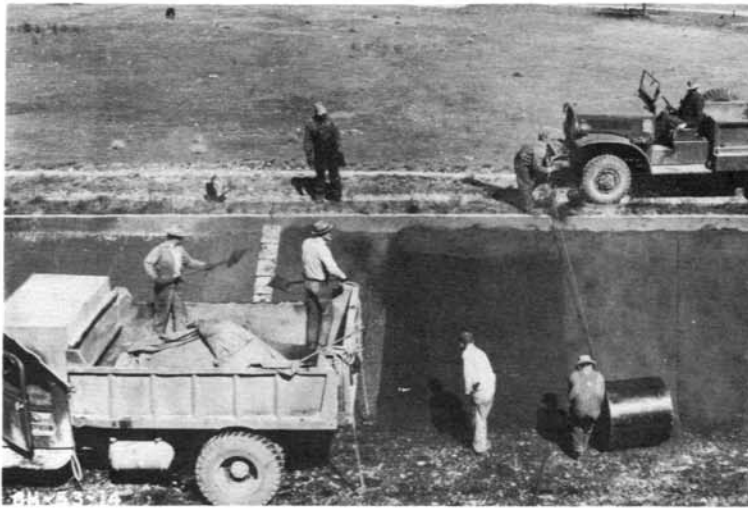
The asphaltic-cement concrete, also plant mixed, consisted of a graded aggregate, 100 percent passing the #4 size screen and approximately 7 percent of 85-100 penetration asphalt cement. This material was placed at a temperature of about 350 degrees, and both side slopes and bottom were rolled as shown.

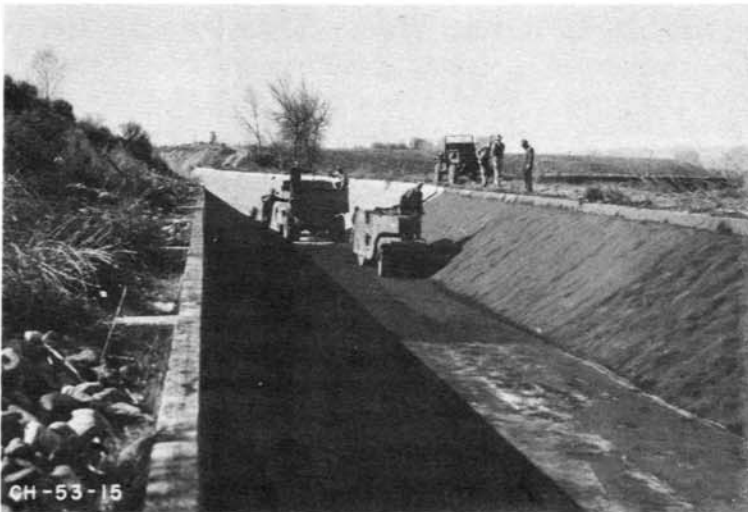
The resurfacing material was very good in appearance at the time placed and, as shown in the lower photograph, there are few cracks and very little spalling after 8 years of service and exposure. Some roller marks are still apparent and the protective resurfacing mat is intact and hard.

In general the entire resurfaced section of canal is considered in poor condition with the exception of the hot-mixed asphaltic-cement concrete. This latter shows some cracks and roller marks. Both these deficiencies probably could be eliminated partially by increasing the thickness of the resurfacing material and more careful rolling at the time of placement.
