# **WATER OPERATION AND MAINTENANCE**

**BULLETIN NO. 140**

June 1987

## OUTLET WORKS BYPASS PIPE FAILURE

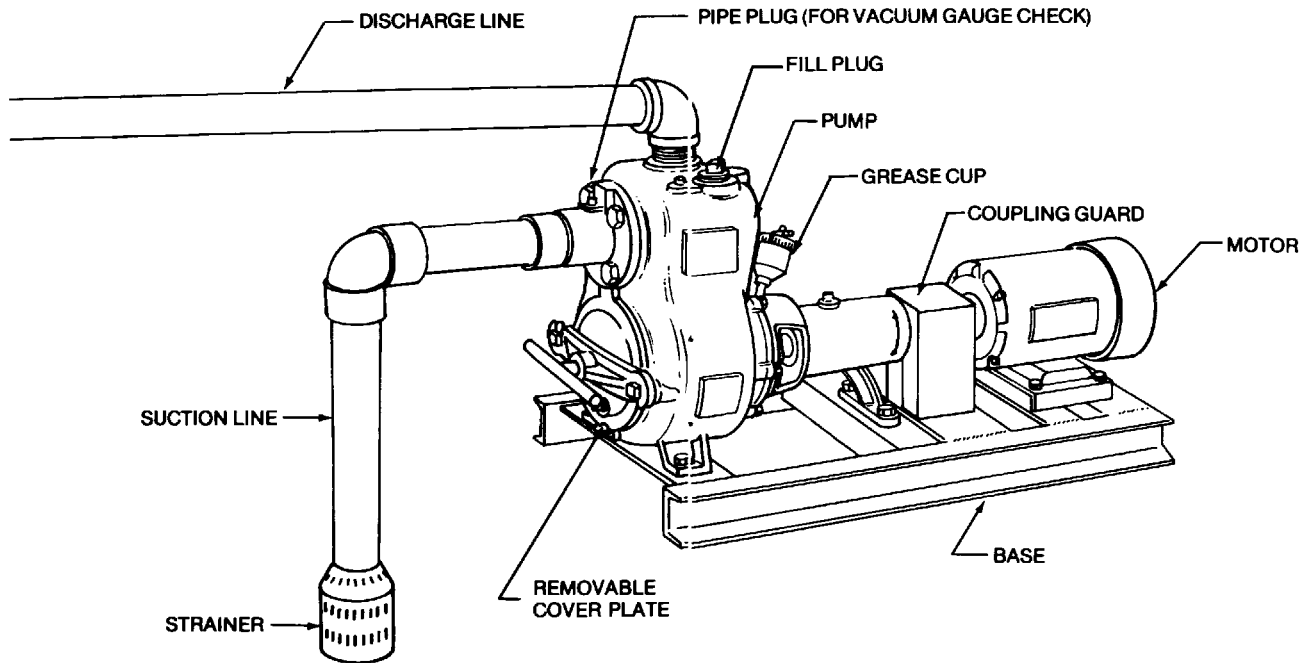
**General Pump Diagram**

5. Check impeller clearance.—If the clearance between impeller and wear plate or wear rings is beyond recommended limits, pumping efficiency will be reduced. If the clearance is less than that recommended, components will wear excessively. If tolerances are too close, rubbing could cause an overload on the engine or motor. Check the impeller clearance against pump manual specifications and adjust if necessary.

6. Check the seal.—Most pumps are equipped with a double seal lubricated under pressure — with a spring-loaded grease cup — or an oil-lubricated tungsten titanium carbide seal for long, trouble-free service. If your pump has a single seal and it is lubricated with the water being pumped, sand and other solids can cause rapid wear. Check and replace the seal if worn. Replace seal liner or shaft sleeve if it has scratches.

7. Check bearings.—Worn bearings can cause the shaft to wobble. Eventually, the pump will overheat; and sooner or later, it will freeze up and stop. Replace bearings at the first sign of wear.

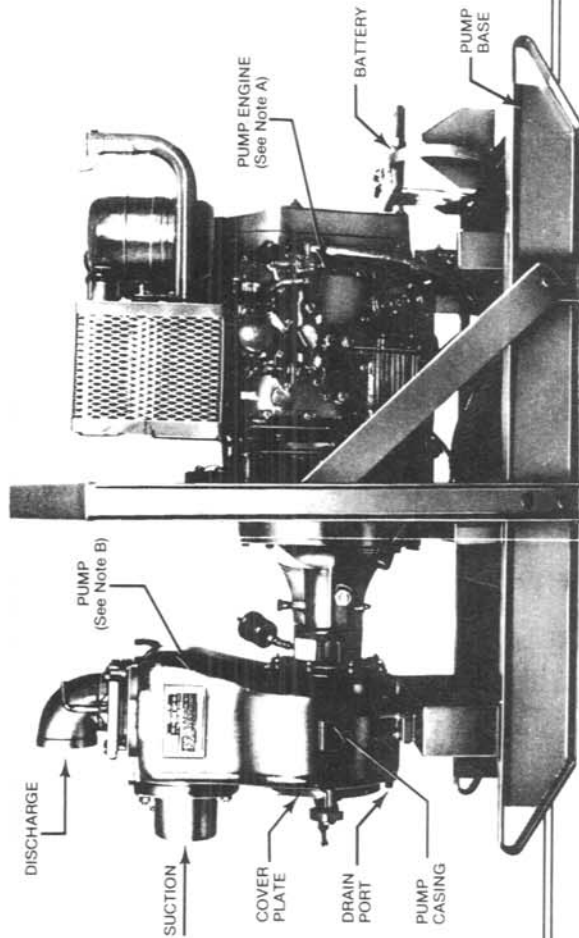
Figure 1

The purpose of this bulletin is to provide maintenance and storage information to those individuals who find it necessary to remove their Gorman-Rupp pumps from service for extended periods of time during the cold winter months. By following these few and relatively simple procedures, you can help to ensure more hours of trouble-free operation and also extend the working life of your pump.
