WATER OPERATION AND MAINTENANCE

BULLETIN NO. 144

June 1988

BUREAU OF RECLAMATION'S NEEDLE VALVE INVESTIGATION PROGRAM AND NEEDLE VALVE REPLACEMENT PROGRAM

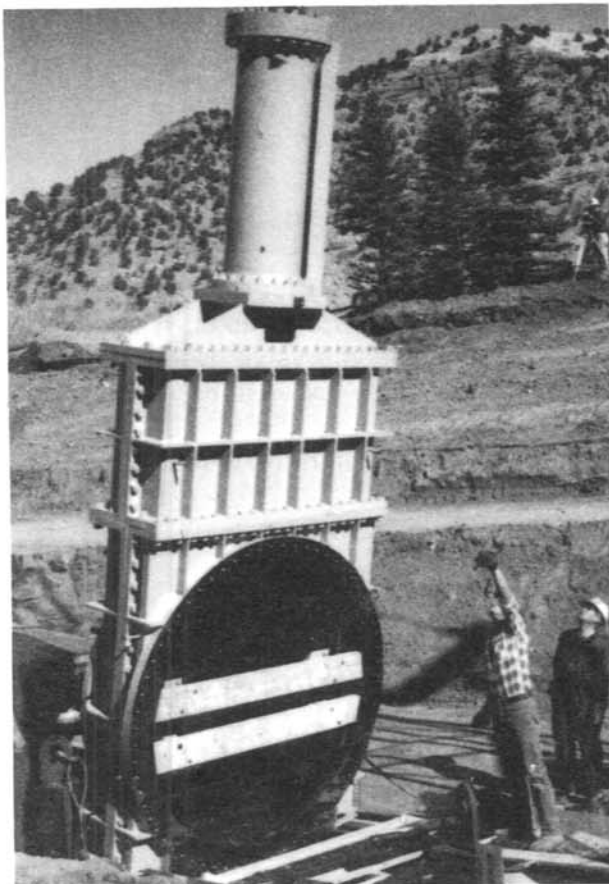
Photo 8. - Echo Dam, Utah

Downstream face of 60-inch-
jet-flow gate as it is lifted
from shipping crate.

Needle valves have been replaced at Pathfinder Dam in Wyoming (photographs 3 through 7) and Echo Dam in Utah (photographs 8 through 12). It is expected that all Bureau water-operated needle valves will be replaced by the end of fiscal year 1991.

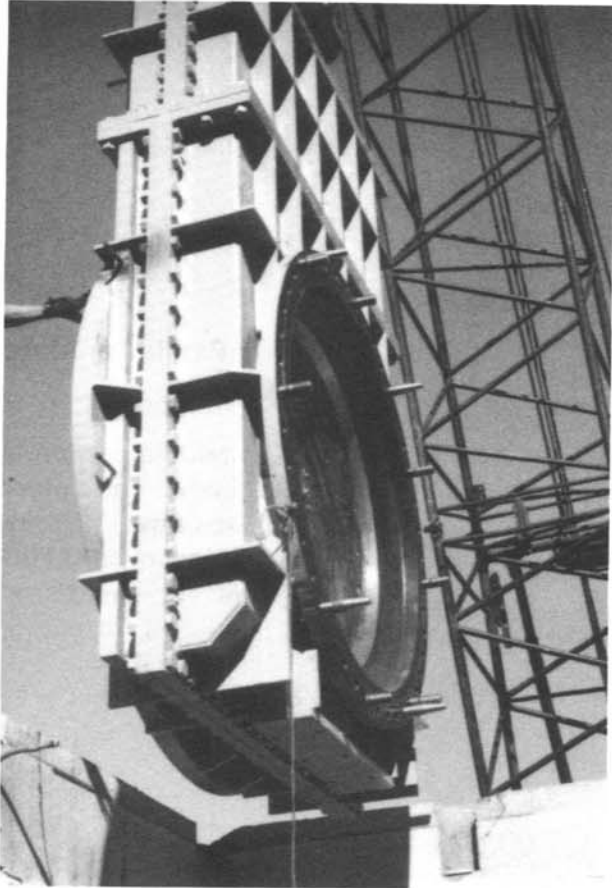
Photo 9. - Echo Dam, Utah

Upstream face of jet-flow gate while being lowered into valve house.

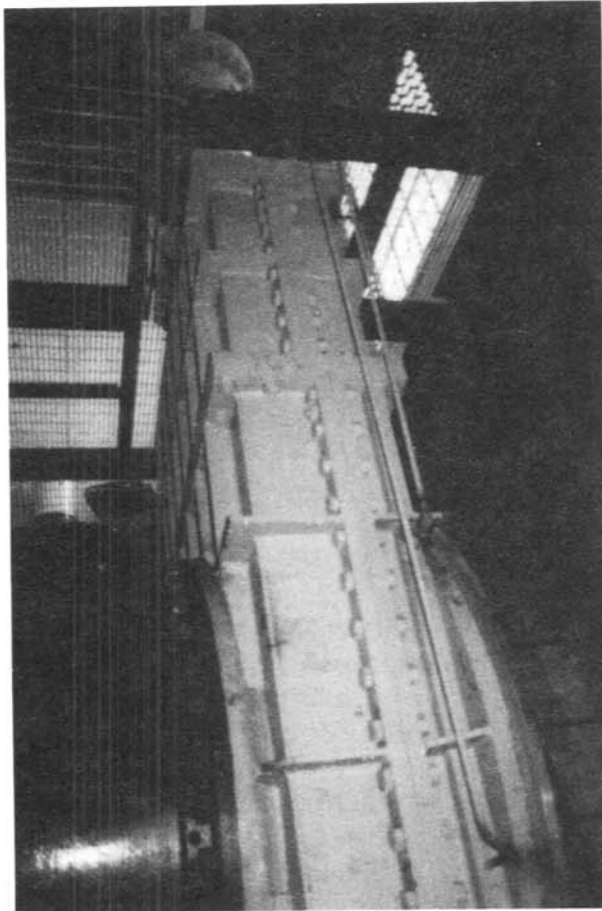
Photo 11. - Echo Dam, Utah

60-inch jet-flow gate in place
in existing valve house.

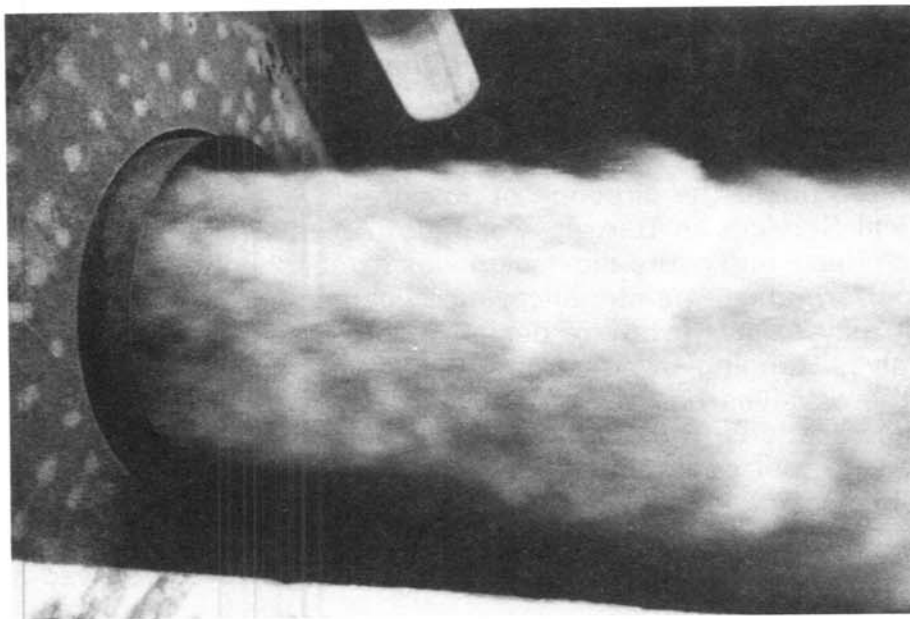
Photo 12. - Echo Dam, Utah

60-inch jet-flow gate operat-
ing at 100 percent open.

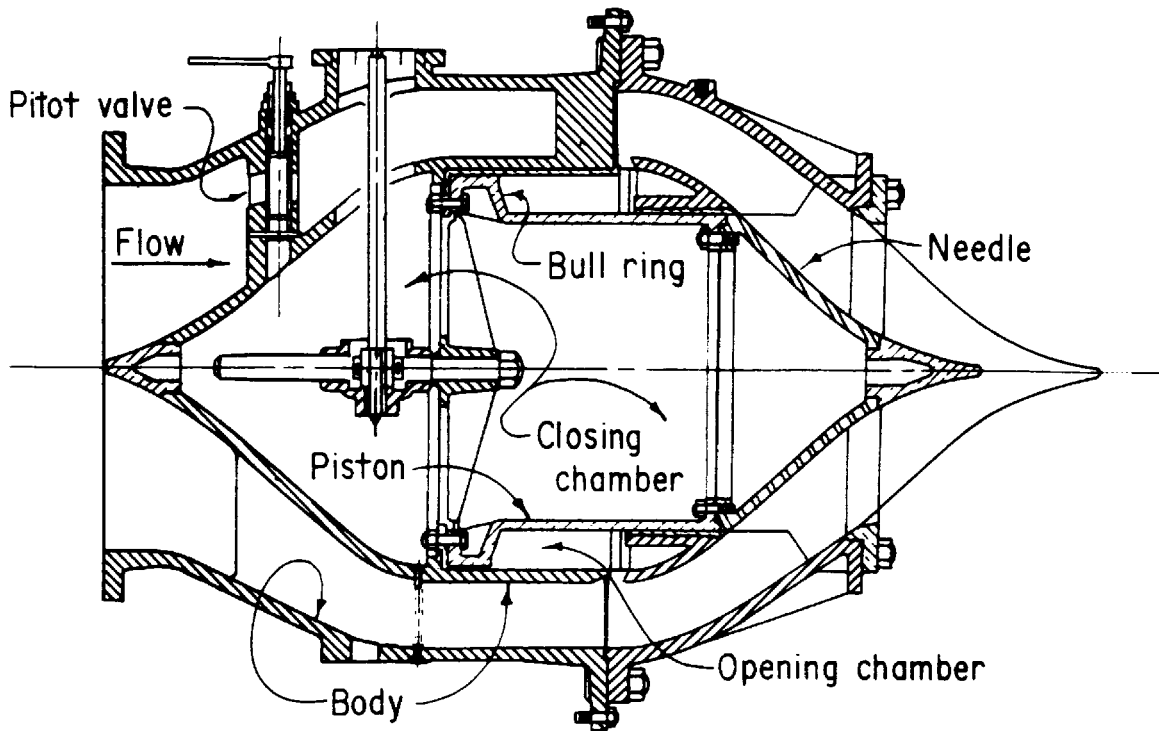
Figure 2. - Balanced needle valve.

3. Buildup of an organic material between the surfaces of the control liner and piston of the paradox control for the internal and interior valves (figures 3 and 4), and the two concentric sleeves of the control unit for the balanced valves (figure 2), can result in inoperable needle valves. Experience has shown that these controls must be dismantled and cleaned yearly, as a minimum.

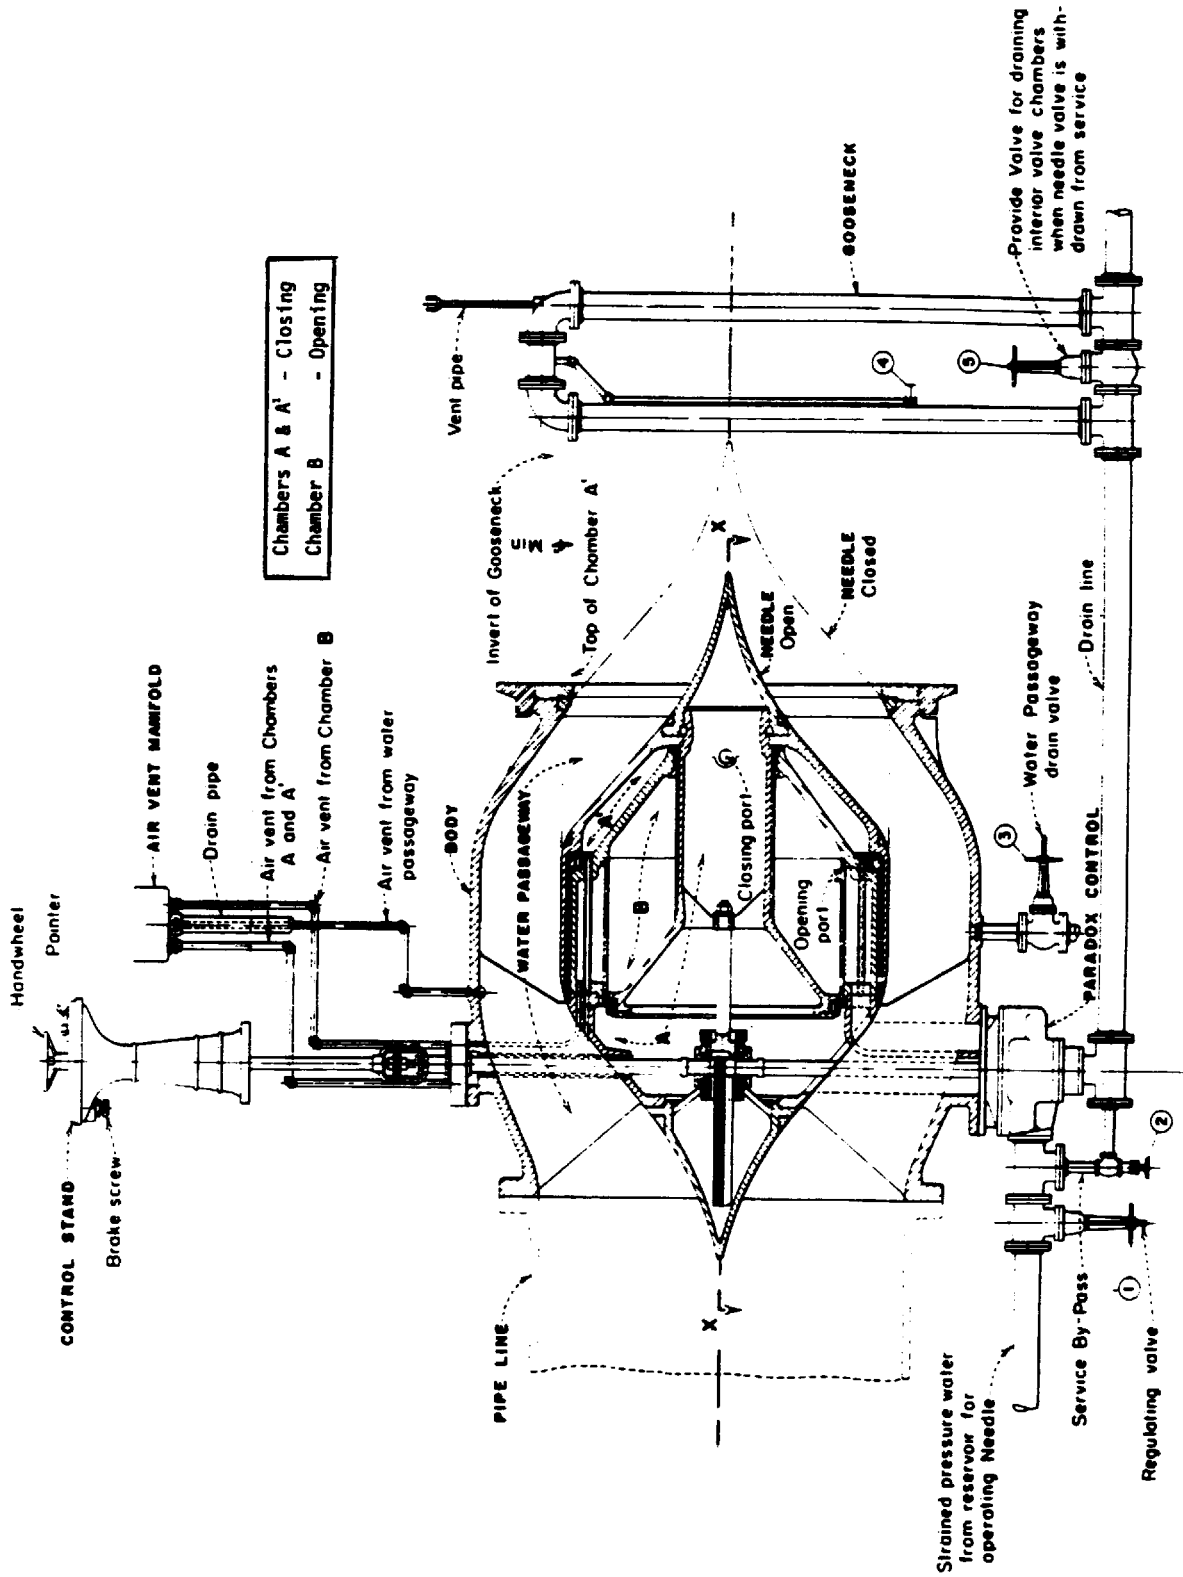
Figure 5.
 LONGITUDINAL SECTIONAL ELEVATION OF NEEDLE VALVE
 AND SCHEMATIC ARRANGEMENT OF OPERATING EQUIPMENT

4. The operating chambers must be maintained full of water at all times that the needle valve is in service. Partially drained chambers permit the presence of air which provides a compressible gas that could result in uncontrolled rapid needle movement. Two features were designed into each needle valve system that were intended to ensure that the chambers remain full of water - an automatic air vent manifold and a "gooseneck" piping arrangement on the operating chamber discharge. The automatic vents consisted of a poppet-type valve from each operating chamber. These devices have proven to be unreliable and, in most cases, have been replaced with manual valves. With manually operated air vent valves, air can accumulate in the chambers during normal operation.

3. The drain piping from the operating chambers of the needle valves contains a gooseneck piping arrangement (figure 5), with its invert slightly above the top of the

operating chambers of the needle valve. This arrangement insures that the chambers of the valve remain full of water during all operating conditions. Investigation of historical records and on-site inspection confirmed that the gooseneck piping arrangement was being bypassed by leaving valve No. 5 (figure 5) open during normal operating conditions. This procedure, while increasing the differential pressure across the operating chambers of the valve to obtain movement of the needle, will permit draining of the operating chamber directed to discharge and, therefore, the presence of air in the chamber. When a future adjustment in flow is made, the air can be compressed resulting in rapid uncontrolled movement of the needle.

1. The old original manifold style of air vent system, or manual valving, was replaced. The new automatic venting system consists of an automatic air release valve, sight glass flow indicator, check valve, and purge valve on the air vent pipe from each operating chamber. All air vent pipe was also replaced with new pipe.
2. The gooseneck bypass pipe valve No. 5 (figure 5) was removed and replaced with blind flanges.
3. Supply and drain piping were disassembled and inspected for obstruction. All piping either was cleaned or was replaced.
