# **WATER OPERATION AND MAINTENANCE**

**BULLETIN NO. 150**

December 1989

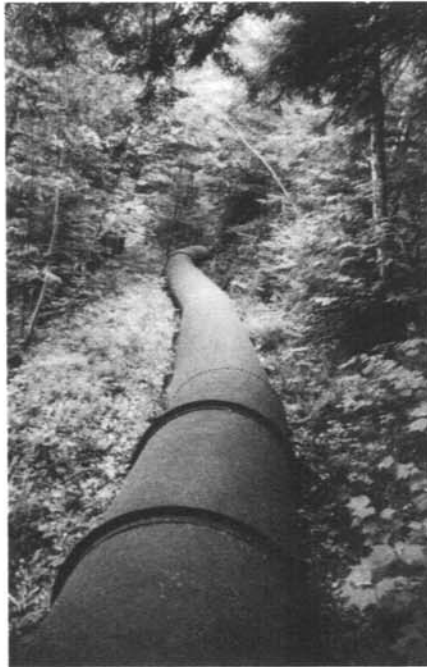
The rough terrain and heavy vegetation surrounding the pipe contributed to the complexity of the problem, thus adding to the cost of the project.

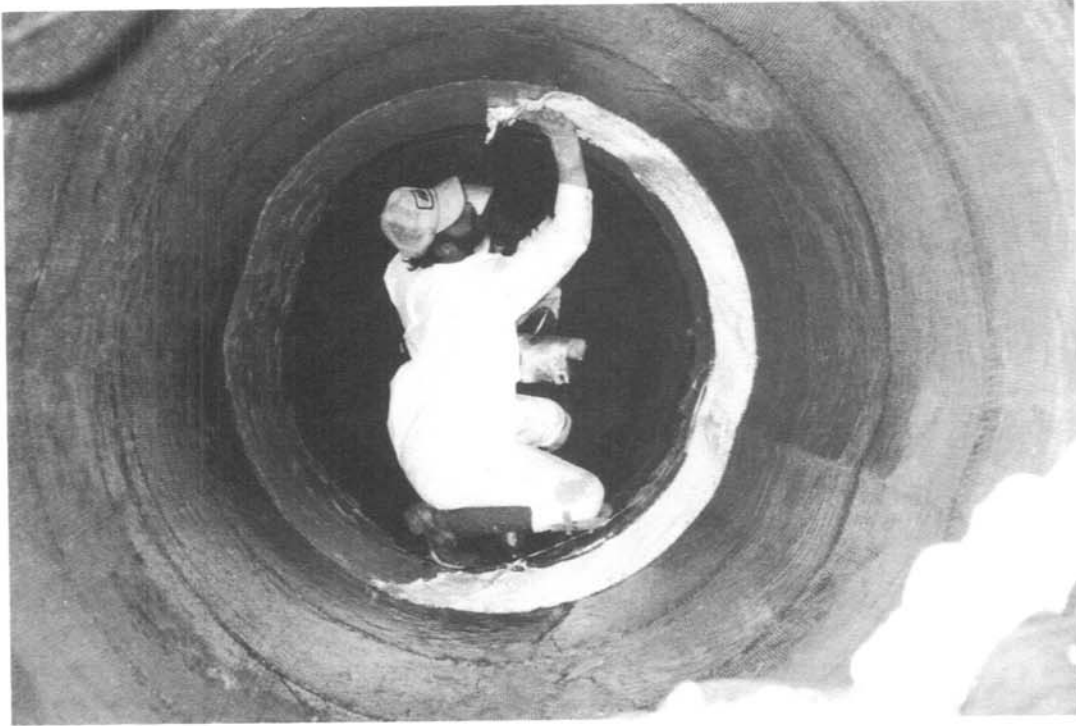
Figure 3. – High-tensile-strength fiberglass reinforcement is embedded in the putty.

The interior of the penstock was first abrasive-blasted to a white-metal condition. Welded patches were placed in a few selected areas that had severe pitting. Immediately after blasting, each area was primed to preserve the white-metal condition. Next, the corrosion pits were filled with a putty material to make a smooth surface. Spaces around rivets were also filled with putty and tapered to provide a gradual buildup over contours. High-tensile-strength fiberglass reinforcement was embedded into the putty and saturated with resin. After this layer cured, two layers of chopped strand mat were applied and allowed to cure. Two topcoats containing abrasion-resistant additives and wax sealers were then applied to complete the system. A metal band was lapped over the leading upstream edge of the fiberglass-to-steel transition to provide additional protection against the possibility that waterflow might separate the fiberglass from the steel. The thickness of the fiberglass at the downstream terminus of the lining was tapered to prevent localized turbulence. The \$250,000 repair project was completed on December 10, 1987, after 11 weeks of work.

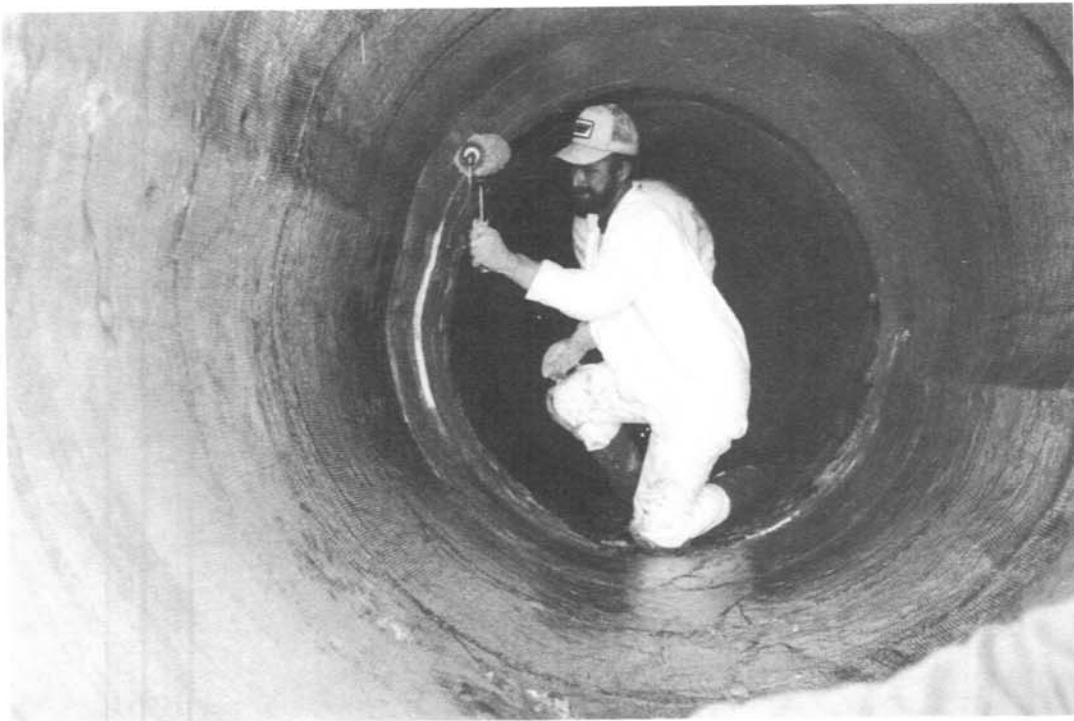
Figure 4. – The fiberglass is then saturated with resin and allowed to cure.

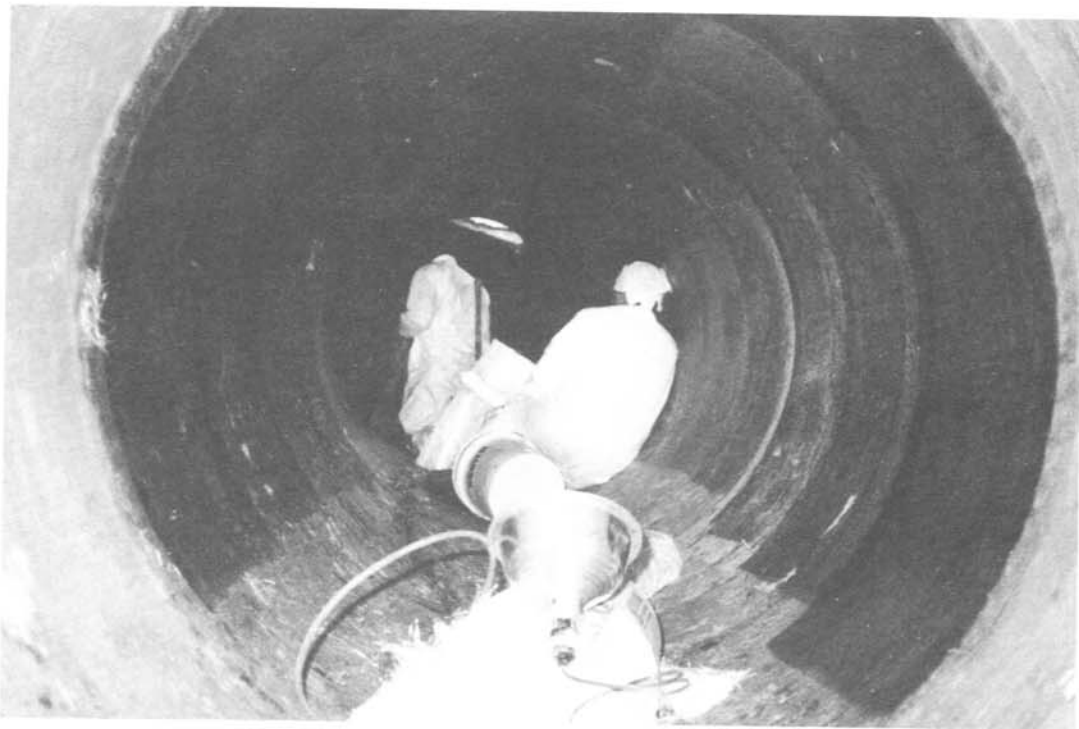
Figure 5. – Two layers of chopped mat are applied (above) and allowed to cure. After this, two top coats containing abrasion-resistant additives and wax sealers will be applied to complete the coating system.

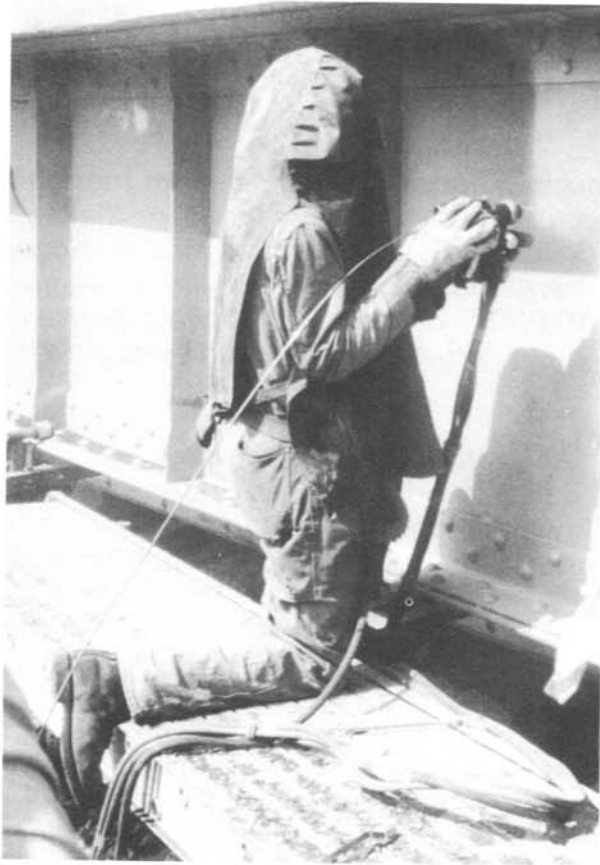
Zinc being sprayed on to the steel understructure of a bridge in Ohio; 20 years maintenance-free service is expected as a result.

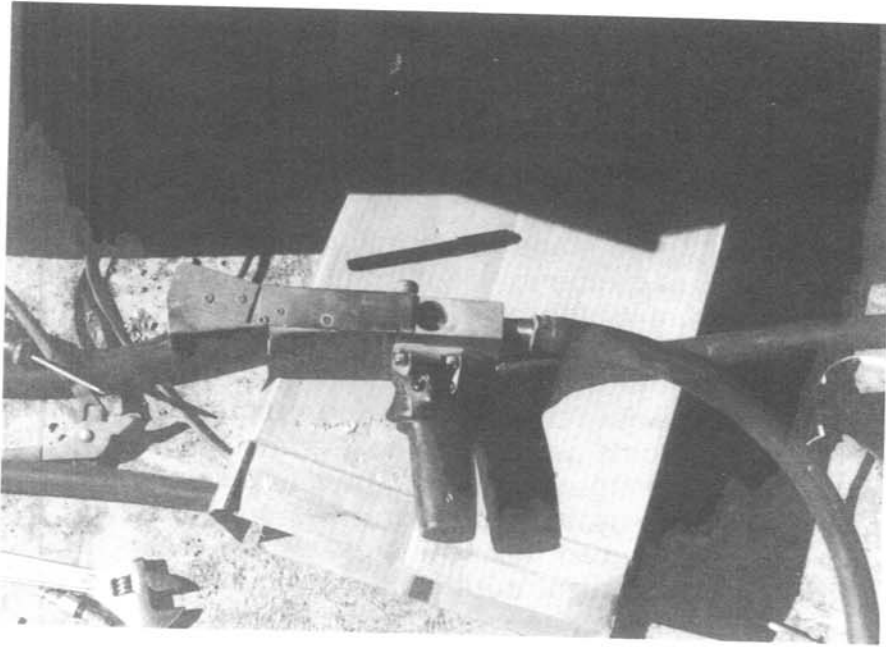
Thermion arc gun with spray nozzle.

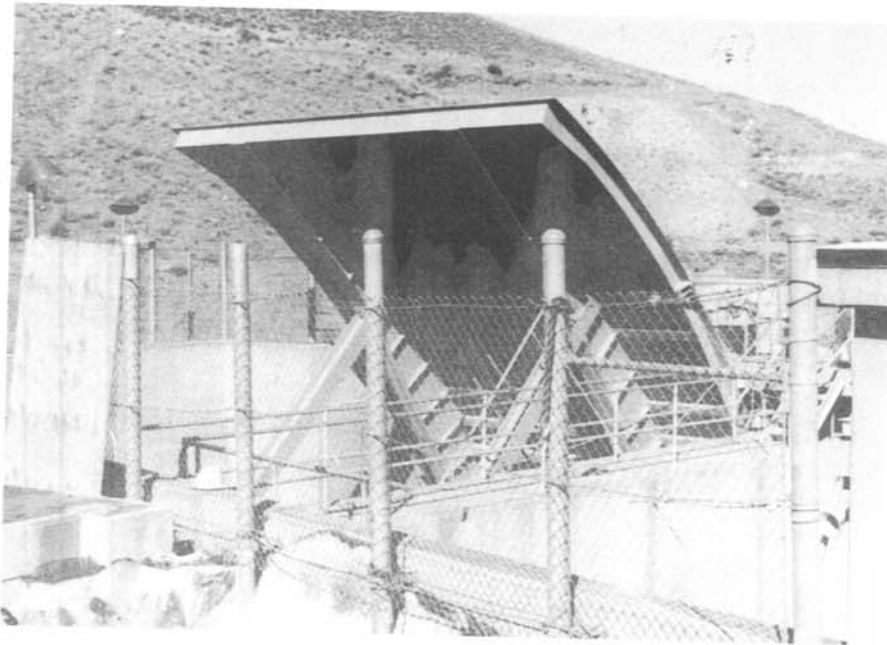
First coat of epoxy polyamide green primer.

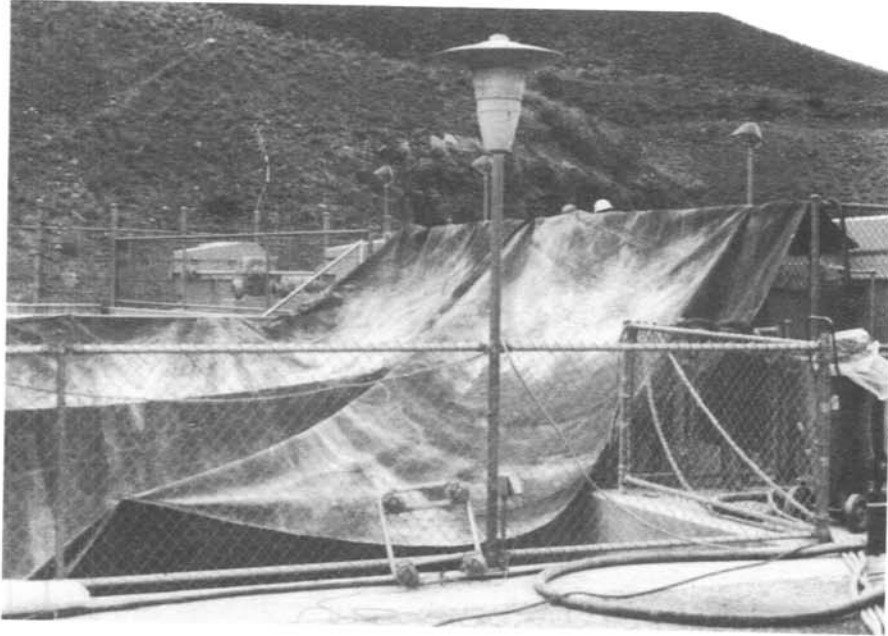
Enviro tarp used to contain abrasives.

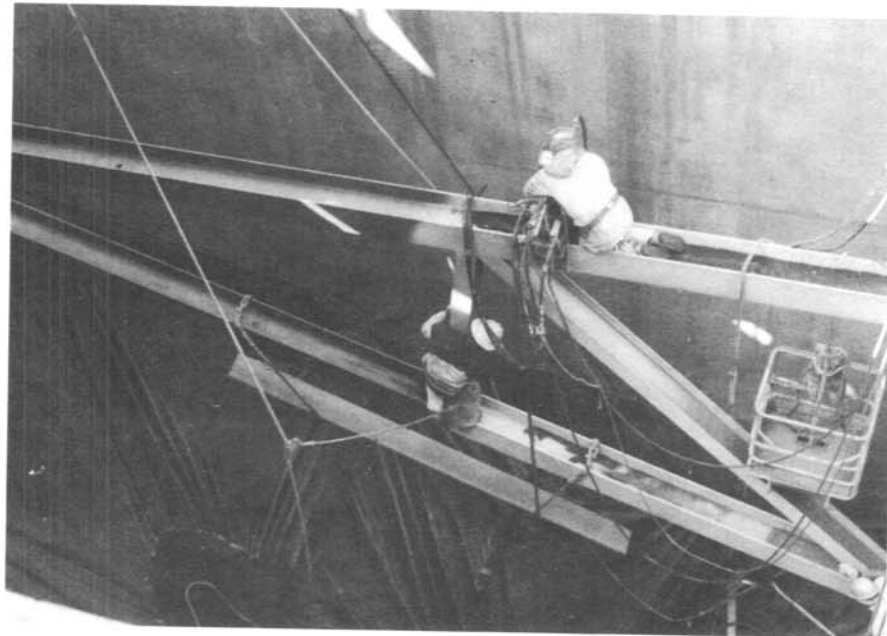
Metalizing operation with Enviro tarp below the work area to collect abrasives and spillage.

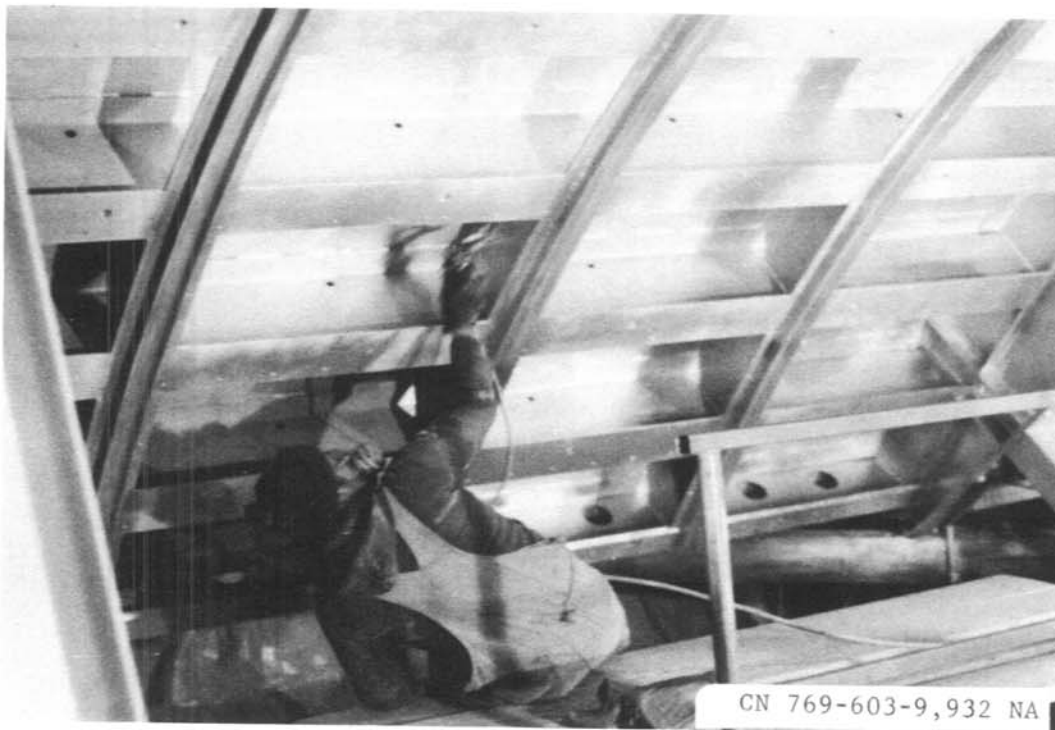
Photo 2. - McClusky Canal. Contractor is using an airless paint sprayer to apply the aluminum vinyl seal coat to the inside of the south radial gate at New Johns Lake. 3/8/89

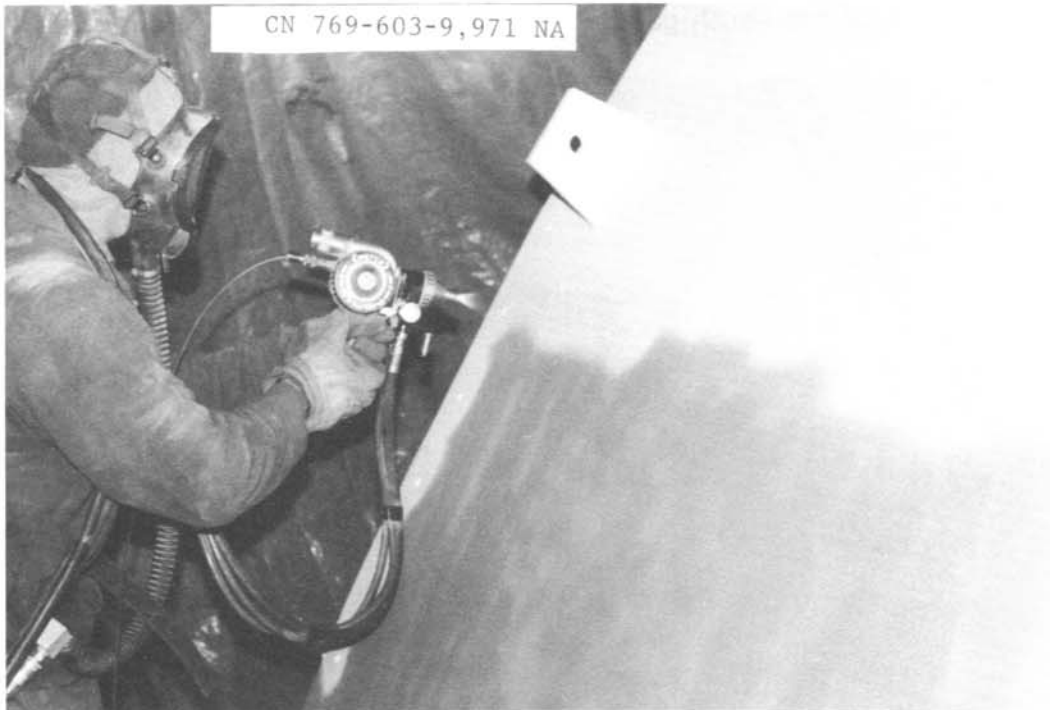
Photo 4. - McClusky Canal. Contractor applying the initial zinc coating to the 2-foot-wide section that was sandblasted just prior to metalizing. A Metco wire gas spray applicator was used to apply the zinc coating. The zinc wire is being pulled through the rear of the applicator, and the hoses attached to the bottom of the applicator supply the acetylene and oxygen.
