FILL SLOPE REPAIR USING SOIL BIOENGINEERING SYSTEMS¹

by Robbin B. Sotir and Donald H. Gray, Ph.D.²

THE SLUICEWAY FAILURE OF RIVERSIDE DIVERSION DAM

by Bill Bouley and Arthur Glickman¹

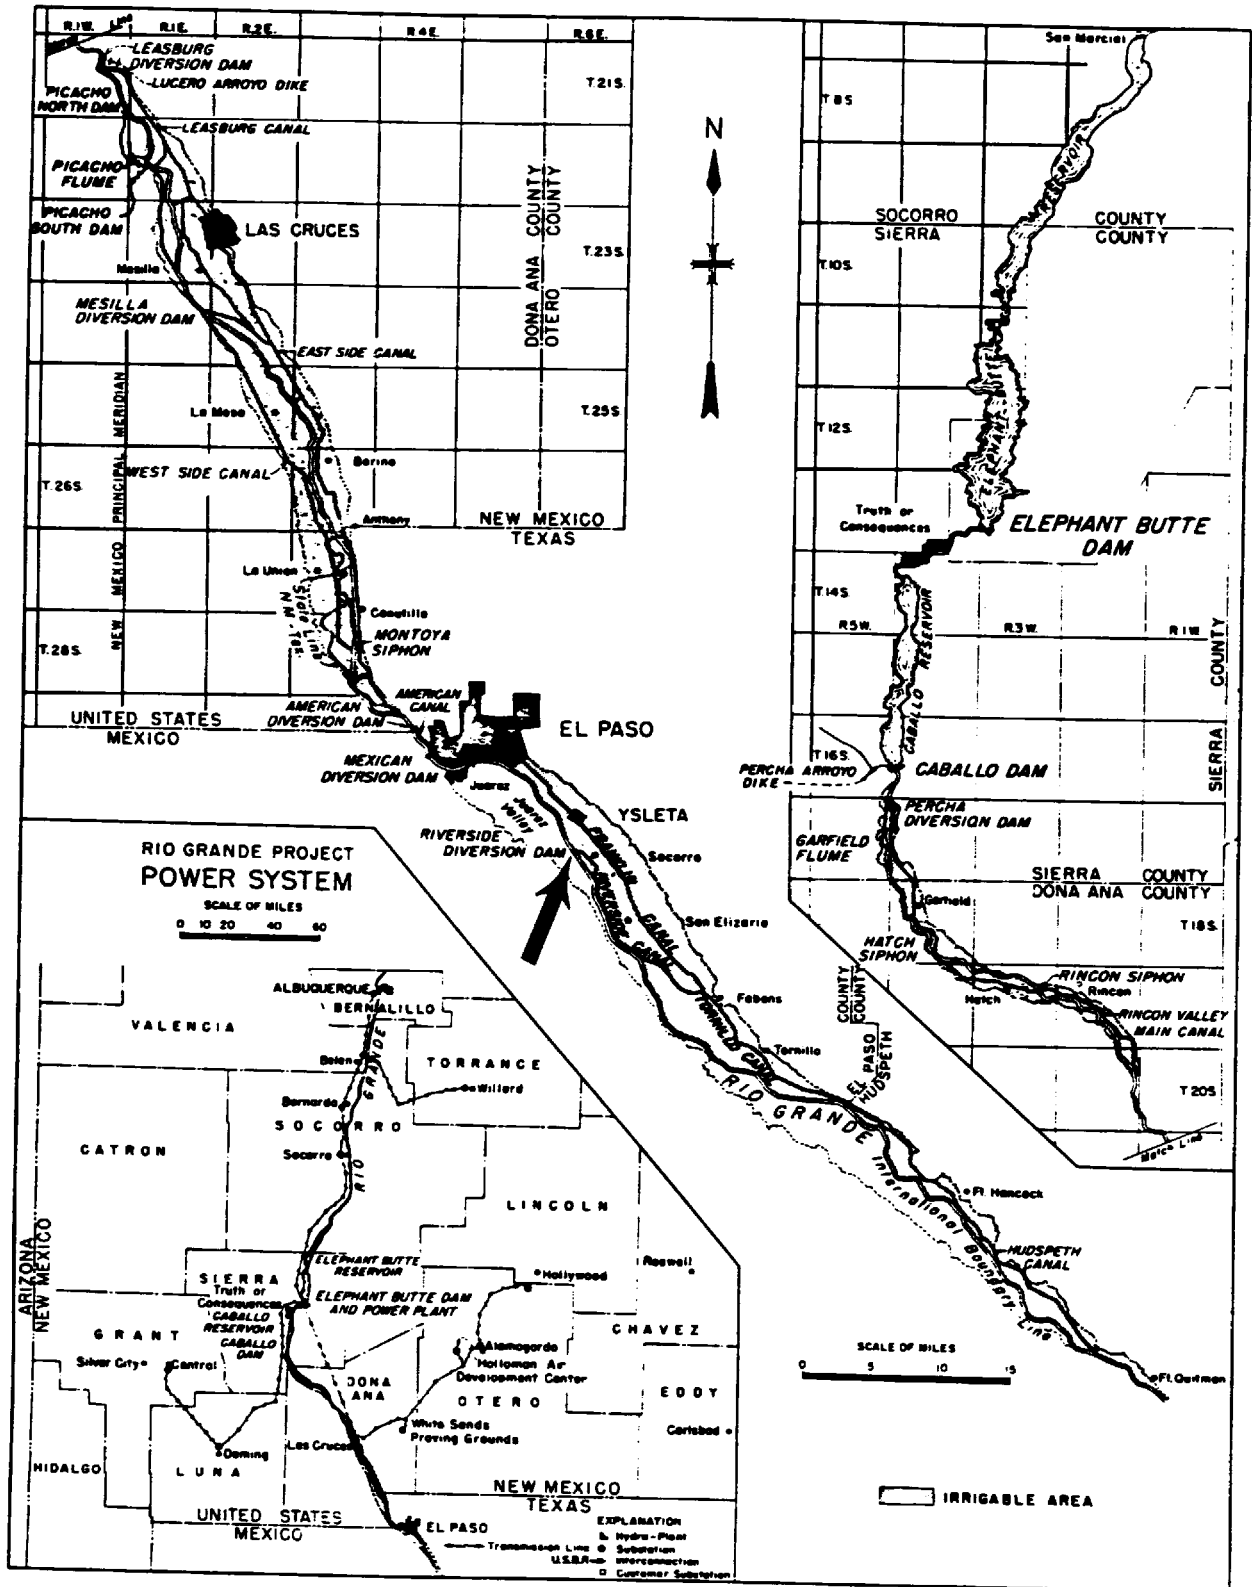
Figure 1

Riverside Diversion Dam, constructed in 1927, is the southernmost of the four diversion dams on the Rio Grande Project (figure 1). It provides the headworks for Riverside and Tornillo Canals, which serve 40,000 acres in the El Paso and Hudspeth Counties of Texas. The El Paso County Water Improvement District No. 1 operates and maintains the diversion dam. The diversion dam is located 15 miles southeast of El Paso, Texas, on the Rio Grande which forms the international boundary with Mexico. The diversion dam consists of a headworks, with five radial gates, having a design capacity of 900 ft³/s; a sluiceway, with six radial gates; and a concrete overflow weir (photograph 1). Because of the international boundary, certain aspects of the operation and maintenance are subject to the approval of the International Boundary and Water Commission (IBWC).

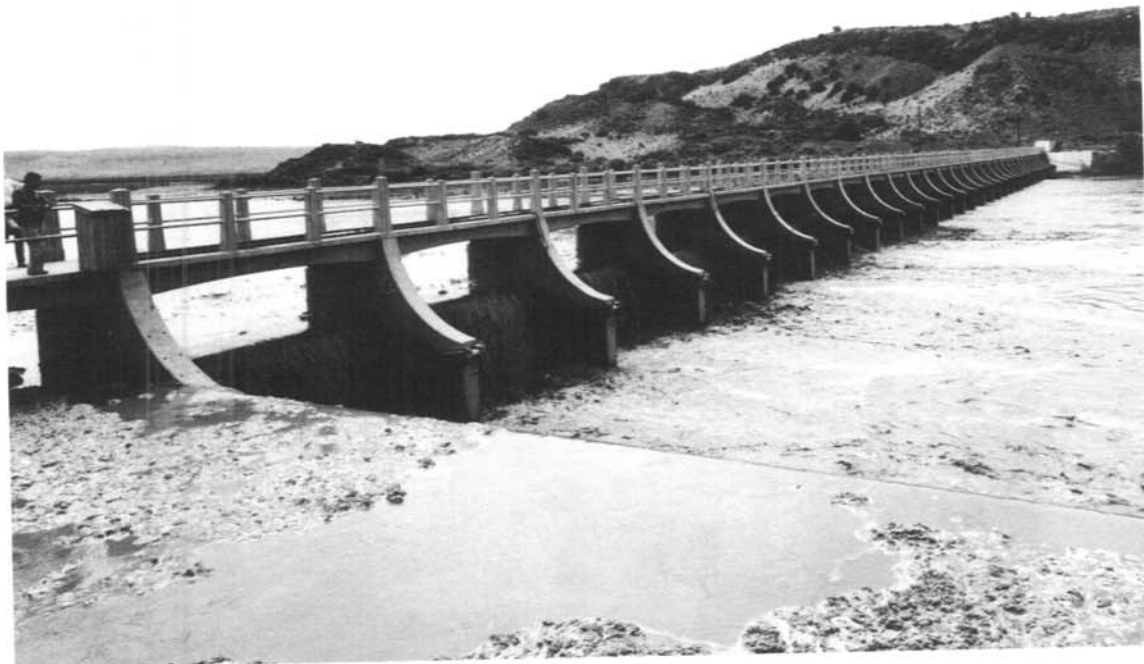
Figure 1. - Downstream view of San Acacia Diversion Dam from canal headworks. 6/30/66
