**WATER OPERATION
AND MAINTENANCE**

BULLETIN NO. 172

June 1995

REPAIR AND REHABILITATION OF PRESTRESSED CONCRETE PIPE AT THE CENTRAL ARIZONA PROJECT

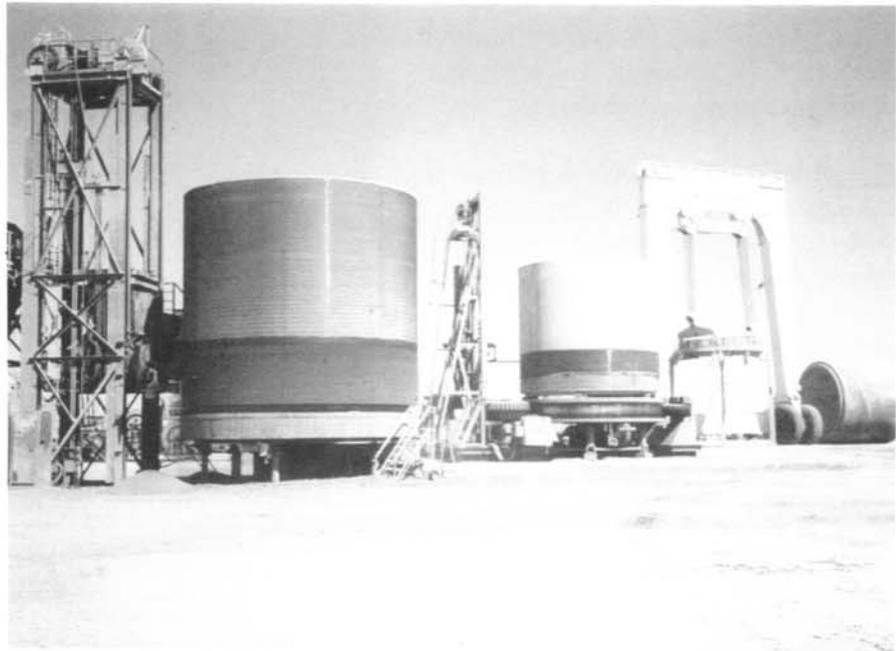
Figure 1.—To fabricate such large pipe, strategically located manufacturing plants were positioned in the desert.

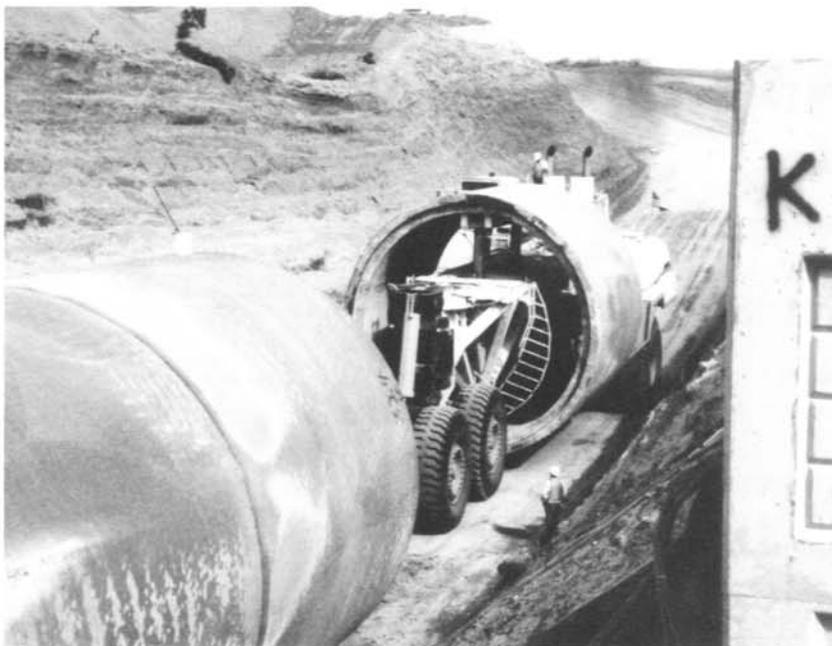
Figure 2.—The pipe was joined in the pipe trench with large-scale equipment that was specially designed by the pipe manufacturer.

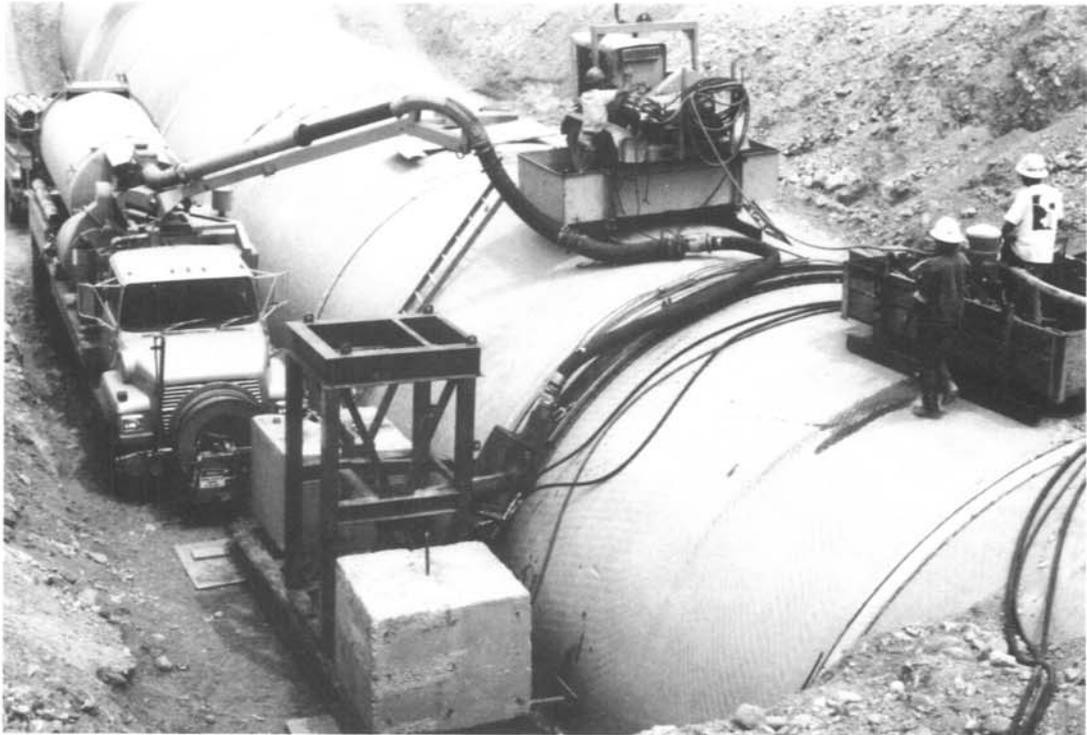
Figure 9.—The specialized excavation equipment required for the type II repair.

A repair which could be performed safely while the damaged pipe remained in service, allowing water deliveries to continue, was also developed. The repair differed from the previous repair in that it called for the tendons to be wrapped directly over the mortar coating and underlying prestressing wire. As previously mentioned, computer modeling had determined that such a repair was feasible provided the prestressing wire of the deteriorated pipe had not fractured near springline. The development of this repair, however, also required another consideration. Pipe in service must remain supported, and excavation is generally tolerable only to springline. Minimal excavation through a narrow annulus beneath the pipe therefore had to be performed before tendons could be installed below springline. Excavation techniques (such as vacuum extraction or water jetting) which had not been used for this application had to be fine tuned and analyzed for their effectiveness. Companies specializing in this type of excavation were contracted, their equipment modified, and their techniques evaluated.

Repairs were implemented as shotcrete was applied to areas where loose mortar coating had been removed. The shotcrete was allowed to cure for at least 3 days prior to tendon installation. The specialized technique used to excavate below springline consisted of placing a channel, which conformed to the outside diameter of the siphon, on the crown of pipe adjacent to the area being excavated. The channel was designed to contain a second inverted channel on which a chain was welded which extended the entire circumferential length. The second channel also contained protruding teeth on one end as well as water jets and a return hose. The chain sockets of the second channel were placed into the teeth of a worm gear. The worm gear was fastened to a steel frame that was stabilized by concrete thrust blocks. Excavation occurred as the worm gear thrust the channel up and down and water jetting freed the select material below springline. Vacuum extraction was used to remove the loosened debris (figure 9). Tendons were installed through the excavated annulus (figure 10), stressed, and staggered as previously outlined for the type IA repairs. The annulus was

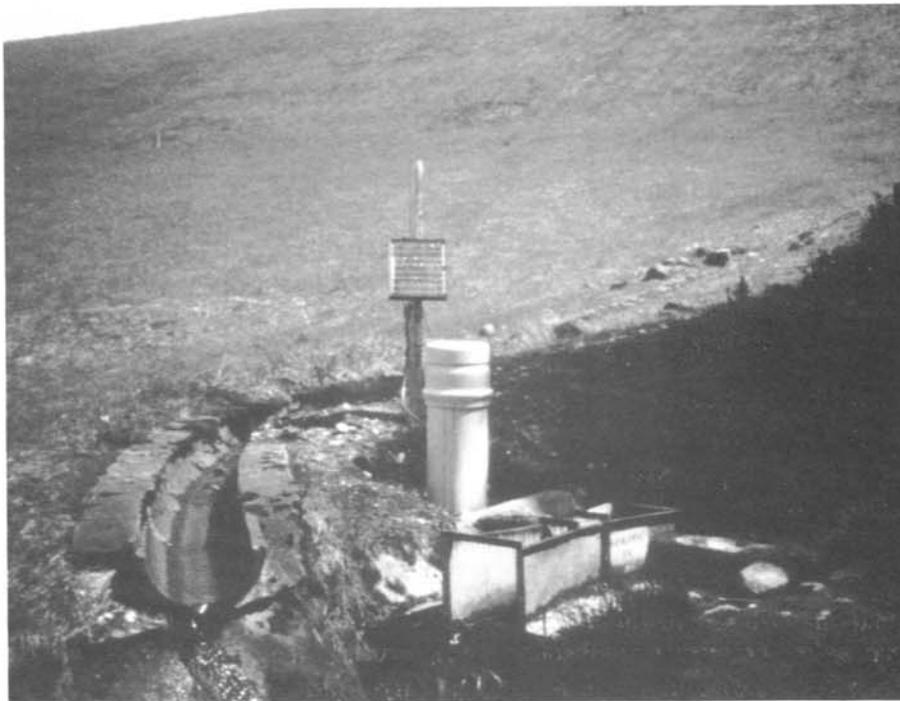
Typical seepage gauge installation.

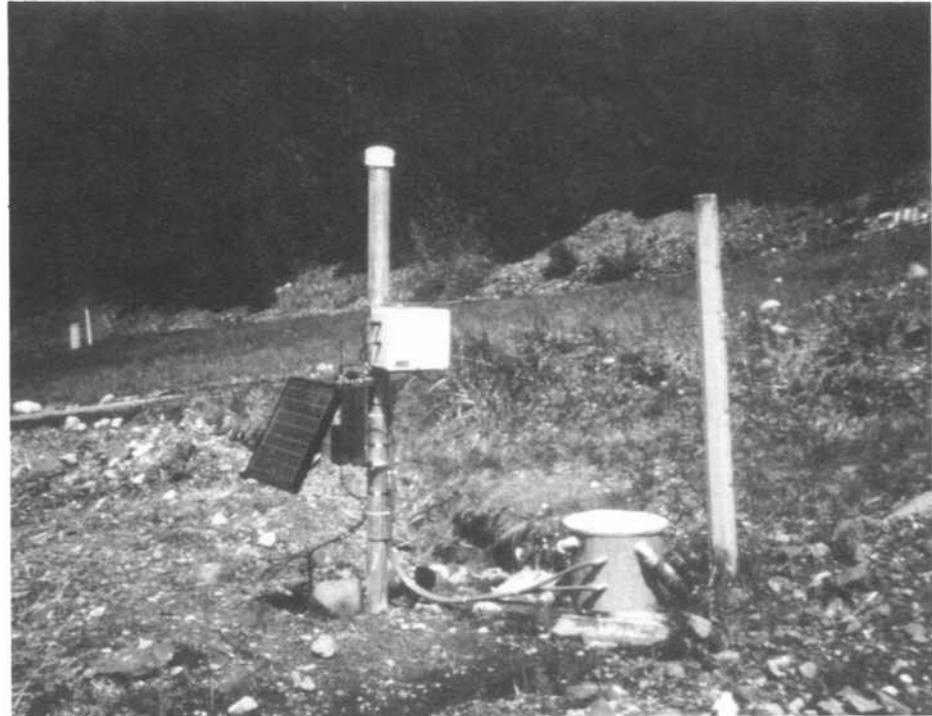
Typical piezometer installation, including solar panels and measurement control unit.

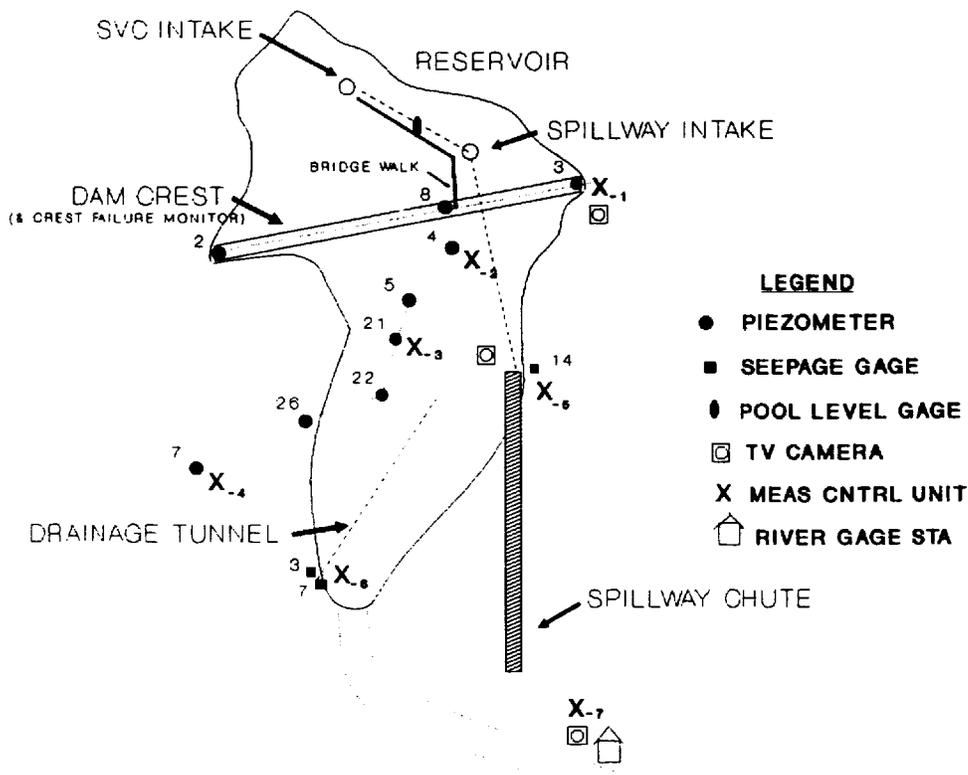
Figure 15.—Plan of instrumentation layout.

The instruments were connected to local Measurement Control Units (MCU's), which are microprocessor-controlled data acquisition units. The MCU houses signal conditioning equipment to operate up to six vibrating wire instruments. The MCU operates off a solar-charged battery power pack (or a-c power, available at two locations) and has radio transmission equipment to communicate with other MCU's, or to send data and alarms, via the "Gateway" MCU No. 1, back to the Network Monitoring Station (NMS), located about 8 kilometers (5 miles) away in the water treatment plant. A total of eight MCU's were installed to serve the widely spread array of ADAS instrumentation at the dam and along the river. See figure 15 for a plan of the ADAS instrumentation layout.

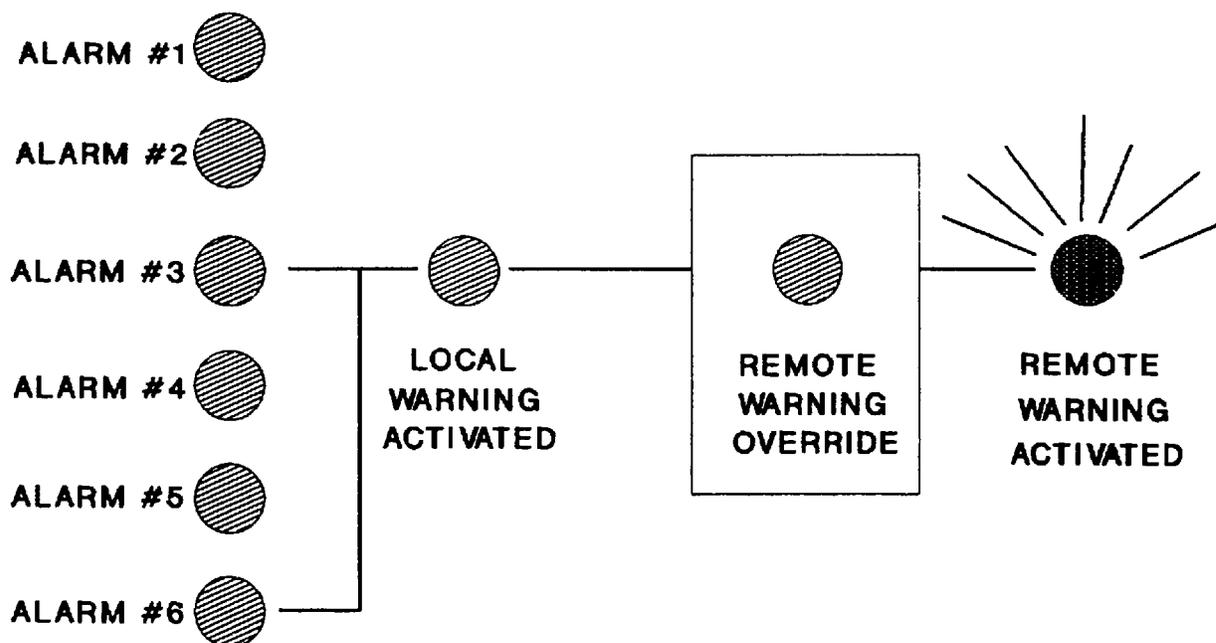
Figure 16.—Alarm console diagram.

The alarm criteria developed for the Tolt system attempts to balance the need to provide early warning to the public with the need to detect the possibility of instrument failure and spurious alarm conditions. The alarm signal console, located with the NMS in the water treatment plant, is shown in figure 16. Low and mid-level alarms 1, 2, 4, and 5 indicate developing problems or hazardous situations. Alarms 1 and 2 identify situations dealing with the river downstream from the dam, and alarms 4 and 5 alert operators to situations with the instruments on the dam face. When these lights illuminate, a quick reference to the NMS computer will indicate the exact problem. If the upstream or downstream river gauge exceeds its established maximum threshold limits, the crest monitor instrument shows a failure condition, or the pool level shows a greater than allowable pool drop, then

high-level alarms 3 or 6 are triggered. Local warning sirens are immediately sounded at various locations around the nearby water treatment plant and a time-delay switch starts closing, leading to activation of the public warning sirens.

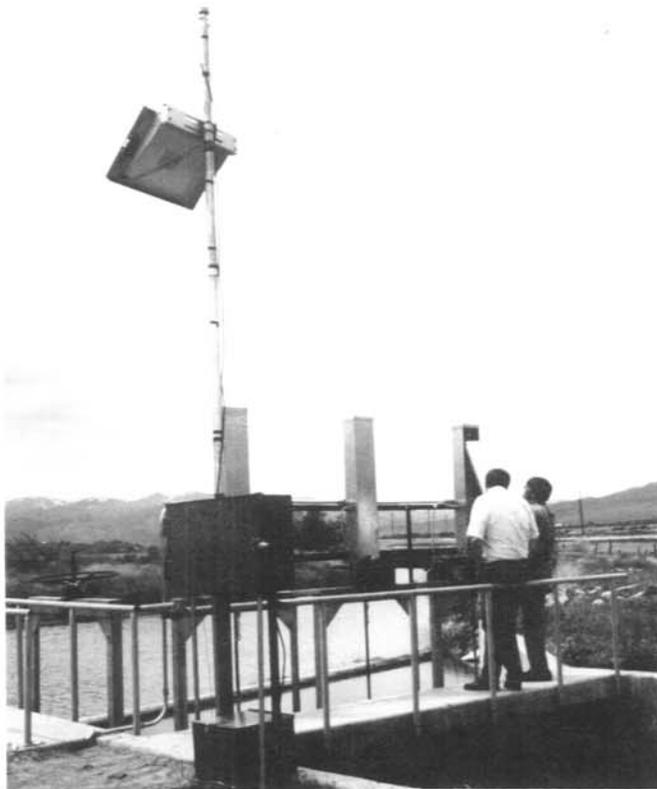
Figure 17.—Automated solar-powered gates at Richfield, Utah.

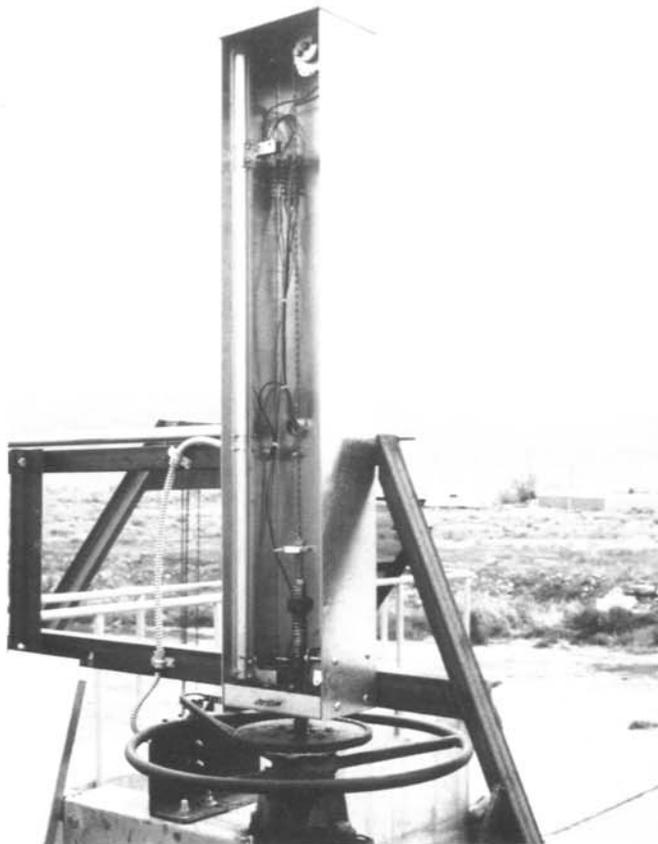
Figure 18.—Drive installation with position and limit switches.

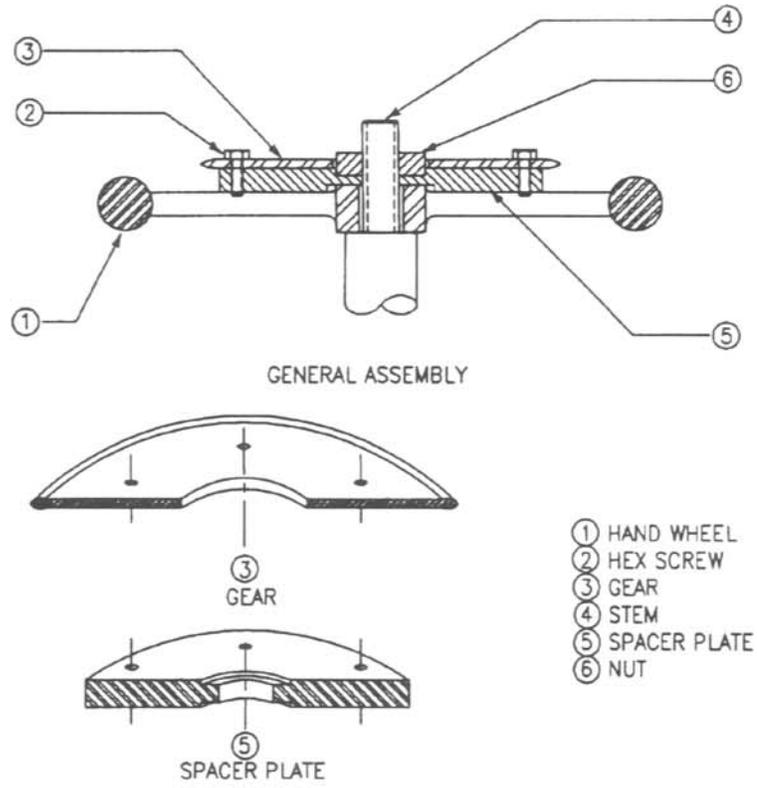
A spacer plate, as shown in figure 19, is used to attach a gear to the gate handwheel. The spacer plate also aligns and centers the gear on the handwheel. Additionally, the adapter provides spacing between the handwheel and gear for clearance between the chain and handwheel. Figure 20 is a typical rising stem slide gate installation. The gear motor is attached to the gate frame with a bracket that allows adjustment of the chain. Idler sprockets should not be used.

Figure 19.—Gate handwheel adapter assembly.

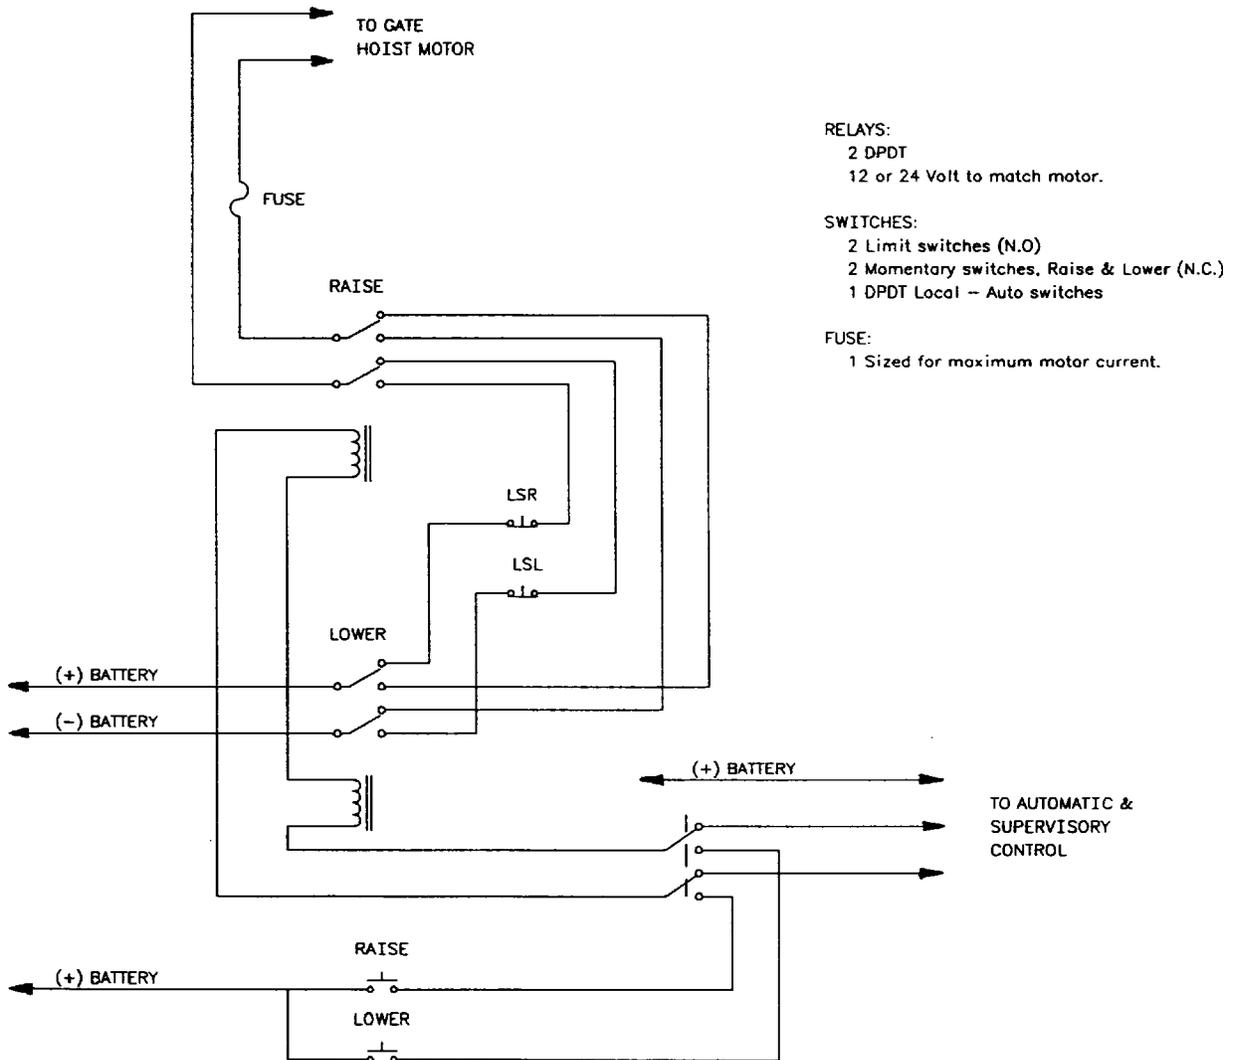
A reversing motor controller is made with two double-pole, double-throw relays. The relays have 12- or 24-volt coils to match the gate hoist motors and 10- to 15-amp contacts to match the motor ratings. The relays are wired to provide an interlock to stop the motor should both relays activate at the same time. A fuse is installed in the motor circuit as a secondary safety device. The fuse is sized to blow should the motor stall or draw heavy current. These problems could occur if the gate is jammed with debris, the hoist is jammed, or a limit switch fails. Figure 21 is a schematic of the gate controller. The controller can be driven by outputs from controllers such as the Campbell Scientific CR10 or the Geomation 2300 series.

Figure 21.—Motor controller schematic.

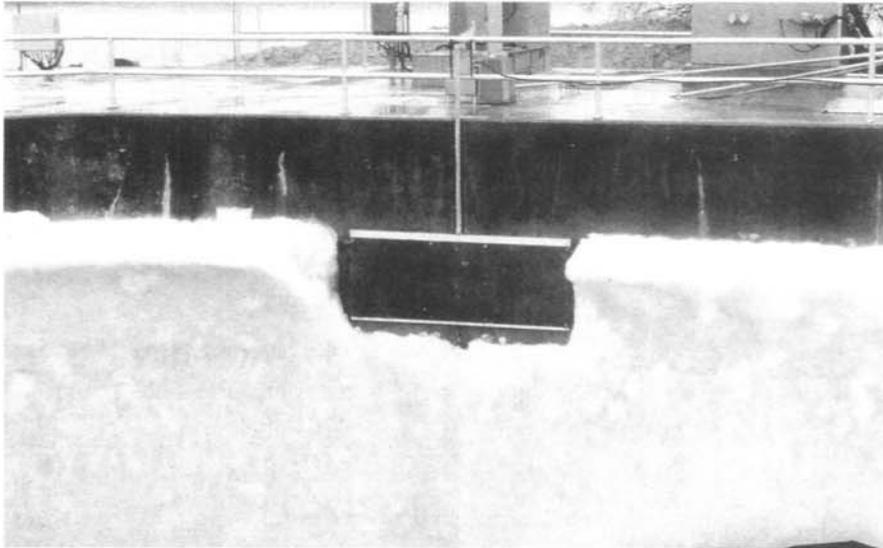
The use of panel water heaters to control and minimize icing in miter gate recess areas is an effective solution to the icing problem at Starved Rock Lock and Dam on the Illinois River. A panel heater was installed at this location in December 1993, just in time for one of the worst winters of the decade. The panel was bolted onto the concrete wall in the miter gate recess area (figure 22) and was very successful in keeping the wall ice free (figure 23).

Figure 22.—Closeup of the panel.

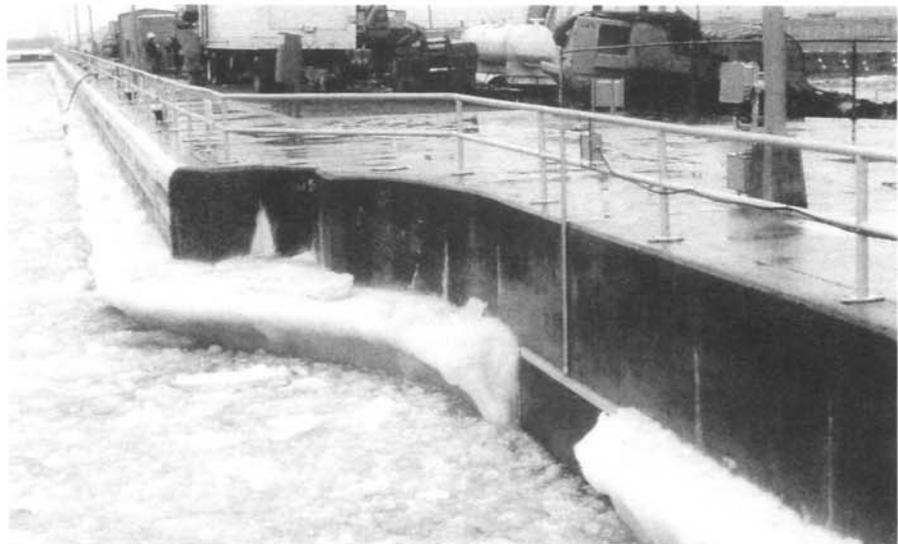
Figure 23.—Longer perspective shot of the panel from the side.
