# WATER OPERATION AND MAINTENANCE BULLETIN

No. 179

March 1997

## SLIPPAGE OF SPILLWAY RADIAL GATE WIRE ROPES AT YELLOWTAIL DAM, MONTANA

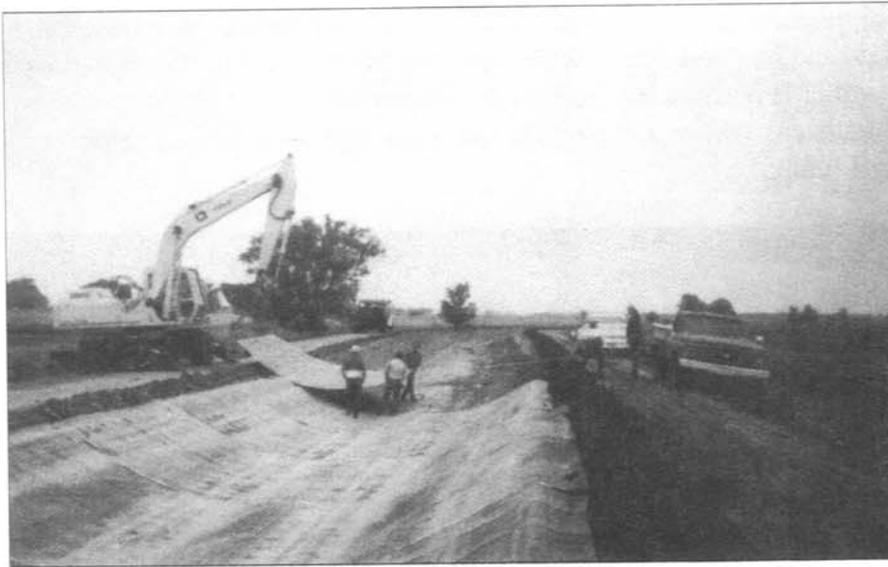
The Kennewick Washington bituminous liner was installed over three sections totaling about 400 m in length. One of these sections was placed over a deteriorated concrete section of canal. The concrete surface was patched to provide a smooth surface and the liner installed

*Fig. 1. Bituminous geomembranes being installed near Altus, Oklahoma, May 1994.*

by district forces. No firm data are available on seepage rates; however, the water district reports that they are pleased with the performance of the liner to date and have not noted any signs of deterioration. Following canal lining in Oklahoma, arable land adjacent to the test section was utilized for the first time in over a decade.

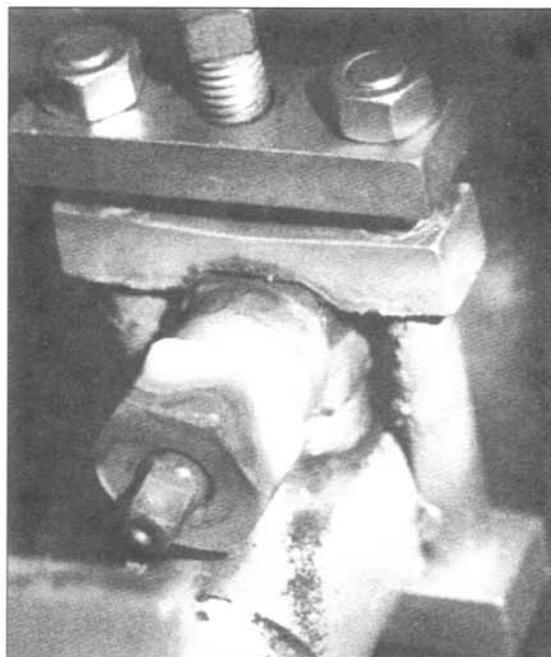
*When exposed to chlorine, special paint turns bright red (shown above as a dark stain on the fitting).*
