WATER OPERATION AND MAINTENANCE BULLETIN

No. 185

September 1998

INSPECTION OF BRAKE MOTORS AND SPEED REDUCERS FOR GATE HOISTS

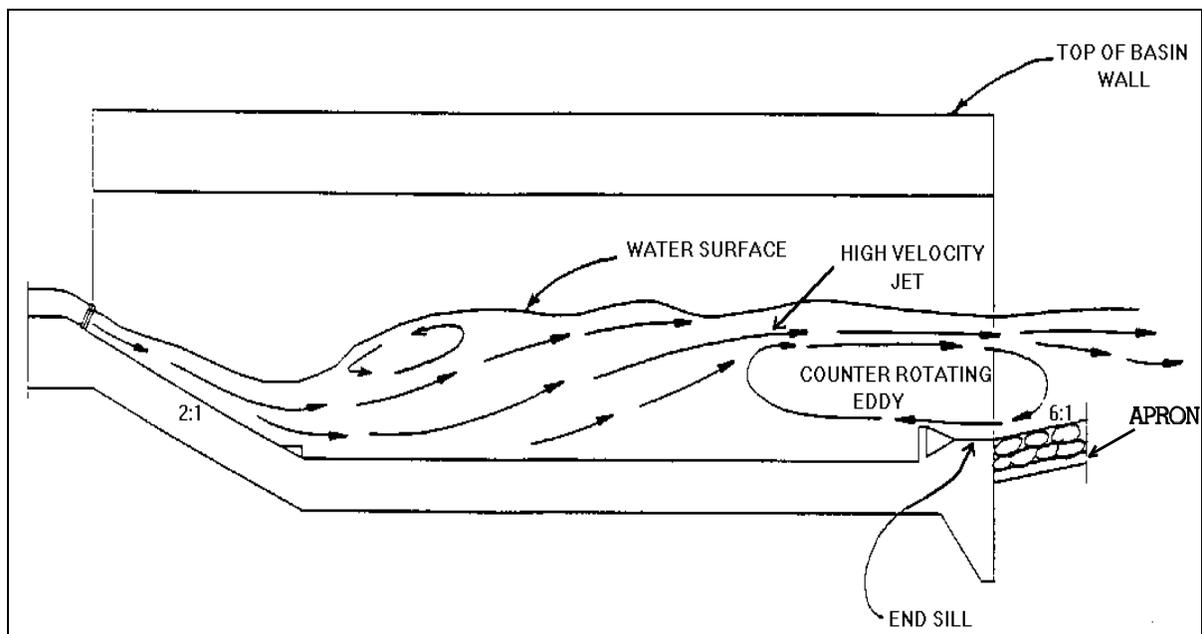
Many stilling basins have experienced damage caused by rock, gravel, and sand brought into the basin by back flow over the stilling basin end sill. Normal operation of a hydraulic jump energy dissipation basin can cause a reverse flow eddy over the basin end sill and lower apron, as shown in figure 1. This counter-rotating eddy is driven by a high-velocity jet rising off the basin floor near the end of the basin. Riprap placed on the apron downstream of the basin end sill is typically designed to be stable under this condition. However, small material can be transported into the basin and trapped where turbulent flow continually moves the material about the surface, eroding the concrete. The cost for these repairs, in terms of time, effort, and money, can be significant. If a means to reduce the reverse flow can be found, large savings can be obtained. One possible solution that is currently being studied at the Bureau of Reclamation's Water Resources Research Laboratory (WRRL) is to install flow deflectors in the basin to improve inter-basin flow conditions and minimize upstream velocities over the basin end sill (figure 2).

Figure 1.—Counter-rotating flow eddy over basin end sill and lower apron.

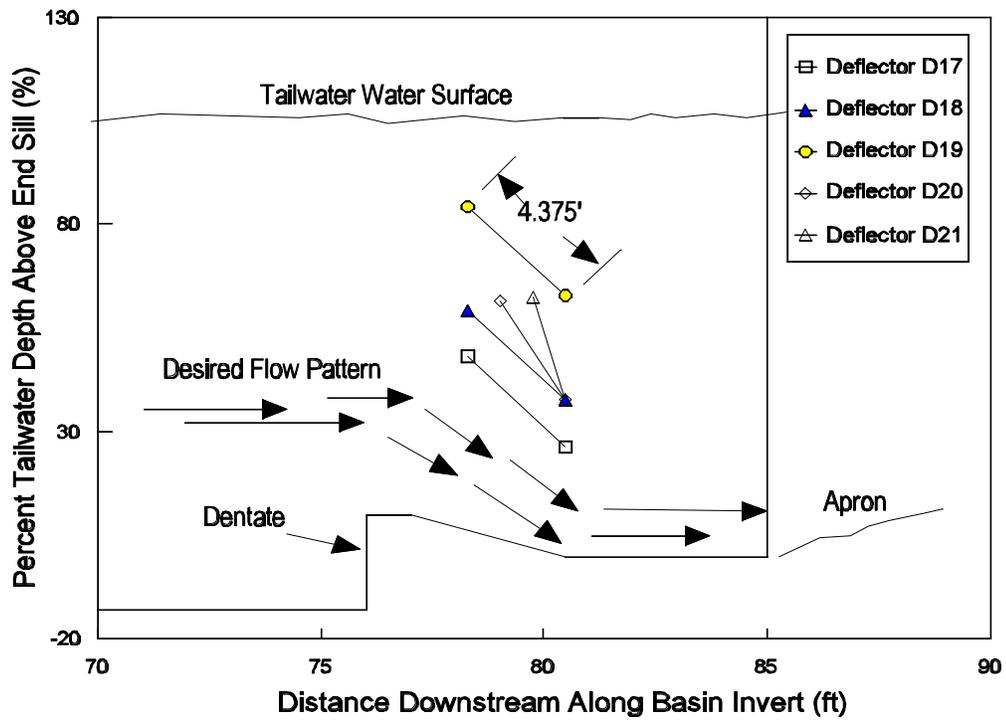
Figure 2.—Deflector locations with respect to tailwater depth above the basin end sill.

All the deflectors tested were 4.375 feet deep and were located as shown in figure 2. Deflectors D17 through D19 were positioned at an angle of 60 degrees, and deflectors D20 and D21 were positioned at 70 and 80 degrees, respectively.

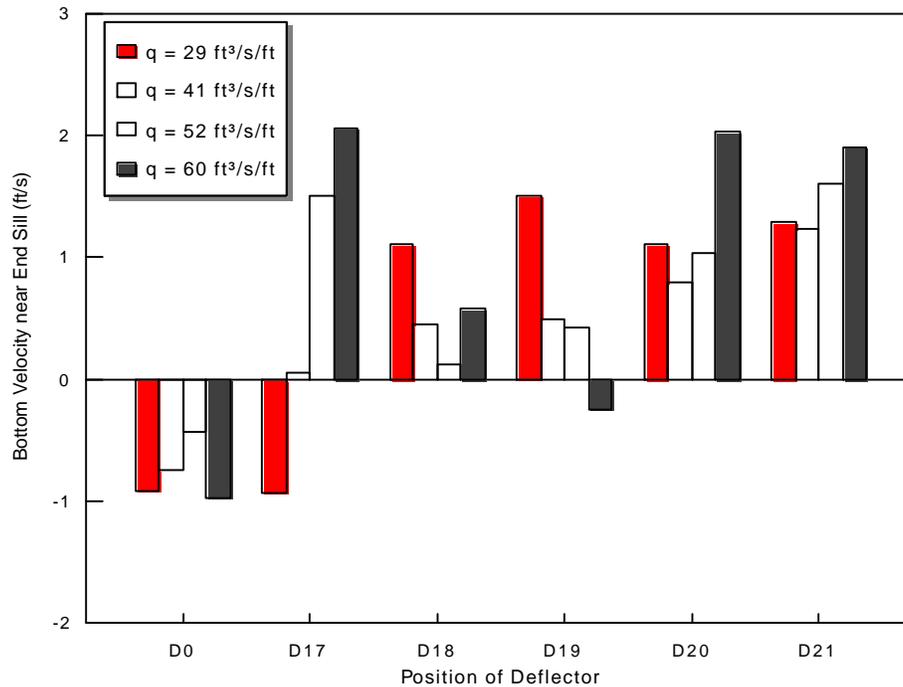
Figure 3.—Bottom velocities (average) measured for each deflector position. (D0 indicates no deflector was installed.)

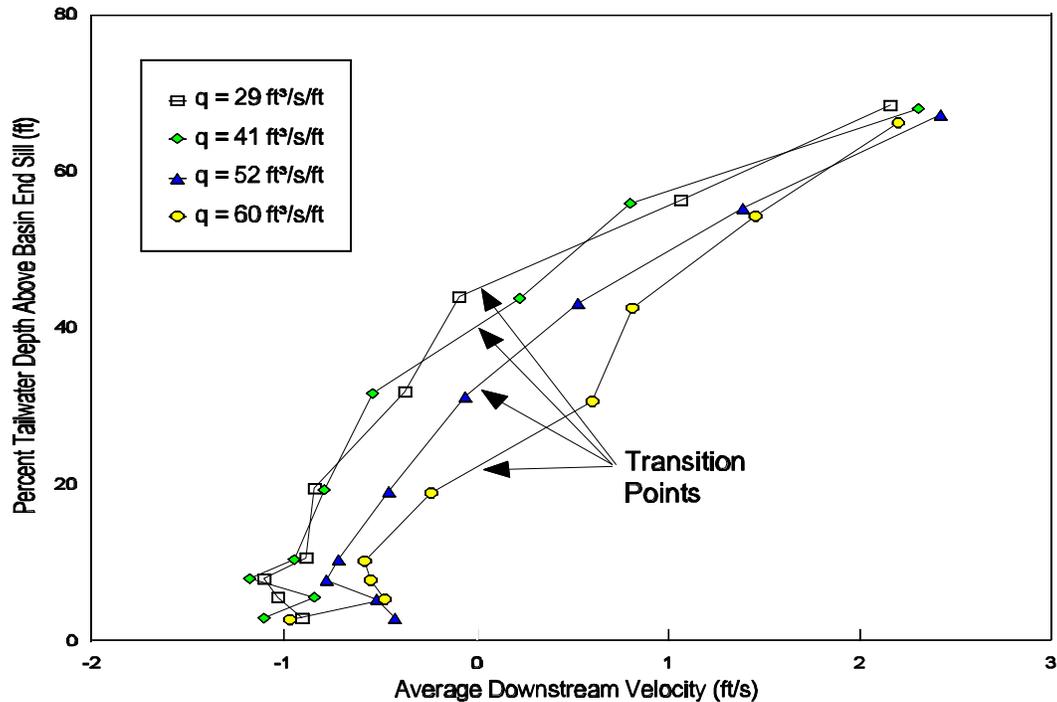
Figure 4 shows bottom velocities measured near the basin end sill for deflector positions D17 through D21 for each flow tested. The results of these investigations show that the performance of each deflector varies over the range of flows. When the deflector was positioned low in the basin and just above the transition points of the higher flows (i.e., D17), the deflector performed well at the high flows. However, it became ineffective as the flow was decreased because the transition point moved above the location of the deflector. As a result, at the lower flows, the deflector missed a major portion of the high-velocity jet because it was positioned below it. A similar problem occurred when the deflector was positioned too high (i.e., D19). Although the deflector was in good position (just above the transition point)

Figure 4.—Velocity profiles measured along the vertical axis above the basin end sill.

to redirect the jet at the lower flows, as the flow was increased, the transition point moved too far below the deflector for it to remain effective. The solution was to position the deflector (D18) between the locations of deflectors D17 and D19 where it would be less sensitive to the movement of the transition point. This produced positive downstream velocities (average) throughout the range of flows.

Figure 4 demonstrates that flow conditions were improved as the angle was increased, and the best overall results, throughout the range of flows, occurred with deflector D21 installed.

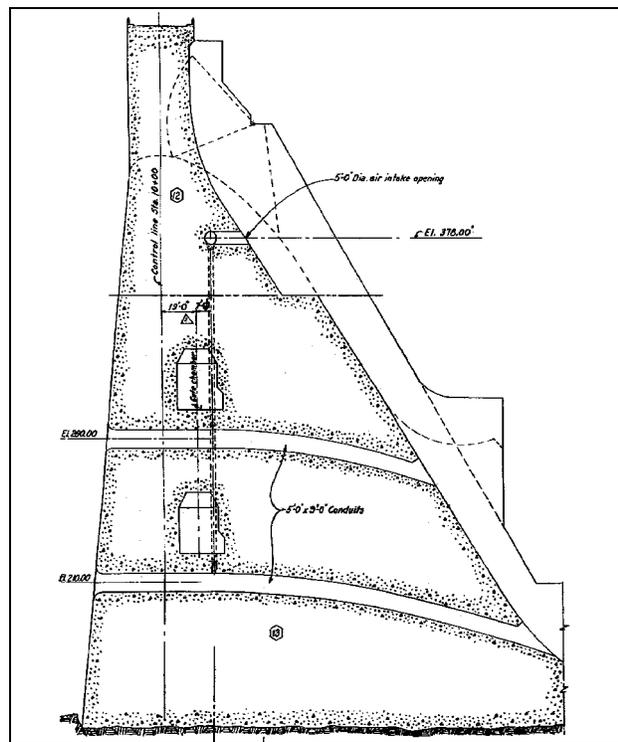
The dam features two tiers of four outlets each (figure 1), controlled by 5- by 9-foot slide gates. The outlets consist of rectangular conduits of formed concrete passing through the dam and exiting on the face of the service spillway.

Historically, the outlets have not been operated much. Flood releases in 1955, 1963, and 1964 resulted in cavitation damage initiating at the constriction on the crown of the outlets just upstream from the junction with the spillway face. The 1955 flood conditions were studied by the Corps using the model for Red Rock Dam which had a similar outlet configuration (Corps, 1965). These tests revealed scaled vapor pressure readings at several piezometer locations near where the damage had occurred. Reclamation studied the problem using a 1:16.7 scale sectional model of one of the upper tier outlets (Isbester, 1971). An eyebrow-type flow deflector was tested and later installed at Folsom over each outlet exit (figure 2). Besides the eyebrow, a gate operating restriction of 60-percent maximum was set when combining outlet works flows with spillway flows. These modifications to the structure and operating criteria have performed well over the years, and no additional damage has occurred at the outlet/spillway junction.

Figure 1.—Section through the dam showing outlet works.

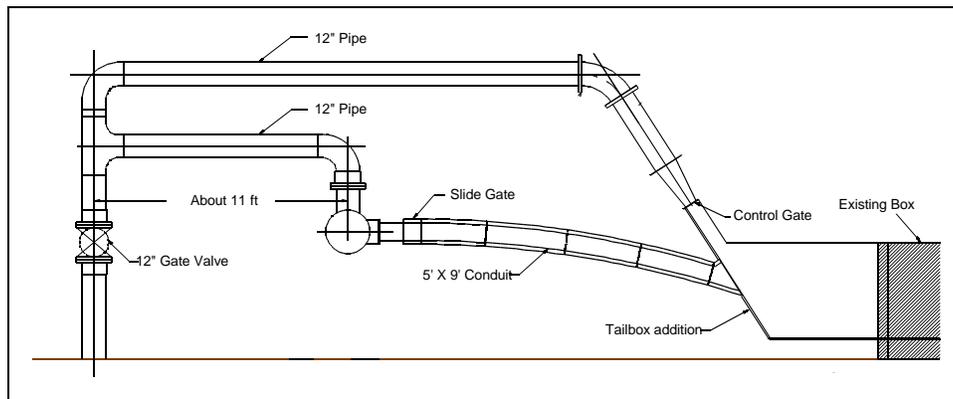
Figure 6.—Elevation of the 1:12 scale hydraulic sectional model.

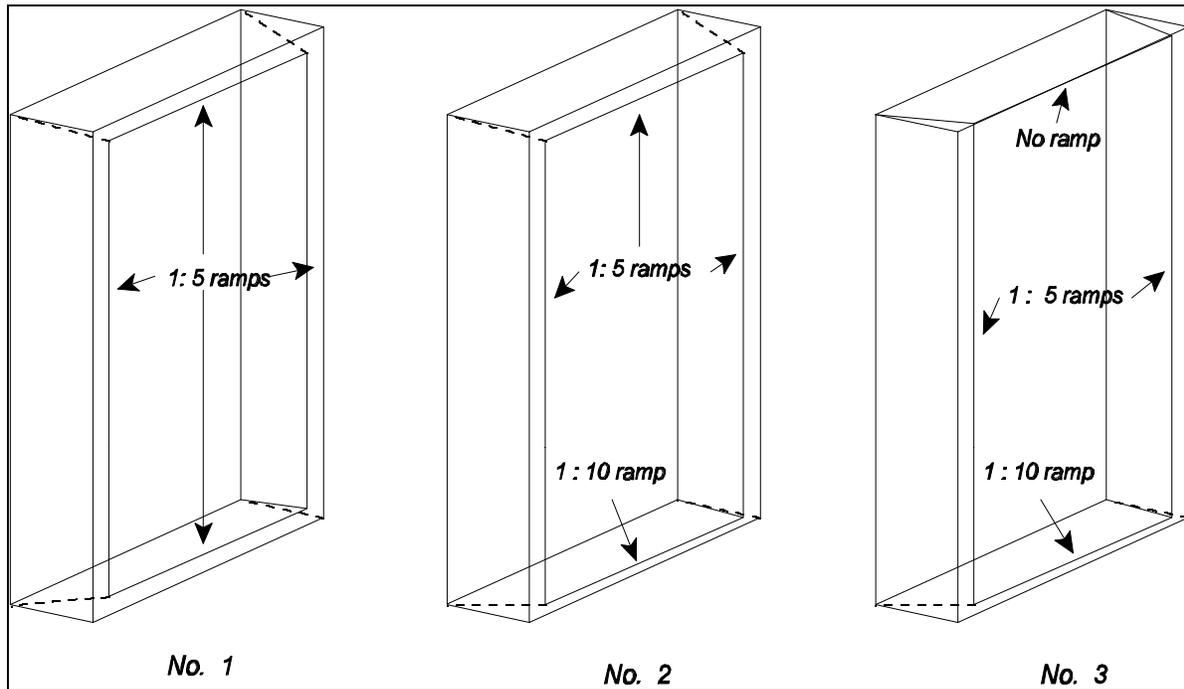
The model was first used to verify data for the as-built condition. Once this was completed, an insert resembling the constriction in a jet-flow gate was installed and tested. The 6-inch-high ramp angled at 45 degrees yielded a large reduction in discharge capacity (20 to 25 percent) and was abandoned in favor of reduced slope, smaller offset ramps. Three different aeration ramp configurations were tested. These ramps were placed just downstream from the regulating gate. All ramps had a 15-inch horizontal length, yielding offsets of 3 inches and 1.5 inches for the 1:5 and 1:10 ramps, respectively. The modifications which were tested are shown on figure 7. These ramps were designed to allow air from the present vent system to be distributed down the sidewalls and along the conduit floor.

Figure 7.—Ramp configurations tested in the hydraulic scale model.

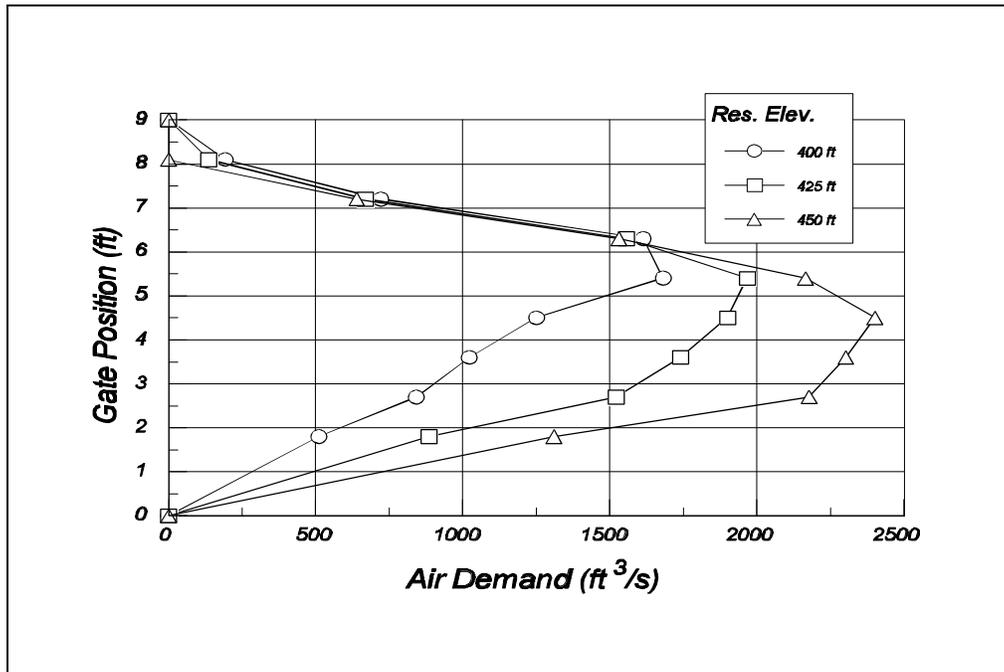
Figure 9.—Air demand for a low-level outlet conduit, as-built conditions.

Air demands measured for the as-built condition (no ramps) showed a substantial air flow into the conduit behind the gate. At a reservoir elevation of 450 feet, a maximum demand of 2,400 cubic feet per second (ft³/s) was measured for a single low-level outlet. The corresponding demand for an upper-level outlet would be about 1,600 ft³/s. Using these data, a total air flow requirement, if all eight gates were operating at a reservoir elevation of 450 feet, would be about 16,000 ft³/s of air. With the present 5-foot-diameter air header, velocities would easily exceed the design limitations of maintaining subsonic flow.

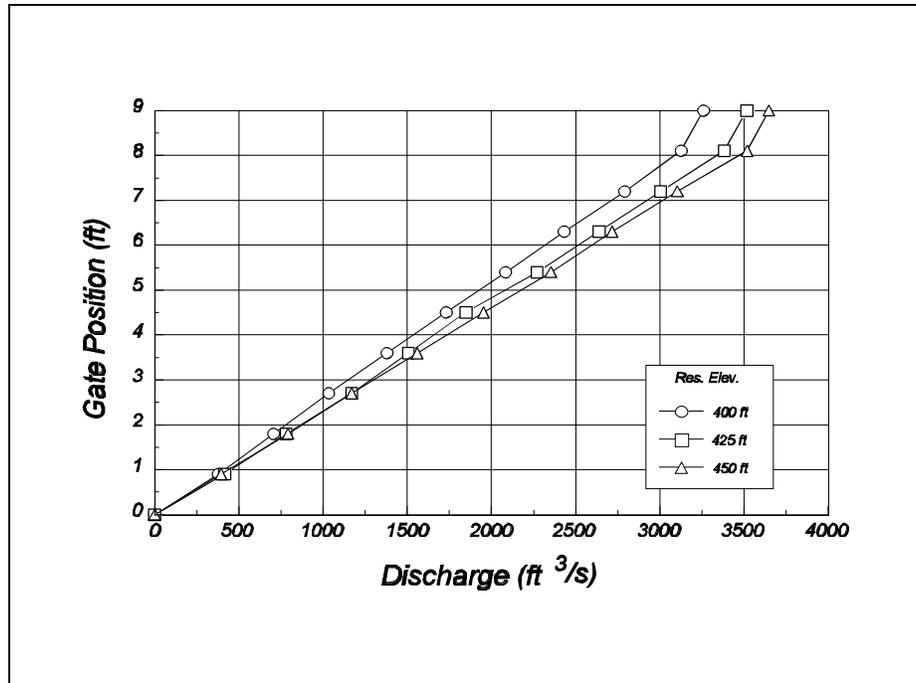
The third and final insert that was tested featured no upper ramp. The side ramps remained at a 1:5 slope, and the bottom ramp was at 1:10 (figure 7). The data reported for this insert were taken at range of reservoir elevations from 400 to 450 feet and an air vent loss coefficient of $K=6.91$. The discharge with insert No. 3 in place appears on figure 11. The air demand and piezometric pressures downstream from the gate are shown on figures 12 and 13, respectively.

Figure 11.—Discharge for one low-level outlet conduit with insert No. 3 installed.

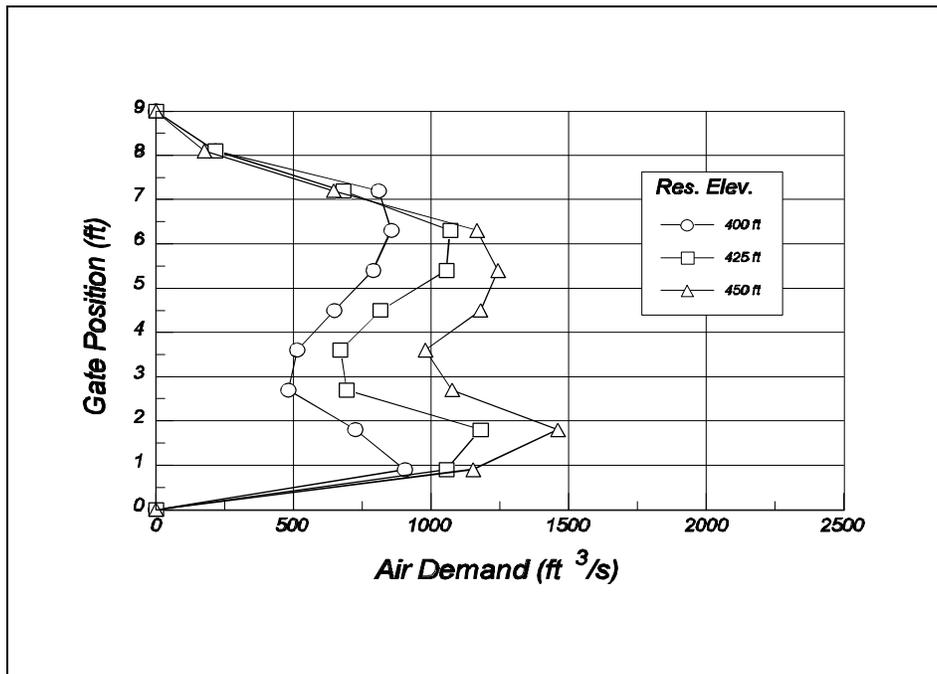
Figure 12.—Air demand for one low-level outlet conduit with insert No. 3 installed.

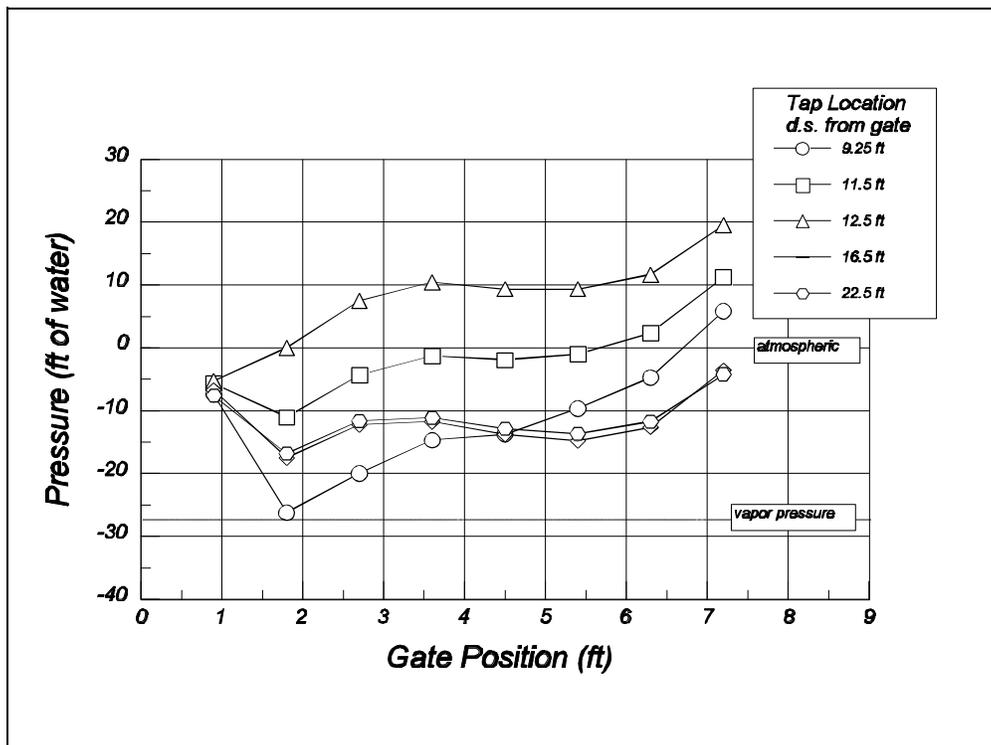
Figure 13.—Piezometric pressures downstream of the regulating gate with insert No. 3 in place.

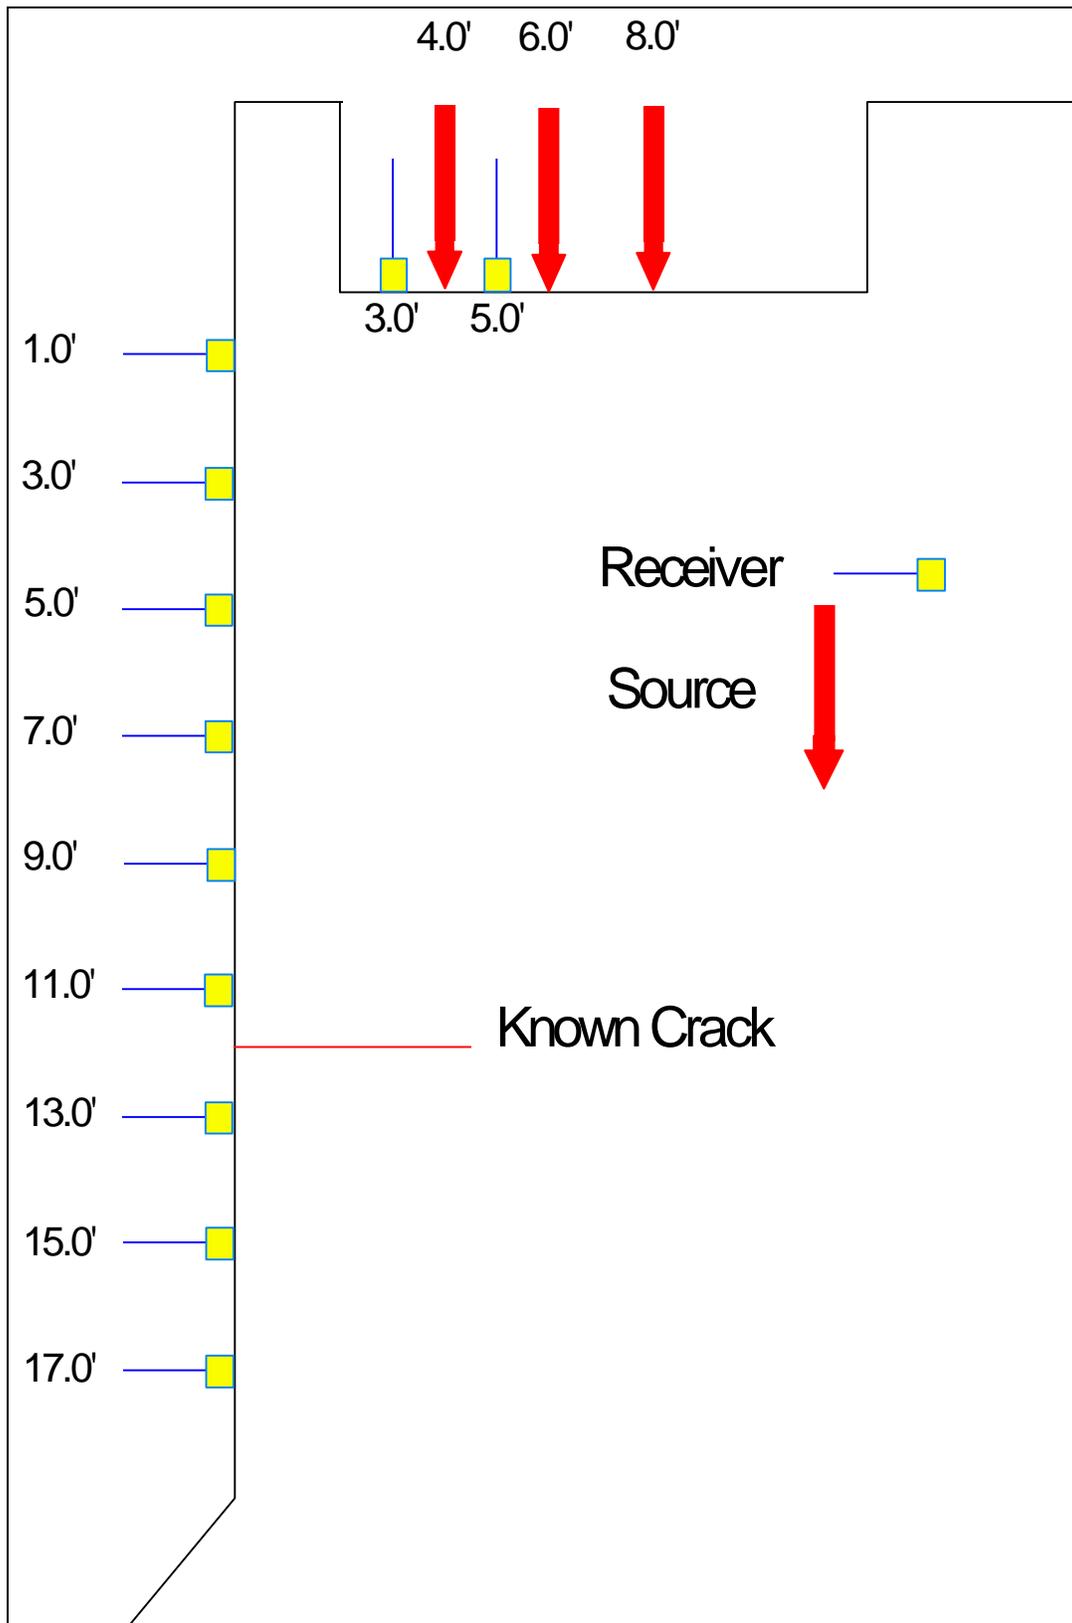
By placing sensors on the top and sides of the dam, and possibly in the adits (as shown in figure 1), we can measure the velocity within the structure. We generate the sound wave by hitting the dam with a hammer connected to the data acquisition system. By using a simple, off-the-shelf, tomographic program, we can map the velocities as they change within the dam. This allows us to find weak areas, cracks, and other anomalies inside the structure. It is just like performing a CAT Scan on a dam—only simpler.

Figure 1.—Source and receiver locations.

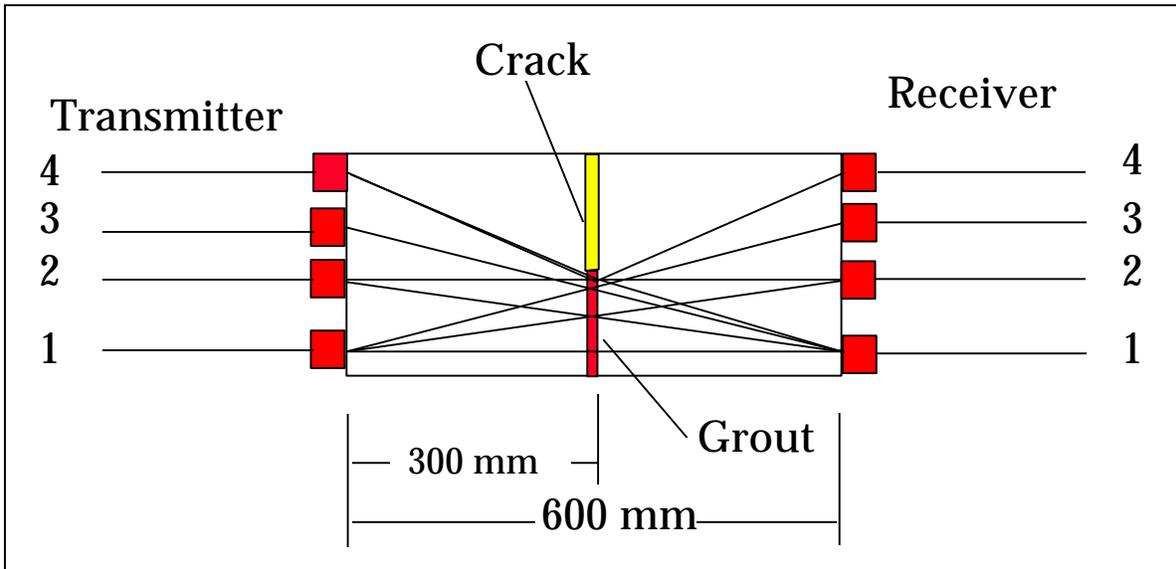
In the beginning, we tested a piece of concrete core sample in the laboratory. This sample was broken in half and then grouted back together, leaving a crack that went half way through the core, as shown in figure 2. We placed transducers on each end and made simple velocity measurements through the uncracked concrete and through the cracked section. The results were "bang on" to the expected values. At the same time, we were testing concrete core from Hoover Dam. That concrete was in great shape. It was so good that we could not find a lift line in the core. This is a group of engineers and technicians that look at concrete for a living, and we could not find a lift line to save our lives. We knew where it was supposed to be, but that did not help either. We even x-rayed the core and had no luck. So, on a lark, we connected up our sensors to the core and tested it. The results are shown in figure 3. The lift line determined by the nondestructive testing was within 1.0 inch of where it was supposed to be.

Figure 2.—Laboratory tests on a partially cracked piece of concrete core.

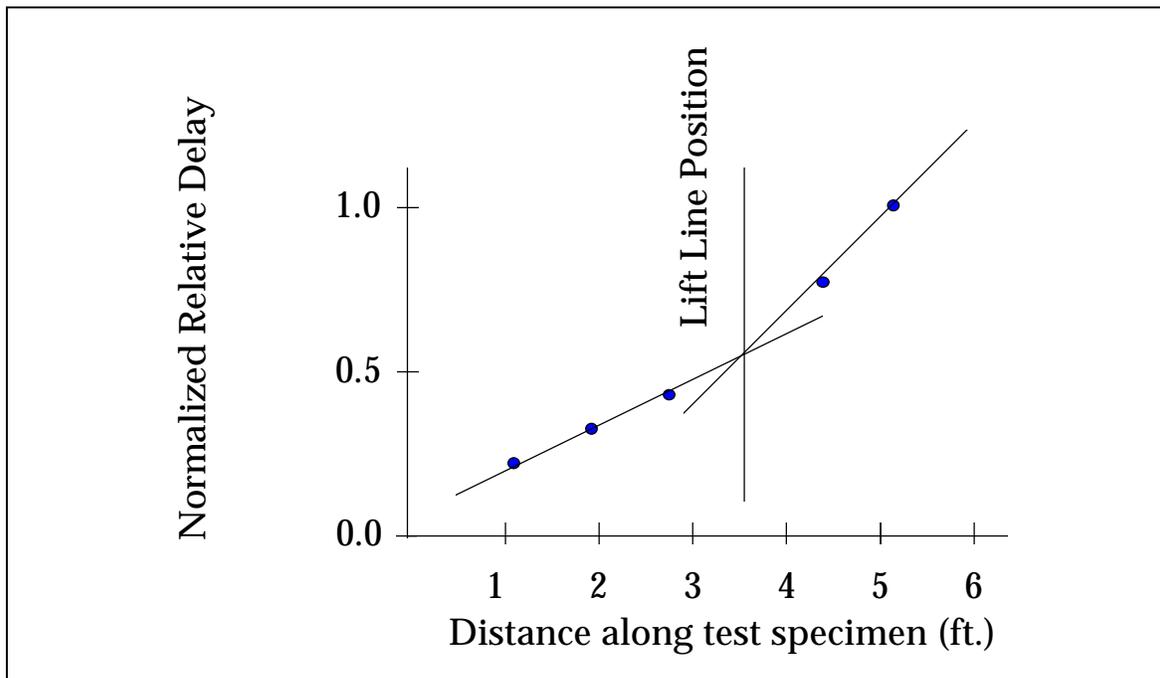
Figure 3.—Travel time measurements on a piece of Hoover Dam core.

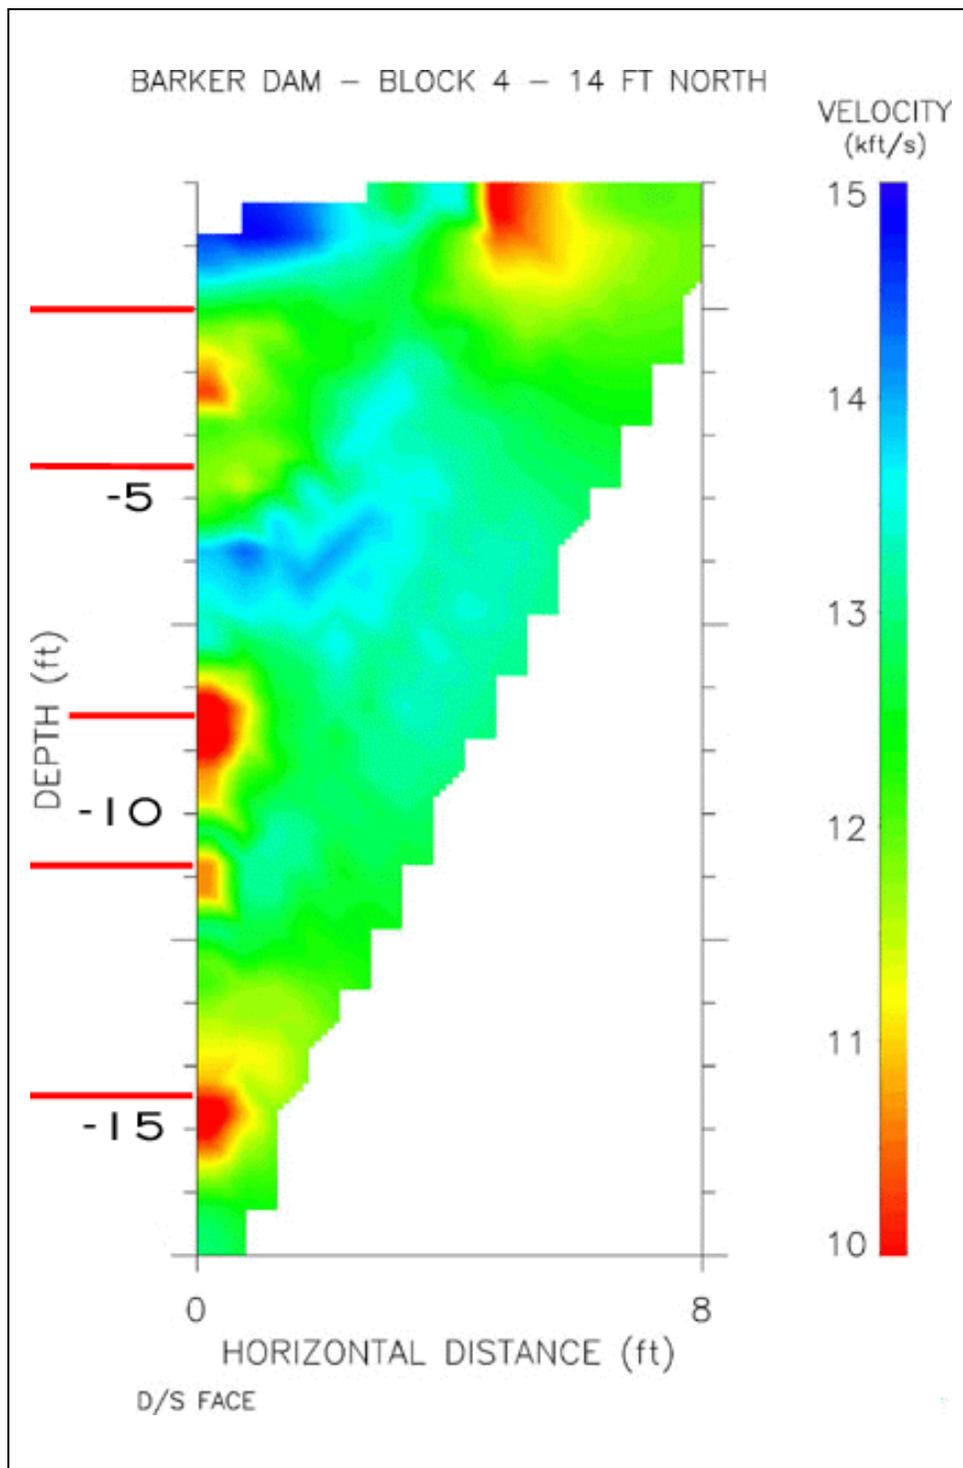
It worked! As you can see in figure 6 and the following table, the basic concept worked.

Figure 6.—Initial tomograph of Barker Dam.

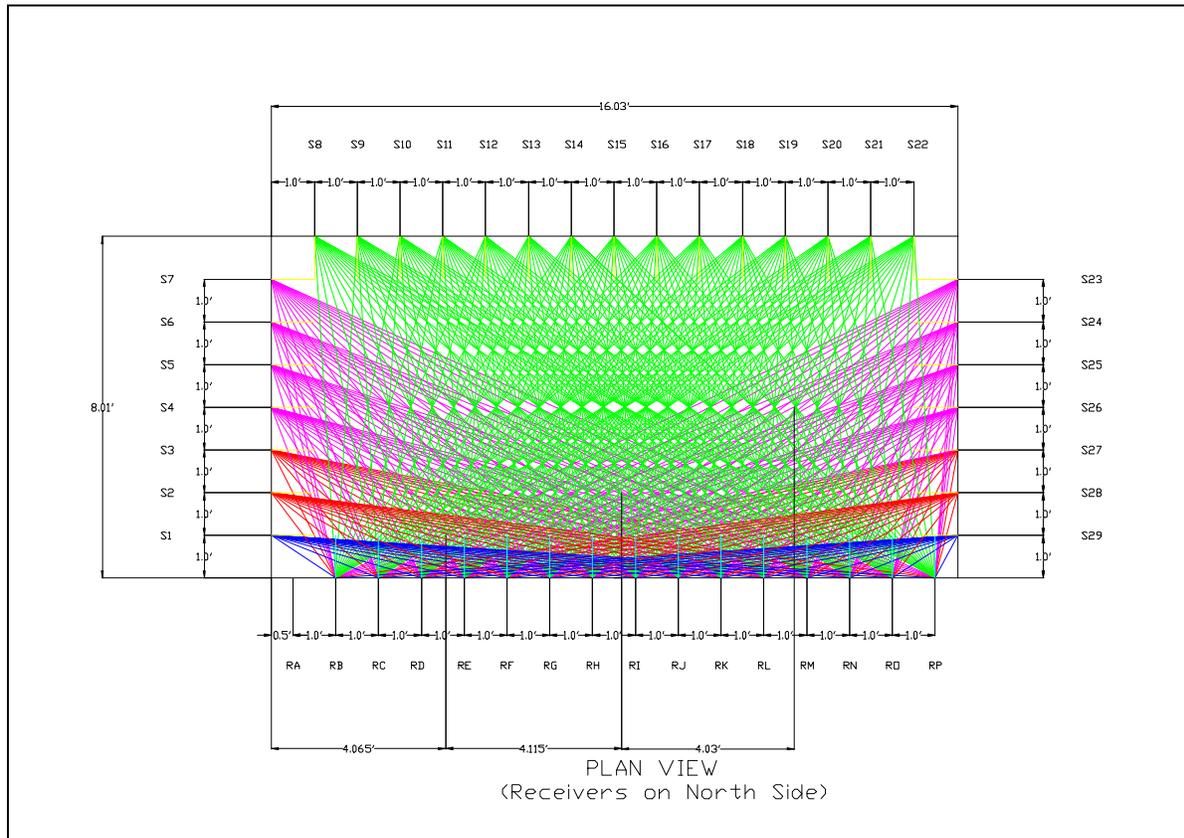
We went back to Barker Dam the next year to improve our testing techniques. We placed transducers on the top and downstream face of the dam and then hit it with a sledge hammer on the upstream face. This gave us a much better test mesh, as shown on figure 7.

Figure 7.—Straight ray paths through test specimen.

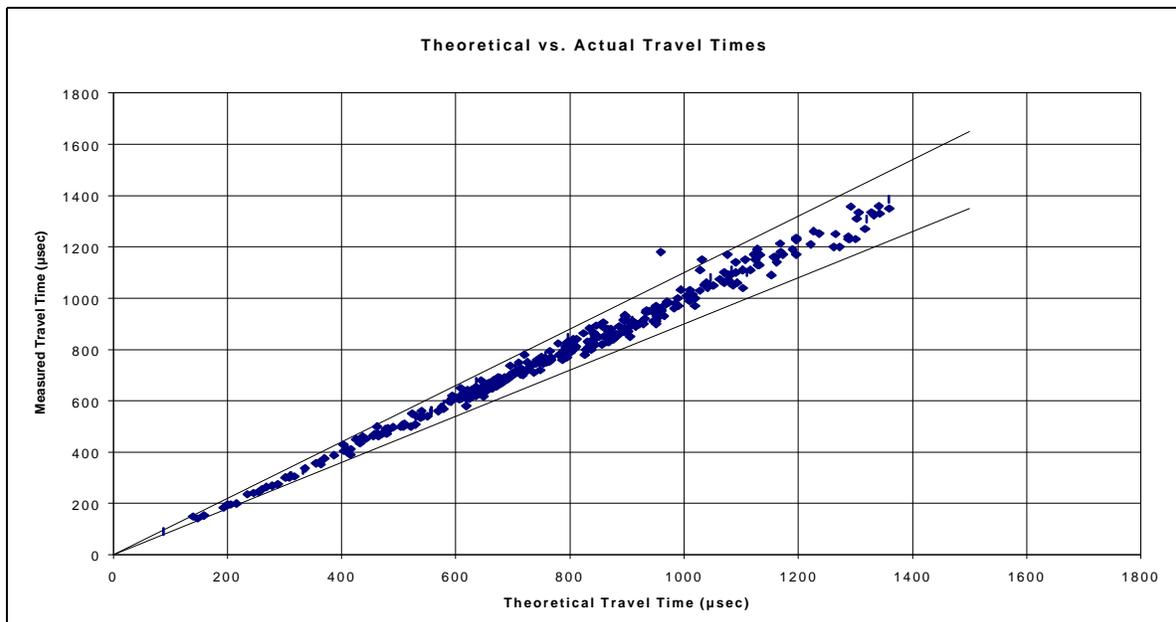
As any lab hand knows, concrete is not easy to test. Test results never match up well—any time the correlation between two tests is greater than 60 percent, we are happy. The correlation for this nondestructive testing technique is 99.5 percent. Figure 8 shows the measured travel time compared to the theoretical travel time. This figure also shows the ± 10 percent lines. Ninety-five percent of the actual data are within ± 5.6 percent of the theoretical travel times.

Figure 8.—Theoretical travel time versus actual test measurements (± 10 percent lines are also shown).
