Water Operation and Maintenance Bulletin

No. 227

Carbon Fiber Reinforced Polymer Repair of Reinforced Concrete Pipe

December 2011

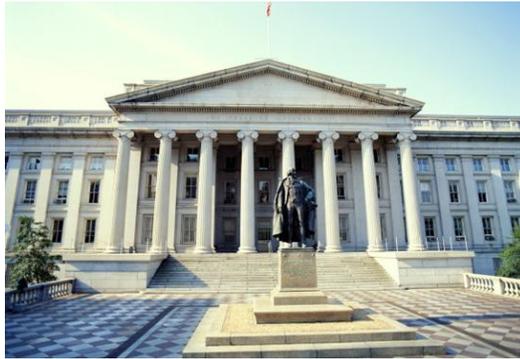
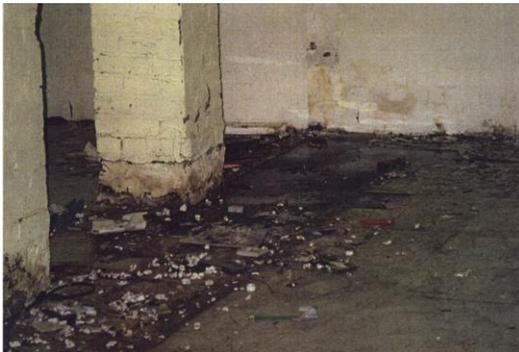
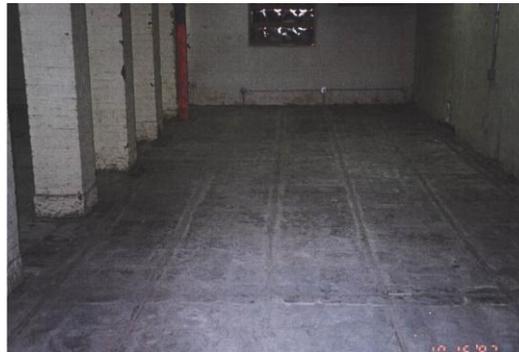
Cover photograph: *U.S. Treasury Building in Washington D.C. showing the conditions before electro-osmotic pulse was installed (left) and after it was installed and operating (right).*

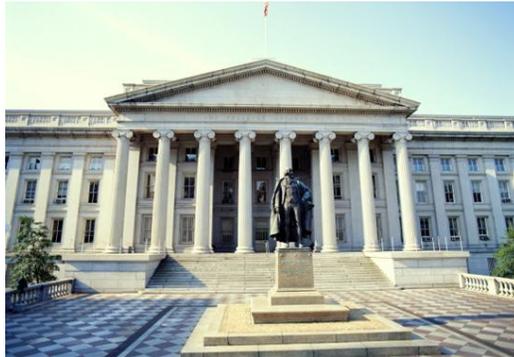
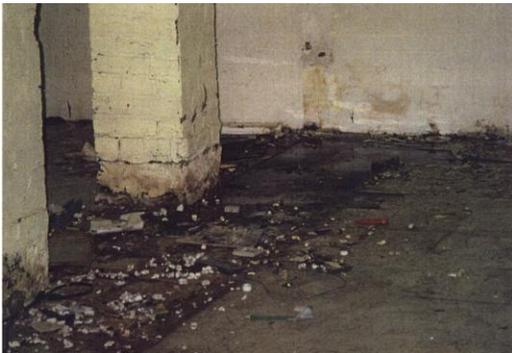
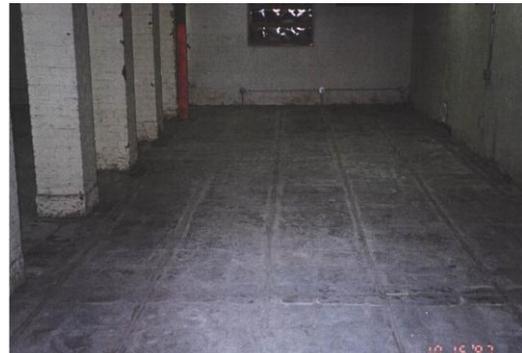
Figure 1.—U.S. Treasury Building in Washington D.C. showing the conditions before EOP was installed (left) and after it was installed and operating (right).

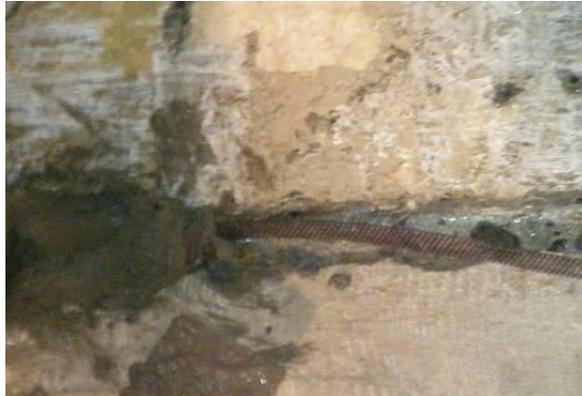
Figure 6.—Strip anode installed in a groove and then packed with a portland cement grout.

Mixed metal oxide-coated titanium mesh strip anodes, 12 feet long and ½ inch wide, and probe-type anodes, 6-7 inches long and ½ inch wide, were installed in the test section. The strip anodes were installed in the wall at the floor joint and 6 feet above the floor in saw cut and chipped out grooves approximately 1 inch wide by 1 inch deep. Six probe anodes were installed in holes approximately 3 feet above the floor and 2 feet apart. The anodes (see figures 6 and 7) were inserted in the grooves and holes and then were filled with a portland cement grout (BASF Masterflow 928). A water drip strip was installed approximately 6 inches above the top anodes to prevent water from the wall above flowing over the test area, which might have lead to erroneous readings.

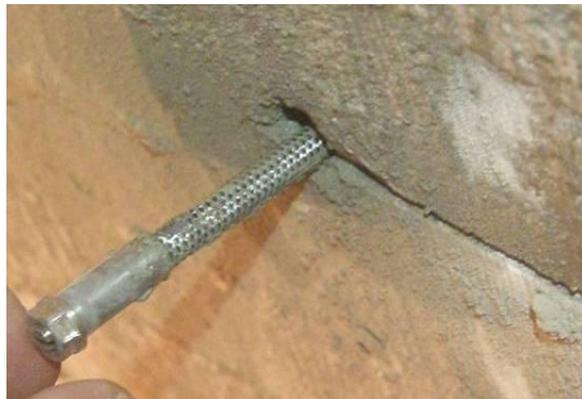
Figure 7.—Probe anode installed in a hole and then packed with a portland cement grout.

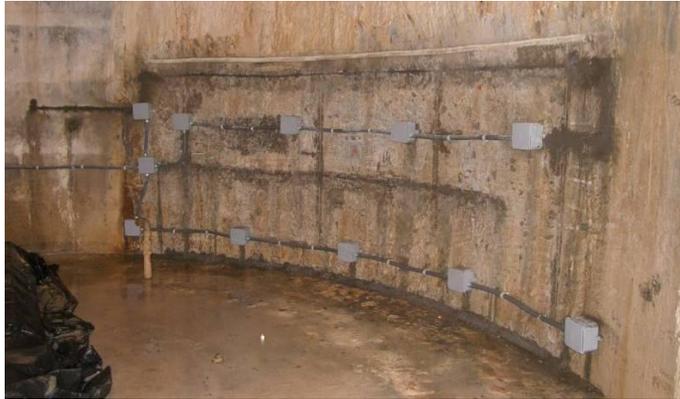
Figure 8.—Completed installation with junction boxes and conduit.

Anode and cathode cables were run through the junction boxes along the wall, and then connected to an anode header cable and a cathode header cable, respectively, in a main junction box. A connection was also made to the rebar to allow the system to supply the rebar with a small amount of protective current and prevent any damage to the rebar due to operation of the system. The main header cables and the cable connected to the rebar were run through conduit to the system controller. The complete installation of all electrodes and junction boxes is shown on figure 8.

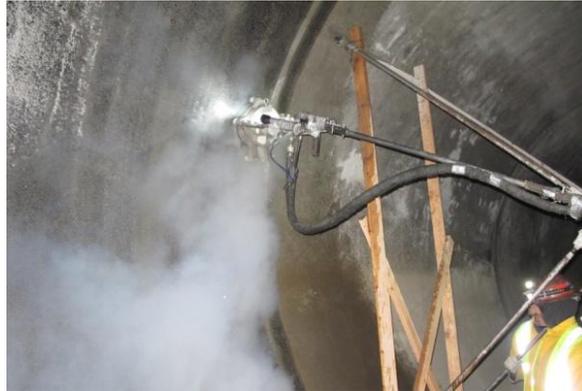
Figure 2.—High-pressure hydroblasting of concrete pipe surface to remove the laitance.

accordance with Guideline No. ICRI 310.2-1997, “Guide for Selecting and Specifying Concrete Surface Preparation for Sealers, Coatings, and Polymer Overlays.” Hydroblasting of the concrete surface is shown on figure 2. Figure 3 shows the surface of the pipe after hydroblasting, including a few of the large concrete repair areas (lighter colored areas). Equipment was then set up to dehumidify the pipe, dry the walls, and ventilate the area.

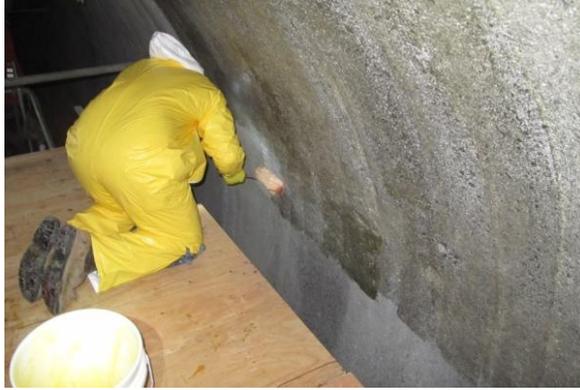
Figure 4.—Application of Tyfo® WP epoxy after concrete surface is hydroblasted.

All the epoxies used in the application of the carbon fiber were 100 percent solids, so they contained no solvents or volatile organic compounds. This was important to avoid the need for personal ventilators. All epoxies were mixed outside, in the open air, prior to transport into the pipe. Tyfo® WP (wet-prime) epoxy primer was applied using paint rollers to the concrete surface after it was hydroblasted as shown on figure 4. Tyfo® S (saturation) epoxy was applied to the surface using trowels (figure 5) after the primer was applied, and any final concrete repairs were completed.

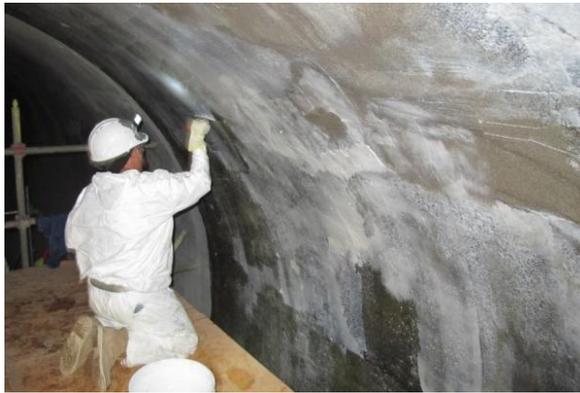
Figure 5.—Application of Tyfo® S epoxy after application of primer and concrete repair.

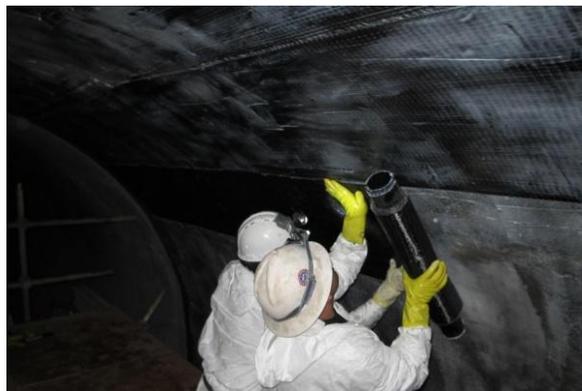
Figure 8.—Application of saturated carbon fiber fabric material in longitudinal direction.

The rolls of saturated fabric were unrolled onto the surface of the pipe. Three layers of fabric were applied to the pipe: the first layer was applied in the longitudinal direction (shown on figure 8), and the second and third layers were applied in the hoop direction (shown on figure 9). The number of hoop layers required was dependent on the structural requirements of the CFRP repair. Air pockets and wrinkles were smoothed out of the fabric using putty knives and hands as shown on figure 10. After each layer of fabric was applied, Tyfo® S was troweled onto the surface as shown on figure 11.

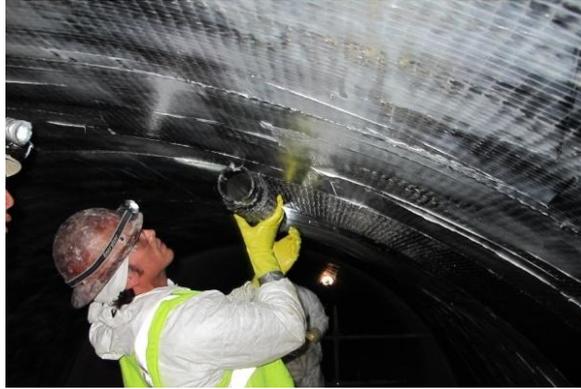
Figure 9.—Application of saturated carbon fiber fabric material in hoop direction.

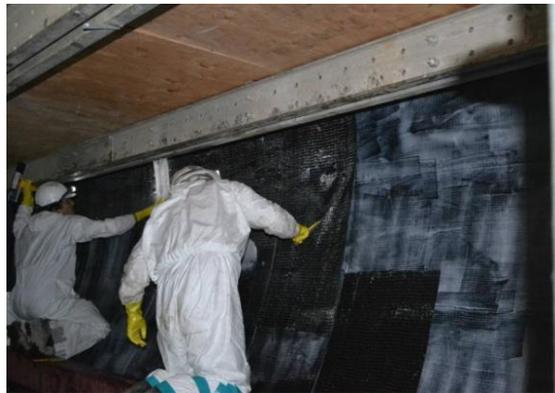
Figure 10.—Smoothing out fabric to remove air pockets and wrinkles.

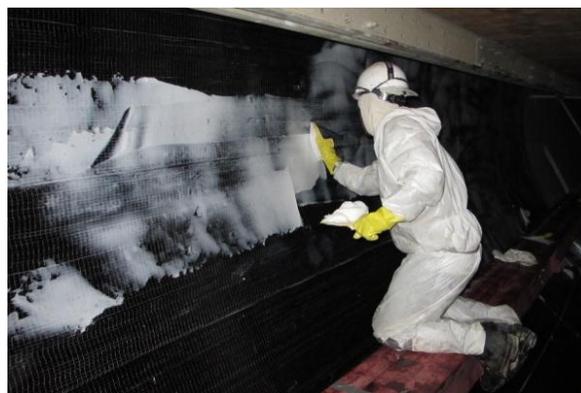
Figure 11.—Application of Tyfo® S epoxy after application of saturated carbon fiber material.
