Water Operation and Maintenance Bulletin

No. 239

Reservoir Sedimentation: Impacts to Operations and Maintenance,
and Potential Solutions

Leadville Mine Drainage Tunnel Treatment Plant Unwatering Under
the Retention Pond

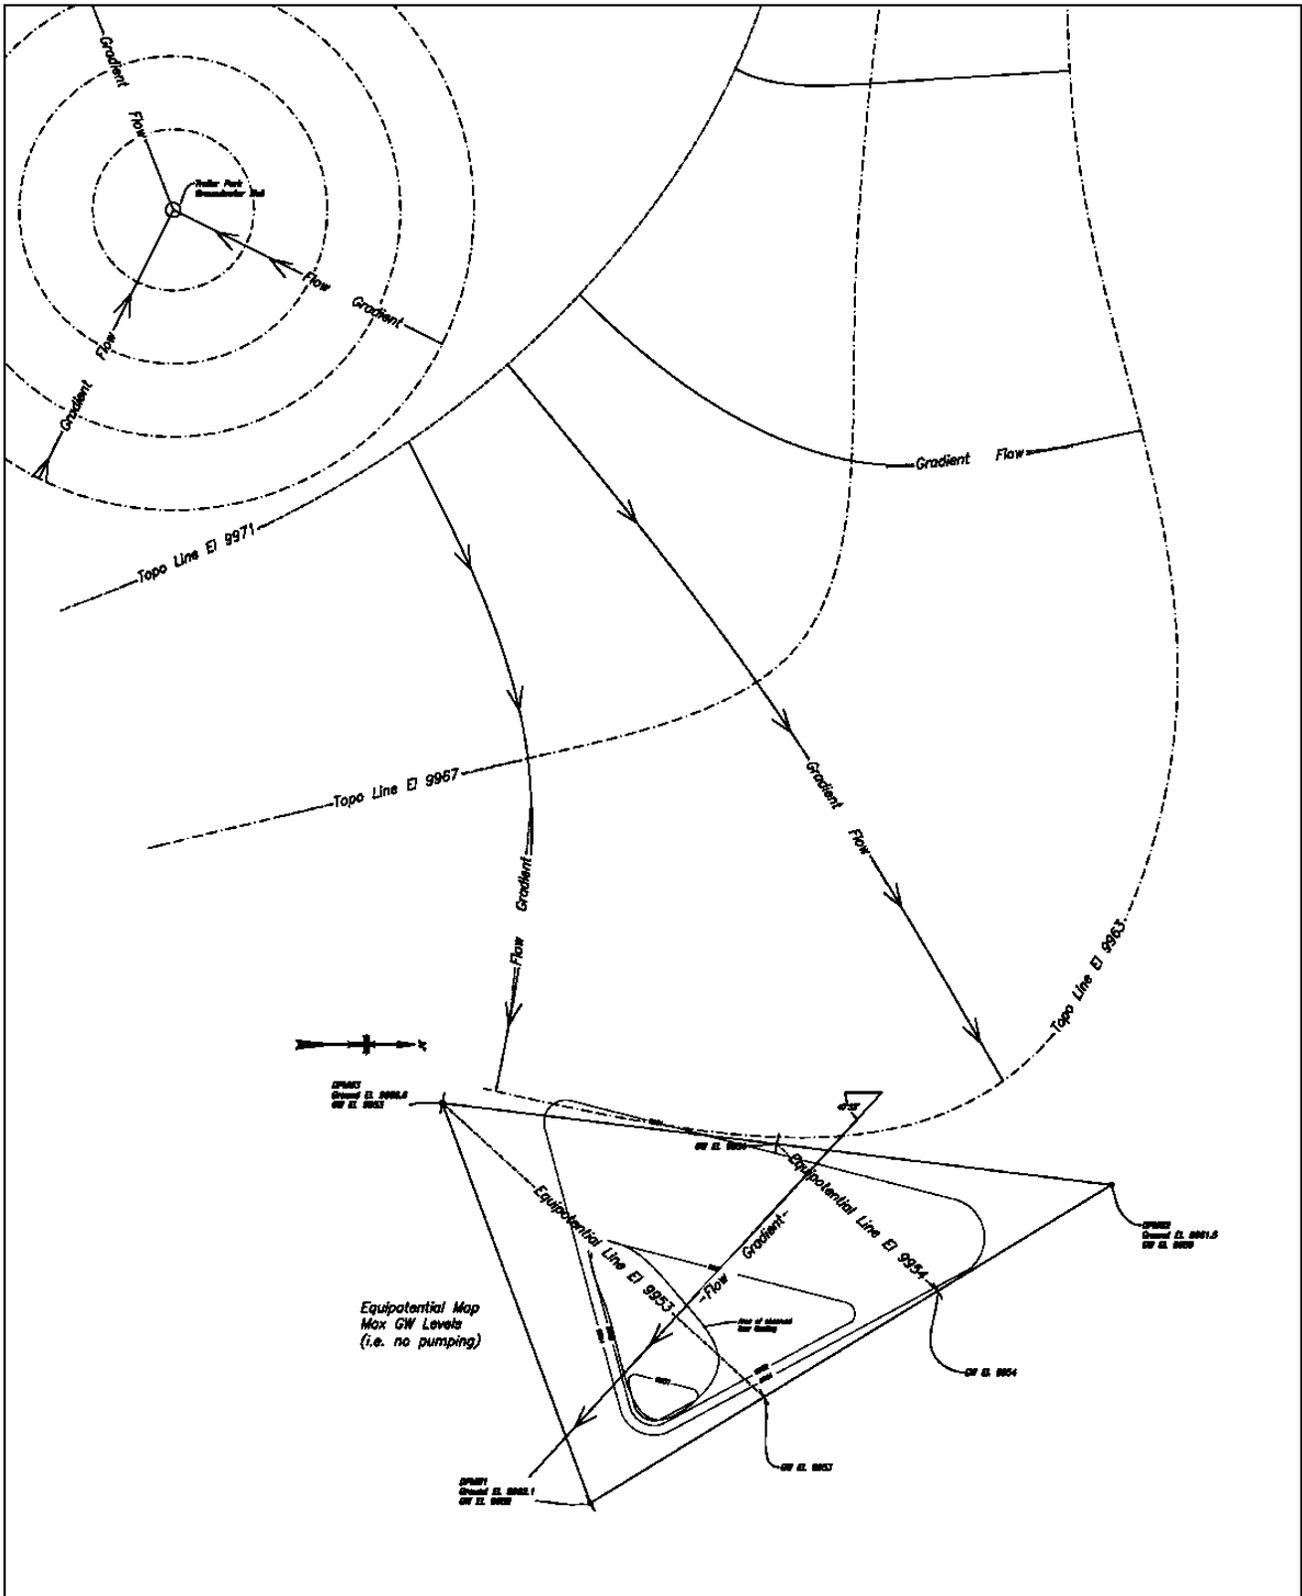
There are two aquifer systems at the site: the bedrock and an unconfined surficial aquifer. The surficial aquifer generally follows topography but is influenced by the geometry of the bedrock.³ Figure 2 shows a conceptual presentation of the potential groundwater flow in the vicinity of the detention pond. Three systems are shown on figure 2; one is the unconfined aquifer flow, which is inferred on the figure based on topography. The second system shown is an empirical cone of depression induced from the Molly Brown Trailer Park water well located southwest of the pond. The third system is the groundwater equipotential gradient calculated from the three monitoring wells and the groundwater levels provided by the area office. The flow lines generated for each system are depicted independently; additional analyses and modeling would be required to establish the interaction effects from each system.

Figure 2.—Conceptual map of regional groundwater in pond vicinity.

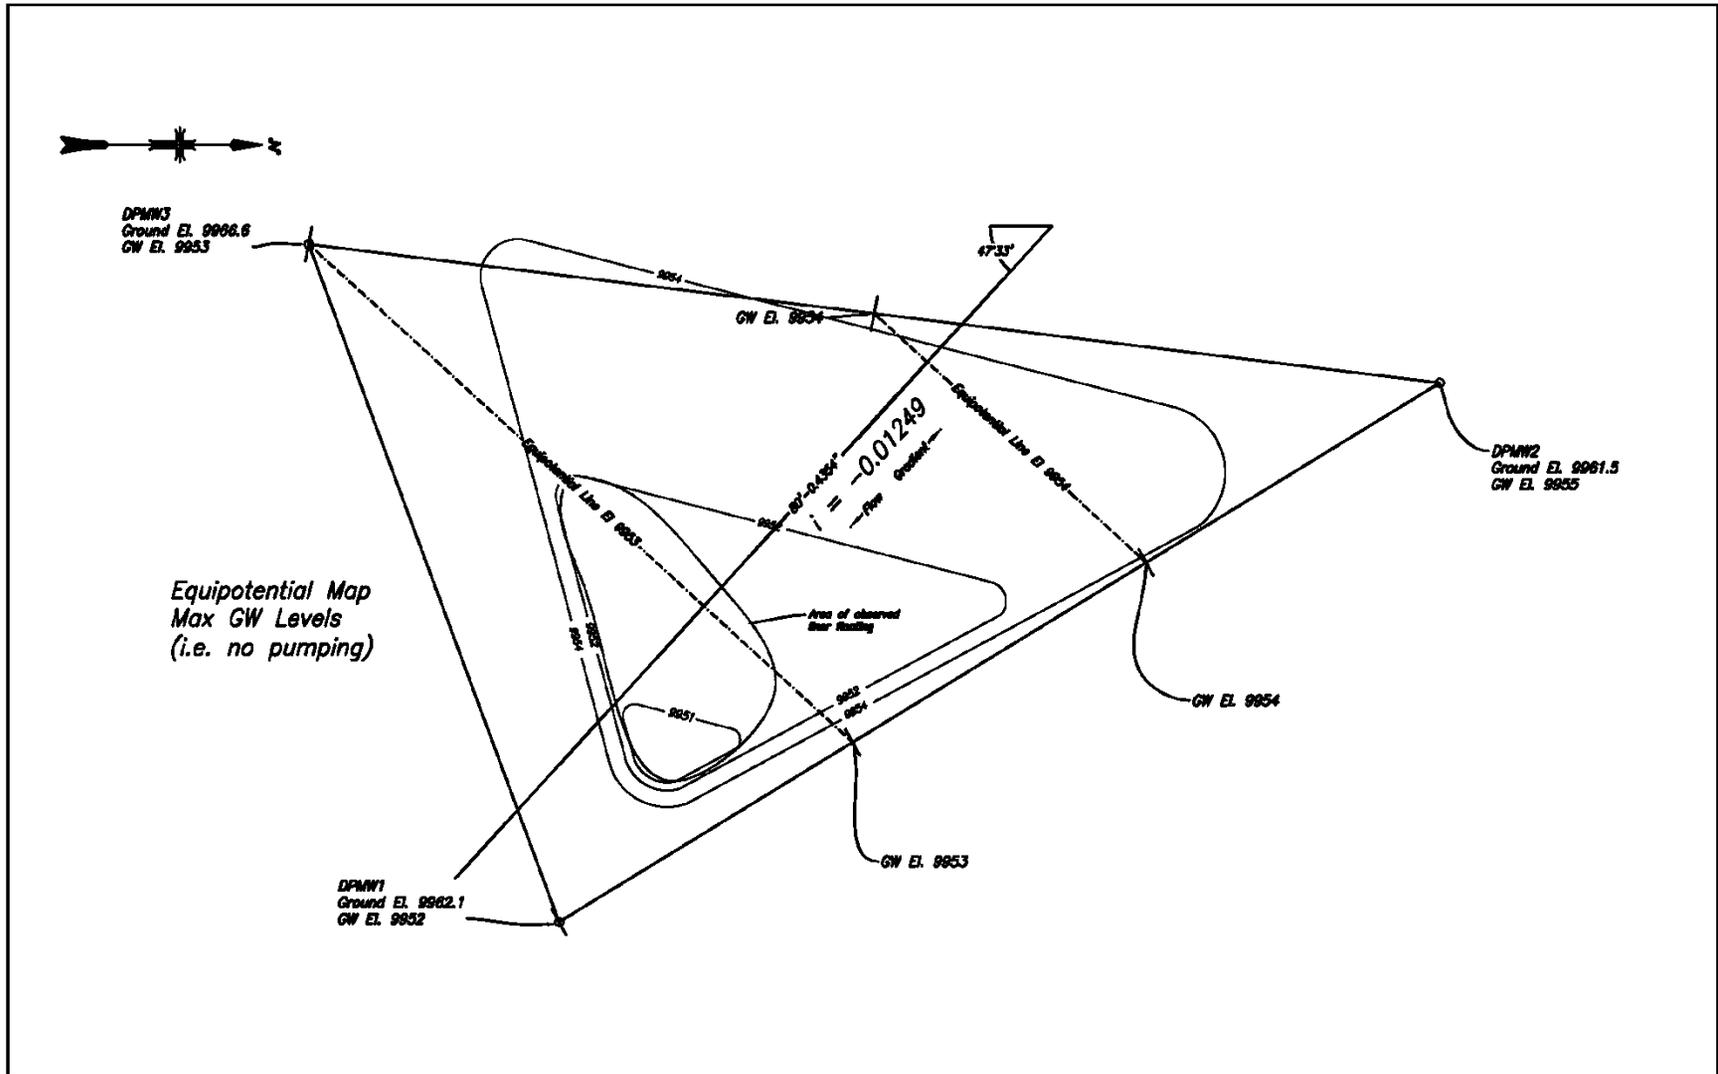
Figures 3 and 4 show the calculated groundwater maps for the pond site before and after the installation of the existing pumps. The groundwater flow at the pond site appears to be flowing southeast, against the topographical slope and away from the river valley to the north. This is the opposite direction from what was anticipated. Based on the equipotential lines, it is apparent on figures 3 and 4 that there is either a groundwater source northwest of the site or a sink southeast of the site.

Figure 3.—Equipotential map of LMDT pond – before pumping.

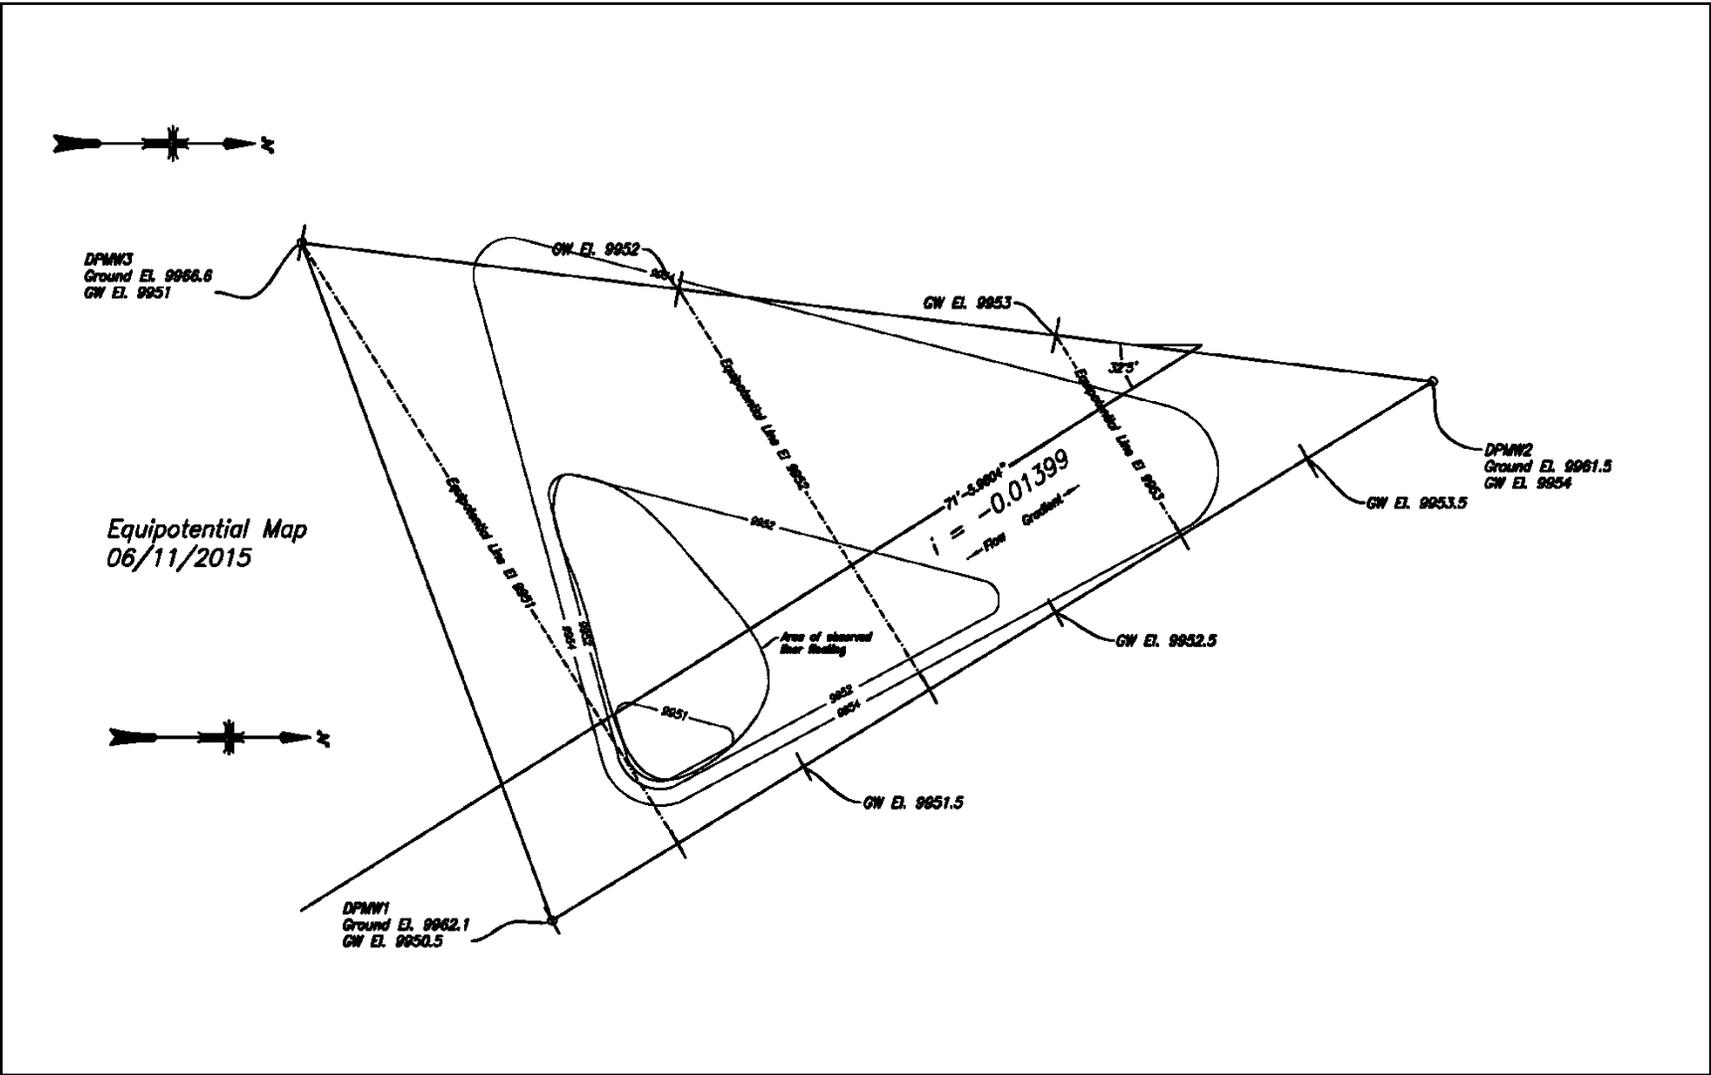
Figure 4.—Equipotential map of LMDT pond – June 11, 2015.

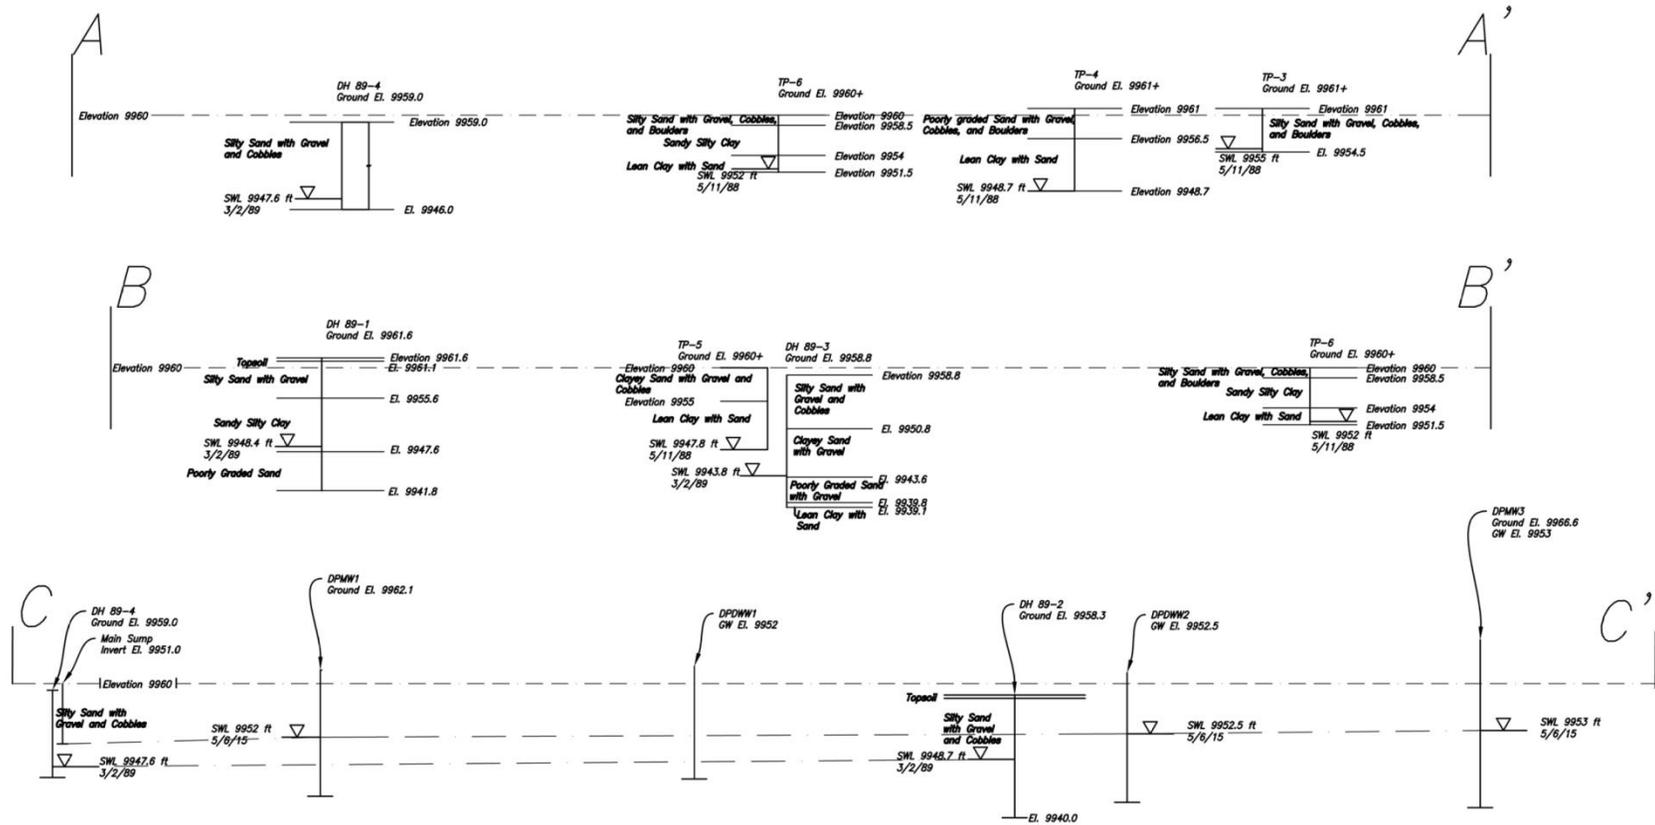
sections developed for the area by the U.S. Geological Survey (USGS)^{4,5} indicate sloping sandstone, quartzite, and granite bedrock in the area as well as a set of faults, which could be a source of upwelling groundwater. The tunnel acts as a sink for groundwater regionally and could be doing the same at the pond site. Finally, the local stratigraphy shows a lean clay confining layer that dips to the west which could be forcing the groundwater to flow toward the south by restricting flow from continuing to the east. Figures 5 and 6 show a plan view and geologic cross sections for the site.

Figure 6.—LMDT site cross sections – DRAFT.
