Water Operation and Maintenance Bulletin

WHAT WE LEARNED!

Haste Makes Wasteway Failures

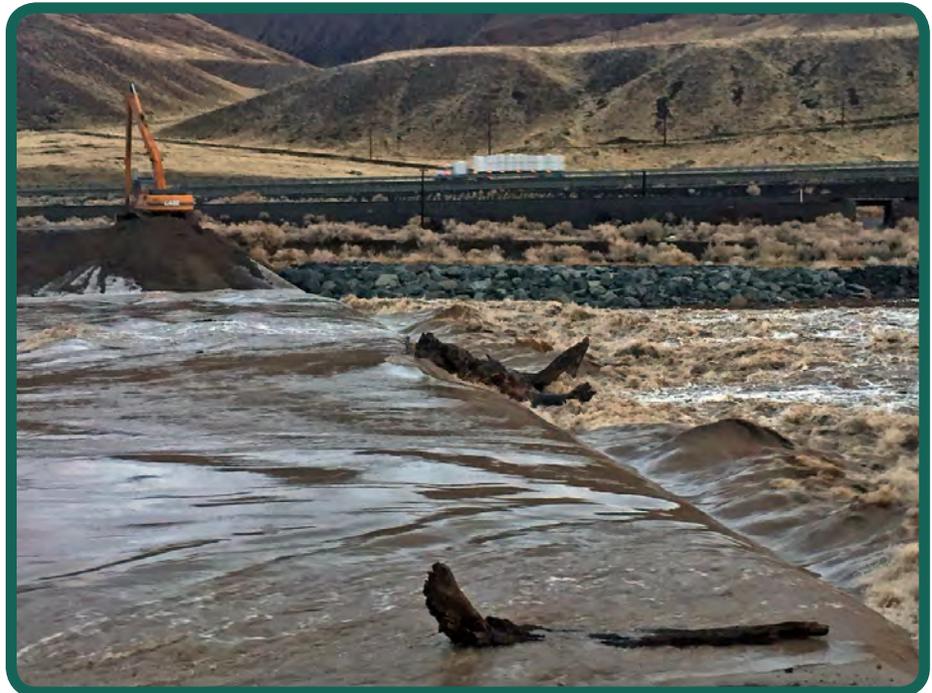
In this same flood, Reclamation and TCID worked together to ensure that the canals could handle the storm surge. Before the storm, TCID and Reclamation had conducted a risk assessment of the canal system. During the storm, the canal started breaching at four sites from cross flows. TCID and Reclamation consulted on this risk assessment and determined how to safely draw down the canal. This event ended up requiring only minor repairs and overtopping events in the canal did not result in losses or breaches.

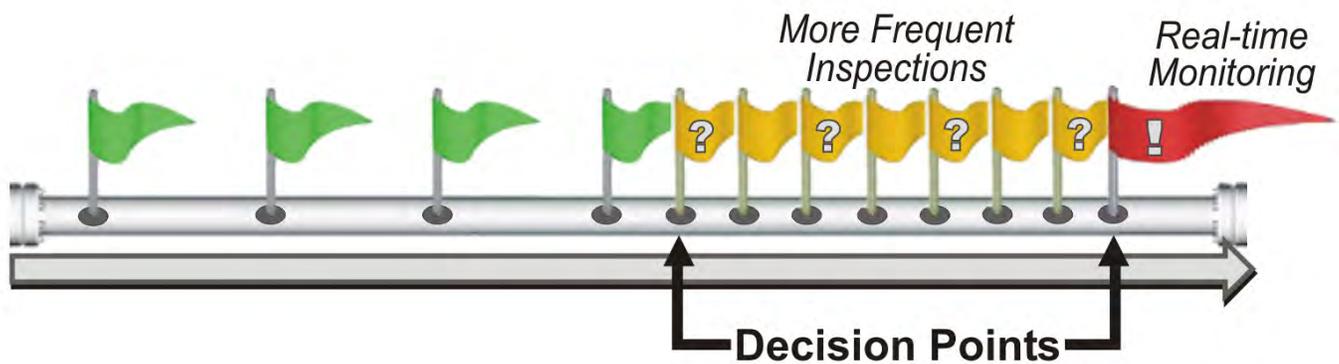
Conceptual schematic of inspection requirements over a pipe's lifetime.

Looking at an overall system and planning an inspection and repair program will be easier on budgets than addressing problems piecemeal. Implement a regular inspection program and develop a baseline and then inspect pipes every five to six years. Explore the possibility of obtaining spare replacement sections and materials to address emergency situations quickly.

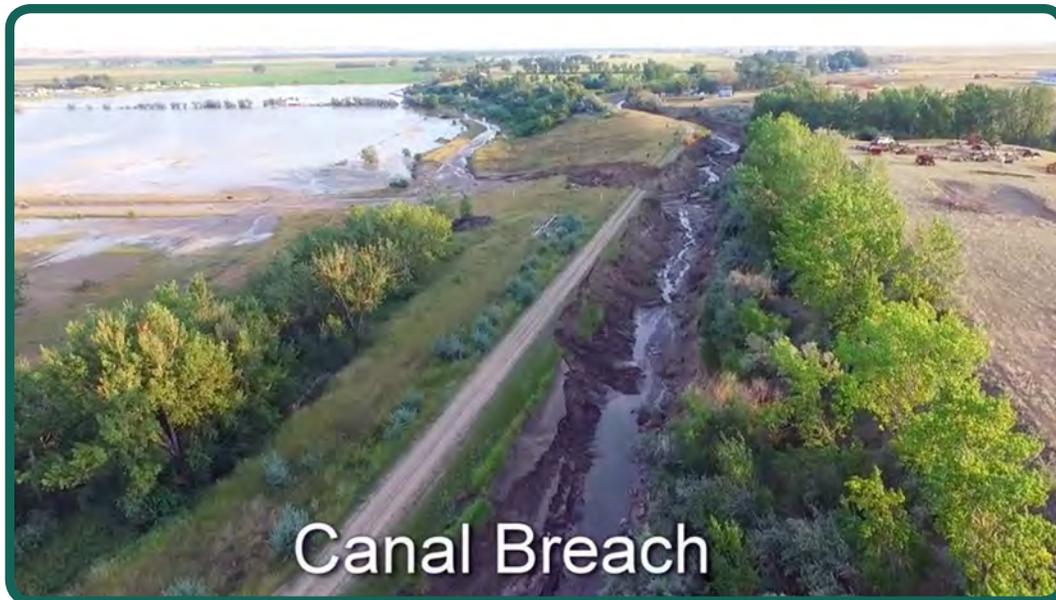
"The amazing thing is, these people moved over 200,000 yards of dirt within only eight days of digging, working 24 hours a day. The quality and the accuracy of what they did is fantastic," says Brower.
