Hot Springs Canyon Fish and Amphibian Monitoring

Paul C. Marsh and Jason C.G. Marsh

November 7, 2013

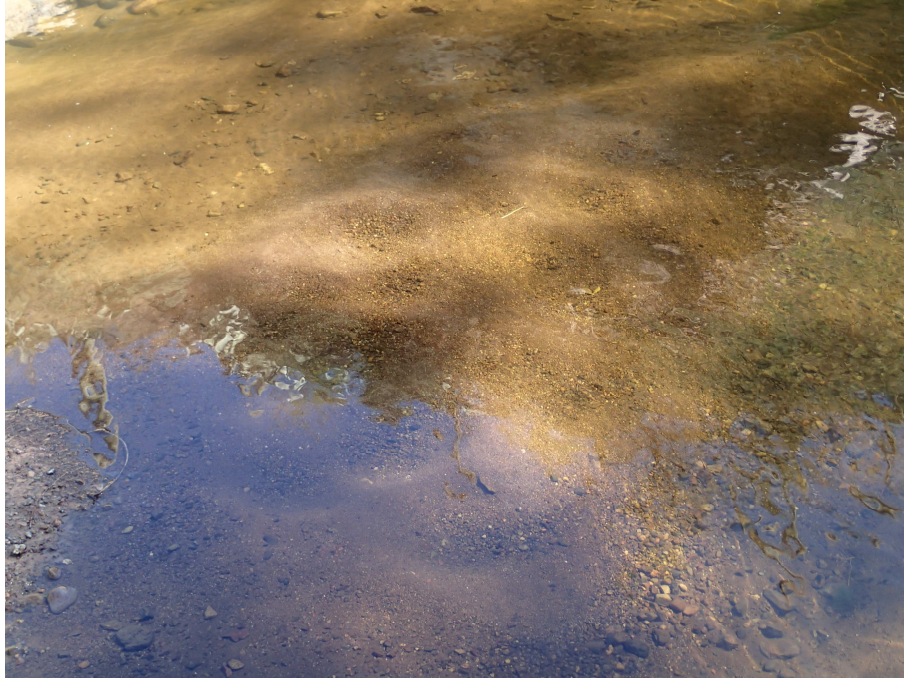
The lower end of the stream was dry and surface water first was encountered approximately 1.2 km below the barrier. Adult and larval fish, presumably longfin dace, were rare and in a variety habitats throughout the reach. Longfin dace nests were present, few in number, and found sporadically along the reach and upstream (Fig. 1).

Fig. 1. Hot Springs Canyon, Cochise Co., Arizona, showing longfin dace *Agosia chrysogaster* nests upstream from the constructed fish barrier; October 28, 2013.

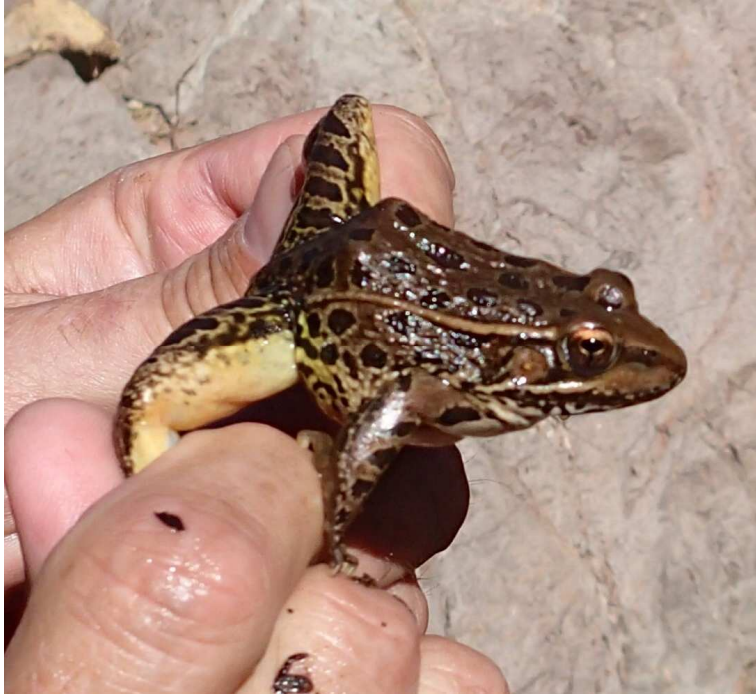
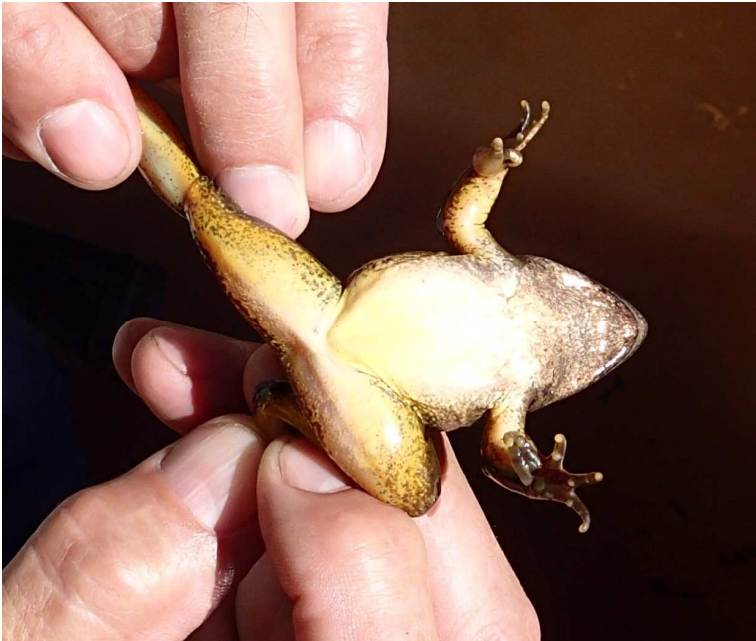
Multiple confirmed and perhaps two dozen unconfirmed adult lowland leopard frog adults were captured or observed; most were downstream from the barrier. No egg masses or tadpoles were encountered, although these life stages both could potentially be present at this time of year (Brennan and Holycross 2006). Non-native bullfrog was encountered in relatively low numbers above and below the barrier. Both amphibian species were photo-vouchered (Fig. 3)

Fig. 3. Hot Springs Canyon, Cochise Co., Arizona, native lowland leopard frog (above) and non-native bullfrog (below); October 28, 2013.
