El Vado Dam repairs

*Mary Carlson, Public Affairs Specialist,
Albuquerque Area Office, Upper Colorado Region*

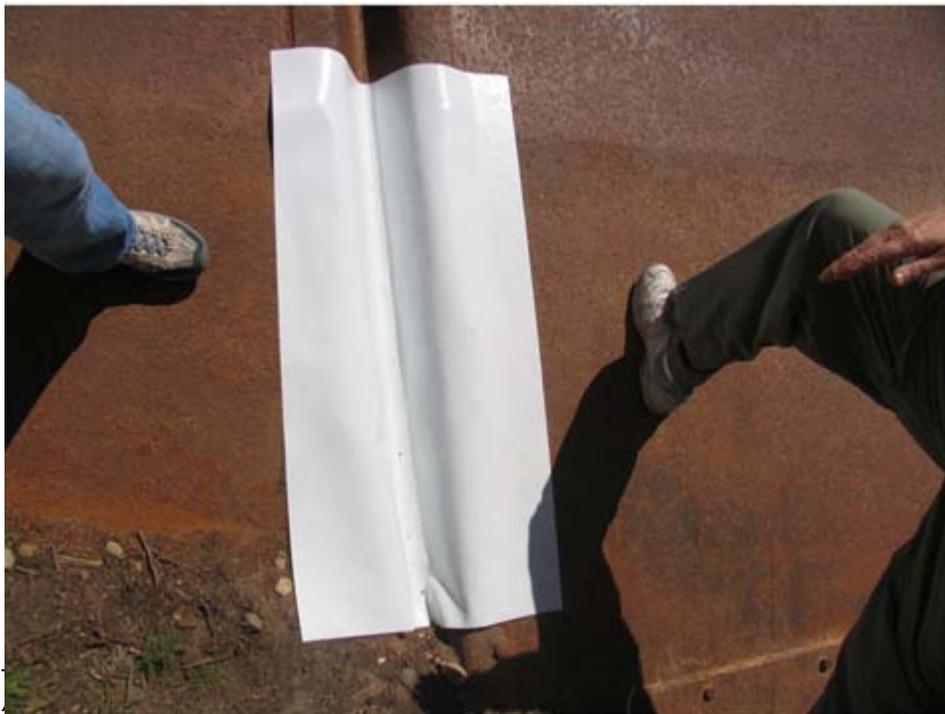
Members of a Reclamation dive team entering or coming out of the water during the repair at El Vado reservoir on April 26.

The crack was covered by the membrane on April 26 after being postponed the previous day due to high winds. One of the critical issues the team had to deal with was the pressure differential caused by high flows going through the crack.

The crack was located approximately 15 feet below the water line. The main portion of crack itself was about a foot and a half long but it likely extended further down the dam. The membrane was placed an additional 15 feet below the main crack to ensure that the entire crack was covered.

These flows create a suction effect that could theoretically catch a diver and pin him or her to the crack. This hazard was overcome by using a Remote Operated Vehicle (ROV) to place material into the crack prior to exposing the divers.

The ROV placed a sizable quantity of Oakum into the crack, which appeared to work very well

The suction of the flows pulled the Oakum in place and made it safe to install the membrane. The temporary repair appears to have been successful, and a decrease in seepage has already been documented.
