**ENGINEERING EVALUATION OF THE RED BLUFF RESEARCH
PUMPING PLANT ON THE SACRAMENTO RIVER IN NORTHERN CALIFORNIA:
1995-1998**

**A Summary Report
Red Bluff Research Pumping Plant
Report Series: Volume 6**

September 1999

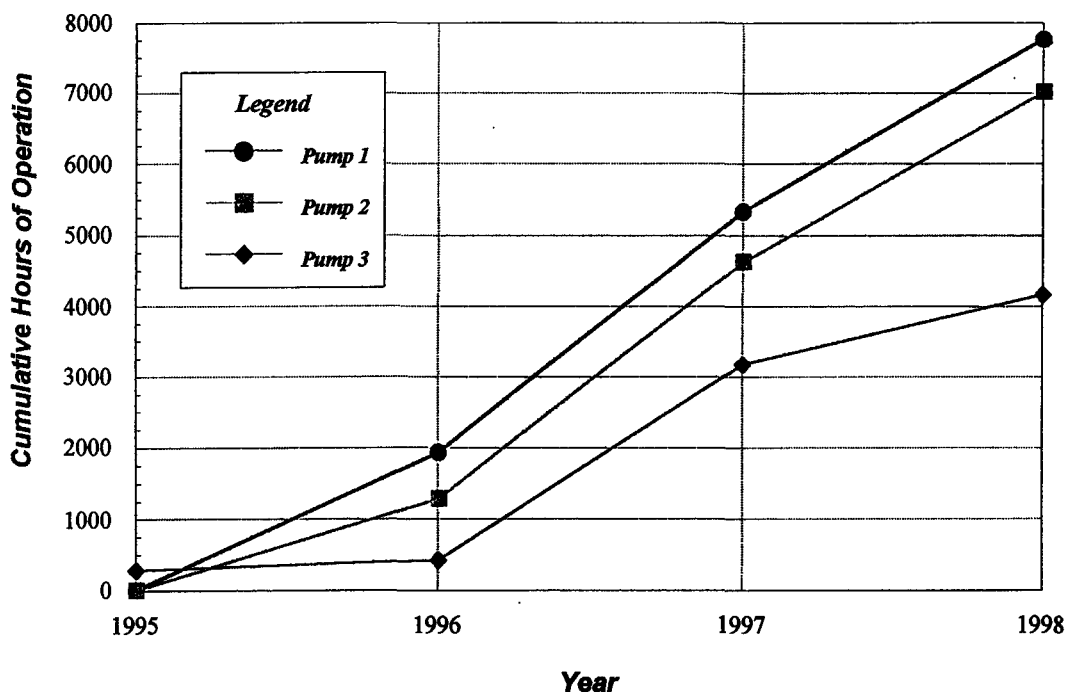
Figure 11. Cumulative hours of pumps operation. Total cumulative hours of pump operation by year for the period of evaluation, 1995-1998.

Over the course of the evaluation period covered in this report (1995-1998), the pumps operated rather sporadically due to design flaws as well as installation problems. The total cumulative hours of operation as a percent of the total possible hours of operation vary from about 13 percent for the Wemco-Hidrostal to 22 to 25 percent for the CPC Archimedes pumps, figure 11.

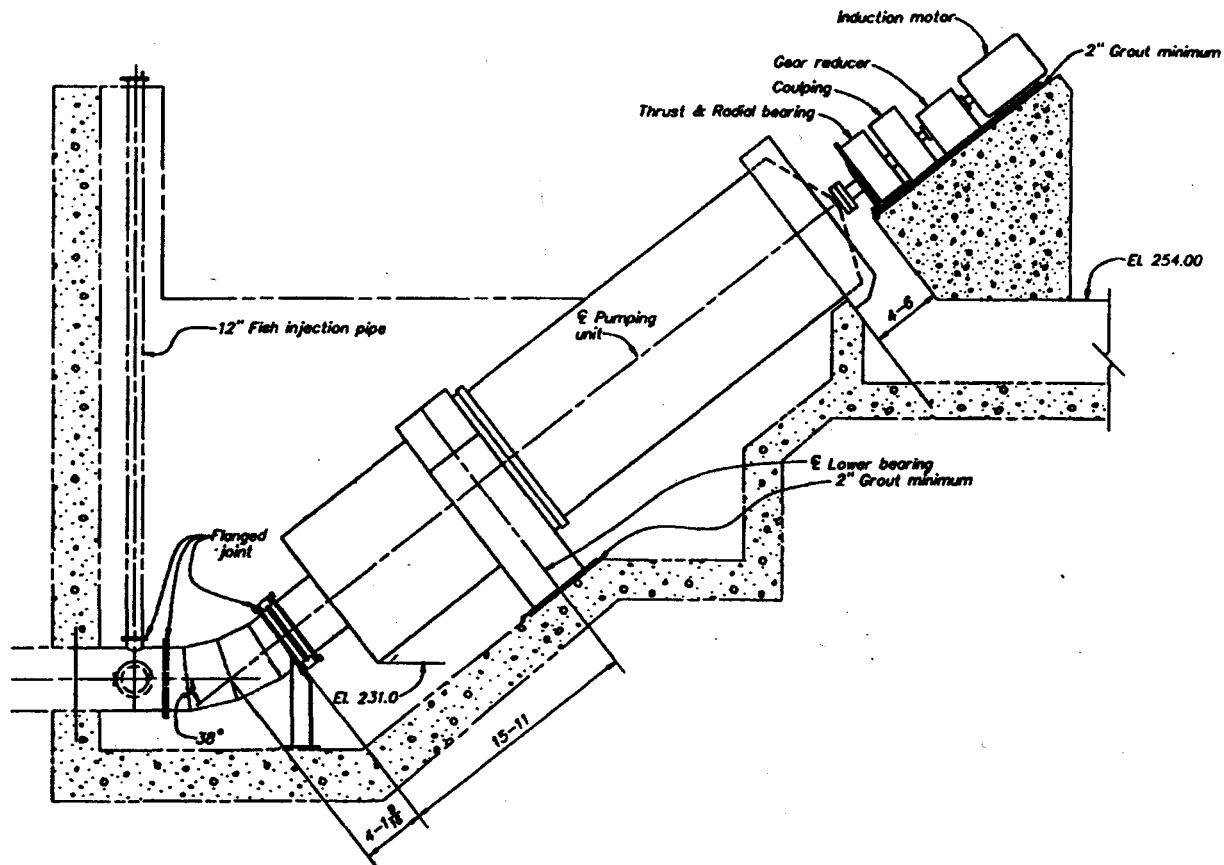
Figure 13. Sealed inlet Archimedes Installation. Red Bluff Research Pumping Plant installation. Note sealed inlet condition with rotating seal.

Rotating Seal. Within the 8-hour period of the initial burn-in test, shavings of UHMW (Teflon) seal material (between fixed pipe and rotating pump) were discovered in the discharge channels of the Archimedes pumps, and were accumulating on the wedge-wire screens. Upon closer inspection of the pump, it was determined that sediment from the river was migrating through the packing and lodging between the seal and the fixed roller pipe. This caused the seal to wear excessively. The pumps were shut down and the seal and packing were disassembled. Sediments in the size range of 1/8 inch and smaller had lodged between the UHMW seal and the fixed pipe, causing scoring and excessive wear of the relatively soft seal material, figure 14. Sediment traps were considered as a means to eliminate the sediment from the water prior to entering the intake manifold. This solution was quickly discounted due to the detrimental effects it would have on the inlet velocity and its low probability of success. A redesign of the seal was needed to allow operation with any amount and size of suspended sediments that may be pumped from the river. After several months of unsuccessfully working with the manufacturer to develop a solution without success, Reclamation designers developed a seal which could be manufactured and installed quickly and inexpensively. The seal eliminated large quantities of mechanical equipment and consisted

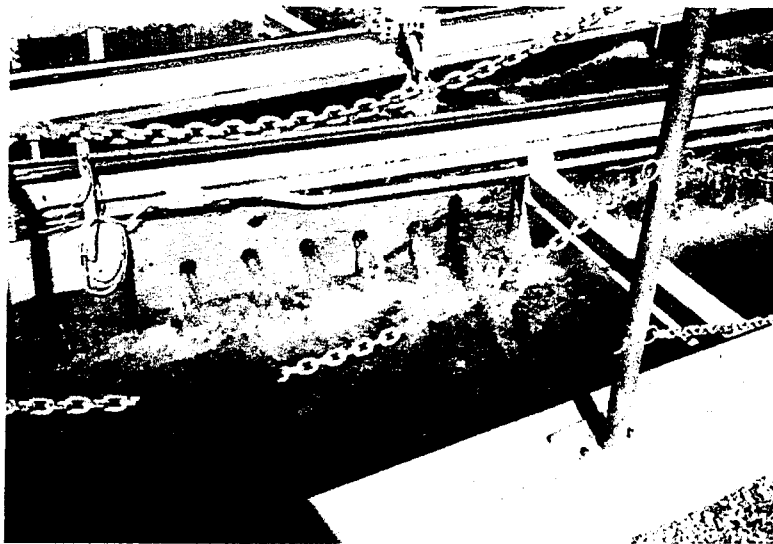
The first attempt at baffling was with fixed area baffles constructed of plywood and bolted to the backside of the downstream half of each side of the structure, figure 34. These were installed in July 1995. The screen panels closest to the bypass entrance were baffled with 10% open area, the next ones upstream at 25%, and the final baffles were at 50% open area. The upstream 3 panels on each side of the screen structure remained unbaffled. The baffling as a function of the complete screen area was 64 % open.

Figure 34. Temporary plywood baffles. *Plywood sheets with holes cut out created temporary baffles behind the wedgewire screens.*

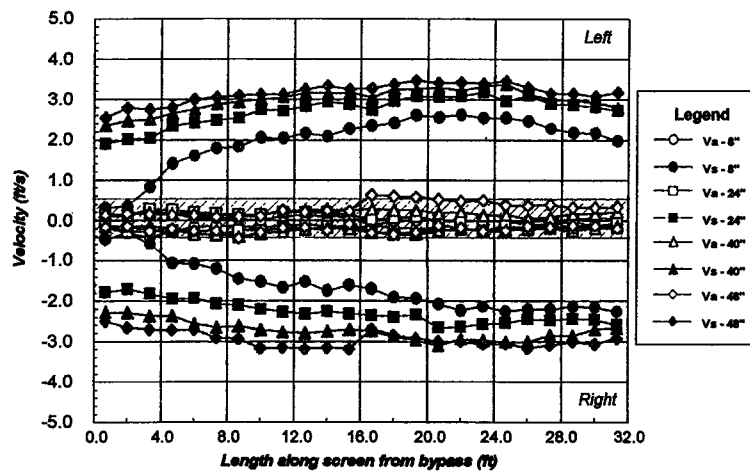
Figure 38. Velocity measurements for fully baffled screens. ADV measurements for fully baffled screens of pump 2, $Q=87 \text{ ft}^3/\text{s}$. Measurements are for various depths above the channel bottom.

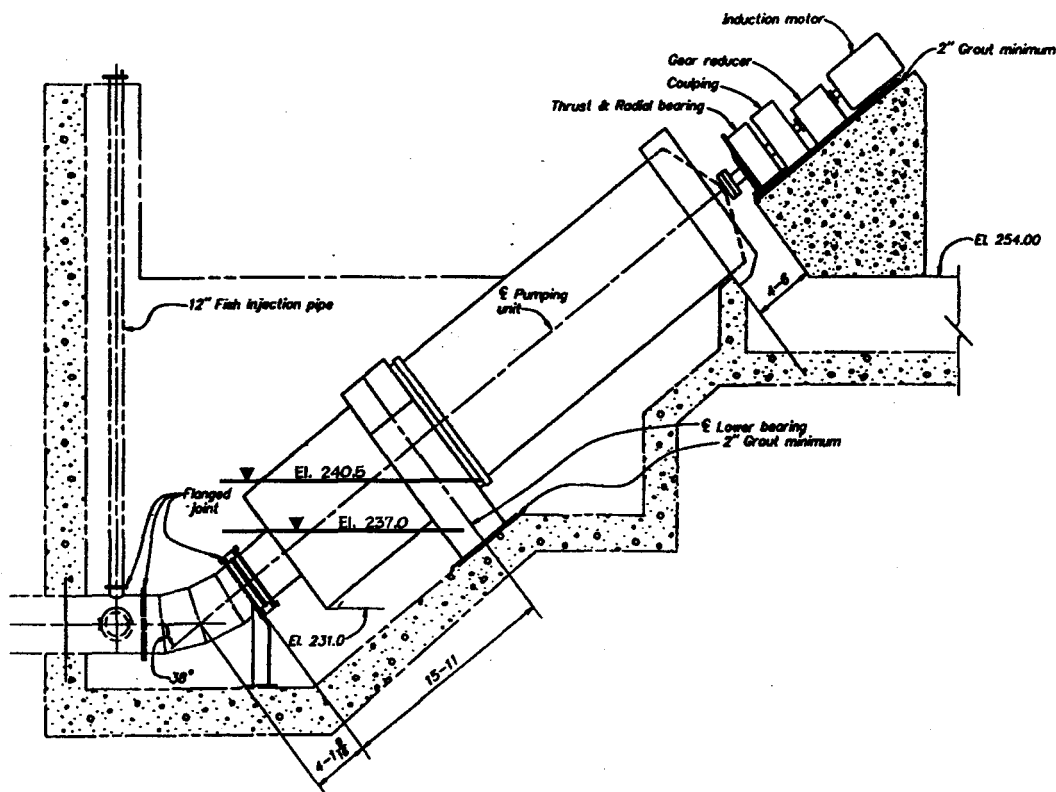
The major design issues with the Archimedes pump involved the rotating seal at the inlet to the pump and the design of the internal flights. Most of the additional problems including failures of couplings and bearings were due to the initial installation being well out of alignment. The rotating seal provided by the pump manufacturer failed within hours of the startup. After several months of trying to work with the manufacturer, Reclamation finally designed and installed a seal which has been performing very well. There has been little or no maintenance required, and leakage was minimal. Cracking of the pump's internal flights was the other major design issue. This problem was a result of both an overload and poor workmanship of the flight-to-flight welds. The cracking began at an abrupt contour change and the beginning of a weld. This type of junction typically has a large stress concentration factor. In addition to this workmanship issue, finite element modeling showed that the size material used for the flights were inadequate. Reinforcing plates were added to each side of the flights over a portion of the pump's length. Through this modification as well as the weld repairs and stop-drilling, most of the cracking has stopped. The setting of the pump elevation in the structure may be a major cause of the cracking due to the high static water loading inside the pump. The lack of experience with a variable water surface at the inlet to the Archimedes pump raises the question as to whether a higher pump elevation setting should have been used. Figure 43 shows the minimum and maximum design water surfaces and how they relate to the pump setting.

Figure 43. Elevation setting of the Internallift Archimedes pumps. Design settings for the Archimedes pumps at RBRPP. Note specified minimum and maximum water surface elevations for pumping, actual maximum was actually closer to 245.
