ENGINEERING GEOLOGIC EVALUATION OF THE NEWMAN WASTEWAY AND STRUCTURES

DELTA MENDOTA CANAL RECIRCULATION FEASIBILITY STUDY

JANUARY 2009

U.S. DEPARTMENT OF INTERIOR
BUREAU OF RECLAMATION
MID PACIFIC REGION GEOLOGY BRANCH
SACRAMENTO, CA

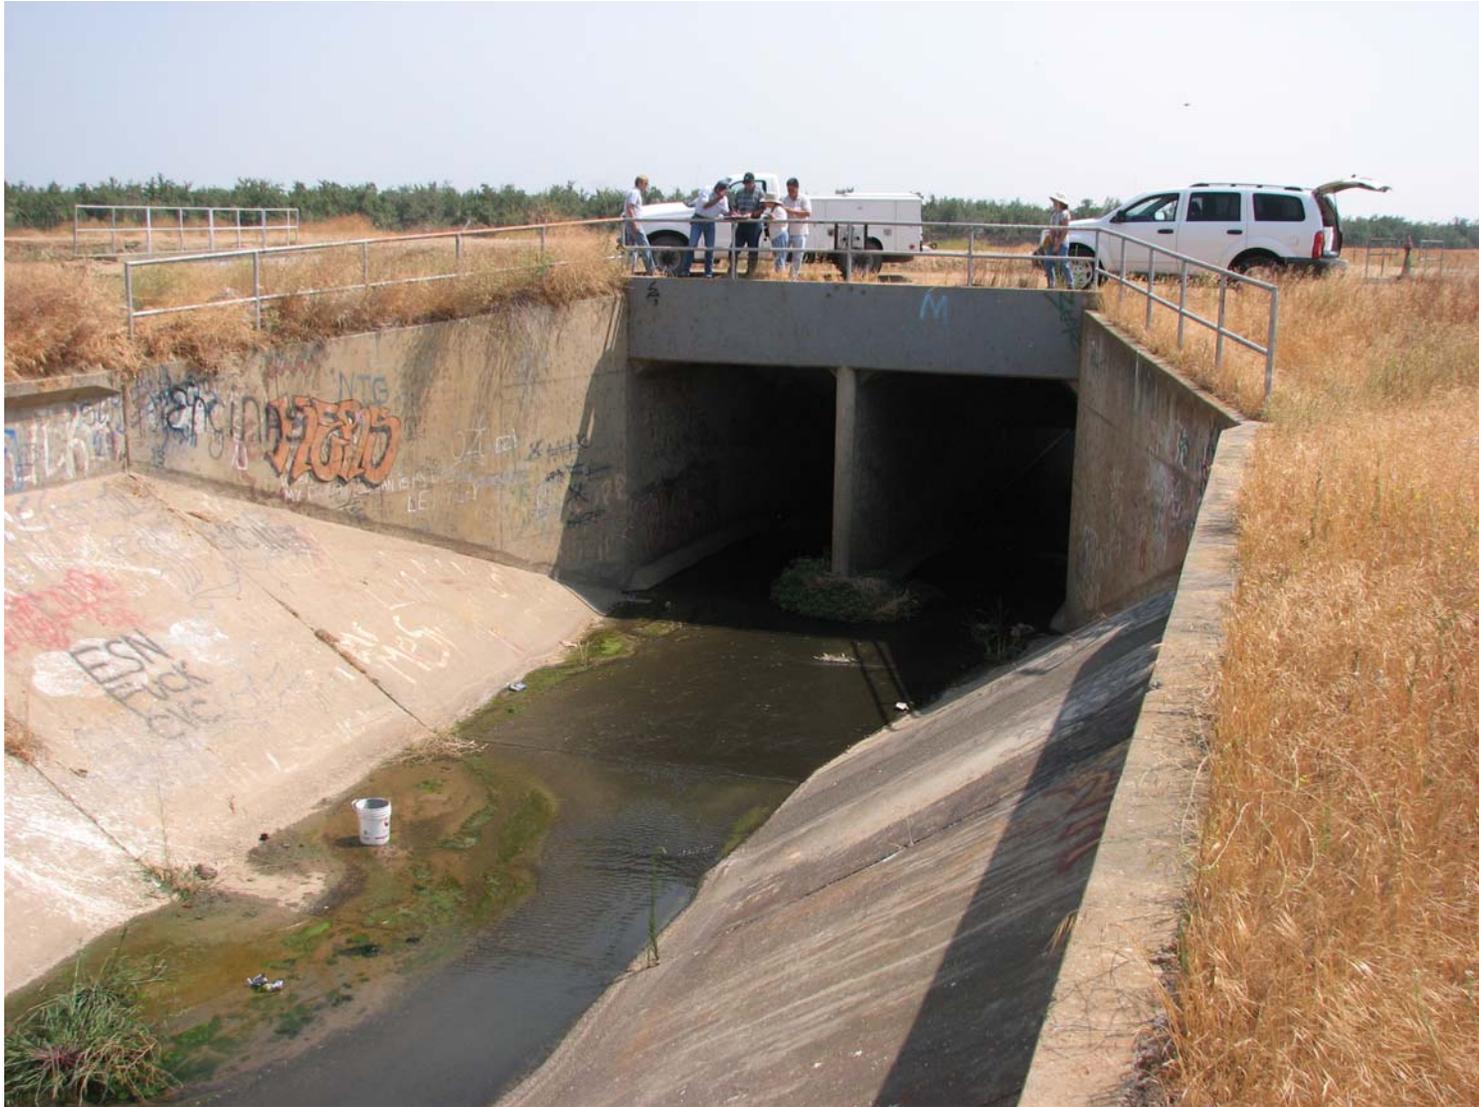
Photo 4

The nearly 60-year-old reinforced concrete structures are in excellent condition. Inlet and outlet wing walls show no significant cracking, spalling or evidence of erosion (Pre-Test Flow Photos 4, 5, 12, 15, 23, 26 and 27). Construction joints are tight and show no offset. Wing walls are thoroughly embedded in the canal slopes except as noted below.

Newman Wasteway - Pre-Test Flow (Baseline) Conditions
Delta Mendota Canal Recirculation Project

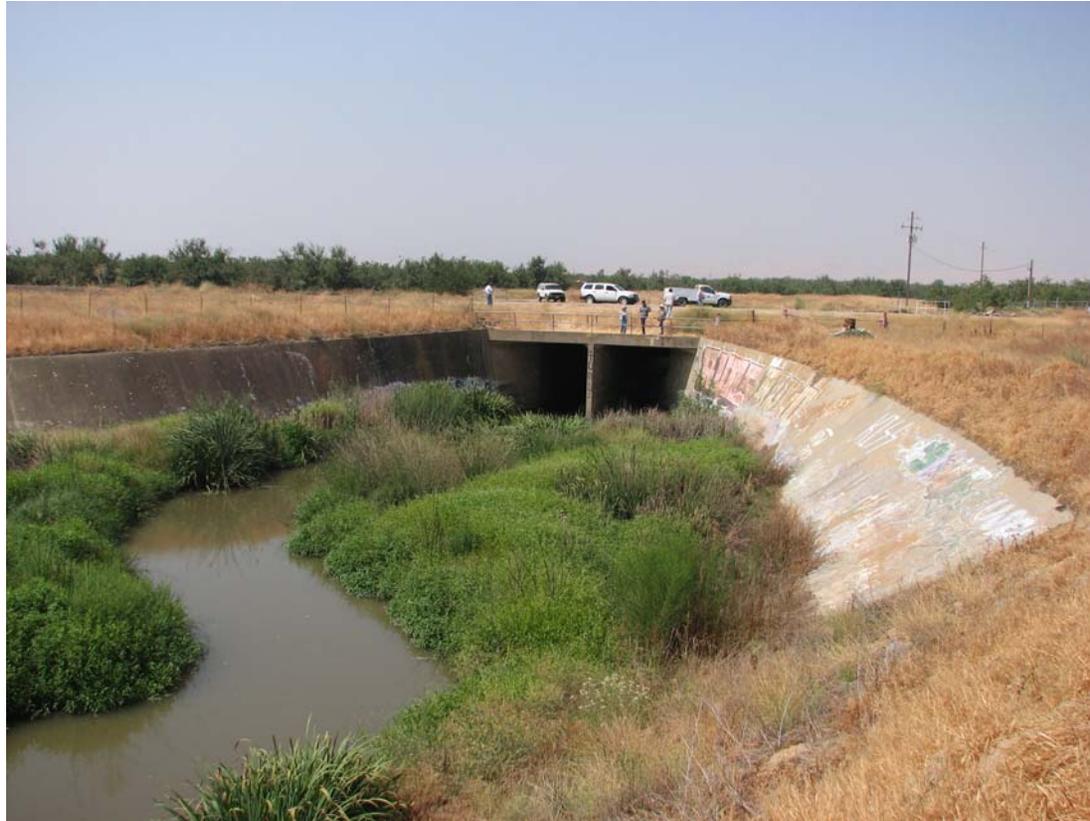
Photo 5

Significant deposits of fine-grained sediment that have been stabilized by dense vegetation are present immediately downstream of either the left or right “barrel” of each drop structure (Pre-Test Flow Photos 5, 16, 20 and 25). These erosion resistant, vegetated deposits impede flow from the drop structures and create stilling basins that promote the settling out of suspended sediment at the drop structure outlets.

Newman Wasteway - Pre-Test Flow (Baseline) Conditions
Delta Mendota Canal Recirculation Project

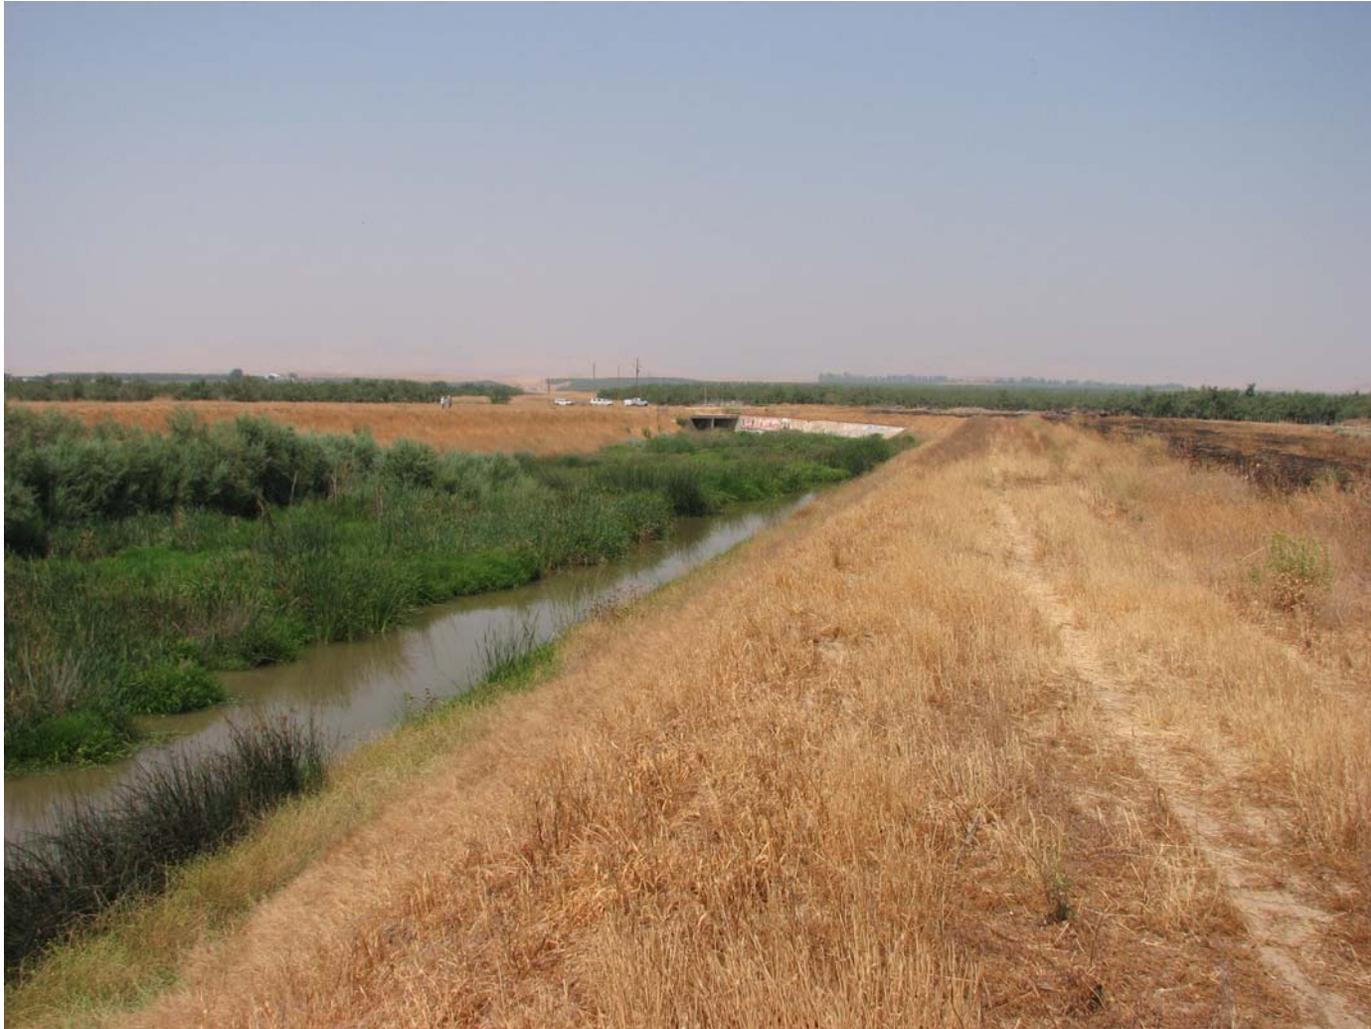
Photo 6

With only a few exceptions as described below, wasteway cutslopes appear stable and show no evidence of erosion or instability (Pre-Test Flow Photos 6, 8, 10, 11, 14, 16-20, 24, 28, 30 and 31). Cutslopes are covered by grasses which provide excellent erosion protection.

Newman Wasteway - Pre-Test Flow (Baseline) Conditions
Delta Mendota Canal Recirculation Project

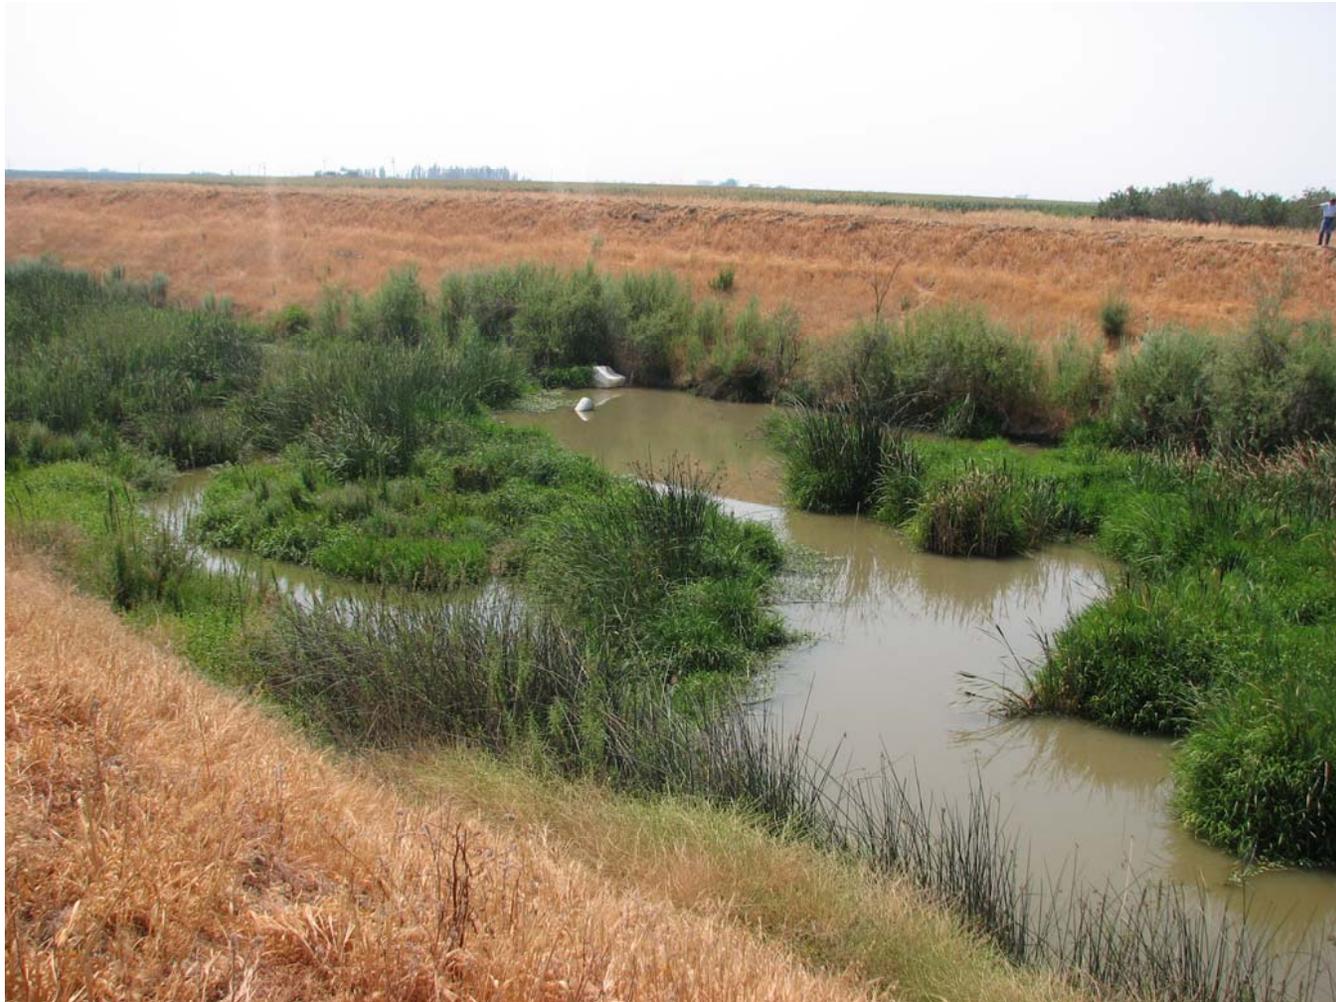
Photo 7

A number of beaver dams are reported to exist within the wasteway between MP 1.44 and MP 6.86. The only dam observed on July 25 is located at MP 1.66, about 1,000 feet downstream of the MP 1.44/Main Canal Drop Structure (Pre-Test Flow Photos 7 and 8). The beaver dam at MP 1.66, considered to be representative of all beaver dams, extends diagonally across the entire wasteway invert and is constructed of reeds and mud. As shown in Pre-Test Flow Photos 7 and 8, the beaver dam is difficult to differentiate from the surrounding vegetation and vegetated sedimentary “islands”.

Newman Wasteway - Pre-Test Flow (Baseline) Conditions
Delta Mendota Canal Recirculation Project

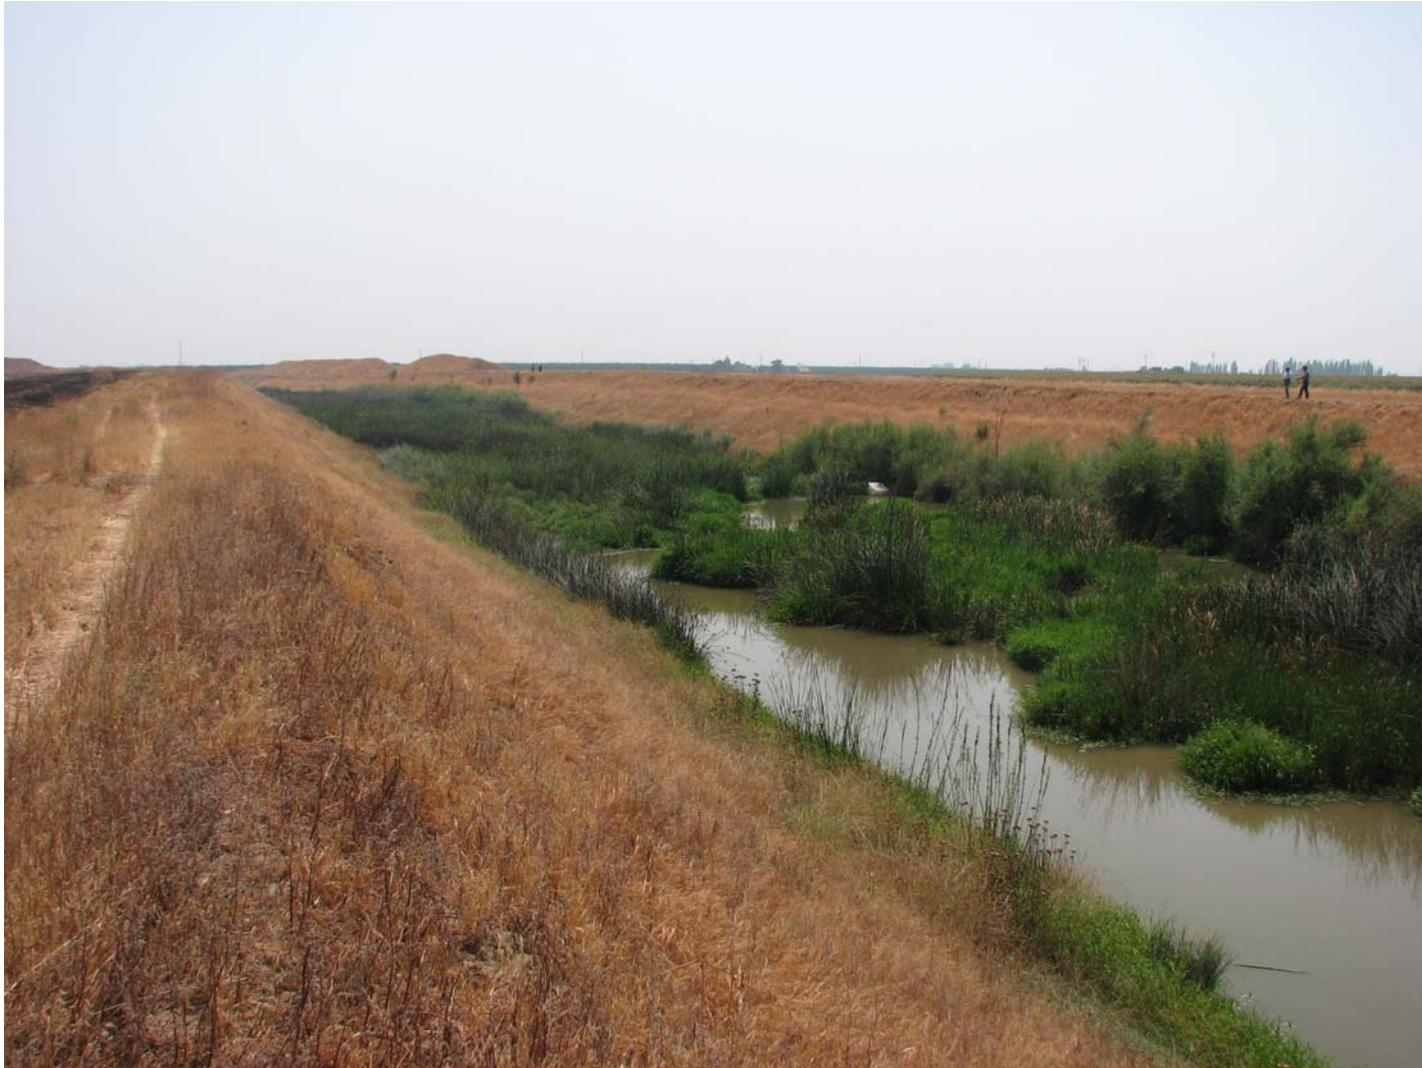
Photo 8

Newman Wasteway - Pre-Test Flow (Baseline) Conditions
Delta Mendota Canal Recirculation Project

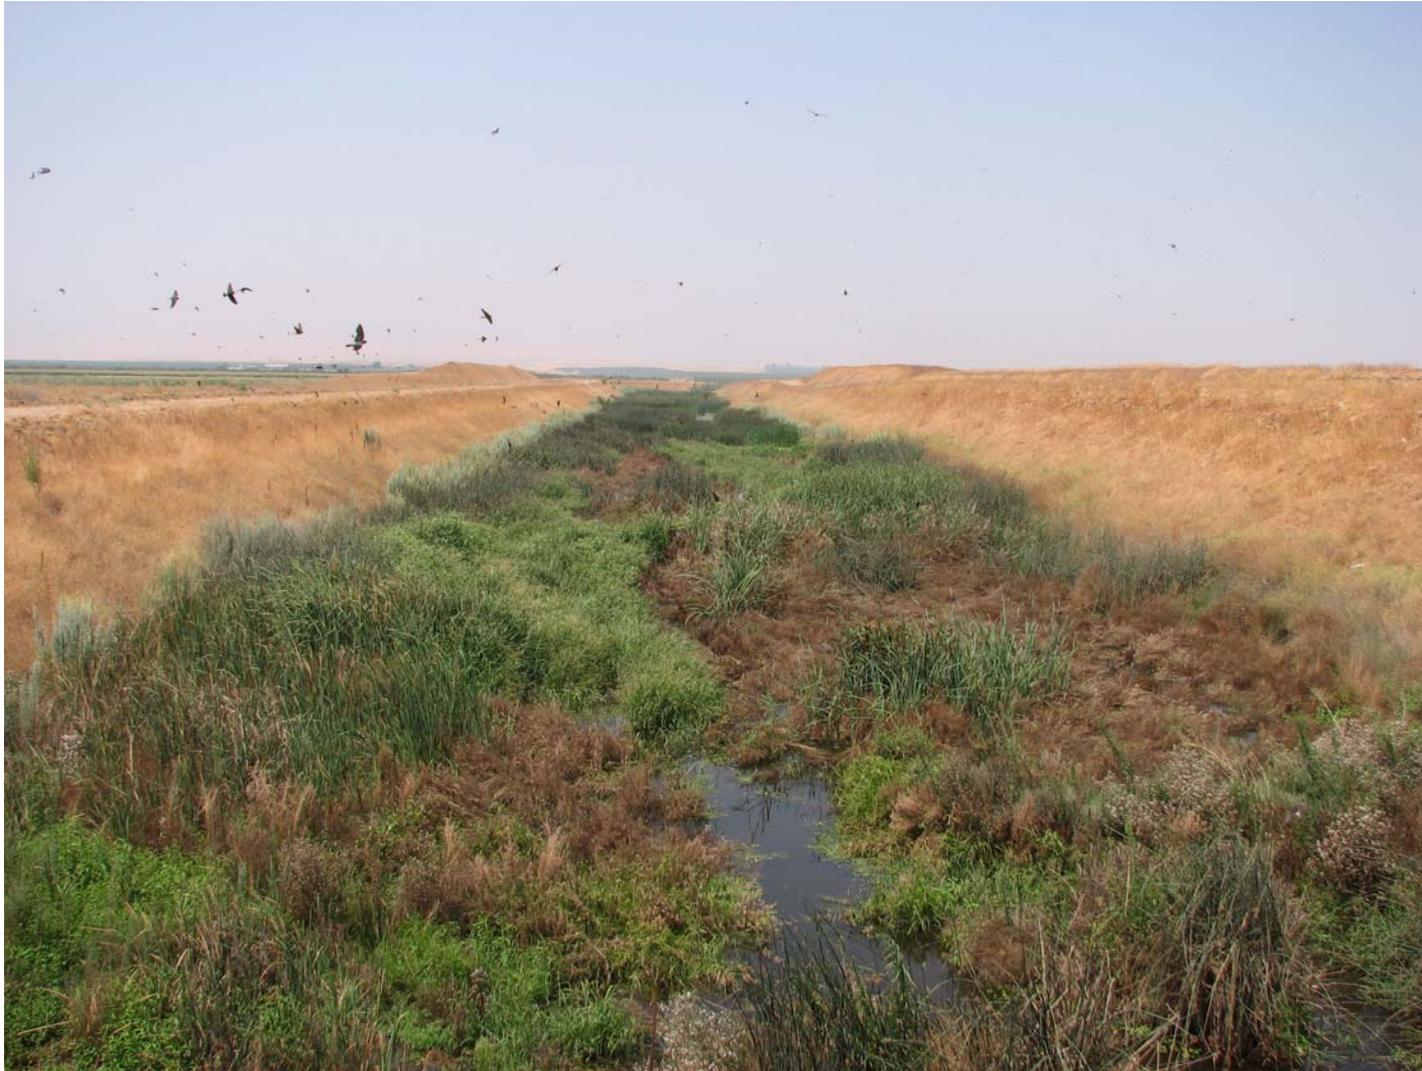
Photo 10

Newman Wasteway - Pre-Test Flow (Baseline) Conditions
Delta Mendota Canal Recirculation Project

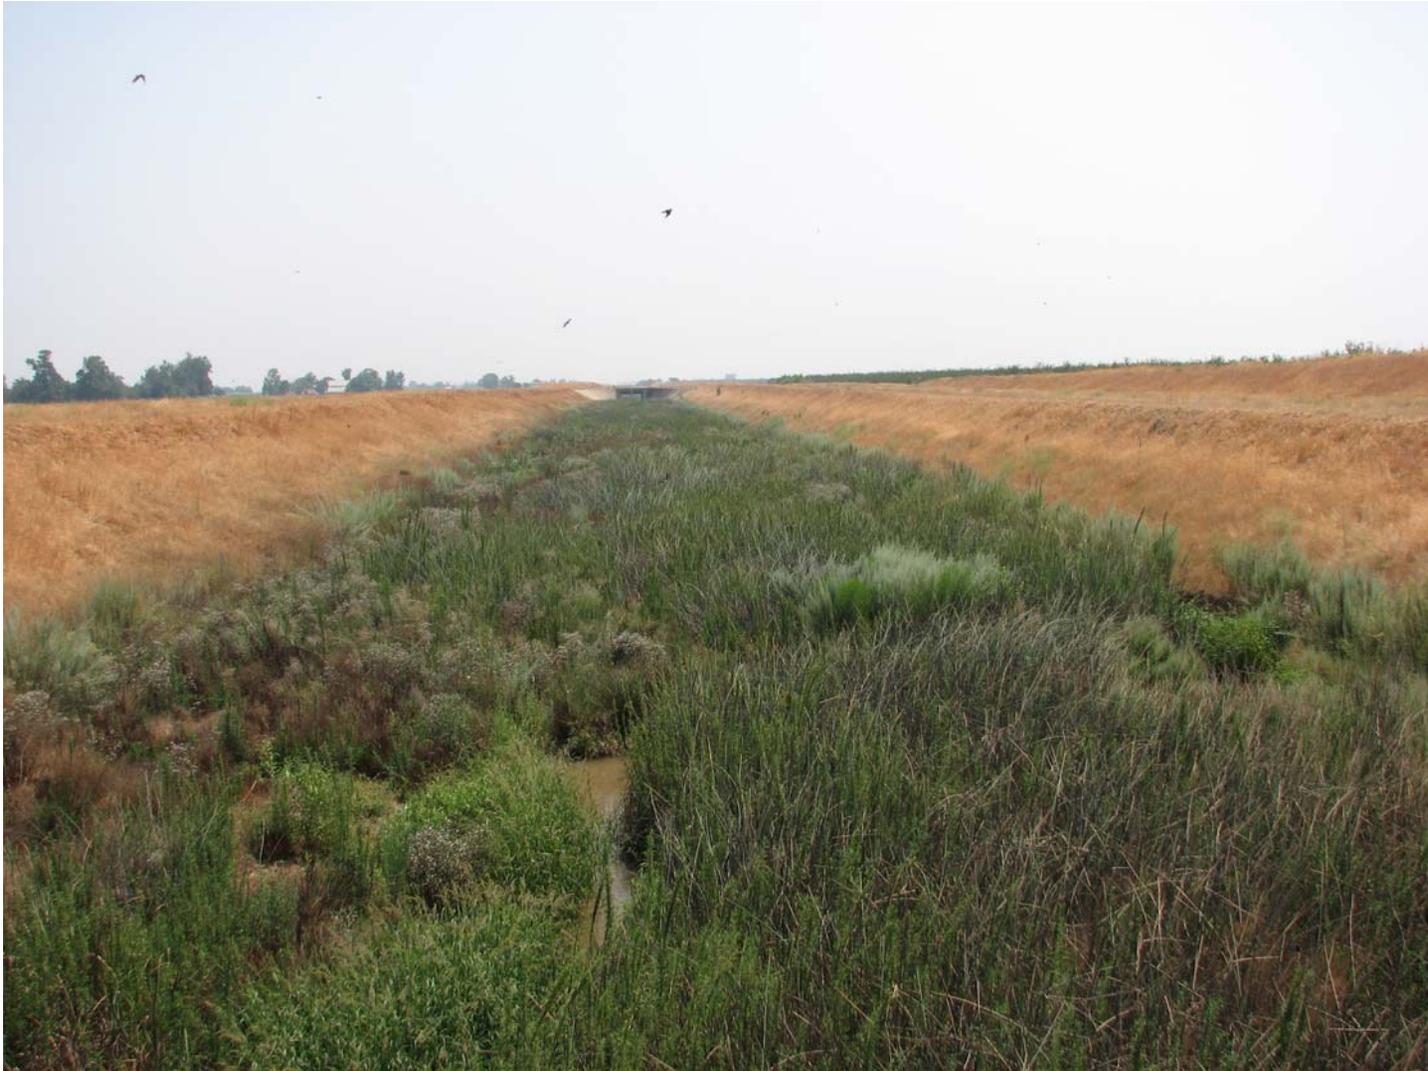
Photo 11

Newman Wasteway - Pre-Test Flow (Baseline) Conditions
Delta Mendota Canal Recirculation Project

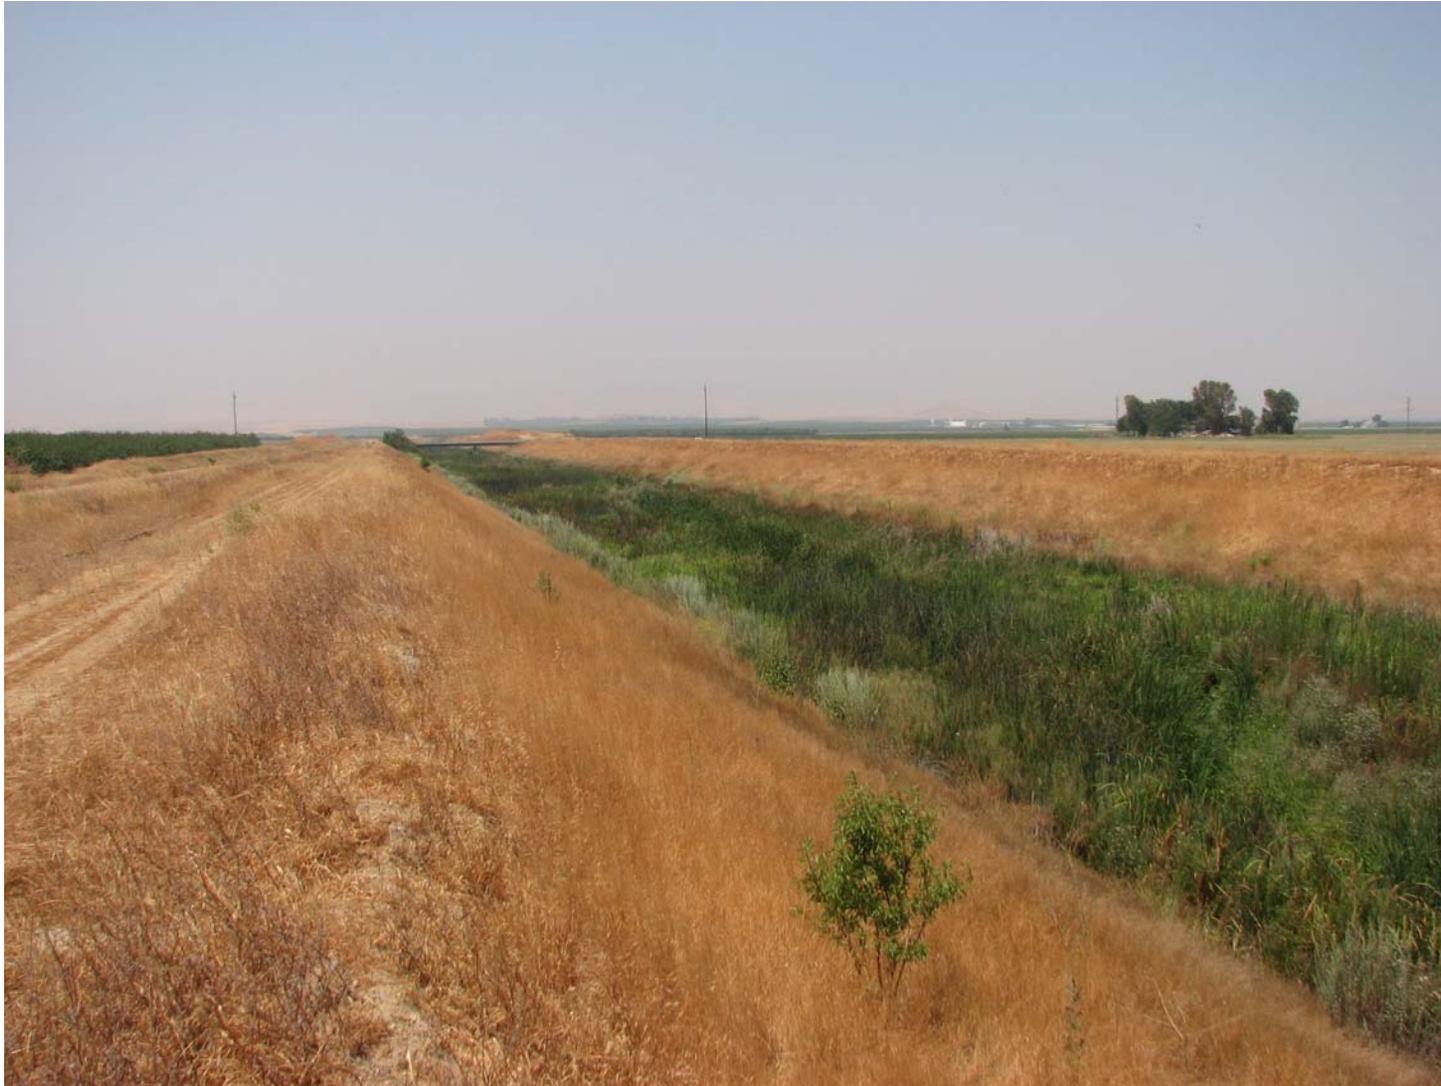
Photo 14

Newman Wasteway - Pre-Test Flow (Baseline) Conditions
Delta Mendota Canal Recirculation Project

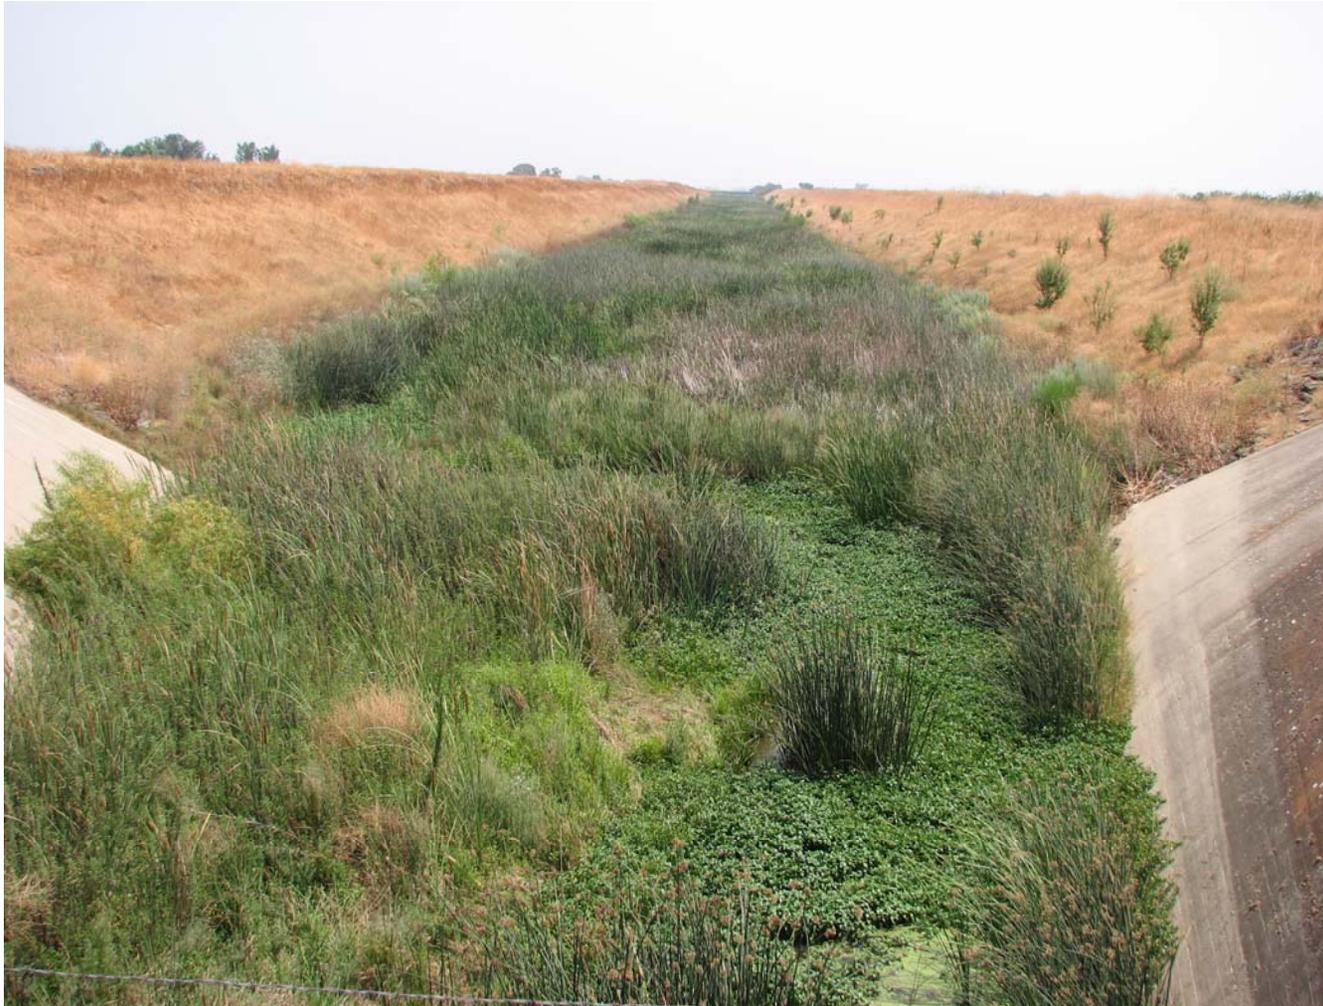
Photo 16

Newman Wasteway - Pre-Test Flow (Baseline) Conditions
Delta Mendota Canal Recirculation Project

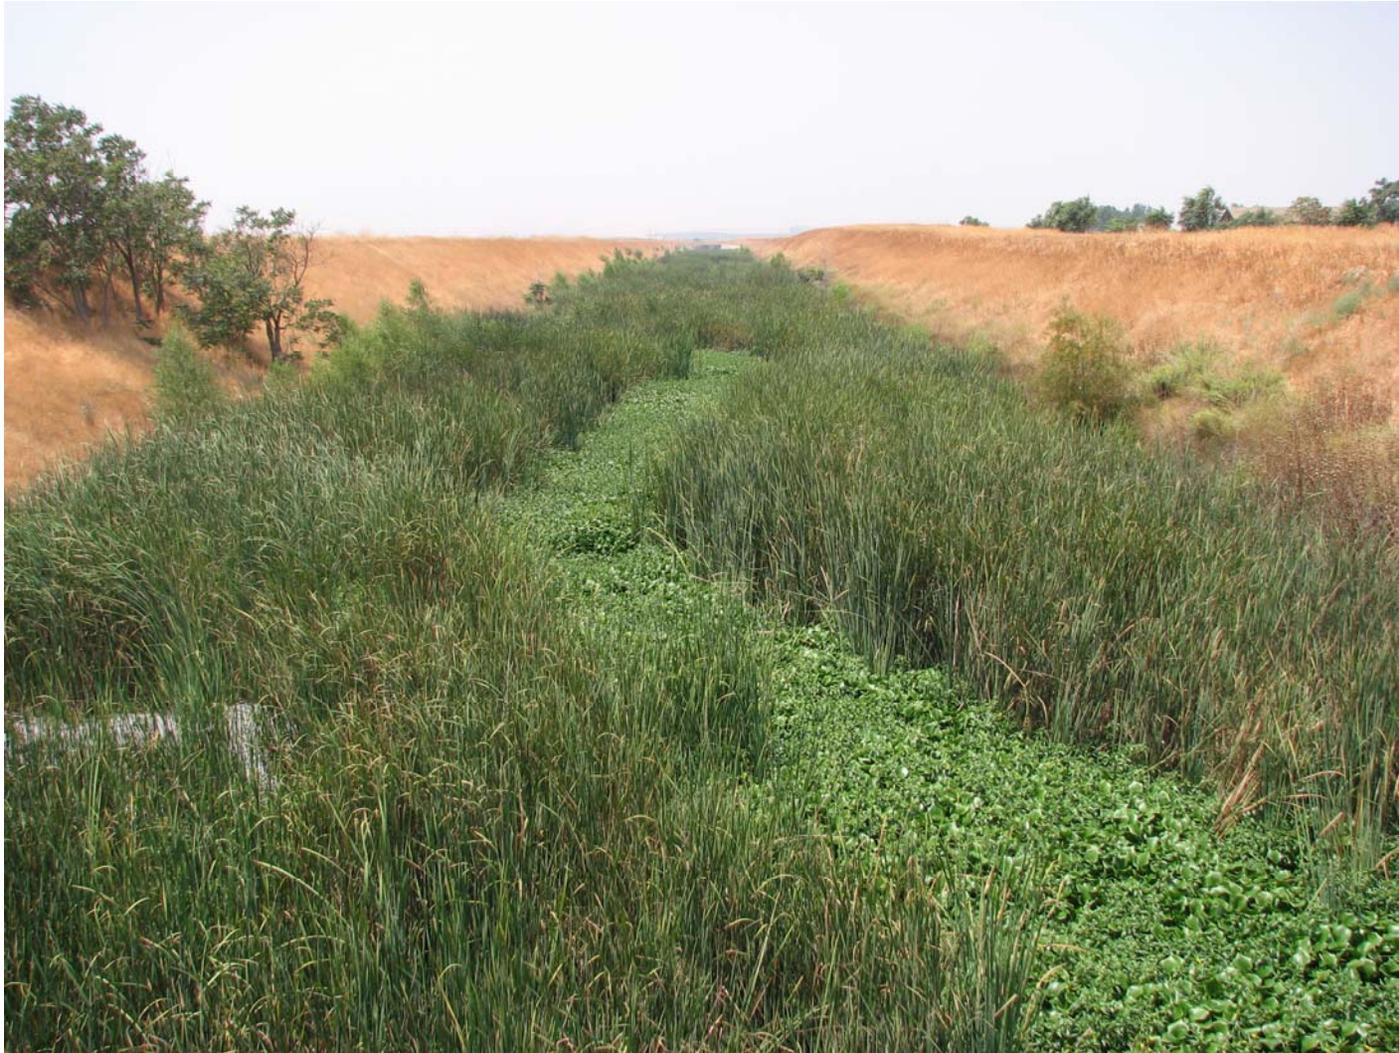
Photo 17

Newman Wasteway - Pre-Test Flow (Baseline) Conditions
Delta Mendota Canal Recirculation Project

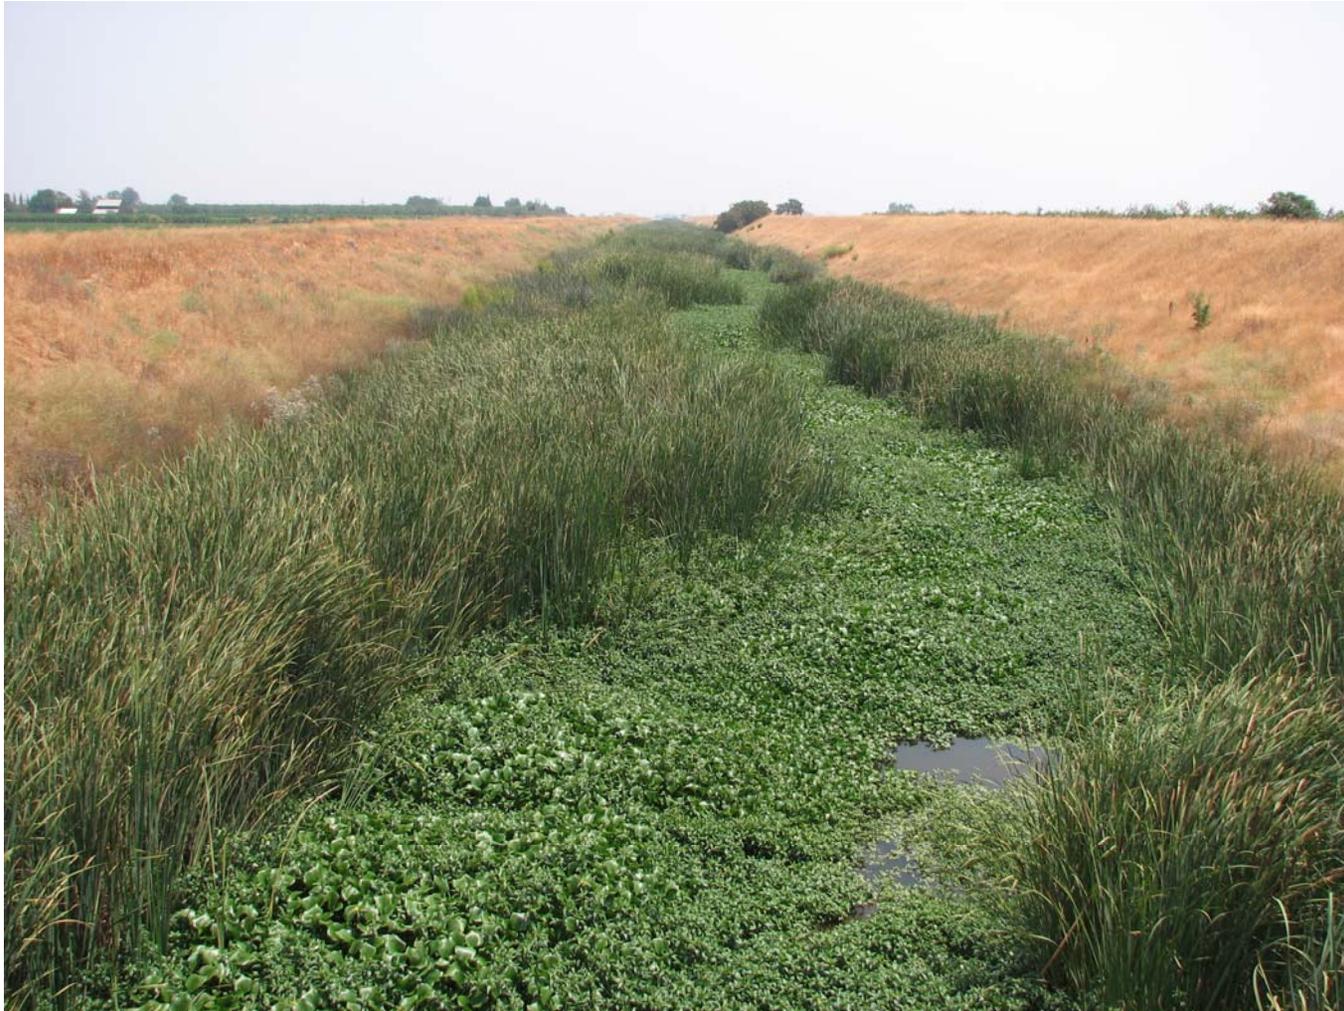
Photo 18

Newman Wasteway - Pre-Test Flow (Baseline) Conditions
Delta Mendota Canal Recirculation Project

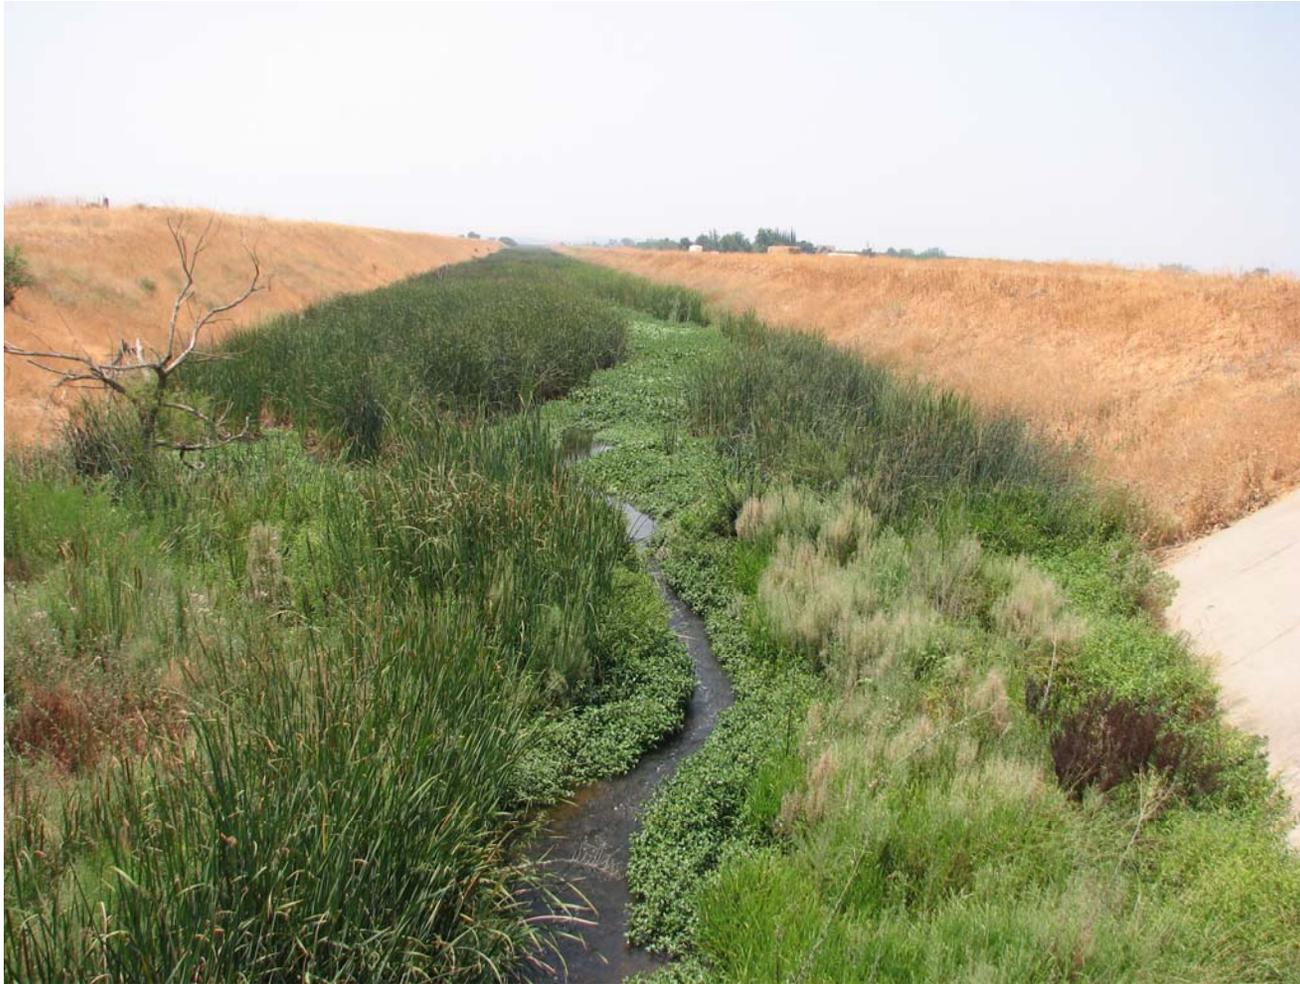
Photo 19

Wasteway flow is primarily irrigation runoff discharged by over 20 drains and a far lesser amount of leakage from the DMC past the radial gates at the Newman Canal headworks (Pre-Test Flow Photo 9). Flows steadily increase in the downstream direction in response to an increase in the number of drains discharging into the wasteway. A flow of 6 cfs was estimated just upstream of the MP 4.21/Hwy 33 Drop Structure on July 25 (Photo 19).

Newman Wasteway - Pre-Test Flow (Baseline) Conditions
Delta Mendota Canal Recirculation Project

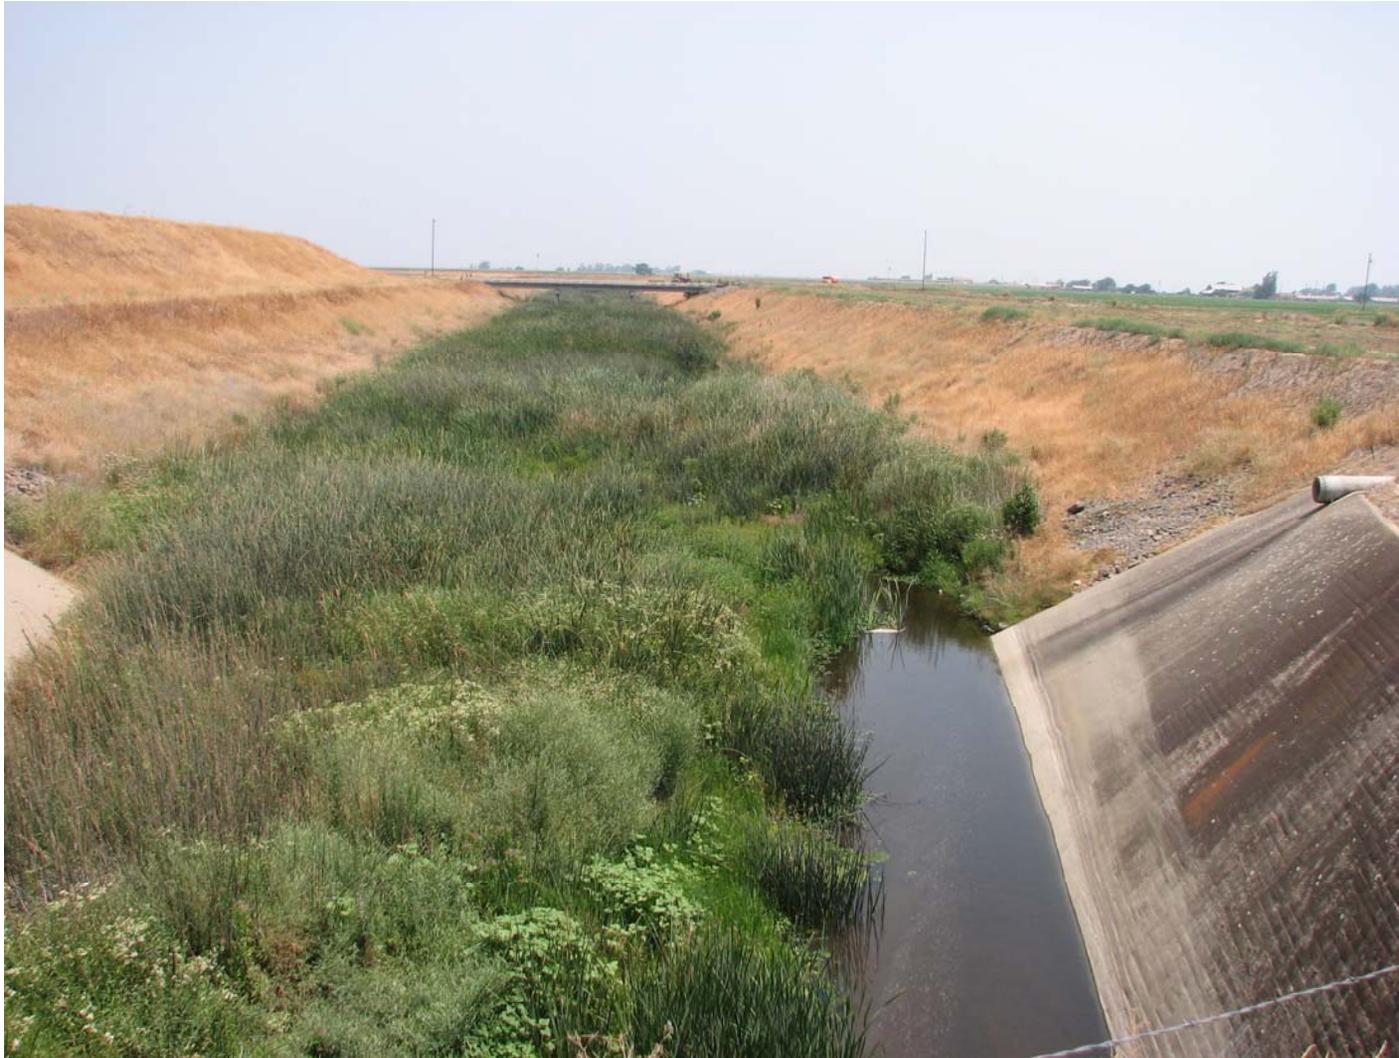
Photo 20

Newman Wasteway - Pre-Test Flow (Baseline) Conditions
Delta Mendota Canal Recirculation Project

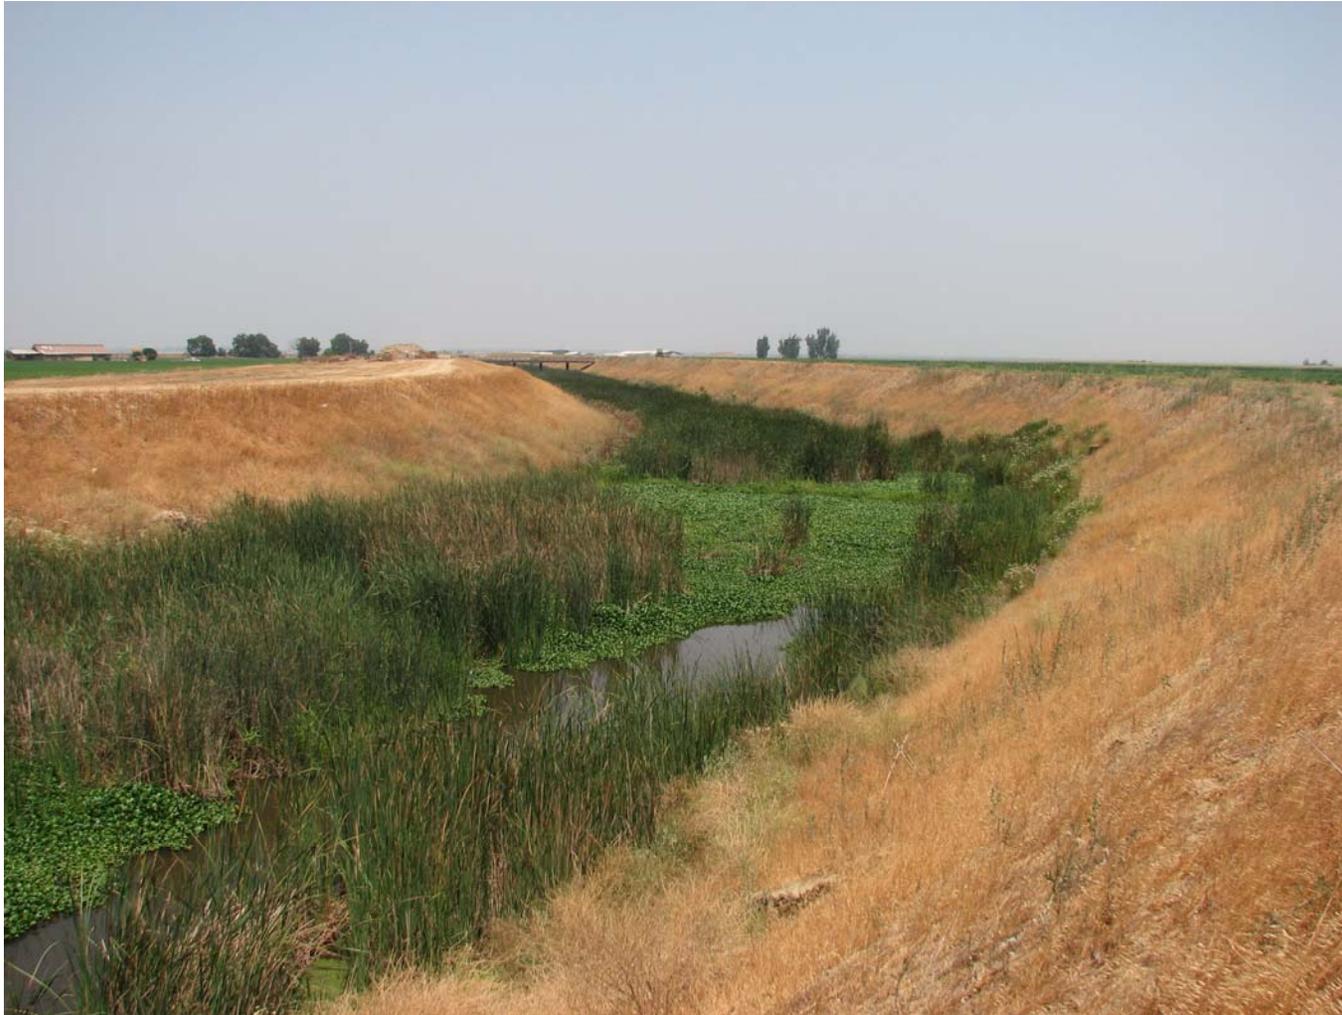
Photo 21

For much of the 5.4 mile length of this reach, the wasteway invert is characterized by a well-defined, generally sinuous, central channel or waterway that is flanked by a dense growth of reeds or, less commonly grasses, that covers most of the wasteway invert (Pre-Test Flow Photos 5 to 12 and 14 to 28). The central channel carries the majority of the wasteway flow and is open and free of vegetation from the MP 1.44 Drop to the MP 2.48 Drop (Pre-Test Flow Photos 5 to 8, 21, 22 and 24) and is mostly filled with a dense growth of water plants (mainly primrose) from the MP 2.48 Drop to the MP 6.86 Drop (Pre-Test Flow Photos 16 to 19 and 25).

Newman Wasteway - Pre-Test Flow (Baseline) Conditions
Delta Mendota Canal Recirculation Project

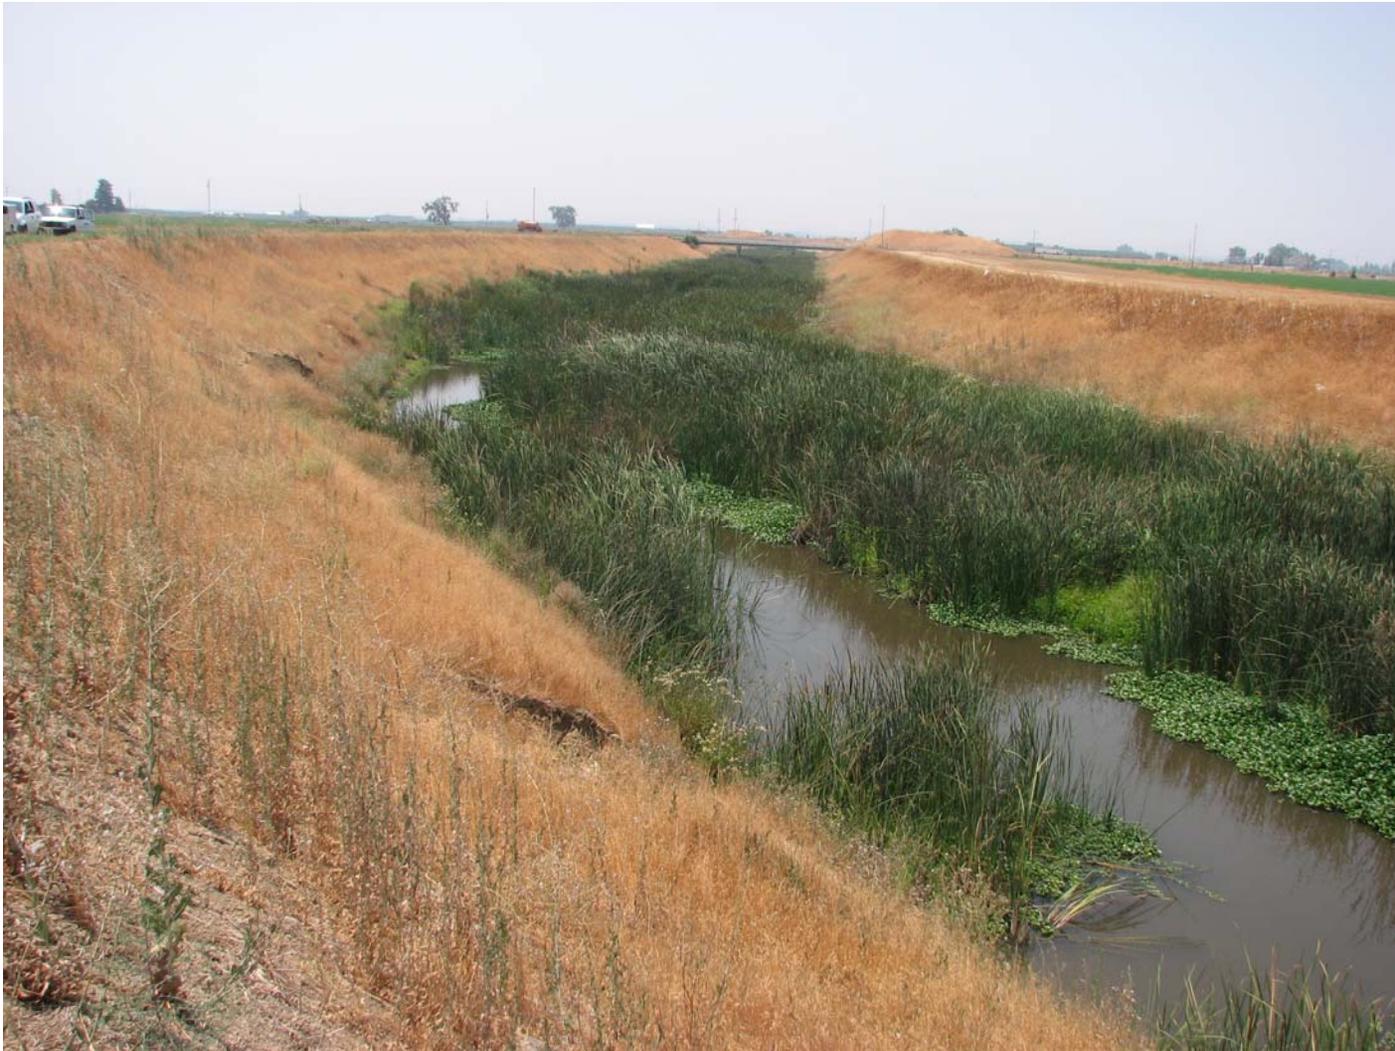
Photo 22

Newman Wasteway - Pre-Test Flow (Baseline) Conditions
Delta Mendota Canal Recirculation Project
