ENGINEERING GEOLOGIC EVALUATION OF THE NEWMAN WASTEWAY AND STRUCTURES

DELTA MENDOTA CANAL RECIRCULATION FEASIBILITY STUDY

JANUARY 2009

U.S. DEPARTMENT OF INTERIOR
BUREAU OF RECLAMATION
MID PACIFIC REGION GEOLOGY BRANCH
SACRAMENTO, CA

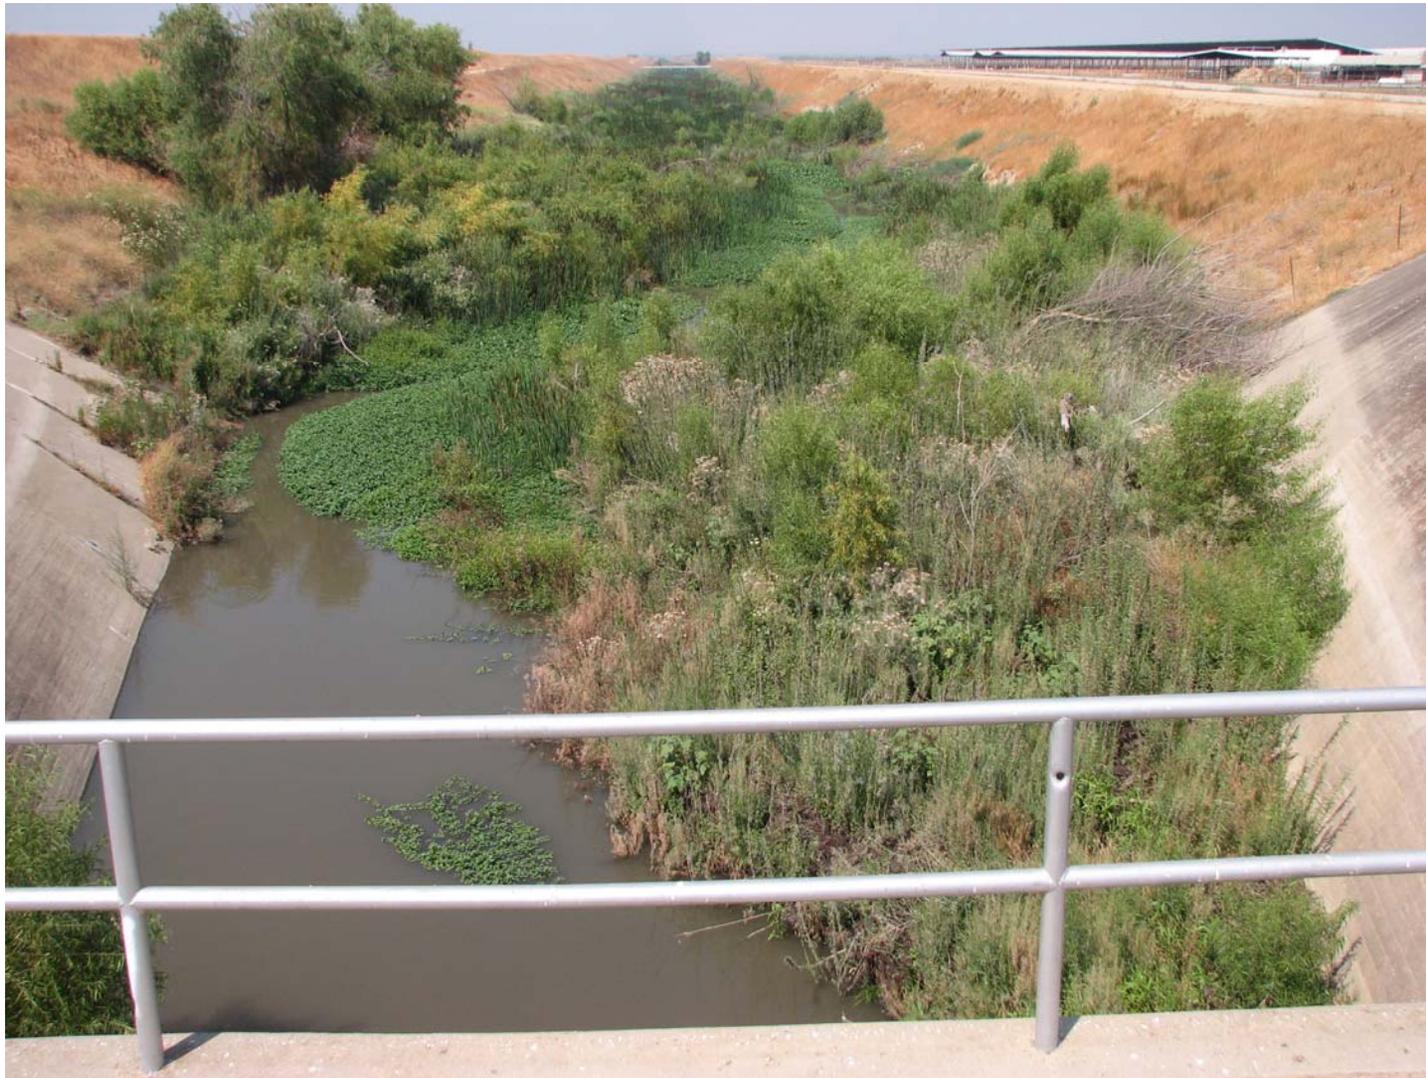
Photo 25

View looking northeast (downstream) from the drop structure. A deposit of fine-grained sediment that has been stabilized by dense vegetation is present downstream of the right barrel (see also Photo 26).

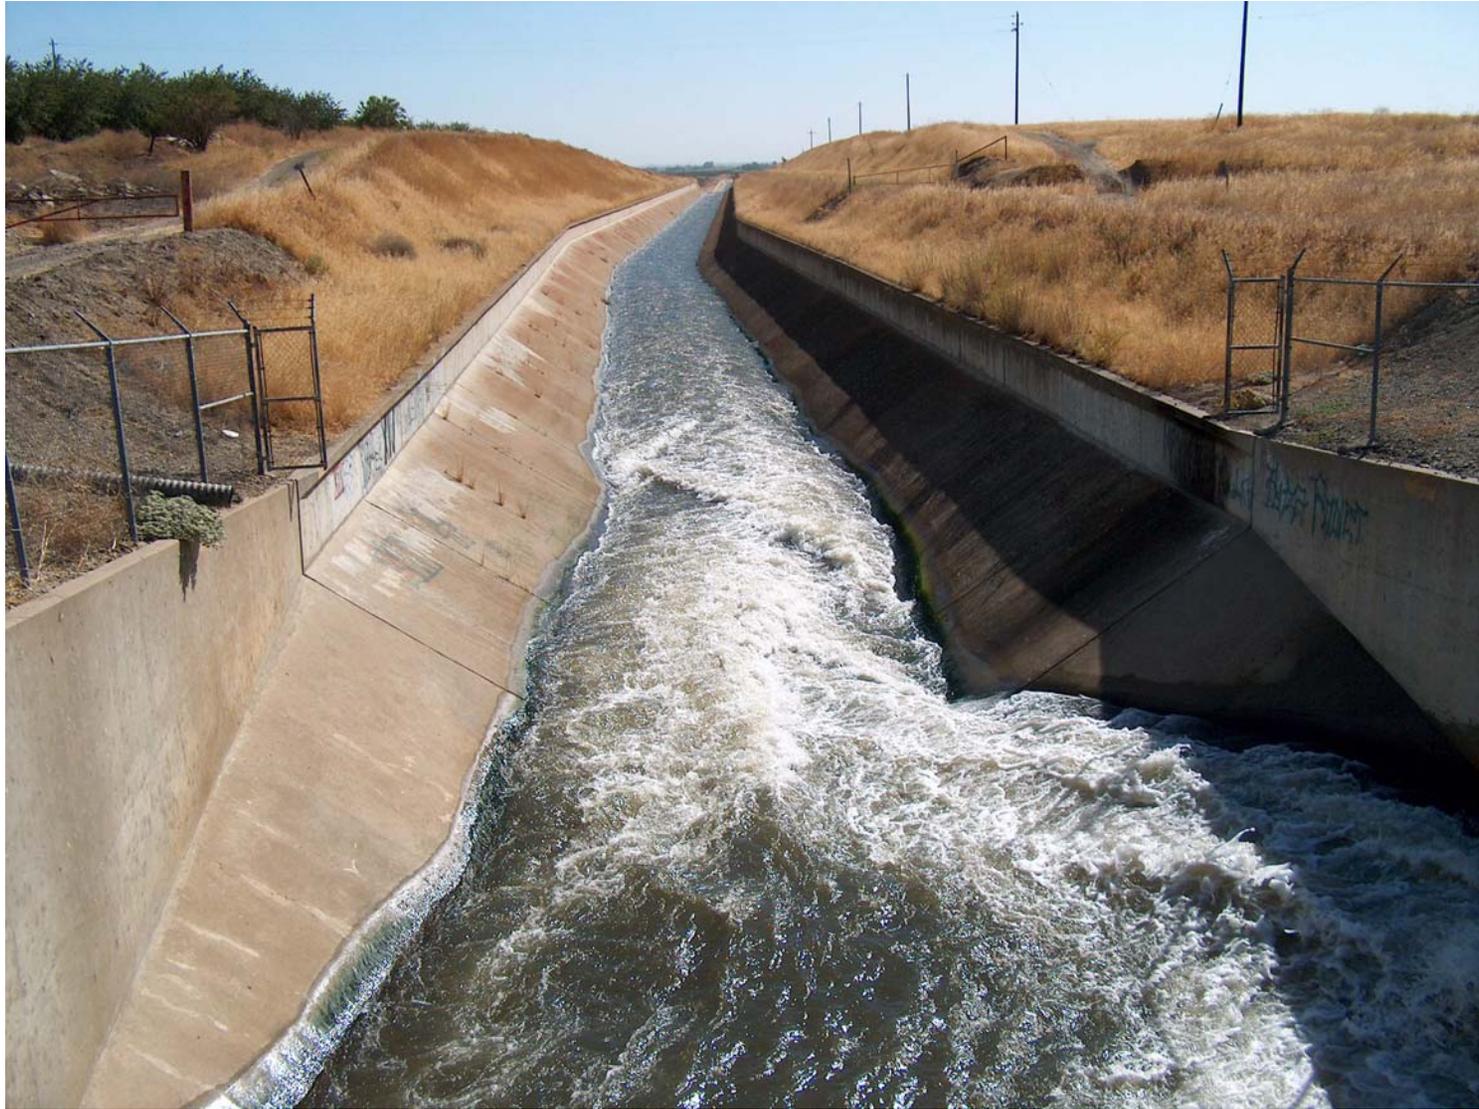
Photo 1

View east (downstream) at a test flow of approximately 250 cfs,
R. Patras

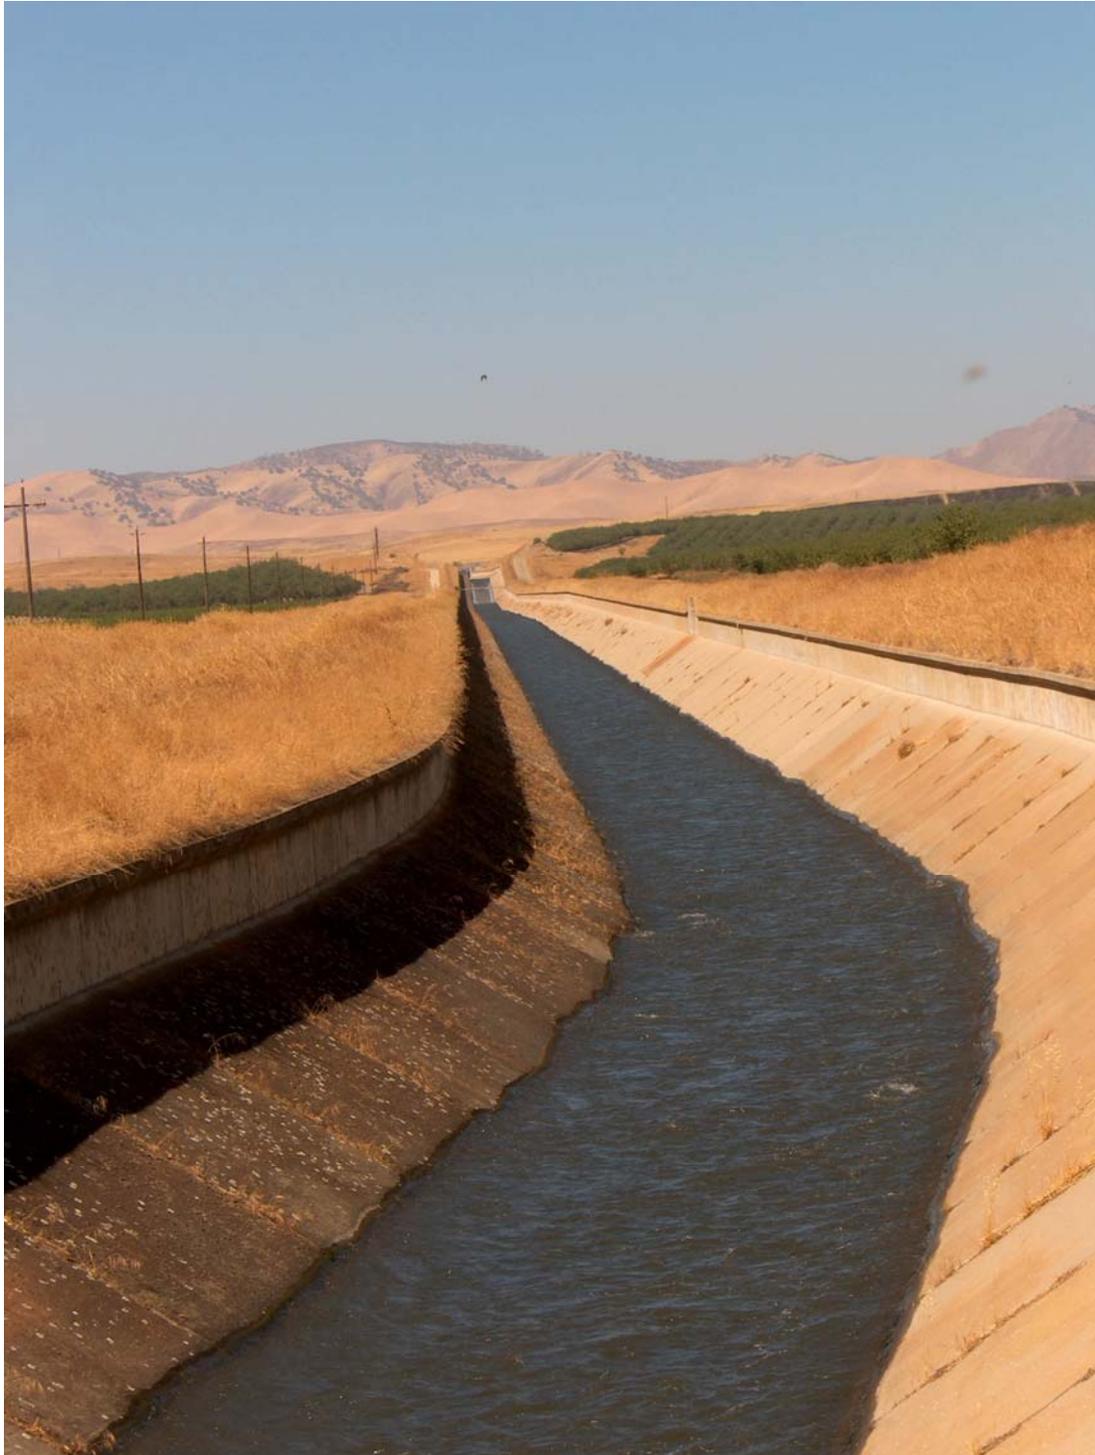
Photo 2

View west (upstream) at a test flow of approximately 250 cfs,
R. Patras

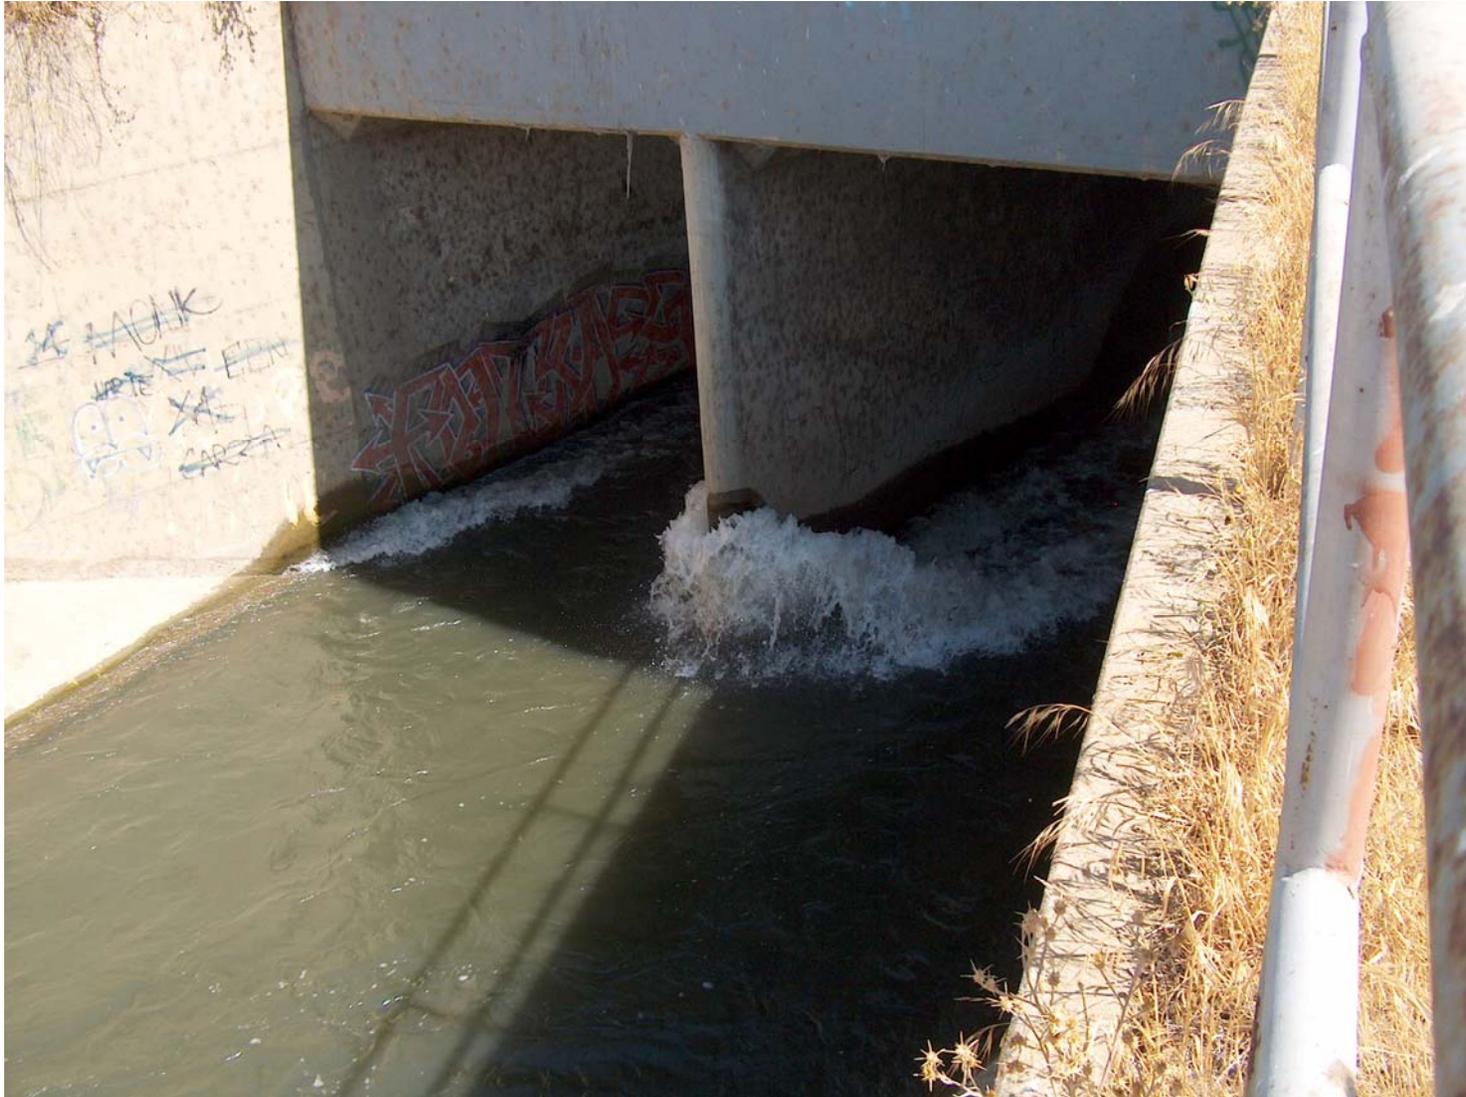
Photo 4

View northeast (downstream) at the drop structure inlet passing approximately 250 cfs,
R. Patras

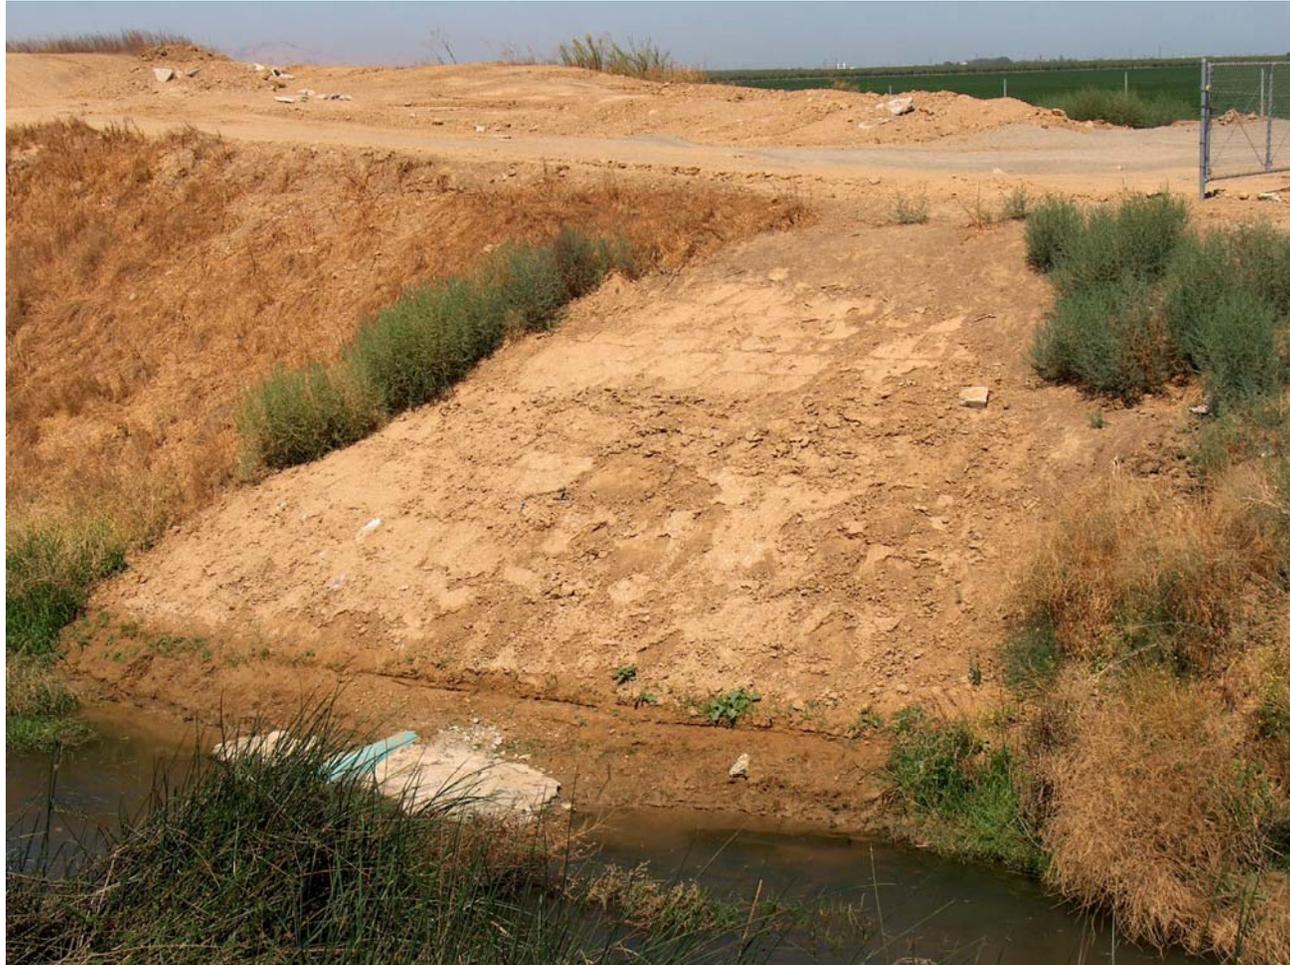
Photo 9

View northwest (upstream left) at a drain inlet that was replaced prior to the high test flows. No erosion or degradation of the compacted, fine-grained fill is evident.

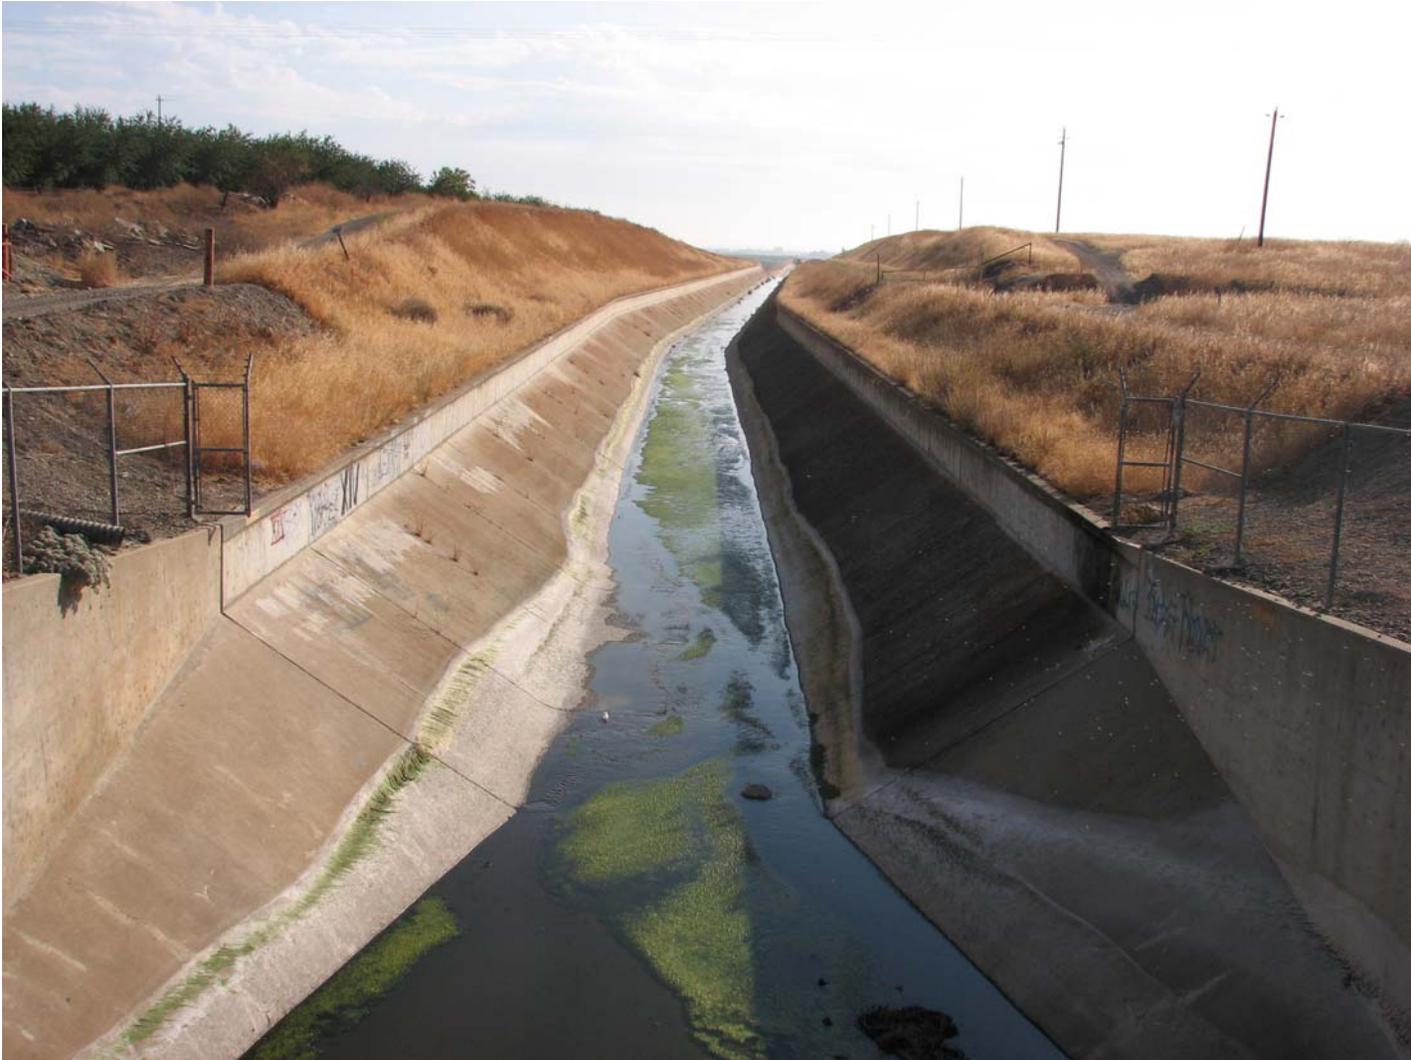
Photo 1

View east (downstream). All concrete remains in excellent condition following high test flows. Compare to Pre-Test Flow Photo 1.

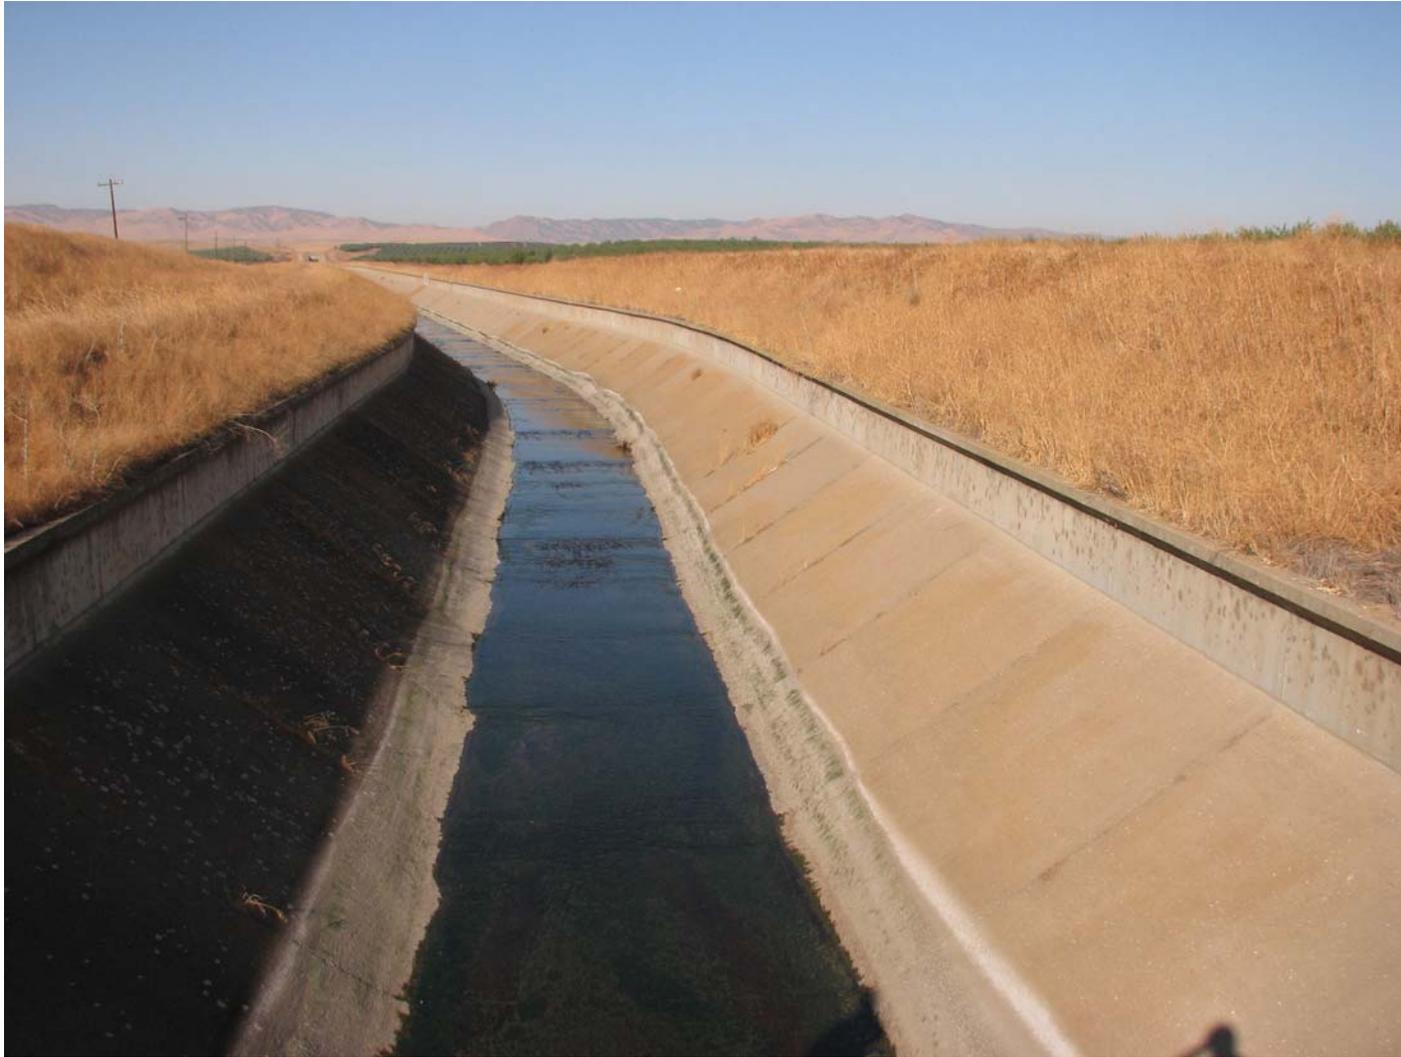
Photo 2

View west (upstream). All concrete remains in excellent condition following high test flows. Compare to Pre-Test Flow

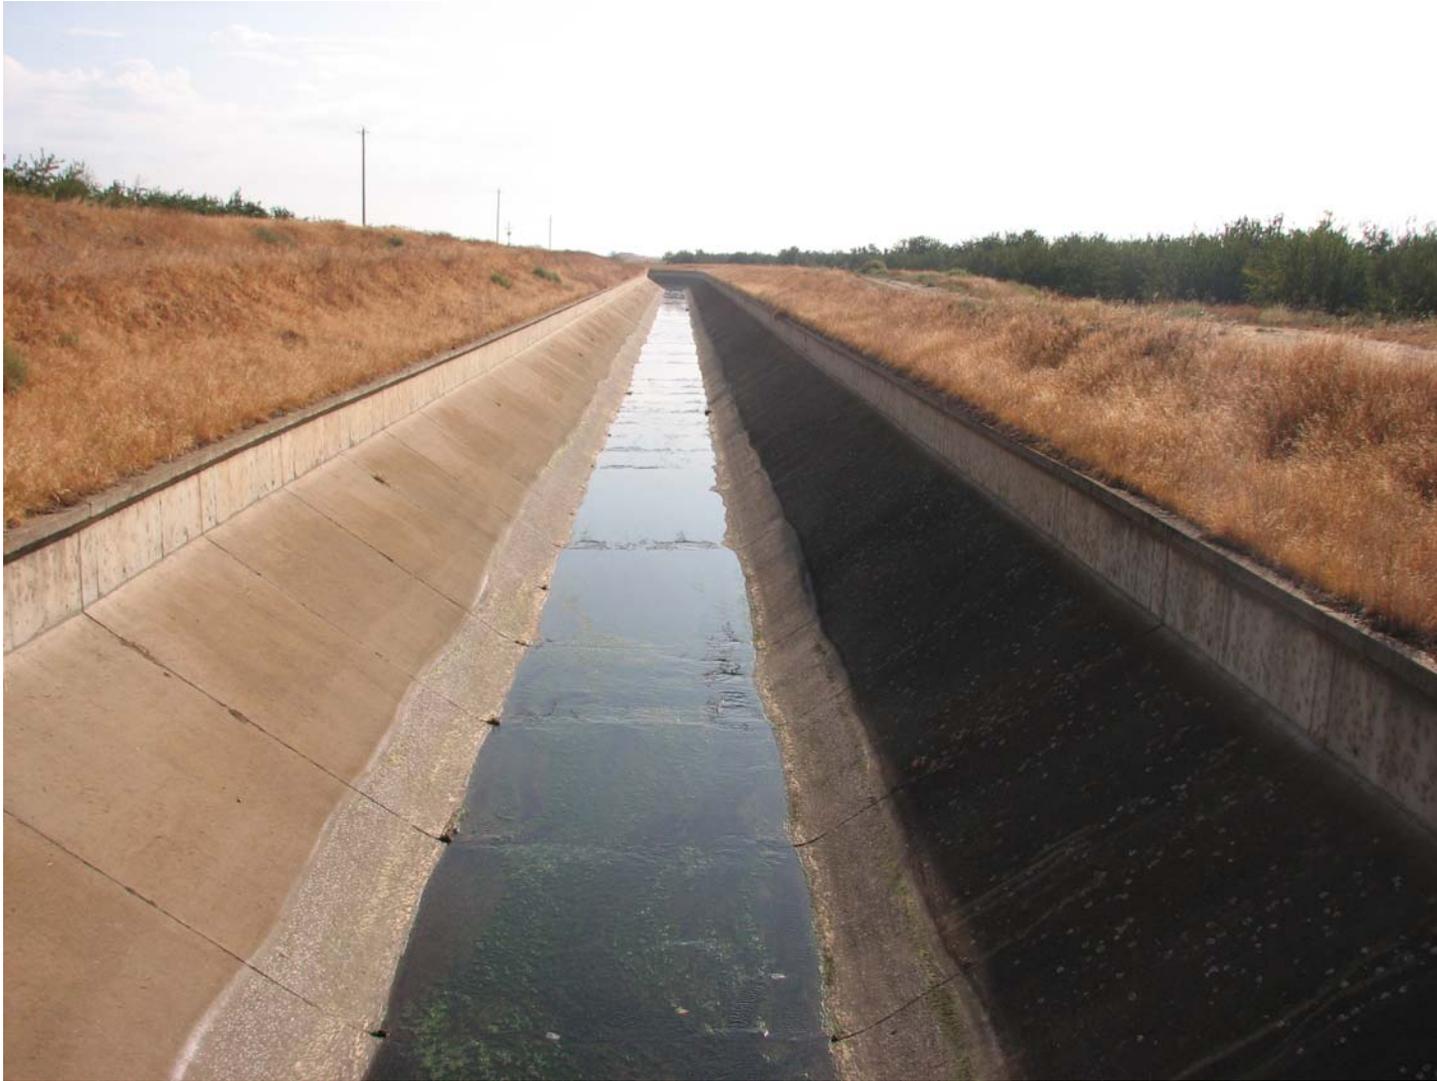
Photo 3

View east (downstream). All concrete remains in excellent condition following high test flows. Compare to Pre-Test Flow Photo 3.

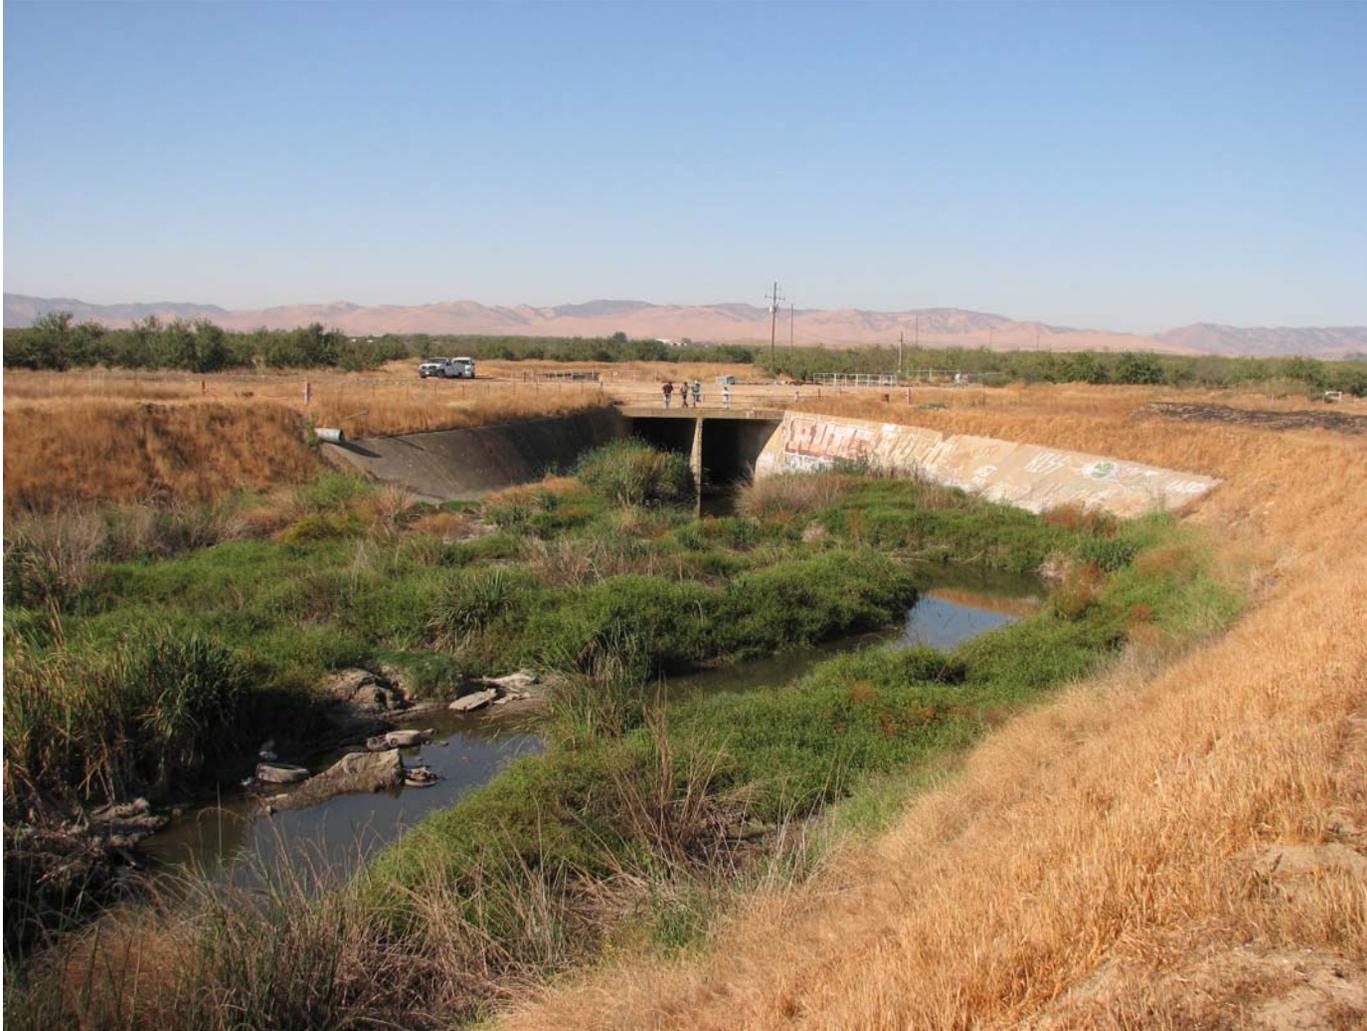
Photo 5

View southwest (upstream) at the drop structure outlet and outlet transition wing walls. High test flows flattened or removed a significant amount of vegetation and the inner channel shifted to the left (looking downstream) just downstream of the outlet (see also Photo 6). Compare to Pre-Test Flow Photo 5.

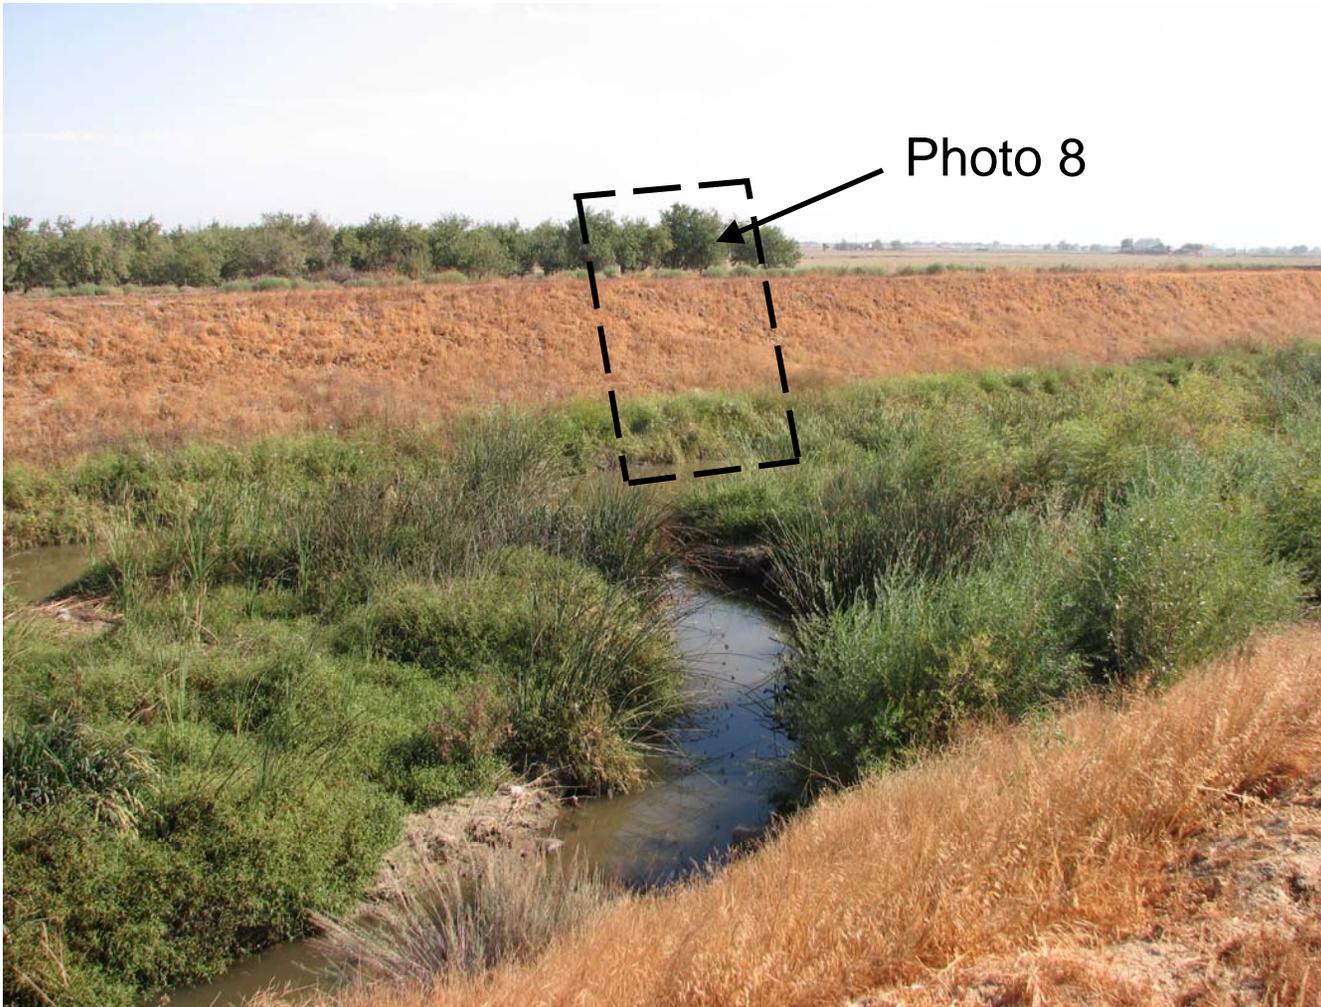
Photo 7

View northeast (downstream left) of the wasteway invert and left cutslope at about MP 1.55, approximately 500 feet downstream of the MP 1.44 Drop Structure. Only small, localized, patches of vegetation were removed by high test flows (lower left foreground). No erosion is evident where the channel runs along the well-vegetated base of the left cutslope. Compare to Test Flow Photo 7.

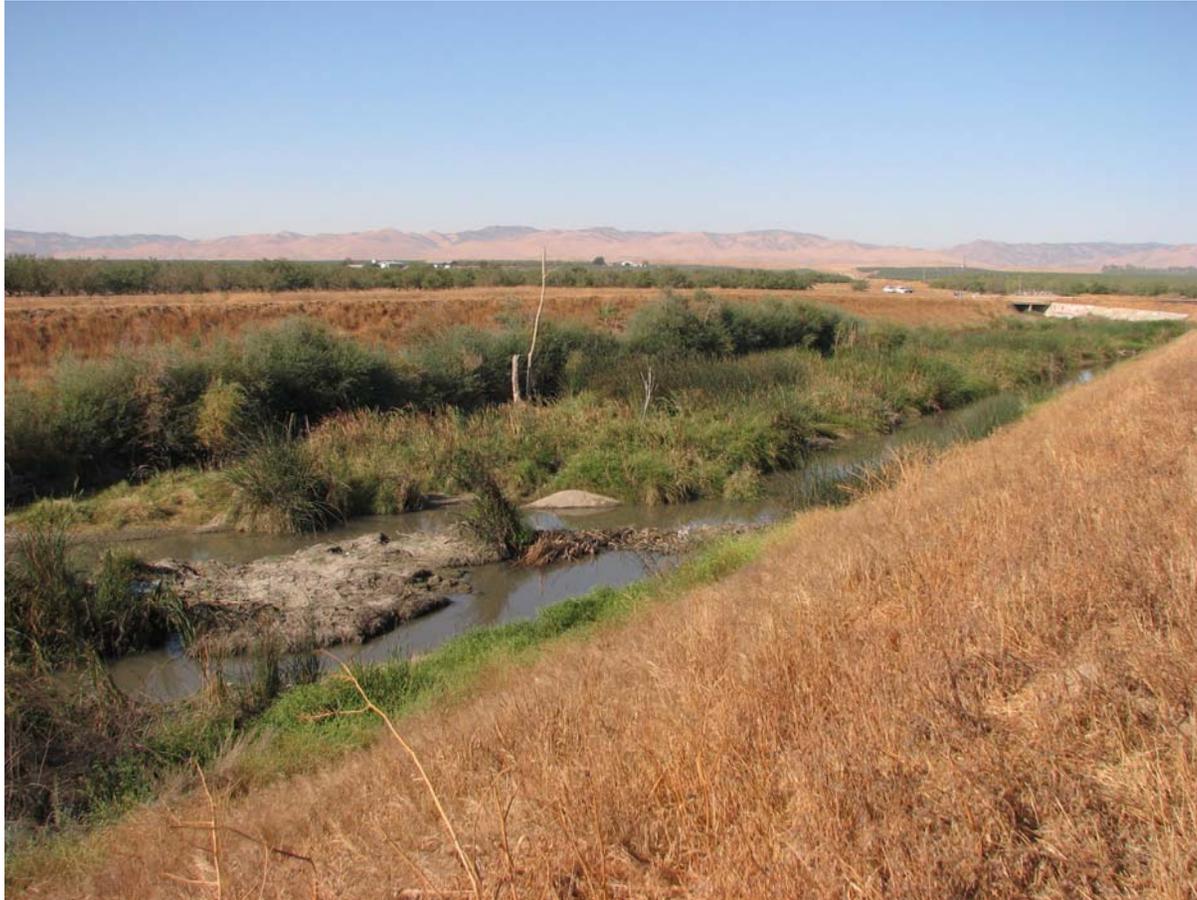
Photo 9

View west (upstream) of the drop structure outlet and downstream wasteway channel. A beaver dam is visible at photo center at about MP 1.66. Compare to Pre-Test Flow Photos 7 and 8 and Test Flow Photo 8.

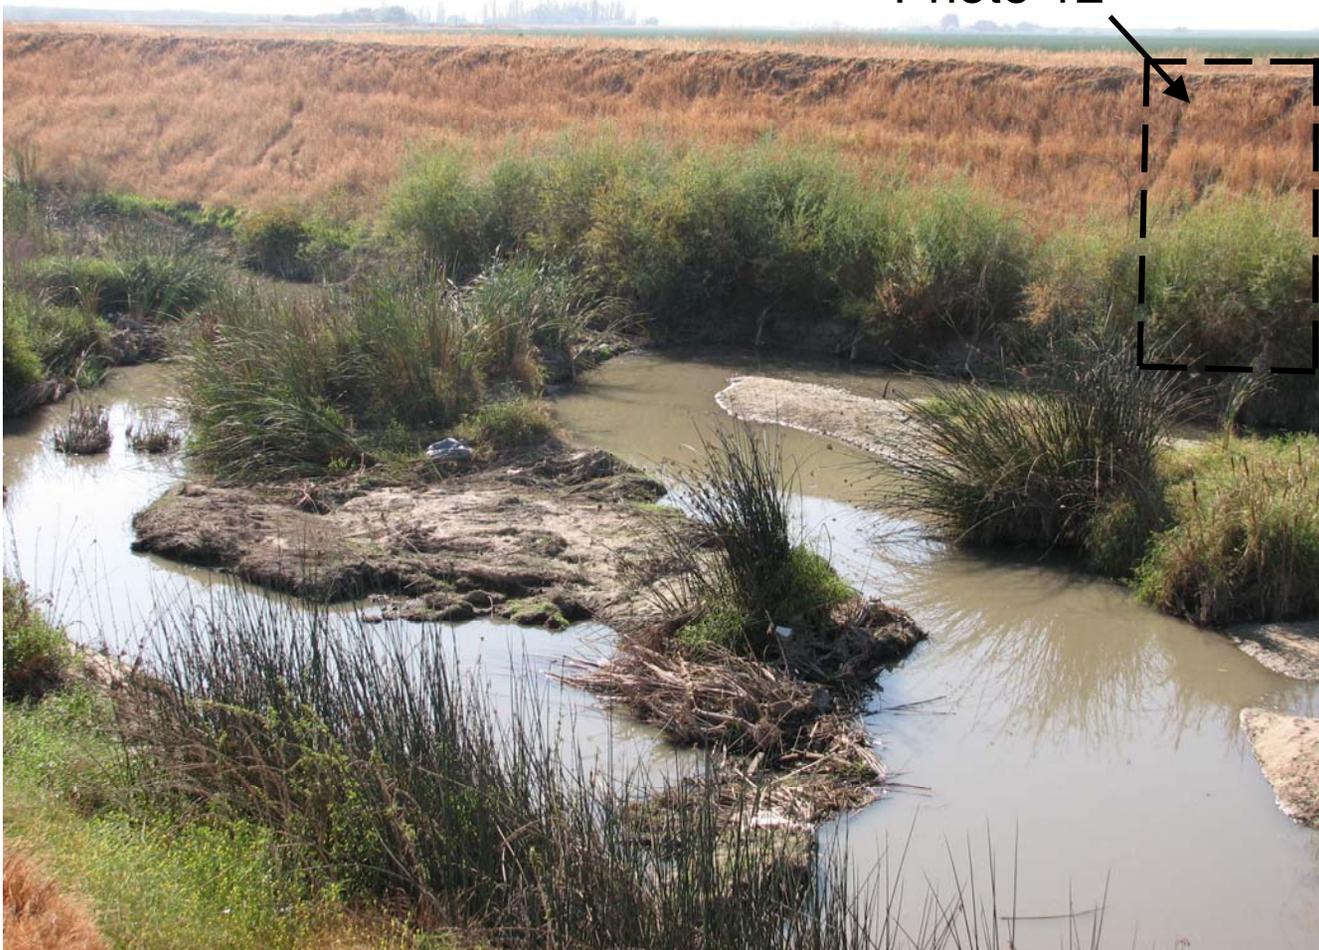
Photo 11

View south (downstream right) at a beaver dam at MP 1.66, about 1000 feet downstream of Drop Structure MP 1.44. Vegetation was flattened or removed by high test flows just downstream of the beaver dam. Sidecutting at the base of the right cutslope was evident for a few hundred feet up- and downstream of the beaver dam. Compare to Pre-Test Flow Photo 7 and Test Flow Photo 8.

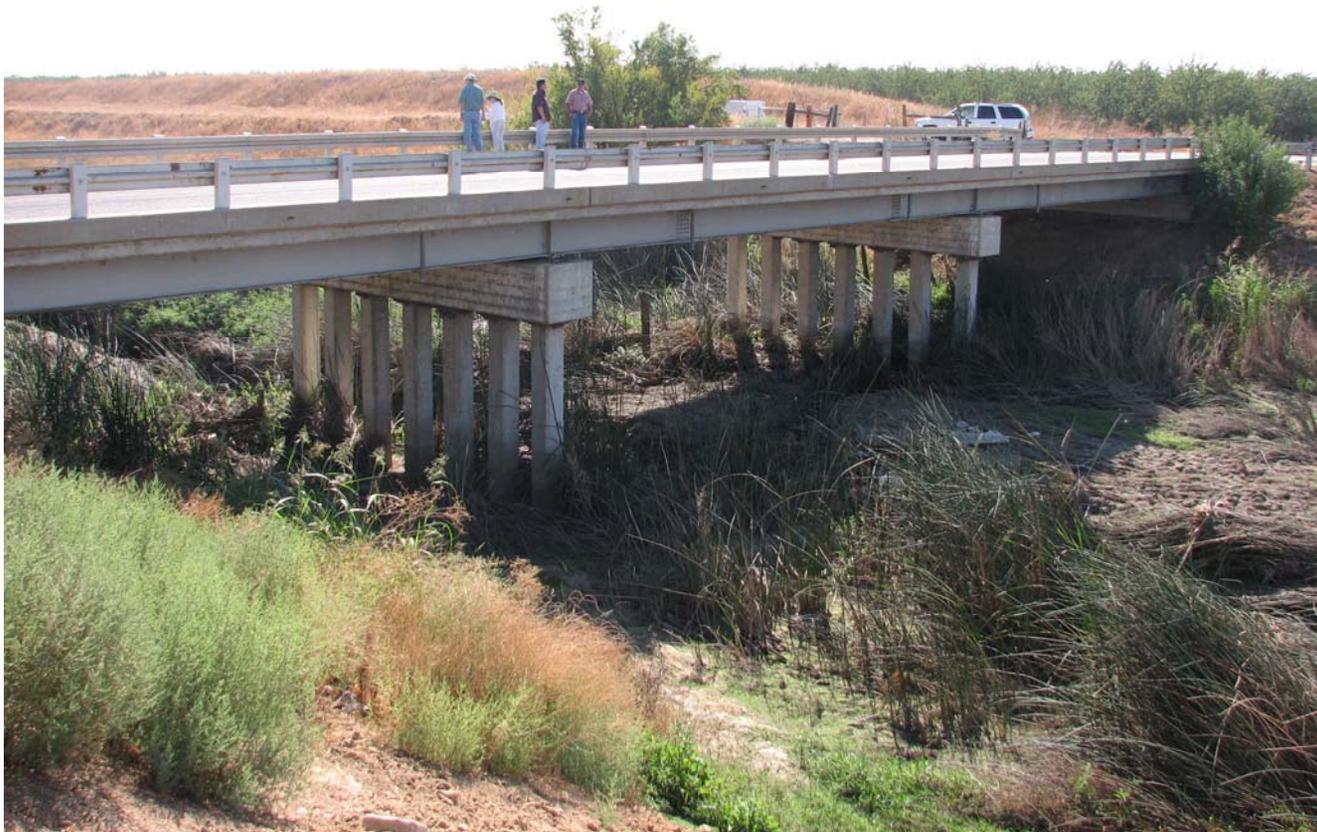
Photo 13

View southeast (downstream right) at Draper Road Bridge. Flattening and some removal of vegetation by high test flows but no soil erosion are evident. Compare to Pre-Test Flow Photo 9.

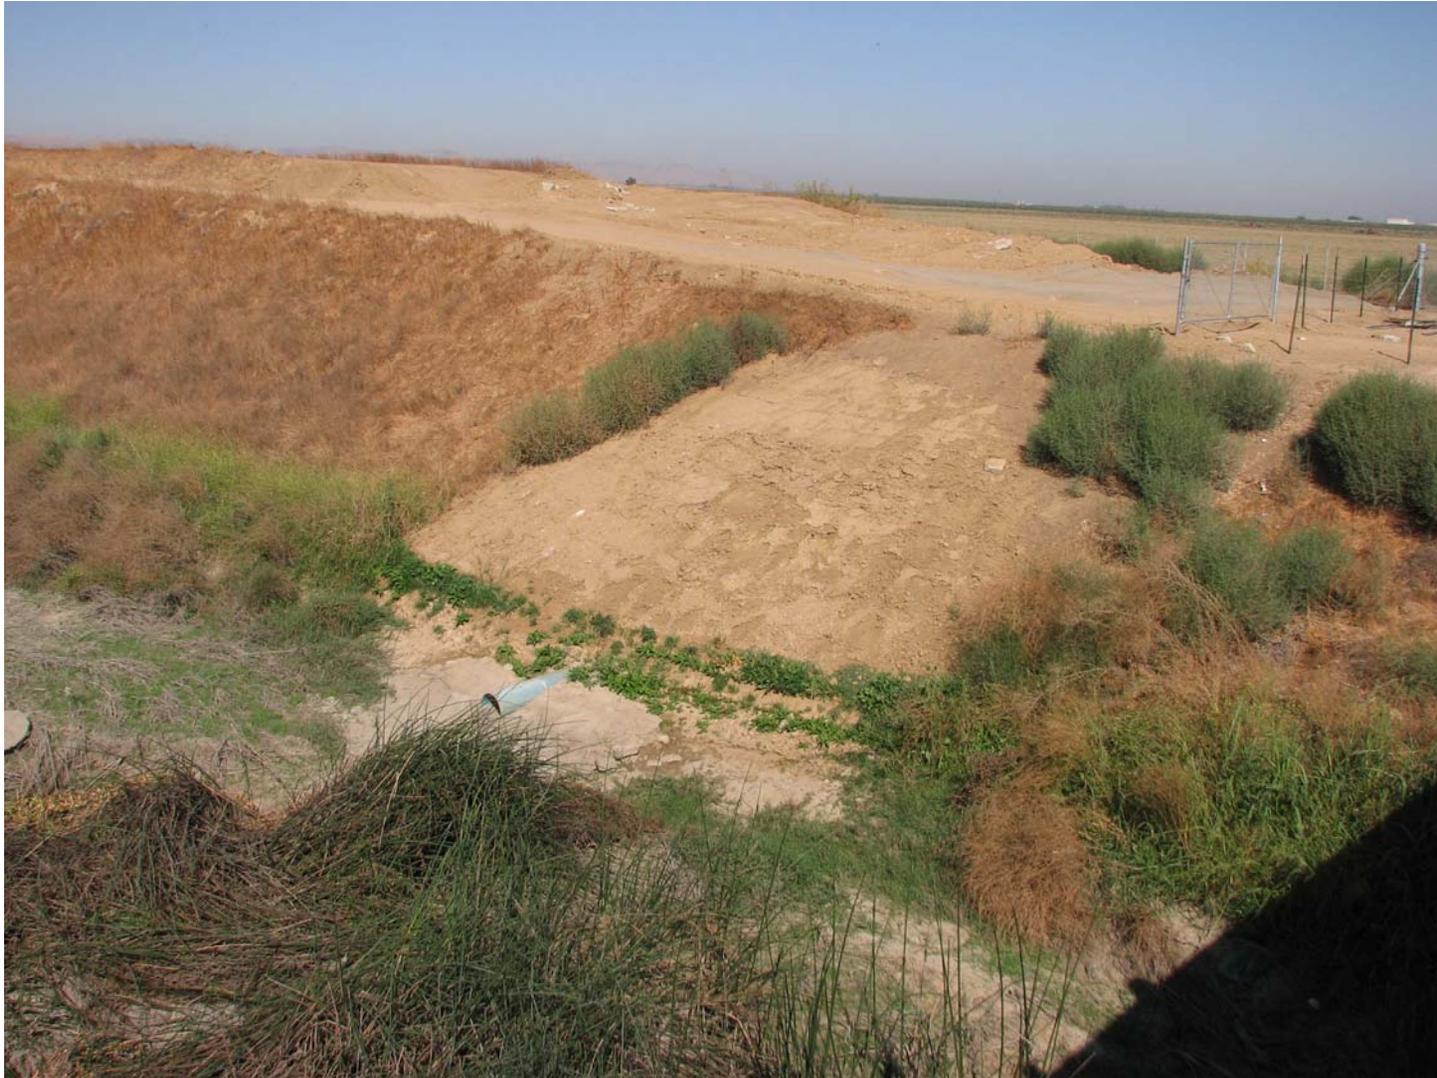
Photo 14

View northwest (upstream left) at a drain inlet that was replaced prior to the high test flows. No erosion or degradation of the compacted, fine-grained fill was observed. The drain pipe was clear. Compare to Test Flow Photo 9.

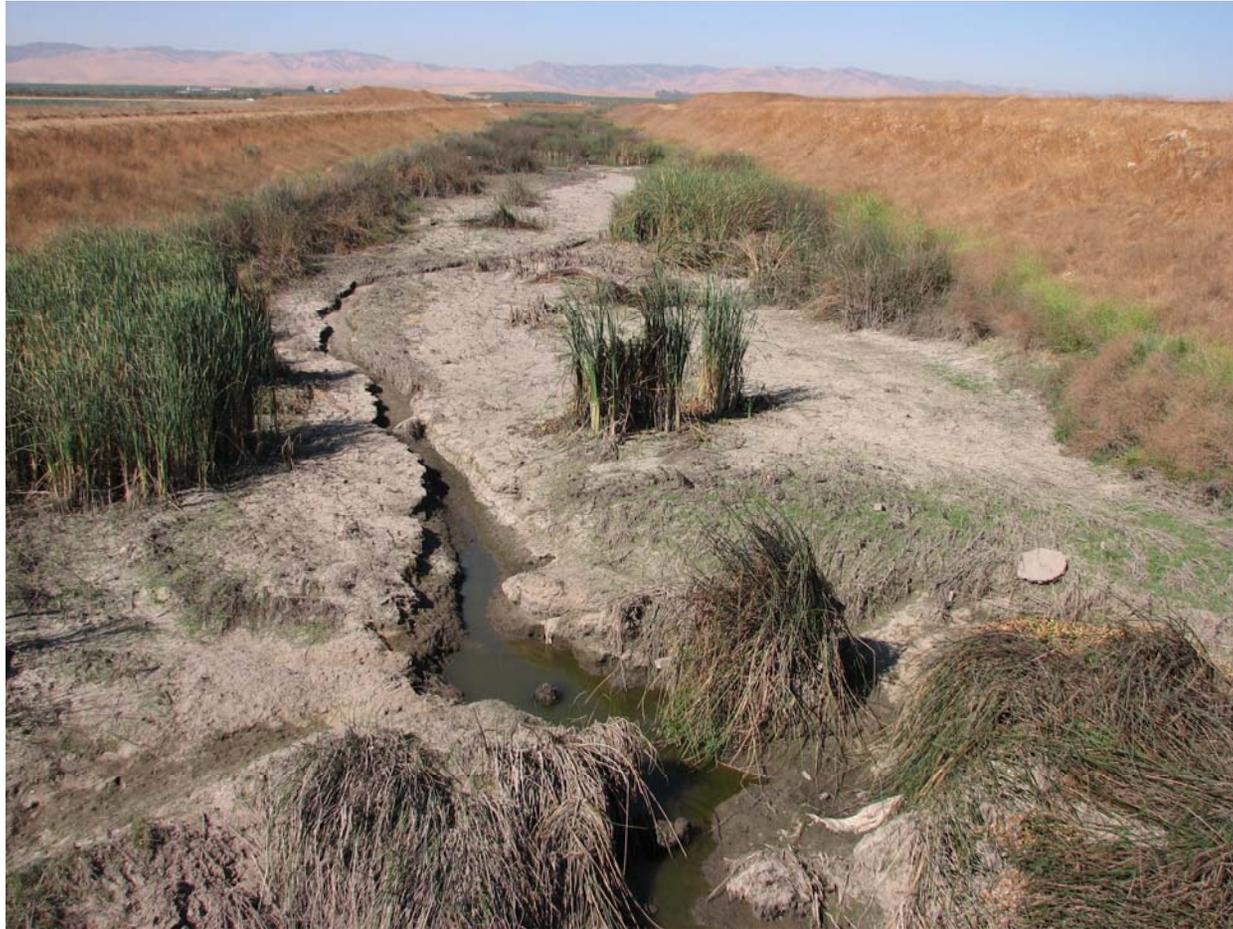
Photo 15

View west (upstream) from Draper Road Bridge. High test flows removed a significant amount of vegetation for a distance of about 300 feet upstream of the bridge. Erosion of the wasteway invert and sideslopes is negligible. Compare to Pre-Test Flow Photo 10 and Test Flow Photo 10.

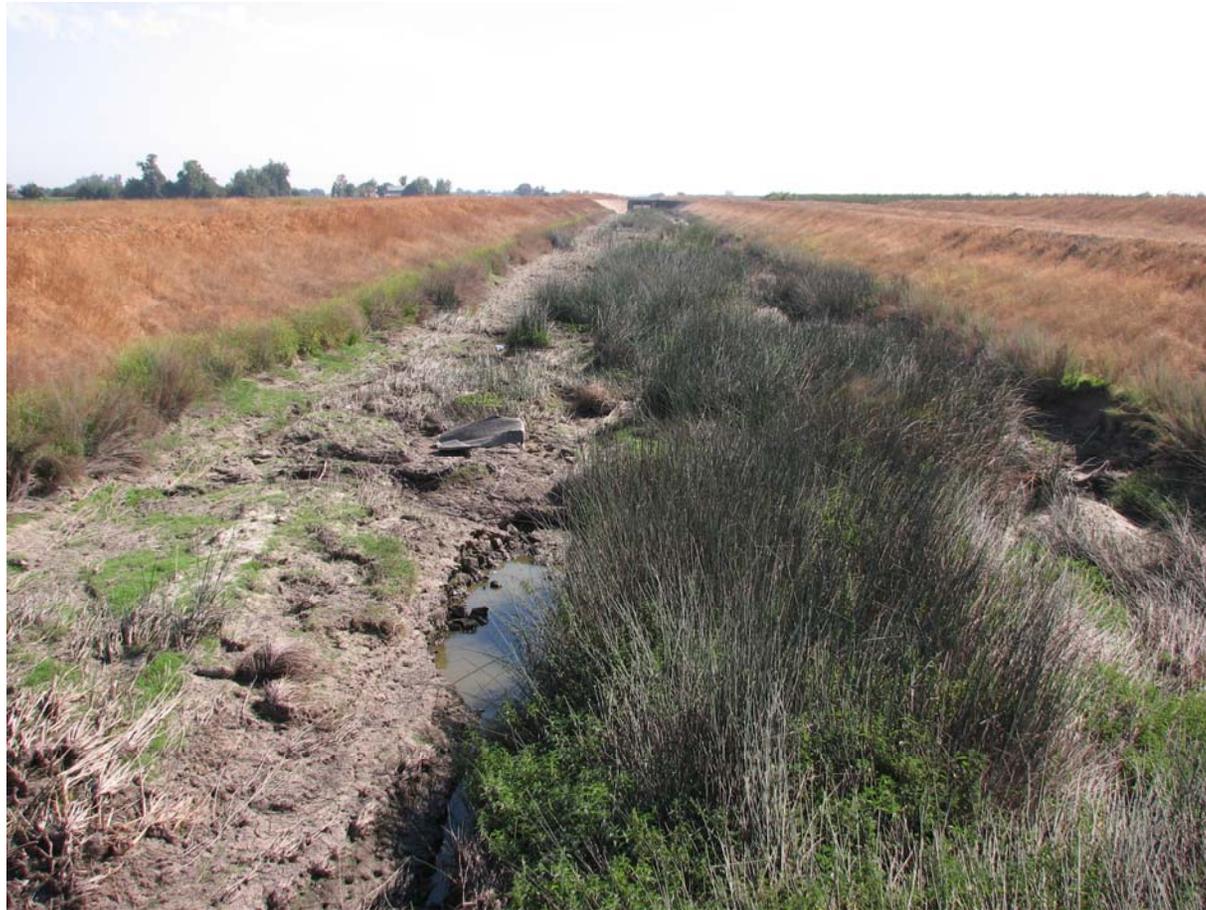
Photo 16

View east (downstream) from Draper Road Bridge. Significant vegetation flattening and removal is evident, mainly on the left side of the wasteway, from Draper Road to the MP 2.48 Drop Structure (center background). A few inches of downcutting of the inner channel and localized sidecutting at the base of the right cutslope are evident for about 100 feet downstream of the bridge. Compare to Pre-Test Flow Photo 11 and Test Flow Photo 11.
