ENGINEERING GEOLOGIC EVALUATION OF THE NEWMAN WASTEWAY AND STRUCTURES

DELTA MENDOTA CANAL RECIRCULATION FEASIBILITY STUDY

JANUARY 2009

U.S. DEPARTMENT OF INTERIOR
BUREAU OF RECLAMATION
MID PACIFIC REGION GEOLOGY BRANCH
SACRAMENTO, CA

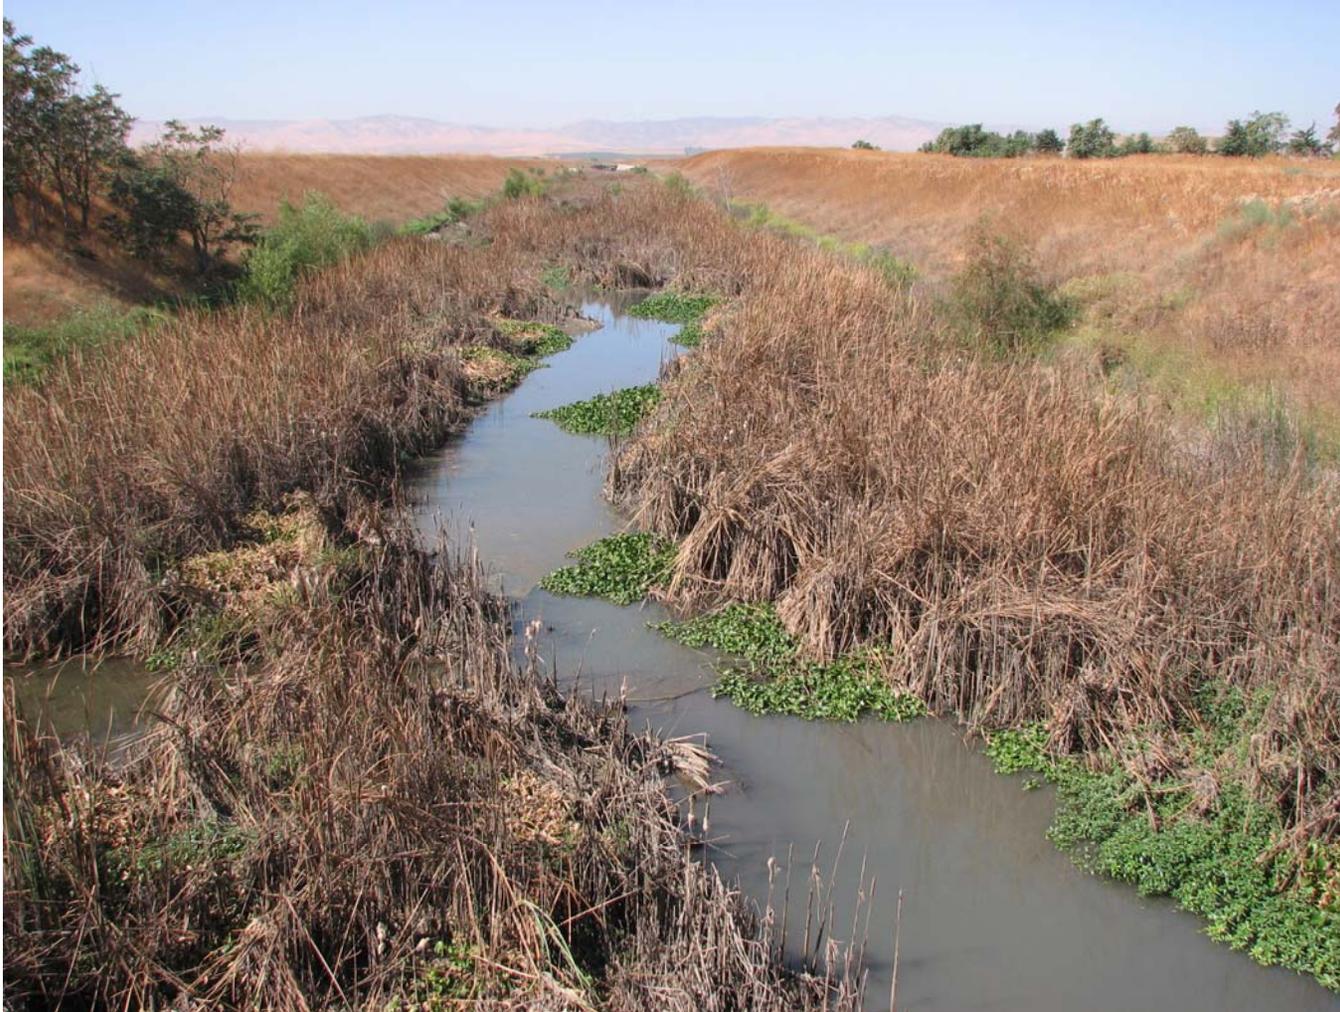
Photo 22

View east (downstream) from the MP 2.48 drop. High test flows flattened and/or removed vegetation within and adjacent to the inner channel and caused no erosion within the outlet transition. Compare to Pre-Test Flow Photo 16.

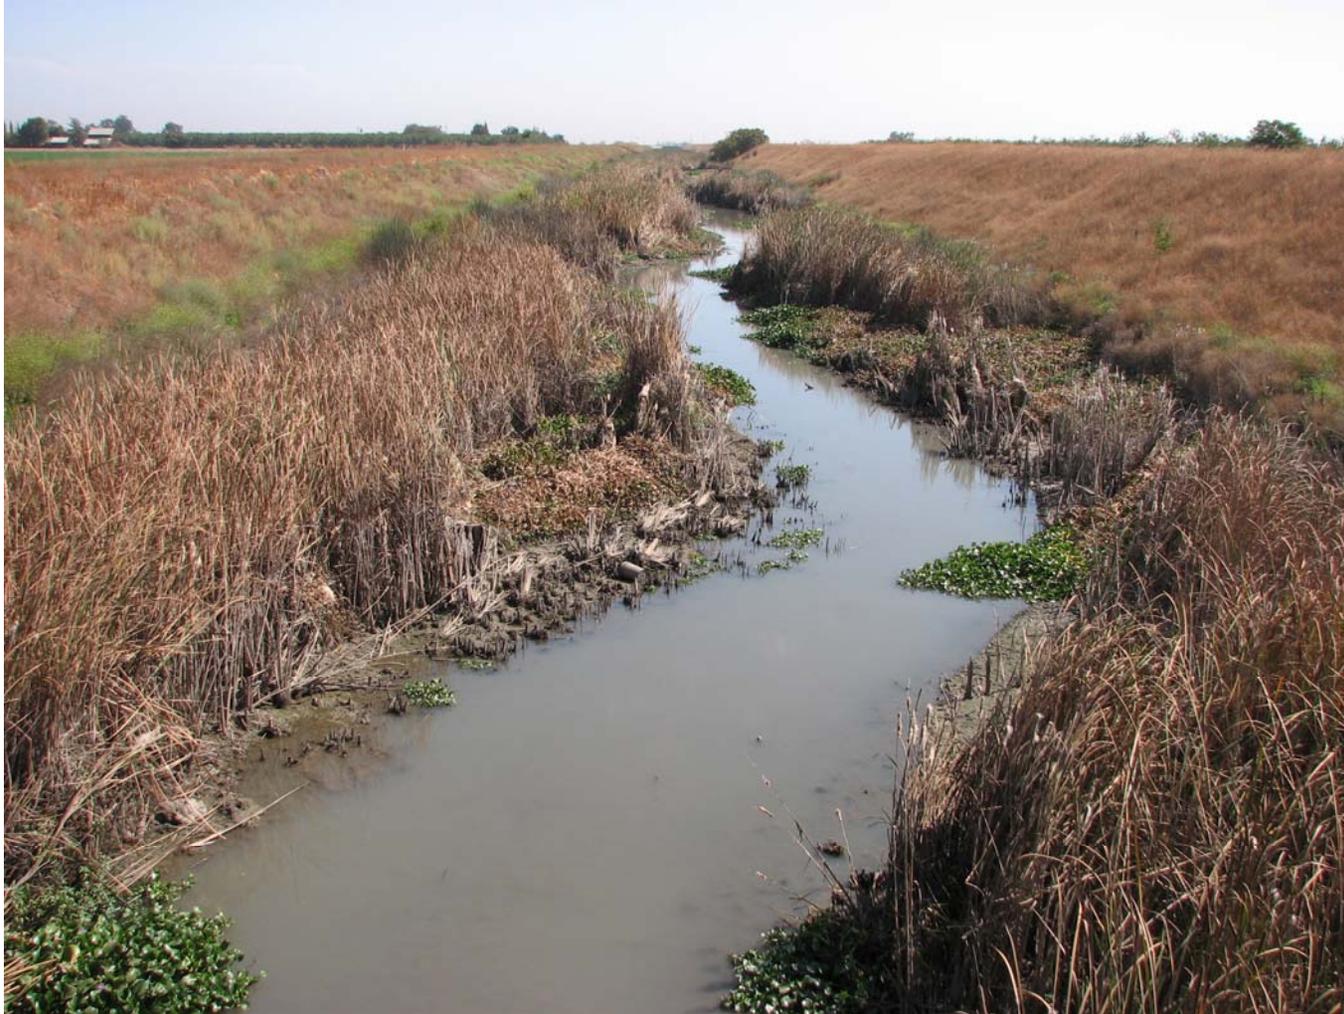
Photo 23

View east (downstream) from the bridge. High test flows removed most of the water plants (primrose) from the inner channel but had minimal impact on the cattails (reeds). Minor erosion is evident as a vertical step at the base of the right cutslope (shaded band at base of slope). Compare to Pre-Test Flow Photo 18 and Test Flow Photo 18.

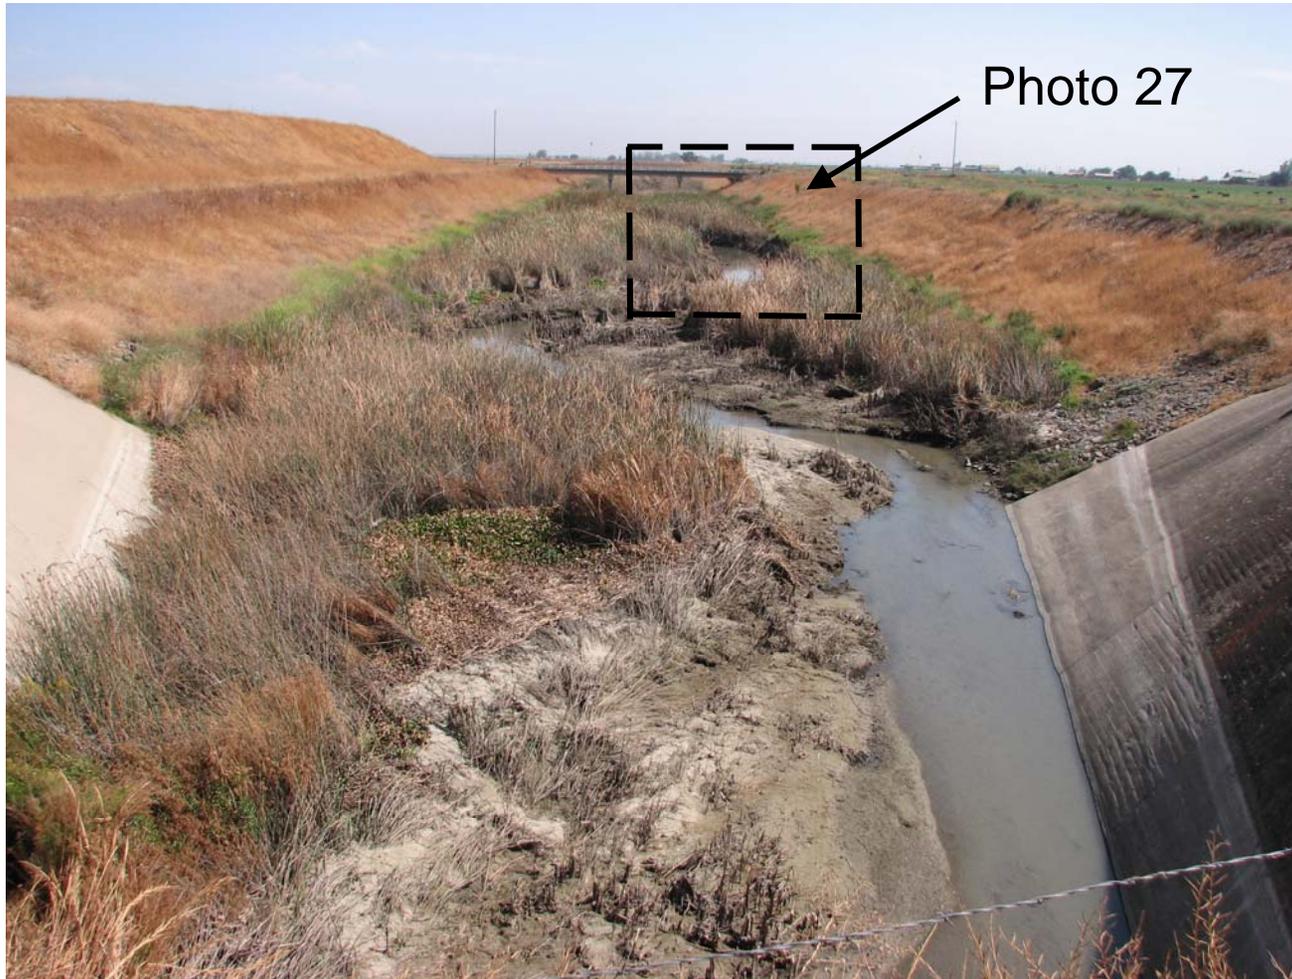
Photo 26

View west (upstream) from the drop structure. High test flows flattened cattails (reeds) and removed water plants (primrose) from the inner channel but caused no observable erosion. A beaver dam constructed of reeds blocks the inner channel. Compare to Pre-Test Flow Photo 19.

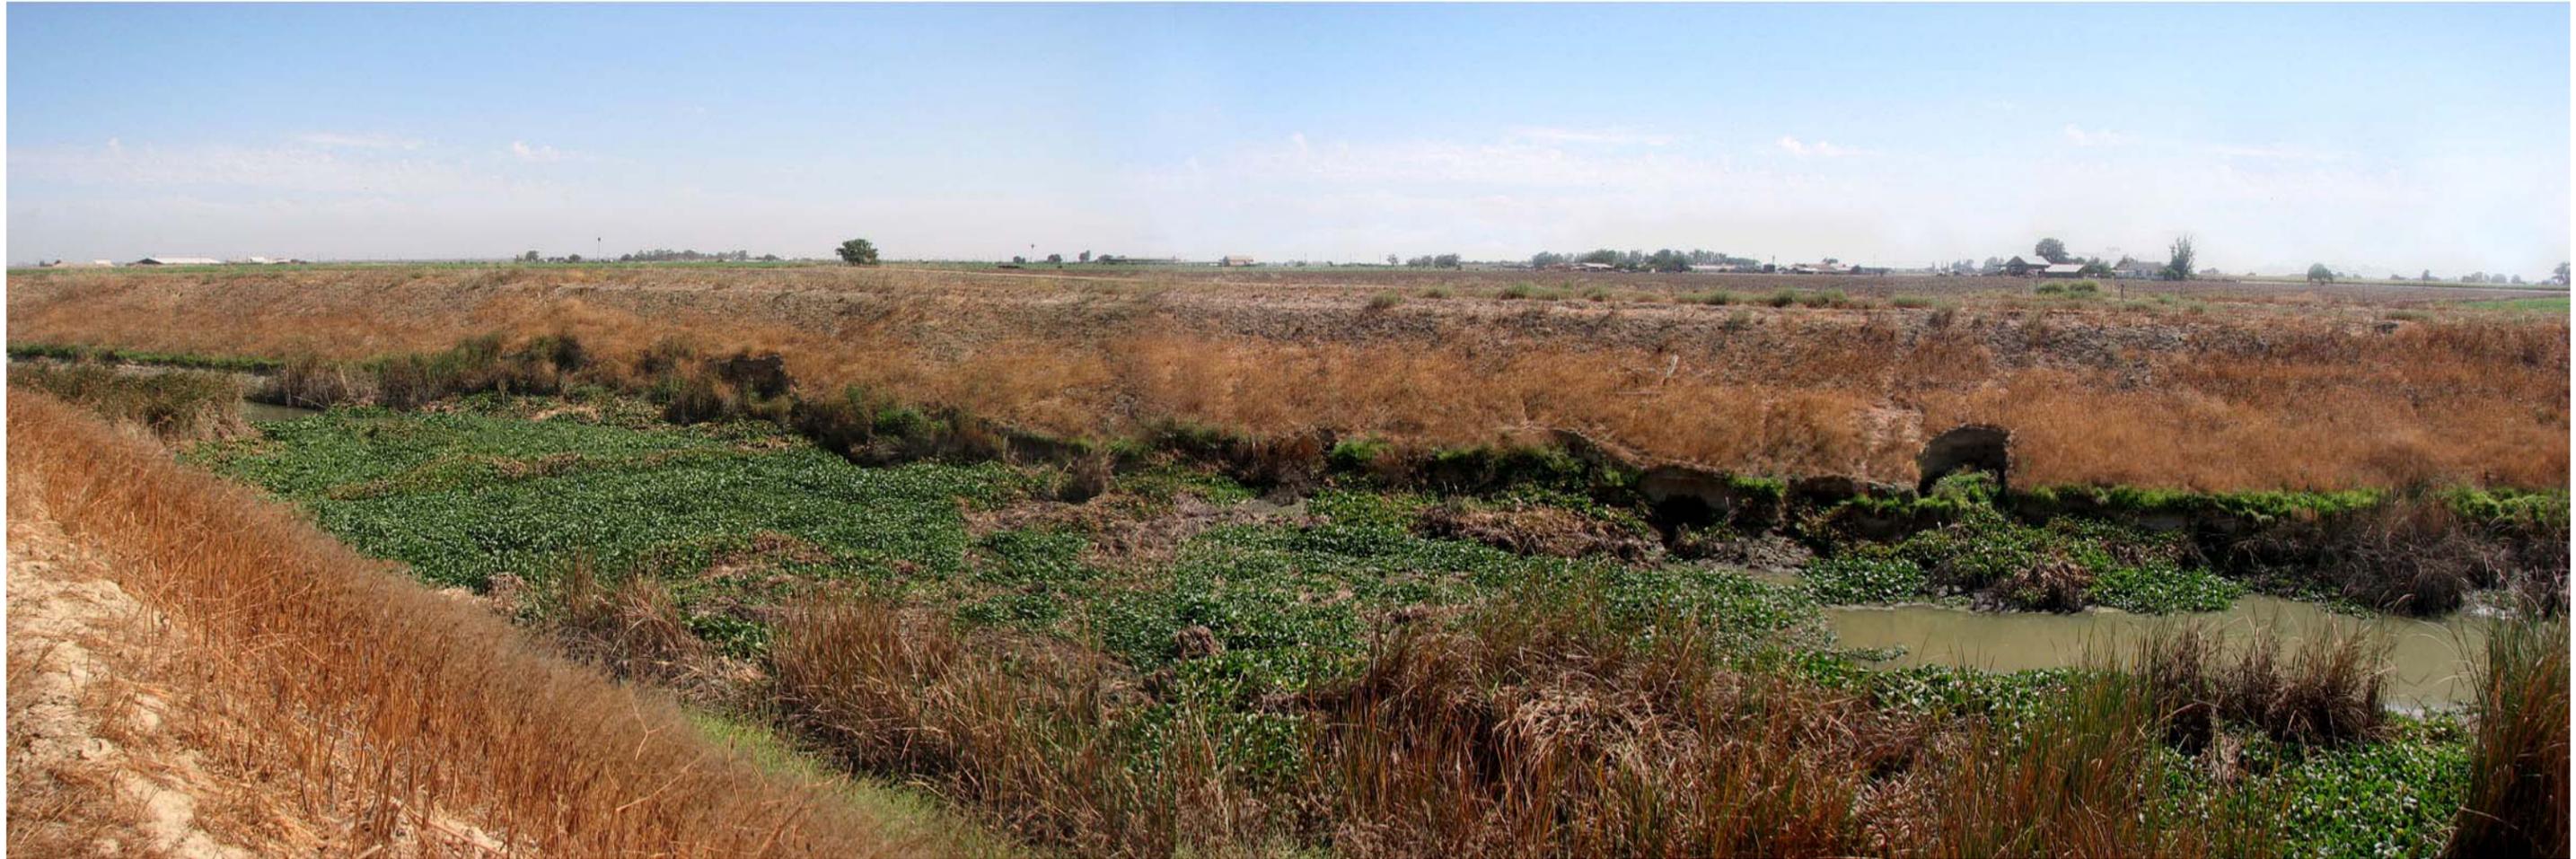
Photo 31

Removal of water plants (mainly primrose) from the sinuous central channel is evident from about the MP 2.48 Drop Structure, the approximate upstream limit of primrose growth) to Drop Structure MP 6.86 (Post-Test Flow Photos 21, 22, 23, 25, 26, 32 and 32 to 35) with the single exception of the Big Bend area (MP 4.65) where primrose growth appears to have expanded or, at least, remained unchanged following the high test flows (Post-Test Flow Photos 28 to 31).

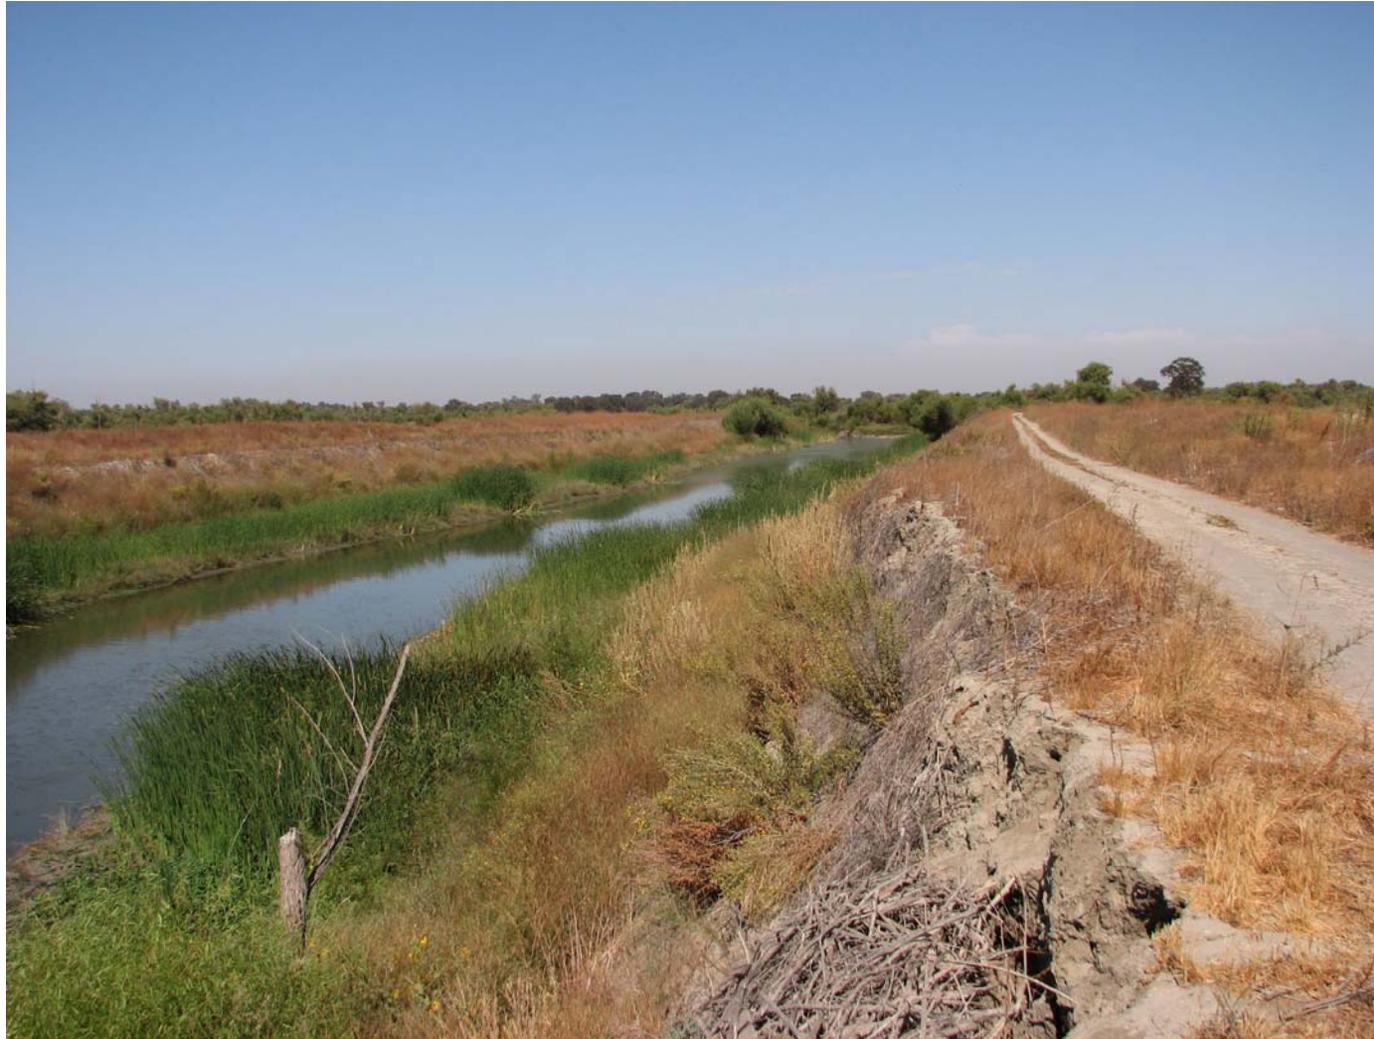
Photo 36

View northeast (downstream) from the drop. Removal of low-lying ground-cover-type plants and grasses is evident for about 300 feet downstream of the outlet. No erosion is apparent. Compare to Pre-Test Flow Photo 29.

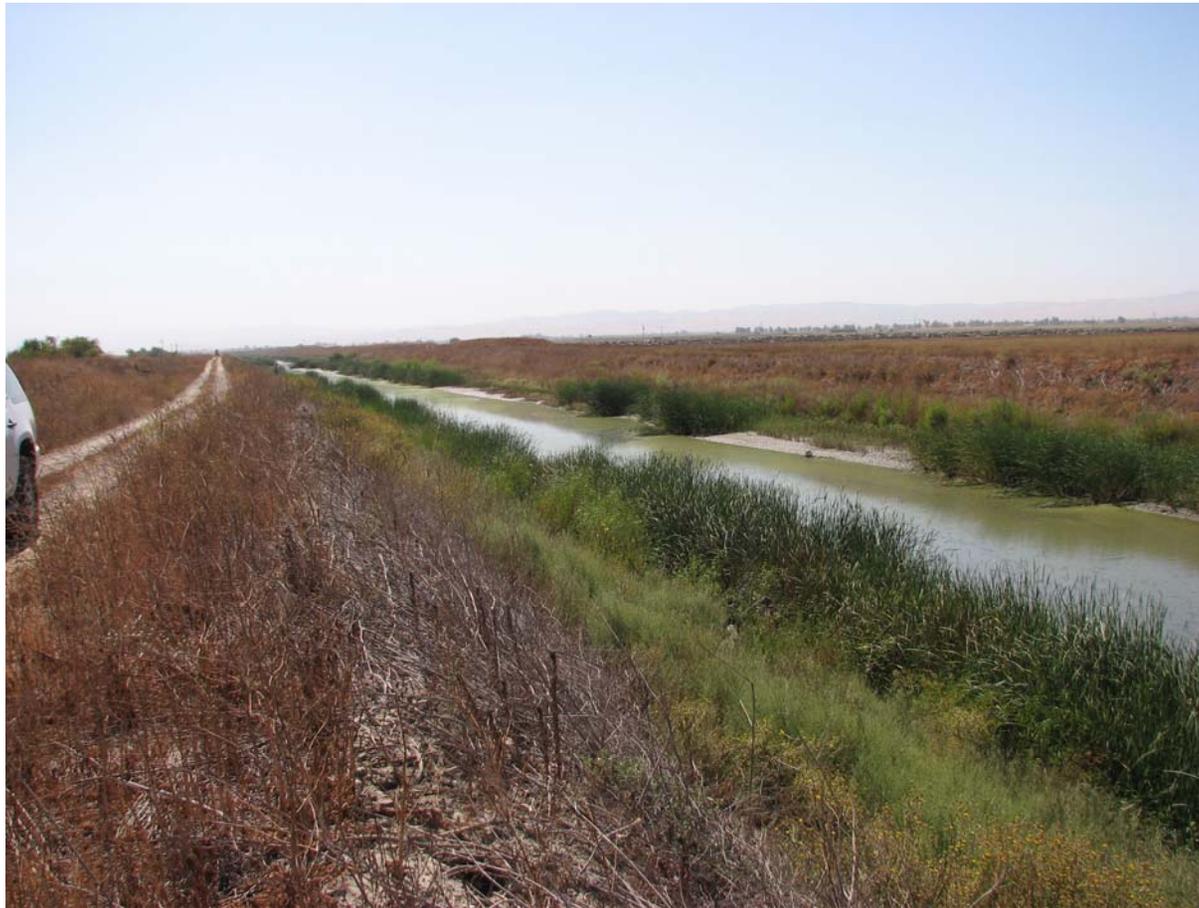
Photo 37

Primrose growth along the channel margins has expanded into 1) previously unvegetated beaches and 2) areas where high test flows had removed reeds (Post-Test Flow Photos 37 and 38). Reed growth along both channel margins appears more lush and extensive as compared to the baseline conditions observed on July 25 (Pre-Test Flow Photo 31).

View northeast (downstream) at the terminal reach at about MP 8.07. Reed growth appears to be denser and more extensive along both sides of the wasteway invert as compared to conditions observed on July 25. Compare to Pre-Test Flow Photo 31.
