## Big Valley Reach Assessment Methow River

Okanogan County, Washington

U.S. Department of the Interior  
Bureau of Reclamation  
Pacific Northwest Region

August 2008

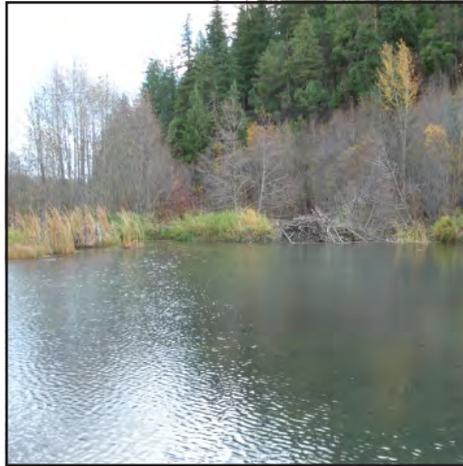
**Photograph No. 2**

View is to the southeast looking downstream at a beaver dam impounding a wetland area that provides off-channel habitat. Bureau of Reclamation Photograph by R. McAfee, October 25, 2006.

Protect and maintain wetlands, side channels and remaining riparian buffer zones (~77 acres) from development (Photograph Nos. 2 and 3). The mainstem and side channels are currently being utilized by ESA listed species for spawning, rearing, migration and refugia. This action is listed as a **Tier 1** in the *Biological Strategy*. It also addresses the limiting and causal factors of loss of habitat quantity and complexity, large woody debris recruitment, canopy cover and water quality.

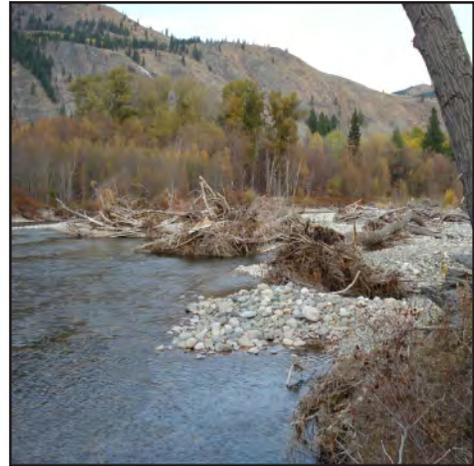
**Photograph No. 3**

View is to the east looking downstream at large woody debris deposited during the 2006 spring flood. Bureau of Reclamation Photograph by R. McAfee, October 25, 2006.

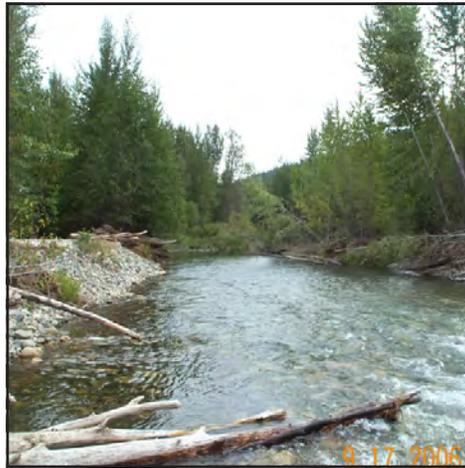
**Photograph No. 4**

View is to the southeast looking downstream where the active channel avulsed during the 2006 spring flood. Bureau of Reclamation Photograph by E. Lyon, September 17, 2006.

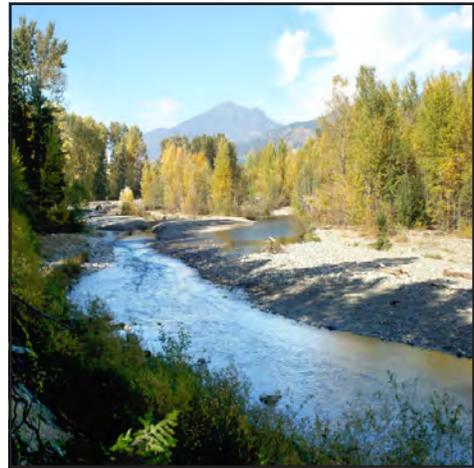
**Photograph No. 5**

View is to the northwest looking upstream along the mainstem. Bureau of Reclamation Photograph by R. McAfee, October 13, 2006.

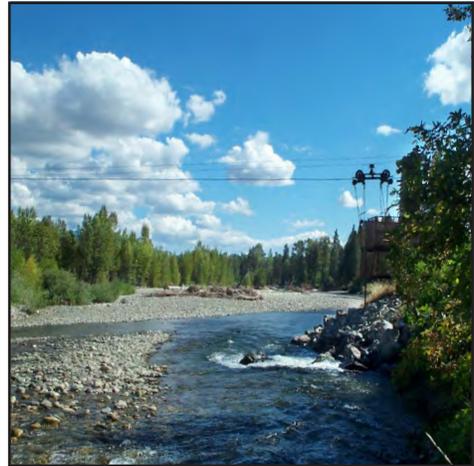
#### Photograph No. 7

View is to the southeast looking downstream at the right abutment of the cable tram that has been protected by riprap. The riprap has increased the shear stresses along the bank resulting in bed scour. Bureau of Reclamation photograph by E. Lyon, September 16, 2006.

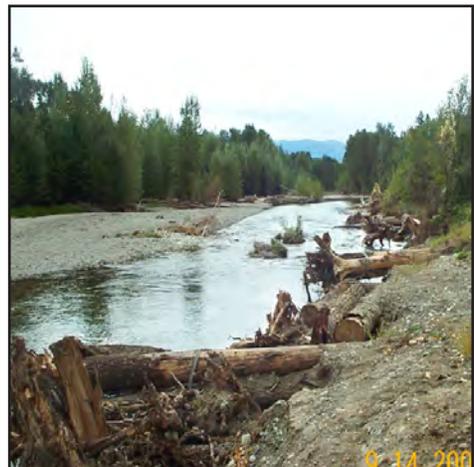
#### Photograph No. 8

View is to the southeast looking downstream at the right riverbank along the outside of a meander. The lack of riparian vegetation to stabilize the bank may be contributing to an accelerated rate of erosion. Bureau of Reclamation Photograph by E. Lyon, September 16, 2006.

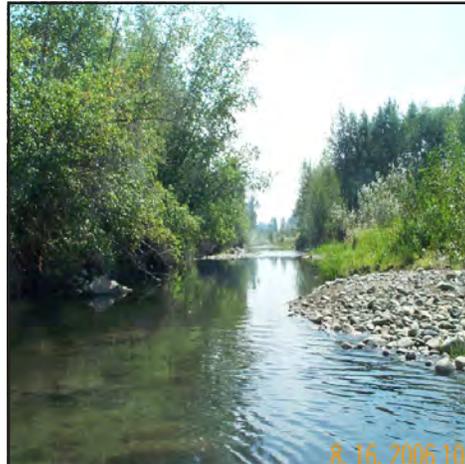
#### Photograph No. 10

View is to the southeast looking downstream along a side channel that is also connected to the outlet of the downstream impoundment (Photograph No. 8). Bureau of Reclamation Photograph by E. Lyon, August 16, 2006.

Protect wetlands, side channels and remaining riparian buffer zones (~220 acres) from further development (Photograph Nos. 10 and 11). The wetlands and side channels are currently being utilized by ESA listed species for rearing and refugia. This action is listed as a **Tier 1** in the *Biological Strategy*. It also addresses the limiting and causal factors of loss of habitat quantity and complexity, large woody debris recruitment, canopy cover and water quality.

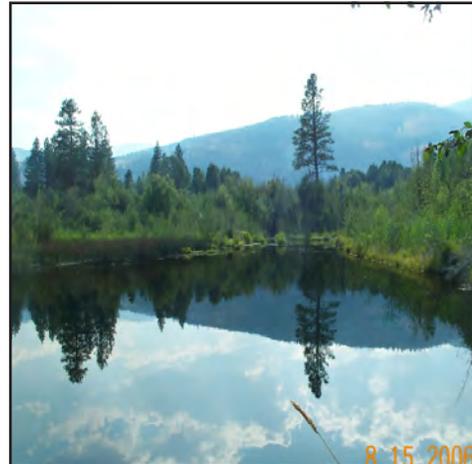
#### Photograph No. 11

View is to the northwest looking across reservoir from embankment dam. Bureau of Reclamation Photograph by E. Lyon, August 15, 2006.

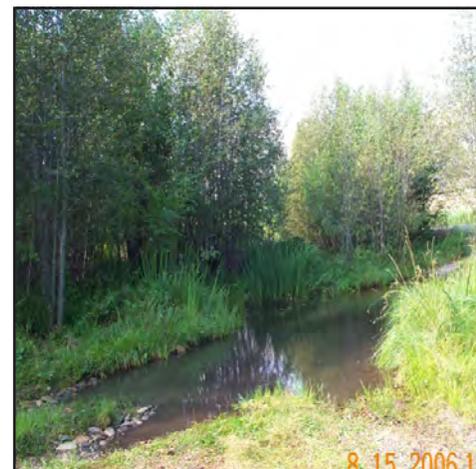
#### Photograph No. 12

View is to the west looking across the lower embankment dam that has a culvert as its primary outlet (center of photograph). Bureau of Reclamation Photograph by E. Lyon, August 15, 2006.

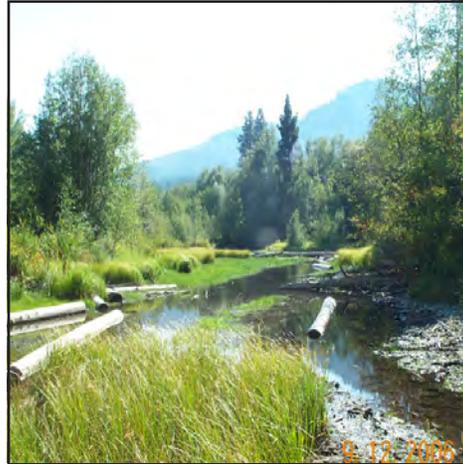
Photograph No. 14

View is to the south looking downstream at a wetland area along river left. Note the logs are "trimmed" suggesting they have been either placed during a restoration project or are from a historic mill. Bureau of Reclamation Photograph by E. Lyon, September 12, 2006

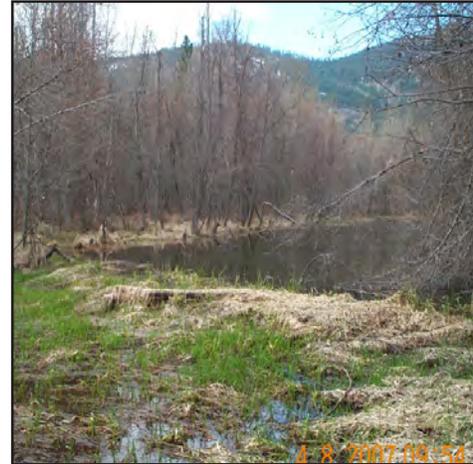
Photograph No. 15

View is to the south looking at a historic beaver dam in the wetland area of a historic channel path (oxbow). Bureau of Reclamation Photograph by E. Lyon, April 8, 2007.

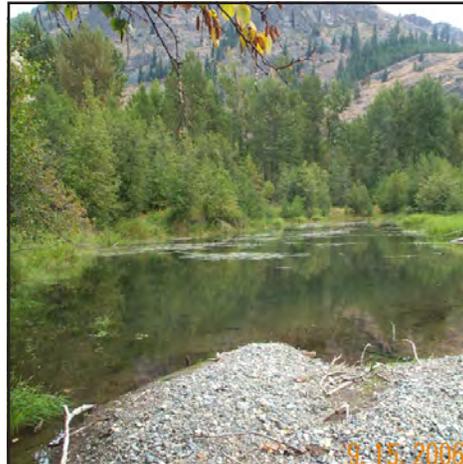
**Photograph No. 18**

View is to the northeast looking upstream at wetlands that occupy an oxbow. Bureau of Reclamation Photograph by E. Lyon, September 15, 2006

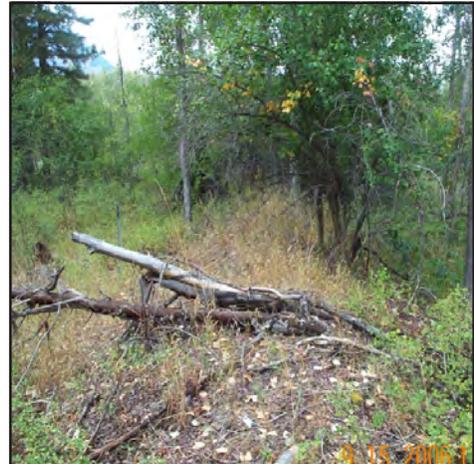
**Photograph No. 19**

View is to the northwest looking at a berm that historically impounded the Fender Mill pond. Bureau of Reclamation Photograph by E. Lyon, September 15, 2006.

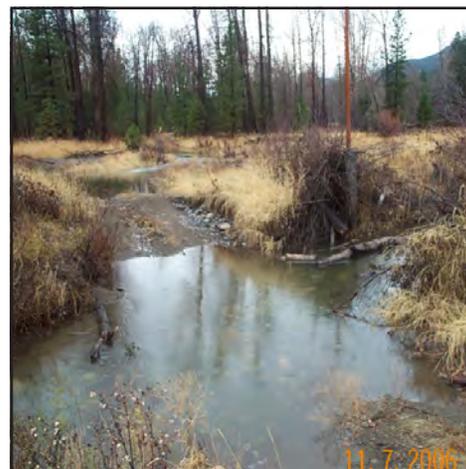
**Photograph No. 20**

View is to the west looking at a ford crossing along the fish return channel of the decommissioned Rockview irrigation ditch during the November 7, 2006 high flows. Bureau of Reclamation Photograph by E. Lyon, November 7, 2006.

Remove, modify or replace ford crossing (1) to reduce fine sediments (Photograph No. 20).

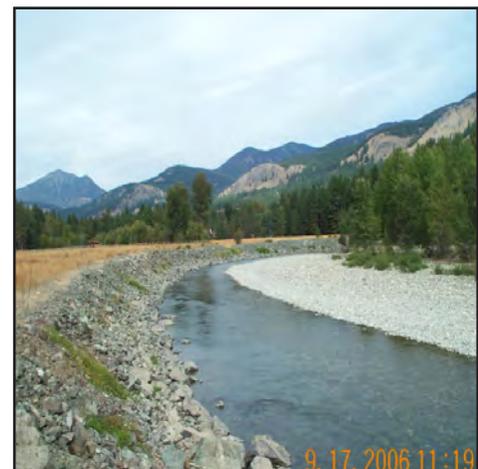
**Photograph No. 21**

View is to the northwest looking upstream at bank protection (riprap) placed along river right. Bureau of Reclamation Photograph by E. Lyon, September 17, 2006.

Construct large woody debris complexes that will stabilize riverbanks and protect infrastructure (~1350 ft riprap) (Photograph No. 21). The riprap placed along river right is failing. The recommendation would be to be proactive and repair with large wood structures. If the repair is completed using rock, the increased flow velocities may put the downstream protection area at risk of degradation. This habitat action should be taken in conjunction with riparian restoration for a long-term benefit. This action is listed as **Tier 3** in the *Biological Strategy* and addresses productivity and abundance VSP parameters. Limiting and causal factors addressed are unstable banks and large woody debris recruitment.

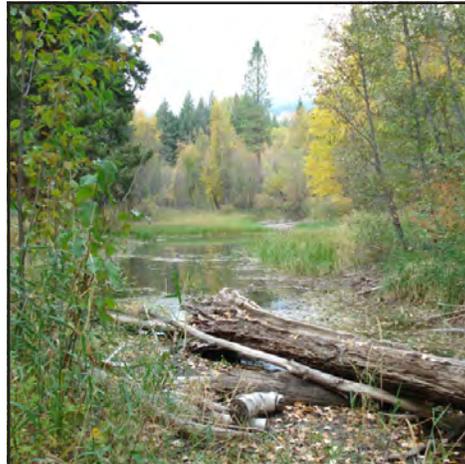
**Photograph No. 23**

View is to the east looking at the west approach to Weeman Bridge along Highway 20 where it bisects the floodplain. Bureau of Reclamation Photograph by R. McAfee, October 14, 2006.

Restore and reconnect wetlands and floodplain (~100 acres) to the riverine system. Remove, modify or replace road embankments (1200 ft of Highway 20 and 10 road crossings) (Photograph No. 23), undersized culverts (6 culverts) (Photograph No. 24) and push-up levees (315 ft) (Photograph No. 25).

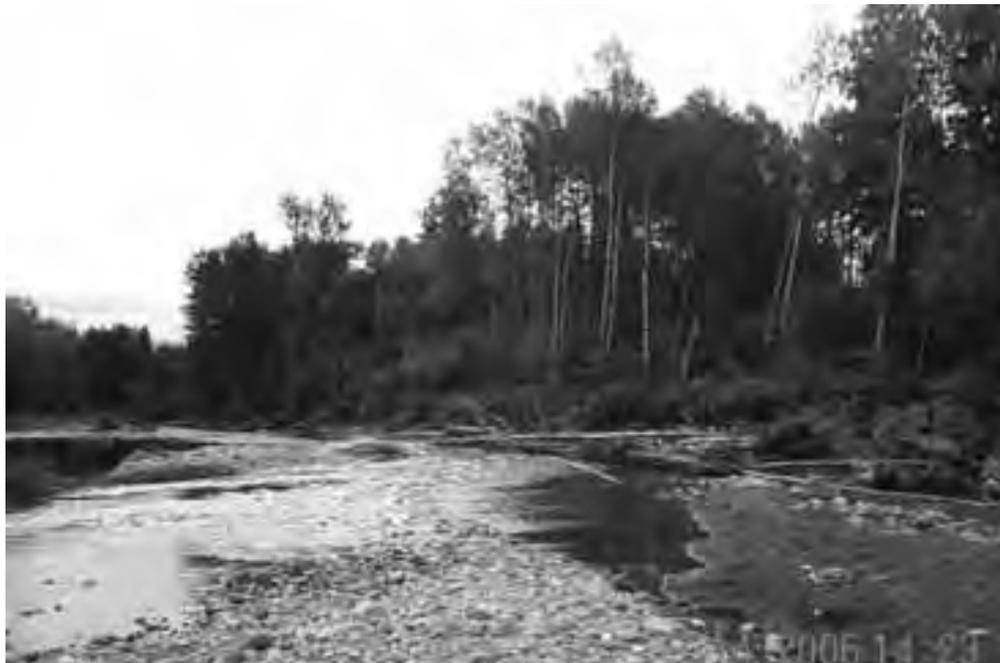
**Photograph No. 6.** View is to the southeast looking downstream along river right where cabled logs and rootwads have been installed for bank protection. MR Prj\_56.0 Project Area – Methow Subbasin, Washington – Bureau of Reclamation Photograph by E. Lyon, September 14, 2006.

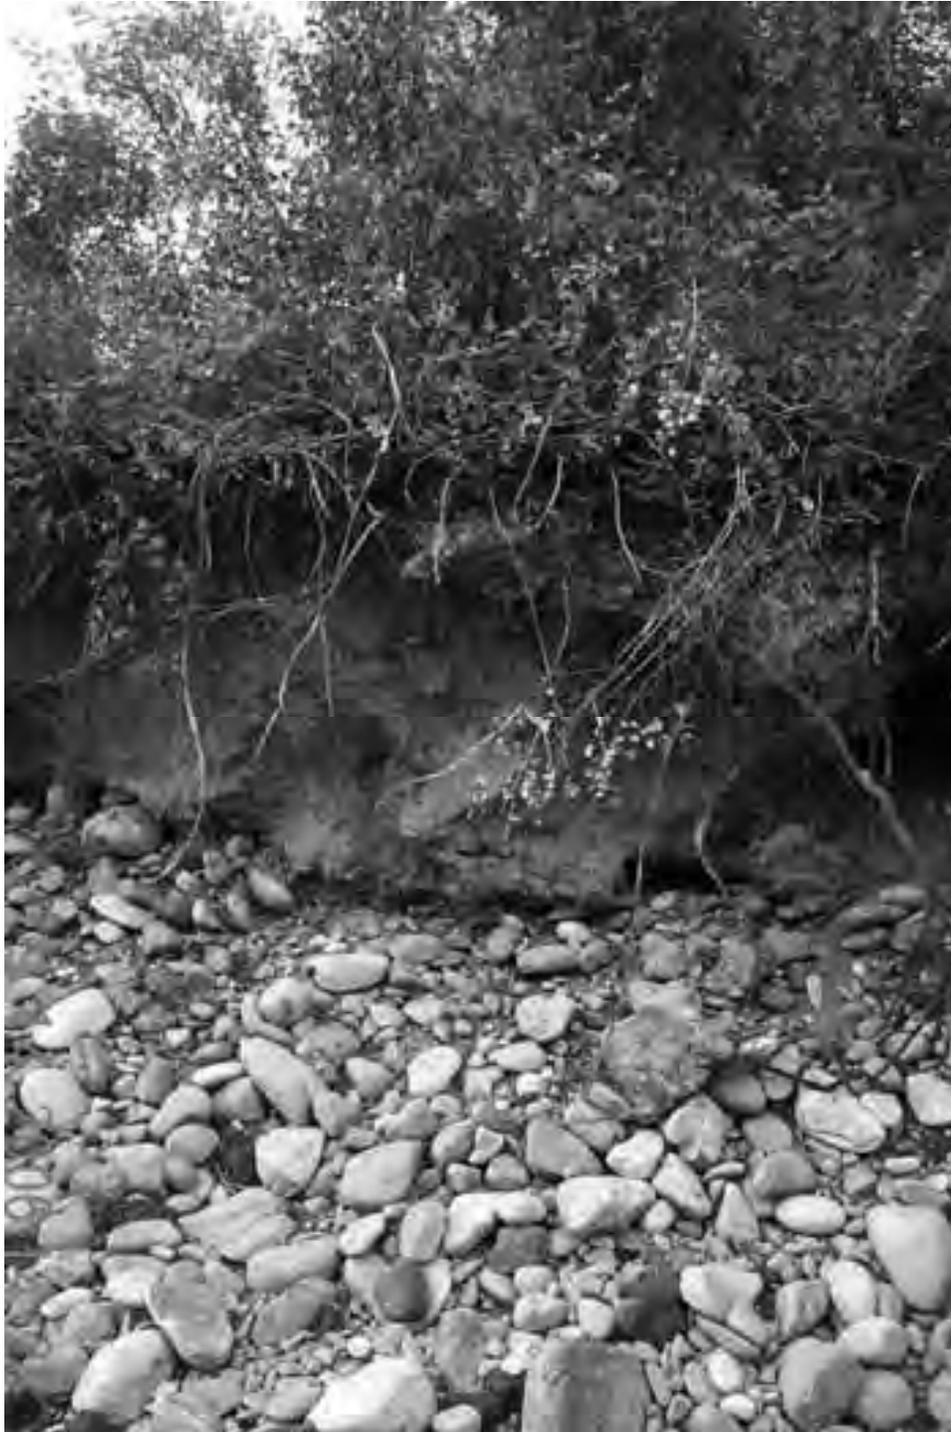
**Photograph No. 9.** View is to the southwest looking at the riverbank along river right showing the thick flood deposits comprised of silty sand. MR Prj\_56.0 Project Area – Methow Subbasin, Washington – Bureau of Reclamation Photograph by E. Lyon, September 14, 2006.

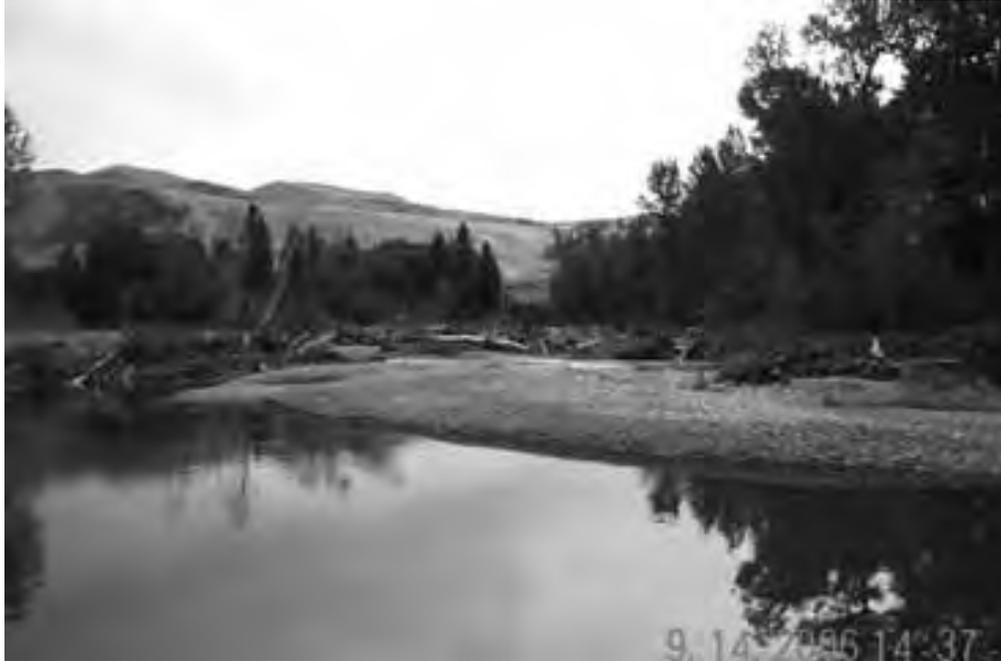
**Photograph No. 12.** View is to the north looking upstream where the river has avulsed. MR Prj\_56.0 Project Area – Methow Subbasin, Washington – Bureau of Reclamation Photograph by E. Lyon, September 14, 2006.

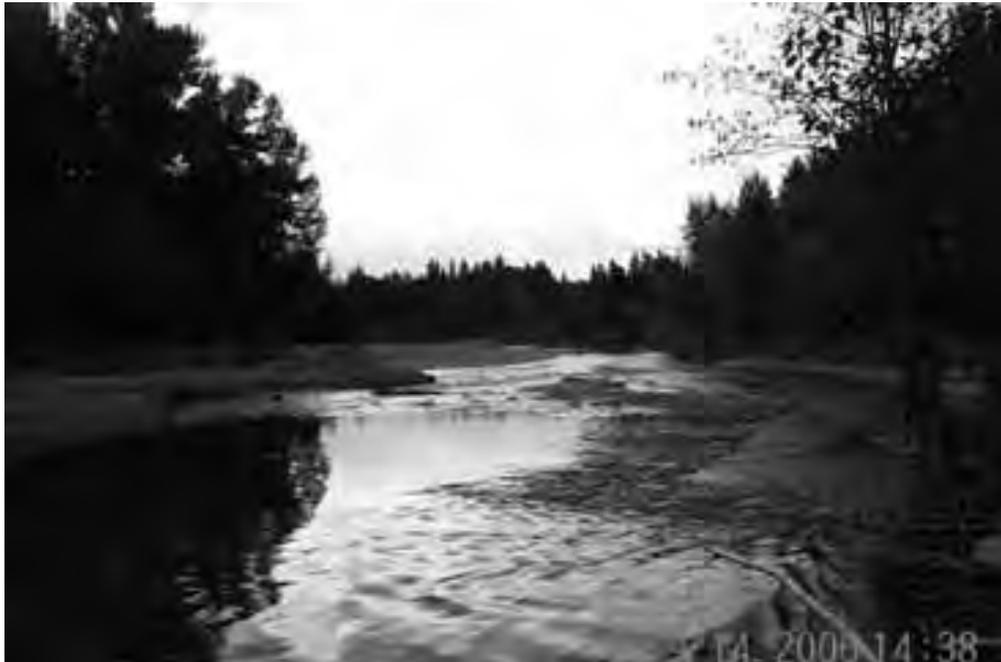
**Photograph No. 13.** View is to the southeast looking downstream along river right where severe erosion occurred during the 2006 spring freshet. MR Prj\_56.0 Project Area – Methow Subbasin, Washington – Bureau of Reclamation Photograph by E. Lyon, September 14, 2006.

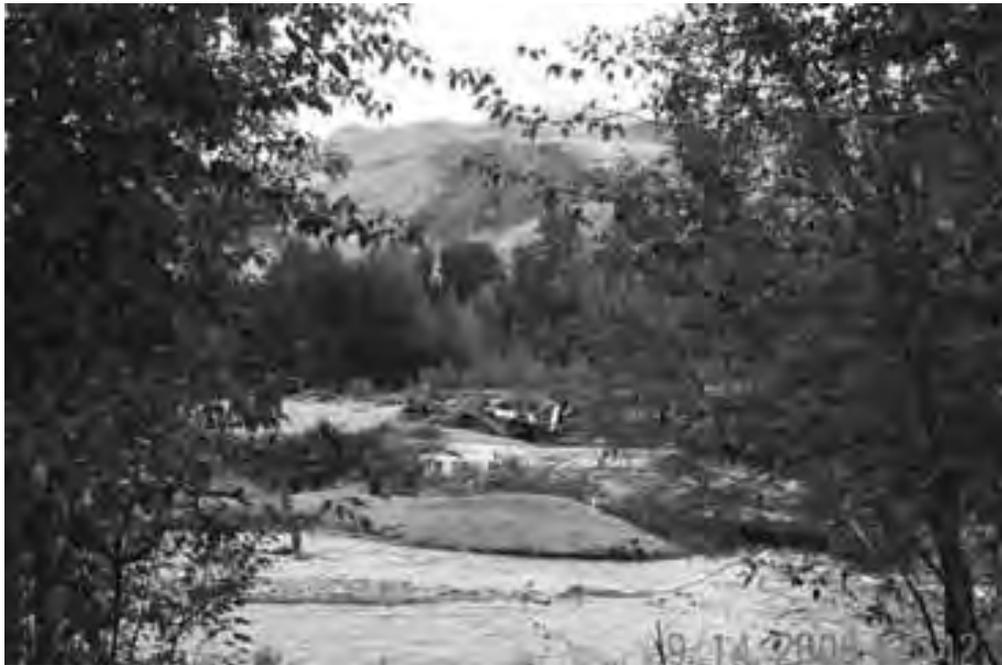
**Photograph No. 15.** View is to the north looking upstream from river right where the river has avulsed. MR Prj\_56.0 Project Area – Methow Subbasin, Washington – Bureau of Reclamation Photograph by E. Lyon, September 14, 2006.

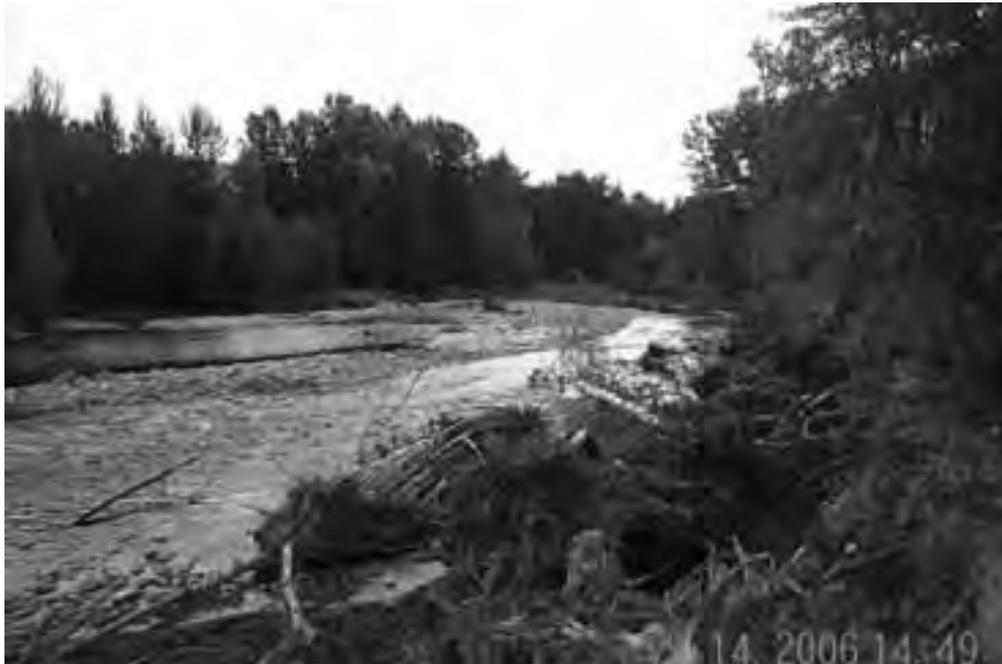
**Photograph No. 17.** View is to the east looking downstream along river right below the cabled logs and rootwads where severe erosion occurred during 2006 spring freshet. MR Prj\_56.0 Project Area – Methow Subbasin, Washington – Bureau of Reclamation Photograph by E. Lyon, September 14, 2006.

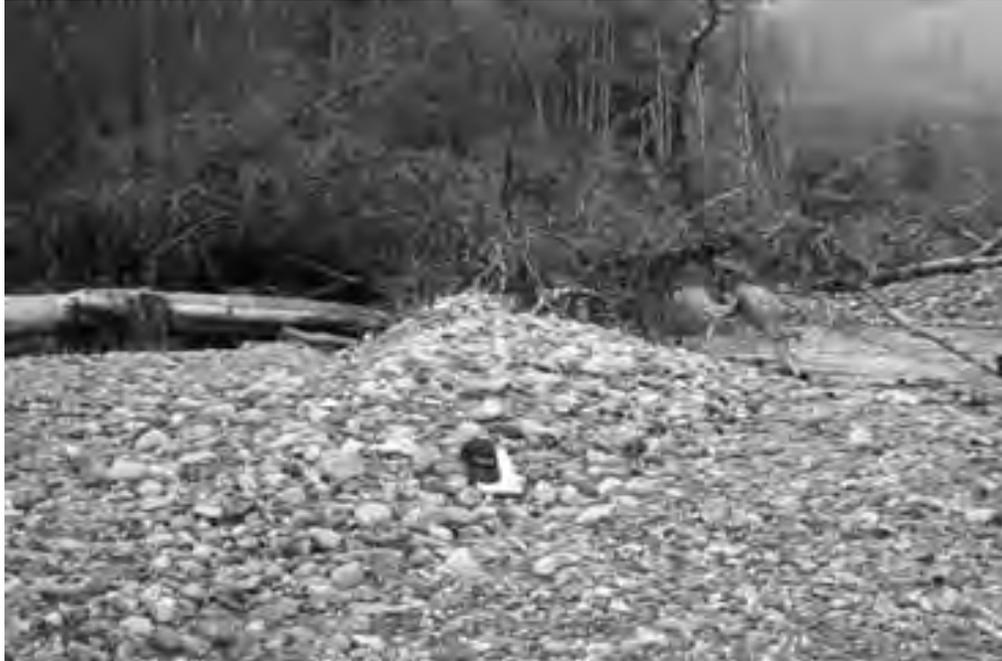
**Photograph No. 20.** View is to the west looking upstream along river right below the large woody debris accumulation at head of overflow channel (Photograph No. 18). Note the accumulation of sediment downstream of large woody debris that moved during the 2006 spring freshet. MR Prj\_56.0 Project Area – Methow Subbasin, Washington – Bureau of Reclamation Photograph by E. Lyon, September 14, 2006.

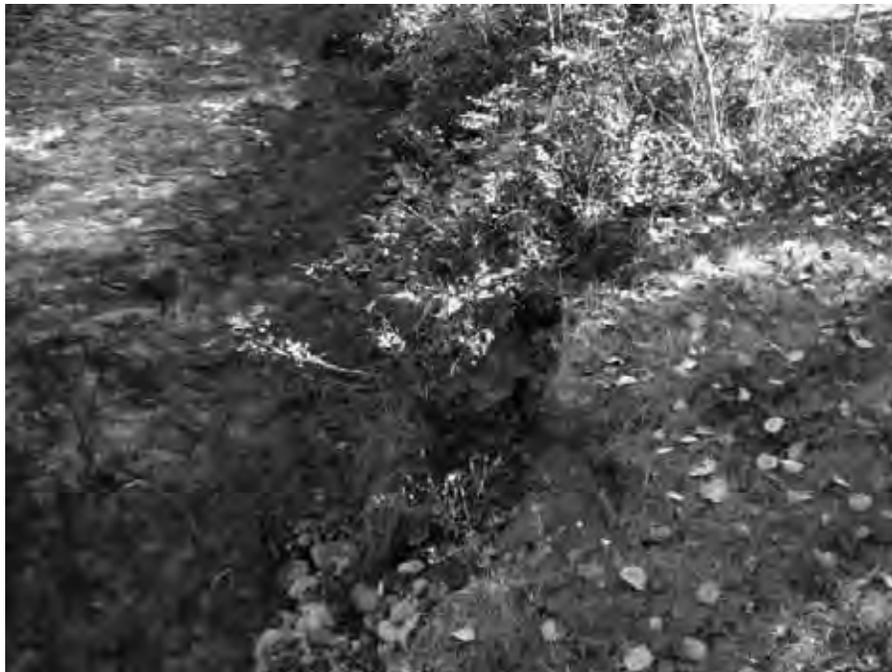
**Photograph No. 21.** View is to the southeast looking downstream along a side channel where erosion occurred during the 2006 spring freshet. MR Prj\_56.0 Project Area – Methow Subbasin, Washington – Bureau of Reclamation Photograph by R. McAfee, October 19, 2006.

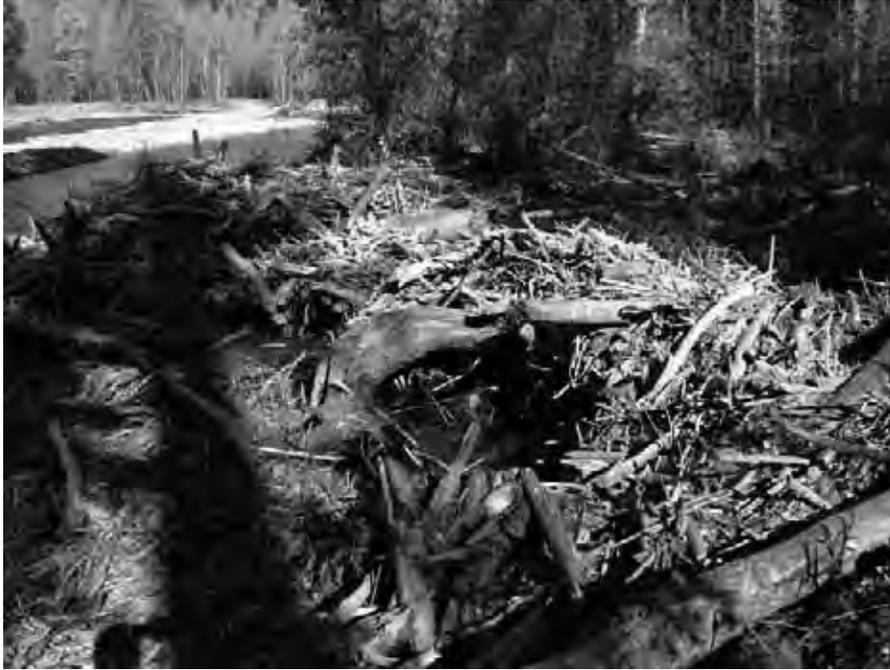
**Photograph No. 22.** View is to the northeast looking across a logjam at the head of an active side channel. MR Prj\_56.0 Project Area – Methow Subbasin, Washington – Bureau of Reclamation Photograph by R. McAfee, October 19, 2006.

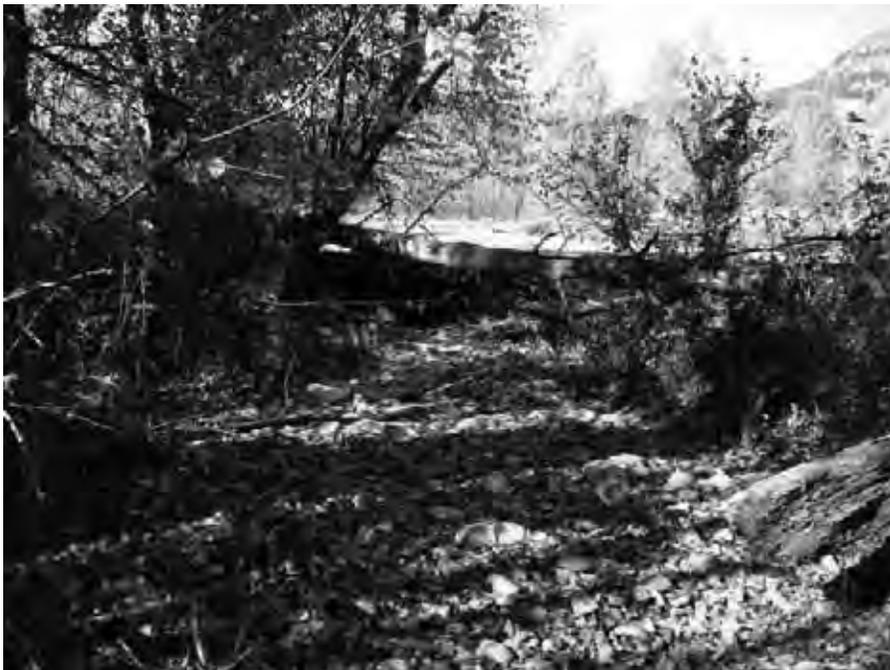
**Photograph No. 23.** View is to the northwest looking upstream along an overflow channel that appears to have been accessed during the 2006 spring freshet. MR Prj\_56.0 Project Area – Methow Subbasin, Washington – Bureau of Reclamation Photograph by R. McAfee, October 19, 2006.

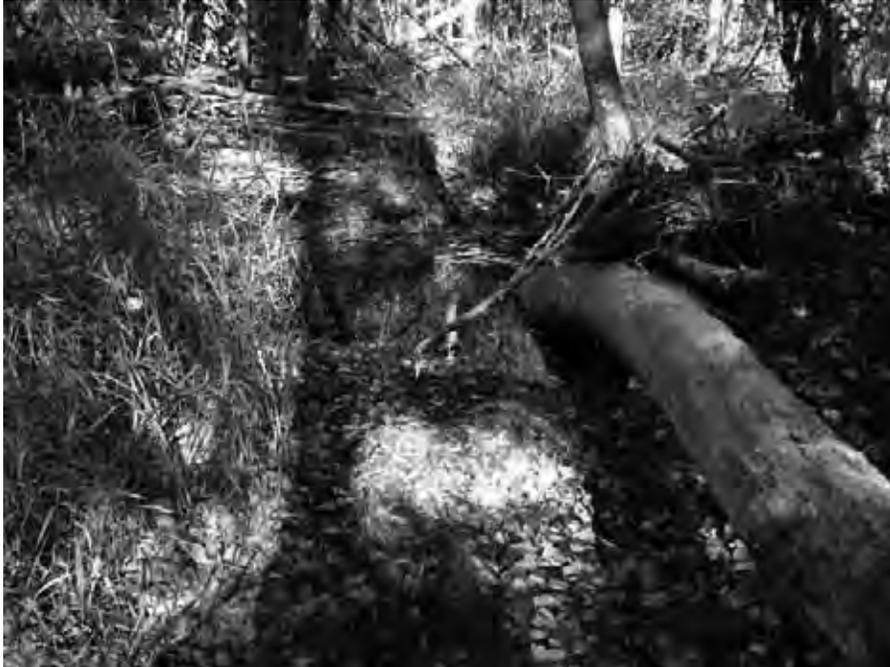
**Photograph No. 24.** View is to the northeast looking across an overflow channel near the logjam in Photograph No. 22. MR Prj\_56.0 Project Area – Methow Subbasin, Washington – Bureau of Reclamation Photograph by R. McAfee, October 19, 2006.

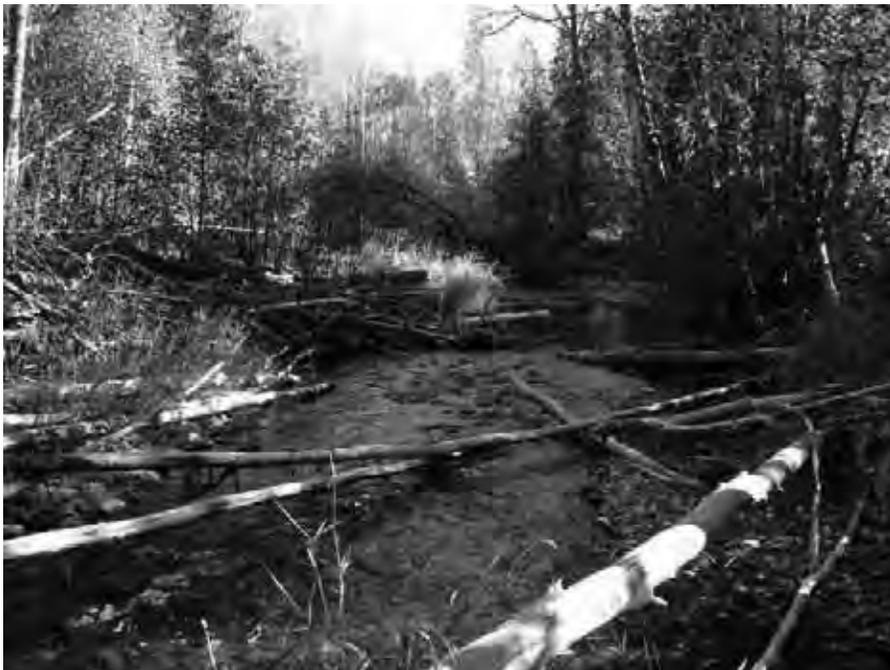
**Photograph No. 25.** View is to the southeast looking downstream along a side channel below the logjam in Photograph No. 22. MR Prj\_56.0 Project Area – Methow Subbasin, Washington – Bureau of Reclamation Photograph by R. McAfee, October 19, 2006.

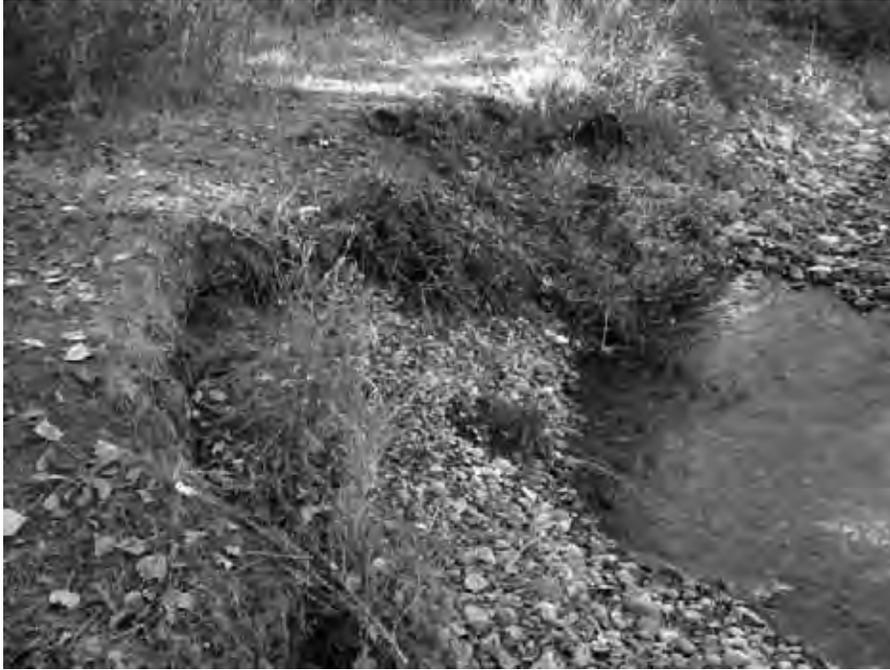
**Photograph No. 26.** View is to the northwest looking upstream at bank erosion that occurred during the 2006 spring freshet along the side channel. MR Prj\_56.0 Project Area – Methow Subbasin, Washington – Bureau of Reclamation Photograph by R. McAfee, October 19, 2006.

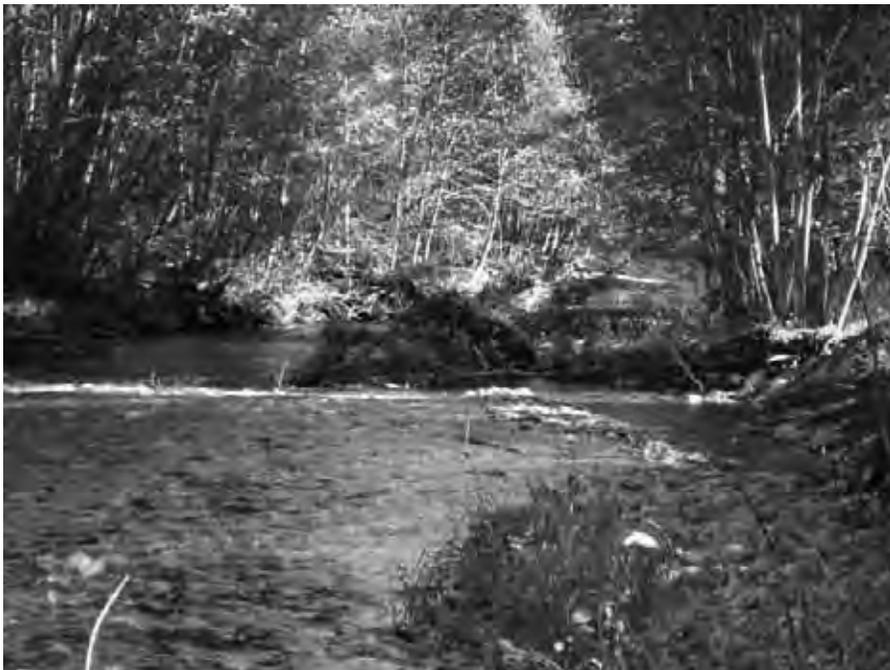
**Photograph No. 27.** View is to the southeast looking downstream along the side channel where fairly severe erosion occurred during the 2006 spring freshet along river right. MR Prj\_56.0 Project Area – Methow Subbasin, Washington – Bureau of Reclamation Photograph by R. McAfee, October 19, 2006.

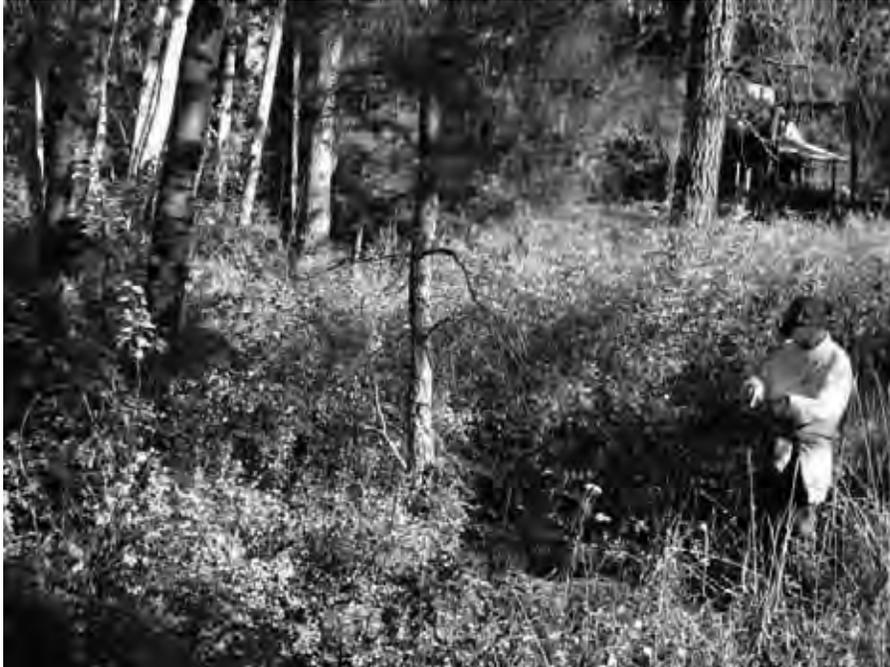
**Photograph No. 28.** View is to the northeast looking at an overflow channel that has been disconnected by a road embankment. MR Prj\_56.0 Project Area – Methow Subbasin, Washington – Bureau of Reclamation Photograph by R. McAfee, October 19, 2006.

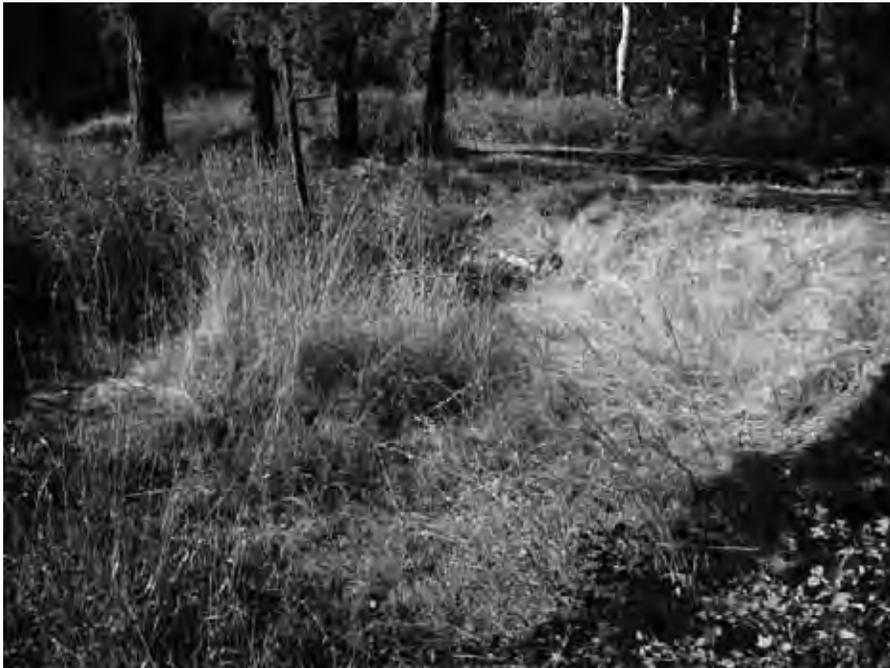
**Photograph No. 29.** View is to the west looking at an overflow channel that has been disconnected by a road embankment. MR Prj\_56.0 Project Area – Methow Subbasin, Washington – Bureau of Reclamation Photograph by R. McAfee, October 19, 2006.

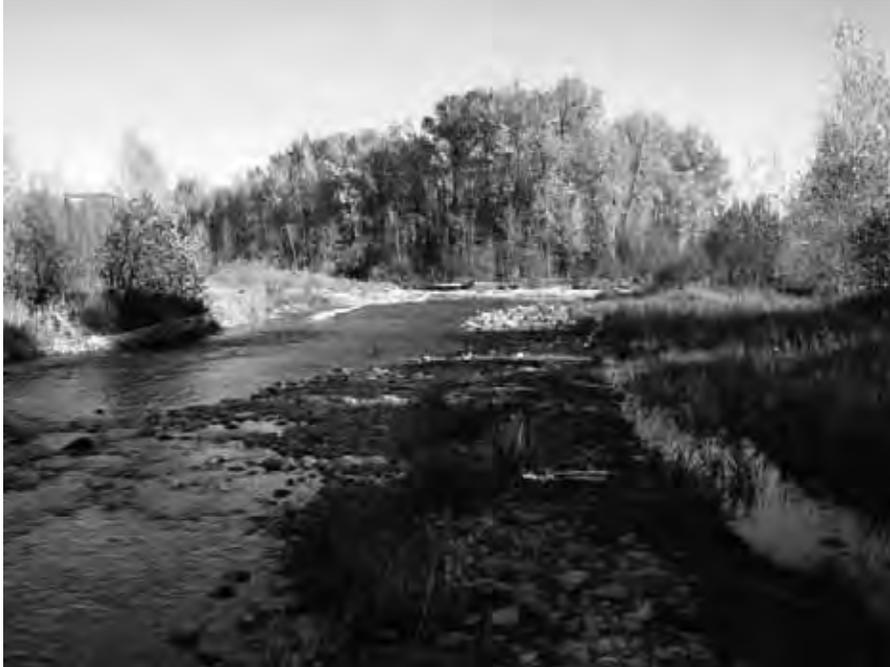
**Photograph No. 32.** View is to the southeast looking downstream toward confluence of side channel and mainstem along gravel bar on river right. MR Prj\_56.0 Project Area – Methow Subbasin, Washington – Bureau of Reclamation Photograph by R. McAfee, October 19, 2006.

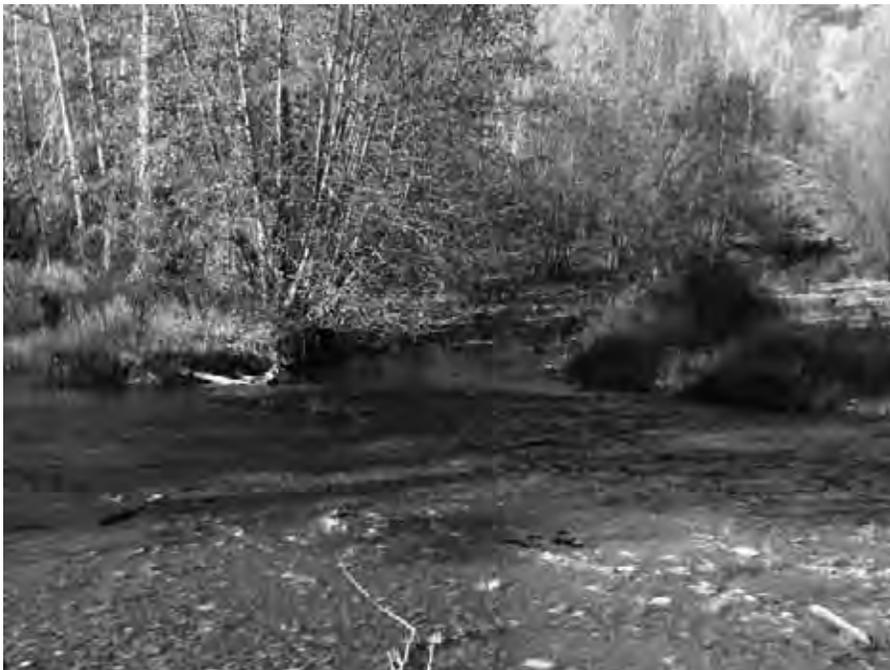
**Photograph No. 33.** View is to the north looking across the side channel from river right toward secondary side channel. Salmon were observed spawning in this section of the side channel. MR Prj\_56.0 Project Area – Methow Subbasin, Washington – Bureau of Reclamation Photograph by R. McAfee, October 19, 2006.

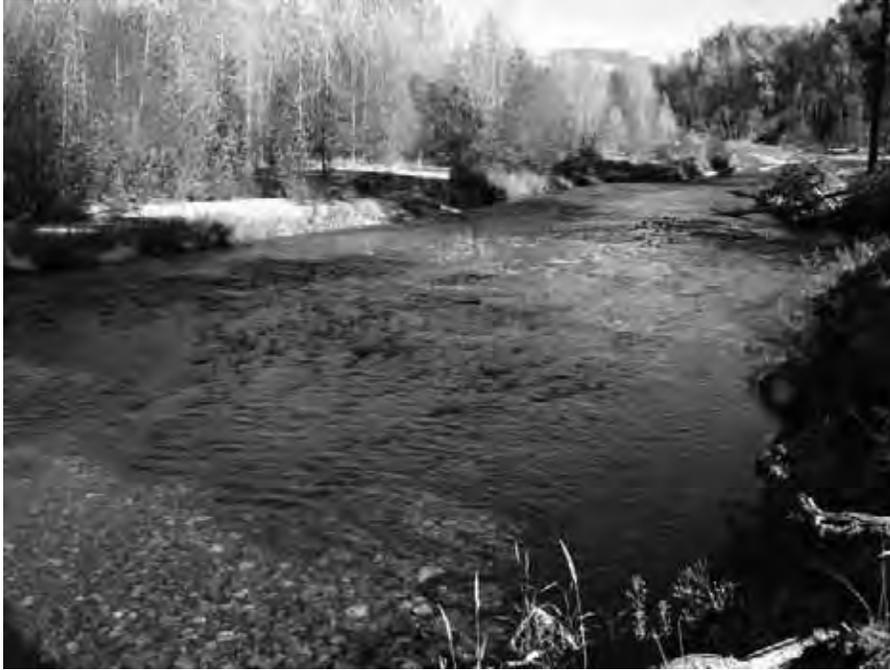
**Photograph No. 34.** View is to the southeast looking downstream along side channel toward confluence with mainstem on river right. MR Prj\_56.0 Project Area – Methow Subbasin, Washington – Bureau of Reclamation Photograph by R. McAfee, October 19, 2006.

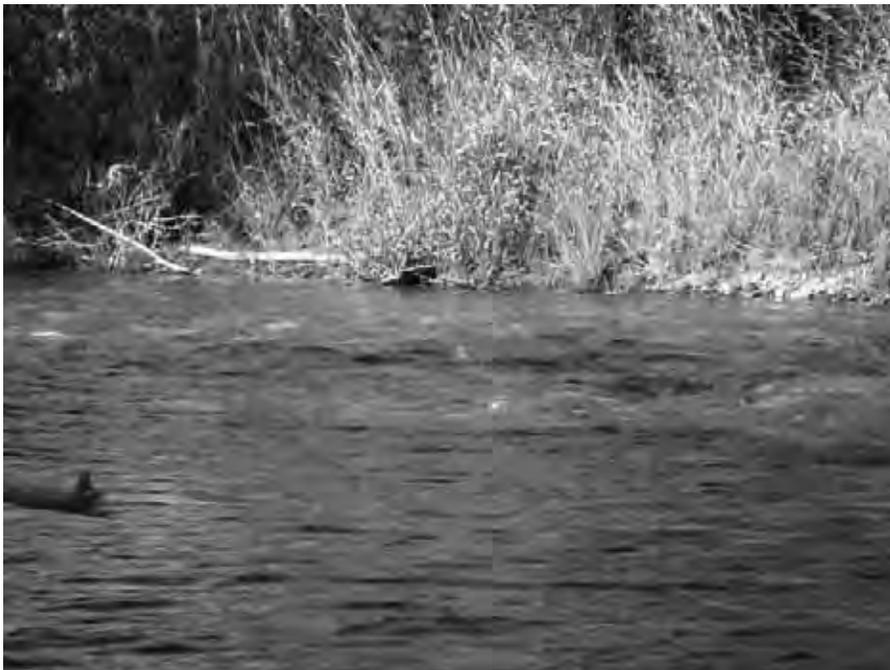
**Photograph No. 35.** View of salmon utilizing side channel for spawning. Note dorsal fin in the center of photograph. MR Prj\_56.0 Project Area – Methow Subbasin, Washington – Bureau of Reclamation Photograph by R. McAfee, October 19, 2006.

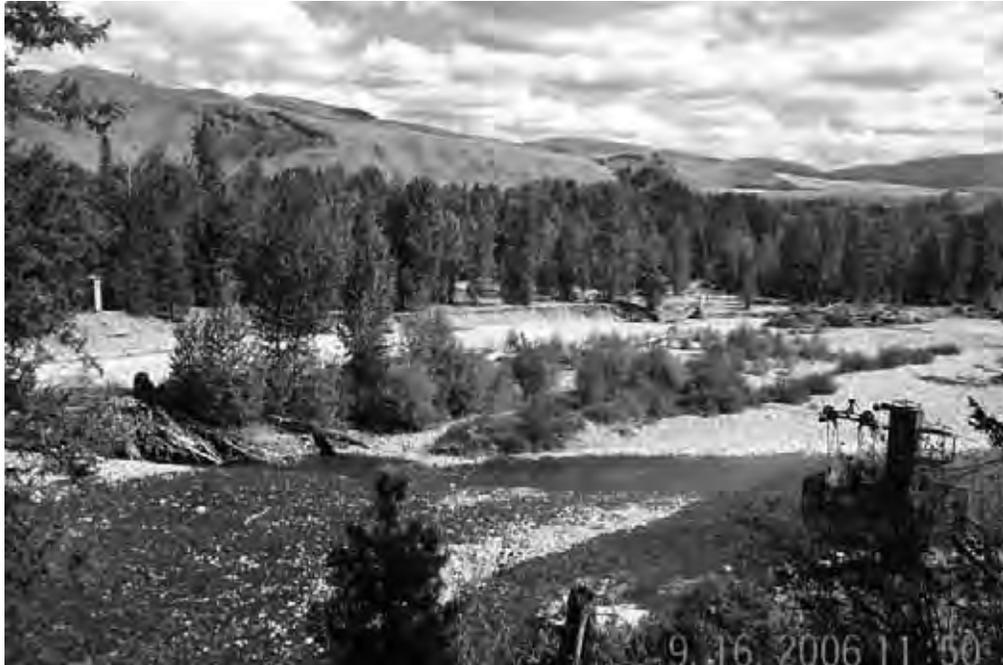
**Photograph No. 36.** View is to the southeast looking downstream along river right where a cable tram crosses the river. MR Prj\_56.0 Project Area – Methow Subbasin, Washington – Bureau of Reclamation Photograph by E. Lyon, September 16, 2006.

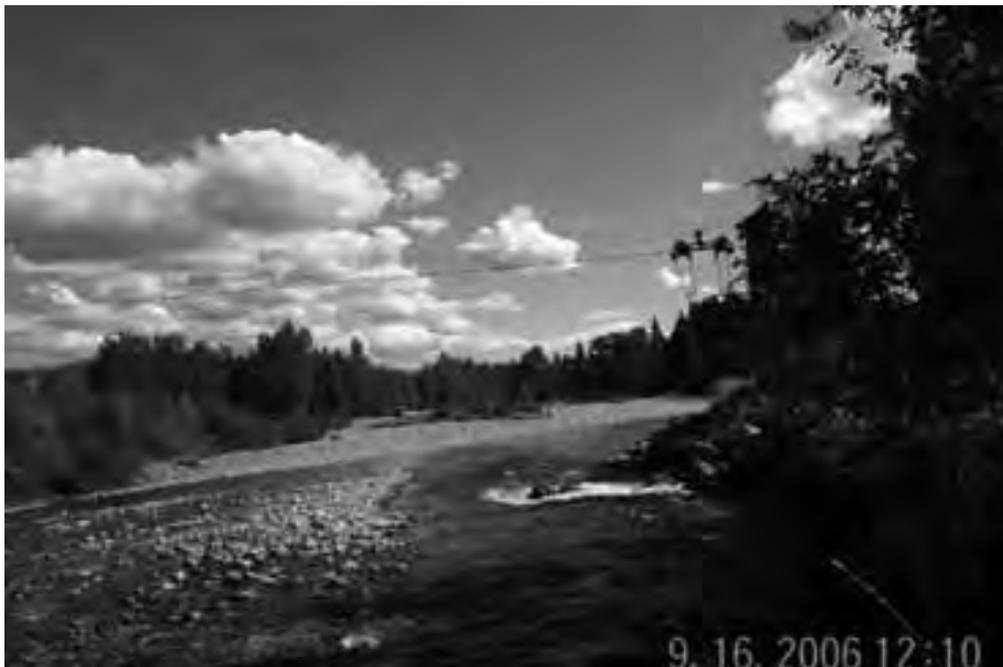
**Photograph No. 37.** View is to the southeast looking downstream along river right where cable tram is located. Note riprap protecting the right abutment of the cable tram. MR Prj\_56.0 Project Area – Methow Subbasin, Washington – Bureau of Reclamation Photograph by E. Lyon, September 16, 2006.

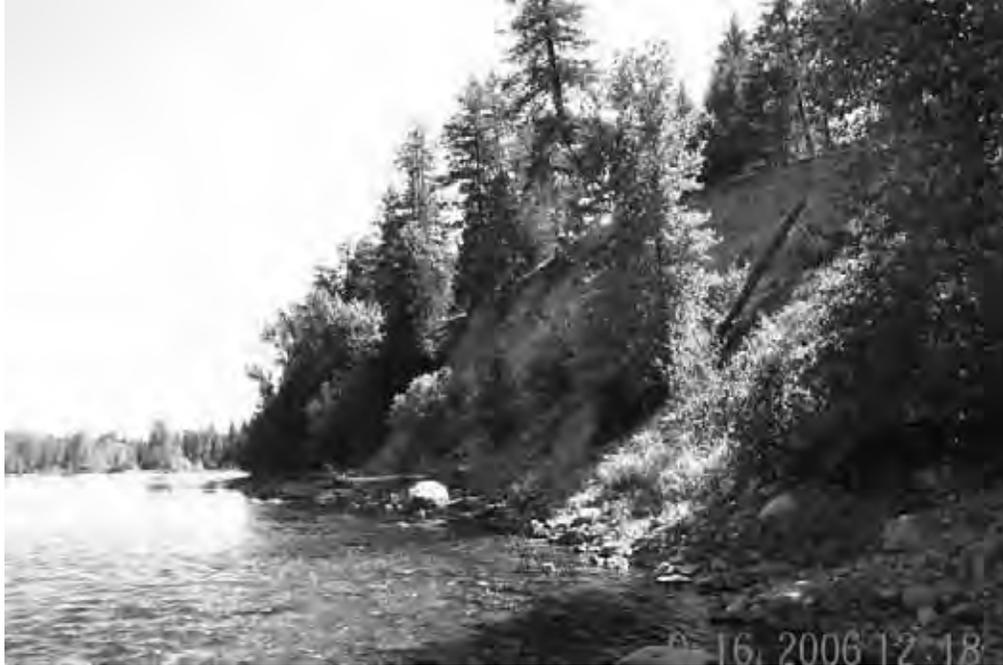
- An active slide area along river right provides sediment to the system during high flows (Photograph No. 38).
- The river avulsed during the 2006 spring freshet and abandoned its historic channel path (Photograph Nos. 12 and 15).

**Photograph No. 38.** View is to the south looking downstream along river right where a slide area was re-activated during the 2006 spring freshet. MR Prj\_56.0 Project Area – Methow Subbasin, Washington – Bureau of Reclamation Photograph by E. Lyon, September 16, 2006.

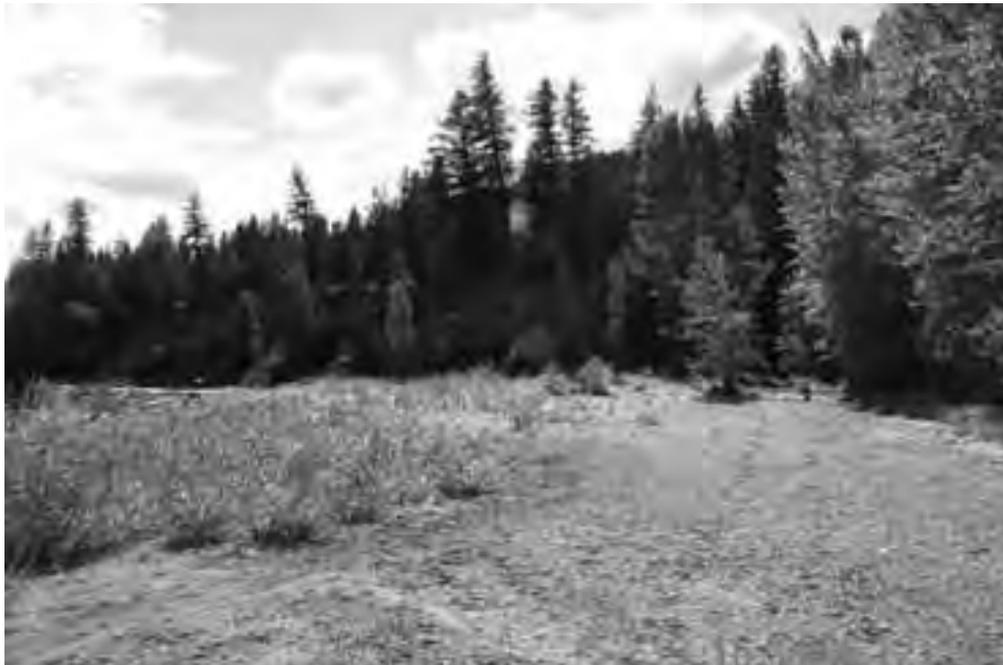
**Photograph No. 39.** View is to the south looking downstream along side channel on river right near its confluence with the mainstem. MR Prj\_56.0 Project Area – Methow Subbasin, Washington – Bureau of Reclamation Photograph by E. Lyon, September 16, 2006.
