## Big Valley Reach Assessment Methow River

Okanogan County, Washington

U.S. Department of the Interior  
Bureau of Reclamation  
Pacific Northwest Region

August 2008

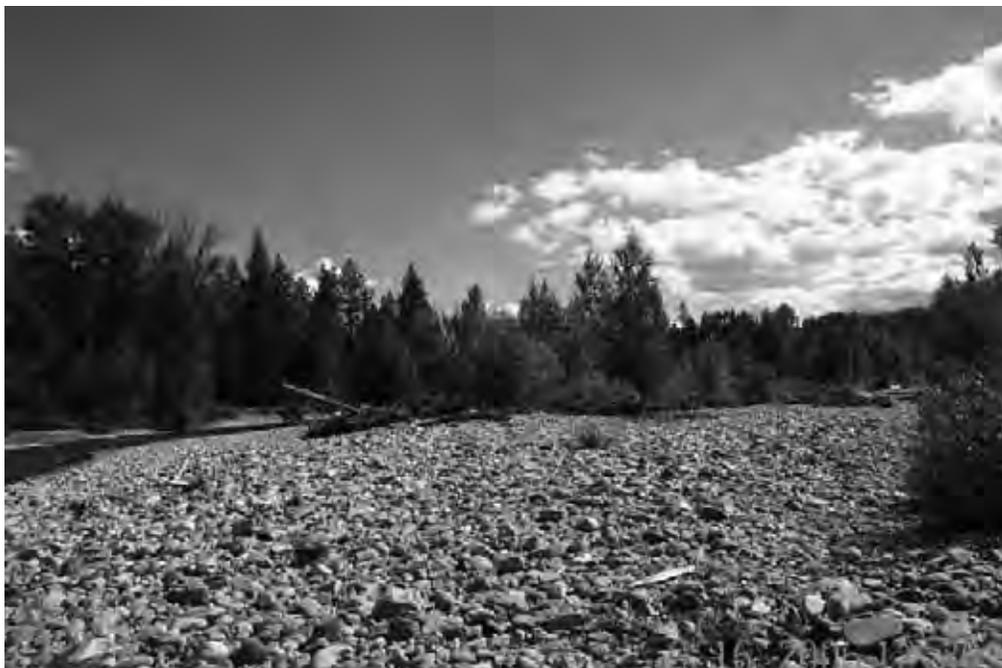
**Photograph No. 40.** View is to the south looking downstream along side channel on river right near its head. MR Prj\_56.0 Project Area – Methow Subbasin, Washington – Bureau of Reclamation Photograph by E. Lyon, September 16, 2006.

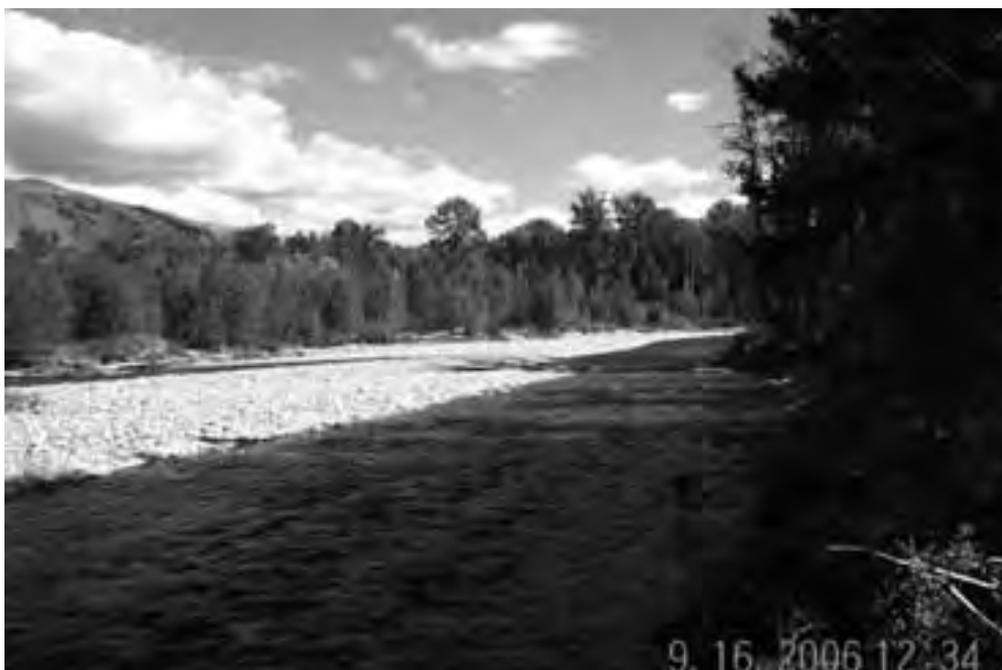
**Photograph No. 41.** View is to the southeast looking downstream along river right where the bank experienced some relatively severe erosion during the 2006 spring freshet. MR Prj\_56.0 Project Area – Methow Subbasin, Washington – Bureau of Reclamation Photograph by E. Lyon, September 16, 2006.

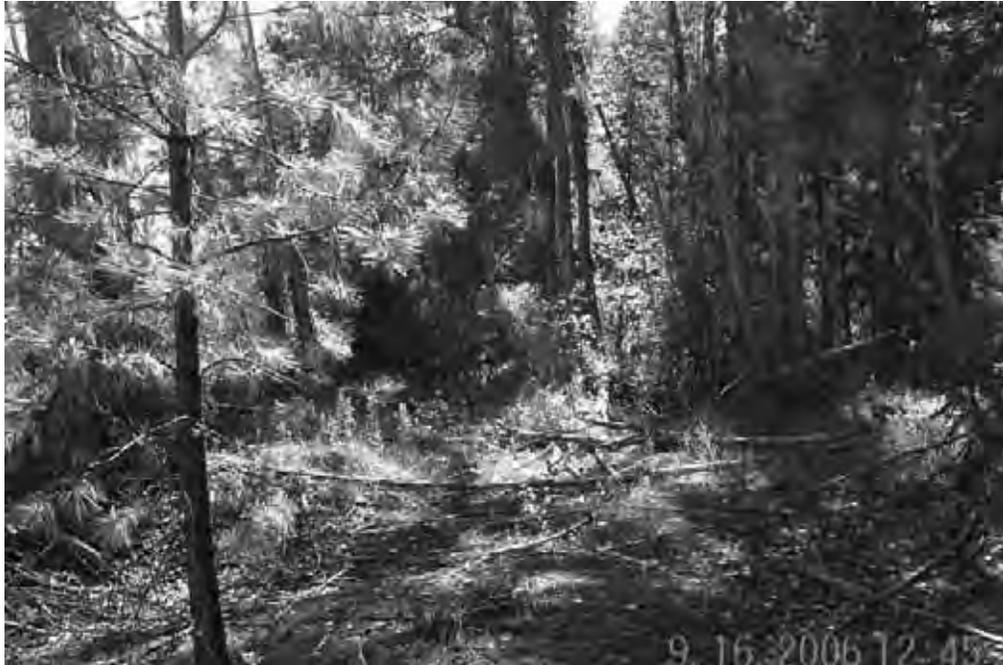
**Photograph No. 42.** View is to the south looking downstream along an overflow channel along river right where overbank flows accessed the channel during the 2006 spring freshet. MR Prj\_56.0 Project Area – Methow Subbasin, Washington – Bureau of Reclamation Photograph by E. Lyon, September 16, 2006.

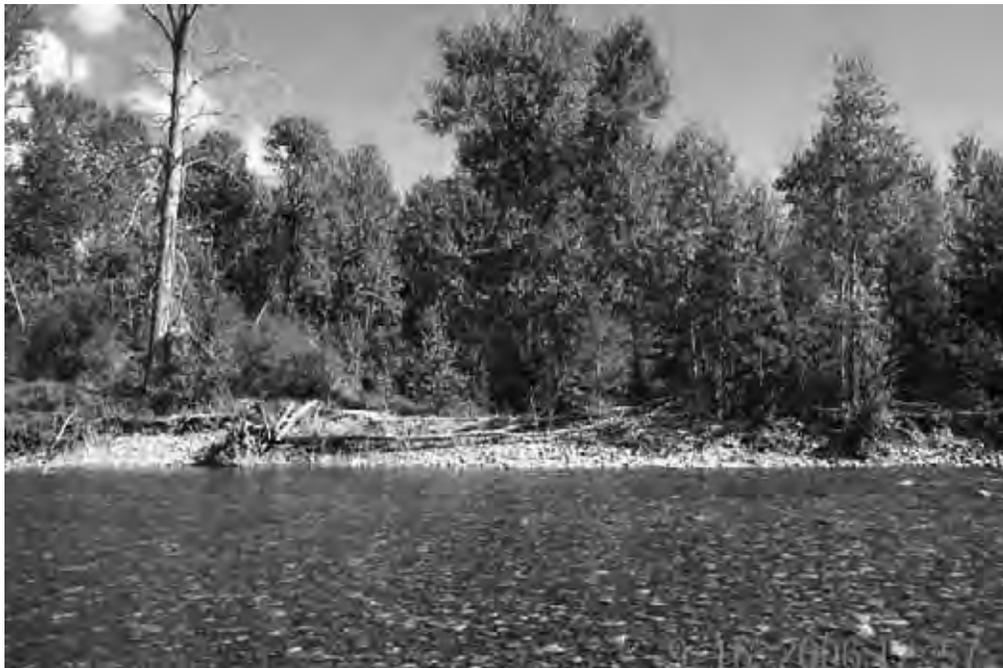
**Photograph No. 43.** View is to the east looking across the river to the left bank a historic channel flowed and created an oxbow. The bank height is about 3 feet. MR Prj\_56.0 Project Area – Methow Subbasin, Washington – Bureau of Reclamation Photograph by E. Lyon, September 16, 2006.

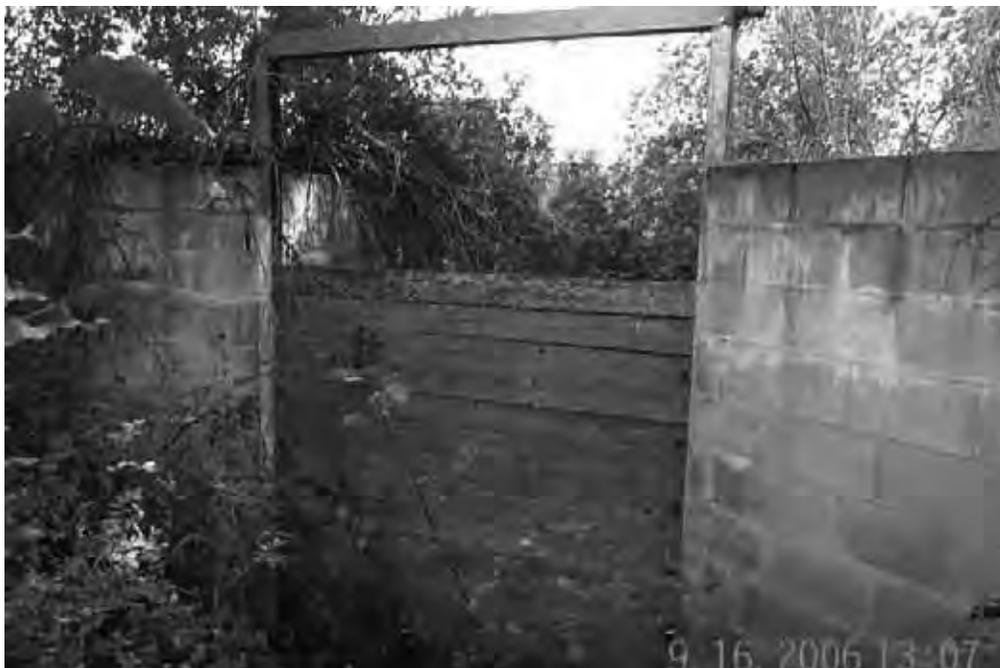
- There is one footbridge crossing an overflow channel.
- There is one bridge crossing an overflow channel.
- There is a headgate along a decommissioned irrigation ditch (Photograph No. 44).

**Photograph No. 44.** View of a headgate near the cable tram on river right. Irrigation ditch appears to have been decommissioned. MR Prj\_56.0 Project Area – Methow Subbasin, Washington – Bureau of Reclamation Photograph by E. Lyon, September 16, 2006.

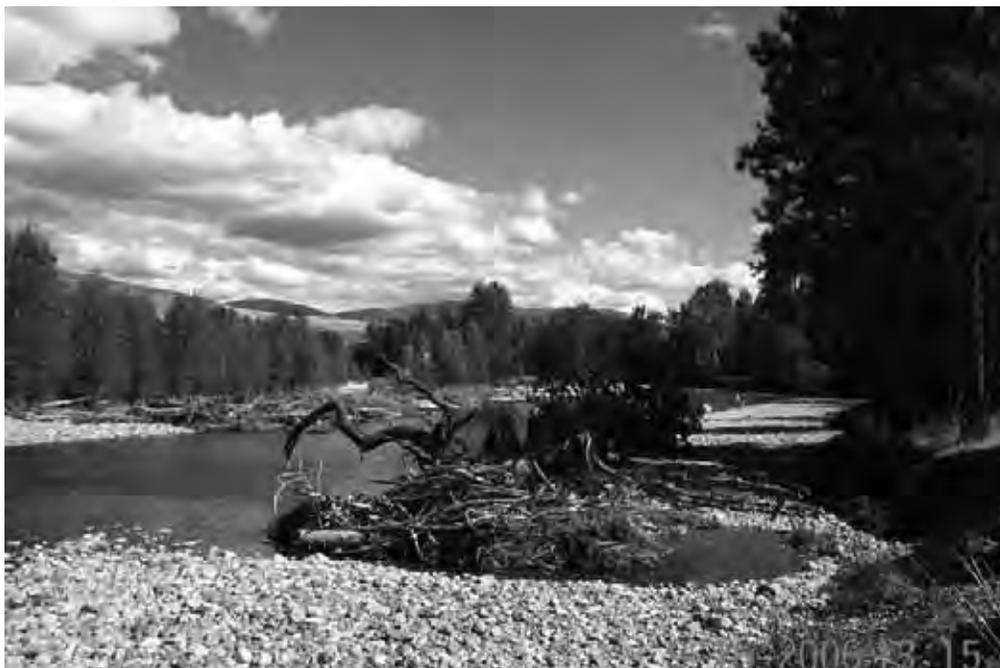
**Photograph No. 45.** View is to the southeast looking downstream along river right where severe bank erosion occurred during the 2006 spring freshet. MR Prj\_56.0 Project Area – Methow Subbasin, Washington – Bureau of Reclamation Photograph by E. Lyon, September 16, 2006.

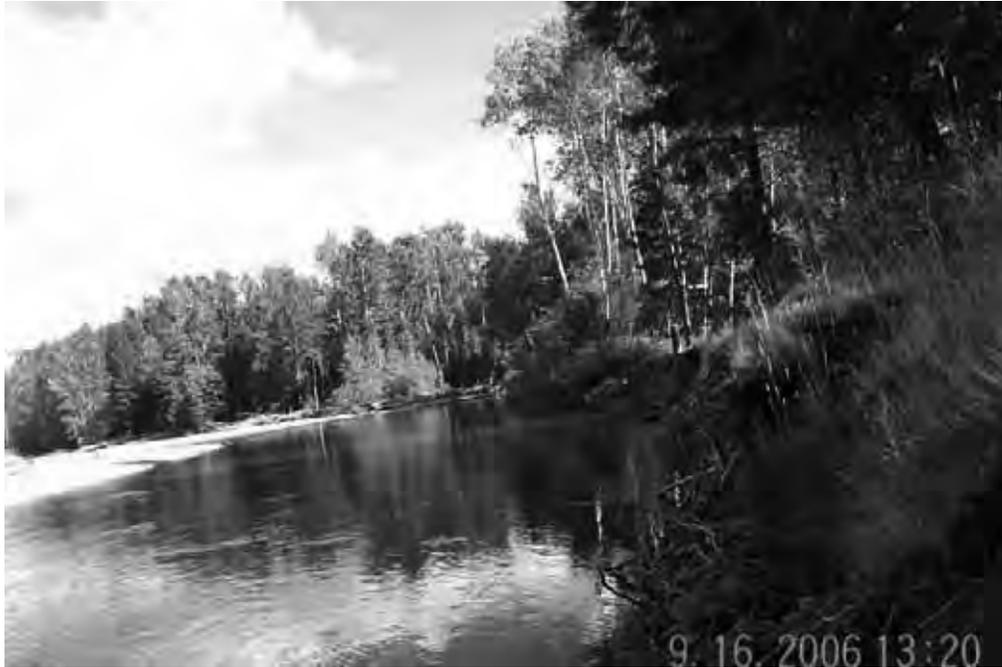
**Photograph No. 46.** View is to the east looking downstream along river right where severe bank erosion occurred during the 2006 spring freshet. Note the well casing along the active channel. MR Prj\_56.0 Project Area – Methow Subbasin, Washington – Bureau of Reclamation Photograph by E. Lyon, September 16, 2006.

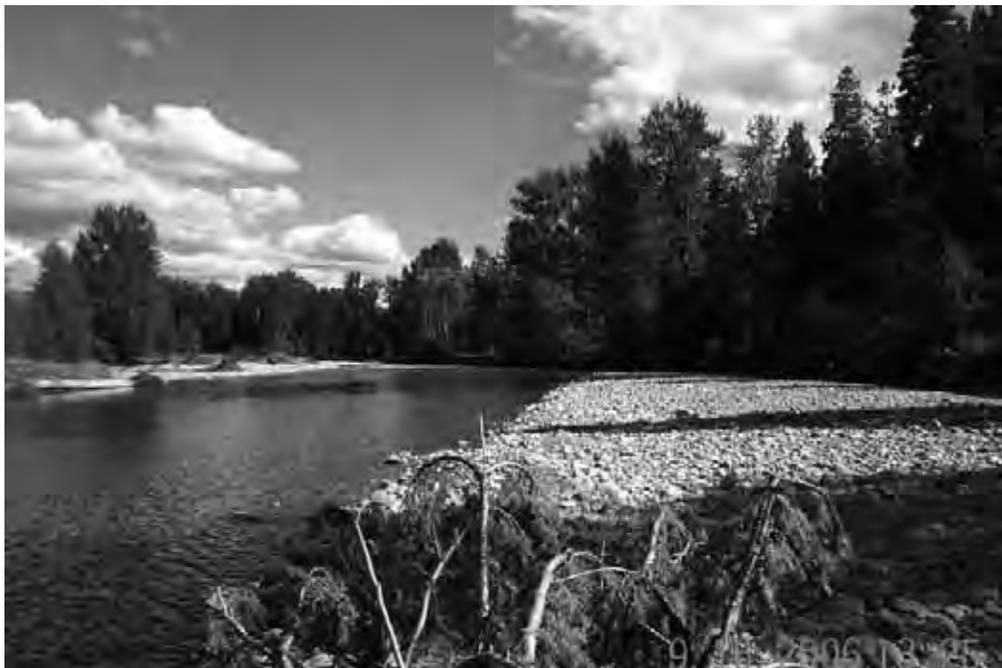
**Photograph No. 47.** View is to the southeast looking downstream along river right where a large conifer fell into the river. MR Prj\_56.0 Project Area – Methow Subbasin, Washington – Bureau of Reclamation Photograph by E. Lyon, September 16, 2006.

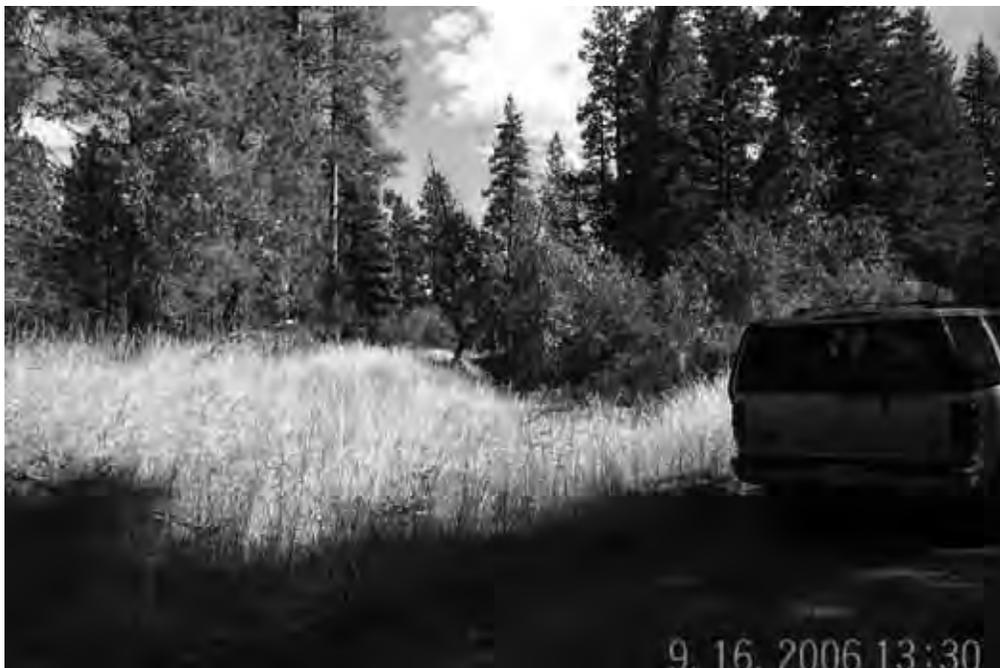
**Photograph No. 48.** View is to the southeast looking downstream along an irrigation ditch(?) that is believed to head near the cable tram. MR Prj\_56.0 Project Area – Methow Subbasin, Washington – Bureau of Reclamation Photograph by E. Lyon, September 16, 2006.

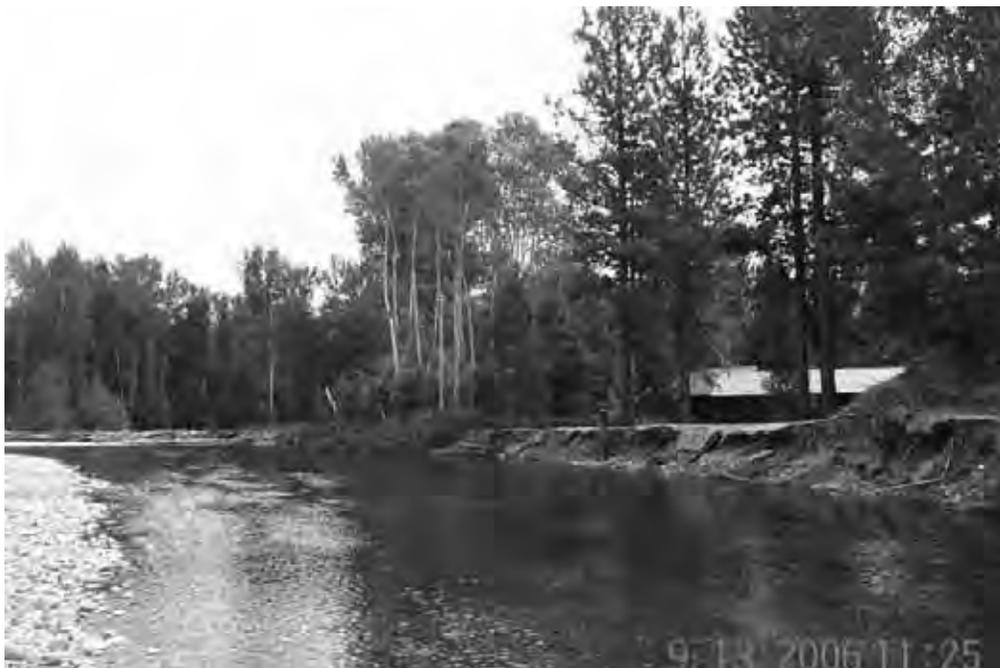
**Photograph No. 49.** View is to the southeast looking downstream from river left at the severe bank erosion that occurred during the 2006 spring freshet. MR Prj\_56.0 Project Area – Methow Subbasin, Washington – Bureau of Reclamation Photograph by E. Lyon, September 16, 2006.

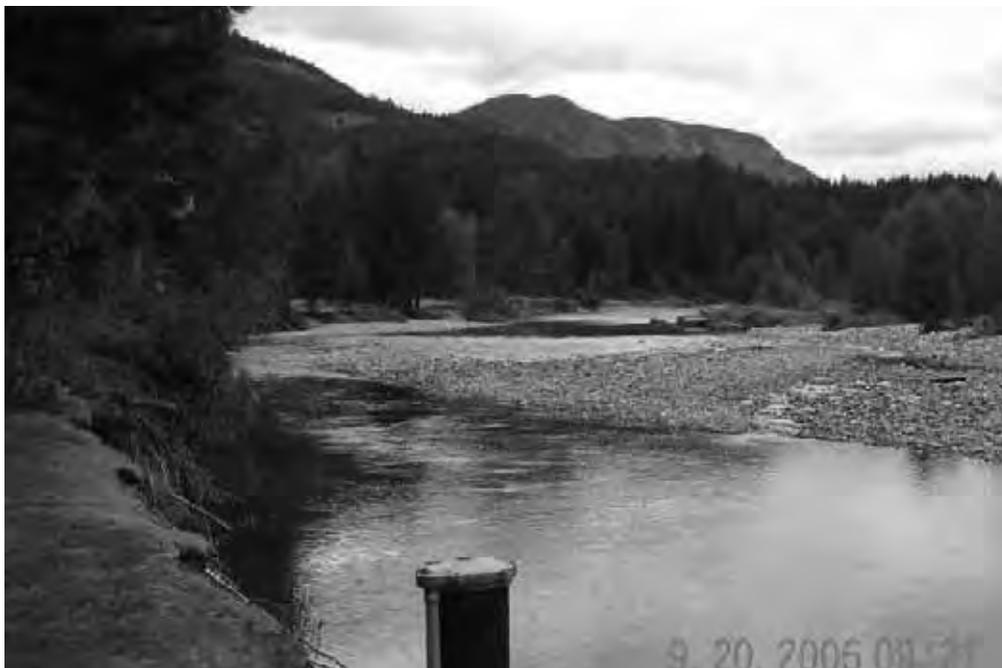
**Photograph No. 50.** View is to the northwest looking upstream from river right at abandoned well and eroded bank. MR Prj\_56.0 Project Area – Methow Subbasin, Washington – Bureau of Reclamation  
Photograph by E. Lyon, September 20, 2006.

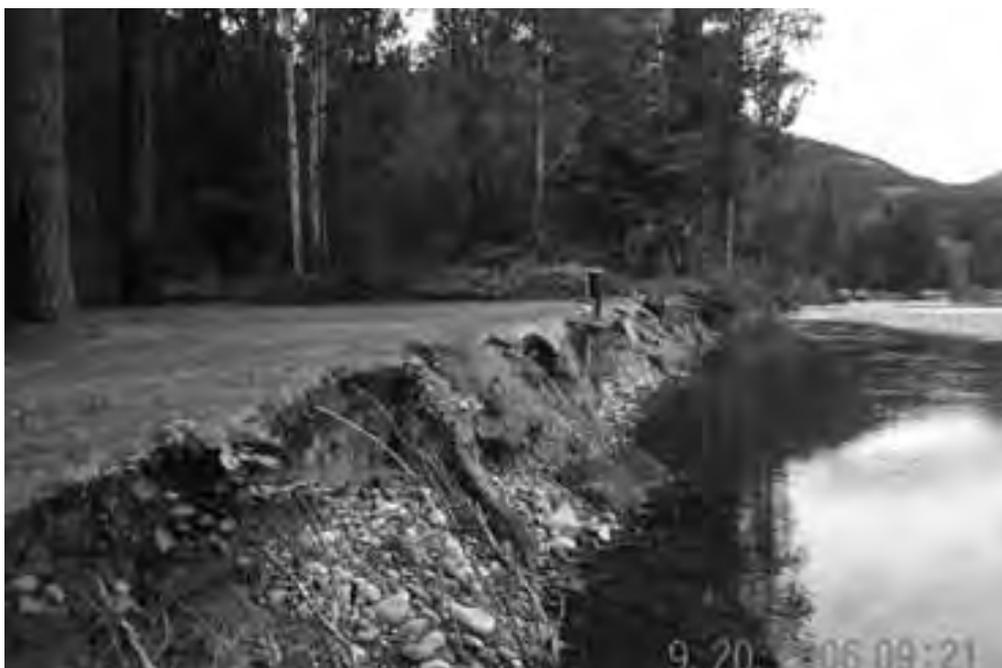
**Photograph No. 51.** View is to the northwest looking upstream along river right at abandoned well and eroded bank. MR Prj\_56.0 Project Area – Methow Subbasin, Washington – Bureau of Reclamation  
Photograph by E. Lyon, September 20, 2006.

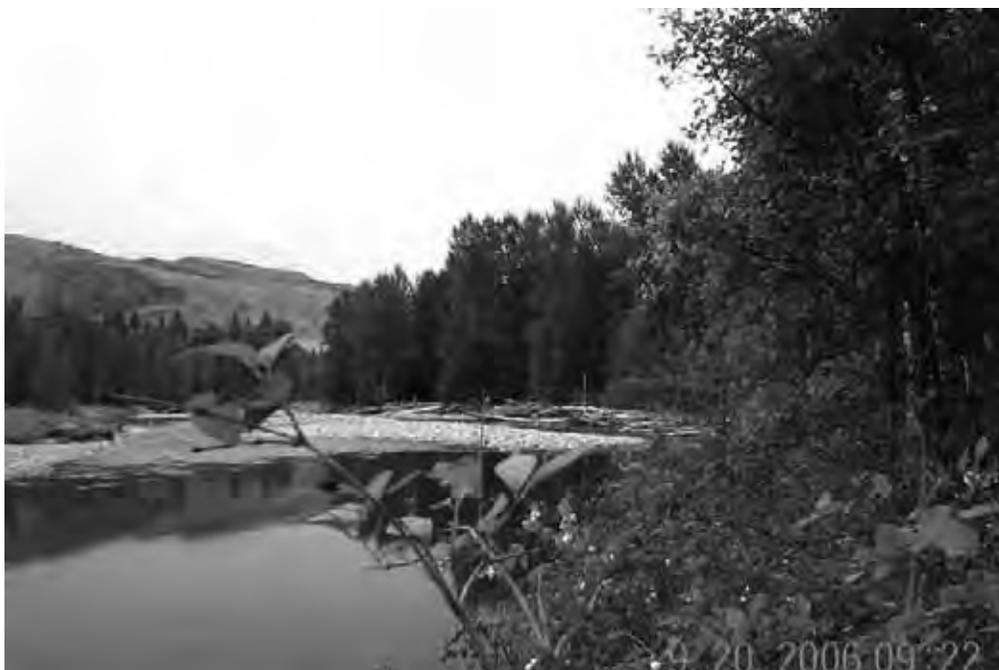
**Photograph No. 52.** View is to the east looking downstream from river right at logjam at head of side channel. MR Prj\_56.0 Project Area – Methow Subbasin, Washington – Bureau of Reclamation Photograph by E. Lyon, September 20, 2006.

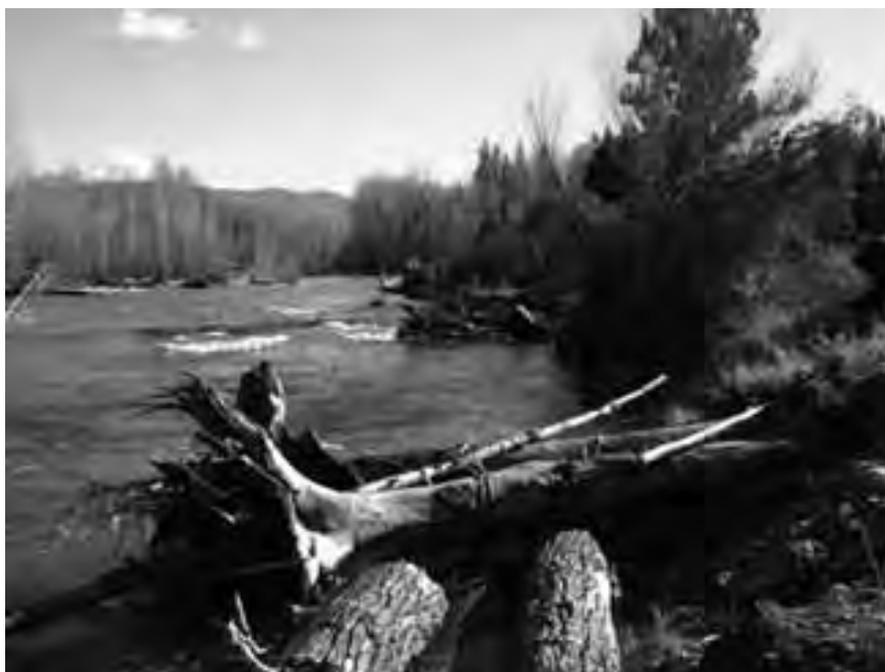
**Photograph No. 53.** View is to the southeast looking downstream during the November 8, 2006 rain event along river right at rootwads placed during the 2006 spring freshet. MR Prj\_56.0 Project Area – Methow Subbasin, Washington – Bureau of Reclamation Photograph by R. McAfee, November 8, 2006.

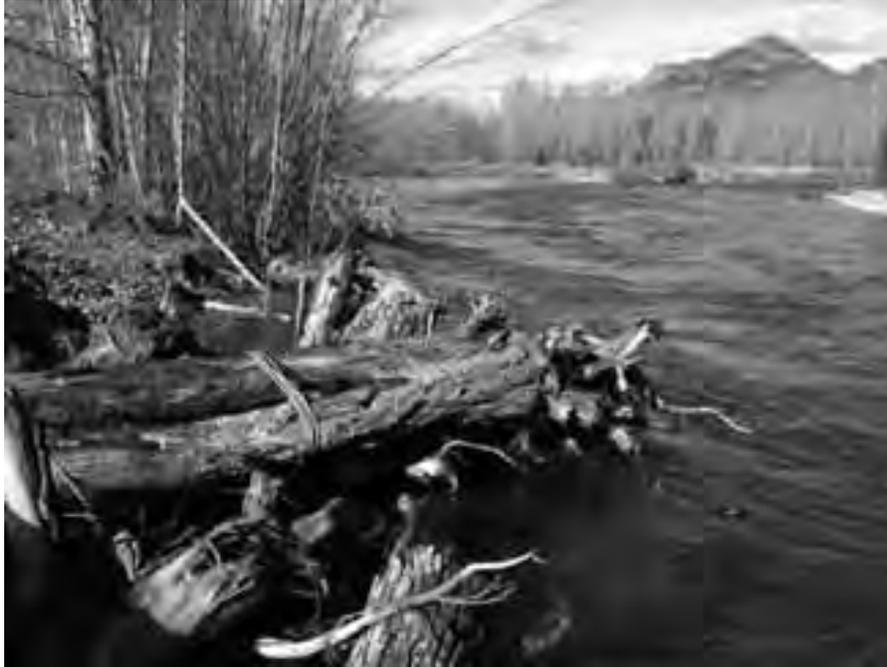
**Photograph No. 54.** View is to the northwest looking upstream during the November 8, 2006 rain event along river right at rootwads placed during the 2006 spring freshet. MR Prj\_56.0 Project Area – Methow Subbasin, Washington – Bureau of Reclamation Photograph by R. McAfee, November 8, 2006.

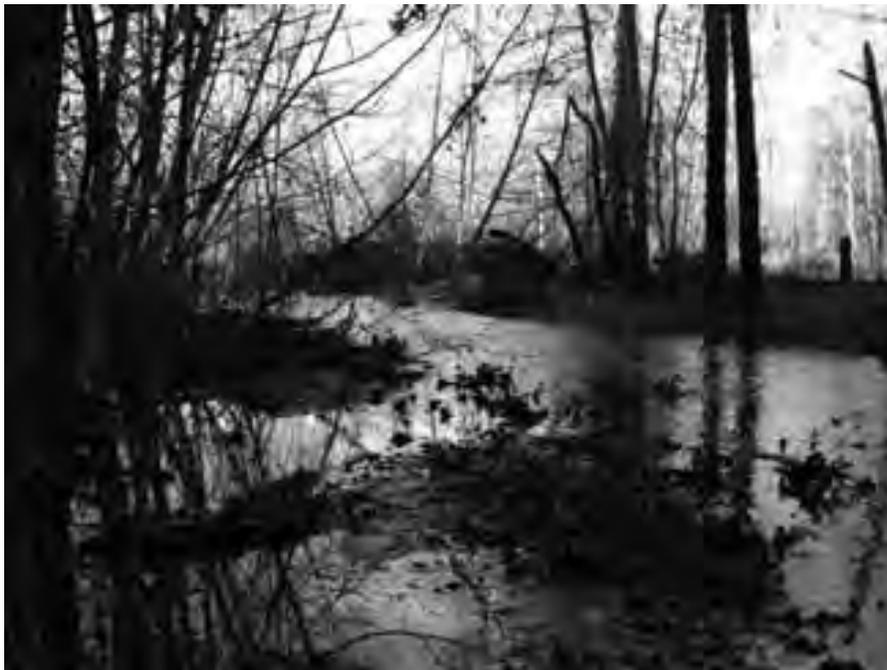
**Photograph No. 55.** View is to the north looking upstream along a side channel that was accessed during the November 8, 2006 rain event along river right. MR Prj\_56.0 Project Area – Methow Subbasin, Washington – Bureau of Reclamation Photograph by R. McAfee, November 8, 2006.

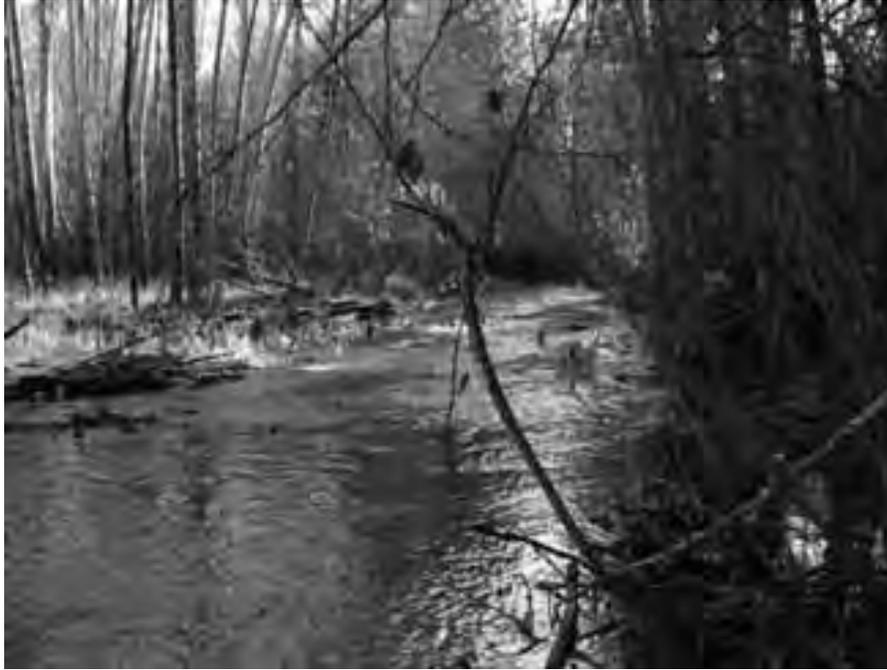
**Photograph No. 56.** View is to the southeast looking downstream along a side channel that was accessed during the November 8, 2006 rain event along river right. MR Prj\_56.0 Project Area – Methow Subbasin, Washington – Bureau of Reclamation Photograph by R. McAfee, November 8, 2006.

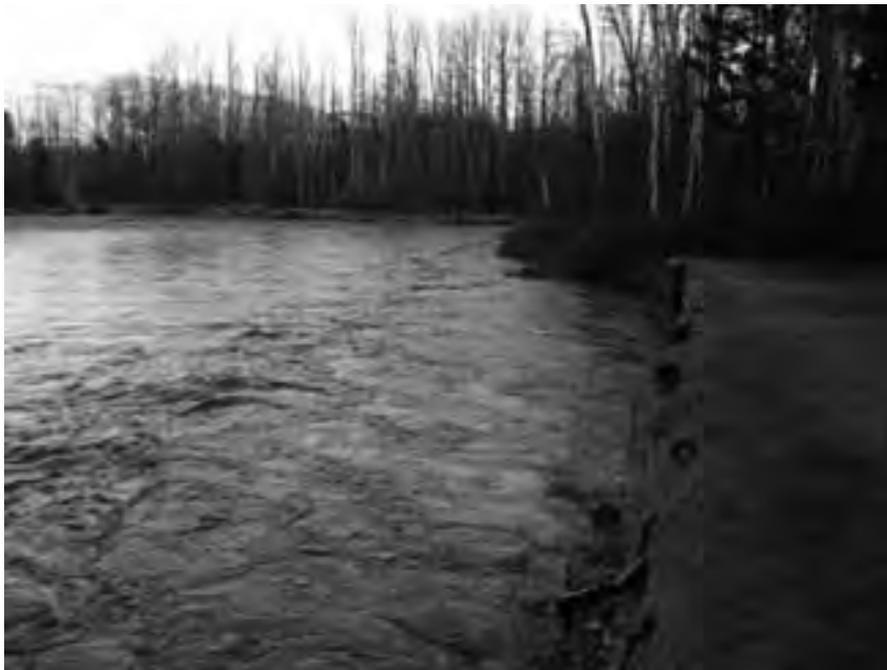
**Photograph No. 57.** View is to the southeast looking downstream along river right during the November 8, 2006 rain event. MR Prj\_56.0 Project Area – Methow Subbasin, Washington – Bureau of Reclamation Photograph by R. McAfee, November 8, 2006.

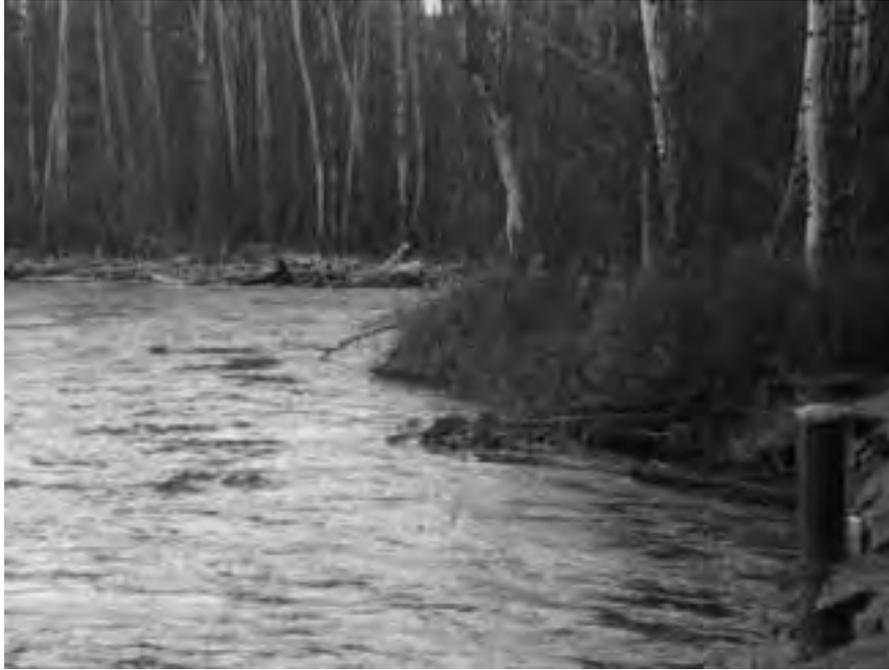
**Photograph No. 58.** View is to the east looking downstream along river right during the November 8, 2006 rain event. MR Prj\_56.0 Project Area – Methow Subbasin, Washington – Bureau of Reclamation Photograph by R. McAfee, November 8, 2006.

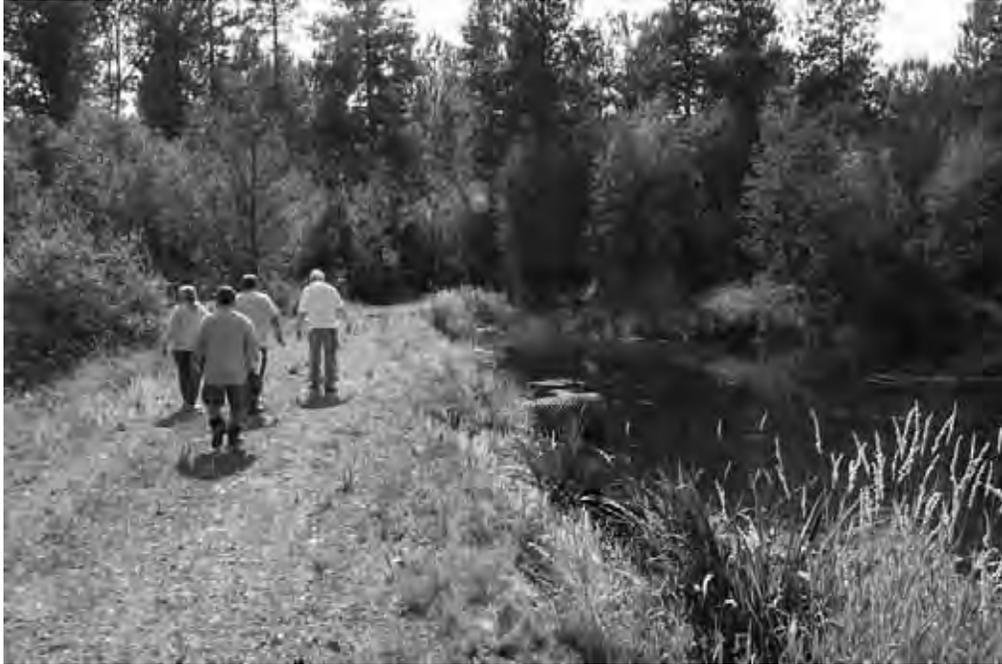
- Three embankment dams were observed that impound a groundwater charged wetland complex (Photograph Nos. 1, 3 and 4). These embankment dams appear to be fish passage barriers into the wetland complex.

**Photograph No. 1.** View is to the west looking across embankment dam that has a culvert as its primary outlet and dual culverts as emergency spillways. This dam was breached at the dual culverts during the 2006 spring freshet on the west side. MR Prj\_56.5 Project Area – Methow Subbasin, Washington – Bureau of Reclamation Photograph by E. Lyon, August 15, 2006.

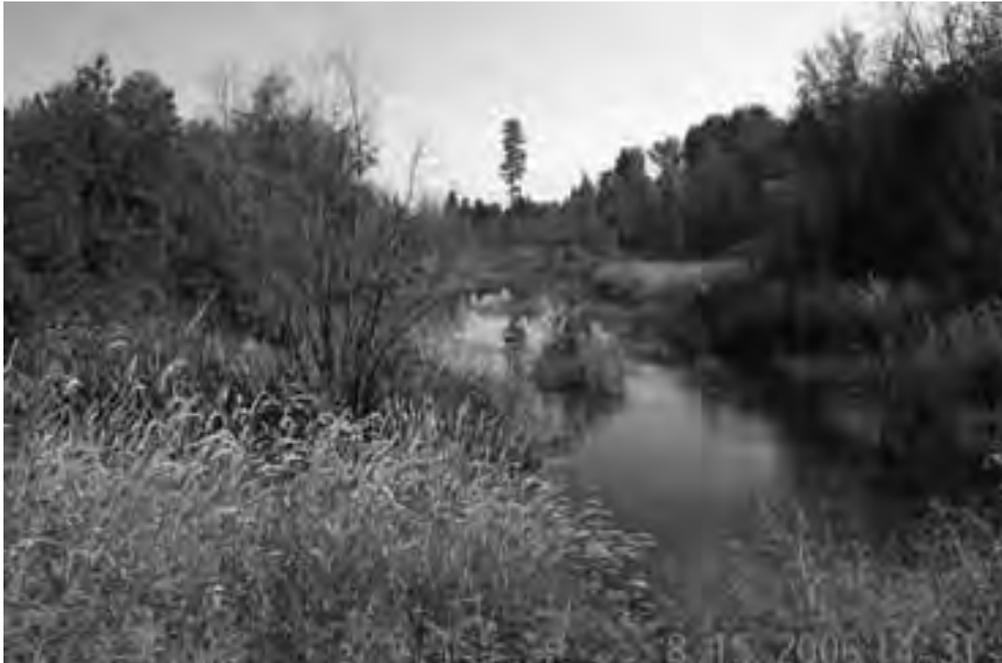
- About 150 linear feet of riprap was noted along river left (Photograph Nos. 26, 27 and 37).
- The wetland complex could provide excellent rearing habitat and high water refugia (Photograph Nos. 2, 8, 10 and 11). However, the wetland complex has resident brook trout and consideration will have to be given to remove or eradicate them.

**Photograph No. 2.** View is to the southeast looking downstream from embankment dam in Photograph No. 1. MR Prj\_56.5 Project Area – Methow Subbasin, Washington – Bureau of Reclamation Photograph by E. Lyon, August 15, 2006.

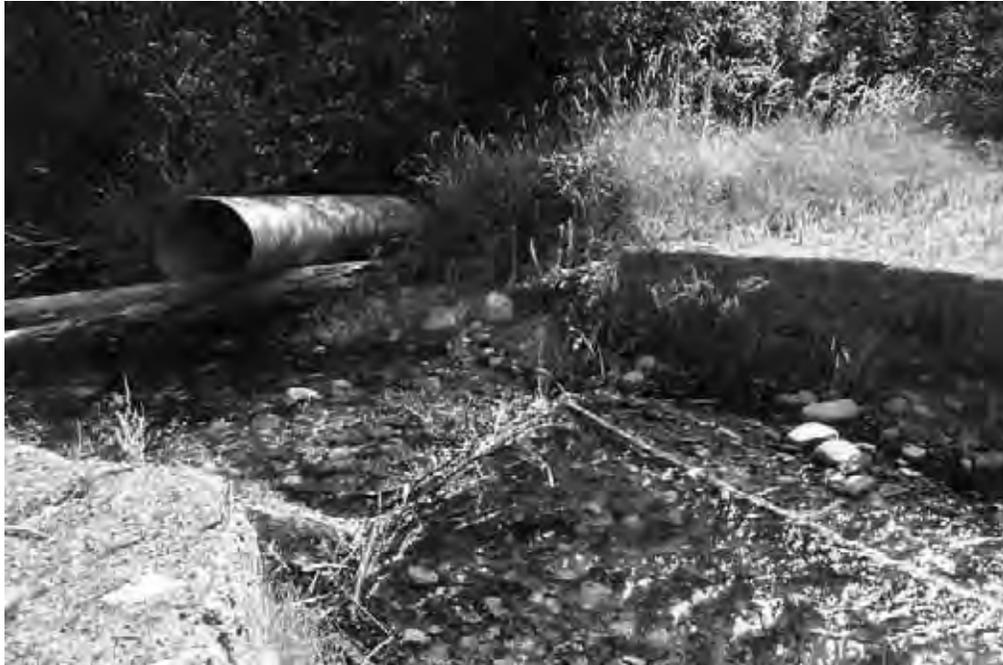
**Photograph No. 3.** View of breach in embankment dam that had dual culverts for an emergency spillway. The breach occurred during the 2006 spring freshet. MR Prj\_56.5 Project Area – Methow Subbasin, Washington – Bureau of Reclamation Photograph by E. Lyon, August 15, 2006.

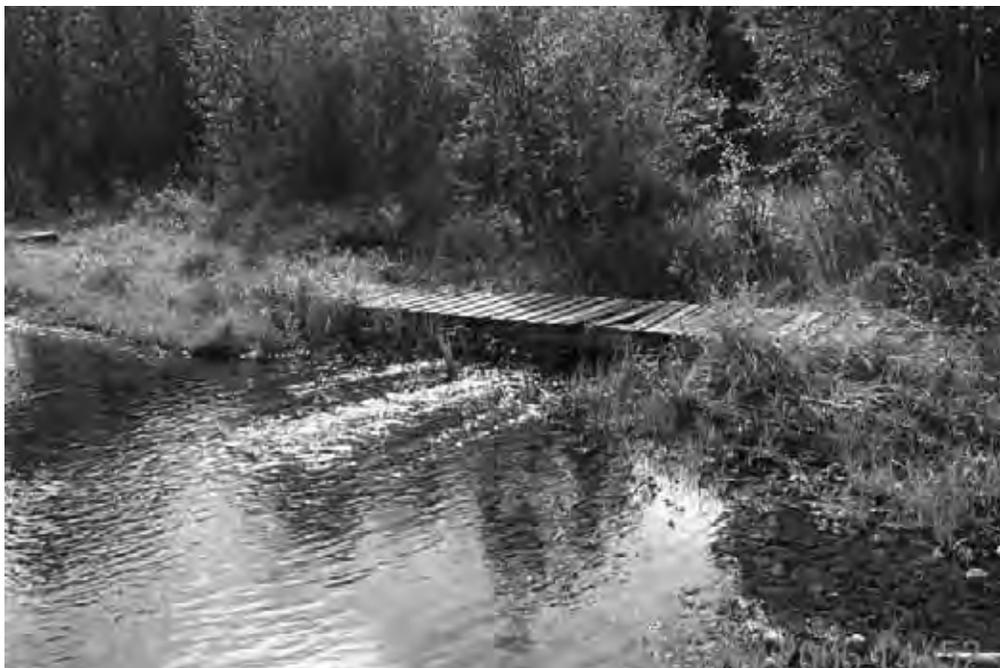
**Photograph No. 5.** View is to the northwest looking at an overflow channel from pond crossing road. MR Prj\_56.5 Project Area – Methow Subbasin, Washington – Bureau of Reclamation Photograph by E. Lyon, August 15, 2006.

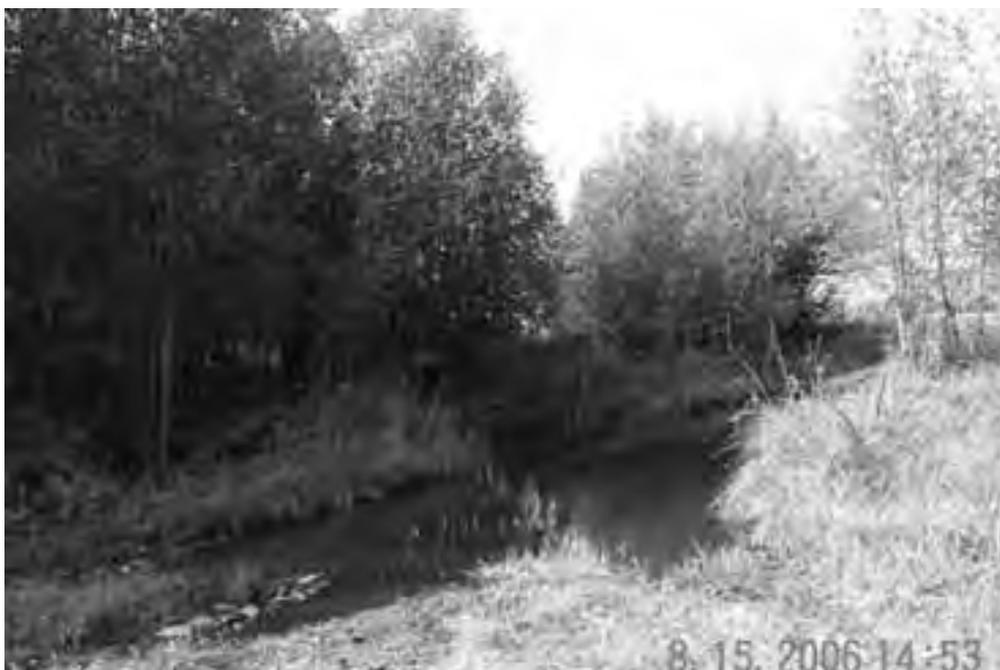
**Photograph No. 6.** View is to the northwest looking at a ford crossing an overflow channel flowing from pond. MR Prj\_56.5 Project Area – Methow Subbasin, Washington – Bureau of Reclamation Photograph by E. Lyon, August 15, 2006.

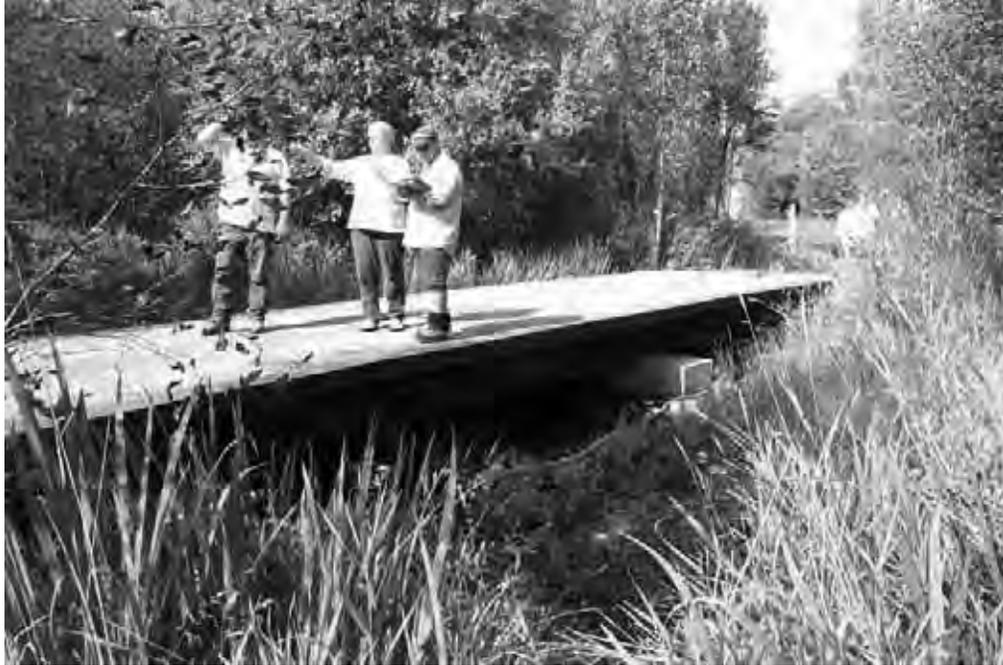
**Photograph No. 7.** View is to the north looking upstream at a bridge over the pond's outlet channel. MR Prj\_56.5 Project Area – Methow Subbasin, Washington – Bureau of Reclamation Photograph by E. Lyon, August 15, 2006.

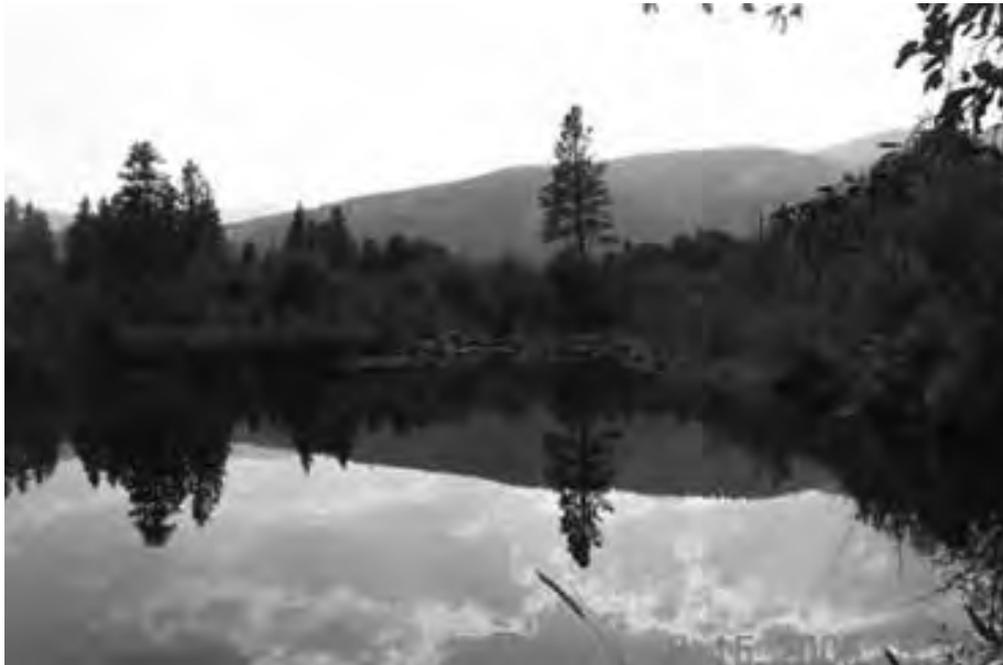
**Photograph No. 8.** View is to the northwest looking across pond from embankment dam. MR Prj\_56.5 Project Area – Methow Subbasin, Washington – Bureau of Reclamation Photograph by E. Lyon, August 15, 2006.

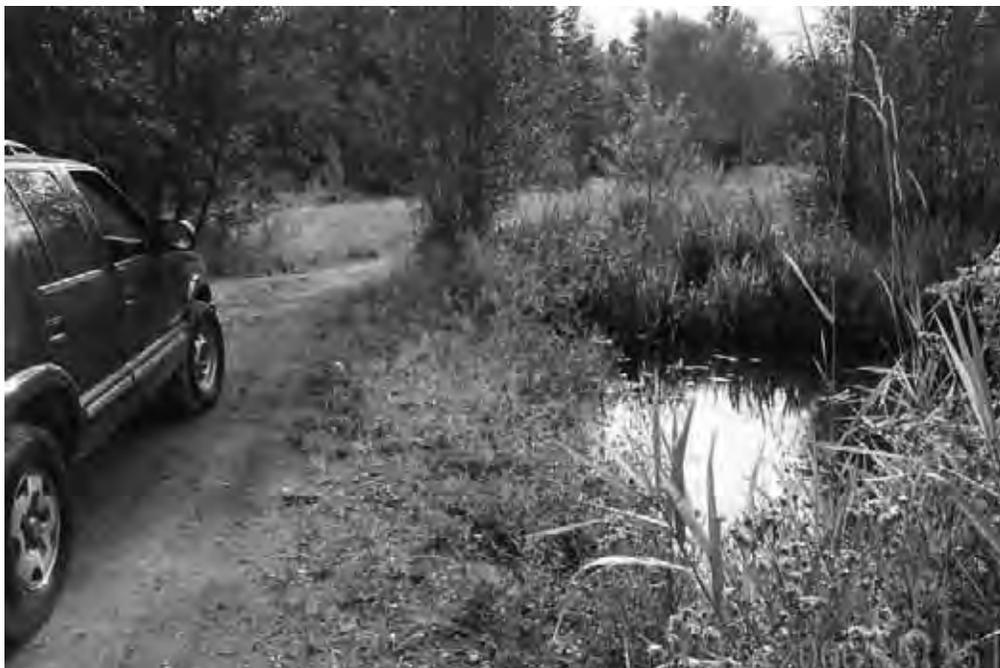
- One house (abandoned?) is located within the floodplain (Photograph No. 29).
- One culvert of sufficient size was observed at a road crossing (Photograph No. 9).

**Photograph No. 9.** View is to the southwest looking at a road crossing with culvert at overflow channel. MR Prj\_56.5 Project Area – Methow Subbasin, Washington – Bureau of Reclamation Photograph by E. Lyon, August 15, 2006.

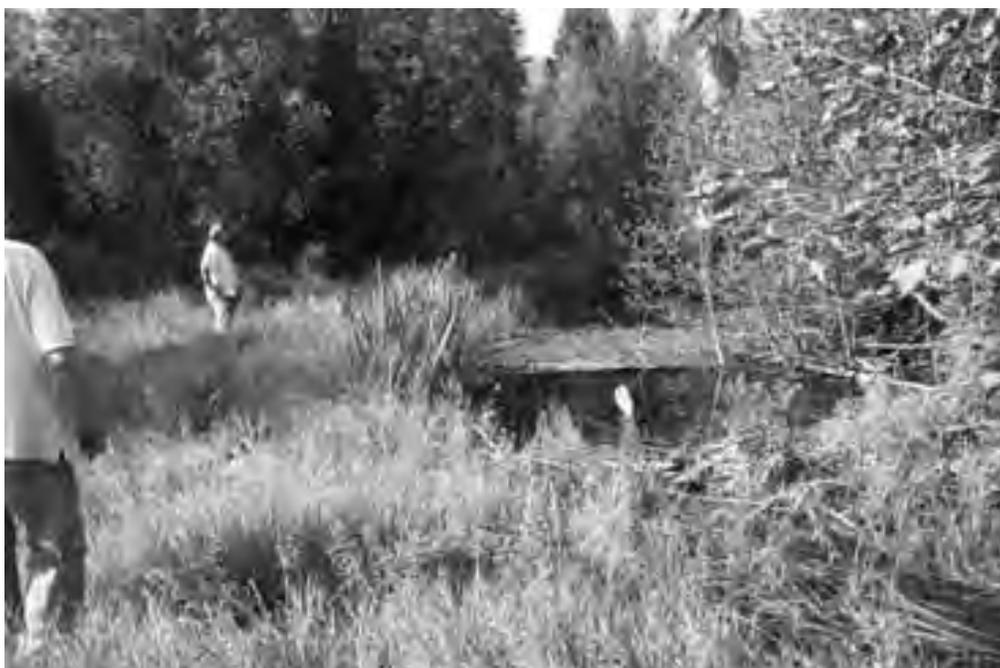
**Photograph No. 10.** View is to the northwest looking upstream at a small beaver dam impeding overflow channel from pond. MR Prj\_56.5 Project Area – Methow Subbasin, Washington – Bureau of Reclamation Photograph by E. Lyon, August 15, 2006.

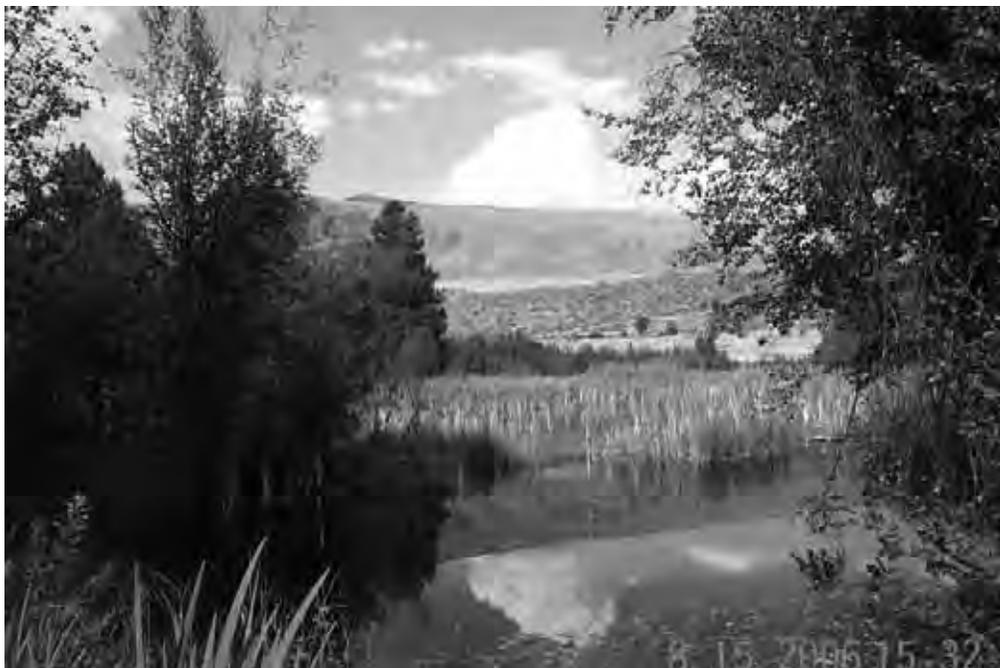
**Photograph No. 11.** View is to the north looking across pond impounded by embankment dam with overflow channels impeded by beaver dams. MR Prj\_56.5 Project Area – Methow Subbasin, Washington – Bureau of Reclamation Photograph by E. Lyon, August 15, 2006.

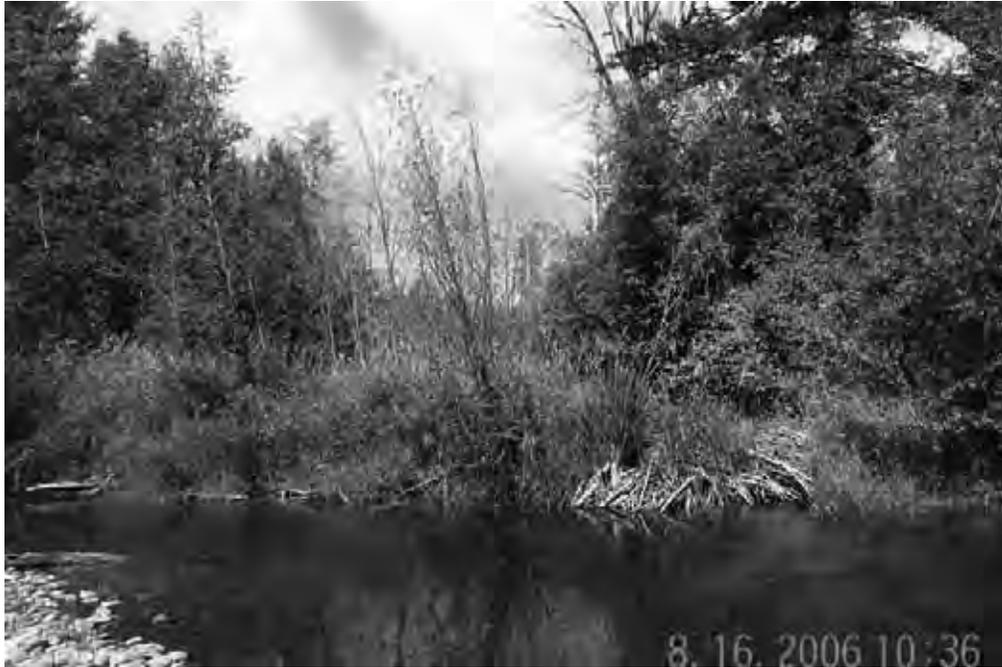
**Photograph No. 13.** View is to the northwest looking upstream along a side channel at a beaver dam that could be a potential fish passage barrier to wetland complex. MR Prj\_56.5 Project Area – Methow Subbasin, Washington – Bureau of Reclamation Photograph by E. Lyon, August 16, 2006.

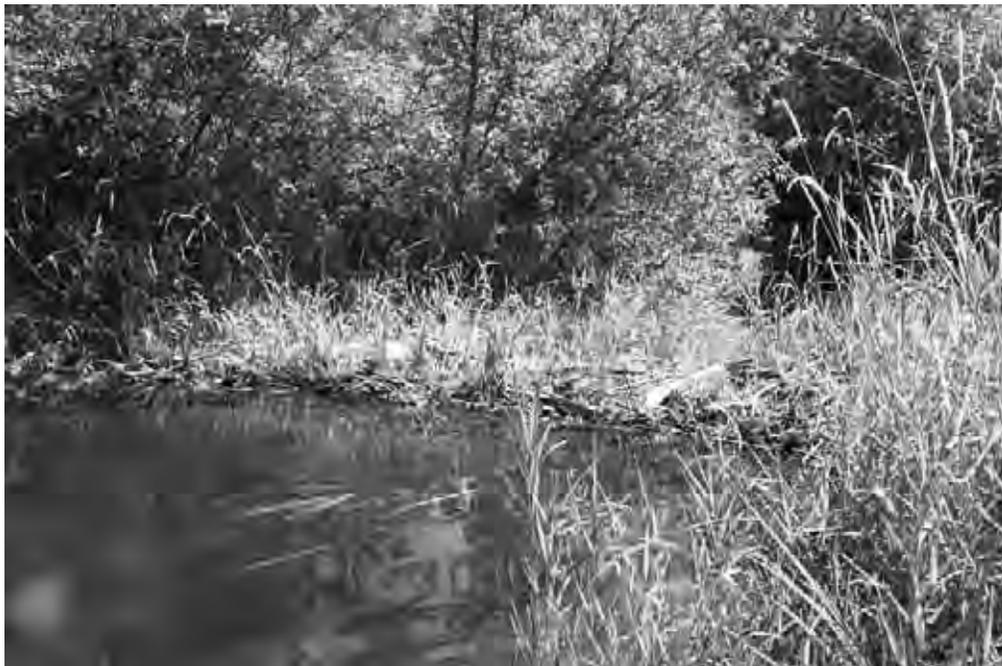
**Photograph No. 14.** View is to the east looking downstream at beaver dam that could be a potential fish passage barrier along side channel to beaver pond complex. MR Prj\_56.5 Project Area – Methow Subbasin, Washington – Bureau of Reclamation Photograph by E. Lyon, August 16, 2006.
