## Big Valley Reach Assessment Methow River

Okanogan County, Washington

U.S. Department of the Interior  
Bureau of Reclamation  
Pacific Northwest Region

August 2008

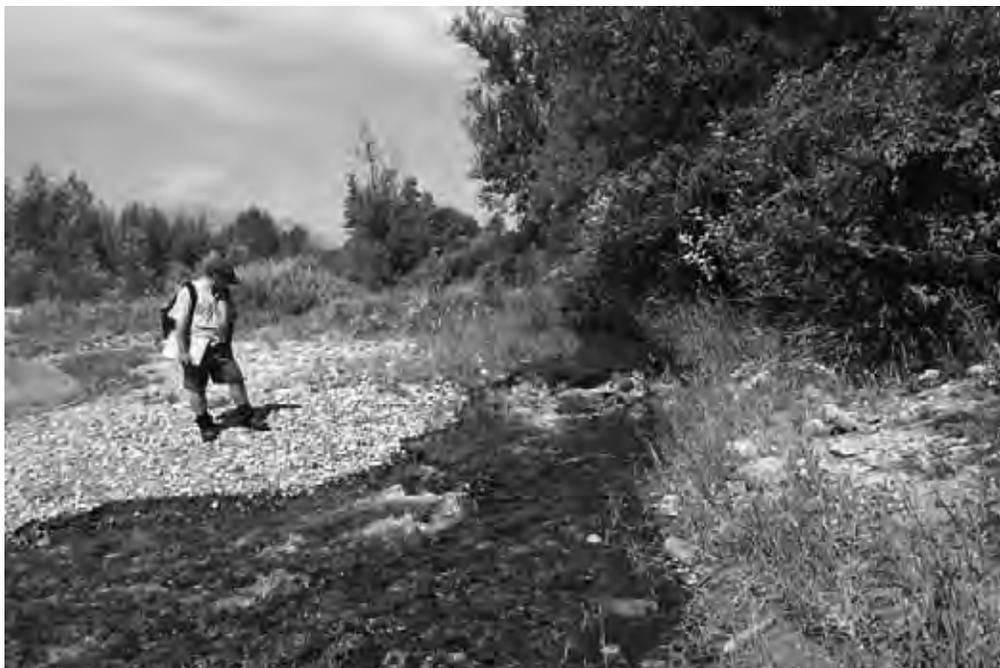
**Photograph No. 17.** View is to the northwest looking upstream along side channel at trail crossing. MR Prj\_56.5 Project Area – Methow Subbasin, Washington – Bureau of Reclamation Photograph by E. Lyon, August 16, 2006.

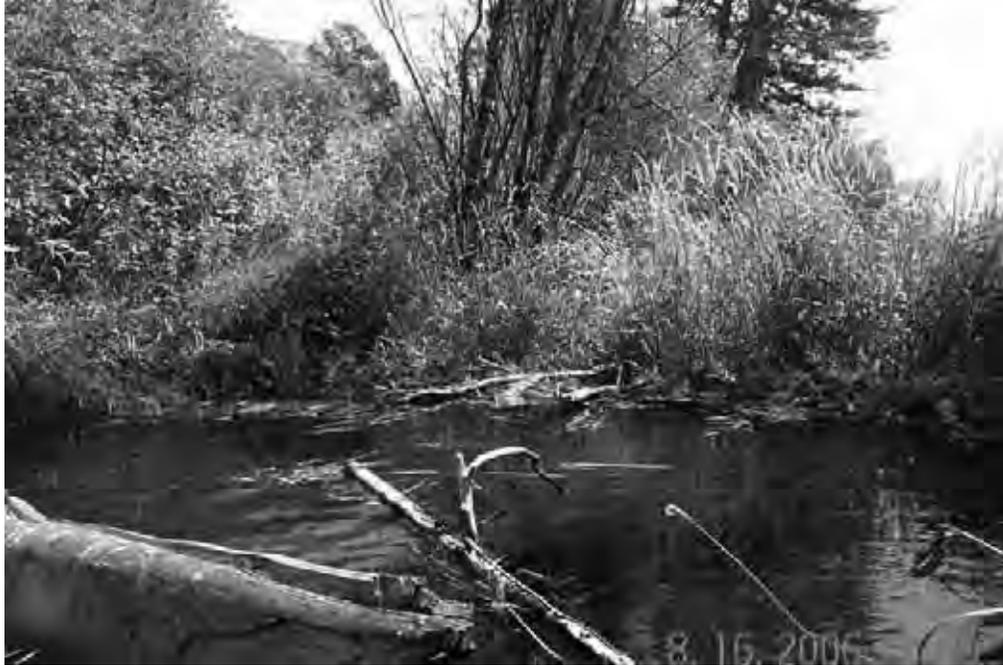
**Photograph No. 19.** View is to the north looking downstream at beaver dam that appears to be a potential fish passage barrier. MR Prj\_56.5 Project Area – Methow Subbasin, Washington – Bureau of Reclamation Photograph by E. Lyon, August 16, 2006.

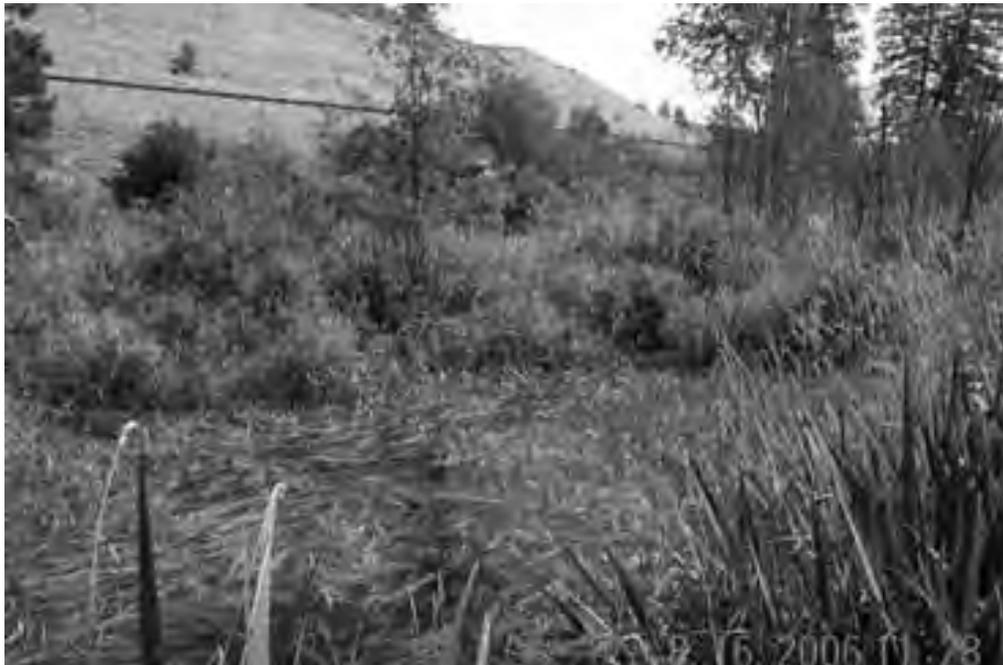
**Photograph No. 20.** View is to the northeast looking downstream at pond impounded by a beaver dam. The beaver dam appears to be a potential fish passage barrier. MR Prj\_56.5 Project Area – Methow Subbasin, Washington – Bureau of Reclamation Photograph by E. Lyon, August 16, 2006.

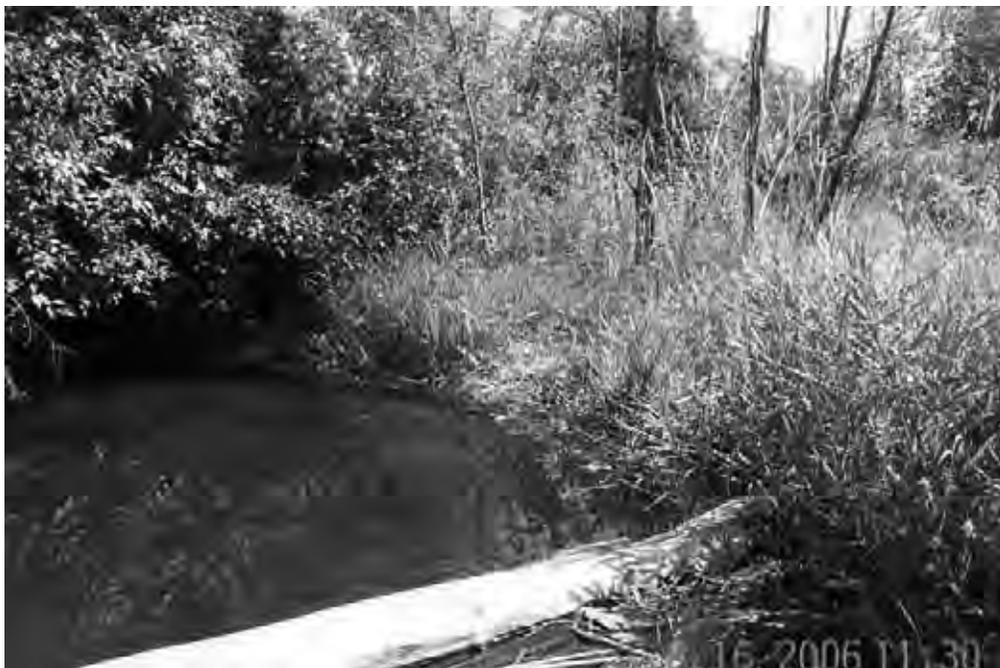
**Photograph No. 21.** View is to the northeast looking downstream at a pond impounded by a beaver dam. The beaver dam appears to be a potential fish passage barrier. MR Prj\_56.5 Project Area – Methow Subbasin, Washington – Bureau of Reclamation Photograph by E. Lyon, August 16, 2006.

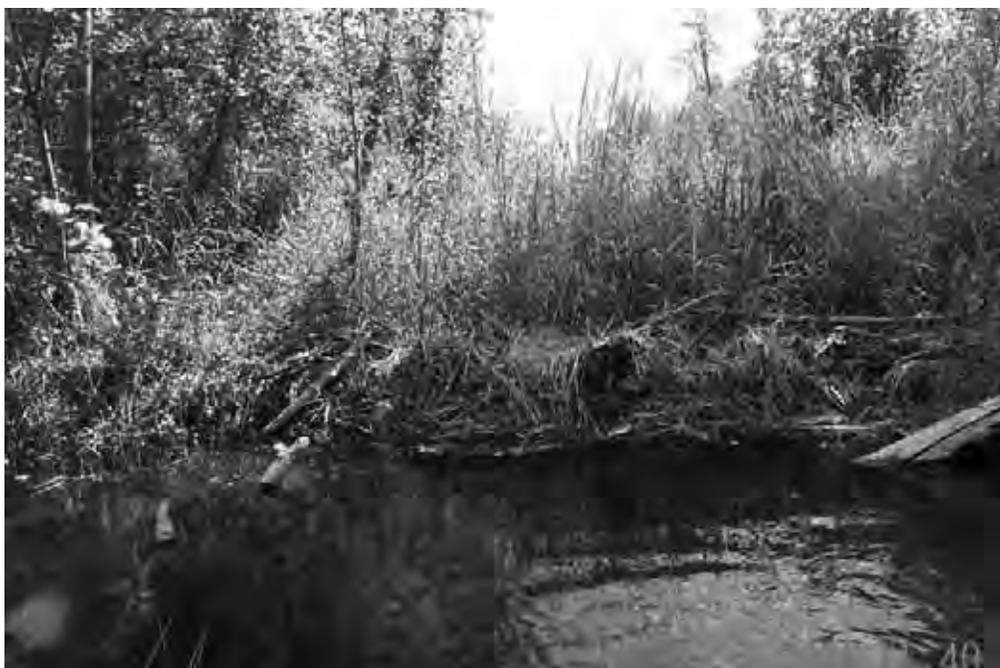
**Photograph No. 23.** View is to the east looking downstream at a pond impounded by a beaver dam. The beaver dam appears to be a potential fish passage barrier. MR Prj\_56.5 Project Area – Methow Subbasin, Washington – Bureau of Reclamation Photograph by E. Lyon, August 16, 2006.

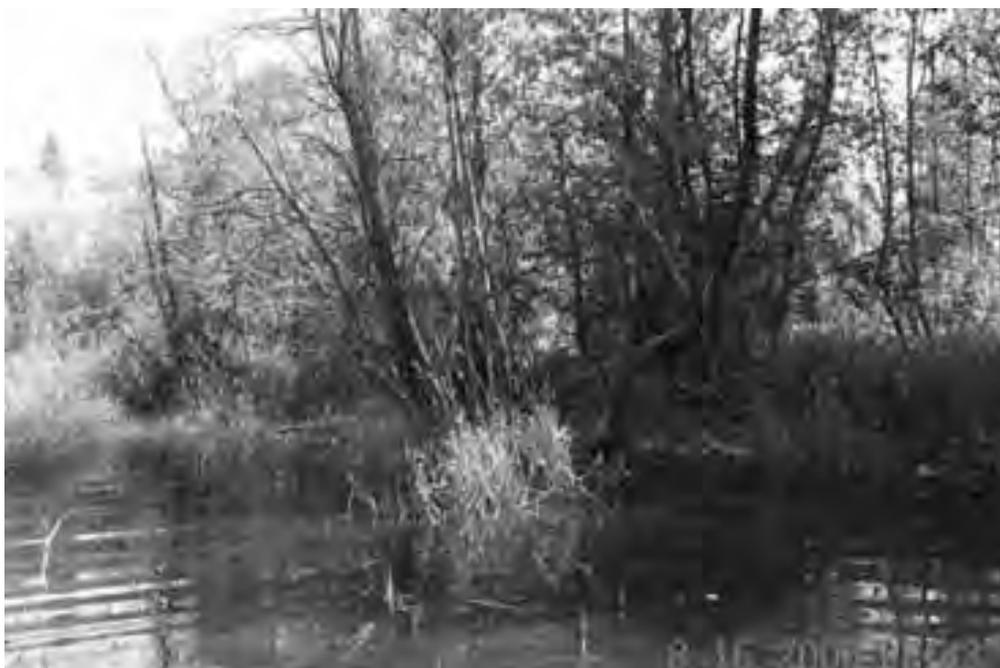
**Photograph No. 24.** View is to the northeast looking downstream at a pond impounded by a beaver dam. The beaver dam appears to be a potential fish passage barrier. MR Prj\_56.5 Project Area – Methow Subbasin, Washington – Bureau of Reclamation Photograph by E. Lyon, August 16, 2006.

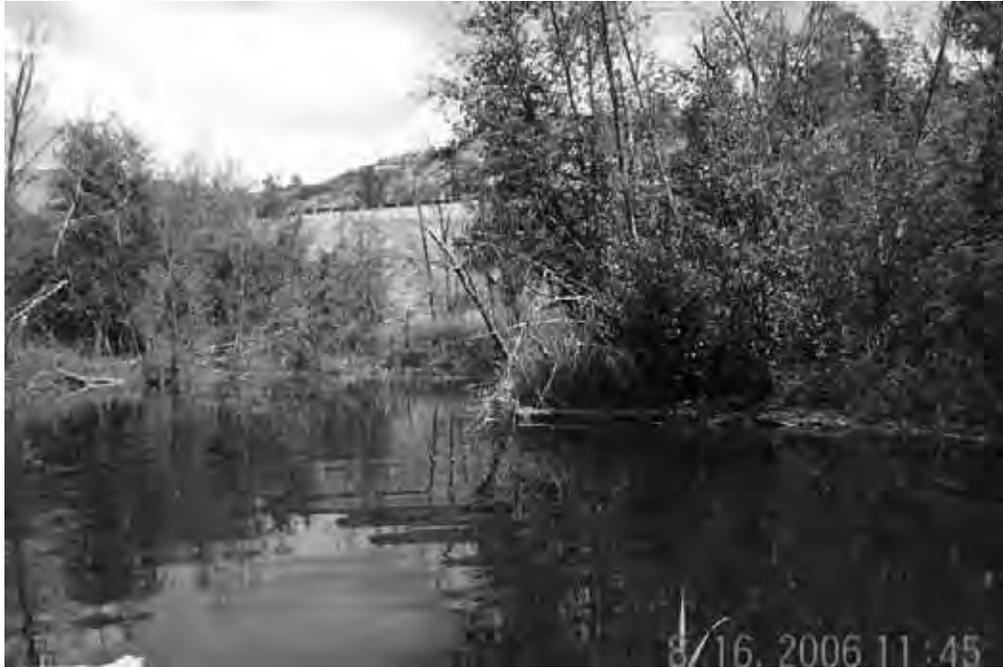
**Photograph No. 25.** View is to the north looking across a pond impounded by a beaver dam. The beaver dam appears to be a potential fish passage barrier. MR Prj\_56.5 Project Area – Methow Subbasin, Washington – Bureau of Reclamation Photograph by E. Lyon, August 16, 2006.

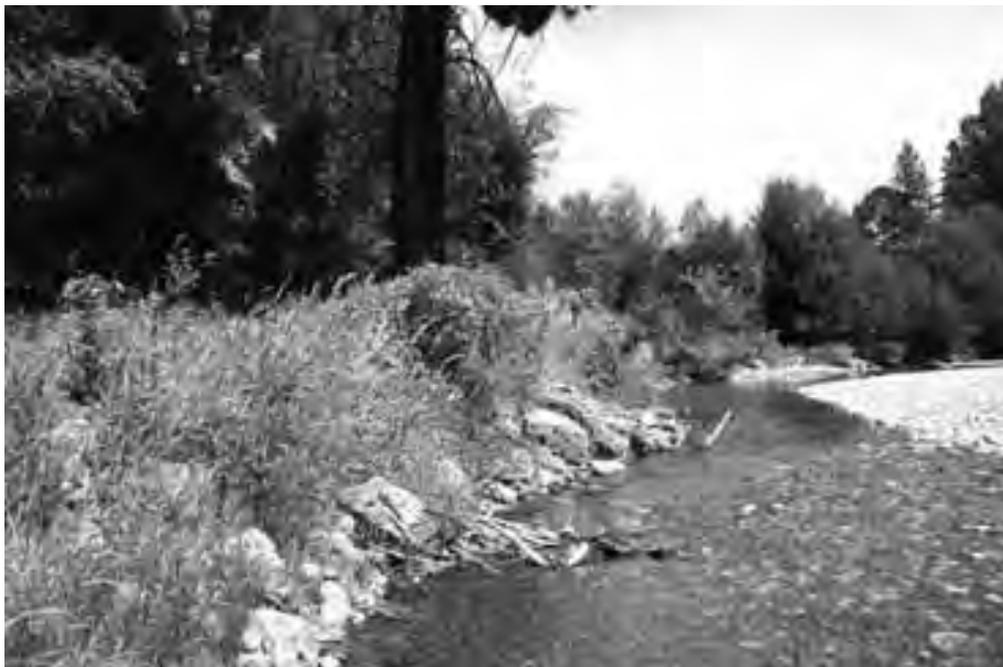
- About 150 linear feet of riprap was noted along river left (Photograph Nos. 26, 27 and 37).
- The wetland complex could provide excellent rearing habitat and high water refugia (Photograph Nos. 2, 8, 10 and 11). However, the wetland complex has resident brook trout and consideration will have to be given to remove or eradicate them.

**Photograph No. 26.** View is to the southeast looking downstream at riprap placed along river left. MR Prj\_56.5 Project Area – Methow Subbasin, Washington – Bureau of Reclamation Photograph by E. Lyon, August 16, 2006.

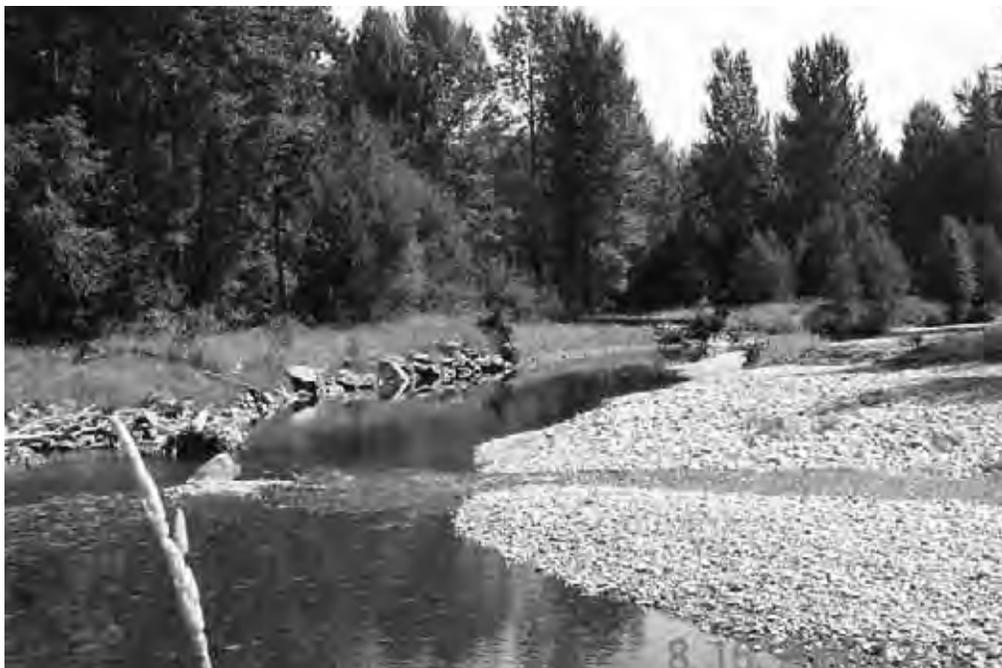
**Photograph No. 27.** View is to the southeast looking downstream at riprap placed along river left. MR Prj\_56.5 Project Area – Methow Subbasin, Washington – Bureau of Reclamation Photograph by E. Lyon, August 16, 2006.

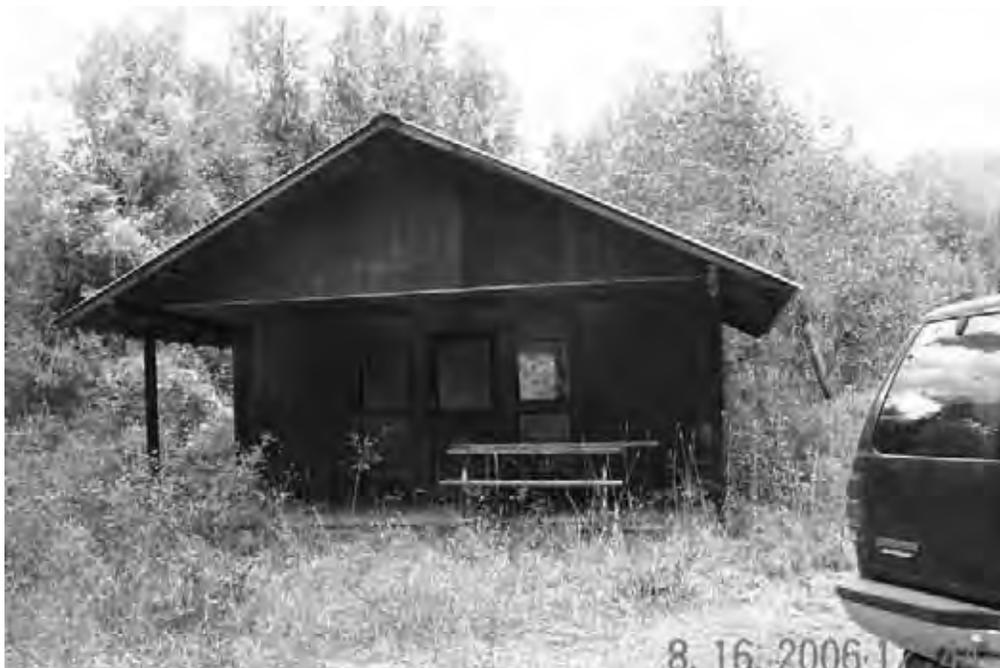
- One house (abandoned?) is located within the floodplain (Photograph No. 29).
- One culvert of sufficient size was observed at a road crossing (Photograph No. 9).

**Photograph No. 29.** View is to the northeast looking a structure found within the river's floodplain. MR Prj\_56.5 Project Area – Methow Subbasin, Washington – Bureau of Reclamation Photograph by E. Lyon, August 16, 2006.

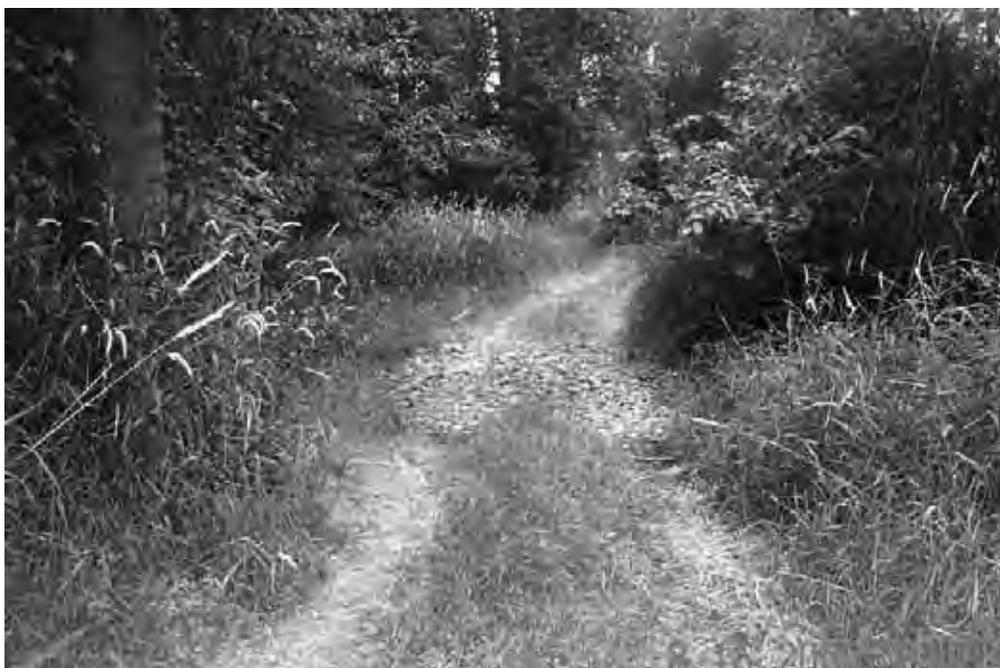
**Photograph No. 31.** View is to the north looking at road embankment that disconnects an overflow channel. MR Prj\_56.5 Project Area – Methow Subbasin, Washington – Bureau of Reclamation  
Photograph by E. Lyon, August 16, 2006.

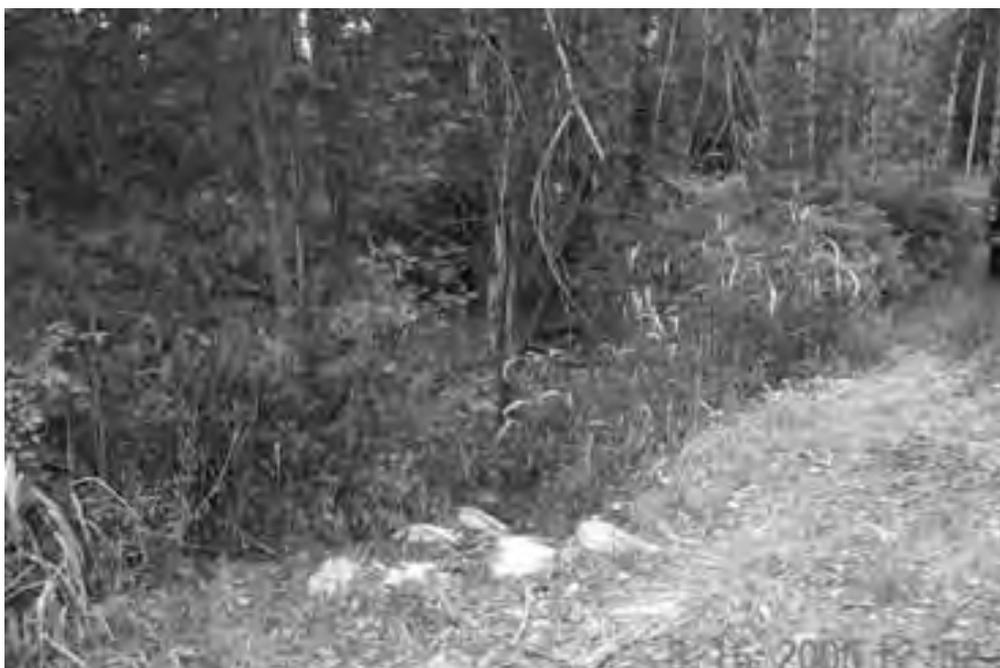
**Photograph No. 32.** View is to the northwest looking at an overflow channel that is disconnected by a road embankment. MR Prj\_56.5 Project Area – Methow Subbasin, Washington – Bureau of Reclamation  
Photograph by E. Lyon, August 16, 2006.

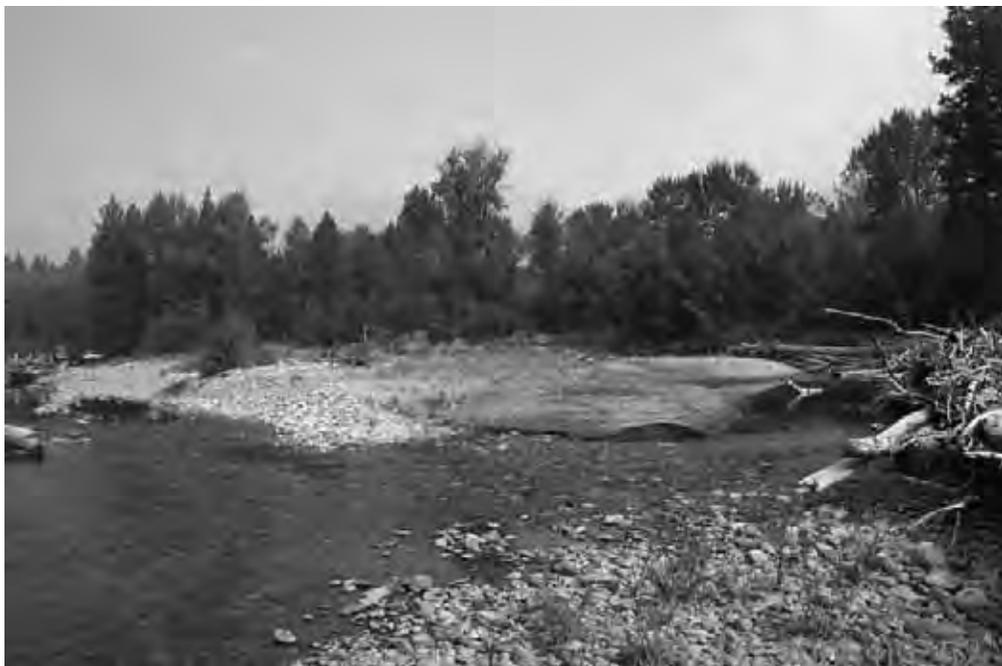
**Photograph No. 33.** View is to the northwest looking upstream at an area where the channel has avulsed. MR Prj\_56.5 Project Area – Methow Subbasin, Washington – Bureau of Reclamation Photograph by E. Lyon, September 12, 2006.

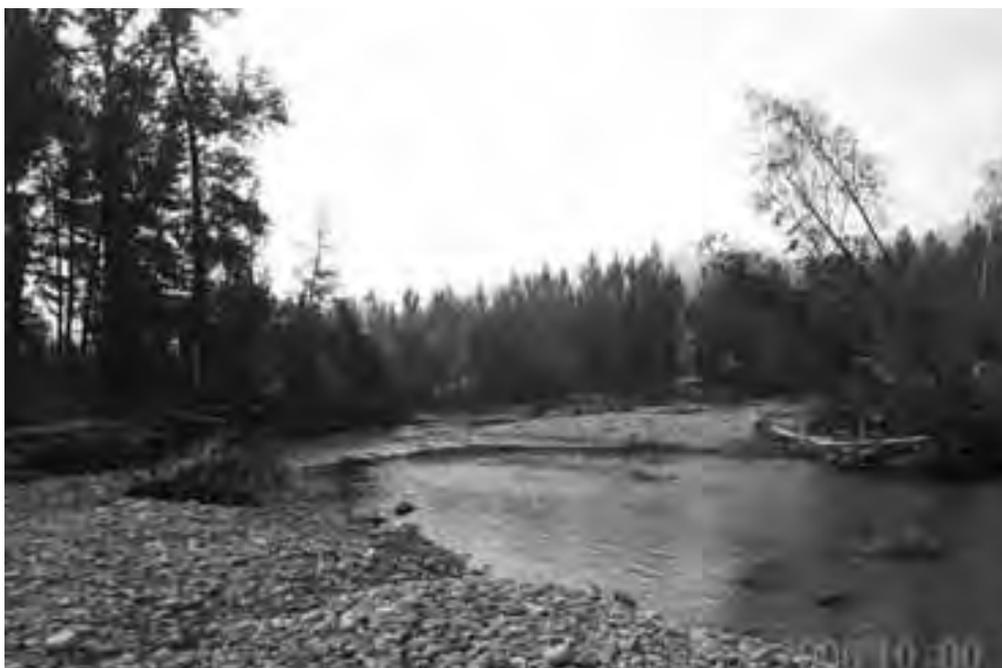
**Photograph No. 34.** View is to the south looking downstream where channel has avulsed. MR Prj\_56.5 Project Area – Methow Subbasin, Washington – Bureau of Reclamation Photograph by E. Lyon, September 12, 2006.

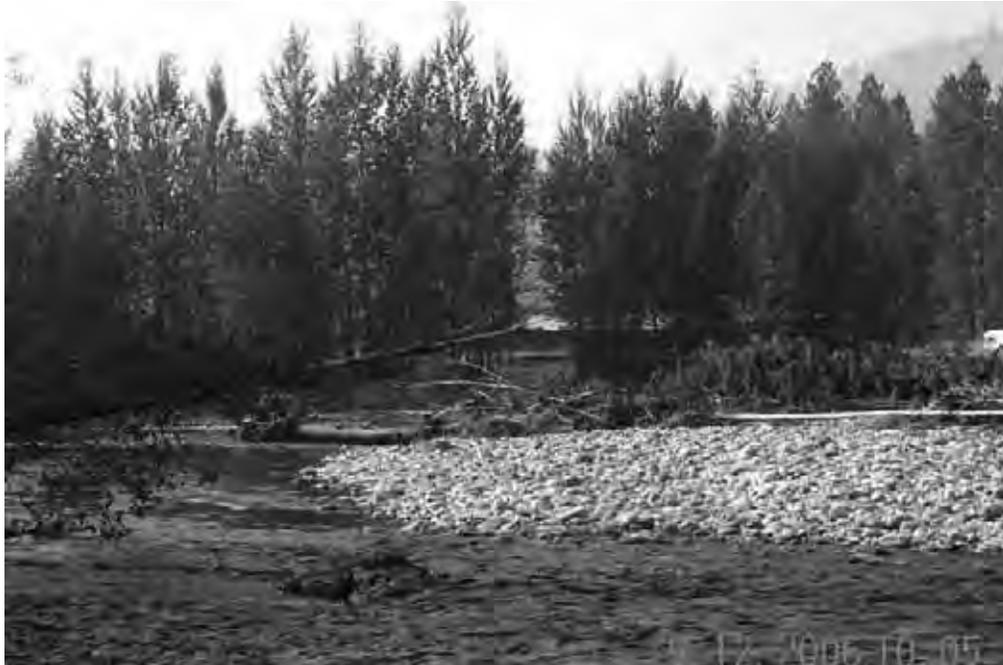
**Photograph No. 35.** View is to the south looking downstream at structure along river right where channel has avulsed. MR Prj\_56.5 Project Area – Methow Subbasin, Washington – Bureau of Reclamation Photograph by E. Lyon, September 12, 2006.

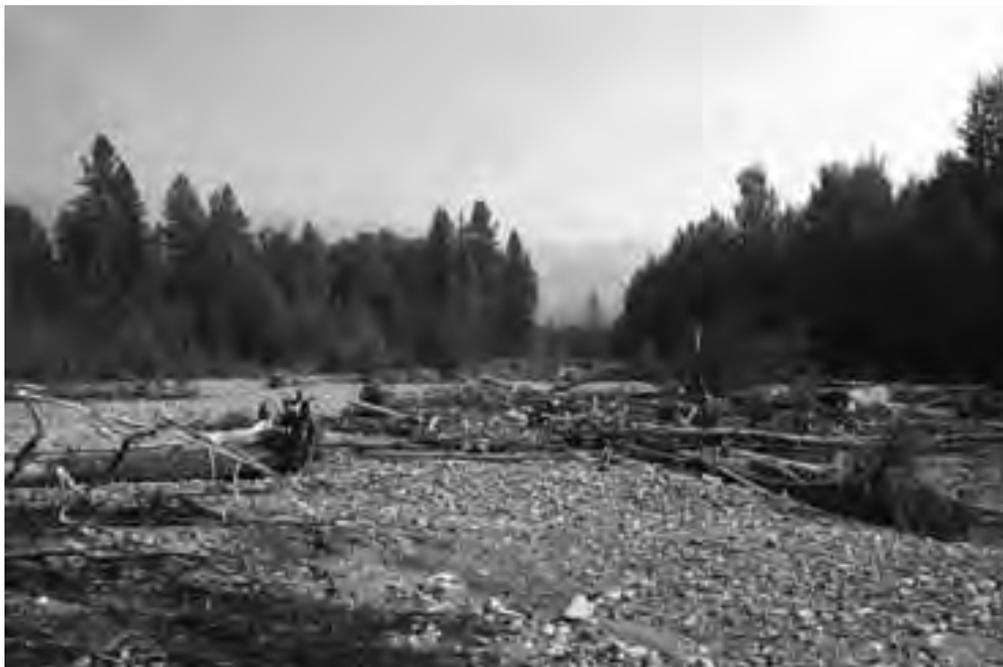
**Photograph No. 36.** View is to the northeast looking downstream at a channel path that is being abandoned by the river except during high flows. MR Prj\_56.5 Project Area – Methow Subbasin, Washington – Bureau of Reclamation Photograph by E. Lyon, September 12, 2006.

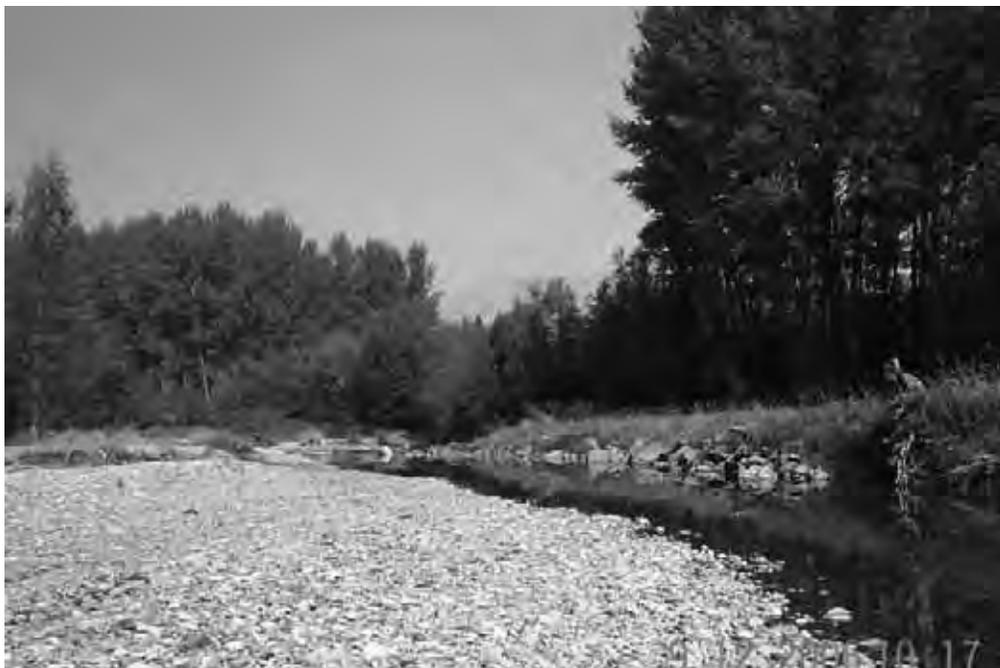
**Photograph No. 37.** View is to the northwest looking upstream at riprap placed along river left. MR Prj\_56.5 Project Area – Methow Subbasin, Washington – Bureau of Reclamation Photograph by E. Lyon, September 12, 2006.

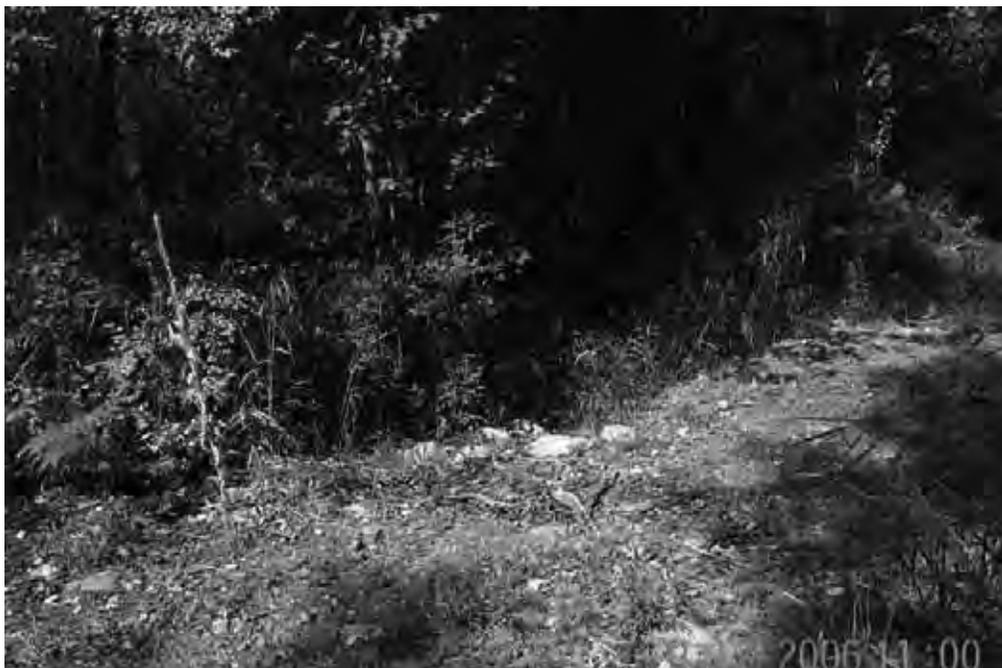
**Photograph No. 40.** View is to the northwest looking at an overflow channel that is disconnected by a road embankment (same as in Photograph No. 32). MR Prj\_56.5 Project Area – Methow Subbasin, Washington – Bureau of Reclamation Photograph by E. Lyon, September 12, 2006.

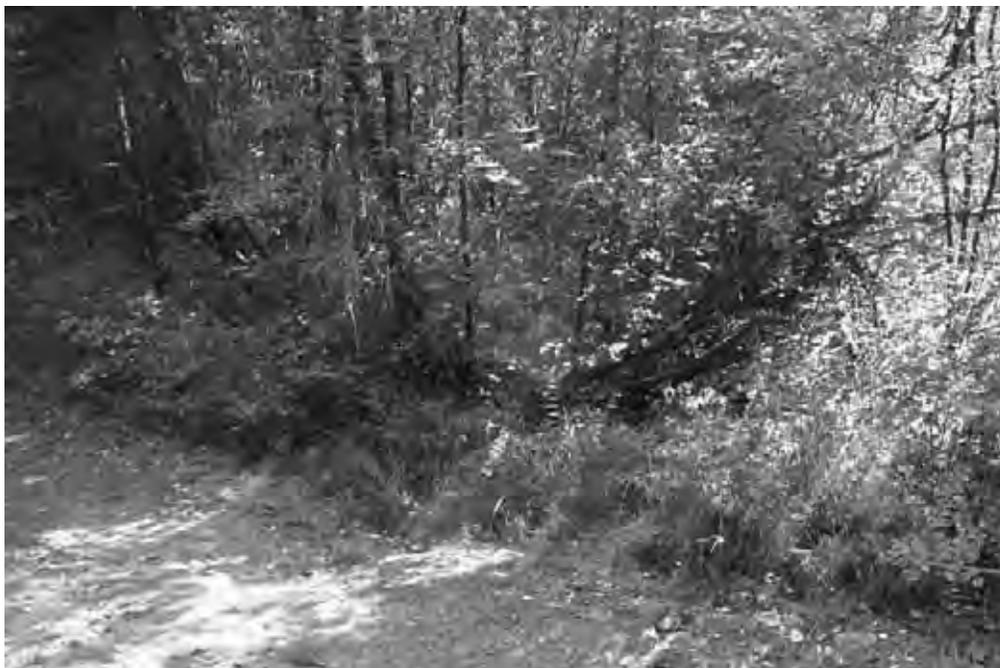
**Photograph No. 41.** View is to the northwest looking at an overflow channel that is disconnected by a road embankment. MR Prj\_56.5 Project Area – Methow Subbasin, Washington – Bureau of Reclamation Photograph by E. Lyon, September 12, 2006.

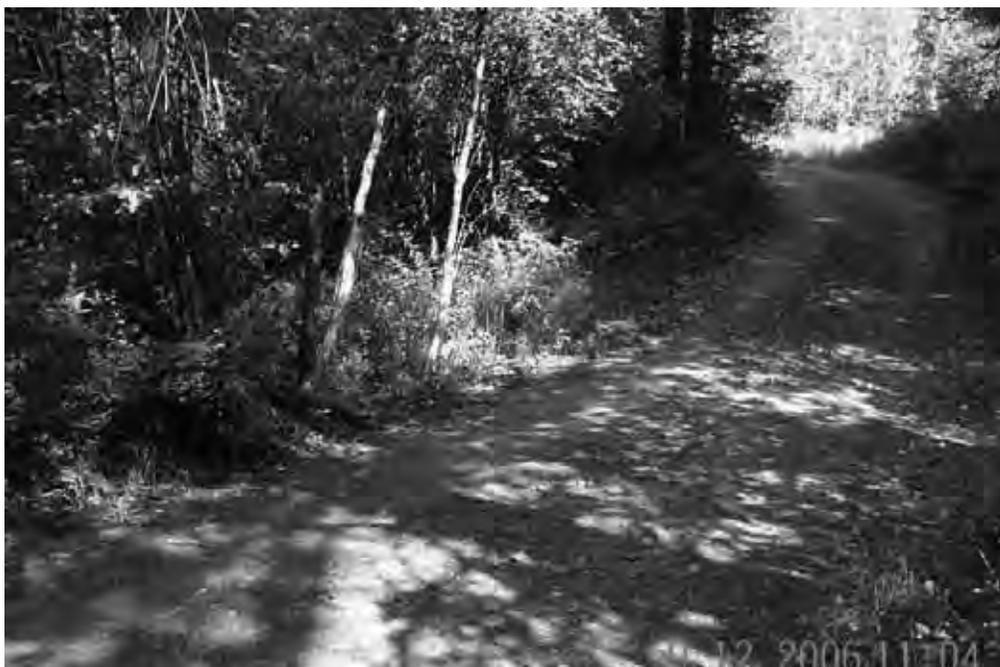
**Photograph No. 42.** View is to the west looking at a road embankment that disconnects an overflow channel as viewed in Photograph No. 41. MR Prj\_56.5 Project Area – Methow Subbasin, Washington – Bureau of Reclamation Photograph by E. Lyon, August 16, 2006.

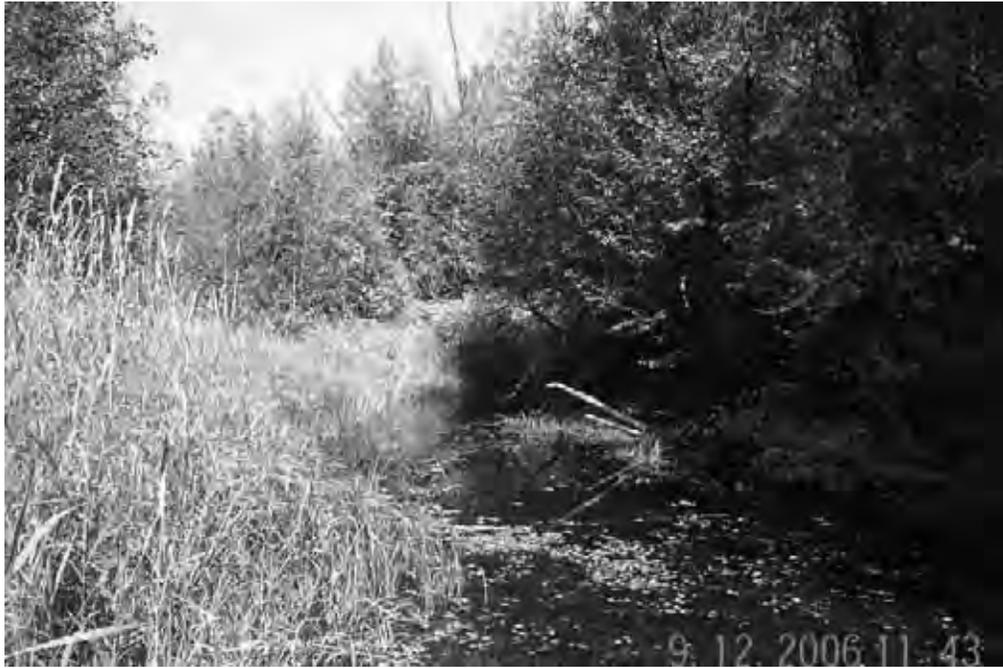
**Photograph No. 1.** View is to the northwest looking upstream toward road embankment that has an elevated and undersized culvert. MR Prj-58.6 Project Area – Methow Subbasin, Washington – Bureau of Reclamation Photograph by E. Lyon, September 12, 2006.

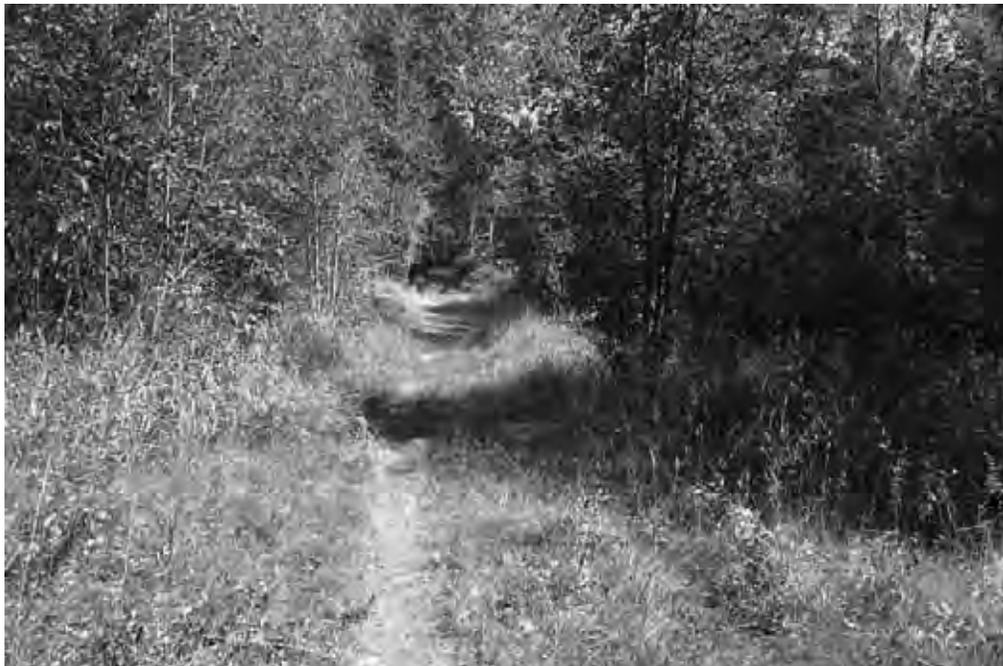
**Photograph No. 2.** View is to the east looking at road embankment shown in Photograph No. 1. MR Prj-58.6 Project Area – Methow Subbasin, Washington – Bureau of Reclamation Photograph by E. Lyon, September 12, 2006.

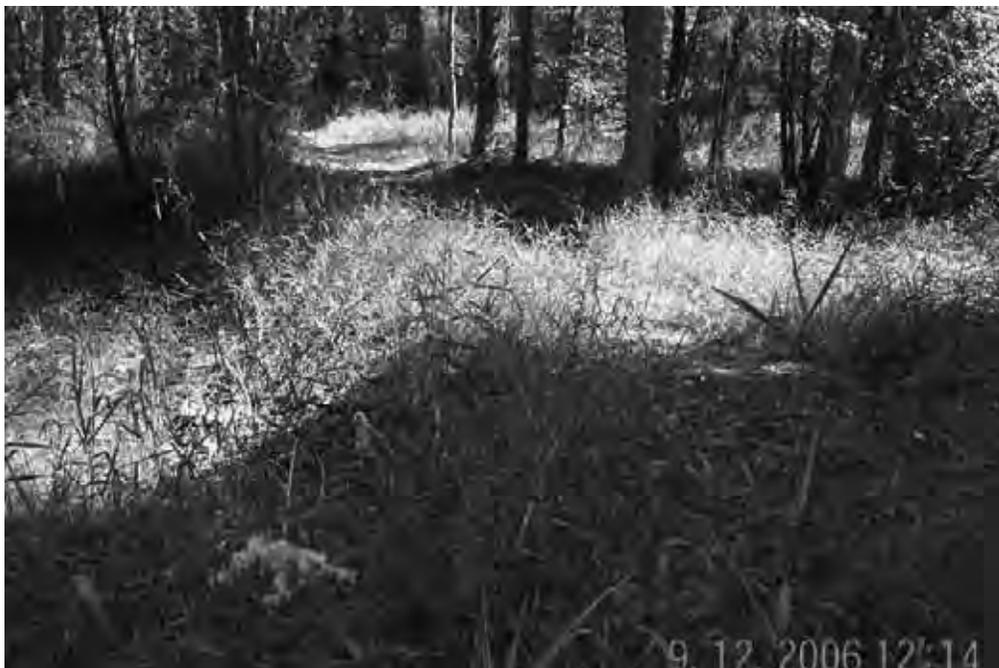
**Photograph No. 3.** View is to the east looking at road embankment without a culvert that bisects a historical channel path. MR Prj-58.6 Project Area – Methow Subbasin, Washington – Bureau of Reclamation Photograph by E. Lyon, September 12, 2006.

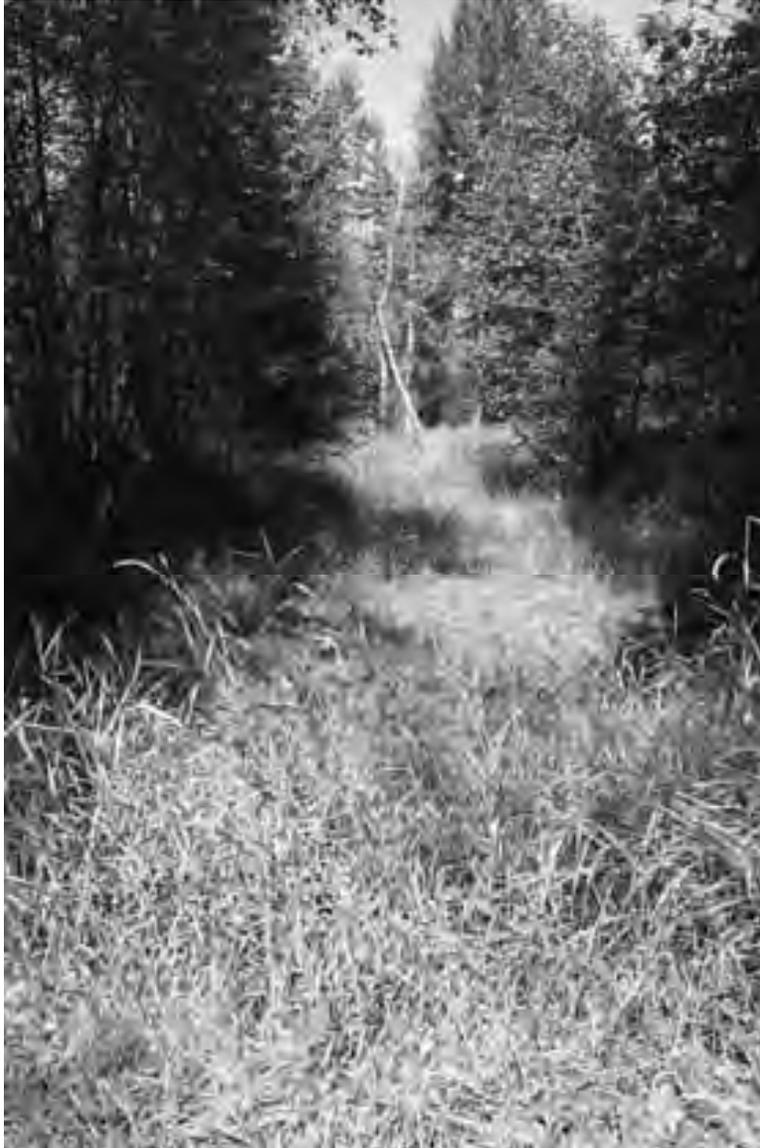
**Photograph No. 4.** View is to the north looking upstream from road embankment in Photograph No. 3 at historical channel path. MR Prj-58.6 Project Area – Methow Subbasin, Washington – Bureau of Reclamation Photograph by E. Lyon, September 12, 2006.

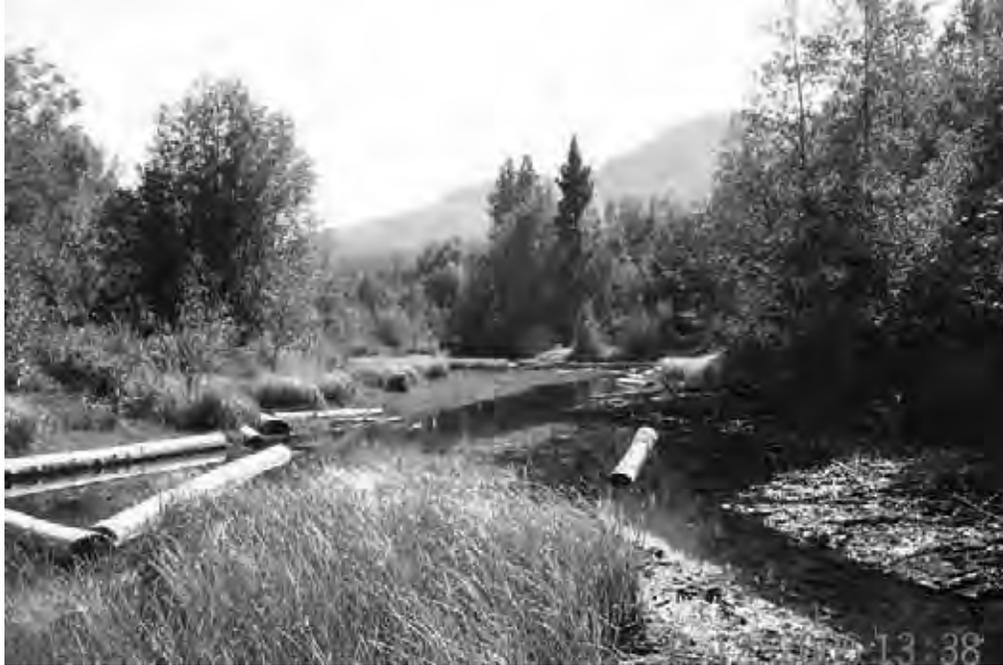
**Photograph No. 5.** View is to the south looking downstream at wetlands area that is being fed by an irrigation return and groundwater. Note logs are “trimmed” suggesting they have either been placed during a restoration project or could be from a historic mill. MR Prj-58.6 Project Area – Methow Subbasin, Washington – Bureau of Reclamation Photograph by E. Lyon, September 12, 2006.

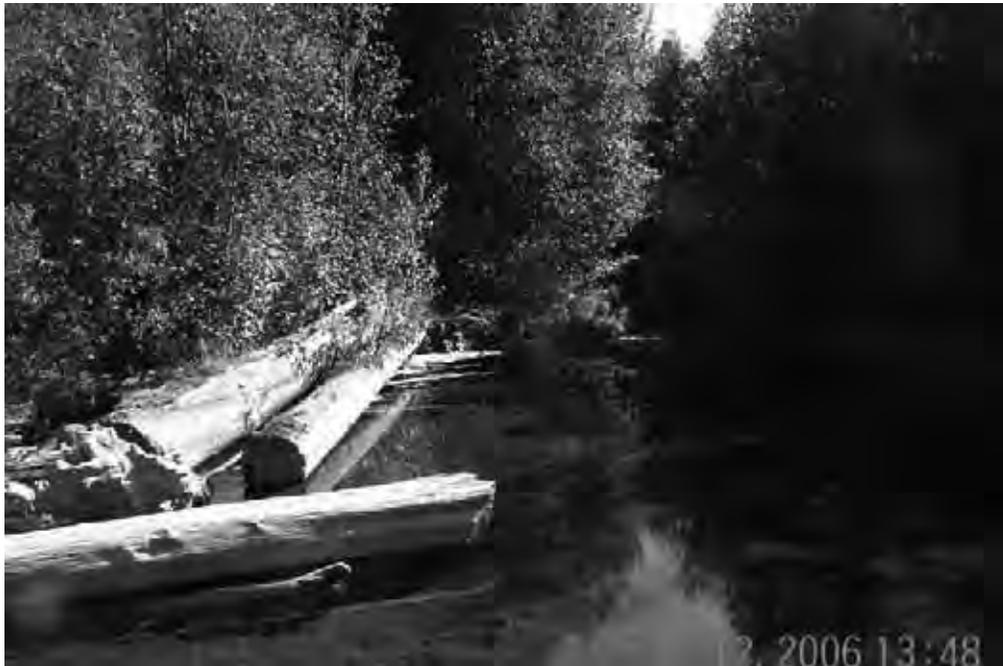
**Photograph No. 6.** View is to the southeast looking downstream toward historic logjam that is being utilized by beavers to pond water. MR Prj-58.6 Project Area – Methow Subbasin, Washington – Bureau of Reclamation Photograph by E. Lyon, September 12, 2006.

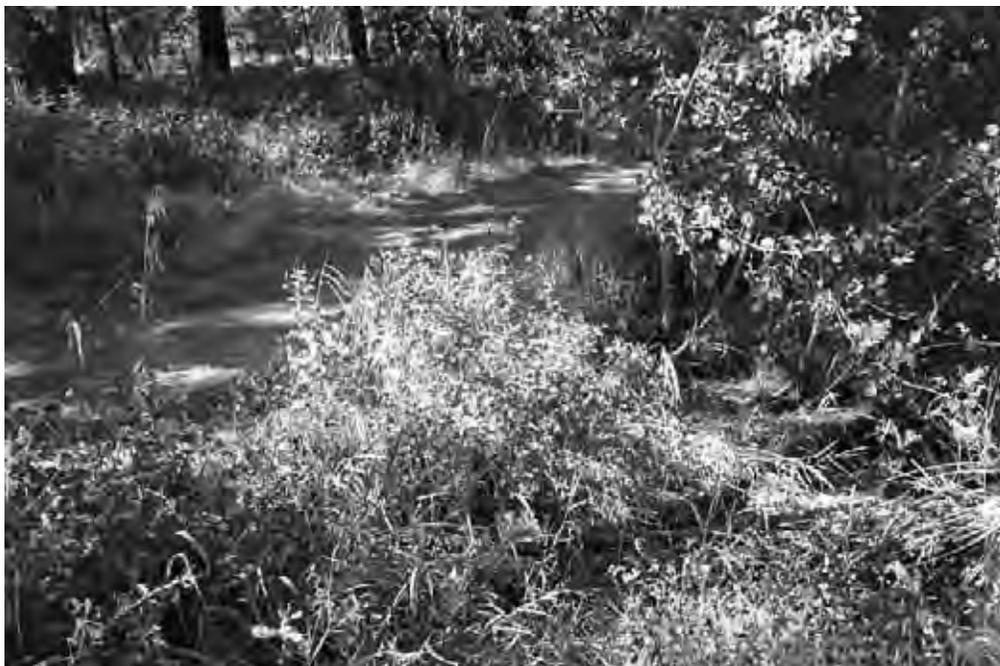
**Photograph No. 7.** View is to the northwest of a road embankment without culvert that blocks the Rockview Irrigation Ditch (?). MR Prj-58.6 Project Area – Methow Subbasin, Washington – Bureau of Reclamation Photograph by E. Lyon, September 12, 2006.

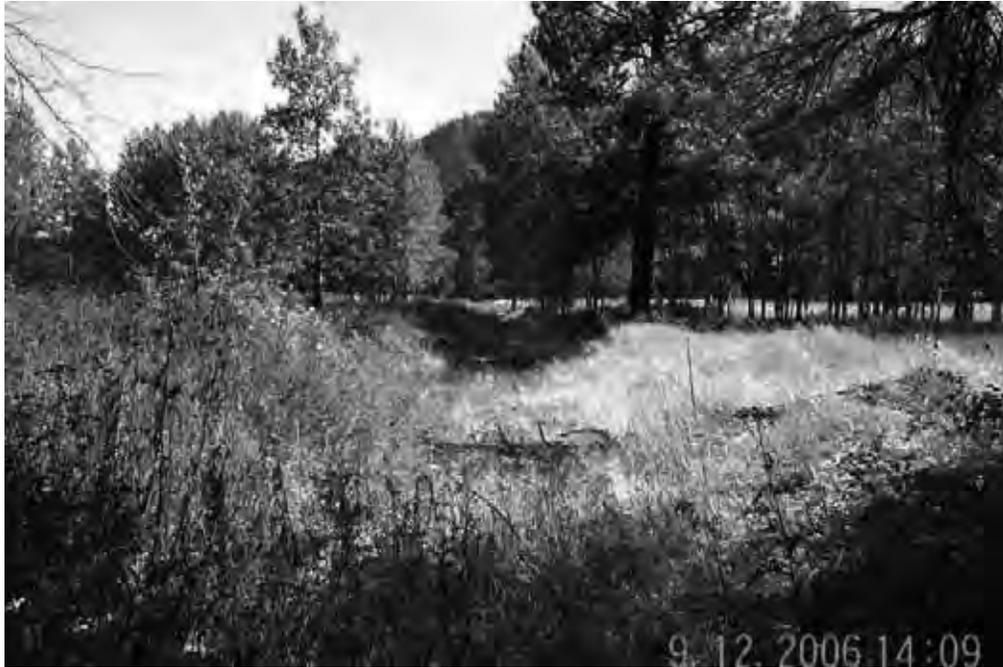
**Photograph No. 9.** View is to the south looking downstream from road embankment at the channelized Rockview Irrigation Ditch (?). MR Prj-58.6 Project Area – Methow Subbasin, Washington – Bureau of Reclamation Photograph by E. Lyon, September 12, 2006.

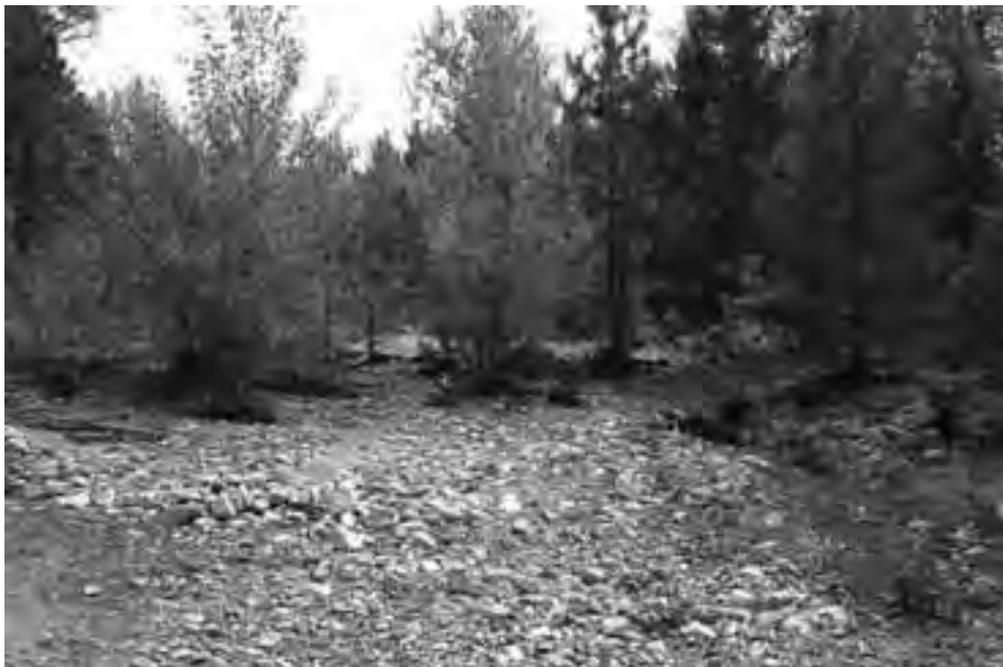
**Photograph No. 10.** View is to the northeast looking downstream from a partially washed-out road embankment near the head of a historic channel path. MR Prj-58.6 Project Area – Methow Subbasin, Washington – Bureau of Reclamation Photograph by E. Lyon, September 13, 2006.

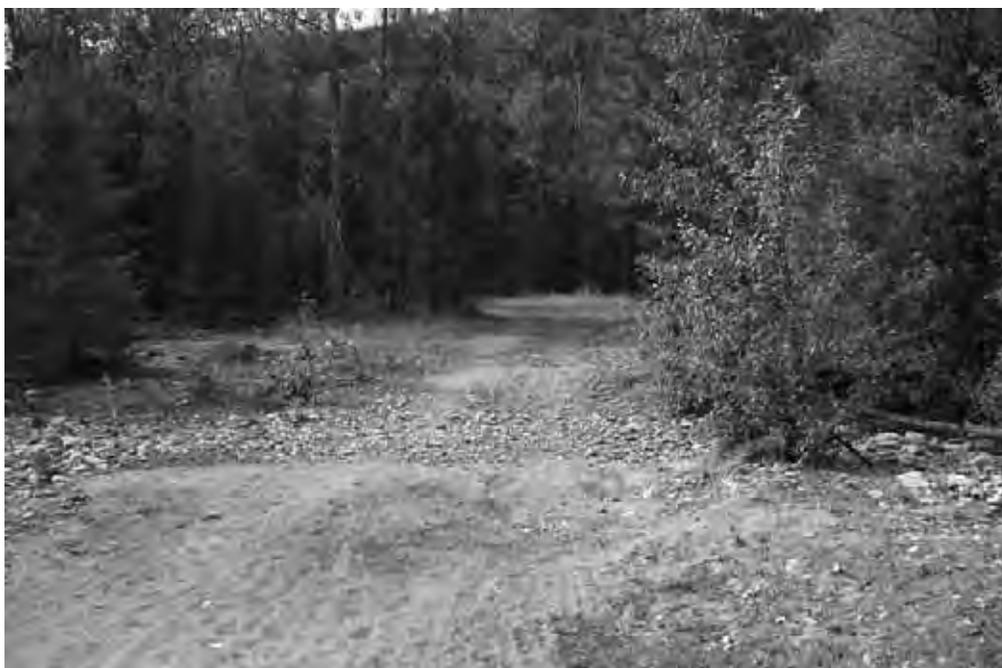
**Photograph No. 11.** View is to the south looking at the partially washed-out road embankment. MR Prj-58.6 Project Area – Methow Subbasin, Washington – Bureau of Reclamation Photograph by E. Lyon, September 13, 2006.
