## Big Valley Reach Assessment Methow River

Okanogan County, Washington

U.S. Department of the Interior  
Bureau of Reclamation  
Pacific Northwest Region

August 2008

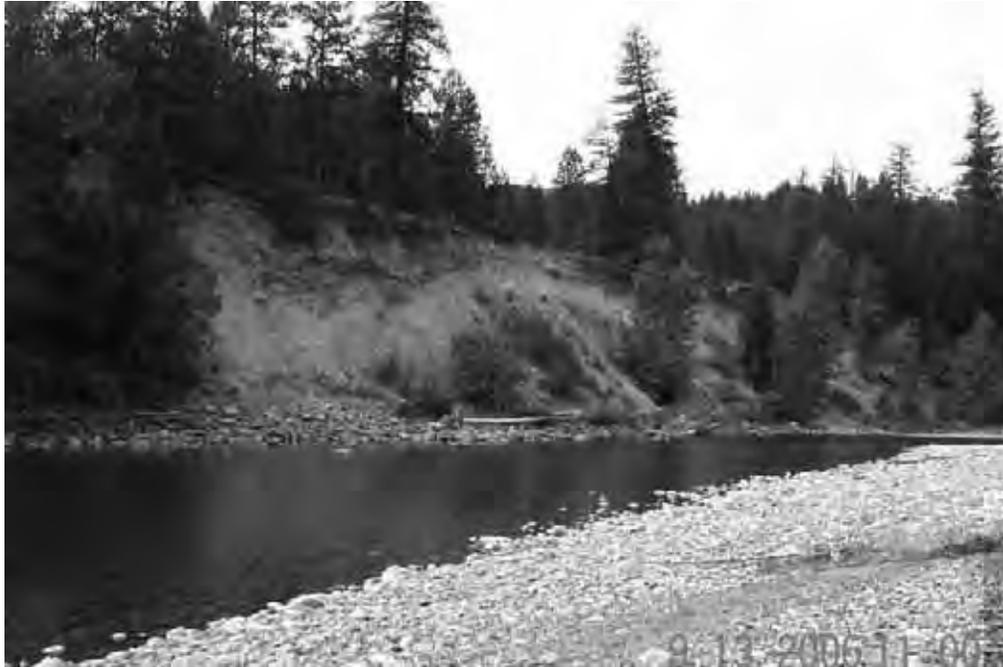
**Photograph No. 13.** View is to the northwest looking upstream at a 15+ meter high glacial bluff that is eroding and providing sediment to the system. MR Prj-58.6 Project Area – Methow Subbasin, Washington – Bureau of Reclamation Photograph by E. Lyon, September 13, 2006.

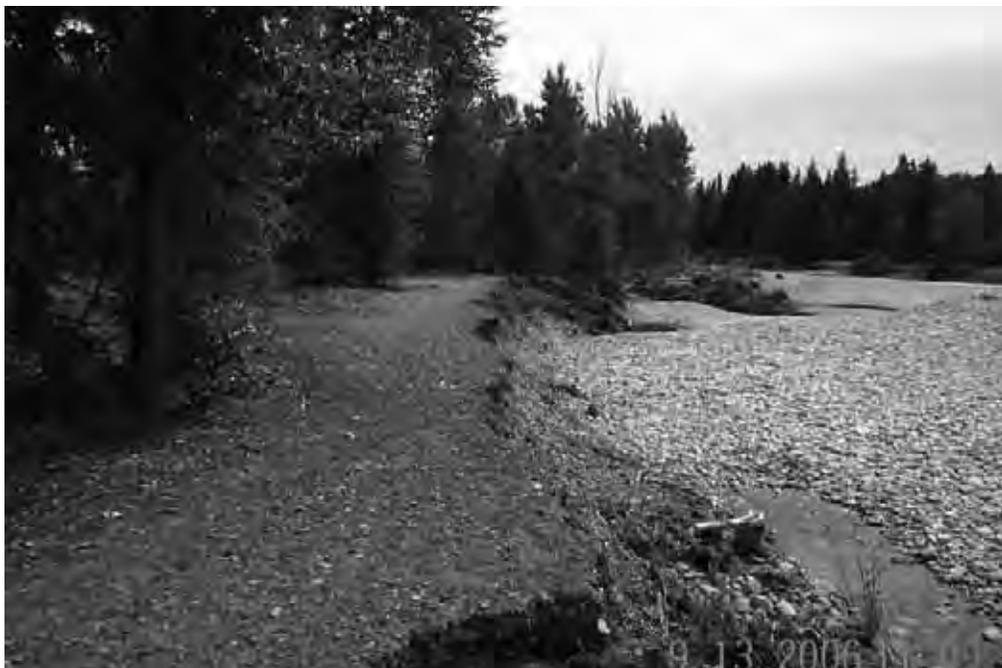
**Photograph No. 15.** View is to the southeast looking downstream along a road that has experienced severe erosion on river left. MR Prj-58.6 Project Area – Methow Subbasin, Washington – Bureau of Reclamation Photograph by E. Lyon, September 13, 2006.

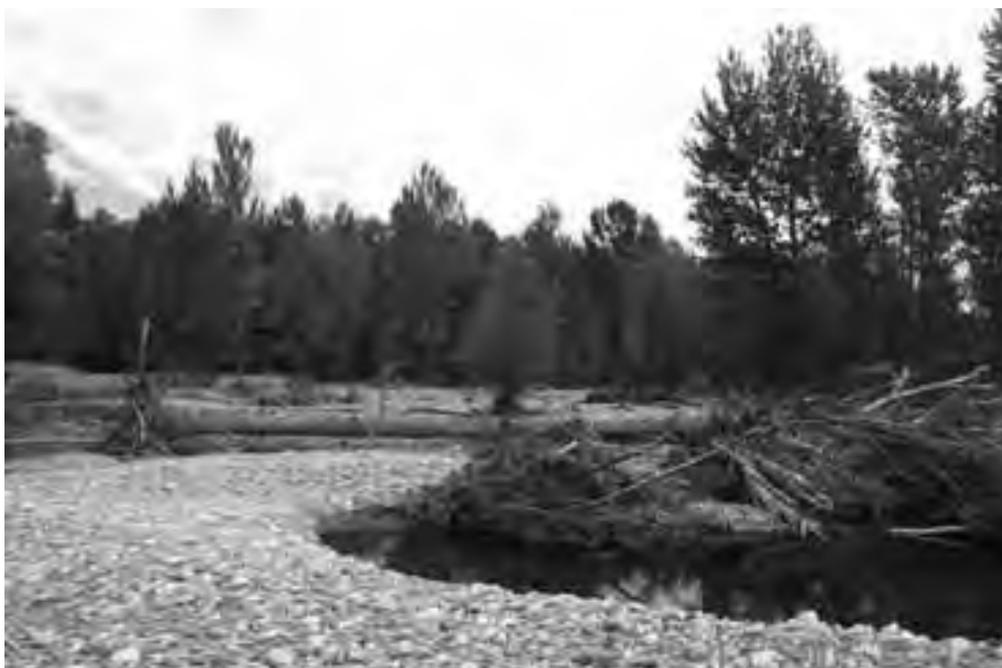
**Photograph No. 16.** View is to the east looking at river left from the main channel where the floodplain was accessed during the 2006 spring freshet. MR Prj-58.6 Project Area – Methow Subbasin, Washington – Bureau of Reclamation Photograph by E. Lyon, September 13, 2006.

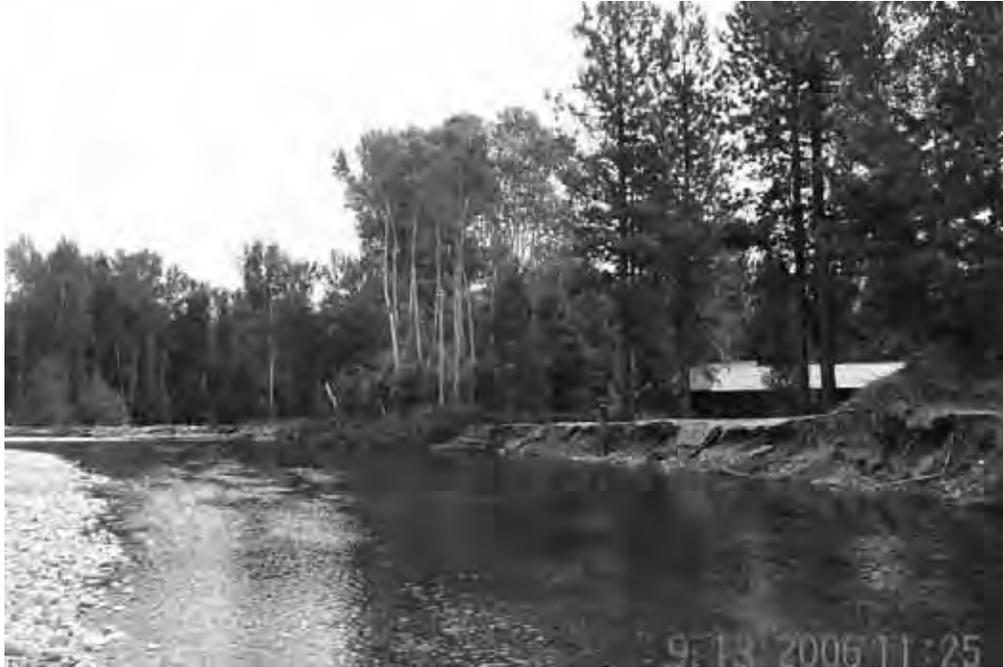
**Photograph No. 17.** View is to the south looking downstream from a gravel bar on river left at erosion that occurred along river right during the 2006 spring freshet. Note well casing near center of picture is almost in the active channel. MR Prj-58.6 Project Area – Methow Subbasin, Washington – Bureau of Reclamation Photograph by E. Lyon, September 13, 2006.

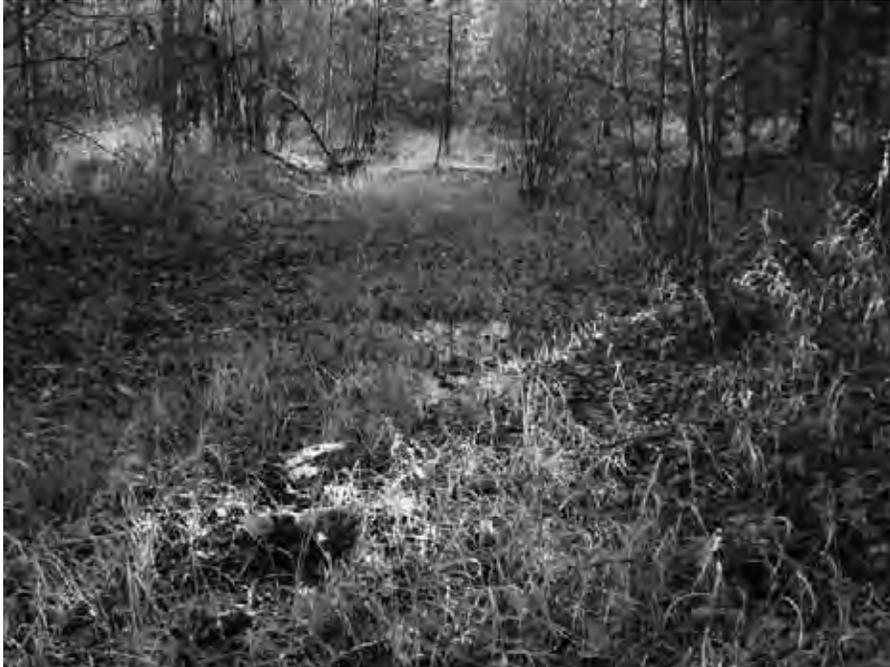
**Photograph No. 21.** View is to the north looking upstream from road embankment with elevated culvert where the embankment has created a wetland area. The November 8, 2006 high flows did not appear to have affected the water levels. MR Prj-58.6 Project Area – Methow Subbasin, Washington – Bureau of Reclamation Photograph by R. McAfee, November 8, 2006.

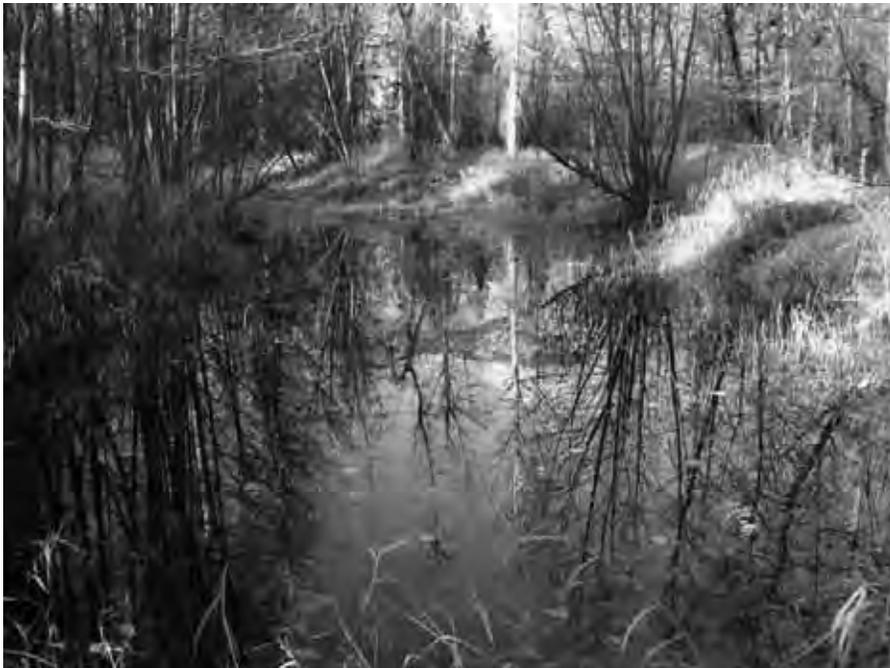
**Photograph No. 22.** View is to the north looking upstream from road embankment where the embankment has created a wetland area. The November 8, 2006 high flows appear to have significantly impacted the water levels. MR Prj-58.6 Project Area – Methow Subbasin, Washington – Bureau of Reclamation Photograph by R. McAfee, November 8, 2006.

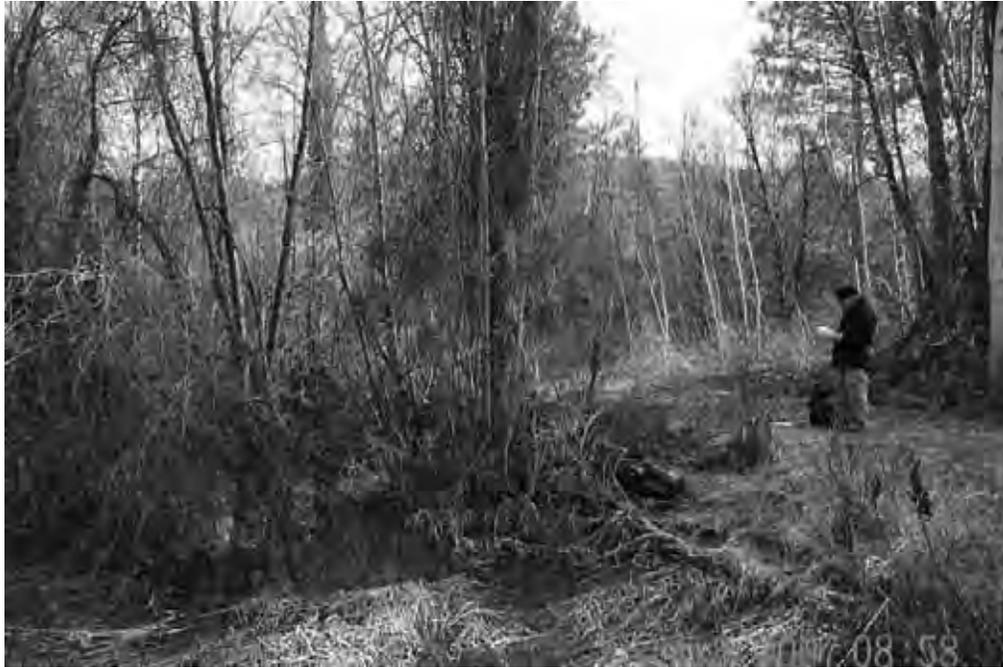
**Photograph No. 23.** View is to the north looking at a road embankment that disconnects a historic channel path. MR Prj-58.6 Project Area – Methow Subbasin, Washington – Bureau of Reclamation Photograph by E. Lyon, April 8, 2007.

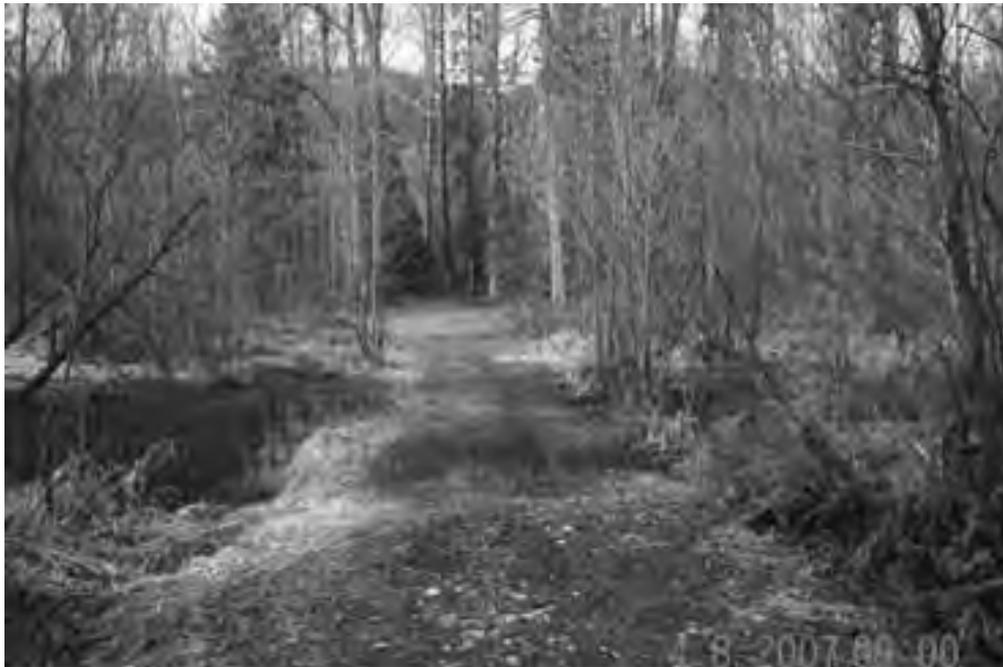
**Photograph No. 24.** View is to the west looking at a road embankment that disconnects historic channel path. Note water is flowing over the road. MR Prj-58.6 Project Area – Methow Subbasin, Washington – Bureau of Reclamation Photograph by E. Lyon, April 8, 2007.

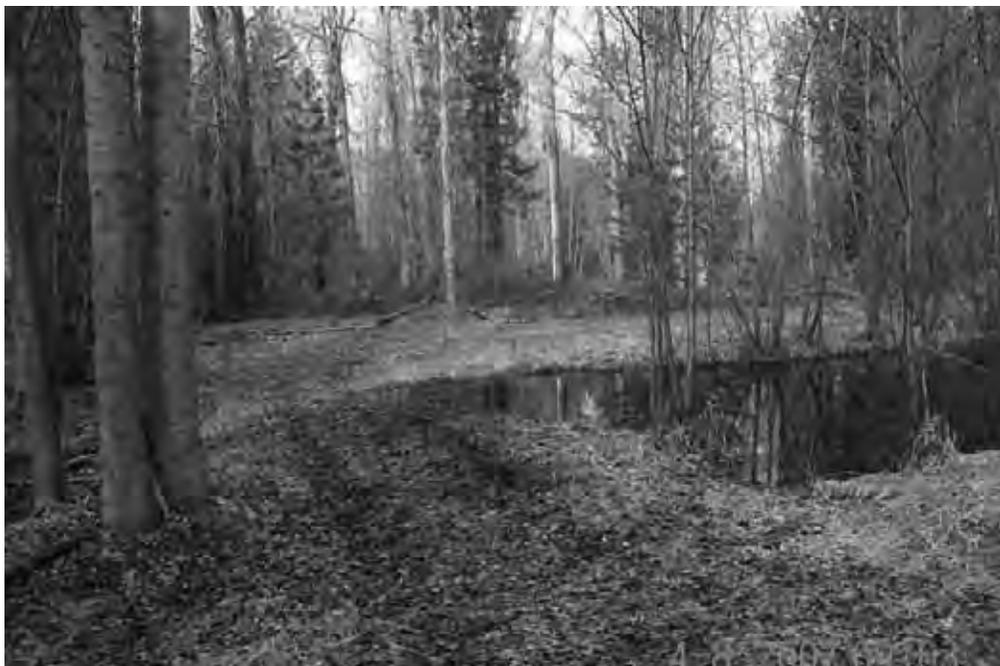
**Photograph No. 25.** View is to the west looking at a road embankment that disconnects historic channel path. Note water is flowing over the road. MR Prj-58.6 Project Area – Methow Subbasin, Washington – Bureau of Reclamation Photograph by E. Lyon, April 8, 2007.

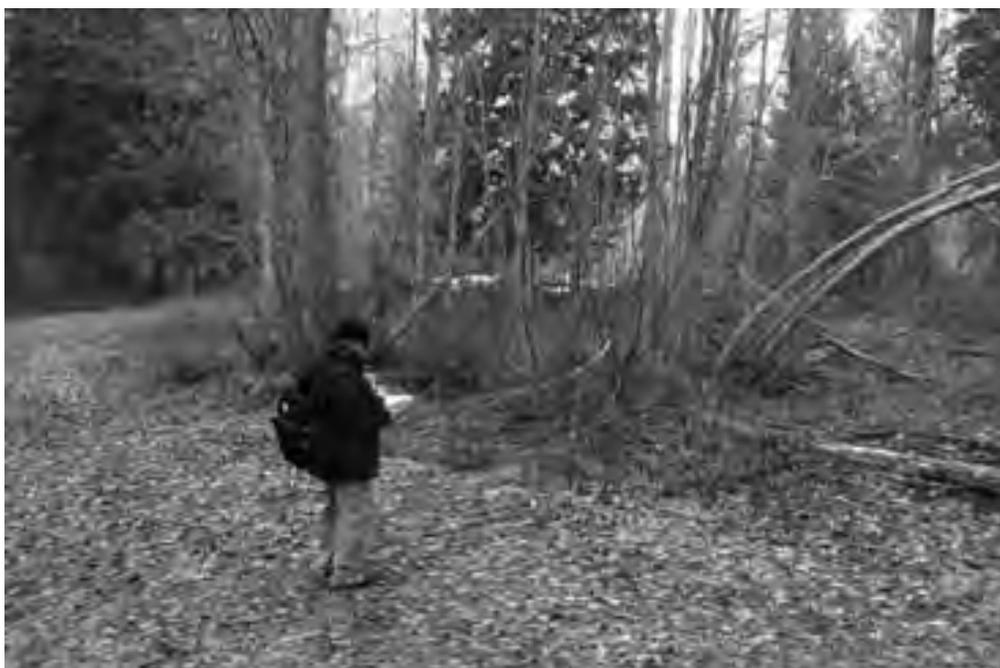
**Photograph No. 26.** View is to the northeast looking at a road embankment that disconnects an overflow channel. MR Prj-58.6 Project Area – Methow Subbasin, Washington – Bureau of Reclamation Photograph by E. Lyon, April 8, 2007.

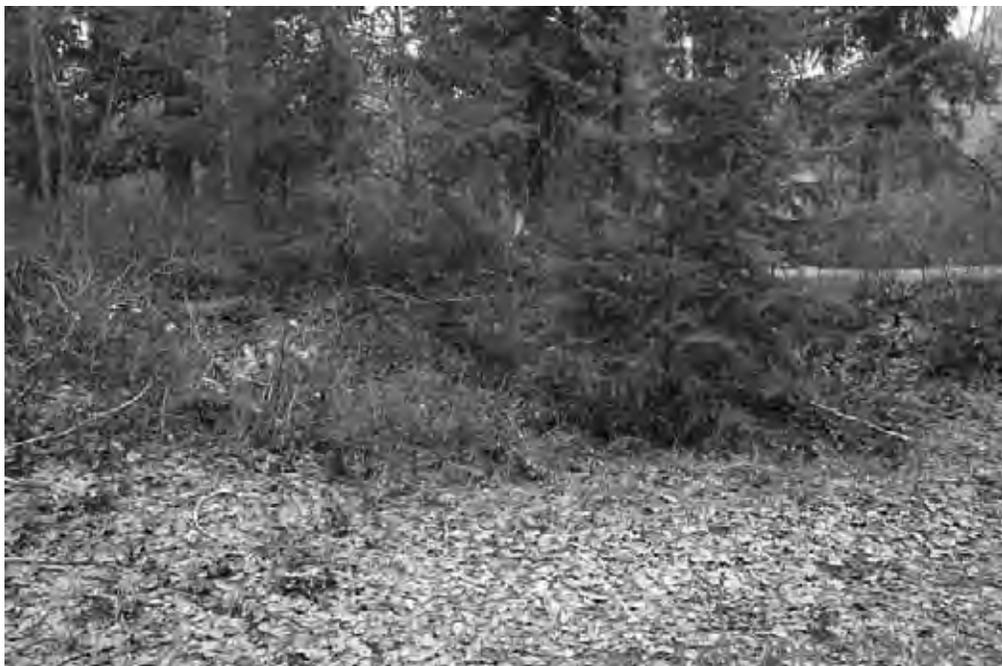
**Photograph No. 27.** View is to the northeast looking at a road embankment that disconnects an overflow channel. MR Prj-58.6 Project Area – Methow Subbasin, Washington – Bureau of Reclamation Photograph by E. Lyon, April 8, 2007.

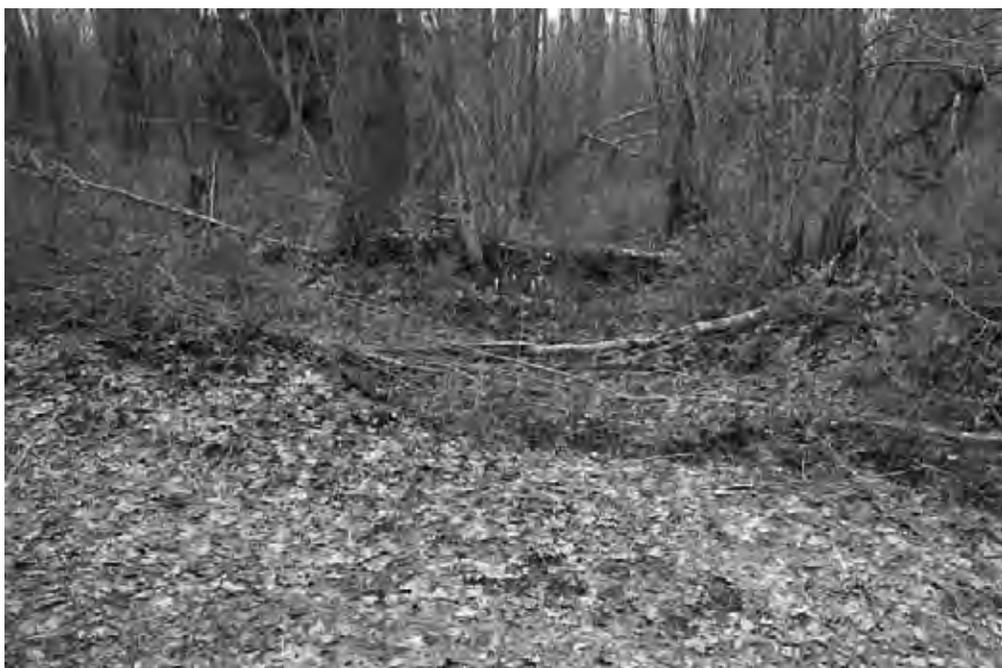
**Photograph No. 28.** View is to the south looking at a road embankment that disconnects an overflow channel. MR Prj-58.6 Project Area – Methow Subbasin, Washington – Bureau of Reclamation Photograph by E. Lyon, April 8, 2007.

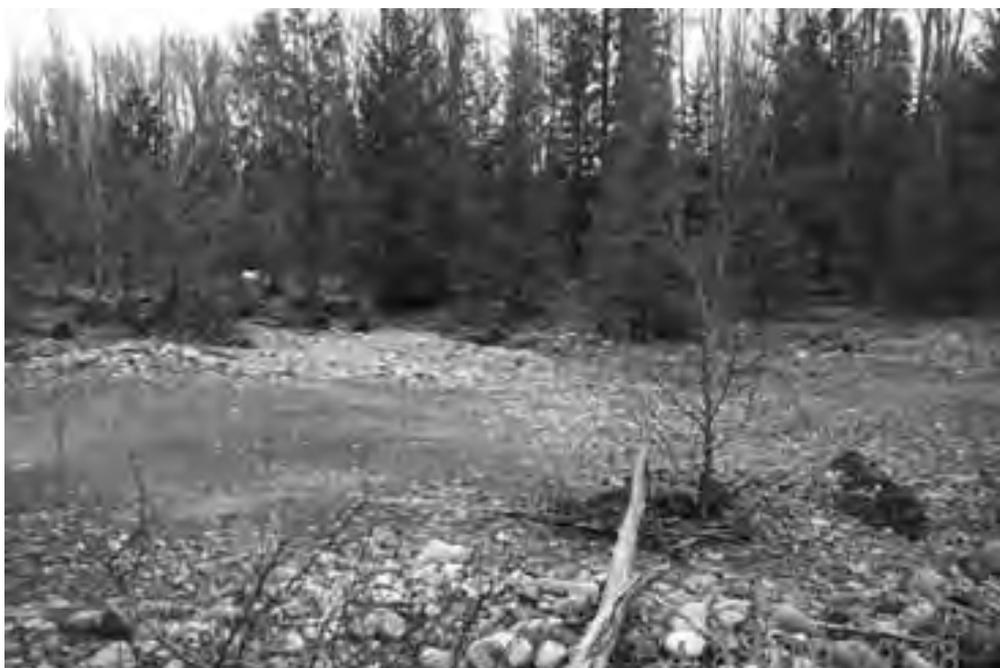
**Photograph No. 30.** View is to the southeast looking at a road embankment that impedes flood flows along historic channel path. Note this area was accessed by the river during the 2006 spring freshet. MR Prj-58.6 Project Area – Methow Subbasin, Washington – Bureau of Reclamation Photograph by E. Lyon, April 8, 2007.

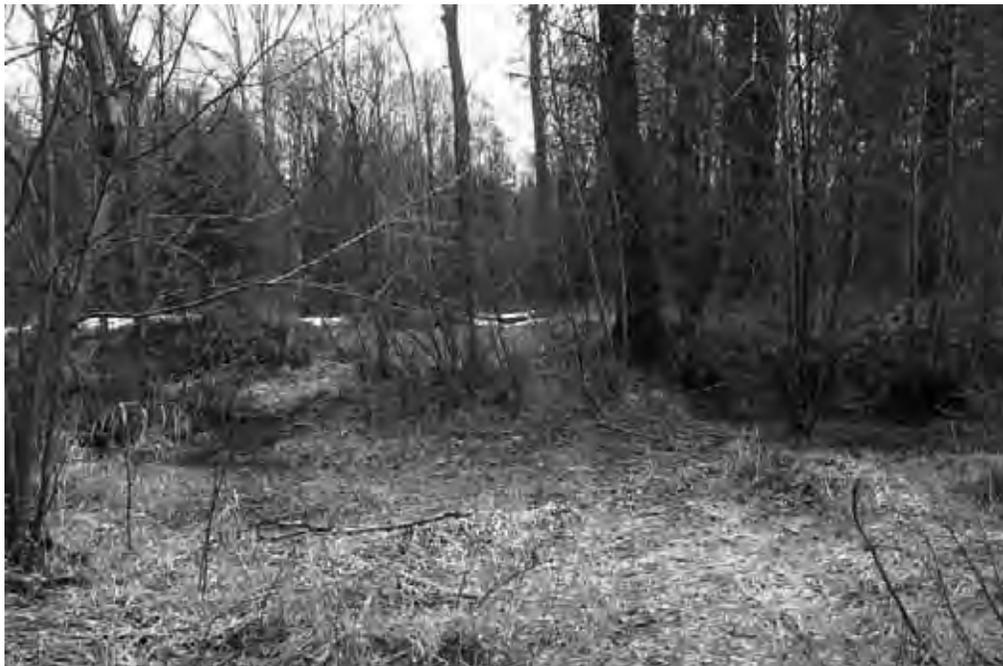
**Photograph No. 40.** View is to the east looking at a road embankment that bisects historic channel path. MR Prj-58.6 Project Area – Methow Subbasin, Washington – Bureau of Reclamation Photograph by E. Lyon, April 8, 2007.

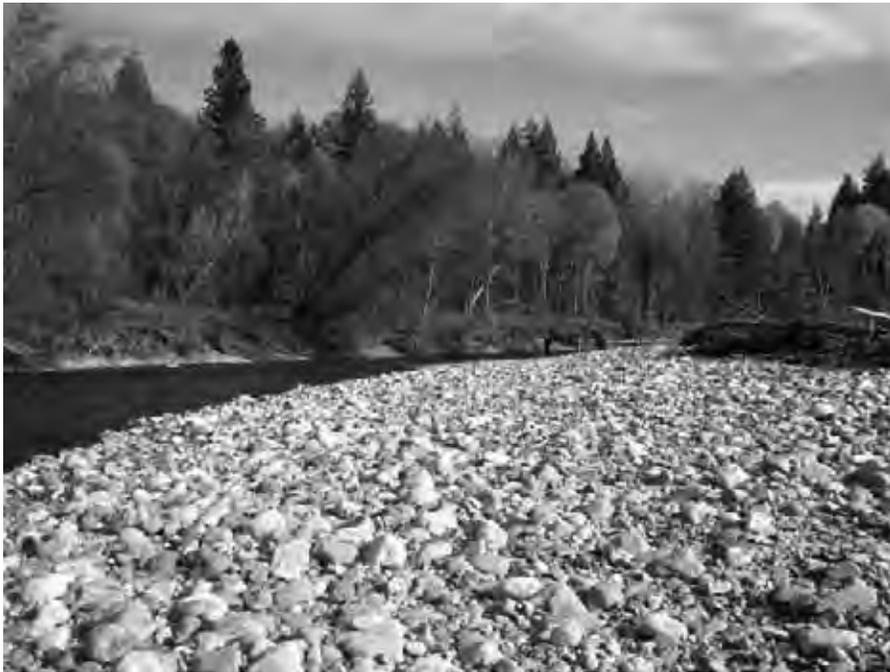
**Photograph No. 2.** View is to the southeast looking downstream along gravel bar on river right at the bank erosion on river left. MR Prj-58.9 Project Area – Methow Subbasin, Washington – Bureau of Reclamation Photograph by R. McAfee, October 25, 2006.

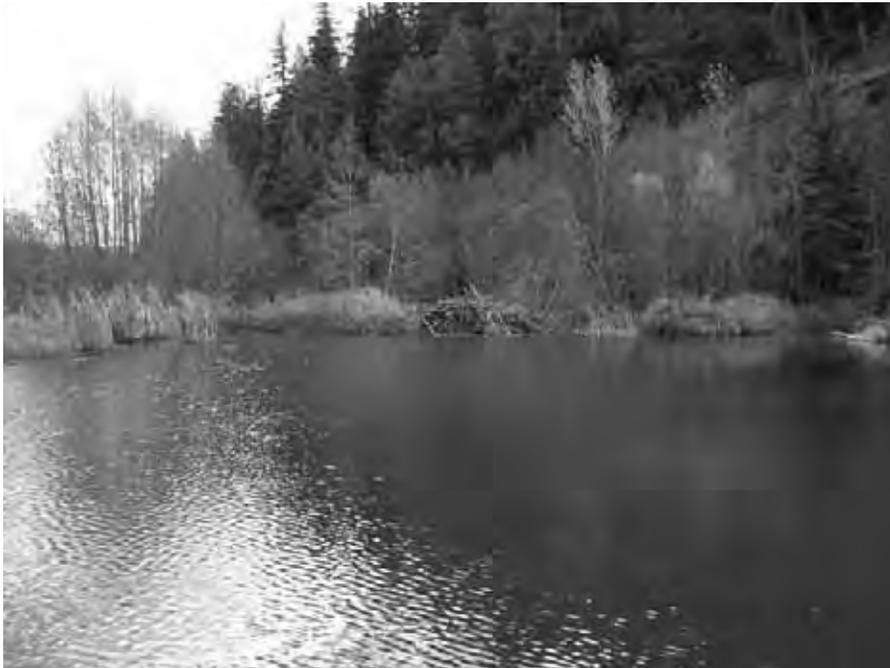
- No anthropogenic features affecting the floodplain's connectivity were observed and the floodplain appears to be functioning properly.
- Overbank flows generally coalesce into overbank channels that feed into wetland complexes (Photograph Nos. 4 through 10).

**Photograph No. 4.** View is to the southeast looking downstream at beaver dam impounding a wetland area. MR Prj-58.9 Project Area – Methow Subbasin, Washington – Bureau of Reclamation Photograph by R. McAfee, October 25, 2006.

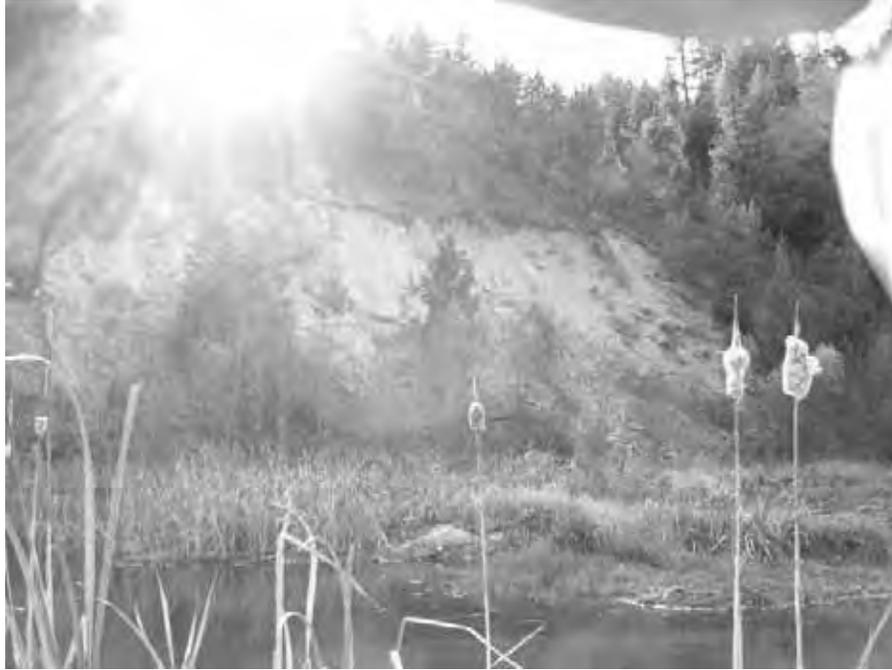
**Photograph No. 5.** View is to the south looking across wetland complex at landslide in glacial deposit. MR Prj-58.9 Project Area – Methow Subbasin, Washington – Bureau of Reclamation Photograph by R. McAfee, October 25, 2006.

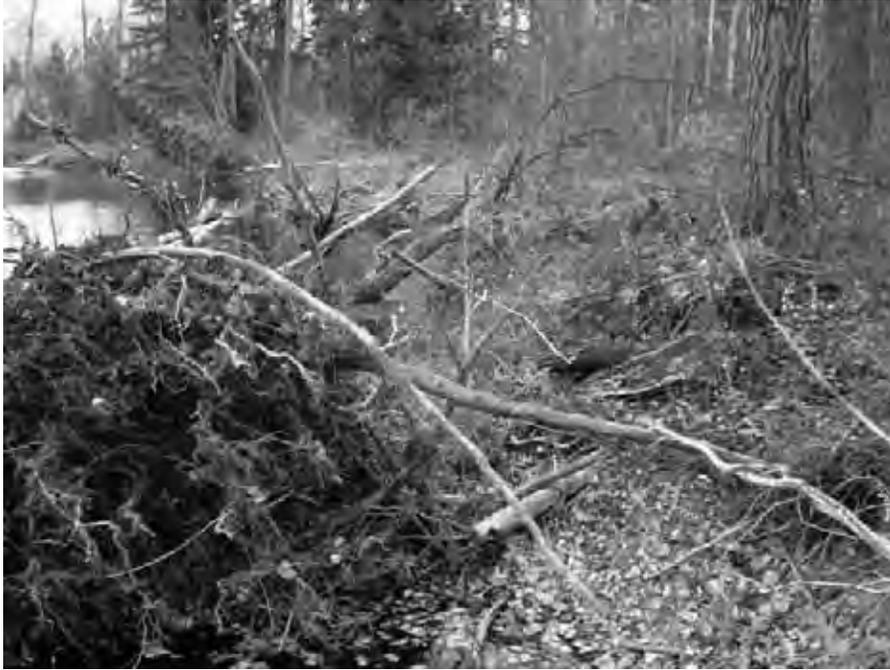
**Photograph No. 15.** View is to the southeast looking downstream at bank erosion that occurred along river right during the 2006 spring freshet. MR Prj-58.9 Project Area – Methow Subbasin, Washington – Bureau of Reclamation Photograph by R. McAfee, October 25, 2006.

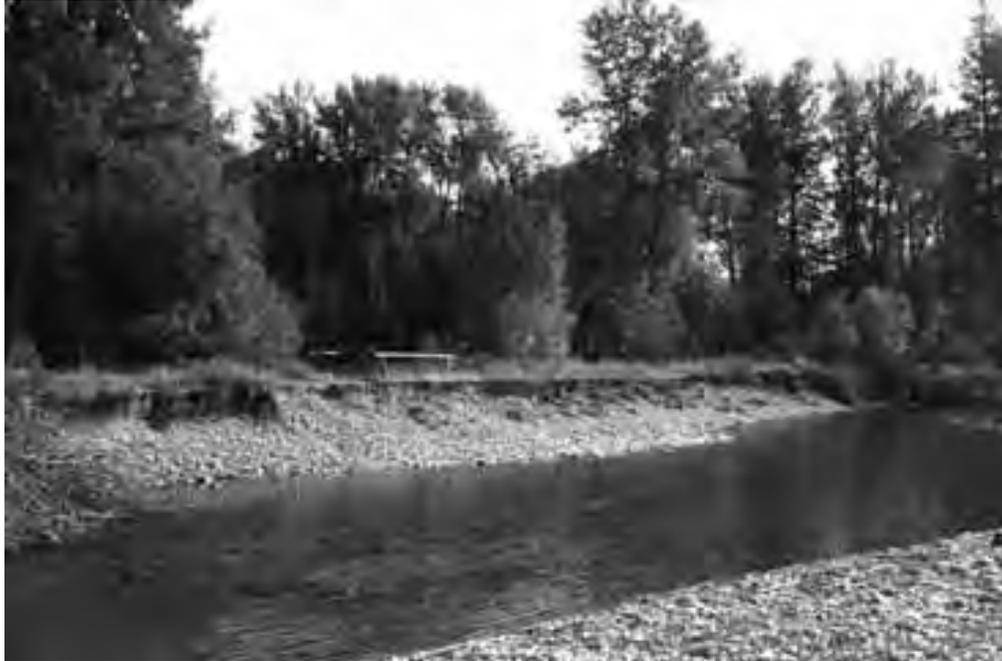
- Spawning gravel recruitment appears to be good (Photograph Nos. 17 and 23).
- There are several overflow and side channels that appear to be in adequate condition (Photograph Nos. 1, 3, 12, 16, 19-22, 24 and 25).

**Photograph No. 17.** View is to the north looking at the Williams' homestead (abandoned) on river left where fairly severe bank erosion occurred during the 2006 spring freshet. MR Prj-58.9 Project Area – Methow Subbasin, Washington – Bureau of Reclamation Photograph by E. Lyon, September 17, 2006.

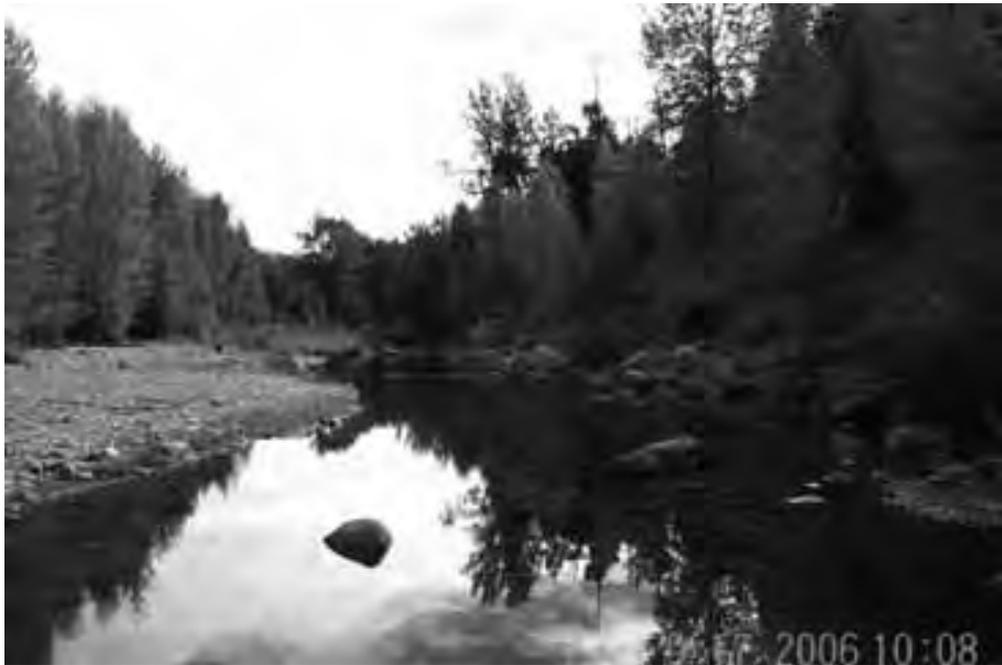
**Photograph No. 22.** View is to the southeast looking downstream along overflow channel on river right as it flows against a slide area. Note the large boulders along the toe of the slide. MR Prj-58.9 Project Area – Methow Subbasin, Washington – Bureau of Reclamation Photograph by E. Lyon, September 17, 2006.

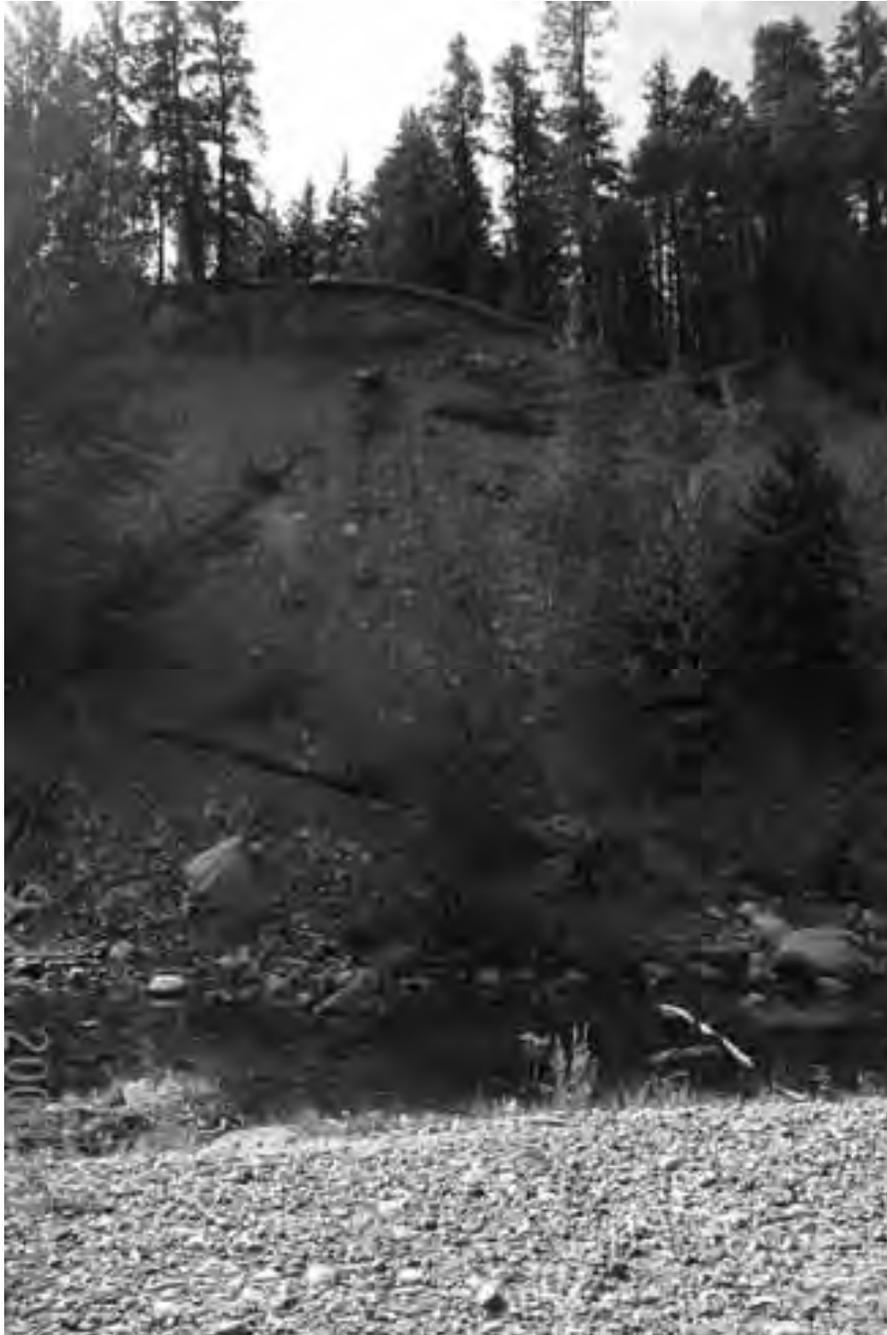
**Photograph No. 23.** View is to the south looking across overflow channel at slide area on river right. MR Prj-58.9 Project Area – Methow Subbasin, Washington – Bureau of Reclamation Photograph by E. Lyon, September 17, 2006.

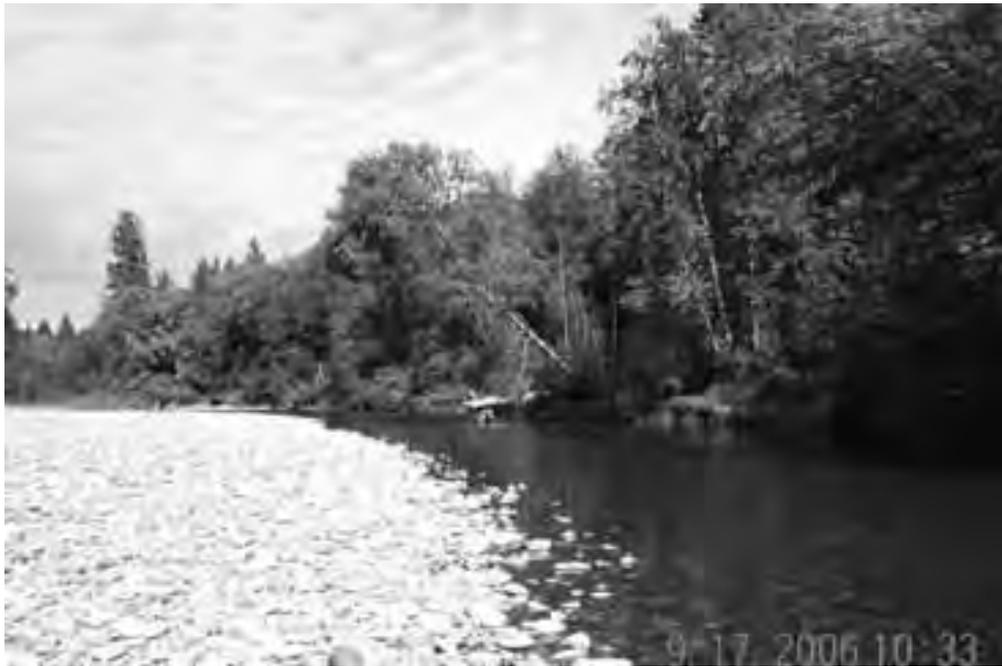
**Photograph No. 27.** View is to the northwest looking upstream at bank erosion along river left. MR Prj-58.9 Project Area – Methow Subbasin, Washington – Bureau of Reclamation Photograph by E. Lyon, September 17, 2006.

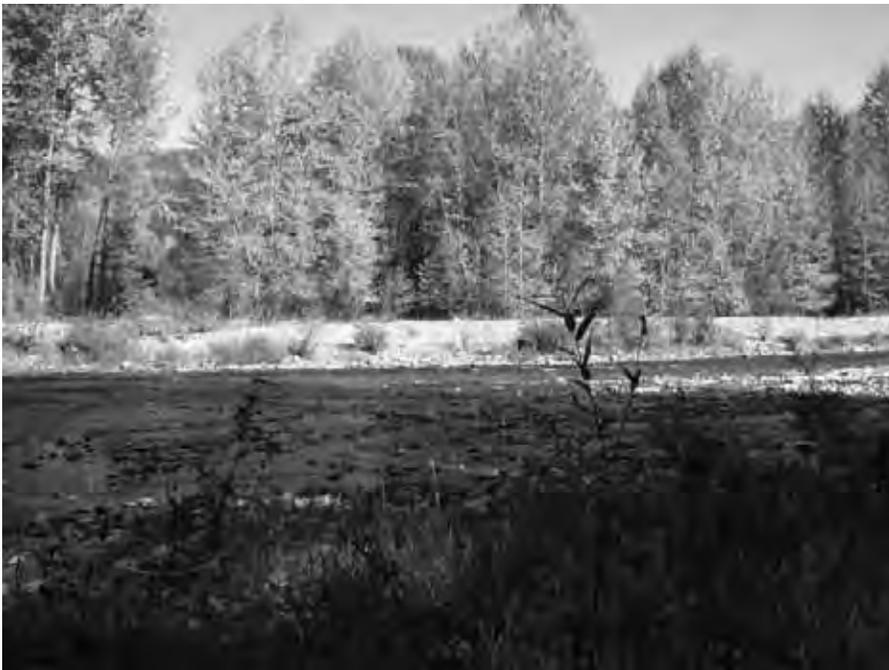
- About 50 feet of bank protection was observed in the project area (Photograph No. 7).
- Upstream of the project area about 850 feet of riprap has been placed along river right (Photograph Nos. 9 through 12).
- Remainder of the project area is in an adequate condition and is being heavily utilized by salmonids (Photograph Nos. 1-6, 8, and 13-33).

**Photograph No. 2.** View is to the northeast looking across the river from river right where Mr. Imes mentioned that the river has incised a few feet. This incision appeared to be localized. Based on antidotal information salmon have been spawning in the channel. MR Prj-59.6 Project Area – Methow Subbasin, Washington – Bureau of Reclamation Photograph by R. McAfee, October 13, 2006.

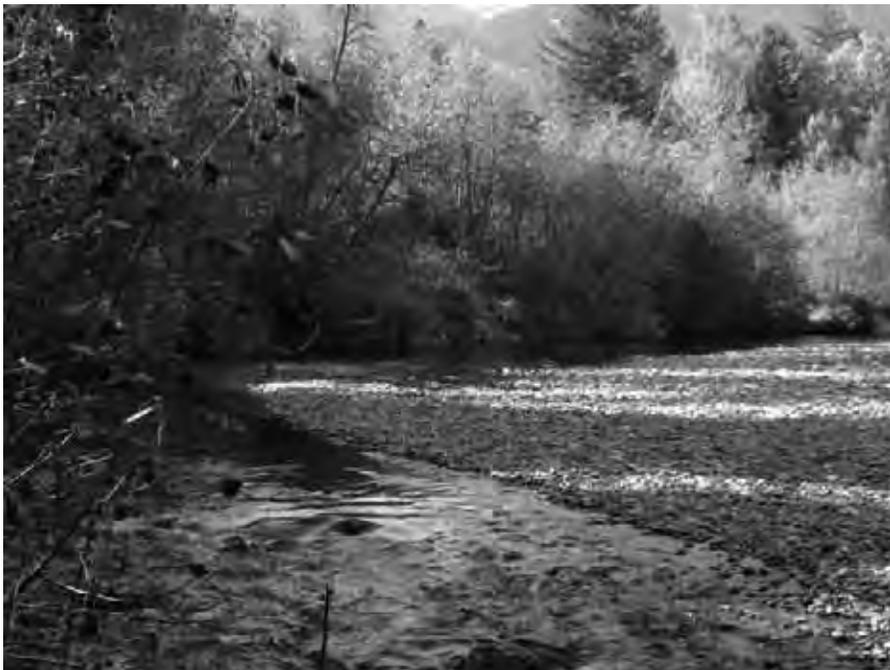
**Photograph No. 7.** View is to the northeast looking downstream along river right where rock spurs and rootwads have been placed for bank protection. MR Prj-59.6 Project Area – Methow Subbasin, Washington – Bureau of Reclamation Photograph by R. McAfee, October 13, 2006.

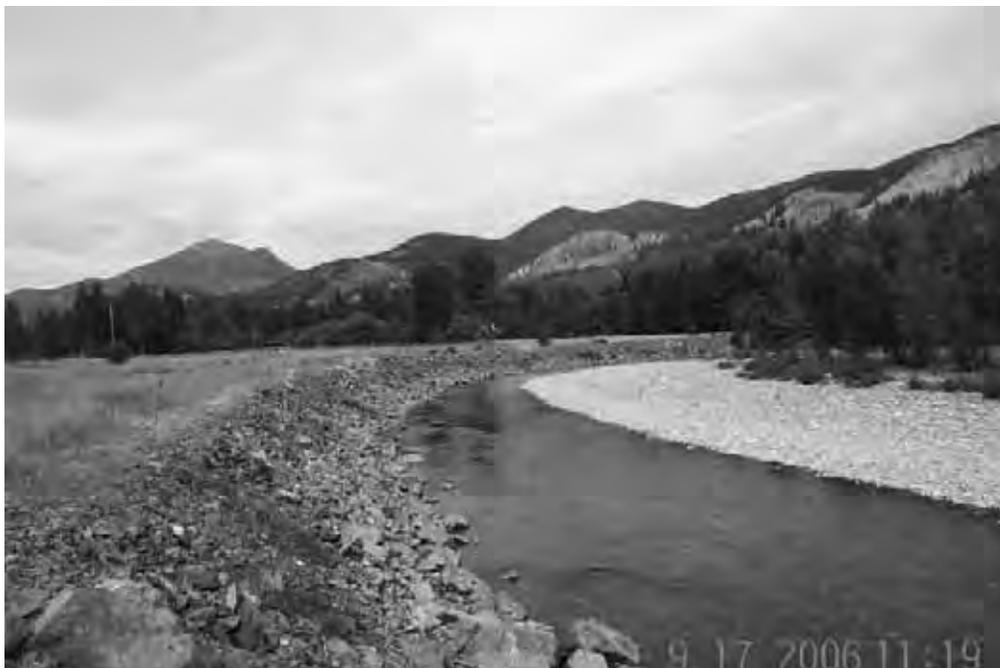
**Photograph No. 8.** View is to the west looking upstream along river right at bank erosion. MR Prj-59.6 Project Area – Methow Subbasin, Washington – Bureau of Reclamation Photograph by R. McAfee, October 13, 2006.

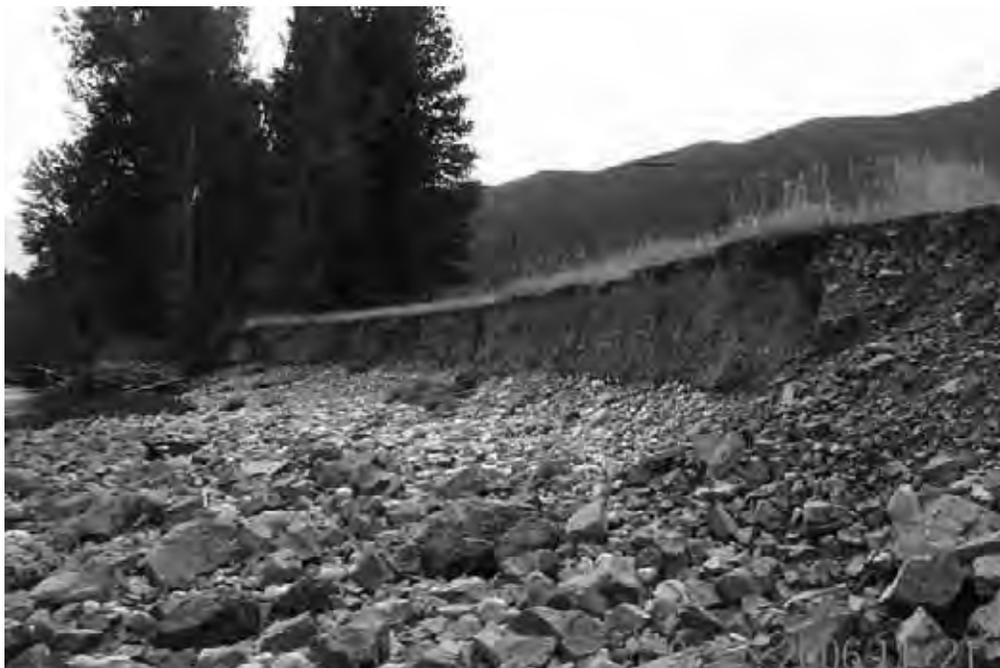
**Photograph No. 9.** View is to the northwest looking upstream at riprap placed along river right. MR Prj-59.6 Project Area – Methow Subbasin, Washington – Bureau of Reclamation Photograph by E. Lyon, September 17, 2006.

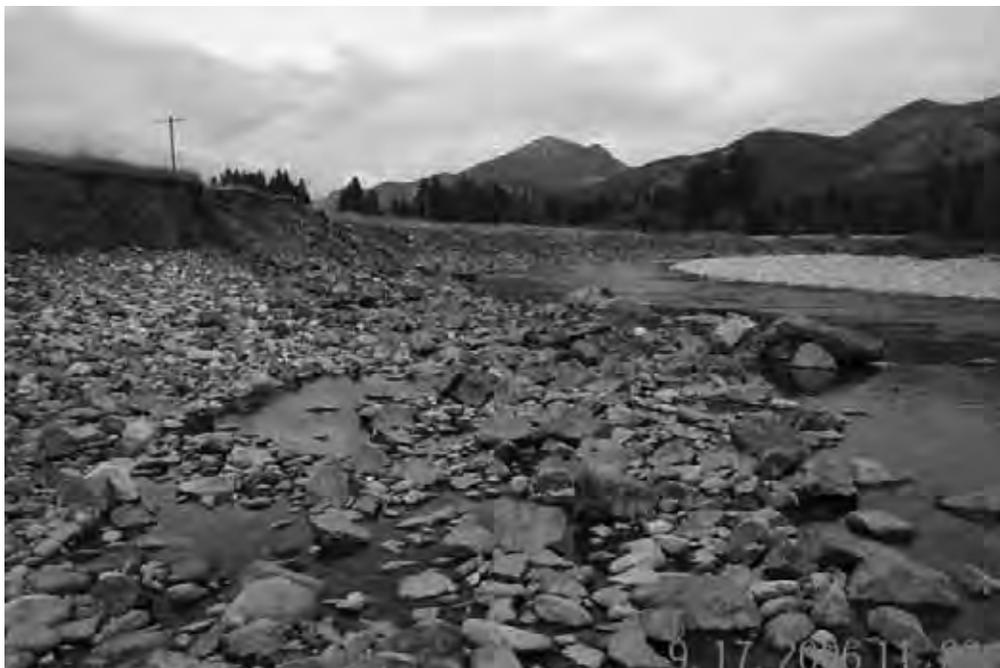
**Photograph No. 10.** View is to the south looking downstream where the riprap ended and the bank eroded during the 2006 spring freshet. MR Prj-59.6 Project Area – Methow Subbasin, Washington – Bureau of Reclamation Photograph by E. Lyon, September 17, 2006.

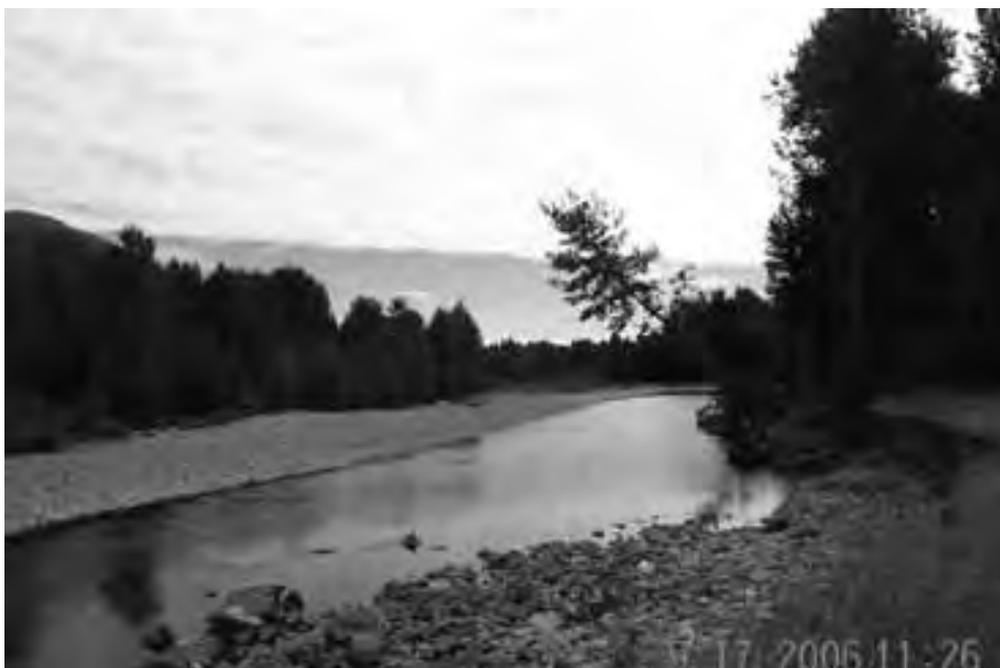
**Photograph No. 11.** View is to the northwest looking upstream at riprap along river right where the riprap was eroded and deposited during the 2006 spring freshet. MR Prj-59.6 Project Area – Methow Subbasin, Washington – Bureau of Reclamation Photograph by E. Lyon, September 17, 2006.

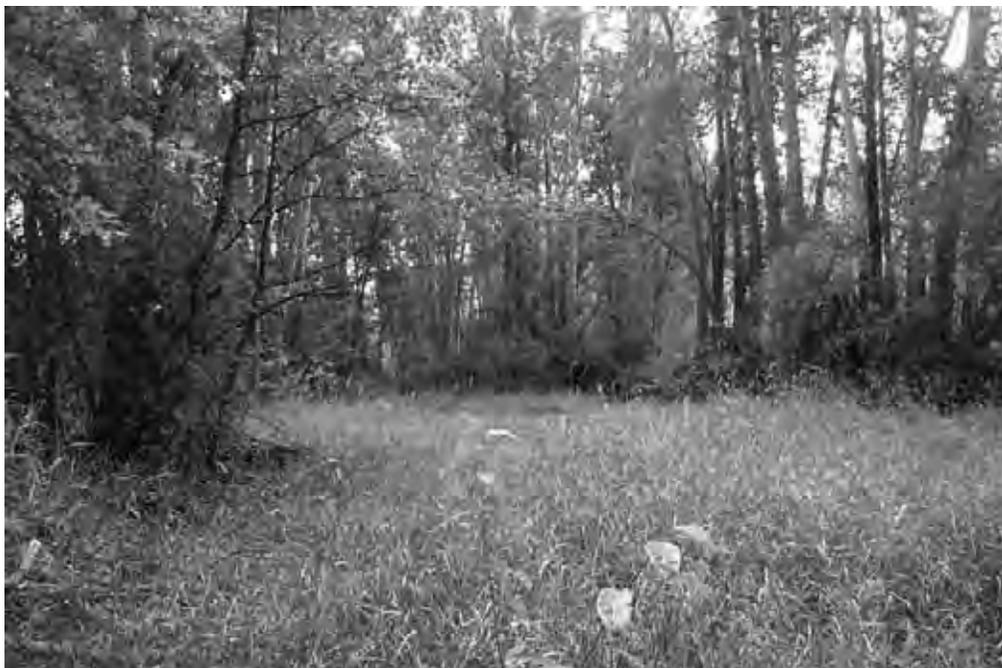
**Photograph No. 12.** View is to the southeast looking downstream along river right where bank erosion occurred during the 2006 spring freshet. MR Prj-59.6 Project Area – Methow Subbasin, Washington – Bureau of Reclamation Photograph by E. Lyon, September 17, 2006.

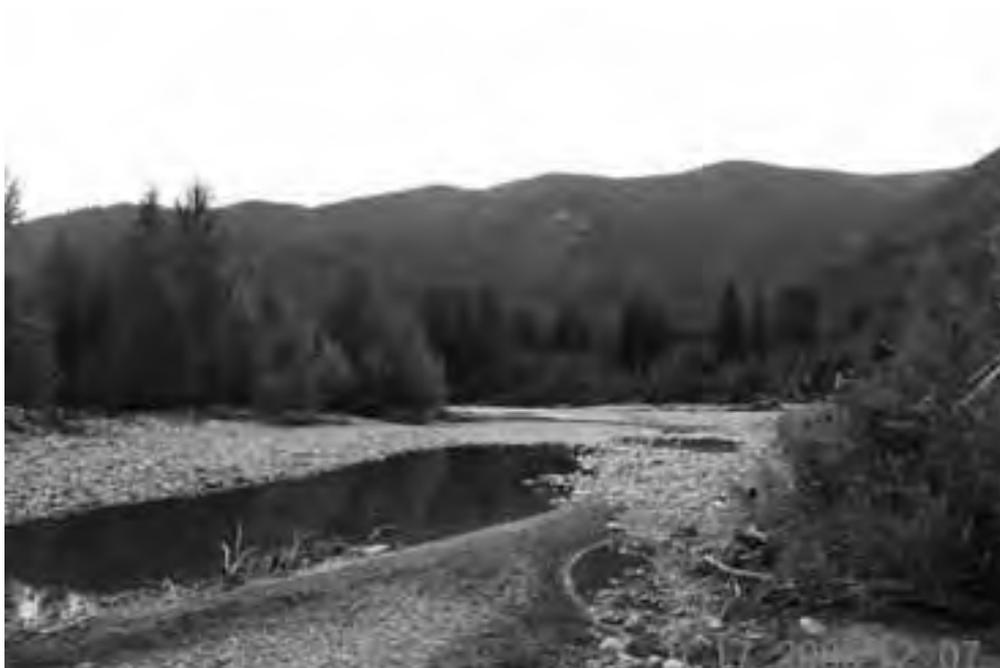
**Photograph No. 19.** View is to the east looking at river left in the historic channel path where erosion occurred during the 2006 spring freshet. MR Prj-59.6 Project Area – Methow Subbasin, Washington – Bureau of Reclamation Photograph by E. Lyon, September 17, 2006.
