## Big Valley Reach Assessment Methow River

Okanogan County, Washington

U.S. Department of the Interior  
Bureau of Reclamation  
Pacific Northwest Region

August 2008

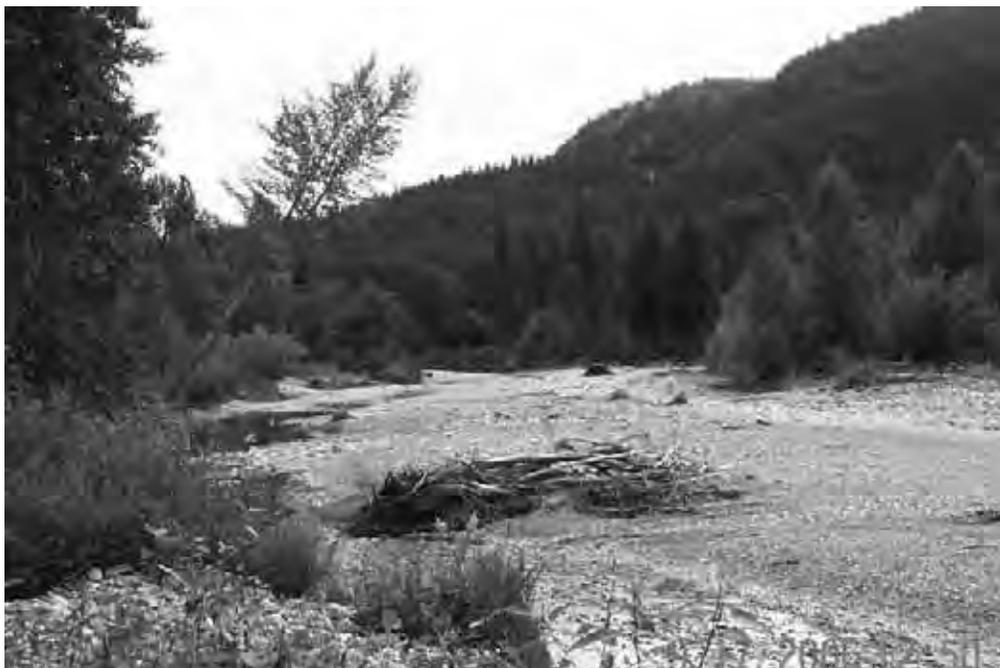
**Photograph No. 27.** View is to the southeast looking downstream where the active channel has cut a new path during the 2006 spring freshet. MR Prj-59.6 Project Area – Methow Subbasin, Washington – Bureau of Reclamation Photograph by E. Lyon, September 17, 2006.

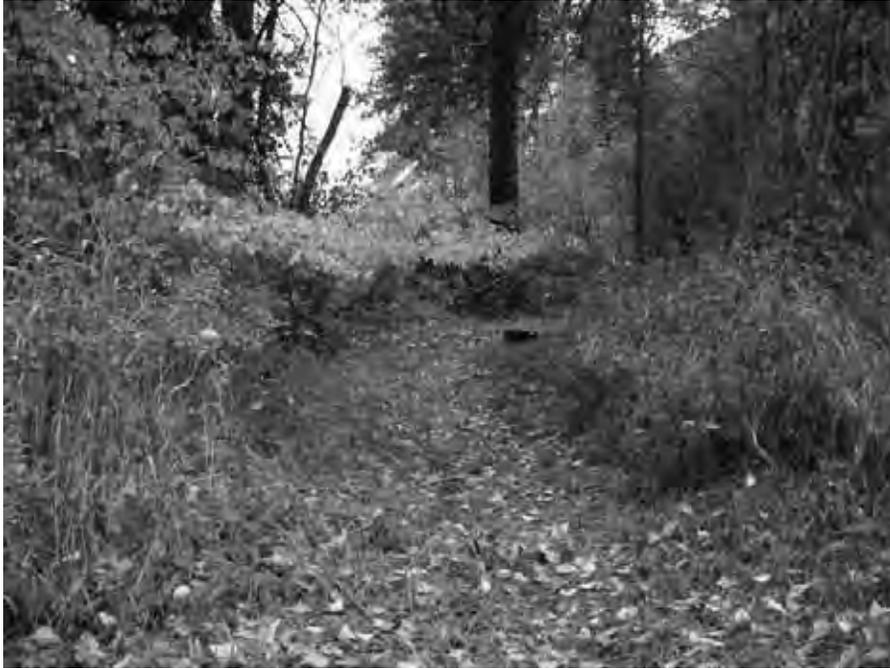
- Lack of landowner access was problematic during our field mapping and photographic documentation.
- The floodplain is being developed and there are numerous houses.
- Two culverts were observed (Photograph Nos. 8 and 9).
- One ford crossing (Photograph No. 10).
- Two road embankments disconnecting floodplain (Photograph Nos. 4, 5, and 6).
- A tributary entering
- + from the north had two road embankments (Photograph No. 11) and one culvert (Photograph Nos. 1, 2, and 3).

**Photograph No. 1.** View is to the northwest looking upstream along tributary channel(?) from road embankment with undersized culvert. MR Prj-60.25 Project Area – Methow Subbasin, Washington – Bureau of Reclamation Photograph by R. McAfee, October 16, 2006.

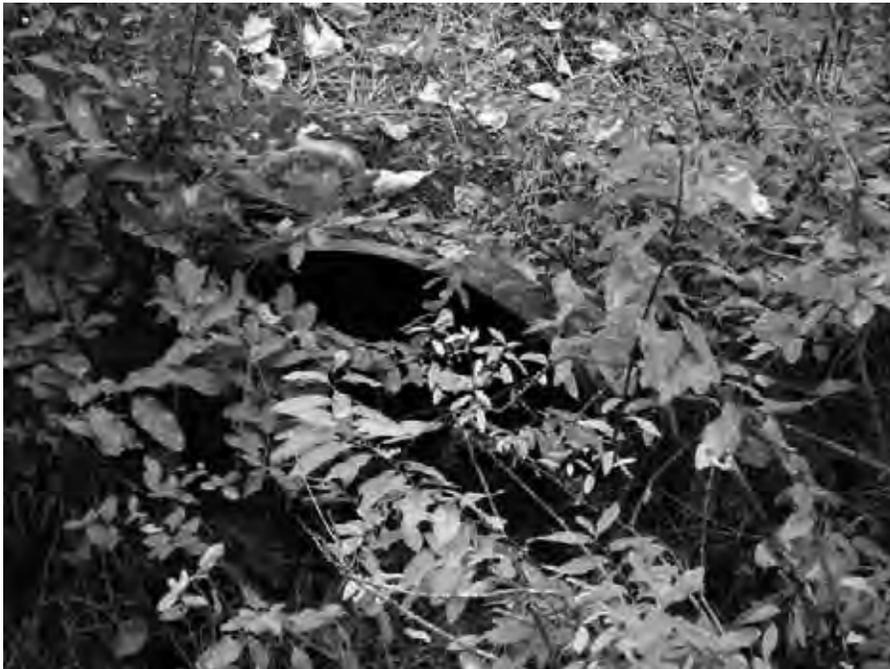
**Photograph No. 2.** View is to the northwest looking upstream at undersized culvert through road embankment. MR Prj-60.25 Project Area – Methow Subbasin, Washington – Bureau of Reclamation Photograph by R. McAfee, October 16, 2006.

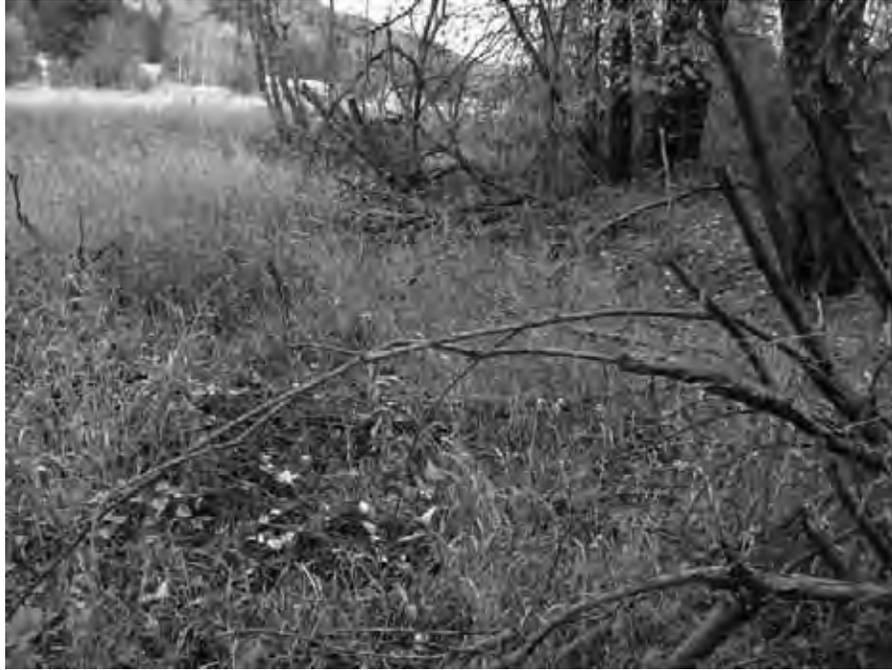
**Photograph No. 3.** View is to the southeast looking downstream along tributary channel from road embankment with undersized culvert. MR Prj-60.25 Project Area – Methow Subbasin, Washington – Bureau of Reclamation Photograph by R. McAfee, October 16, 2006.

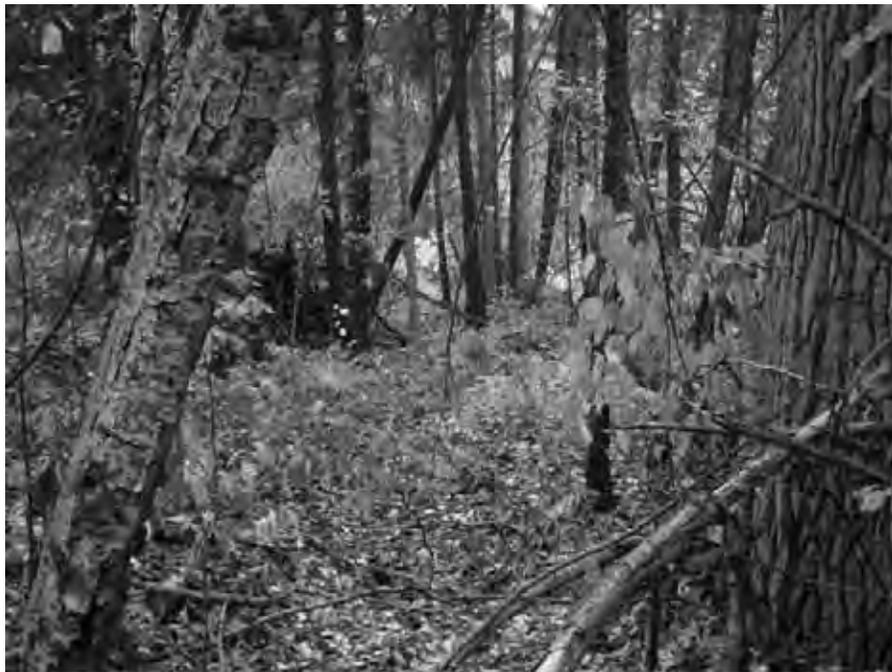
**Photograph No. 4.** View is north looking upstream along overflow channel from road embankment with no culvert. MR Prj-60.25 Project Area – Methow Subbasin, Washington – Bureau of Reclamation Photograph by R. McAfee, October 16, 2006.

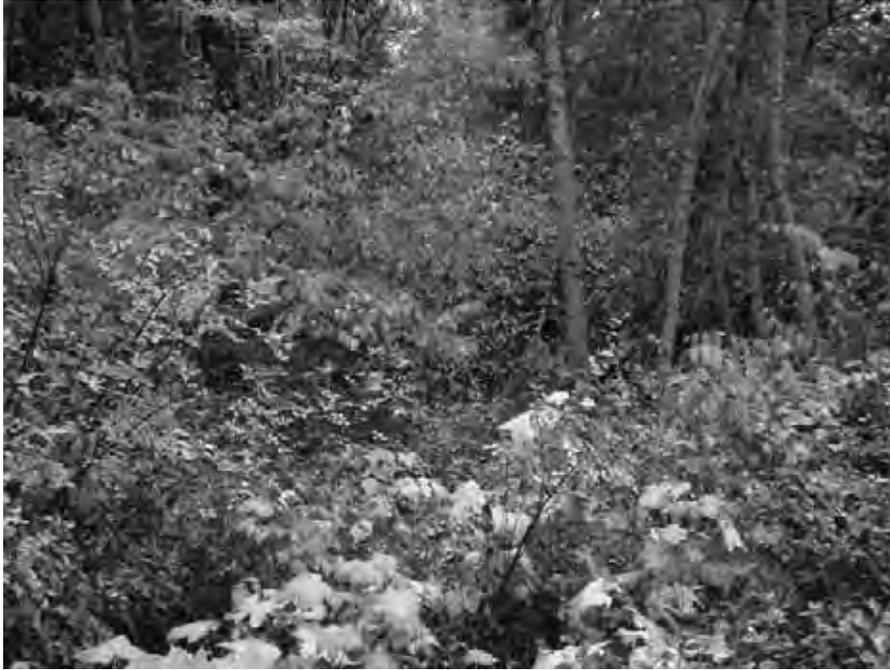
**Photograph No. 5.** View is to the south looking downstream along overflow channel from road embankment with no culvert. MR Prj-60.25 Project Area – Methow Subbasin, Washington – Bureau of Reclamation Photograph by R. McAfee, October 16, 2006.

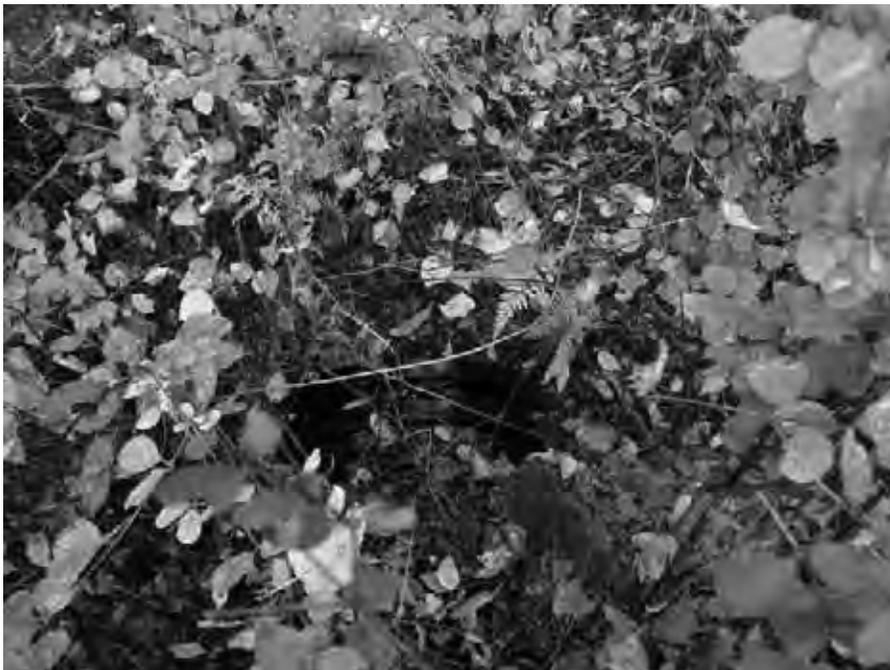
**Photograph No. 6.** View is to the north looking upstream along overflow channel at road embankment with undersized culvert. MR Prj-60.25 Project Area – Methow Subbasin, Washington – Bureau of Reclamation Photograph by R. McAfee, October 16, 2006.

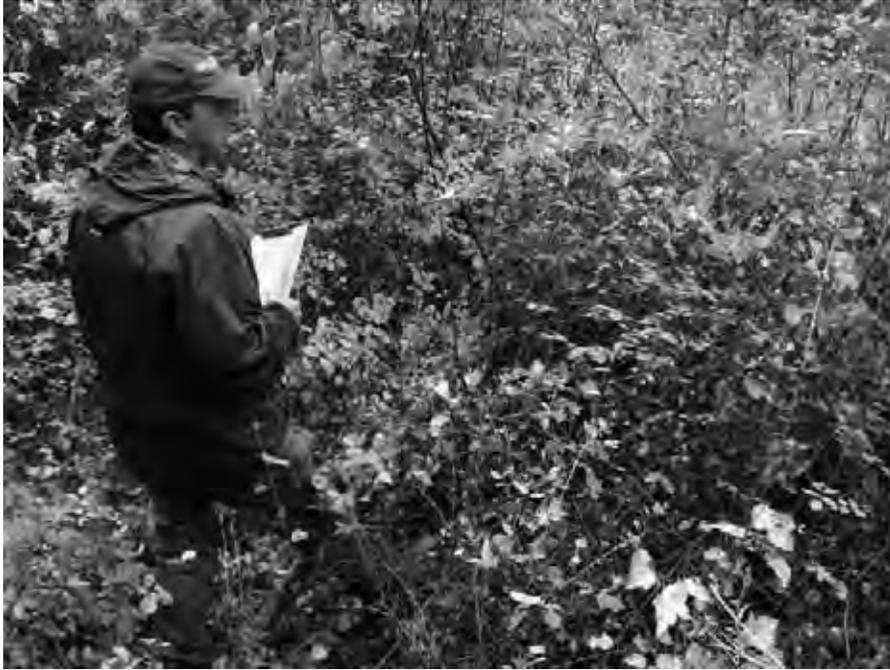
**Photograph No. 7.** View is to the north looking upstream along overflow channel from road embankment with no culvert. MR Prj-60.25 Project Area – Methow Subbasin, Washington – Bureau of Reclamation Photograph by R. McAfee, October 16, 2006.

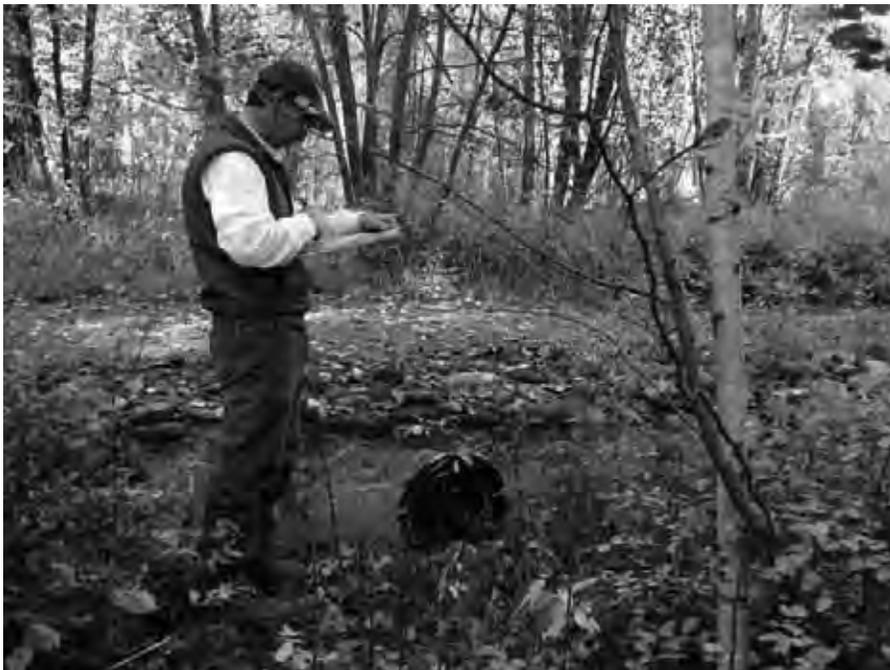
**Photograph No. 8.** View is to the north looking upstream along overflow channel with concrete encased culvert. MR Prj-60.25 Project Area – Methow Subbasin, Washington – Bureau of Reclamation Photograph by R. McAfee, October 16, 2006.

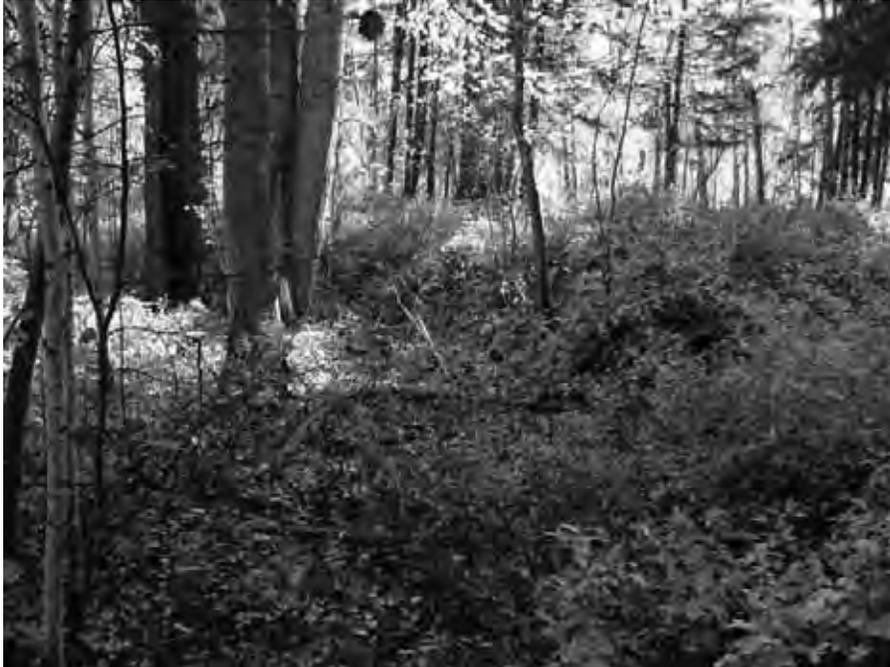
**Photograph No. 9.** View is to the north looking upstream along overflow channel from road embankment. MR Prj-60.25 Project Area – Methow Subbasin, Washington – Bureau of Reclamation Photograph by R. McAfee, October 17, 2006.

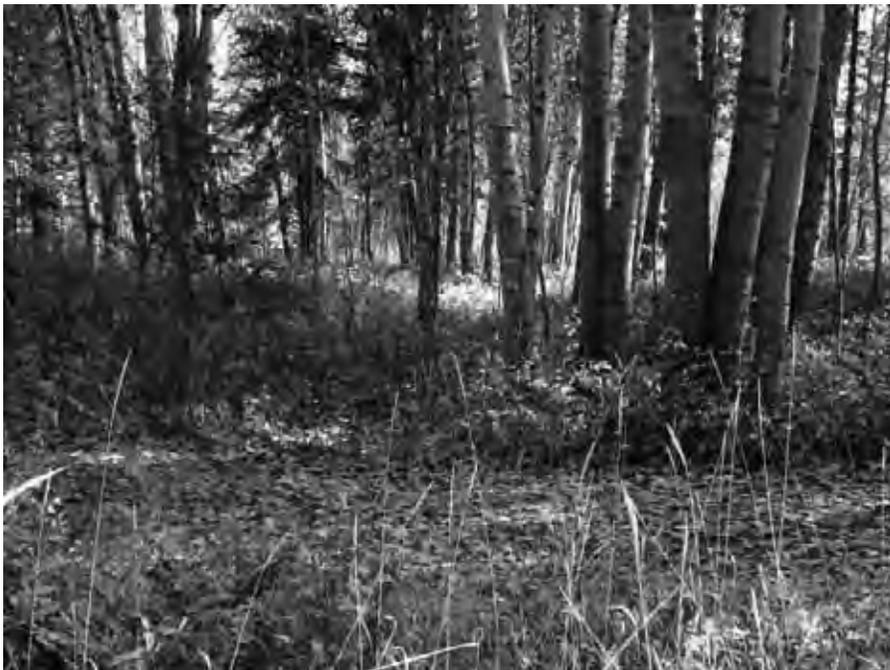
**Photograph No. 10.** View is to the west looking across ford crossing along unimproved road. MR Prj-60.25 Project Area – Methow Subbasin, Washington – Bureau of Reclamation Photograph by R. McAfee, October 17, 2006.

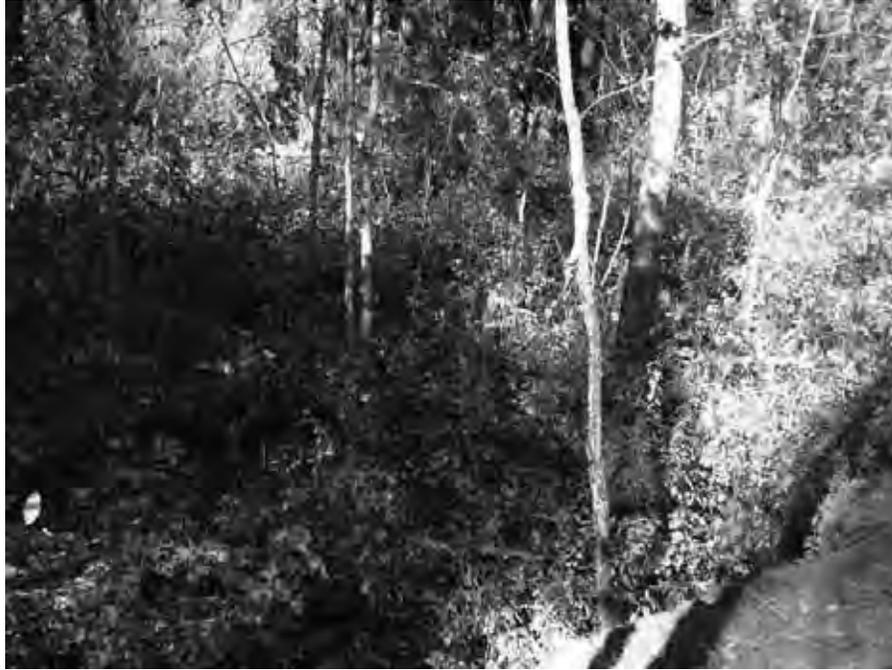
**Photograph No. 11.** View is to the north looking upstream along overflow channel from road embankment without culvert. MR Prj-60.25 Project Area – Methow Subbasin, Washington – Bureau of Reclamation Photograph by R. McAfee, October 17, 2006.

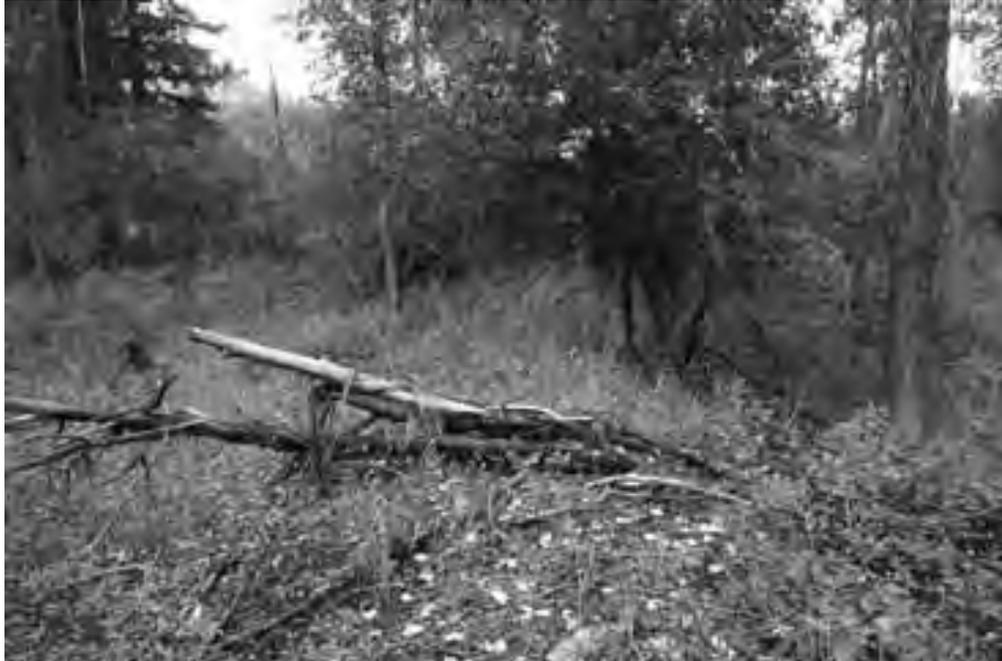
**Photograph No. 7.** View is to the northwest looking at a berm that historically impounded the Fender Mill pond. Height of the berm varies from about 3-5 feet. MR Prj-60.85 Project Area – Methow Subbasin, Washington – Bureau of Reclamation Photograph by E. Lyon, September 15, 2006.

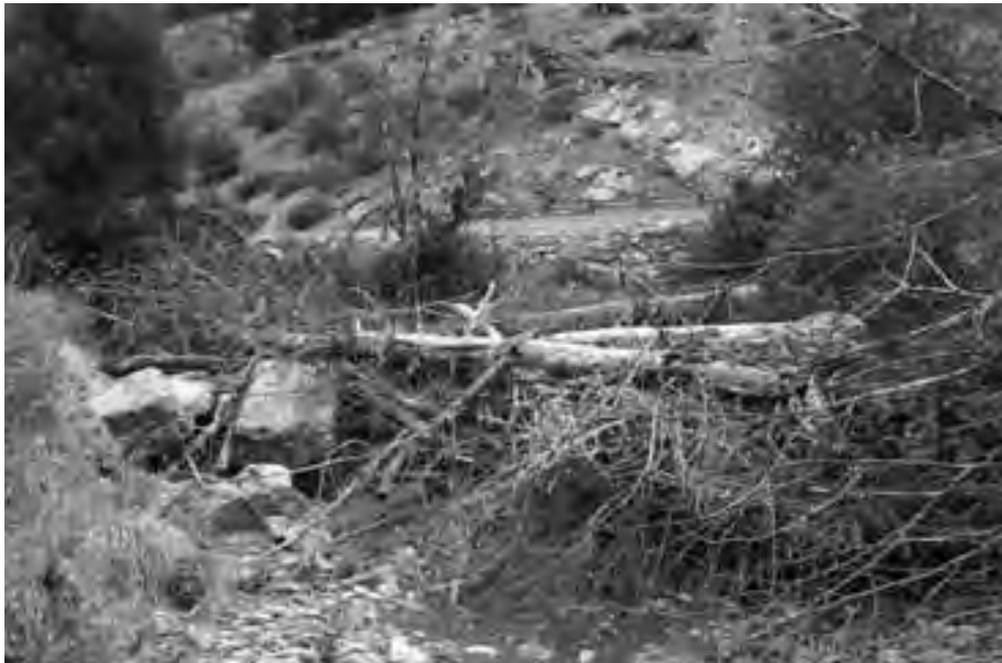
**Photograph No. 10.** View is to the north looking upstream along the Rockview irrigation ditch fish return channel where it exits the mill pond area. Note the numerous concrete blocks in the channel. MR Prj-60.85 Project Area – Methow Subbasin, Washington – Bureau of Reclamation Photograph by E. Lyon, September 15, 2006.

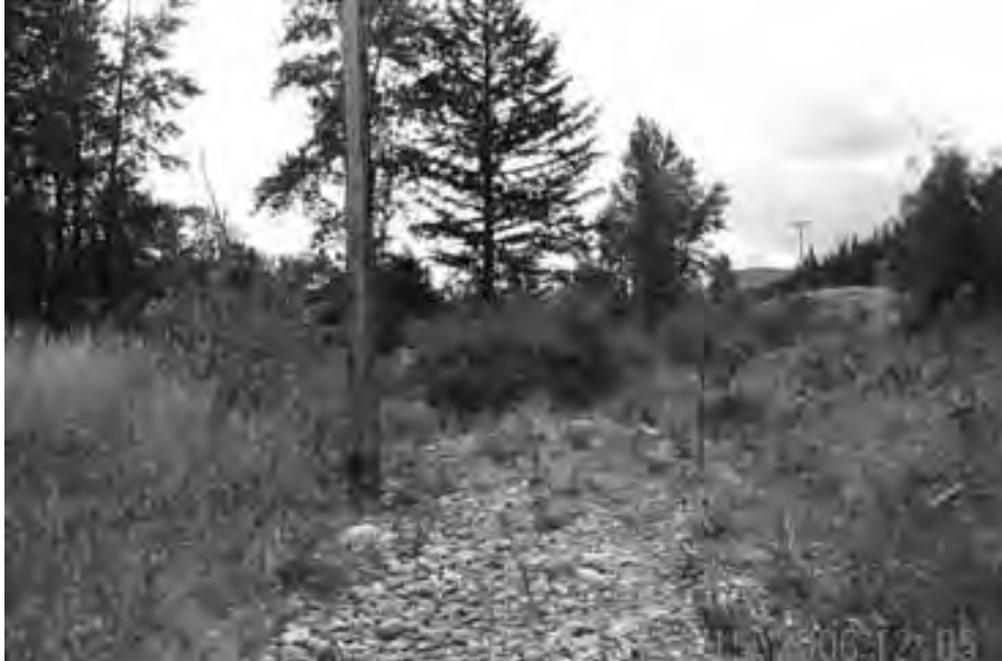
- The fish return channel from the Rockview irrigation ditch flows down into a wetland complex (Photograph Nos. 16 through 22). There is one ford crossing the fish return channel (Photograph Nos. 15 and 18) and a power-pole within the channel (Photograph No. 11). Timbers have been placed in the fish return channel (Photograph No. 12) that impedes the flows, forcing the water to access the floodplain (Photograph No. 14).

**Photograph No. 11.** View is to the northwest looking upstream along the fish return channel at a power-pole that is in the channel. Note the high water mark at the base of the power pole. MR Prj-60.85 Project Area – Methow Subbasin, Washington – Bureau of Reclamation Photograph by E. Lyon, September 15, 2006.

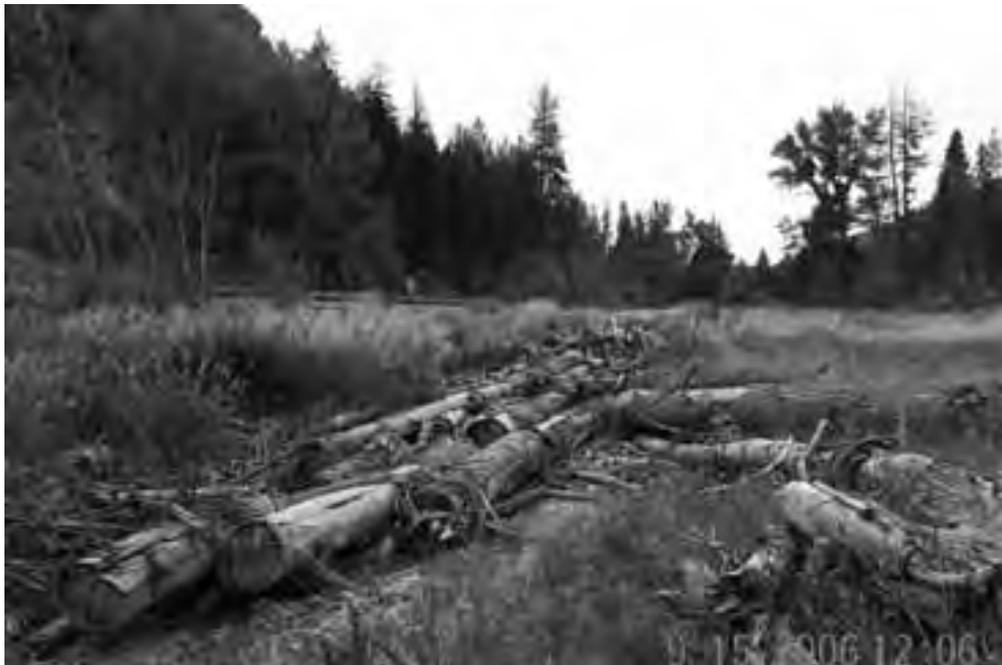
**Photograph No. 12.** View is to the south looking downstream along the fish return channel that has been filled with timbers. MR Prj-60.85 Project Area – Methow Subbasin, Washington – Bureau of Reclamation Photograph by E. Lyon, September 15, 2006.

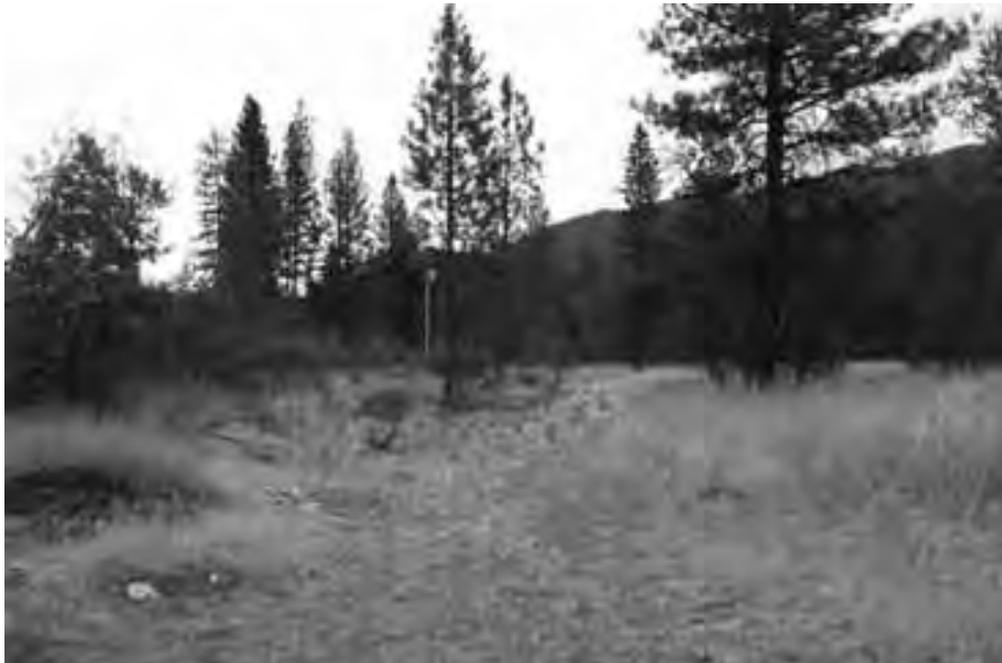
**Photograph No. 14.** View is to the south looking downstream where flows were impeded in the fish return channel by timbers. MR Prj-60.85 Project Area – Methow Subbasin, Washington – Bureau of Reclamation Photograph by E. Lyon, September 15, 2006.

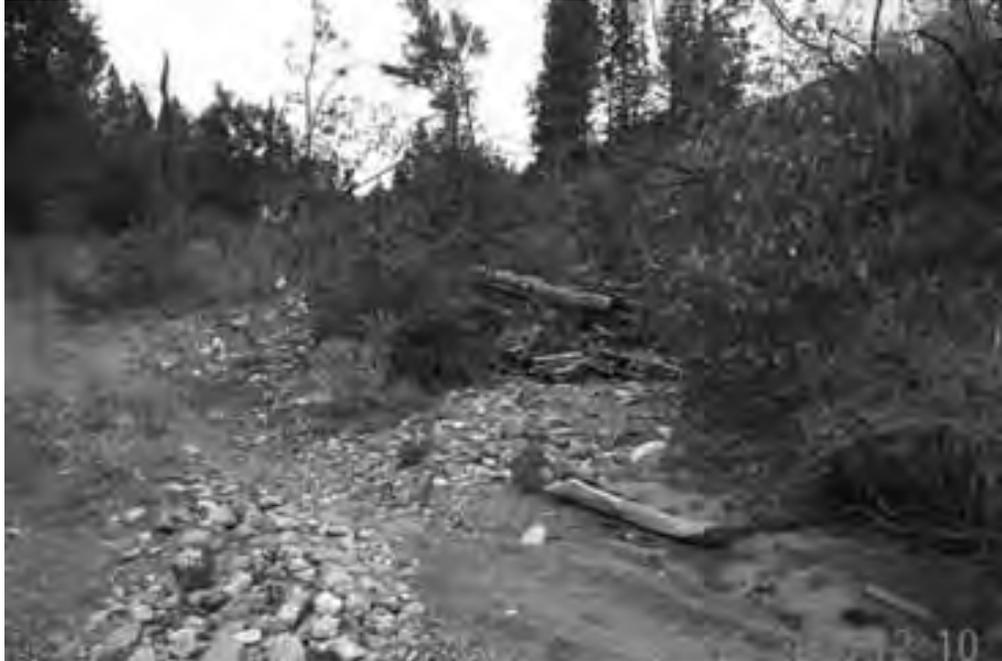
**Photograph No. 15.** View is to the southeast looking downstream along the fish return channel at a ford crossing. MR Prj-60.85 Project Area – Methow Subbasin, Washington – Bureau of Reclamation Photograph by E. Lyon, September 15, 2006.

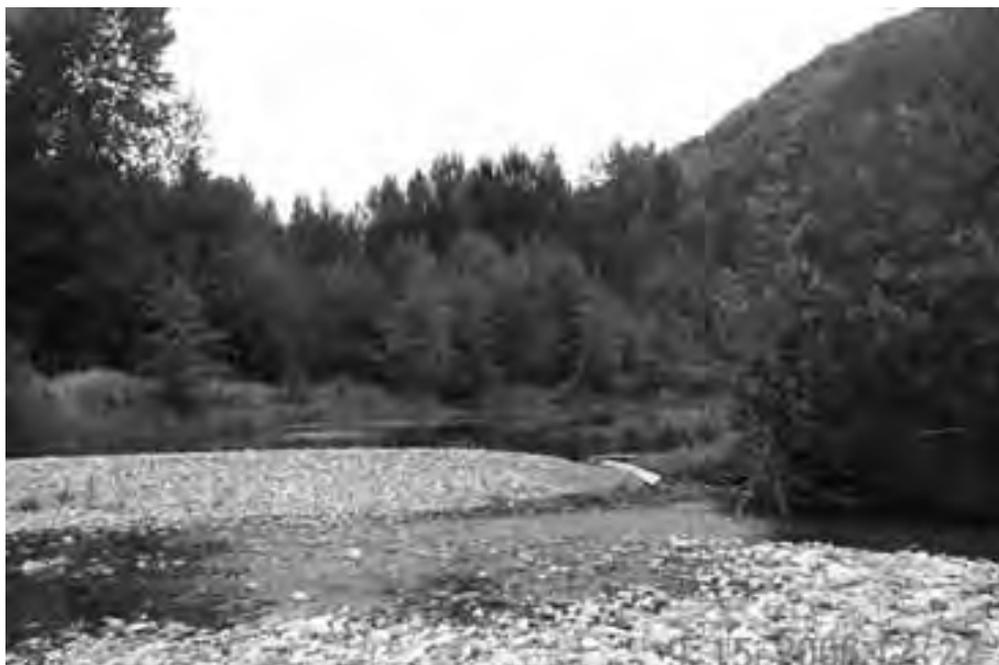
**Photograph No. 20.** View is to the north looking upstream from the active river channel into the wetland area (oxbows). Sediment has accumulated at the confluence, but does not create a complete barrier as there is a small beaver dam on the right side of the gravel bar. MR Prj-60.85 Project Area – Methow Subbasin, Washington – Bureau of Reclamation Photograph by E. Lyon, September 15, 2006.

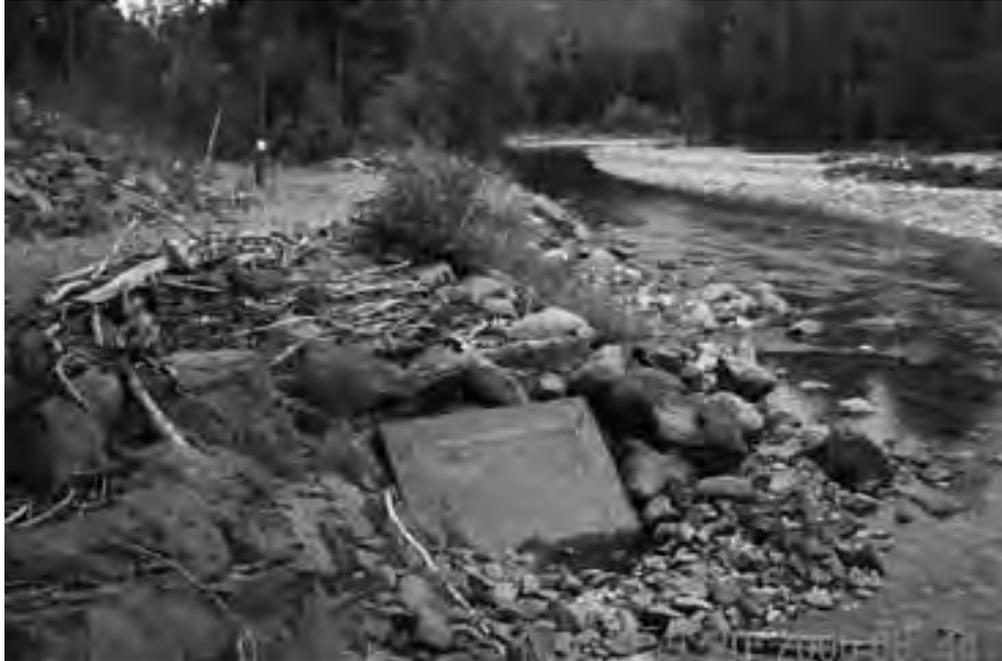
**Photograph No. 27.** View is to the south looking downstream along the left abutment of Weeman Bridge where the inlet to the Rockview irrigation ditch has been sealed. Also note the riprap placed along the left bank to protect the inlet. MR Prj-60.85 Project Area – Methow Subbasin, Washington – Bureau of Reclamation Photograph by E. Lyon, September 20, 2006.

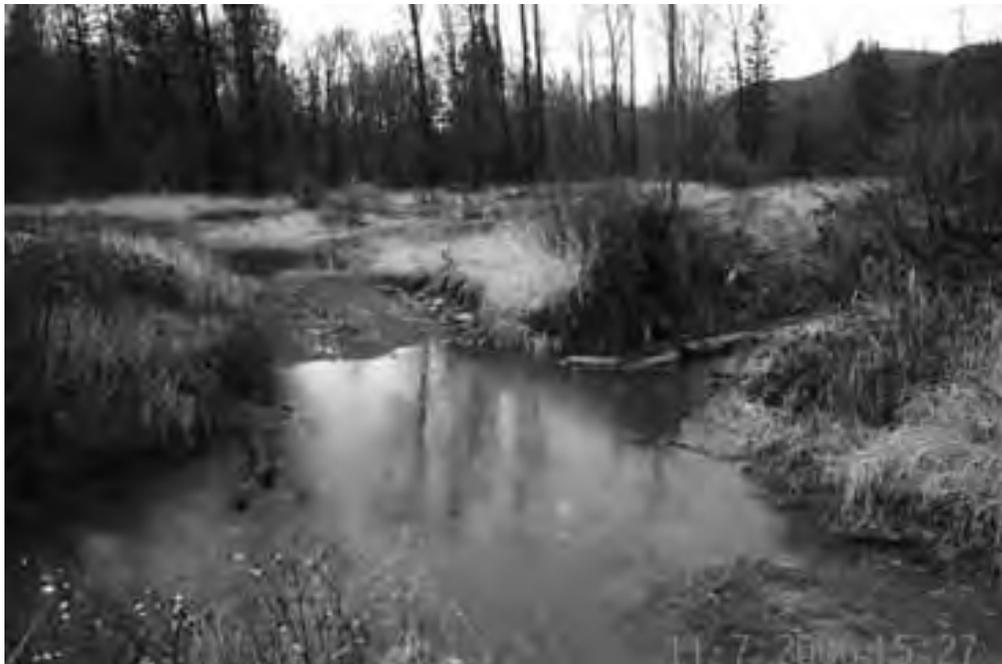
**Photograph No. 28.** View is to the west looking at a ford crossing the fish return channel during the November 7, 2006 high flows. MR Prj-60.85 Project Area – Methow Subbasin, Washington – Bureau of Reclamation Photograph by E. Lyon, November 7, 2006.

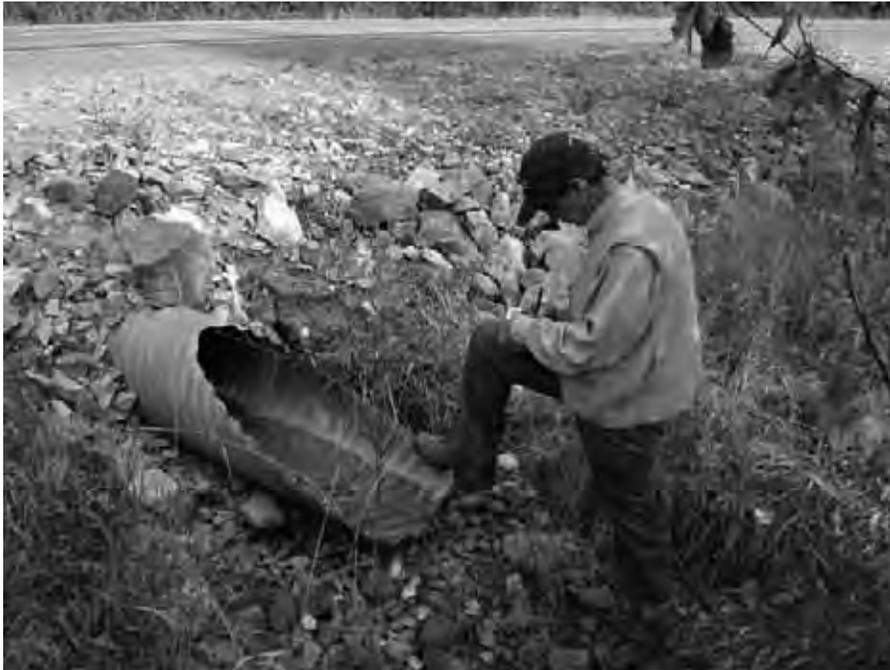
- Six culverts were observed in the project area (Photograph Nos. 1-6, 16, 35, 42, and 43).
- About 315 linear feet of push-up levees are present (Photograph Nos. 8-9 and 20-23).

**Photograph No. 1.** View is to the northeast looking at an undersized culvert placed through the Highway 20 embankment along the west approach to Weeman Bridge. Note the new rock placed along the road embankment where water flowed over the road during the 2006 spring freshet. MR Prj-62.4 Project Area – Methow Subbasin, Washington – Bureau of Reclamation Photograph by R. McAfee, October 14, 2006.

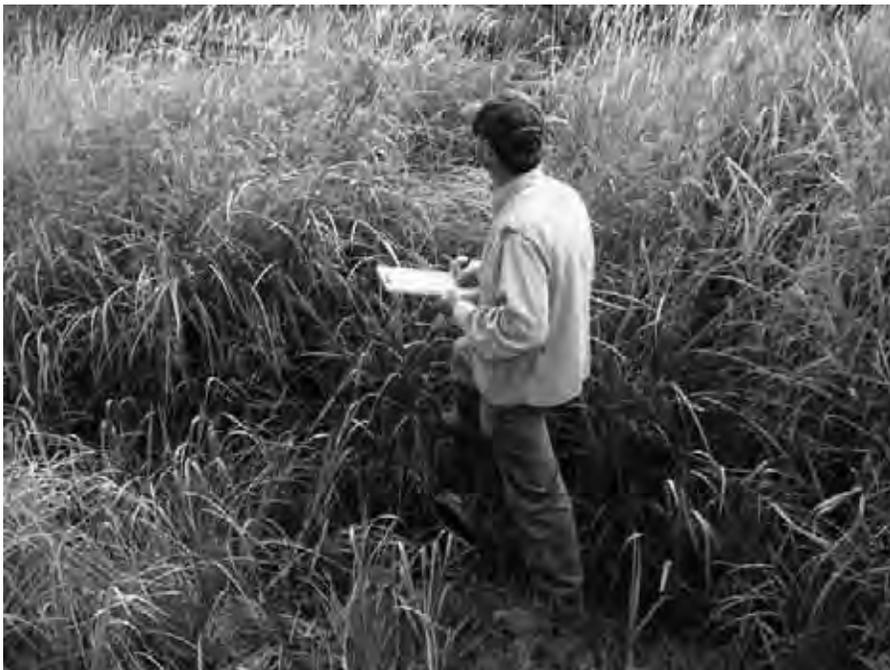
**Photograph No. 2.** View is to the northeast looking at an undersized culvert installed to help drain overflow channel along the road embankment. MR Prj-62.4 Project Area – Methow Subbasin, Washington – Bureau of Reclamation Photograph by R. McAfee, October 14, 2006.

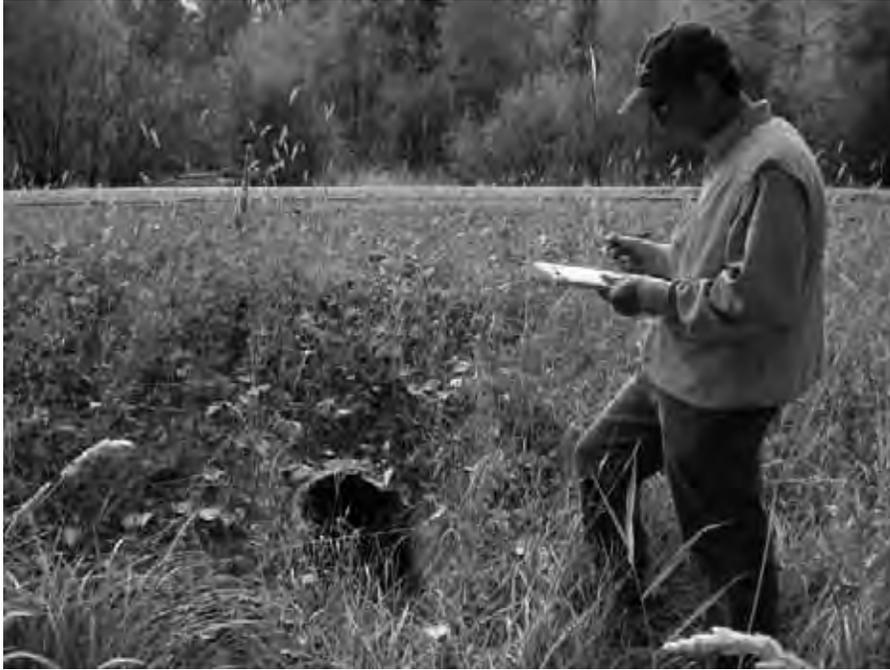
**Photograph No. 3.** View is to the south looking at an undersized culvert installed through the Highway 20 embankment along the west approach to Weeman Bridge. MR Prj-62.4 Project Area – Methow Subbasin, Washington – Bureau of Reclamation Photograph by R. McAfee, October 14, 2006.

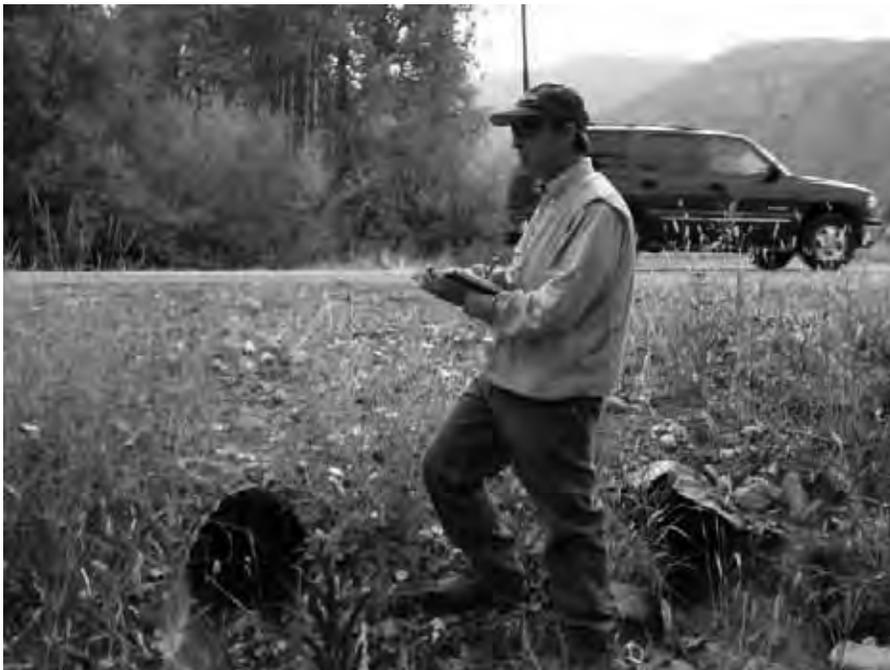
**Photograph No. 4.** View is to the south looking at undersized dual culverts installed through Highway 20 embankment along the west approach to Weeman Bridge. MR Prj-62.4 Project Area – Methow Subbasin, Washington – Bureau of Reclamation Photograph by R. McAfee, October 14, 2006.

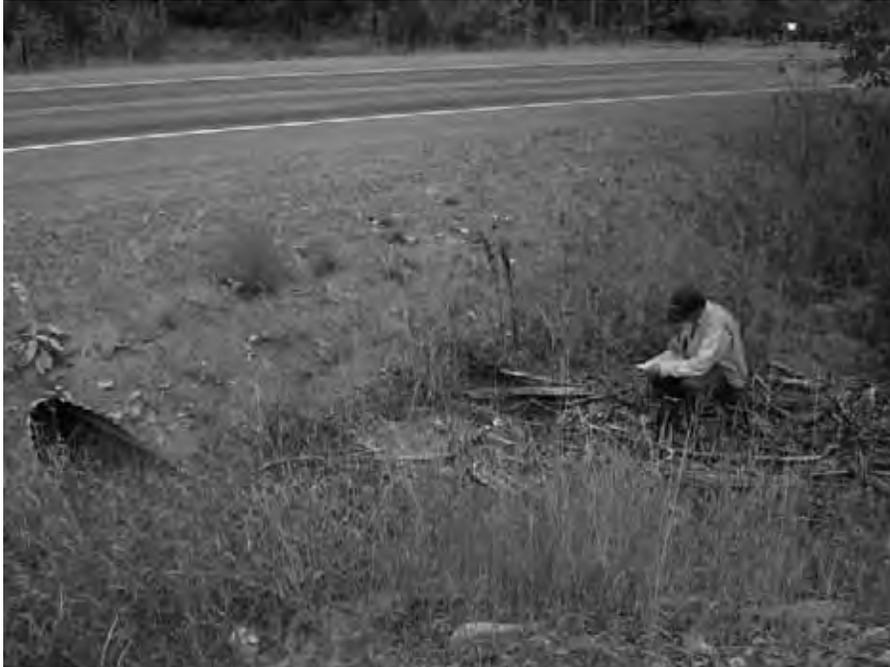
**Photograph No. 5.** View is to the southwest looking at undersized dual culverts installed through Highway 20 embankment along the west approach to Weeman Bridge. MR Prj-62.4 Project Area – Methow Subbasin, Washington – Bureau of Reclamation Photograph by R. McAfee, October 14, 2006.

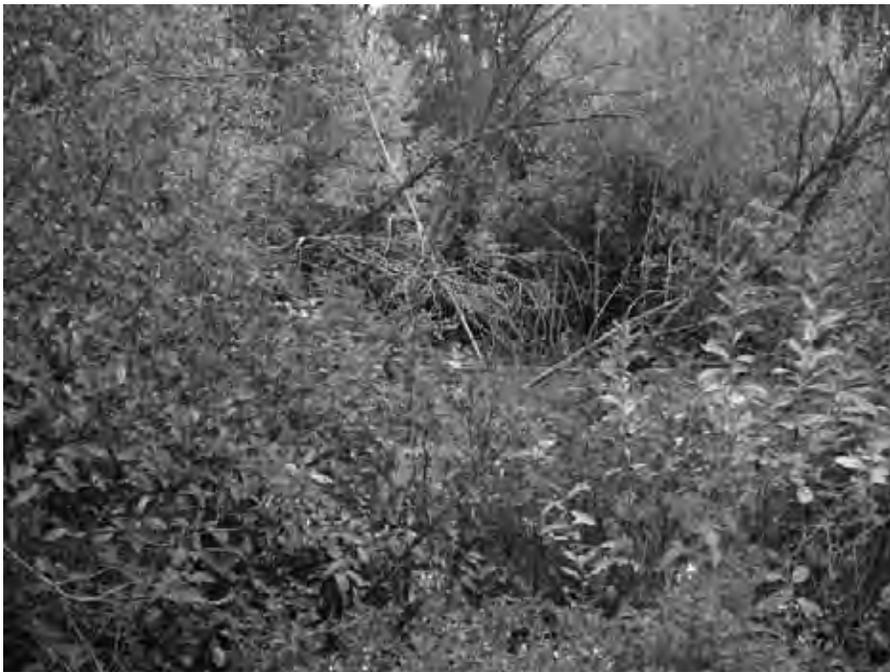
**Photograph No. 6.** View is to the south looking downstream from dual culverts at floodplain. MR Prj-62.4 Project Area – Methow Subbasin, Washington – Bureau of Reclamation Photograph by R. McAfee, October 14, 2006.

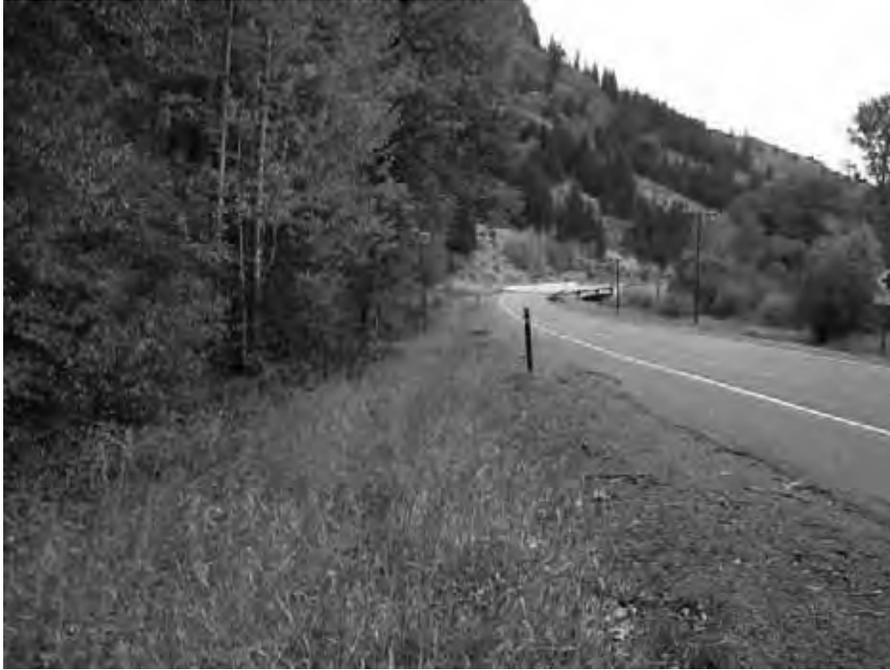
**Photograph No. 7.** View is to the east looking at the west approach to Weeman Bridge where the Highway 20 embankment and undersized culverts disconnect the floodplain. MR Prj-62.4 Project Area – Methow Subbasin, Washington – Bureau of Reclamation Photograph by R. McAfee, October 14, 2006.

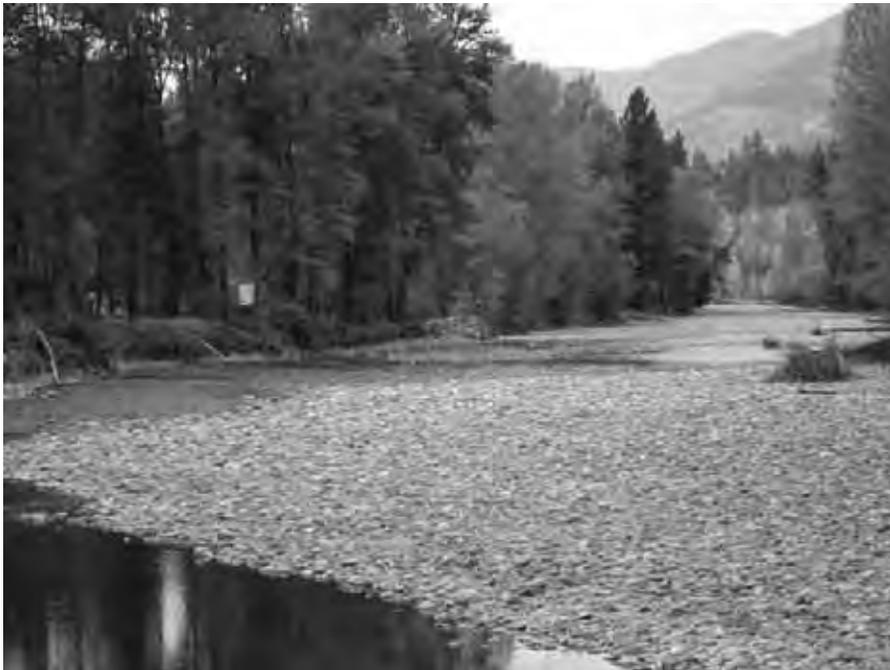
**Photograph No. 8.** View is to the northwest looking upstream along river right near Weeman Bridge at a push-up levee (center of photograph). MR Prj-62.4 Project Area – Methow Subbasin, Washington – Bureau of Reclamation Photograph by R. McAfee, October 14, 2006.

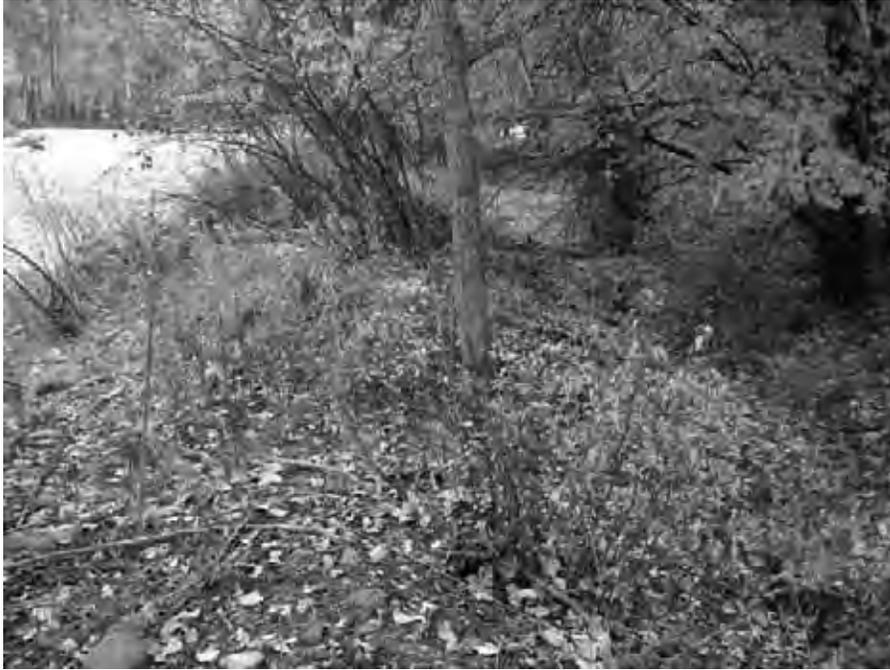
**Photograph No. 9.** View is to the south looking downstream along river right at a push-up levee downstream of Weeman Bridge. MR Prj-62.4 Project Area – Methow Subbasin, Washington – Bureau of Reclamation Photograph by R. McAfee, October 14, 2006.

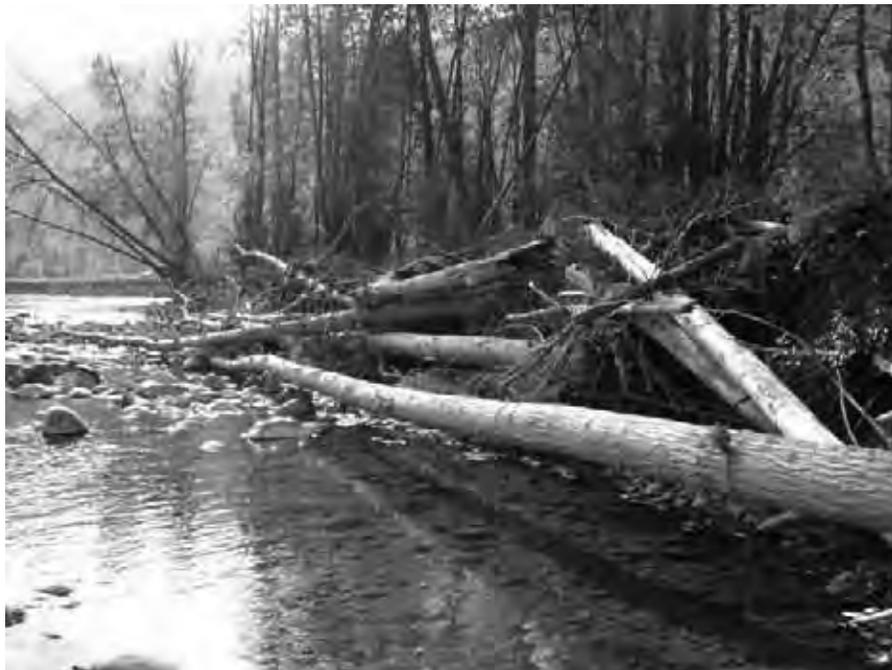
**Photograph No. 12.** View is to the southwest looking downstream along river right where the river bank was actively eroding during the 2006 spring freshet. MR Prj-62.4 Project Area – Methow Subbasin, Washington – Bureau of Reclamation Photograph by R. McAfee, October 14, 2006.

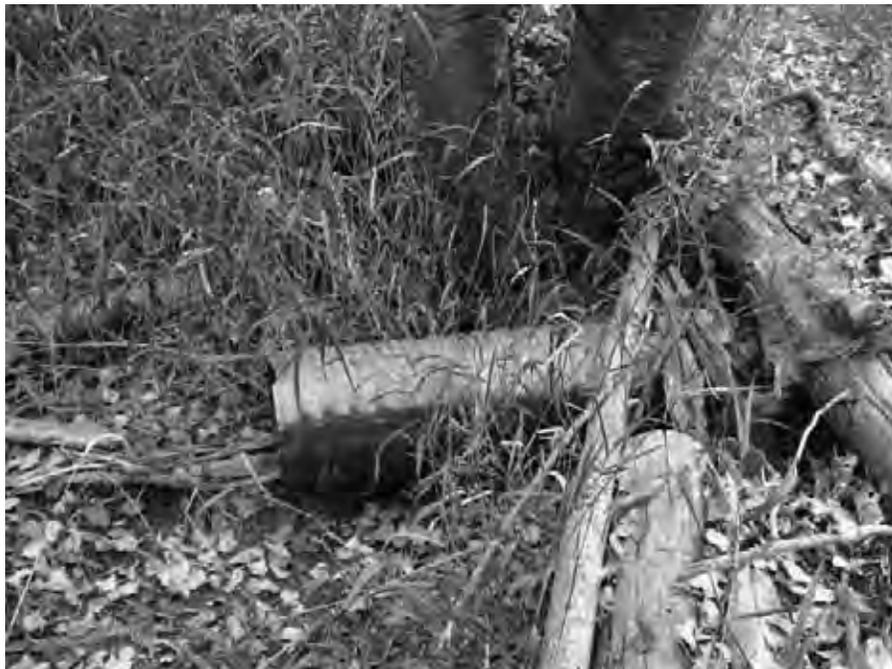
**Photograph No. 16.** View is to the west looking at a culvert through the road embankment that impounds wetland area in Photograph No. 15. MR Prj-62.4 Project Area – Methow Subbasin, Washington – Bureau of Reclamation Photograph by R. McAfee, October 14, 2006.
