## Big Valley Reach Assessment Methow River

Okanogan County, Washington

U.S. Department of the Interior  
Bureau of Reclamation  
Pacific Northwest Region

August 2008

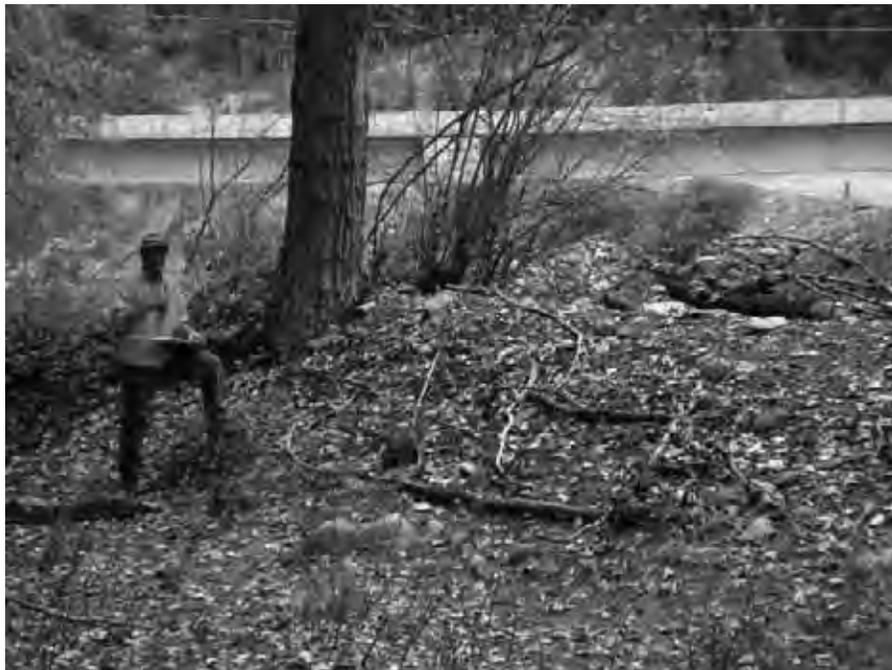
- Six culverts were observed in the project area (Photograph Nos. 1-6, 16, 35, 42, and 43).
- About 315 linear feet of push-up levees are present (Photograph Nos. 8-9 and 20-23).

**Photograph No. 20.** View is to the north looking upstream at a push-up levee that disconnects an overflow channel from river. MR Prj-62.4 Project Area – Methow Subbasin, Washington – Bureau of Reclamation Photograph by R. McAfee, October 14, 2006.

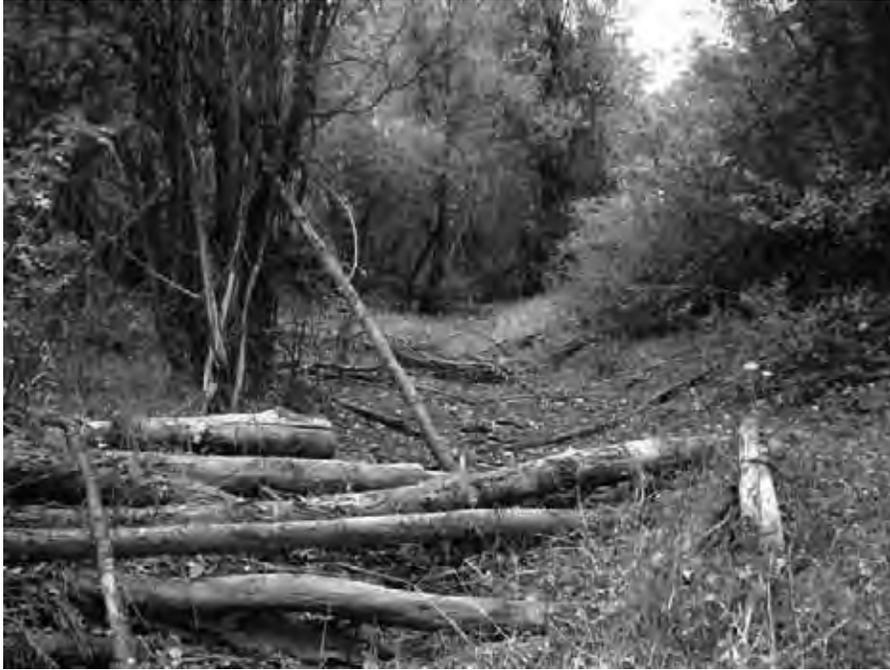
**Photograph No. 21.** View is to the south looking downstream from a push-up levee along an overflow channel. MR Prj-62.4 Project Area – Methow Subbasin, Washington – Bureau of Reclamation Photograph by R. McAfee, October 14, 2006.

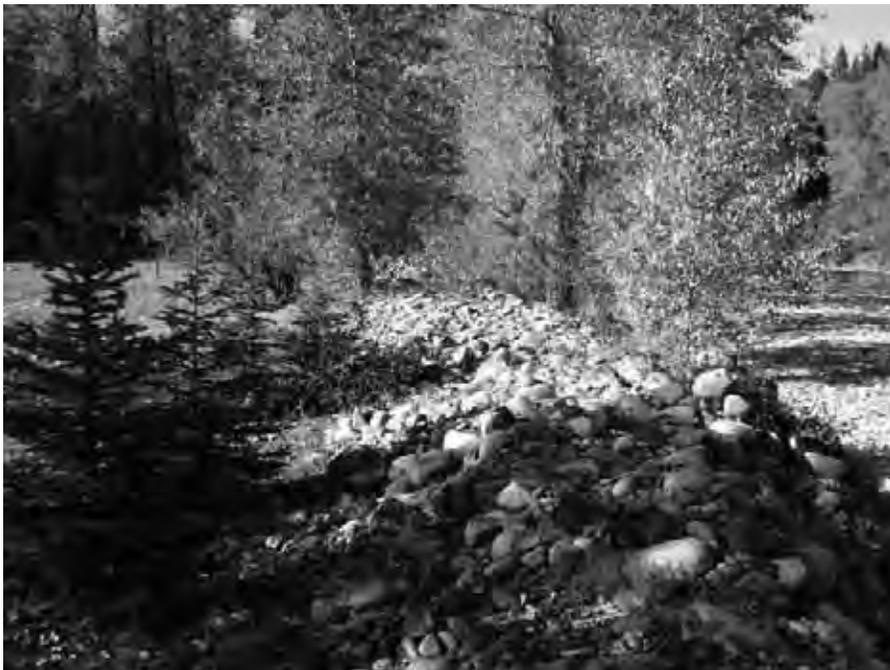
**Photograph No. 22.** View is to the northwest looking upstream along river right at a push-up levee disconnecting floodplain. MR Prj-62.4 Project Area – Methow Subbasin, Washington – Bureau of Reclamation Photograph by R. McAfee, October 17, 2006.

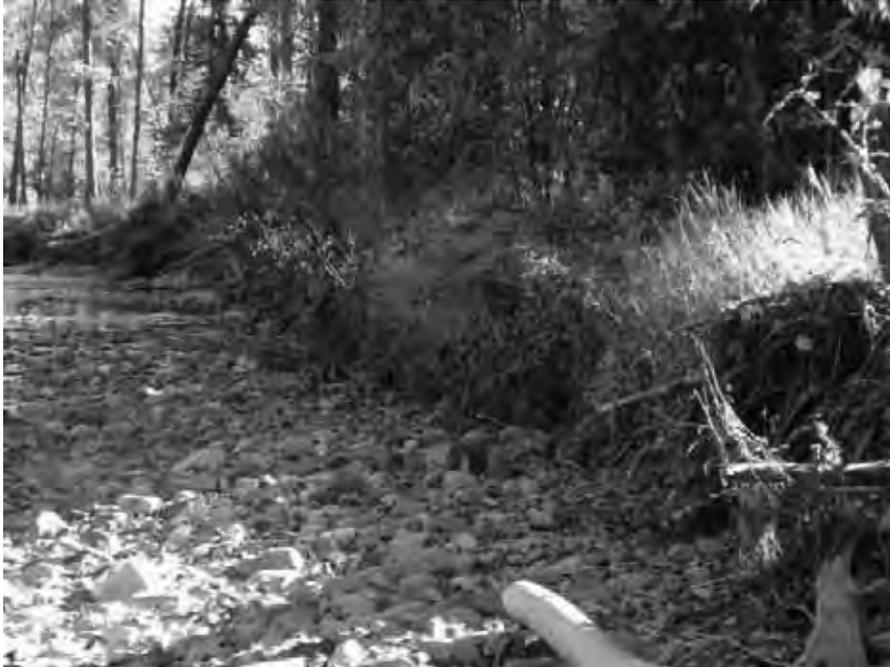
**Photograph No. 23.** View is to the southeast looking downstream along river right below push-up levee (Photograph No. 22) where bank erosion occurred during the 2006 spring freshet. MR Prj-62.4 Project Area – Methow Subbasin, Washington – Bureau of Reclamation Photograph by R. McAfee, October 17, 2006.

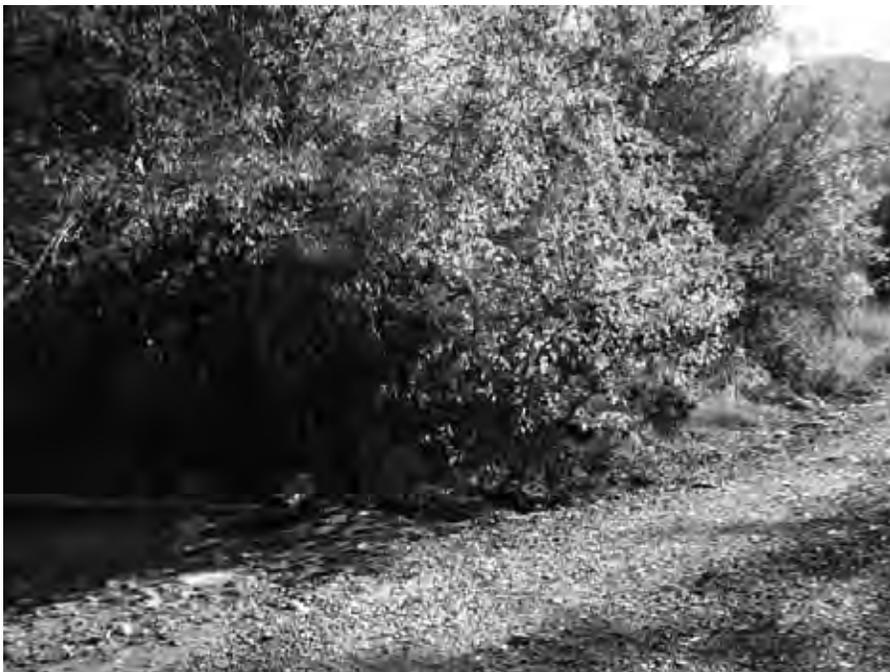
**Photograph No. 24.** View is to the southeast looking at a road embankment that disconnects an overflow channel. MR Prj-62.4 Project Area – Methow Subbasin, Washington – Bureau of Reclamation Photograph by R. McAfee, October 17, 2006.

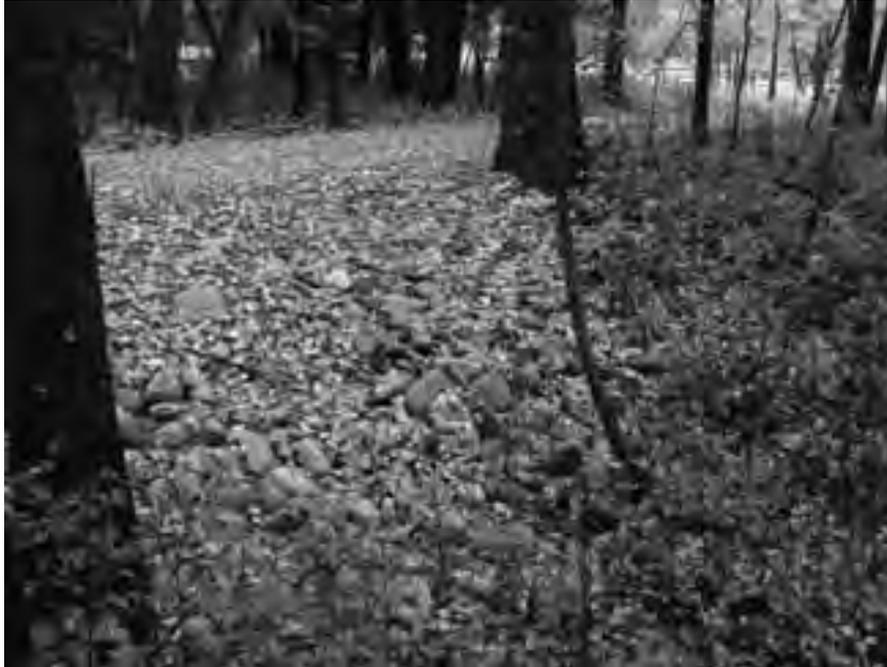
**Photograph No. 25.** View is to the west looking at a road embankment that disconnects an overflow channel. MR Prj-62.4 Project Area – Methow Subbasin, Washington – Bureau of Reclamation Photograph by R. McAfee, October 17, 2006.

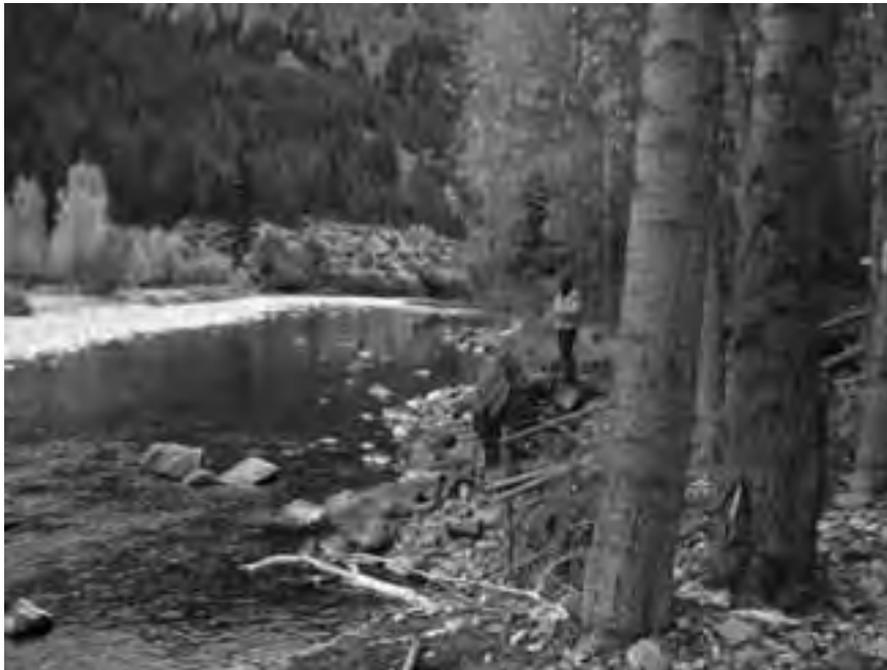
- About 890 linear feet of riprap are present (Photograph No. 28).
- There are two excavated ponds with the spoil pile acting as a levee on the floodplain (Photograph Nos. 37 through 39).

**Photograph No. 28.** View is to the east looking downstream at riprap placed along river right.  
MR Prj-62.4 Project Area – Methow Subbasin, Washington – Bureau of Reclamation Photograph by R. McAfee, October 18, 2006.

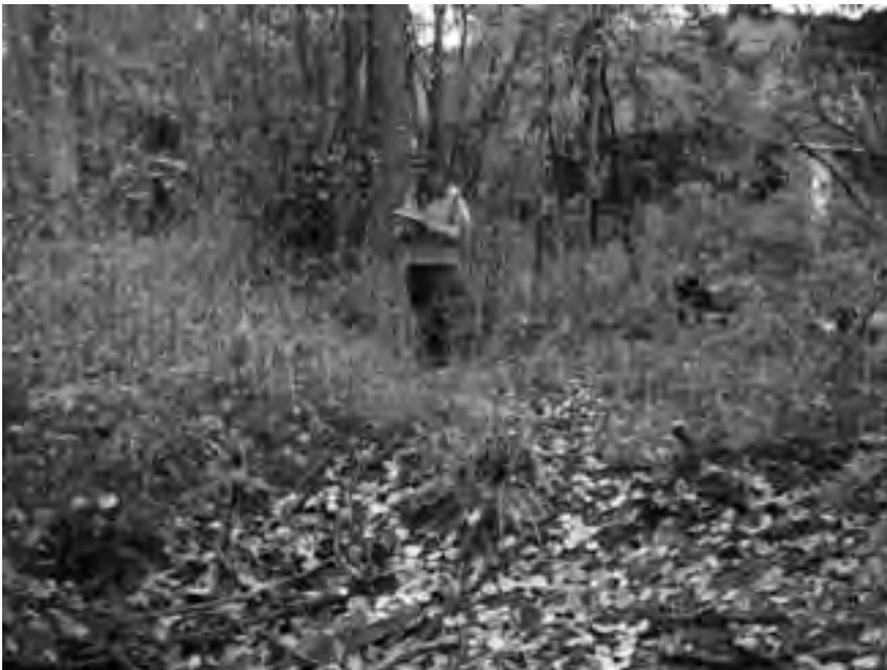
**Photograph No. 34.** View is to the southwest looking downstream at fill placed in an overflow channel. MR Prj-62.4 Project Area – Methow Subbasin, Washington – Bureau of Reclamation Photograph by R. McAfee, October 18, 2006.

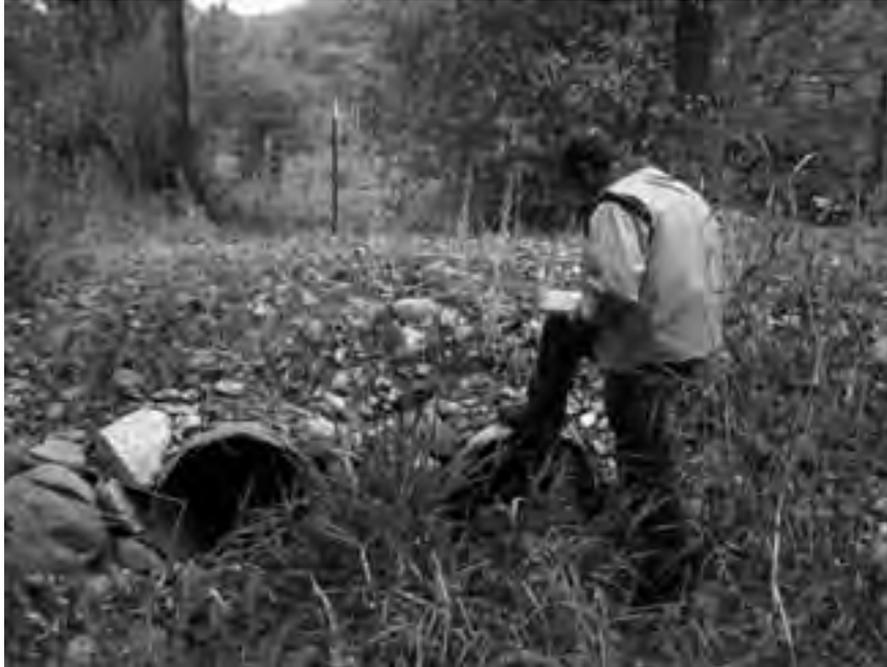
**Photograph No. 35.** View is to the south looking downstream at dual culverts and road embankment across overflow channel. MR Prj-62.4 Project Area – Methow Subbasin, Washington – Bureau of Reclamation Photograph by R. McAfee, October 18, 2006.

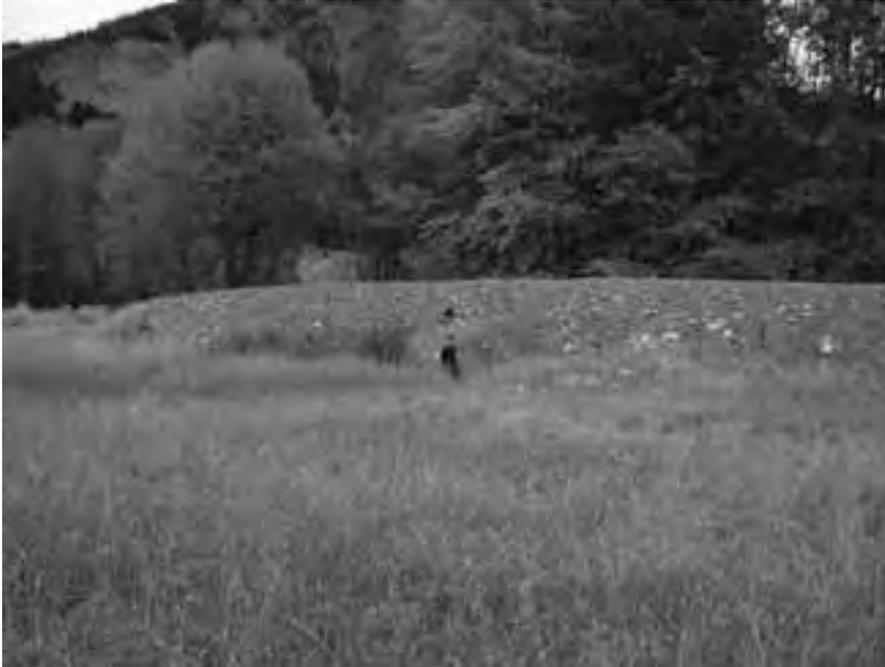
**Photograph No. 37.** View is to the east looking at spoil pile from pond excavation that acts like a levee directing the floodwaters back toward the river. MR Prj-62.4 Project Area – Methow Subbasin, Washington – Bureau of Reclamation Photograph by R. McAfee, October 18, 2006.

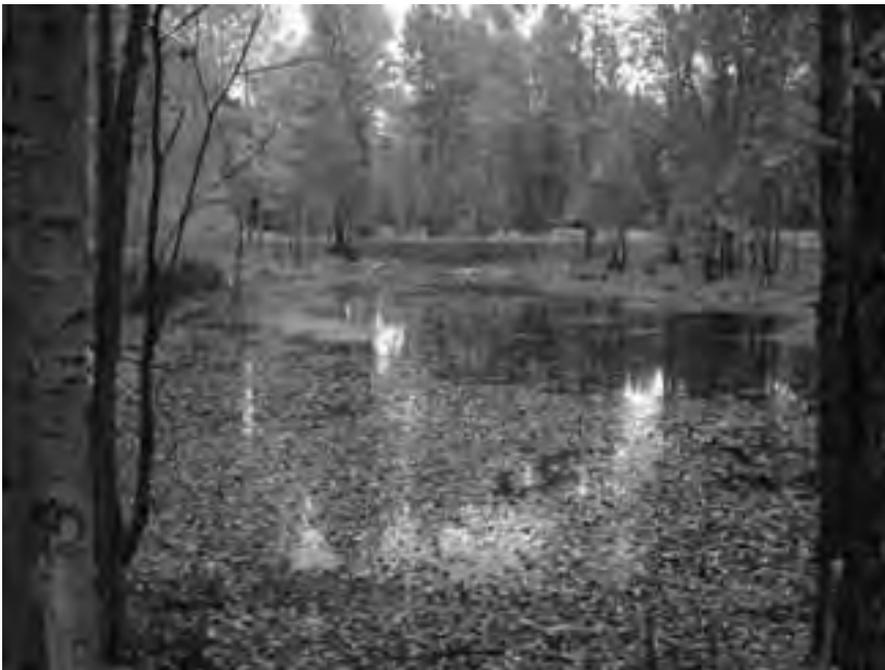
**Photograph No. 38.** View is to the southeast looking at the excavated west pond. MR Prj-62.4 Project Area – Methow Subbasin, Washington – Bureau of Reclamation Photograph by R. McAfee, October 18, 2006.

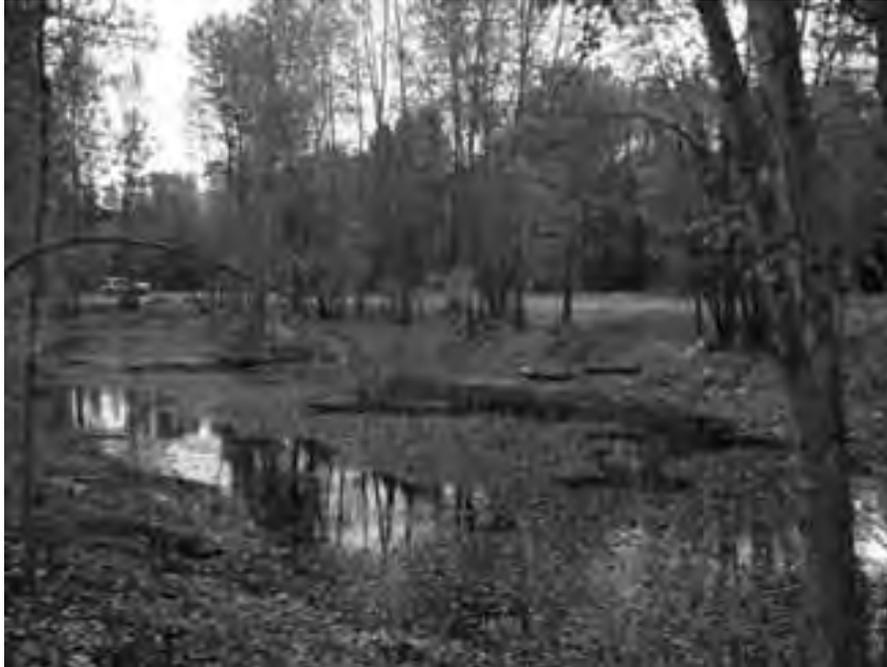
**Photograph No. 39.** View is to the southeast looking at excavated east pond. MR Prj-62.4 Project Area – Methow Subbasin, Washington – Bureau of Reclamation Photograph by R. McAfee, October 18, 2006.

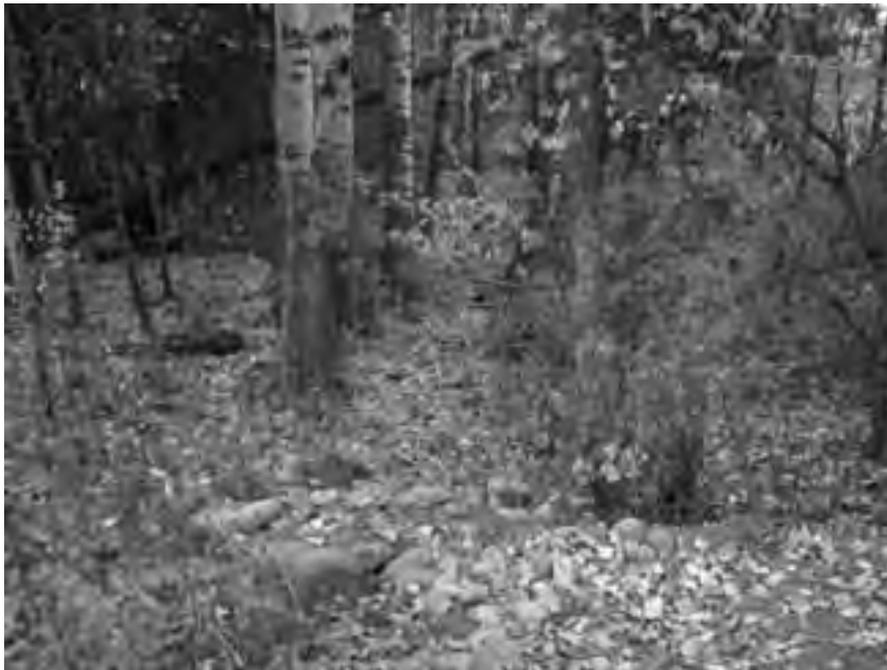
**Photograph No. 40.** View is to the southeast looking downstream along overflow channel that has been filled. MR Prj-62.4 Project Area – Methow Subbasin, Washington – Bureau of Reclamation Photograph by R. McAfee, October 18, 2006.

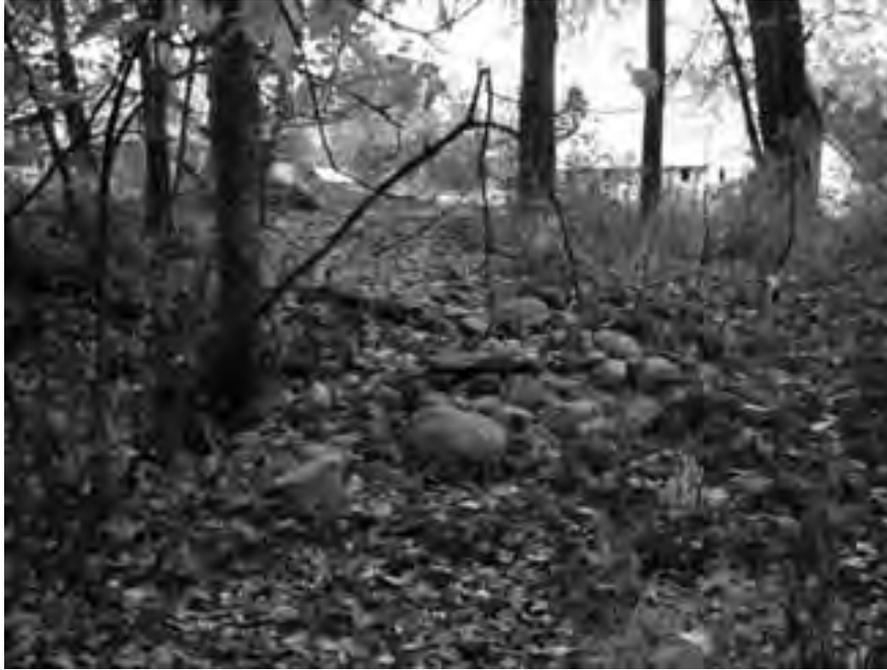
**Photograph No. 41.** View is to the northwest looking upstream along overflow channel at fill material. MR Prj-62.4 Project Area – Methow Subbasin, Washington – Bureau of Reclamation Photograph by R. McAfee, October 18, 2006.

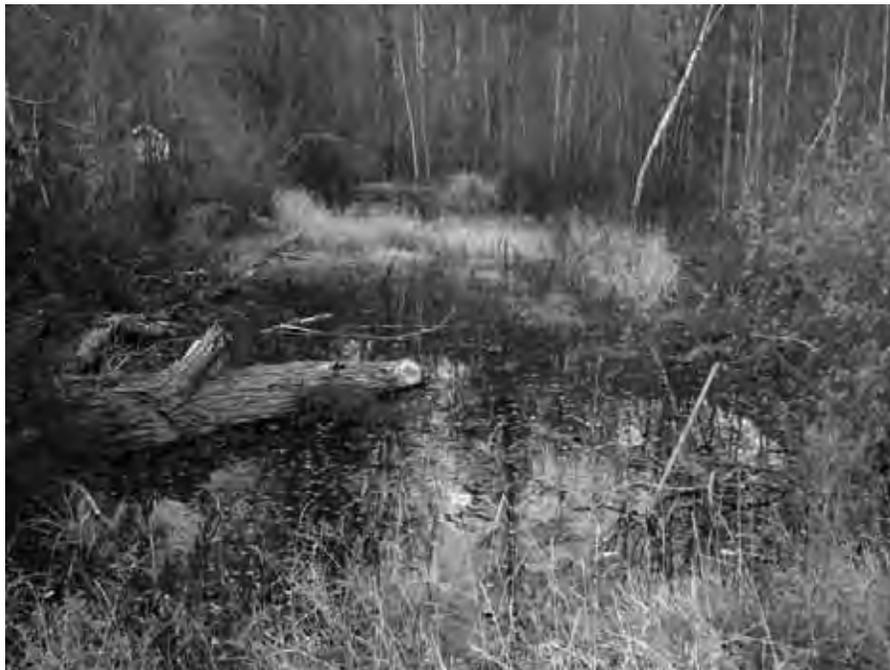
**Photograph No. 42.** View is to the north looking upstream from Highway 20 embankment at dual culverts in Photograph Nos. 4 and 5 where flows were impeded during the November 8, 2006 rain event. MR Prj-62.4 Project Area – Methow Subbasin, Washington – Bureau of Reclamation Photograph by R. McAfee, November 8, 2006.

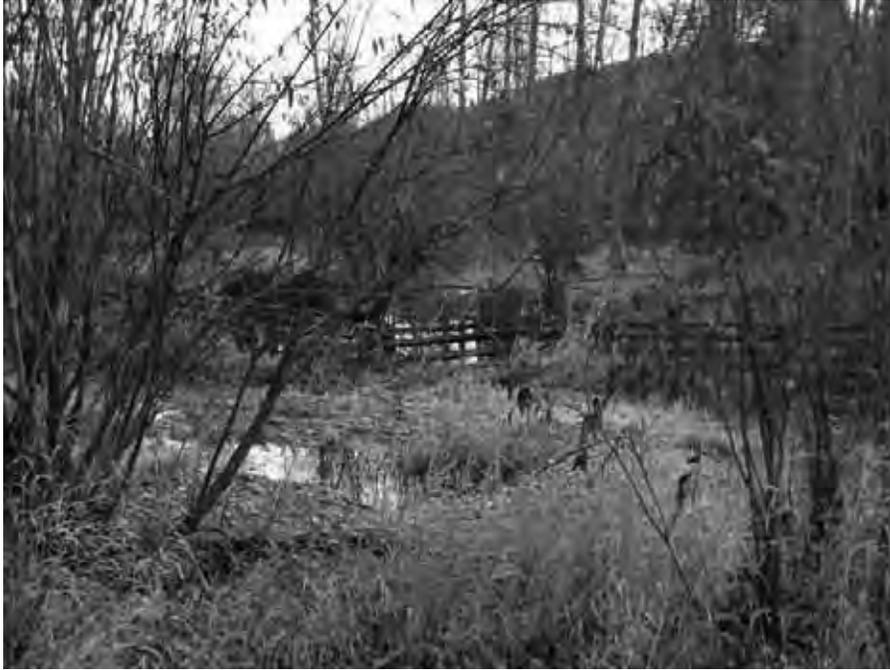
**Photograph No. 43.** View is to the south looking downstream from Highway 20 embankment at single culvert in Photograph No. 1. Ponded water is from flows through the dual culverts in Photograph Nos. 4, 5 and 42 during the November 8, 2006 rain event. **MR Prj-62.4 Project Area – Methow Subbasin, Washington – Bureau of Reclamation Photograph by R. McAfee, November 8, 2006.**

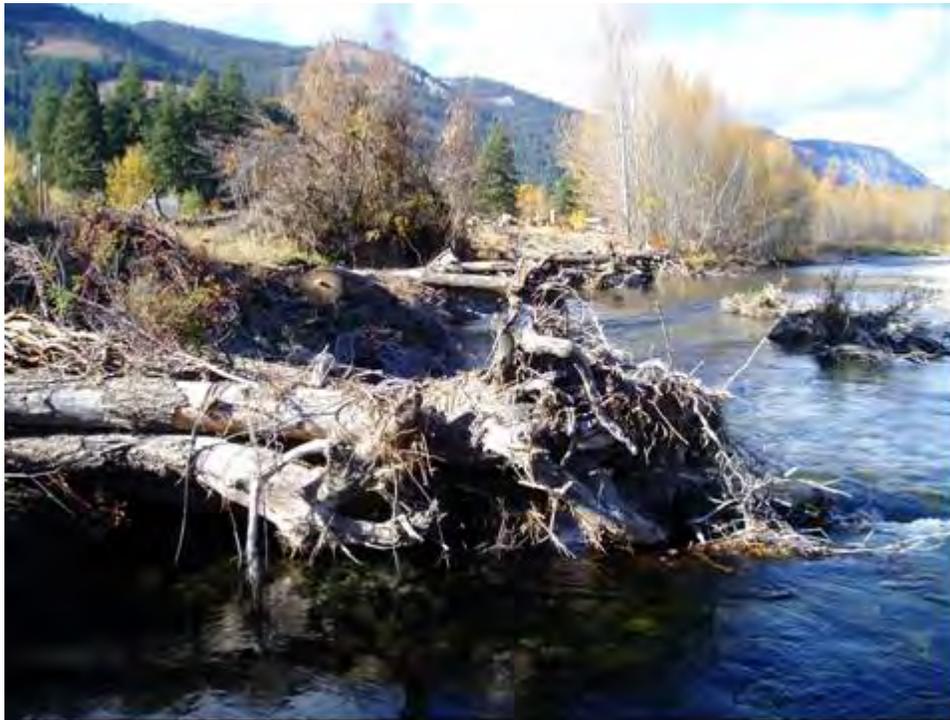
Log structures cabled on banks at Wolf Ridge Resort

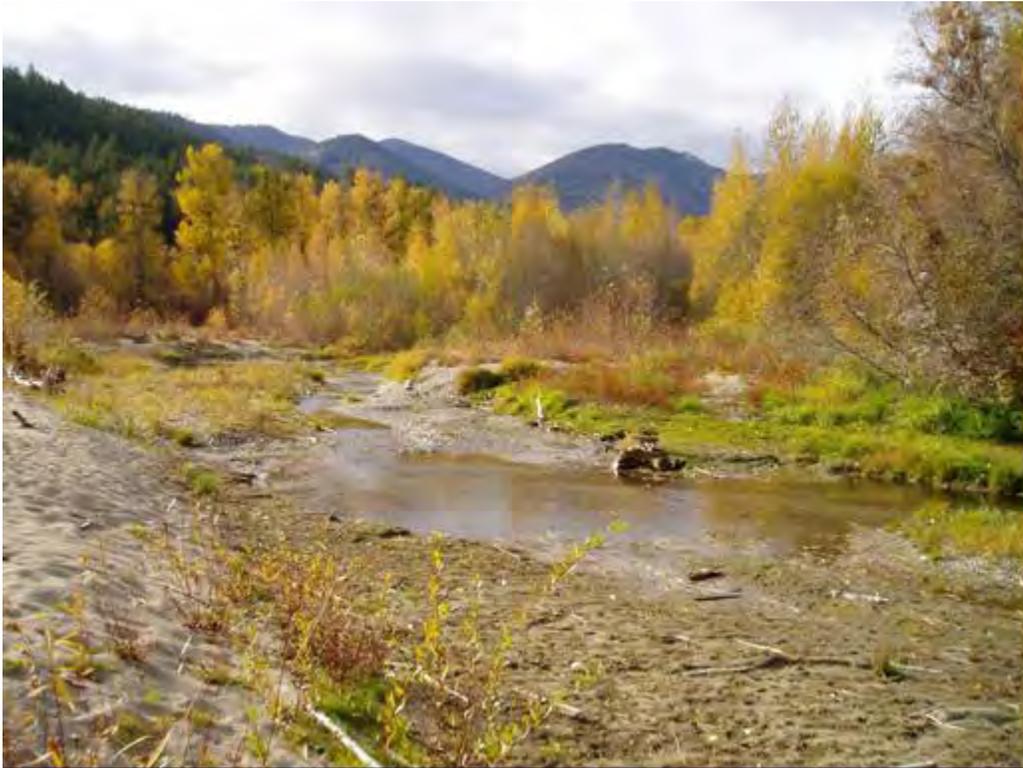
**Sand deposit in side channel near confluence with Methow River**

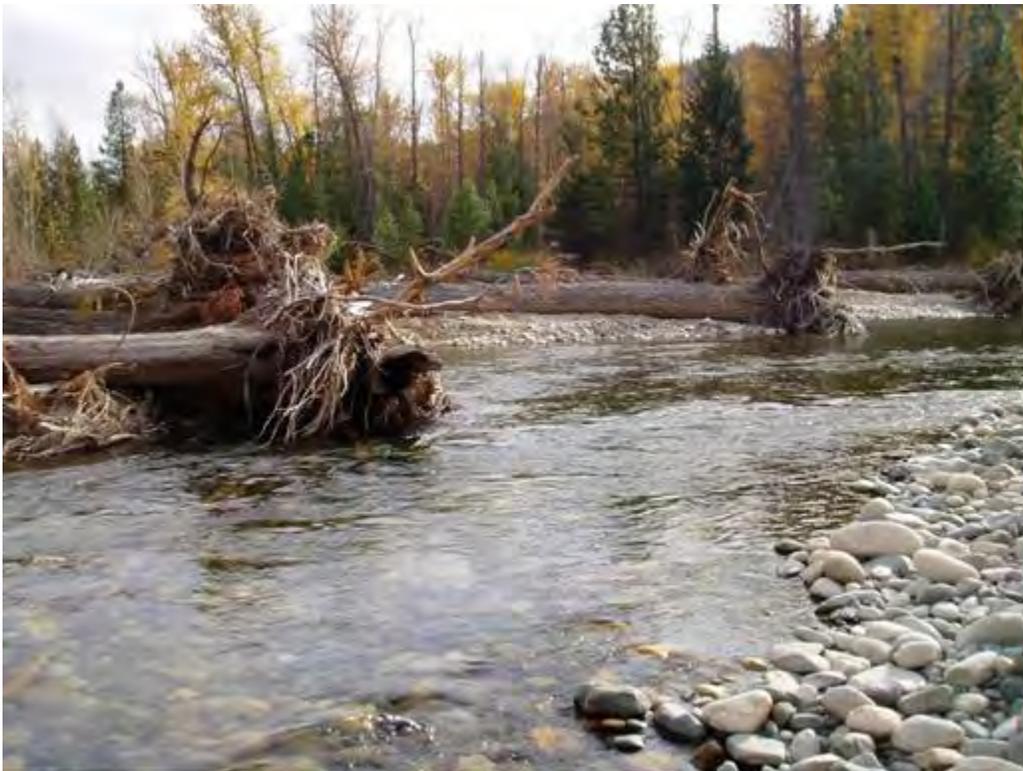
**Downed trees in channel near the end of reach 3**

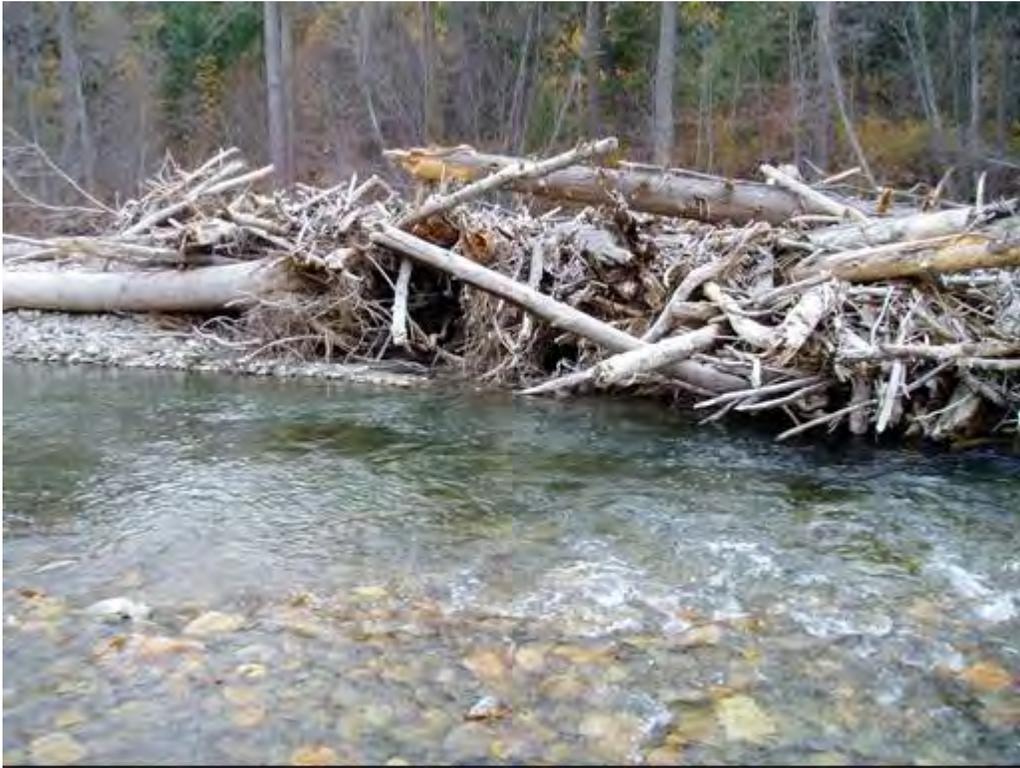
**Log jam in pool in upper segment of reach 4**

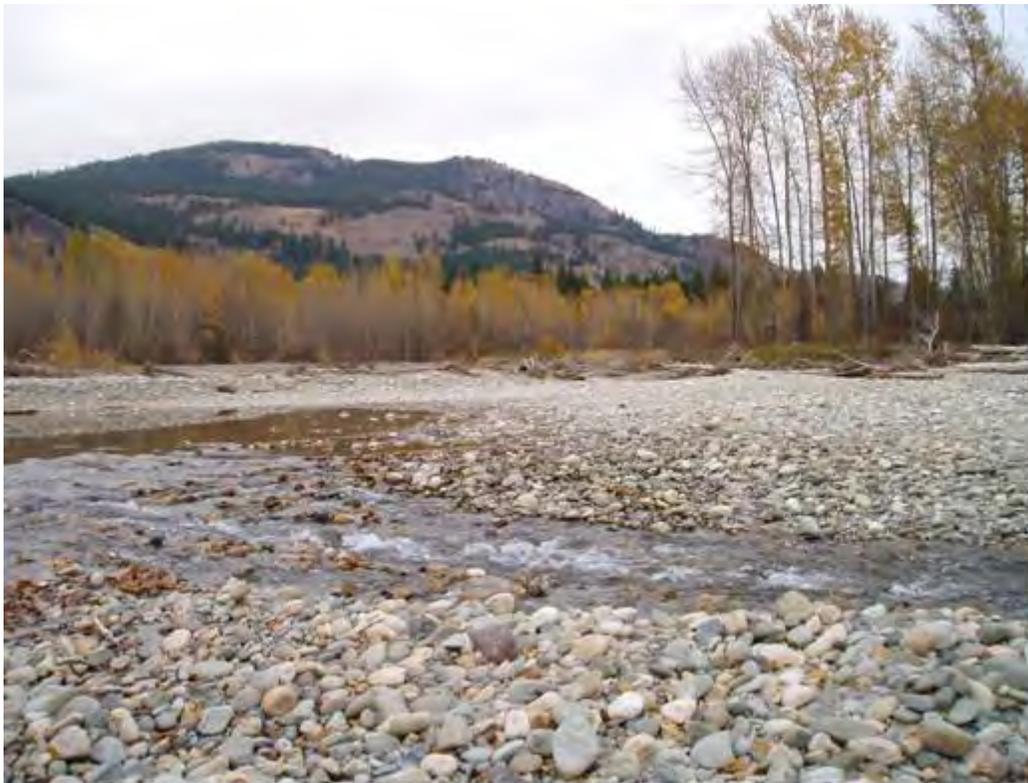
**Top of reach; major side channel on north side of floodplain is dry at low flow**

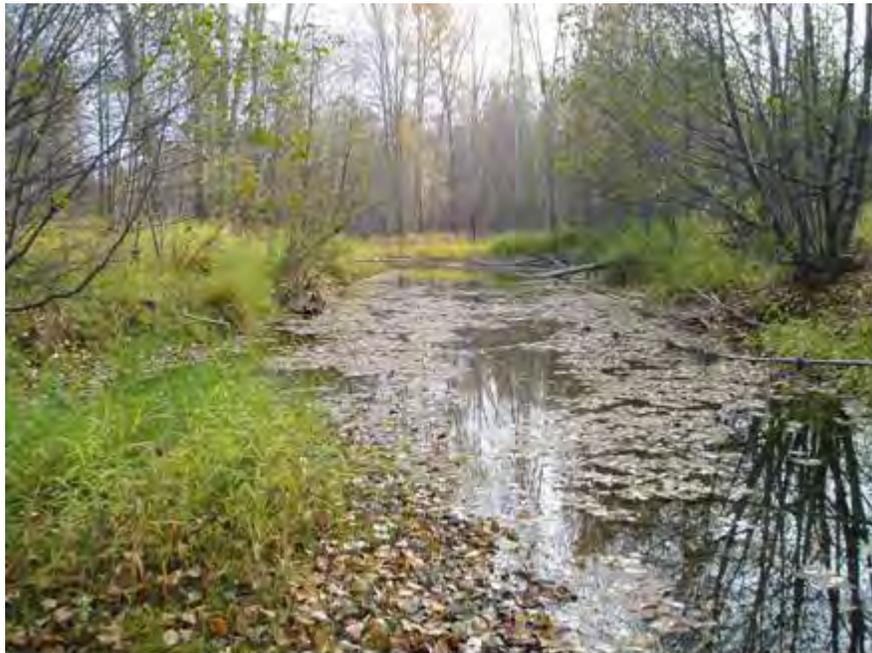
**Off-channel habitat in side channel**

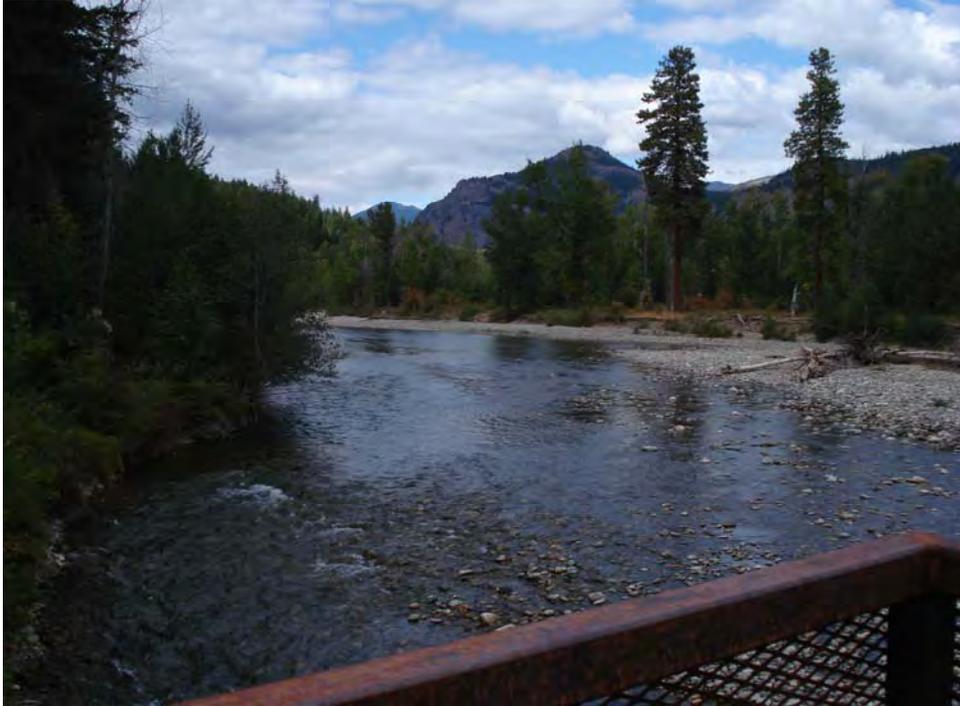
For project area MR-56.0, a few man-made effects were identified, including rootwads, road embankment and a culvert. The river is very dynamic in this project area and significant bank erosion occurred in 2006 because of changes in the main channel location (Figure 28). At present, this project area is functioning well, and no differences are shown between existing and future modeling conditions in terms of floodplain connectivity (Figures 31, 34, 37, 40 and 41). Local stakeholders have expressed concern that possible future development and associated roads would further disrupt channel and floodplain processes, and this area should be considered for protection.

**Figure 25-Photograph looking upstream at main Methow river channel and left river bank near RM 57.**

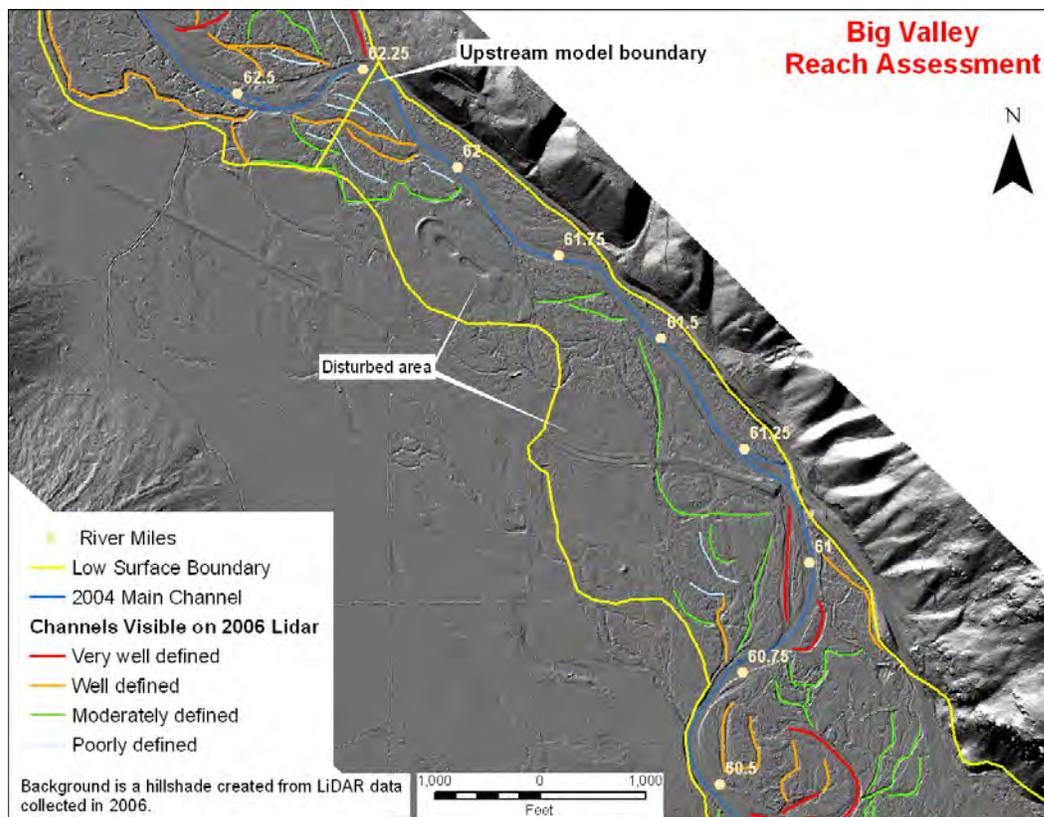
In project area MR-62.4, the surface upstream of Weeman Bridge on river right between RM 61.5 and 62 is interpreted to be an older surface at the base of the alluvial fan that has not had the active channel passing through it since at least 1945, and possibly much longer. Little differences are observed between the present and the future conditions because there are no human features to remove that would improve floodplain connectivity (Figures 29, 32, 35, 38 and 39). Some overflow channels may be inundated for floods greater than the 5-year flood. LiDAR data show a few moderately well-defined channels that connect with the main channel under present conditions that would suggest these areas would provide off-channel habitat (Figure 26). Overflow channels are present, but are not inundated except during large floods greater than the 25-year flood (Figure 26).

**Figure 26 Channel visible for existing conditions for RM 60 to 62.25**

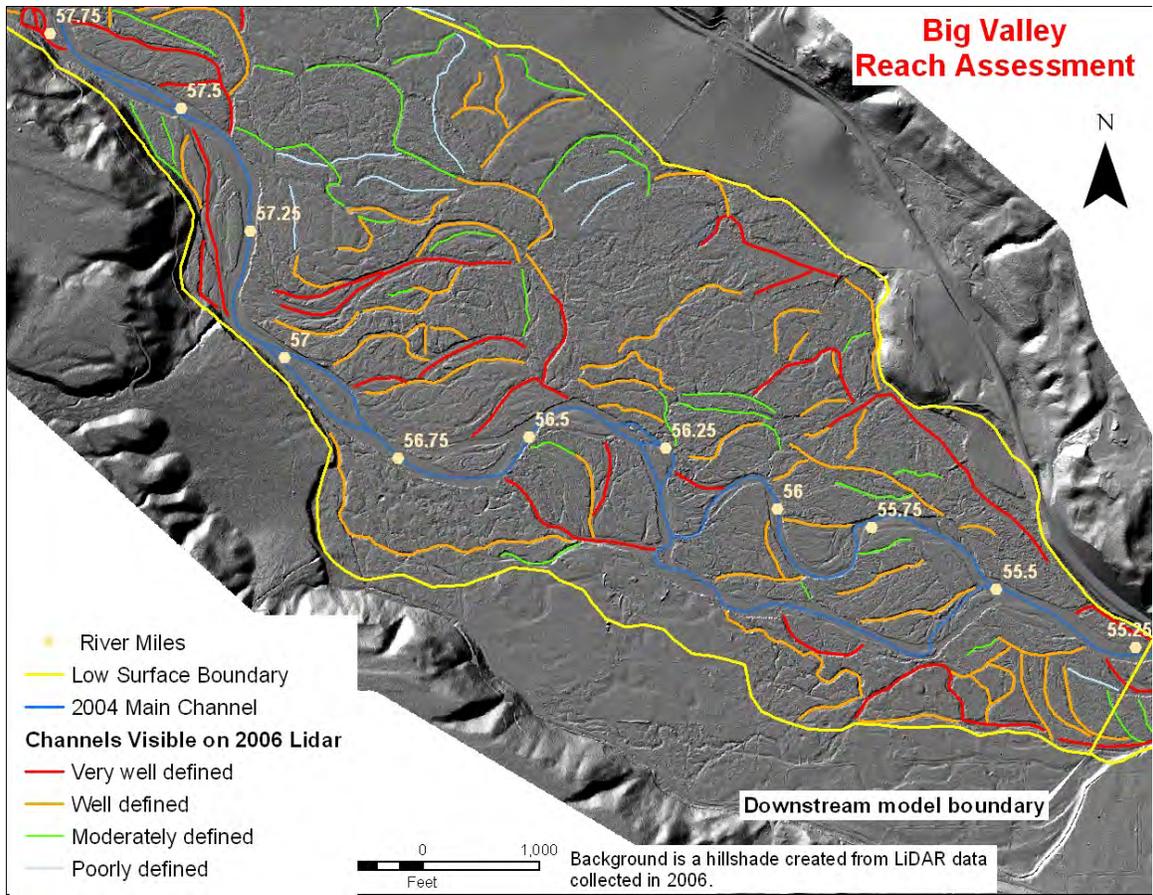
Figure 28-Channel visible for existing conditions RM 55 to 57.75.

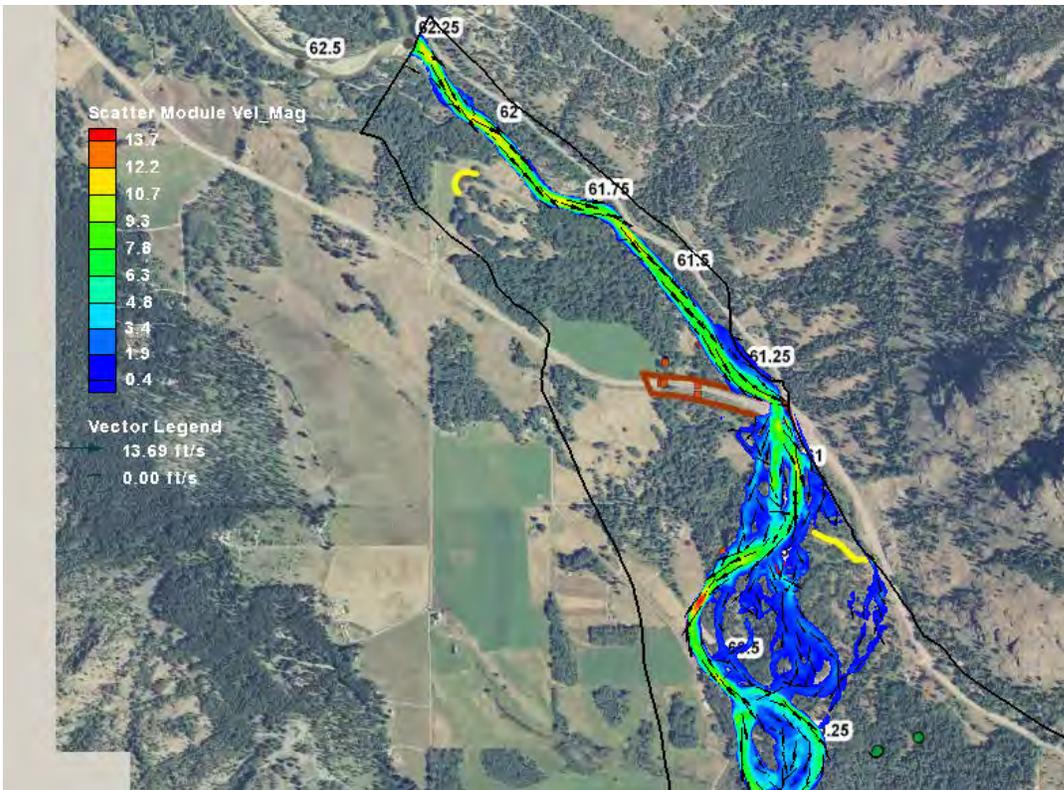
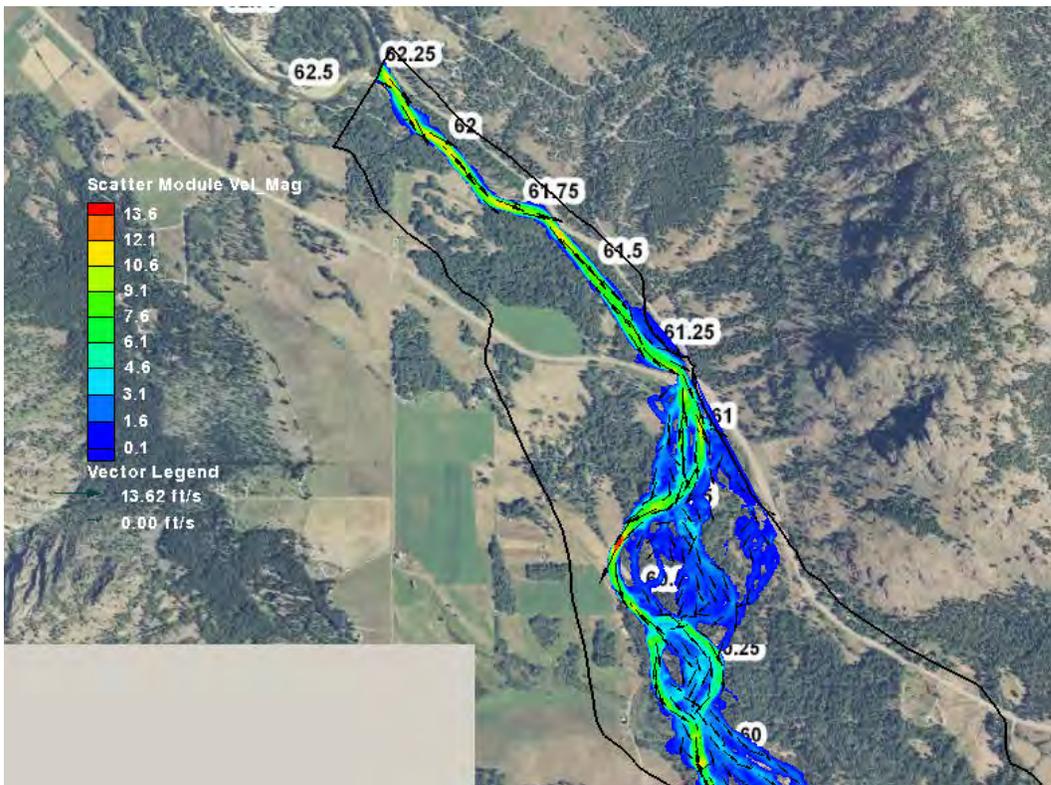
here at the turn of the twentieth century. Despite historic activity at this area, floodplain connectivity is still active. Side channels are being accessed during the 2-year and 5-year floods (Figures 29 and 32).

Figure 29-Velocity vectors for the 2 Year Model of existing (upper image) and future conditions (lower image), in the vicinity of Project Areas 62.4, 60.85, and 60.25 (upper section of BVRA).

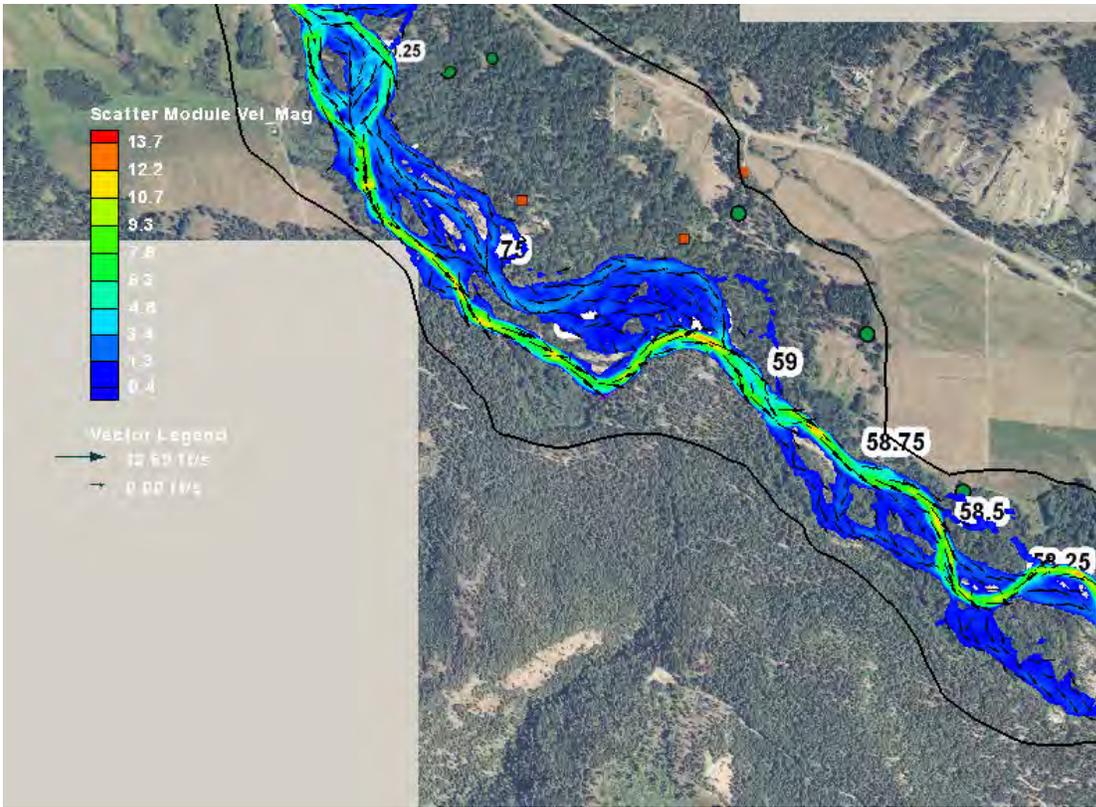
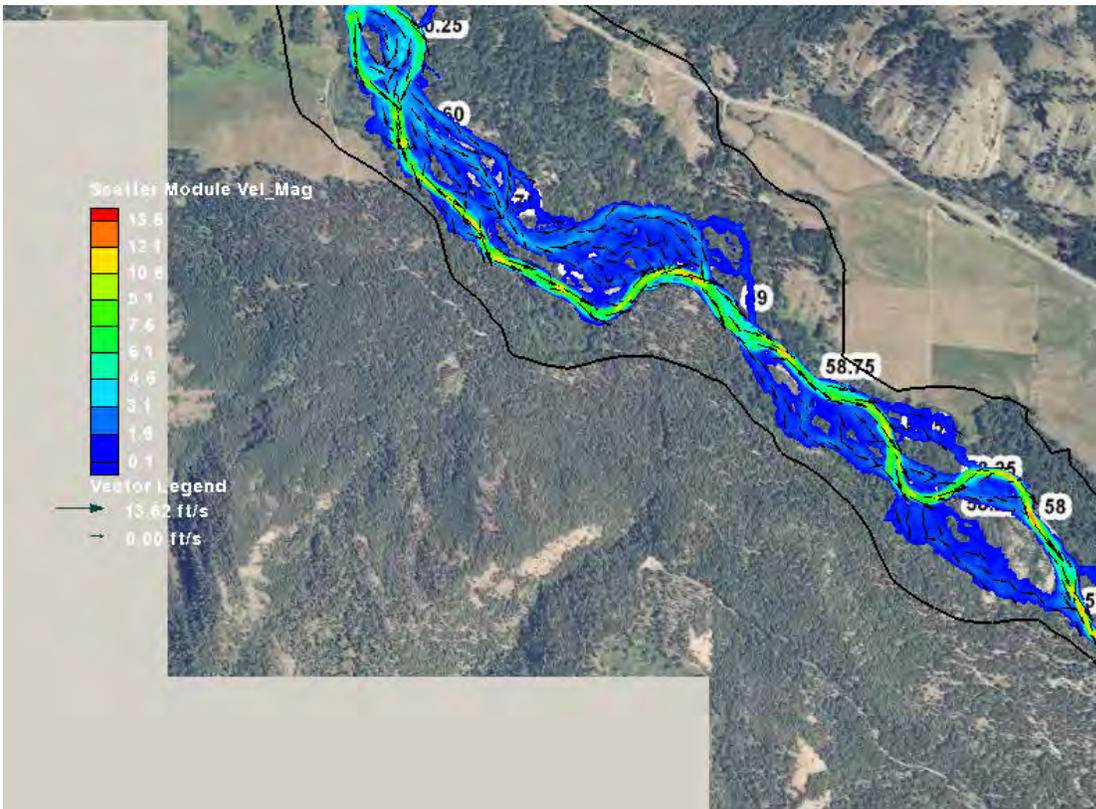
This section of the river is very dynamic and few impacts to hydraulics are found due to man-made conditions. Project areas MR-60.25, MR-59.6, and MR-58.9 represent protection areas where no restoration actions are recommended. Channel processes are functioning well, and the only minor disruptions to floodplain processes are a few small road embankments and undersized culverts located on river left (Figure 27). No detectable hydraulic differences can be seen in comparison of existing and future channel conditions for all modeled floods (Figures 30, 33, 36, 38 and 39).

Figure 30- Velocity vectors for the 2 Year Model for existing and future conditions in the vicinity of Project Areas 60.25, 59.6/60.5, 58.9 and 58.6 (middle section of BVRA).
