## Big Valley Reach Assessment Methow River

Okanogan County, Washington

U.S. Department of the Interior  
Bureau of Reclamation  
Pacific Northwest Region

August 2008

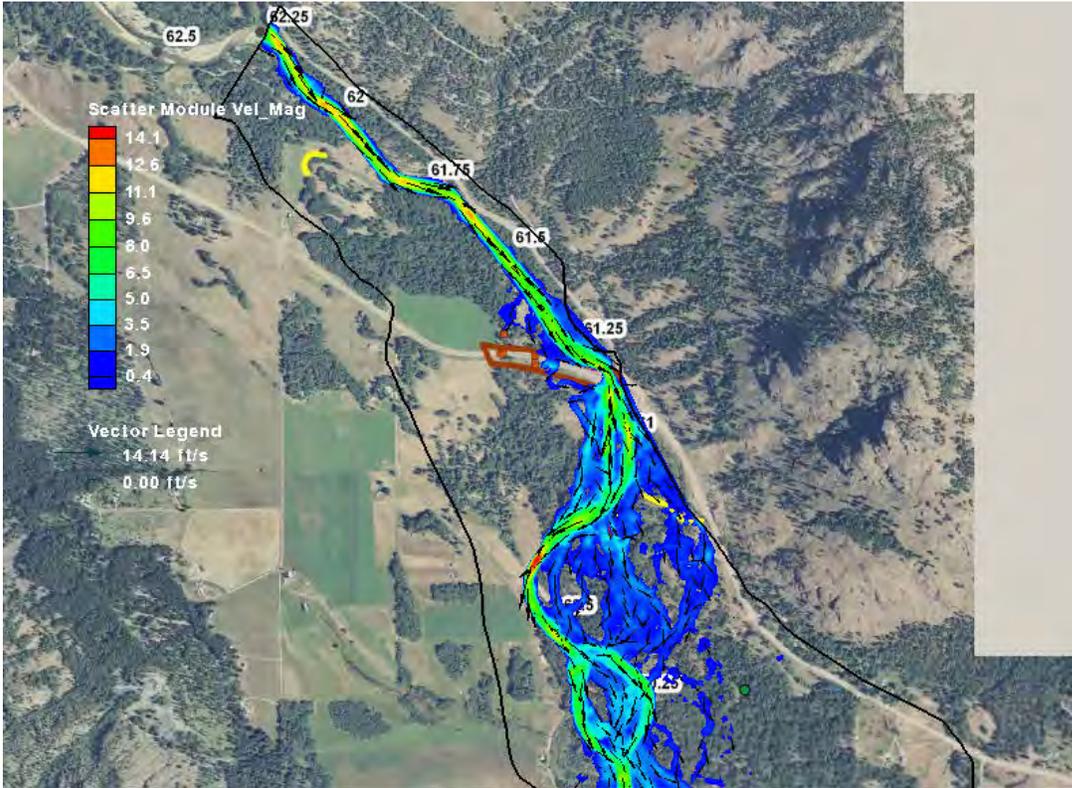
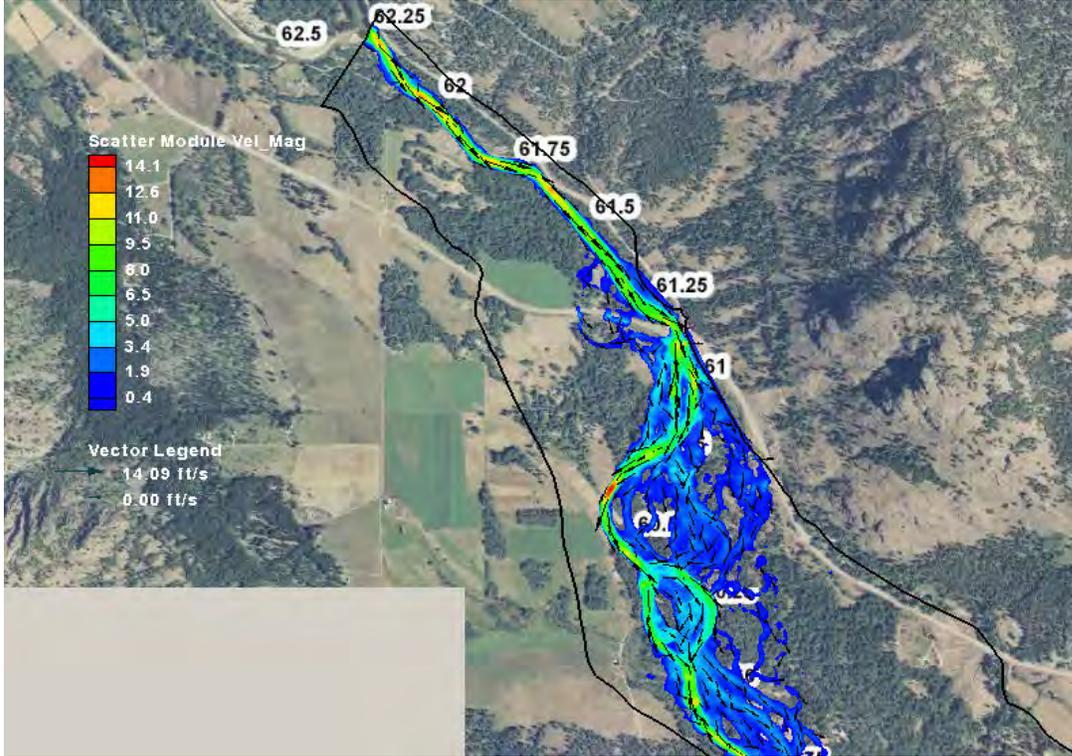
here at the turn of the twentieth century. Despite historic activity at this area, floodplain connectivity is still active. Side channels are being accessed during the 2-year and 5-year floods (Figures 29 and 32).

Figure 32- Velocity vectors for the 5 Year Model for existing and future conditions in the vicinity of Project Areas 62.4, 60.85, and 60.25 (upper section of BVRA).

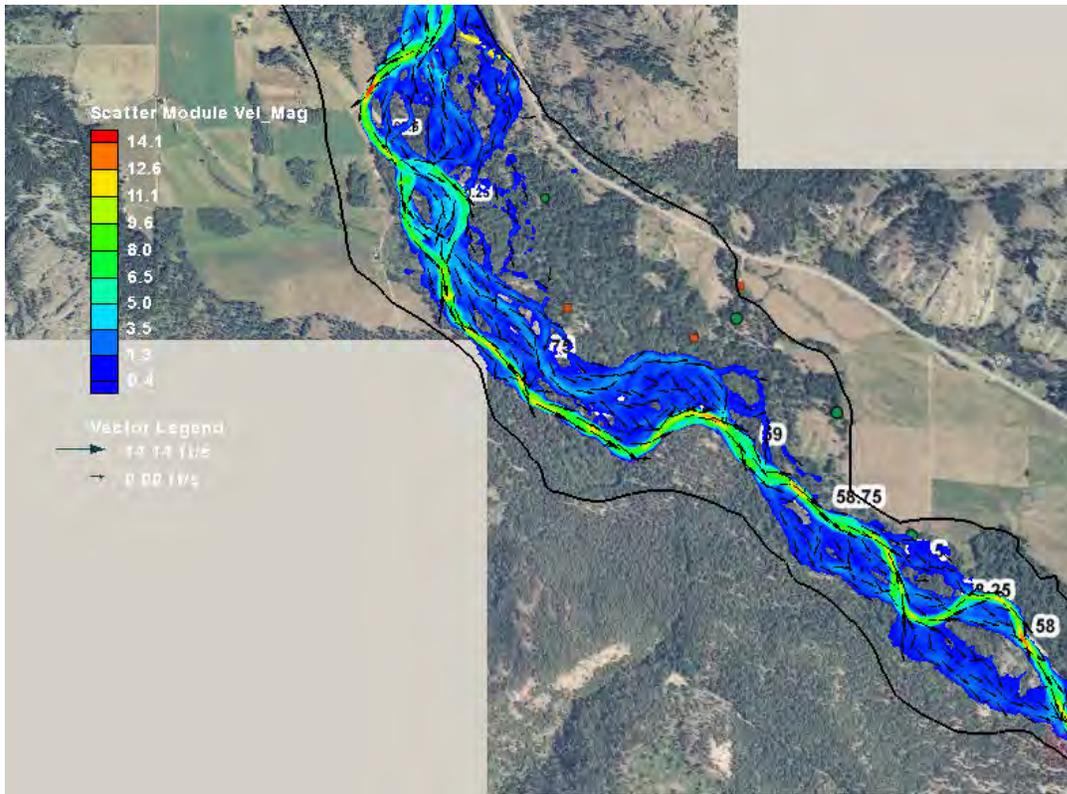
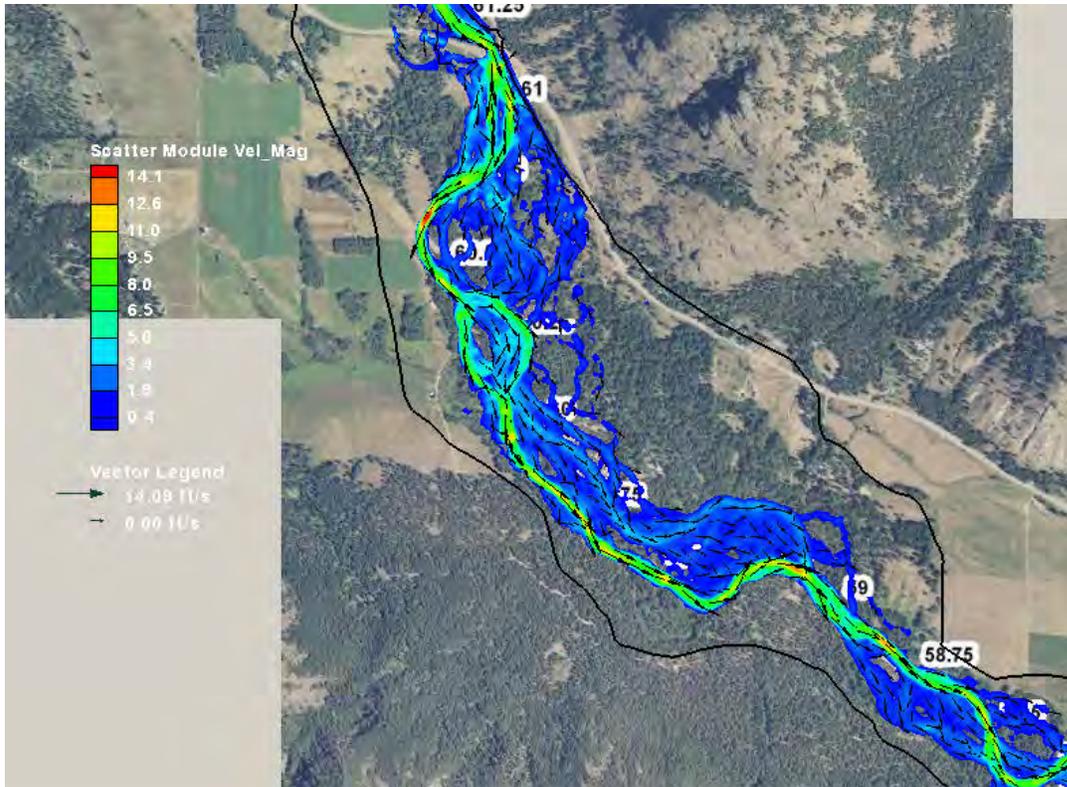
This section of the river is very dynamic and few impacts to hydraulics are found due to man-made conditions. Project areas MR-60.25, MR-59.6, and MR-58.9 represent protection areas where no restoration actions are recommended. Channel processes are functioning well, and the only minor disruptions to floodplain processes are a few small road embankments and undersized culverts located on river left (Figure 27). No detectable hydraulic differences can be seen in comparison of existing and future channel conditions for all modeled floods (Figures 30, 33, 36, 38 and 39).

Figure 33- Velocity vectors for the 5 Year Model, for existing and future conditions in the vicinity of Project Areas 60.25, 59.6/60.5, 58.9 and 58.6 (middle section of BVRA).

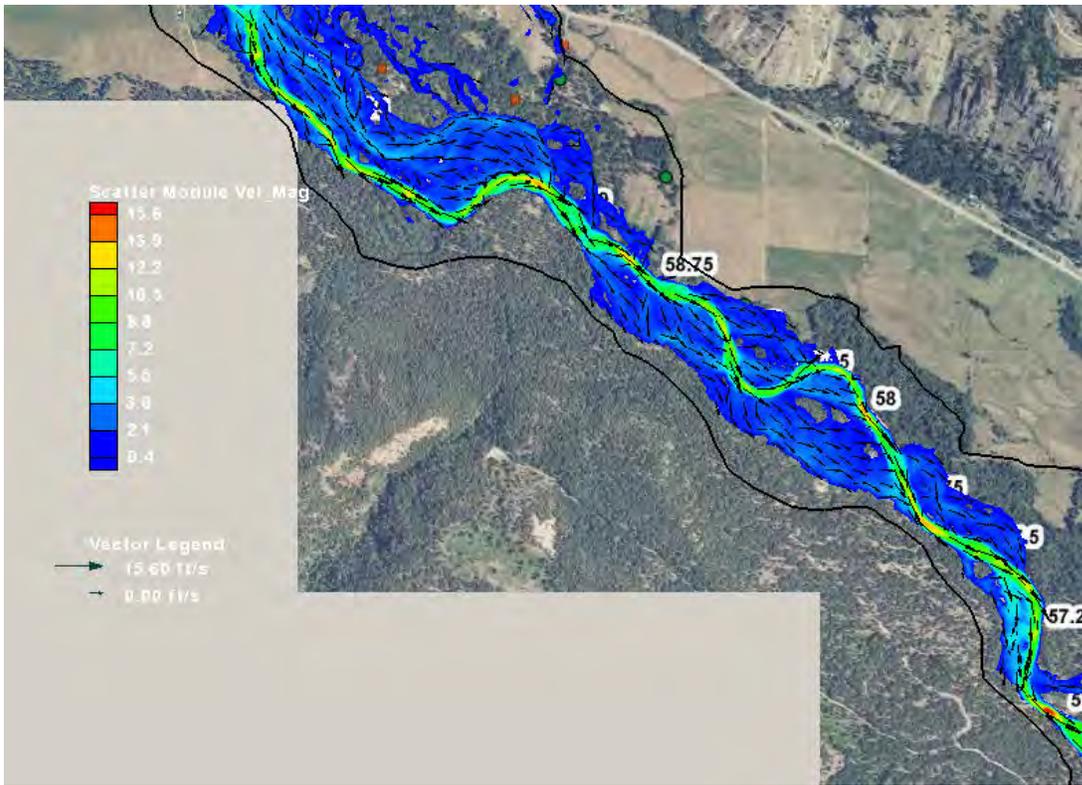
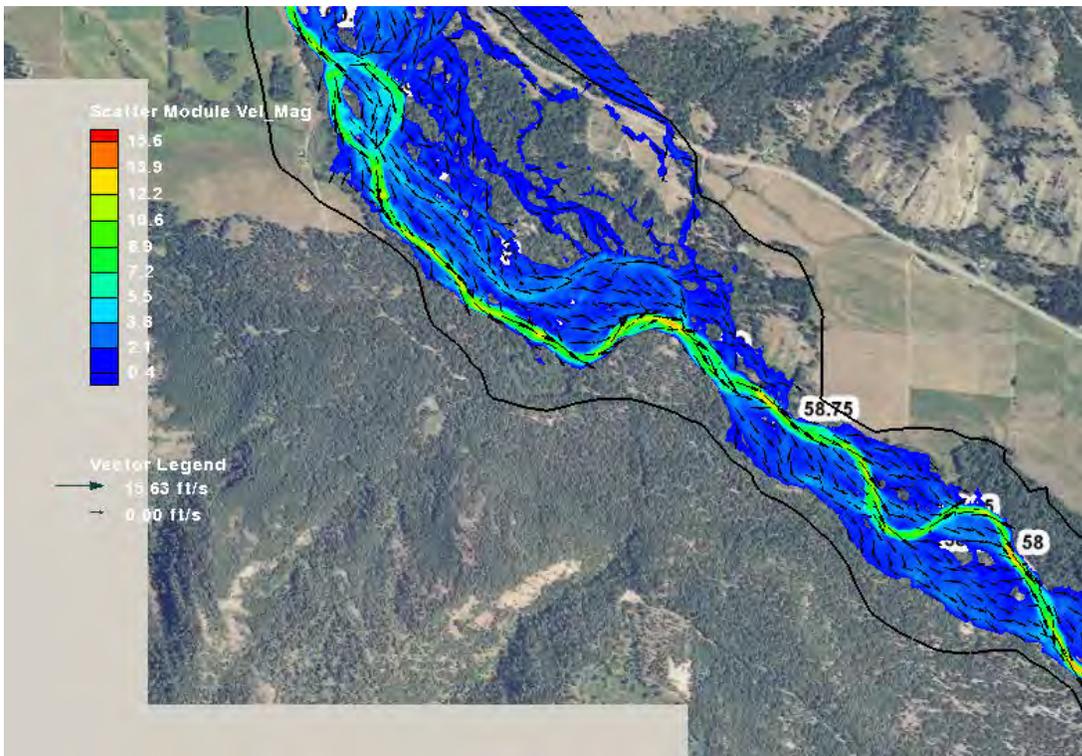
Figure 36- Velocity vectors for the 25 Year Model for existing and future conditions in the vicinity of Project Areas 60.25, 59.6/60.5, 58.9 and 58.6 (middle section of BVRA).

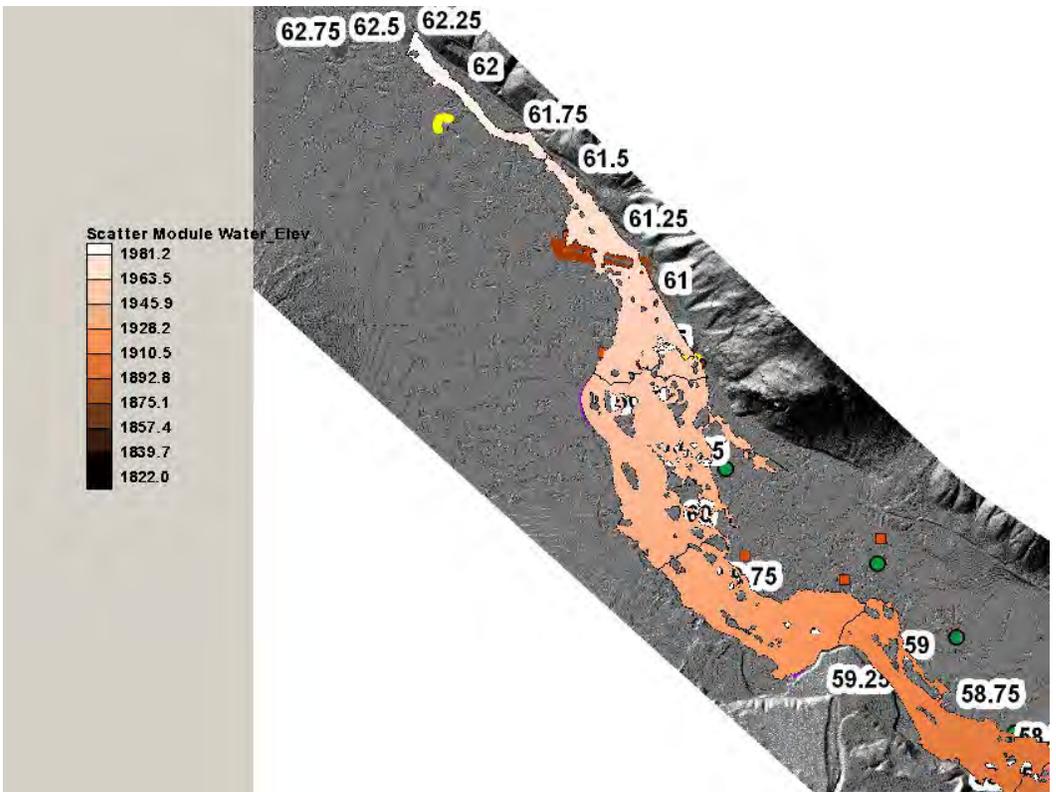
Figure 38-Water surface elevations for the 5 year flood for existing conditions in the vicinity of Project Areas 62.4, 60.25, 60.85, and 59.6/60.5 (upper section of BVRA).

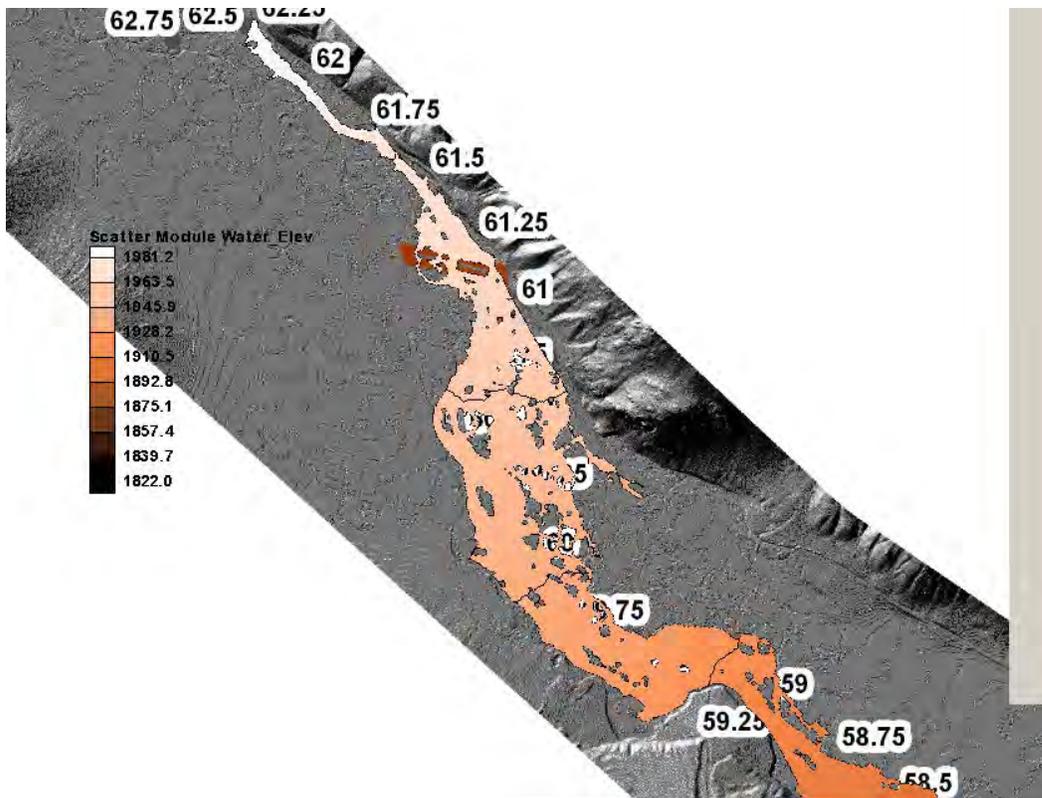
Figure 39- -Water surface elevations for the 5 year flood for future conditions in the vicinity of Project Areas 62.4, 60.25, 60.85, and 59.6/60.5 (upper section of BVRA).
