Upper White Pine Reach Assessment Nason Creek Chelan County, Washington

Bureau of Reclamation
Pacific Northwest Region
Boise, Idaho

March 2009

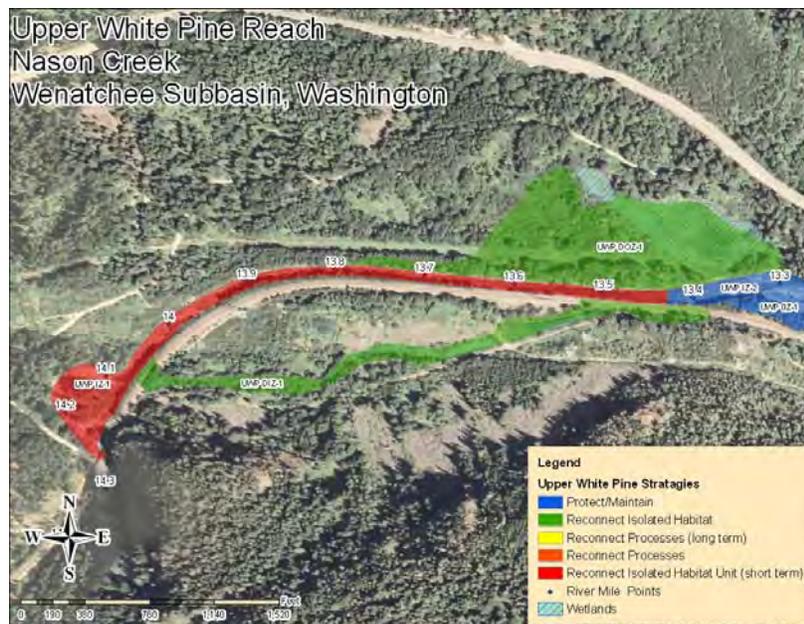
Figure 19 - UWP DOZ-1 and adjacent subreaches in the Upper White Pine reach.

UWP DOZ-1 is located in the upstream section of the Upper White Pine reach in the left floodplain from RM 13.8 to 13.3. (Figure 19). This subreach is rehabilitation-oriented due to the disconnection from the riverine system by a hardened levee.

The subreach is about 20 acres in size and contains 5 acres of wetlands. Anthropogenic features include 1,515 feet of transmission line and 1,037 feet of unimproved road. The largest impact comes from 2,044 feet of hardened levee that disconnects the subreach from the active channel. Natural lateral controls are alluvial fans and colluvium; however, the levee prevents lateral migration of the active channel into the subreach. Impacts to vegetation from anthropogenic features total 2 acres or about 10 percent of the subreach.

The inundation potential of this subreach is just less than 4 acres or 13 percent of the inundation potential for the entire Upper White Pine reach. Rehabilitation options are listed in Table 11. Options are prioritized to maximize geomorphic potential of the subreach through the reconnection and reestablishment of both long-term and short-term processes at the subreach scale. Rehabilitation actions in this subreach should be considered collectively with rehabilitation actions recommended in other subreaches to achieve a holistic reconnection and reestablishment of processes at the reach scale.

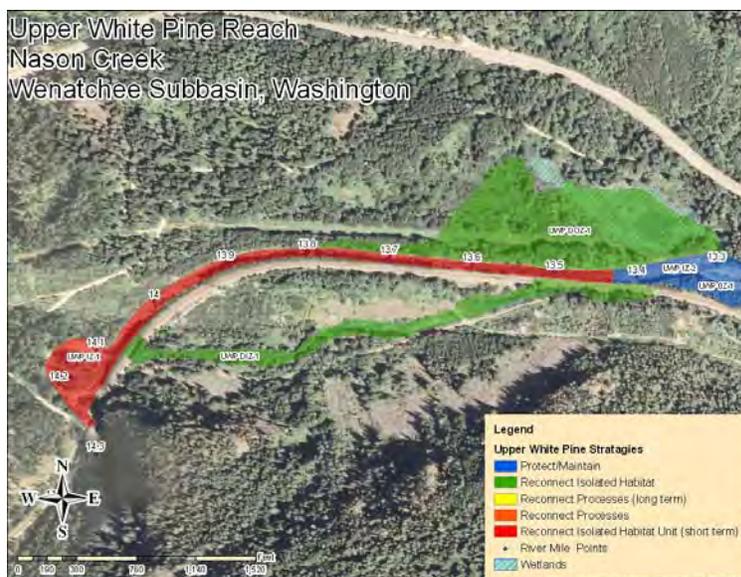
Figure 20 - UWP DIZ-1 and adjacent subreaches in the Upper White Pine reach.

The subreach is located in the upstream section of the Upper White Pine reach from RM 14.1 to 13.4 (Figure 20). The subreach is the historic channel located to the south of the Burlington Northern railroad grade and the current active channel. The impacts of anthropogenic features make this subreach rehabilitation-oriented.

The subreach is about 7 acres in size. Anthropogenic features in this subreach include 550 feet of unimproved road and 225 feet of road embankments or berms across historic channel in three locations. The largest anthropogenic impact is the complete disconnection of the historic channel from the current active channel at the upstream and downstream ends by the Burlington Northern Railroad grade. There are two culverts in the subreach, one that goes through a road embankment and one that goes through the railroad grade at the downstream end. The culvert running through the railroad grade does not provide fish passage at base flow which results in the subreach acting as a catchment pond for runoff and ground water.

The inundation potential of this subreach is slightly less than 7 acres or 25 percent of the inundation potential for the entire Upper White Pine reach. Rehabilitation options are listed in Table 12. Options are prioritized to maximize geomorphic potential of the subreach through the reconnection and reestablishment of both long-term and short-term processes at the subreach scale. Rehabilitation actions in this subreach should be considered collectively with rehabilitation actions recommended in other subreaches to achieve a holistic reconnection and reestablishment of processes at the reach scale.

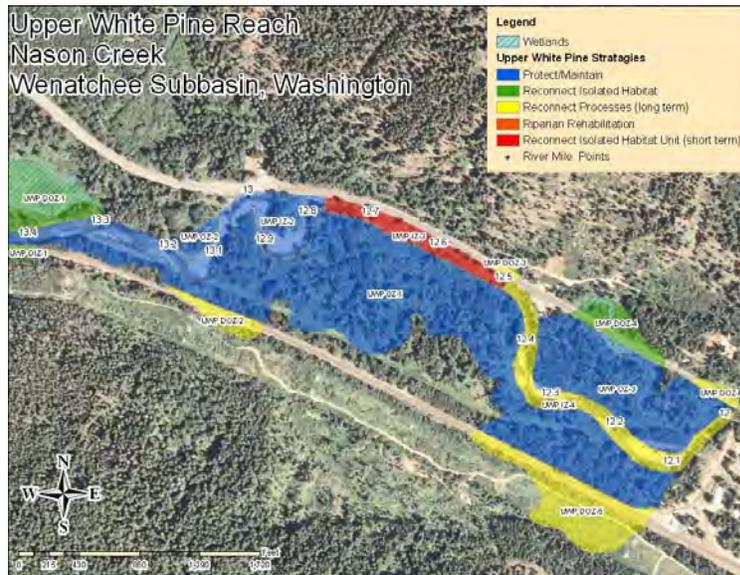
Figure 21 - UWP DOZ-4 and adjacent subreaches in the Upper White Pine reach.

UWP DOZ-4 is located in the downstream section of the Upper White Pine reach in the left floodplain at RM 12.4 (Figure 21). This subreach is rehabilitation-oriented due to the disconnection from the floodplain and riverine system.

The subreach is about 3 acres in size and contains 0.4 acres of wetlands. Natural lateral controls are alluvial fans and bedrock. Anthropogenic features include 775 feet of U.S. Highway 2 and a culvert. Highway 2 disconnects the subreach from the adjacent active floodplain and prevents lateral migration of the active channel into the subreach. Impacts of Highway 2 to vegetation total about 1 acre or about 33 percent of the subreach.

The inundation potential of this subreach is 3 acres or 11 percent of the inundation potential for the entire Upper White Pine reach. Rehabilitation options are listed in Table 13. Options are prioritized to maximize geomorphic potential of the subreach through the reconnection and reestablishment of both long-term and short-term processes at the subreach scale. Rehabilitation actions in this subreach should be considered collectively with rehabilitation actions recommended in other subreaches to achieve a holistic reconnection and reestablishment of processes at the reach scale.

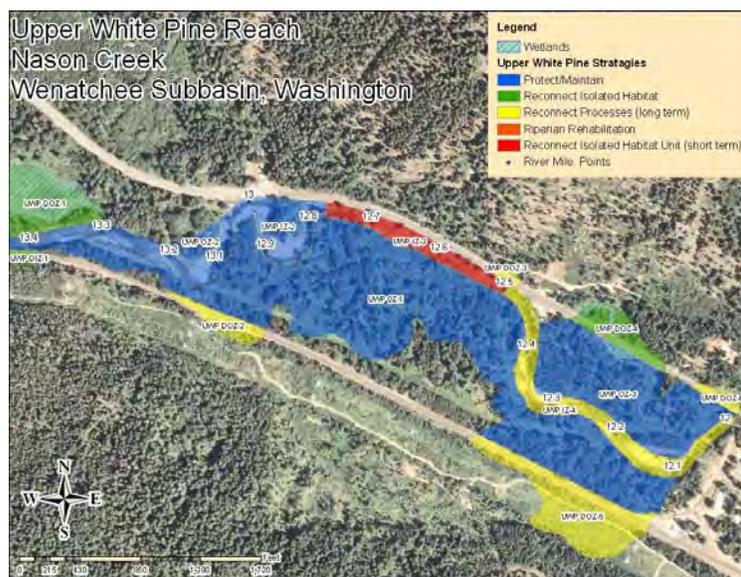
Figure 22 - UWP DOZ-5 and adjacent subreaches in the Upper White Pine reach.

UWP DOZ-5 is located in the downstream section of the Upper White Pine reach in the right floodplain, to the south of the Burlington Northern railroad grade at RM 12.2 (Figure 22). This subreach is rehabilitation-oriented due to the disconnection from the floodplain and riverine system.

The subreach is about 9 acres in size with alluvial fans forming natural lateral controls. Anthropogenic features include 848 feet of unimproved road and 671 feet of power line. The largest impact comes from 1,531 feet of railroad grade which prevent lateral migration of the active channel into the subreach. The railroad grade disconnects the subreach from the adjacent active floodplain. There are culverts through the railroad grade and road, but they appear to be designed to drain runoff water to the river. Impacts from the anthropogenic features to the vegetation total about 5 acres or about 55 percent of the subreach.

The inundation potential of this subreach is 7 acres or 25 percent of the inundation potential for the entire Upper White Pine reach. Rehabilitation options are listed in Table 14. Options are prioritized to maximize geomorphic potential of the subreach through the reconnection and reestablishment of both long-term and short-term processes at the subreach scale. Rehabilitation actions in this subreach should be considered collectively with rehabilitation actions recommended in other subreaches to achieve a holistic reconnection and reestablishment of processes at the reach scale.

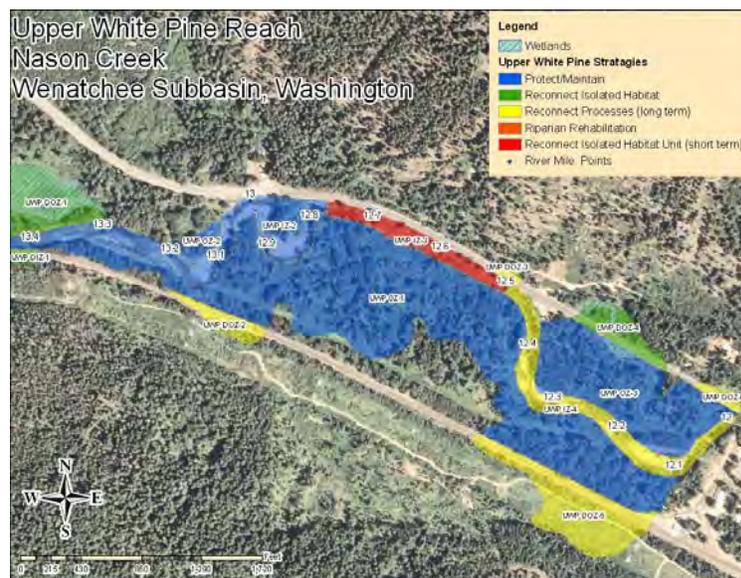
Figure 23 - UWP IZ-4 and adjacent subreaches in the Upper White Pine reach.

The subreach is a section of the current active channel from RM 12.5 to 12.0 in the Upper White Pine reach (Figure 23). The dominant process is transition-to-deposition, as noted by the increase in sinuosity, gravel substrate, and increase in diversity of channel units. The subreach composition is 57 percent runs, 25 percent riffles, and 18 percent pools. Due to the existing functioning conditions of this subreach, it is rehabilitation-oriented.

Rehabilitation options are listed in Table 15. Options are prioritized to maximize geomorphic potential of the subreach through the reconnection and reestablishment of both long-term and short-term processes at the subreach scale. Rehabilitation actions in this subreach should be considered collectively with rehabilitation actions recommended in other subreaches to achieve a holistic reconnection and reestablishment of processes at the reach scale.

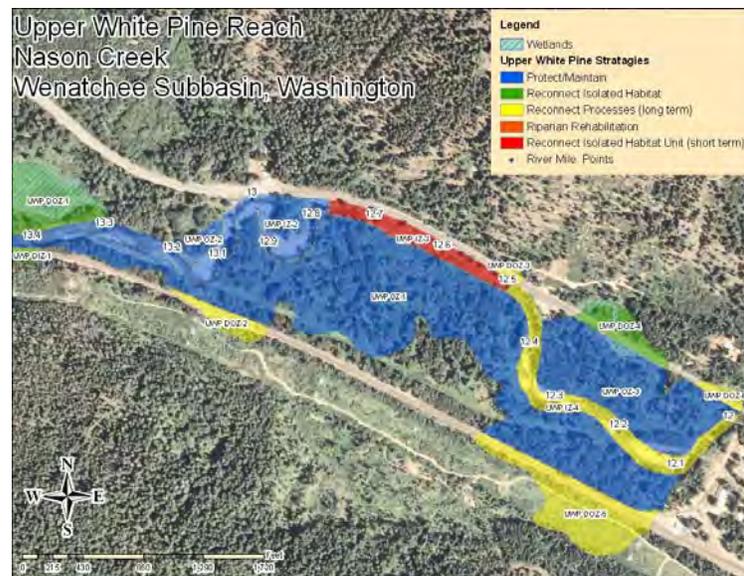
Figure 24 - UWP DOZ-2 and adjacent subreaches in the Upper White Pine reach.

UWP DOZ-2 is located in the upstream section of the Upper White Pine reach in the right floodplain, to the south of the Burlington Northern railroad grade (Figure 24). This subreach is rehabilitation-oriented due to the disconnection from the floodplain and riverine system.

The subreach is about 2 acres in size. Natural lateral controls are alluvial fans, colluvium, and bedrock. Anthropogenic features include a very small section of unimproved road and 2,442 feet of railroad grade. The railroad grade disconnects the subreach from the adjacent active floodplain and prevents lateral migration of the active channel into the subreach. Impacts of the railroad to vegetation total about 1 acre or about 50 percent of the subreach

The potential to increase the area of inundation is low. When comparing 5,000 cfs stream flow for existing conditions versus potential conditions (i.e., with anthropogenic features removed), the 2D-hydraulic model results only show similar acres of inundation. Most of the subreach is inundated at both modeled flows. Rehabilitation options are listed in Table 16. Options are prioritized to maximize geomorphic potential of the subreach through the reconnection and reestablishment of both long-term and short-term processes at the subreach scale. Rehabilitation actions in this subreach should be considered collectively with rehabilitation actions recommended in other subreaches to achieve a holistic reconnection and reestablishment of processes at the reach scale.

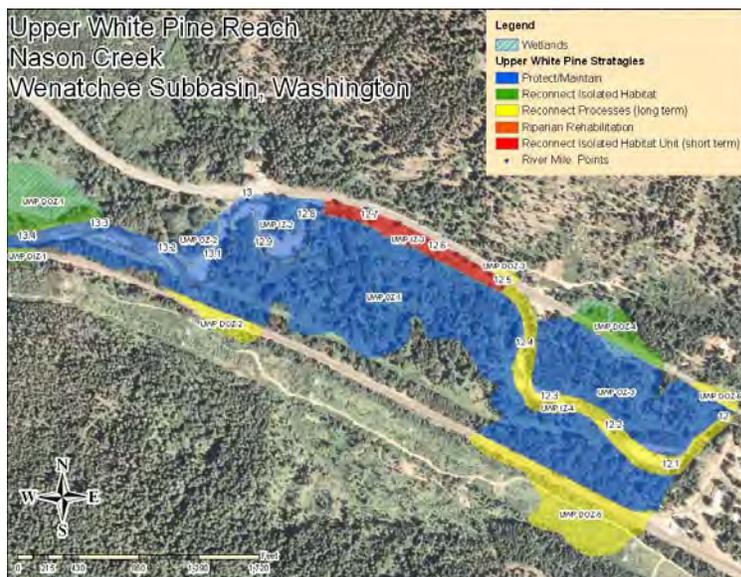
Figure 25 - UWP DOZ-6 and adjacent subreaches in the Upper White Pine reach.

UWP DOZ-6 is located in the downstream section of the Upper White Pine reach in the left floodplain at RM 12.0 (Figure 25). This subreach is rehabilitation-oriented due to the disconnection from the floodplain and riverine system.

The subreach is about 1 acre in size with alluvial fans forming natural lateral controls. Anthropogenic features are limited to 365 feet of Highway 2. Highway 2 disconnects the subreach from the adjacent active floodplain and prevents lateral migration of the active channel into the subreach. Impacts of Highway 2 to the vegetation total about one-half of an acre or about 50 percent of the subreach.

The potential to increase the area of inundation is low. When comparing 5,000 cfs stream flow for existing conditions versus potential conditions (i.e., with anthropogenic features removed), the 2D-hydraulic model results only show an inundation increase of 0.1 acres. Most of the subreach is inundated at both modeled flows. Rehabilitation options are listed in Table 17. Options are prioritized to maximize geomorphic potential of the subreach through the reconnection and reestablishment of both long-term and short-term processes at the subreach scale. Rehabilitation actions in this subreach should be considered collectively with rehabilitation actions recommended in other subreaches to achieve a holistic reconnection and reestablishment of processes at the reach scale.

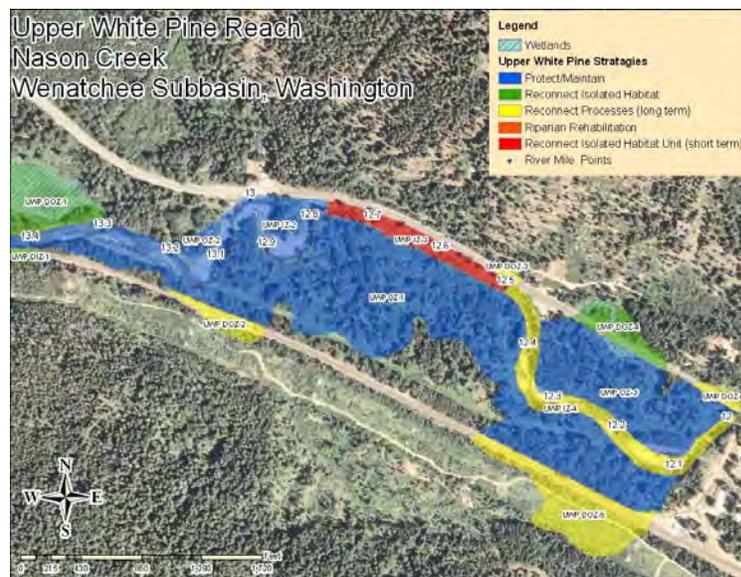
Figure 26 - UWP DOZ-3 and adjacent subreaches in the Upper White Pine reach.

UWP DOZ-3 is located in the mid-section section of the Upper White Pine reach in the left floodplain at RM 12.5 (Figure 26). This subreach is rehabilitation-oriented due to the disconnection from the floodplain and riverine system.

The subreach is about one-half acre in size. It is disconnected from the active floodplain by 245 feet of Highway 2 which also prevents lateral migration of the active channel into the subreach. Impacts of Highway 2 to the vegetation total about one-third of an acre or about 60 percent of the subreach. Natural lateral controls are alluvial fans and bedrock.

The potential to increase the area of inundation is low. When comparing 5,000 cfs stream flow for existing conditions versus potential conditions (i.e., with anthropogenic features removed), the 2D-hydraulic model results only show an inundation increase of 0.3 acres. Rehabilitation options are listed in Table 18. Options are prioritized to maximize geomorphic potential of the subreach through the reconnection and reestablishment of both long-term and short-term processes at the subreach scale. Rehabilitation actions in this subreach should be considered collectively with rehabilitation actions recommended in other subreaches to achieve a holistic reconnection and reestablishment of processes at the reach scale.

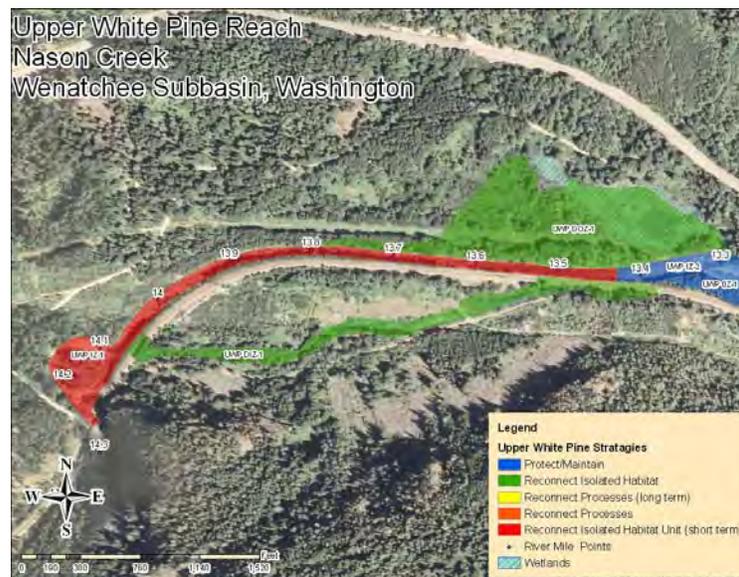
Figure 27 - UWP IZ-1 and adjacent subreaches in the Upper White Pine reach.

The subreach area is a section of the current active channel from RM 14.25 to 13.45 in the Upper White Pine reach (Figure 27). Due to the artificial (engineered) nature of the channel in this subreach and the dominant process being transport, there is much less diversity of channel units than the downstream inner zone subreaches. The channel unit composition within the subreach is 53 percent runs, 31 percent rapids, and 15 percent pools. Due to the straightened nature and simplification of the system, this subreach rehabilitation-oriented.

Natural lateral control for the subreach is an alluvial fan; however, artificial lateral control from the railroad grade imposes greater influence due to the relocation of the channel to the north side of the railroad grade. Within this subreach, existing conditions include reduced lateral migration and increased stream power, similarity of channel units, and decreased

instream habitat complexity. Vertical channel migration would increase but the predominantly boulder substrate prevents it. Large woody debris is very scarce which prevents the creation of complexity at higher flows. It is hypothesized that material passes through the subreach at most flows. The result is a rapid-and-riffle step bedform.

Within the stratified strategy, reconnecting habitat units through in-channel structures is the lowest priority. This is in agreement with the revised biological objective which states adding complexity with in-stream structures is the lowest priority of potential actions (UCRTT 2009). It is recognized that instream structures provide immediate complexity, but the goal of recommending instream structures in this report is to reinitiate habitat-forming processes by retaining sediment. This will lead to an over-all increase in bed elevation that will in turn promote habitat-forming processes, specifically through riverine floodplain interaction. Rehabilitation options are listed in Table 19. Options are prioritized to maximize geomorphic potential of the subreach through the reconnection and reestablishment of both long-term and short-term processes at the subreach scale. Rehabilitation actions in this subreach should be considered collectively with rehabilitation actions recommended in other subreaches to achieve a holistic reconnection and reestablishment of processes at the reach scale.

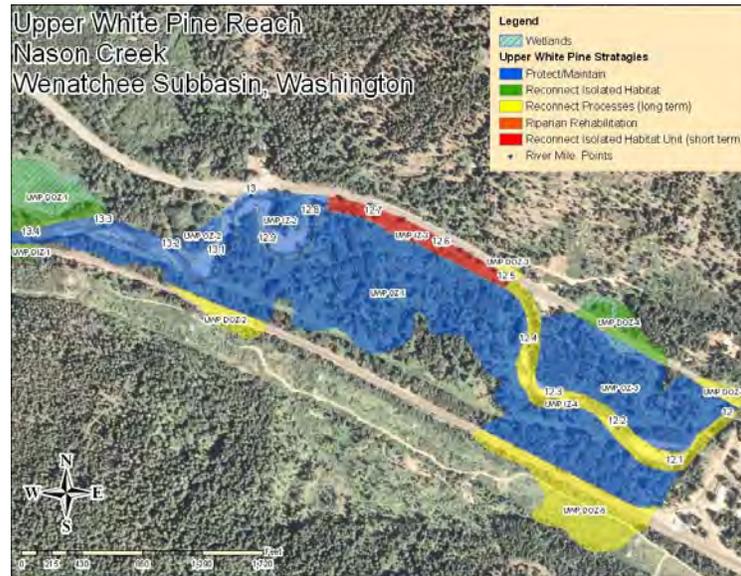
Figure 28 - UWP IZ-3 and adjacent subreaches in the Upper White Pine reach.

The subreach area is a section of the current active channel from RM 12.75 to 12.5 in the Upper White Pine reach (Figure 28). The dominant substrate is gravel and the dominant process in this subreach is transport due to the slightly confined nature of the channel within this subreach. The result is less diversity of channel units than in adjacent upstream and downstream inner zone subreaches. The channel unit composition within the subreach is 72 percent runs, 15 percent riffles, and 13 percent pools. Due to the straightened nature and simplification of the system, this subreach is rehabilitation-oriented.

Natural lateral control for the subreach is alluvial fan material and bedrock. With the dominant process being transport, there is an increase in stream power, similarity of channel units, and decreased instream habitat complexity. Large woody debris is very scarce which prevents the creation of complexity at higher flows. It is hypothesized that material is mobilized with increasing flows and deposited in decreasing flows, resulting in a plane-bed form.

Within the stratified strategy, reconnecting habitat units through in-channel structures is the lowest priority. This is in agreement with the revised biological objectives which states adding complexity with in-stream structures is the lowest priority of potential actions (UCRTT 2009). It is recognized that in-stream structures provide immediate complexity, but the goal of recommending in-stream structures in this report is to reinitiate habitat forming processes by retaining sediment. This will lead to an over-all increase in bed elevation that will in turn promote habitat forming processes, specifically through riverine floodplain interaction. Rehabilitation options are listed in Table 20. Options are prioritized to maximize geomorphic potential of the subreach through the reconnection and reestablishment of both long-term and short-term processes at the subreach scale. Rehabilitation actions in this subreach should be considered collectively with rehabilitation actions recommended in other subreaches to achieve a holistic reconnection and reestablishment of processes at the reach scale.

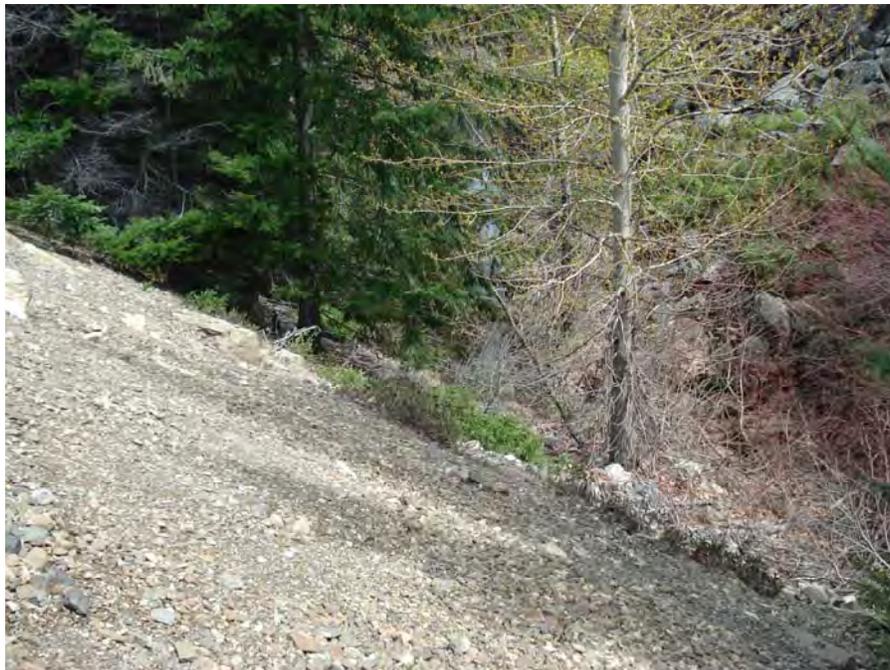
Photograph No. 1. View to the east of the historic channel bed cutoff by the railroad grade. Upper White Pine Reach; Subreach DIZ-1, Nason Creek - Wenatchee Subbasin, Washington. Bureau of Reclamation Photograph by R. McAfee, May 2, 2007

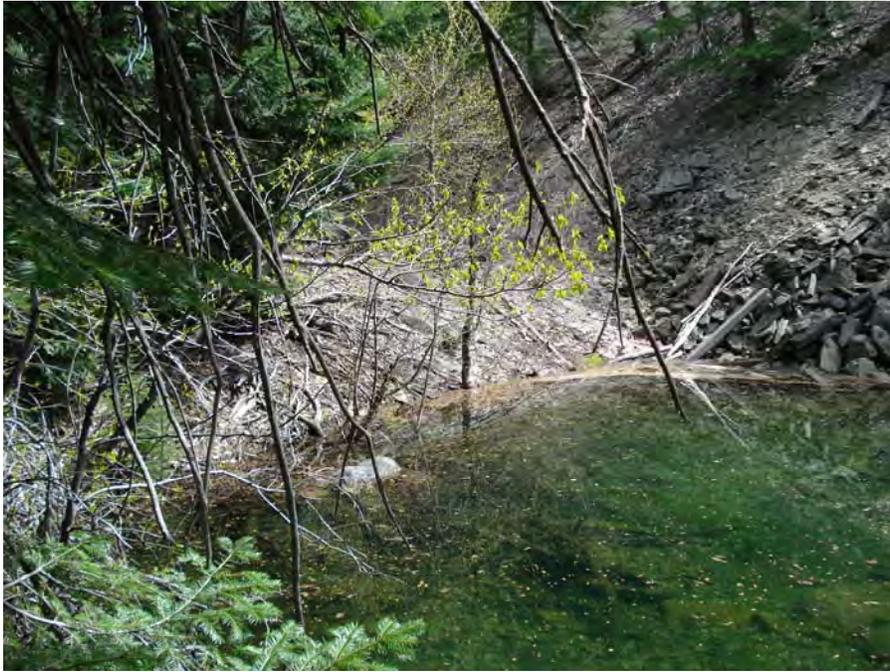
Photograph No. 2. View to the southeast of an embankment that cuts across the wetlands. Upper White Pine Reach; Subreach DIZ-1, Nason Creek - Wenatchee Subbasin, Washington. Bureau of Reclamation Photograph by R. McAfee, May 2, 2007

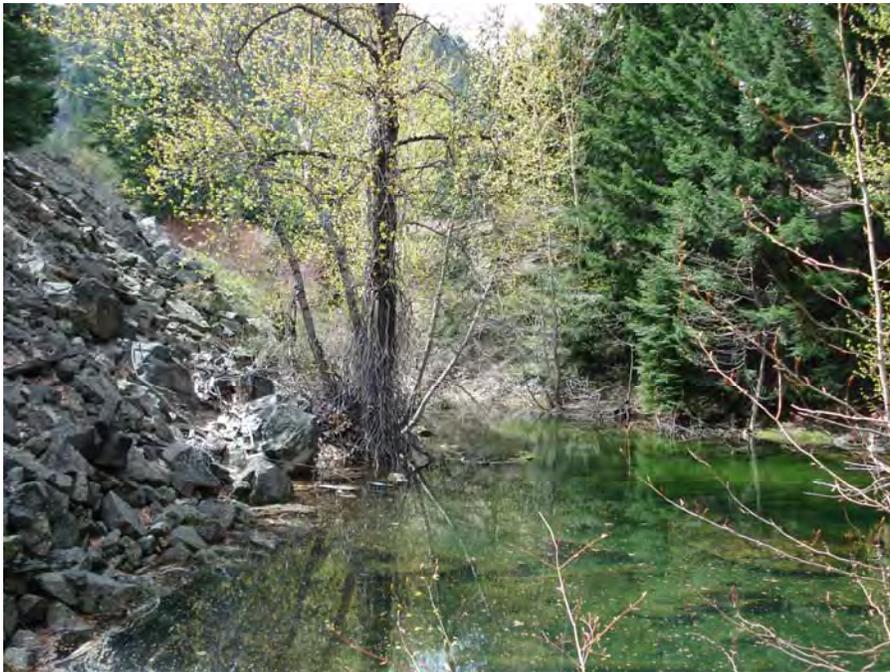
Photograph No. 3. View looking to the west (upstream) from atop an embankment that traps run off water in the historic channel bed. Upper White Pine Reach; Subreach DIZ-1, Nason Creek - Wenatchee Subbasin, Washington. Reclamation Photograph by R. McAfee, May 2, 2007.

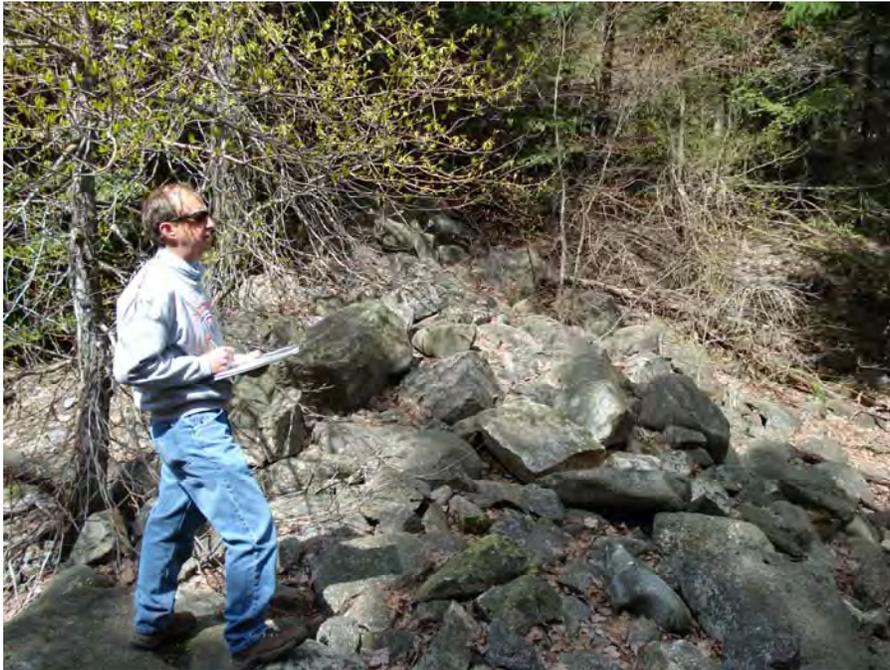
Photograph No. 5. View to the north of the crest of the embankment across the historic channel bed. Note the riprap on the downstream side only. Upper White Pine Reach; Subreach DIZ-1, Nason Creek - Wenatchee Subbasin, Washington. Reclamation Photograph by R. McAfee, May 2, 2007.

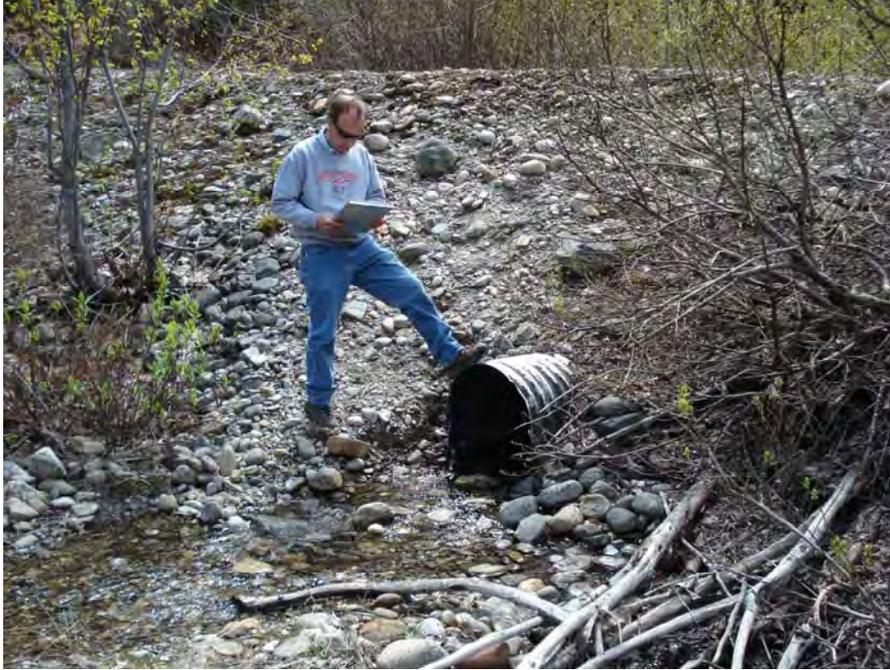
Photograph No. 8. View to the south a road embankment across the historic channel bed and 24-inch culvert that drains the surface water above the embankment. Upper White Pine Reach; Subreach DIZ-1, Nason Creek - Wenatchee Subbasin, Washington. Reclamation Photograph by R. McAfee, May 2, 2007.

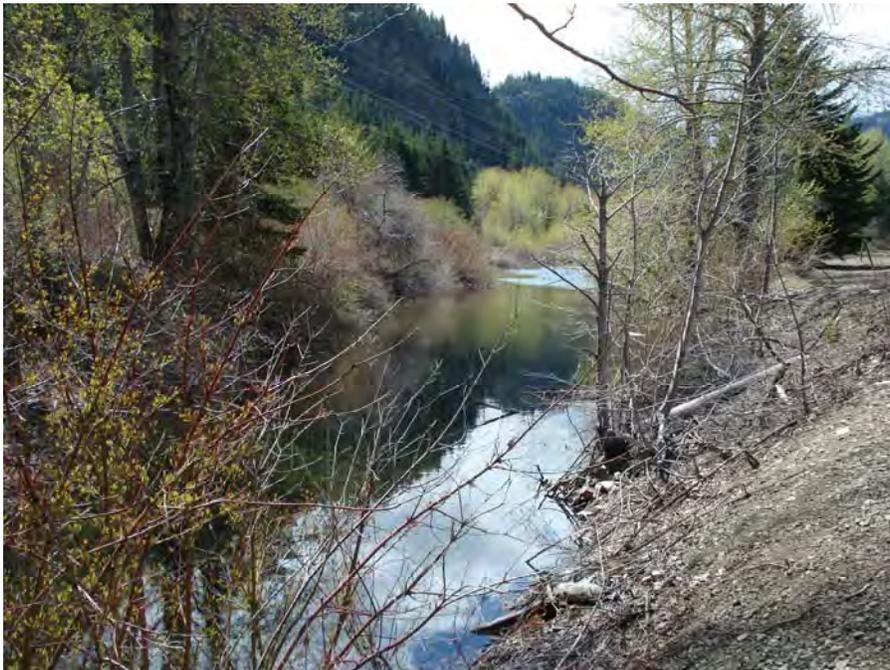
Photograph No. 9. View to the west of the wetlands located in the historic channel bed. The wetlands pinch out against the railroad grade. Upper White Pine Reach; Subreach DIZ-1, Nason Creek - Wenatchee Subbasin, Washington. Reclamation Photograph by R. McAfee, May 2, 2007.

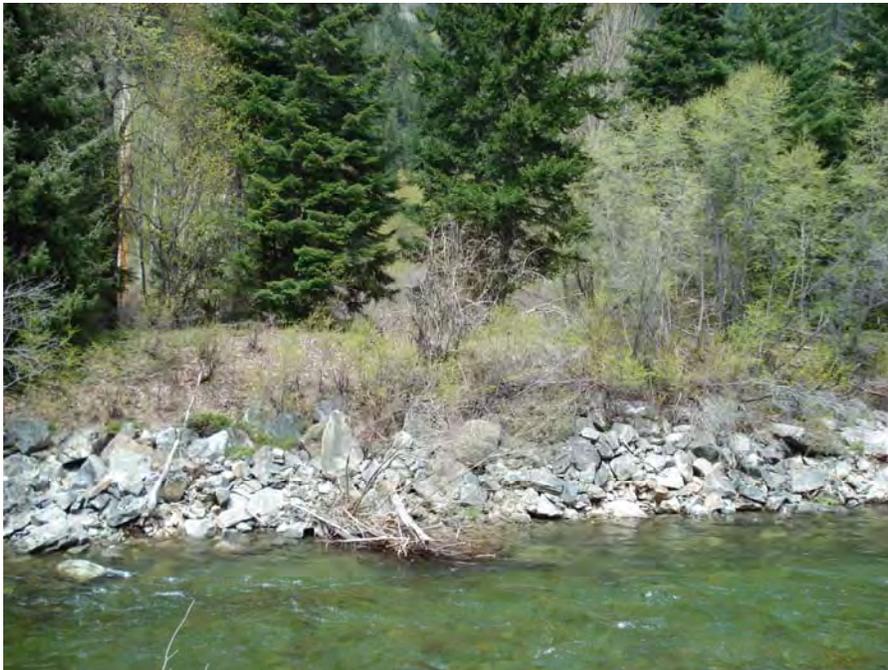
Photograph No. 1. View to the north of the levee and riprap that defines the left bank. Upper White Pine Reach; Subreach DOZ-1, Nason Creek - Wenatchee Subbasin, Washington. Bureau of Reclamation Photograph by R. McAfee, May 2, 2007

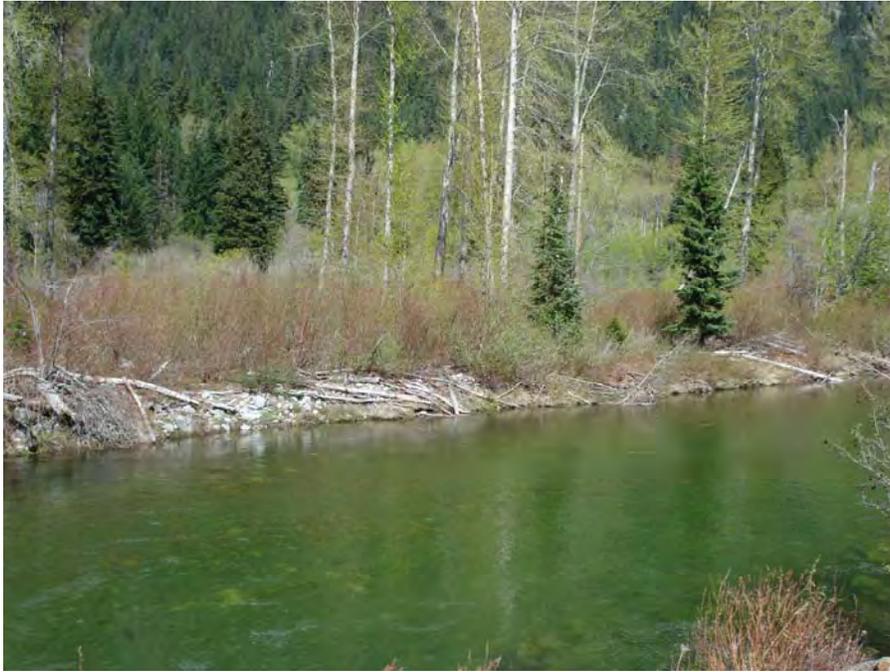
Photograph No. 2. View to the north of the lower levee on the left bank. Upper White Pine Reach; Subreach DOZ-1, Nason Creek - Wenatchee Subbasin, Washington. Bureau of Reclamation Photograph by R. McAfee, May 2, 2007

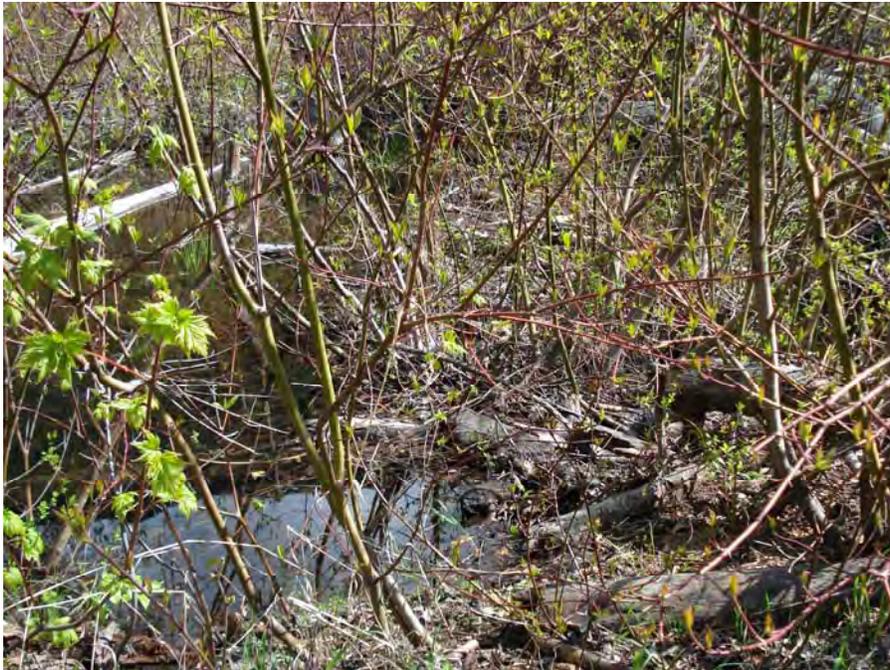
Photograph No. 3. View to the northeast of a wetlands area with return to river blocked impeded by a beaver dam. Upper White Pine Reach; Subreach DOZ-1, Nason Creek - Wenatchee Subbasin, Washington. Bureau of Reclamation Photograph by E. Lyon, May 3, 2007.

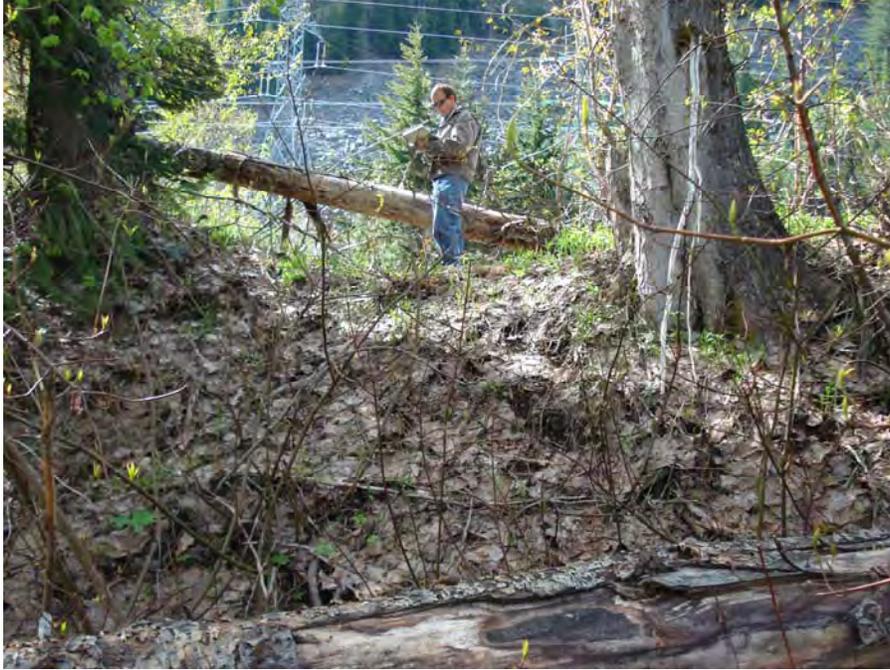
Photograph No.4. View looking to the south from the floodplain at the levee on the left bank. Upper White Pine Reach; Subreach DOZ-1, Nason Creek - Wenatchee Subbasin, Washington. Bureau of Reclamation Photograph by R. McAfee, May 3, 2007.

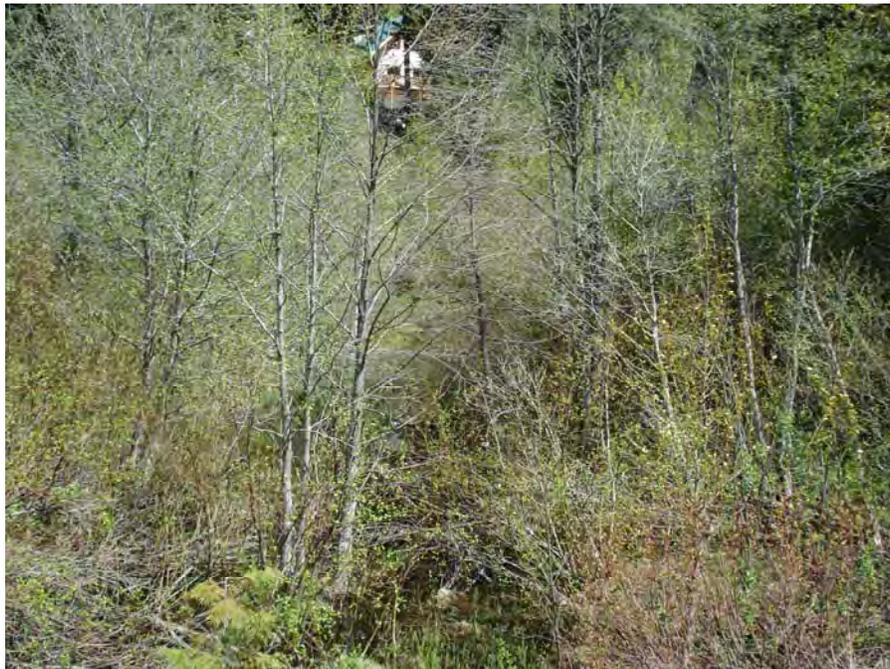
Photograph No. 1. View of the wetlands in the top of an oxbow on the north side of U. S. Highway 2. Upper White Pine Reach; Subreach DOZ-4, Nason Creek - Wenatchee Subbasin, Washington. Bureau of Reclamation Photograph by R. McAfee, May 3, 2007.

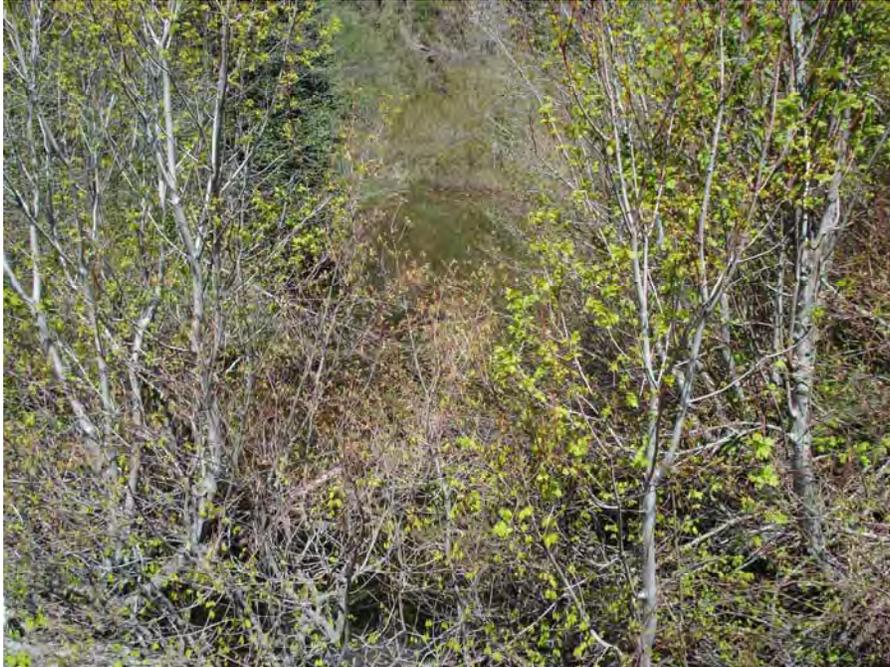
Photograph No. 2. View to the north of wetlands on the north side of U. S. Highway 2. Upper White Pine Reach; Subreach DOZ-4, Nason Creek - Wenatchee Subbasin, Washington. Bureau of Reclamation Photograph by R. McAfee, May 3, 2007.

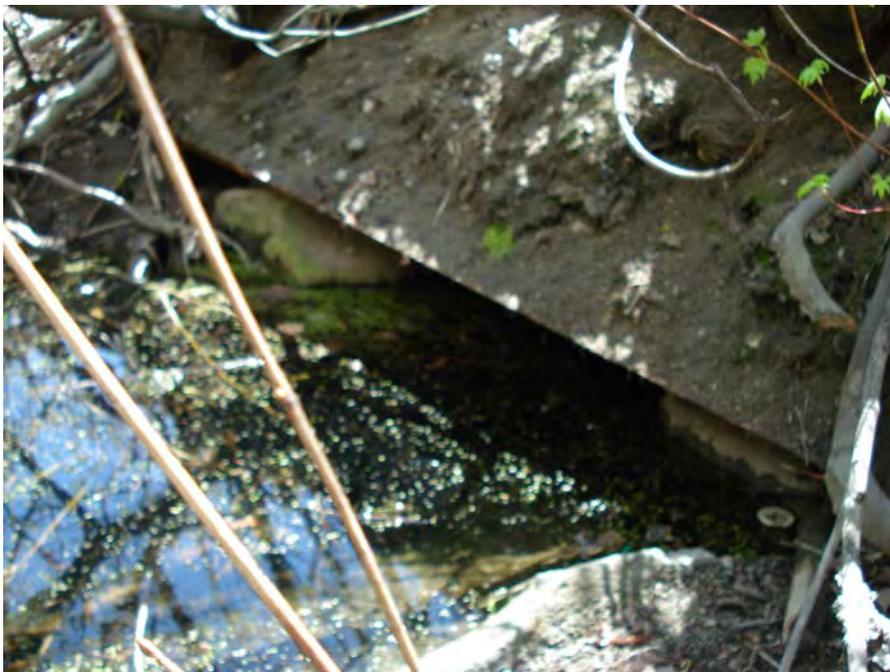
Photograph No. 3. View of the drain mechanism for the wetlands in an oxbow on the north side of U.S. Highway 2. Upper White Pine Reach; Subreach DOZ-4, Nason Creek - Wenatchee Subbasin, Washington. Bureau of Reclamation Photograph by R. McAfee, May 3, 2007.

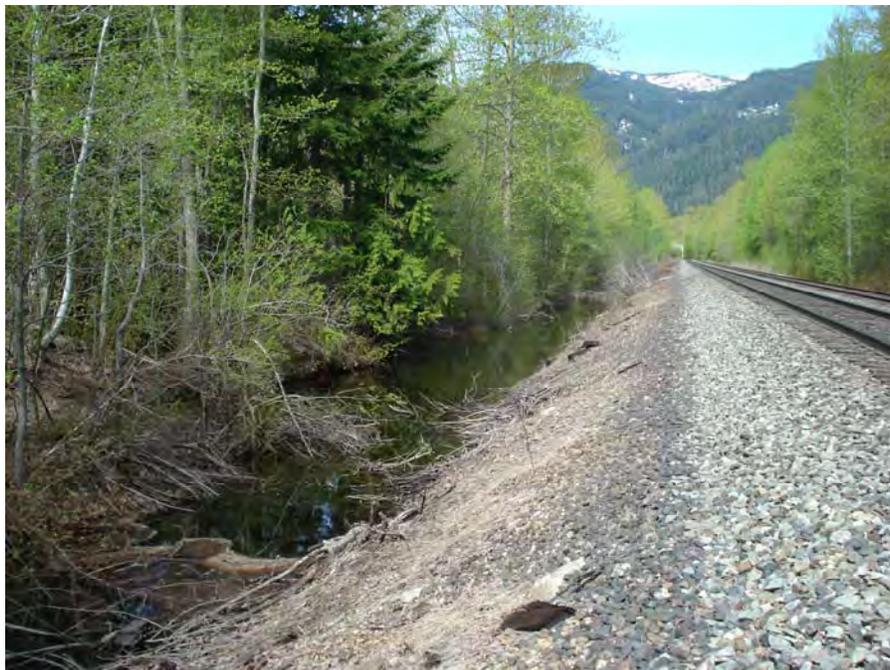
Photograph No.1. View looking to the west of impounded run off water along the south side of the railroad grade. Upper White Pine Reach; Subreach DIZ-1, Nason Creek - Wenatchee Subbasin, Washington. Bureau of Reclamation Photograph by R. McAfee, May 7, 2007.

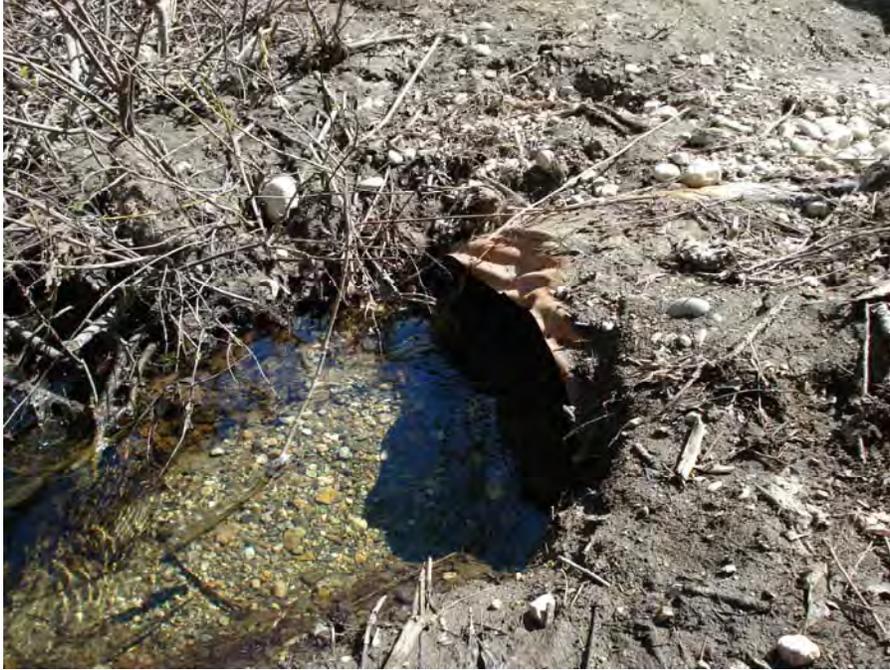
Photograph No. 2. View of a culvert draining run off water from the south side of the railroad grade to the main channel. Upper White Pine Reach; Subreach DIZ-1, Nason Creek - Wenatchee Subbasin, Washington. Bureau of Reclamation Photograph by R. McAfee, May 3, 2007.

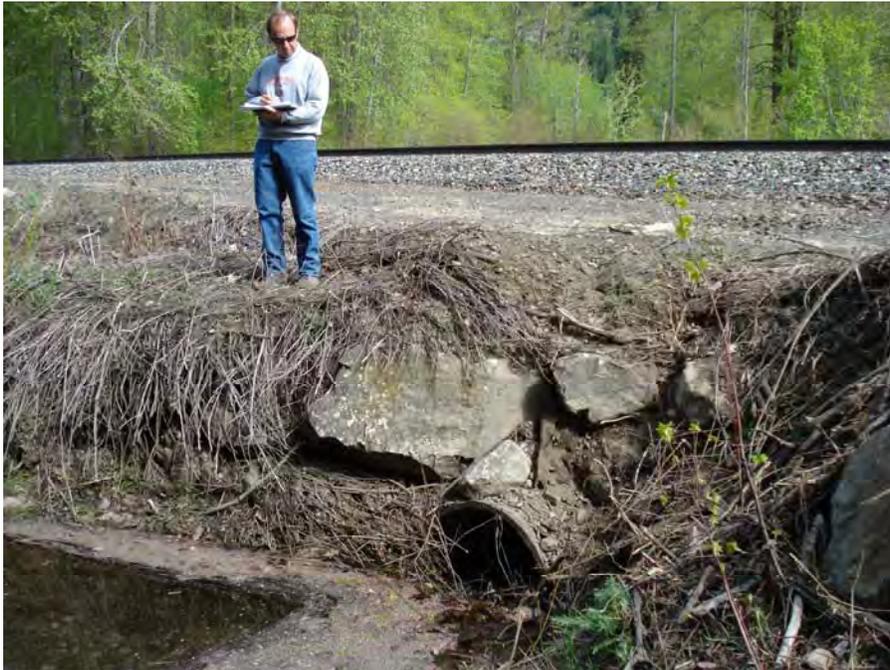
Photograph No.3. Culvert intake that drains the wetlands on the south side of the railroad grade. Upper White Pine Reach; Subreach DIZ-1, Nason Creek - Wenatchee Subbasin, Washington. Bureau of Reclamation Photograph by R. McAfee, May 7, 2007.

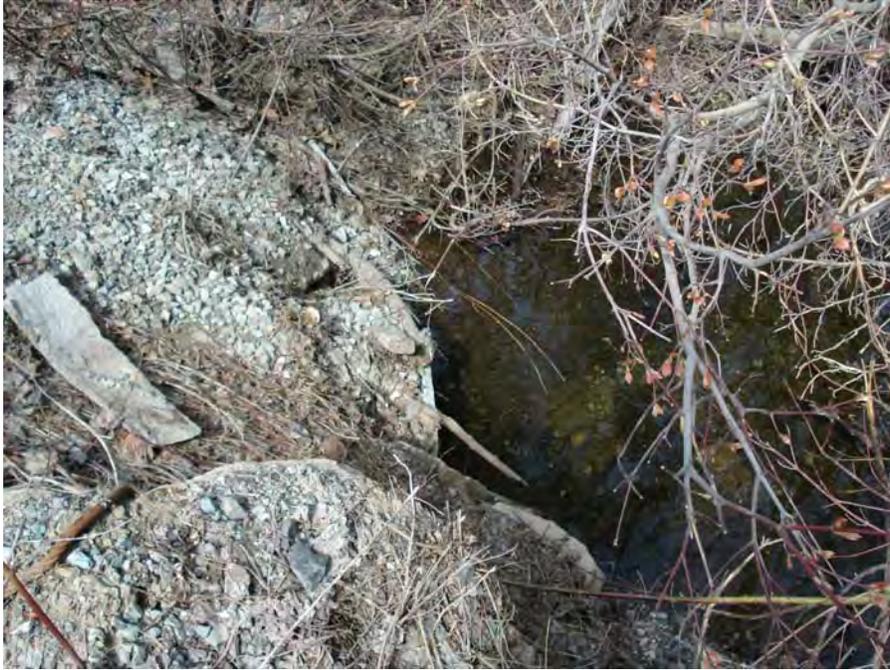
Photograph No. 4 Culvert outfall draining to the river. **Upper White Pine Reach; Subreach DIZ-1, Nason Creek - Wenatchee Subbasin, Washington.** Bureau of Reclamation Photograph by R. McAfee, May 7, 2007.

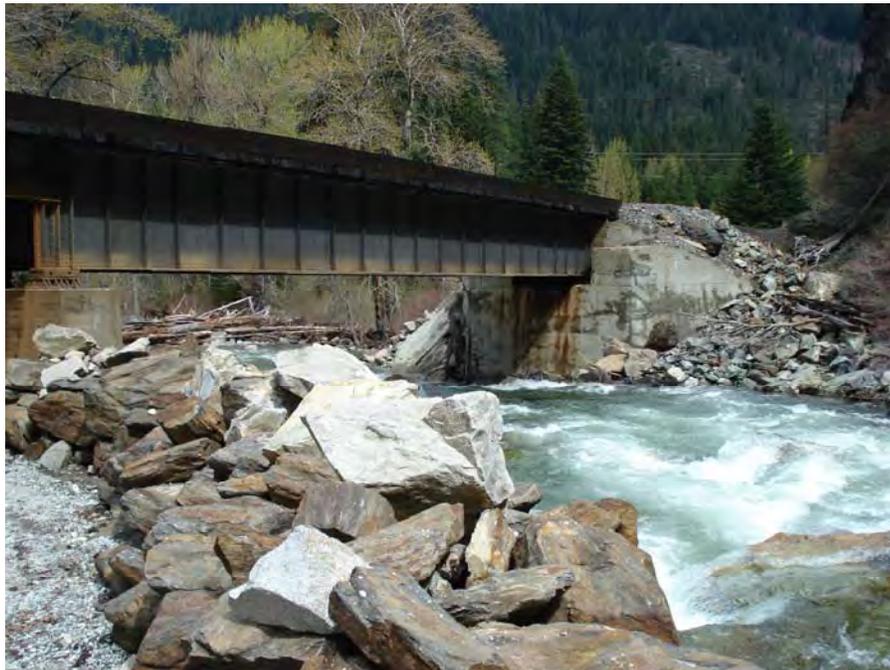
- 400' Riprap exists along both banks throughout much of the reach (Photographs 1, 2 and 9).
- 1 bridge for the railroad crosses the active channel at the top of the reach (Photograph 1)
- Much of the reach is a channelized section that placed the channel to the north of the railroad grade along the right bank (Photographs 10-17).
- Substrate ranges from boulder to cobble.
- A culvert exists through the railroad grade along the right bank but was observed to not provide passage to disconnected inner zone at base flow. (Photographs 21 and 22).

Photograph No.1. View to the northeast (downstream) at riprap on the left bank and the right railroad bridge abutments. Upper White Pine Reach; Subreach IZ-1, Nason Creek - Wenatchee Subbasin, Washington. Bureau of Reclamation Photograph by R. McAfee, May 2, 2007

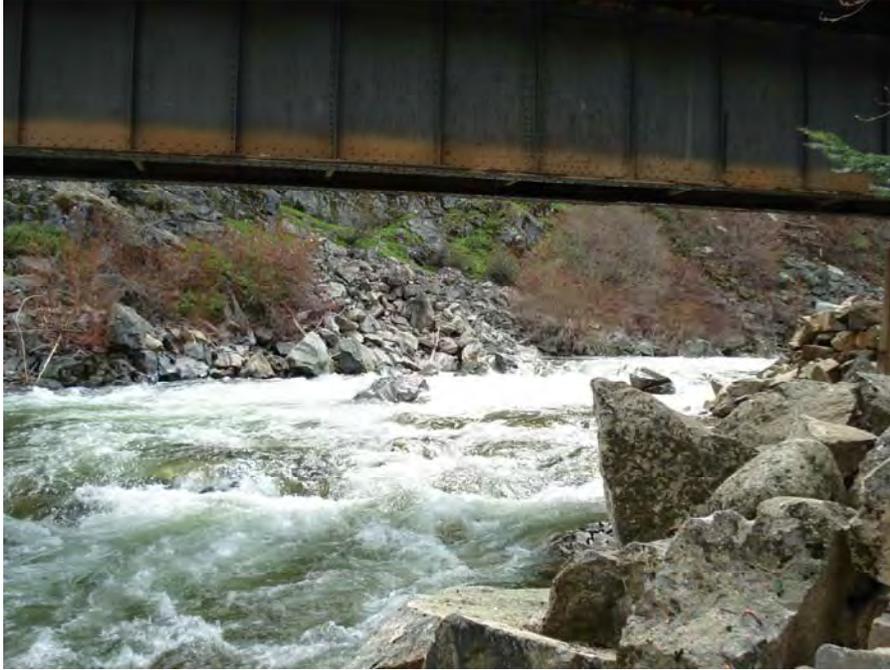
Photograph No. 2. View to the southeast, looking upstream at talus boulders along the right bank, riprap along the left bank and rapid channel units. Upper White Pine Reach; Subreach IZ-1, Nason Creek - Wenatchee Subbasin, Washington. Bureau of Reclamation Photograph by R. McAfee, May 2, 2007.

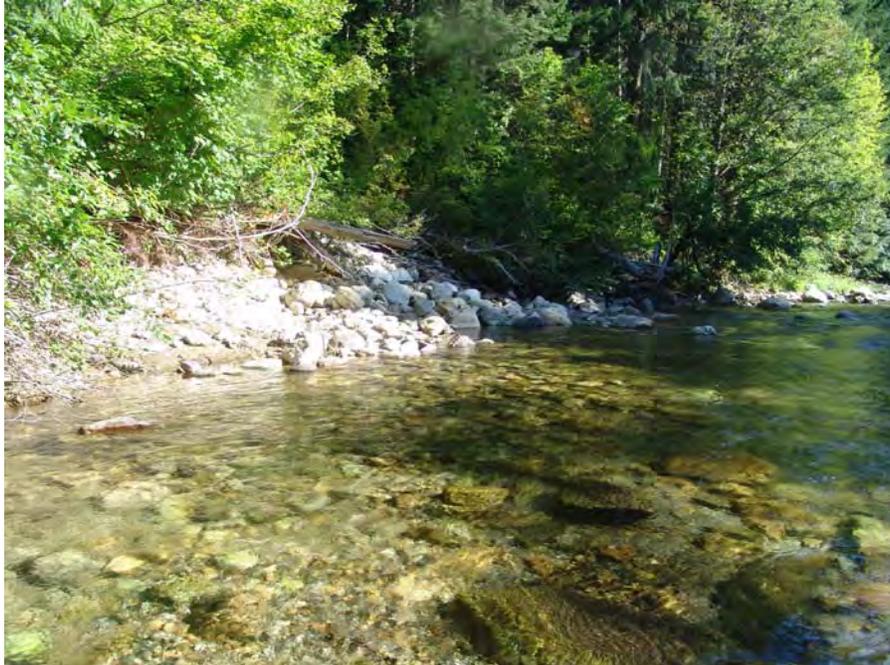
Photograph No.5. View is to the north-northwest looking at boulder and cobble armoring along the left bank. Upper White Pine Reach; Subreach IZ-1, Nason Creek - Wenatchee Subbasin, Washington. Bureau of Reclamation Photograph by D. Bennett 8/7/07.
