Upper White Pine Reach Assessment Nason Creek Chelan County, Washington

Bureau of Reclamation
Pacific Northwest Region
Boise, Idaho

March 2009

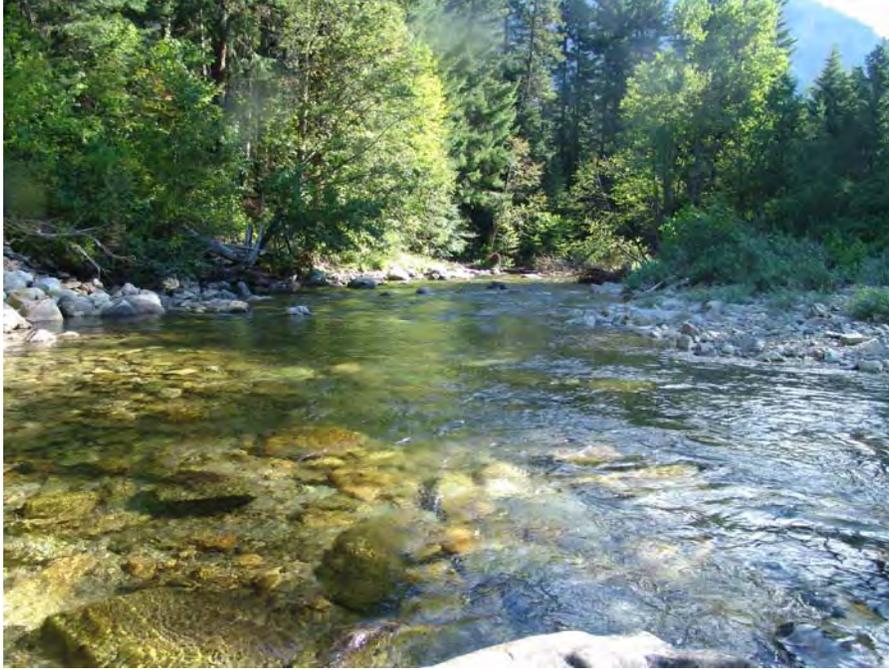
Photograph No.6. View is to the north looking downstream showing the boulder and cobble armoring along the left bank and the boulder and cobble substrate. Upper White Pine Reach; Subreach IZ-1, Nason Creek - Wenatchee Subbasin, Washington. Bureau of Reclamation Photograph by D. Bennett 8/7/07.

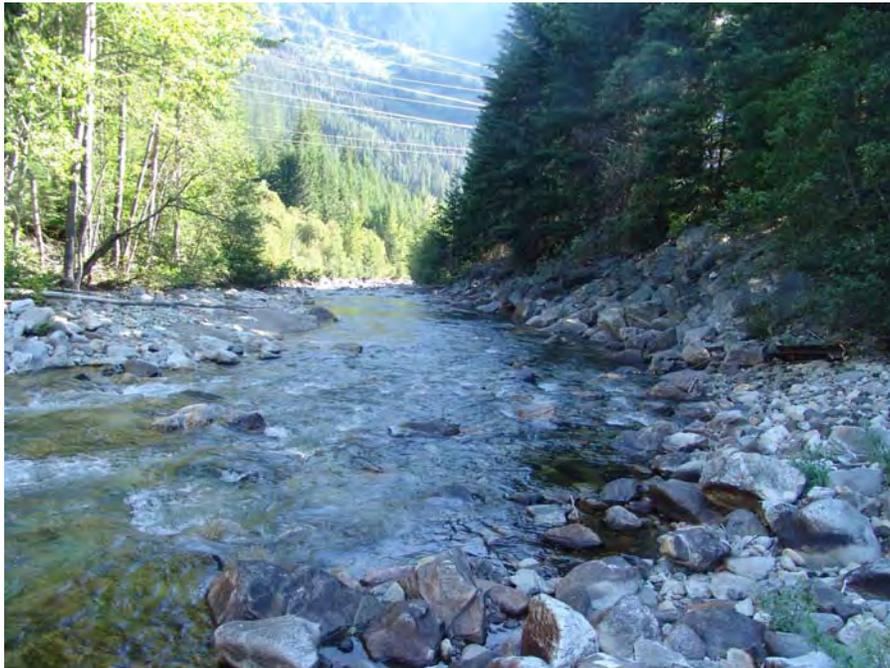
- 400' Riprap exists along both banks throughout much of the reach (Photographs 1, 2 and 9).
- 1 bridge for the railroad crosses the active channel at the top of the reach (Photograph 1)
- Much of the reach is a channelized section that placed the channel to the north of the railroad grade along the right bank (Photographs 10-17).
- Substrate ranges from boulder to cobble.
- A culvert exists through the railroad grade along the right bank but was observed to not provide passage to disconnected inner zone at base flow. (Photographs 21 and 22).

Photograph No.9. View is to the northeast looking downstream along main channel showing cobble and boulder substrate, the railroad grade comprising the right bank and step pool bed form. Upper White Pine Reach; Subreach IZ-1, Nason Creek - Wenatchee Subbasin, Washington. Bureau of Reclamation Photograph by D. Bennett 8/7/07.

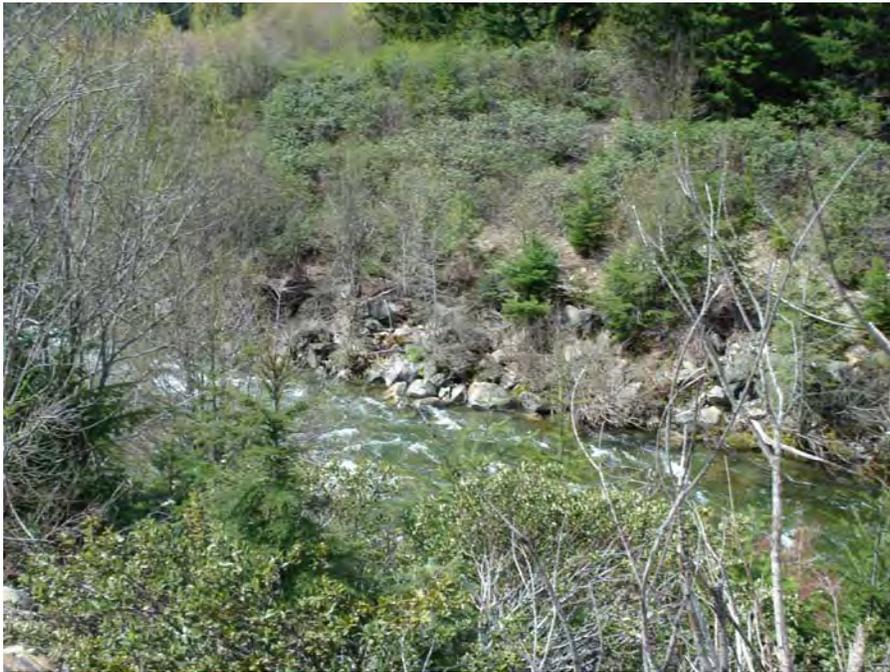
Photograph No.13. View to the northwest of the riprap on the toe of the left bank. Upper White Pine Reach; Subreach IZ-1, Nason Creek - Wenatchee Subbasin, Washington. Bureau of Reclamation Photograph by R. McAfee, May 2, 2007.

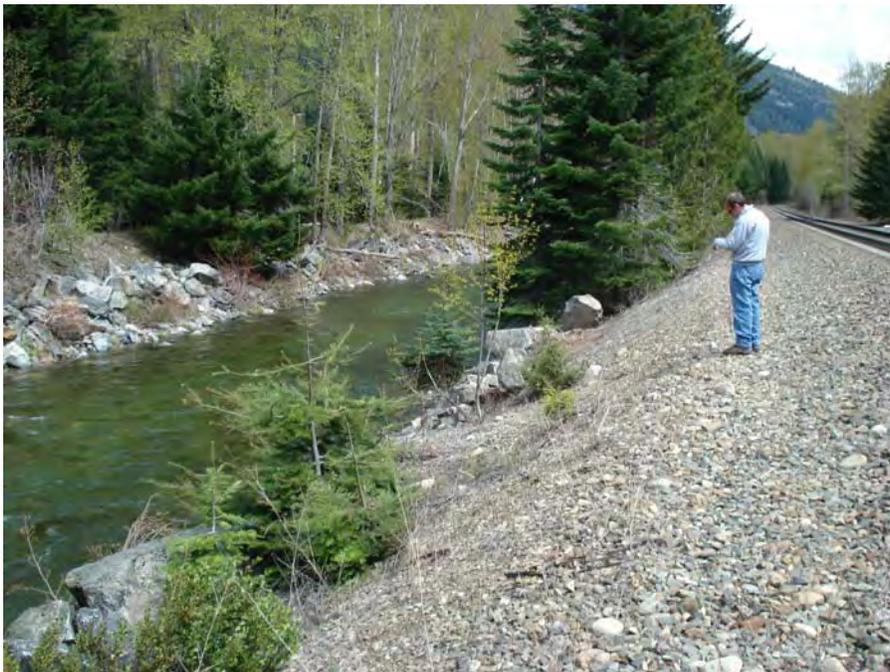
Photograph No.17. View to the northeast of the riprap and levee along the left bank and the riprap at the toe of the railroad grade that defines the right bank. Upper White Pine Reach; Subreach IZ-1, Nason Creek - Wenatchee Subbasin, Washington. Bureau of Reclamation Photograph by R. McAfee, May 2, 2007.

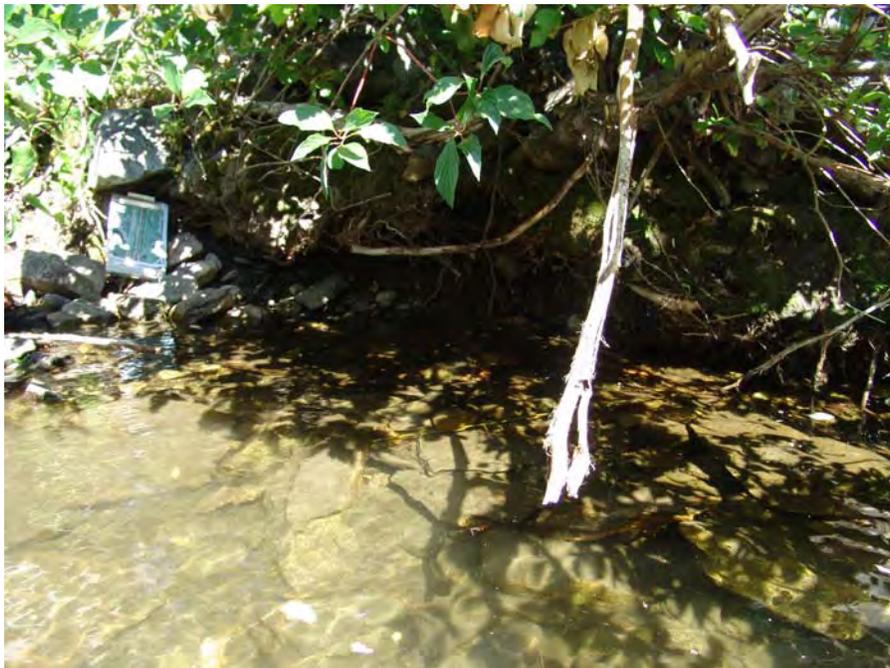
Photograph No.19. View is to the north looking at minor local erosion on the left bank. Upper White Pine Reach; Subreach IZ-1, Nason Creek - Wenatchee Subbasin, Washington. Bureau of Reclamation Photograph by D. Bennett 8/7/07.

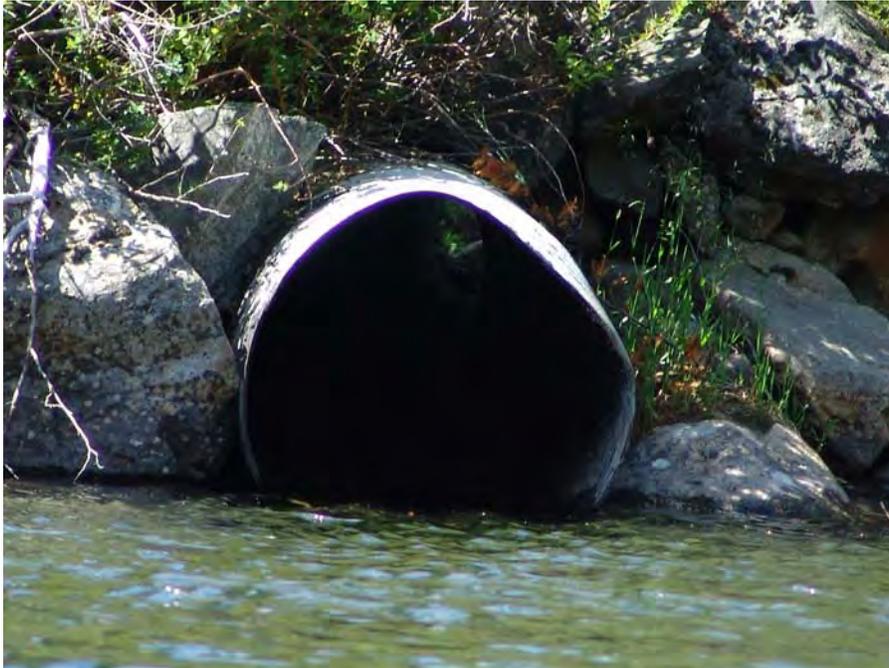
Photograph No.21. View is to the south looking at the culvert on right bank that drains the wetlands in DIZ-1, located to the south of the railroad grade. Upper White Pine Reach; Subreach IZ-1, Nason Creek - Wenatchee Subbasin, Washington. Bureau of Reclamation Photograph by D. Bennett 8/7/07.

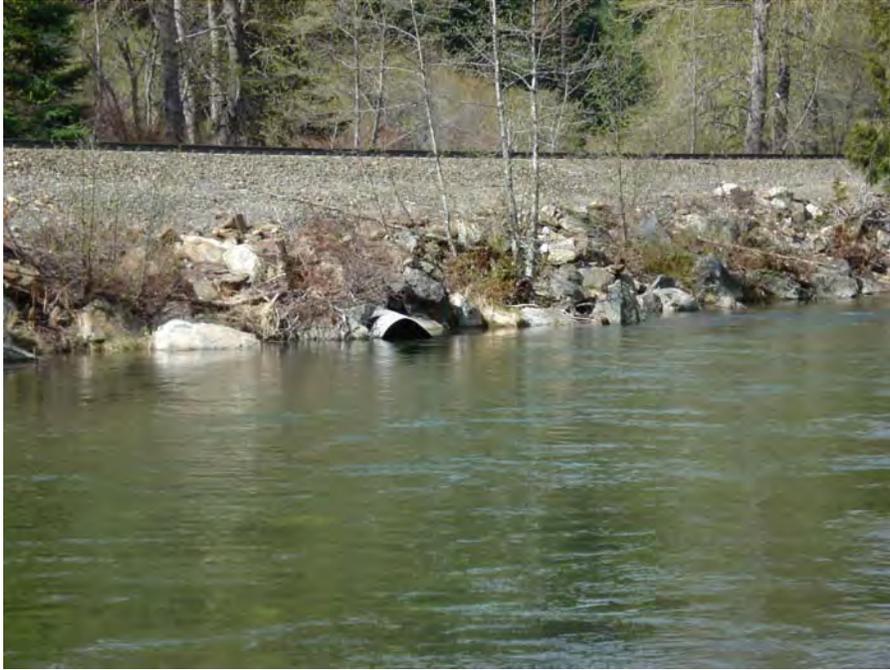
Photograph No. 22. View to the southwest of the culvert that drains the wetlands in DIZ-1, located behind the railroad grade. Upper White Pine Reach; Subreach IZ-1, Nason Creek - Wenatchee Subbasin, Washington. Bureau of Reclamation Photograph by R. McAfee, May 3, 2007.

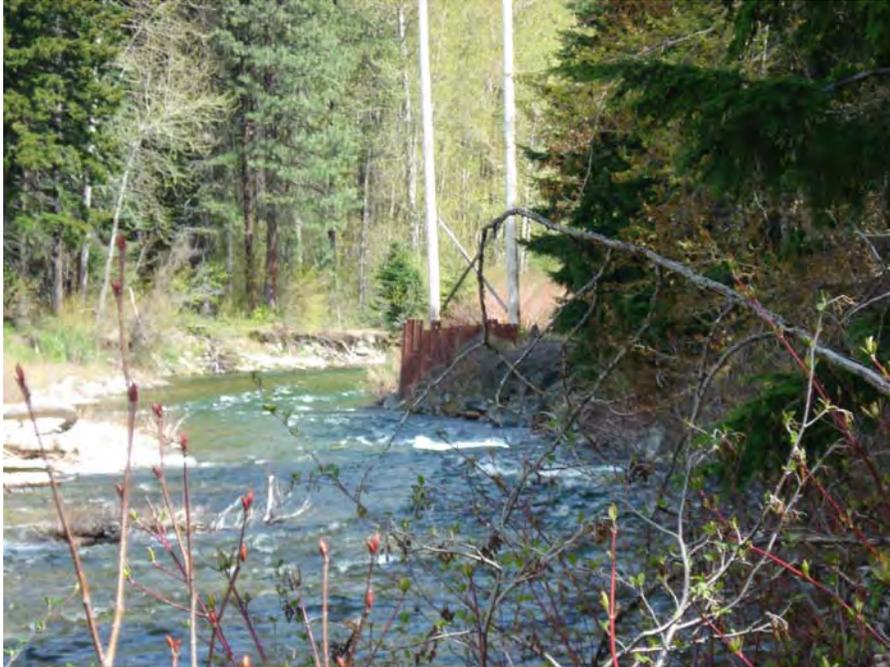
- Human features in the subreach include a small section of sheet piling, two rock spurs, and three cabled logs (Photographs 1 and 2, 16 and 17, 23 and 24) .
- A total of 725' of riprap exists throughout the subreach. The riprap protects the highway and railroad grade throughout the subreach
- Limited bank erosion was observed throughout the subreach (Photographs 7, 9, 14, 20 and 21).

Photograph No.2. View to the east (downstream) of sheet pilings that protect the power pole along the right bank. Upper White Pine Reach; Subreach IZ-2, Nason Creek - Wenatchee Subbasin, Washington. Bureau of Reclamation Photograph by R. McAfee, May 2, 2007.

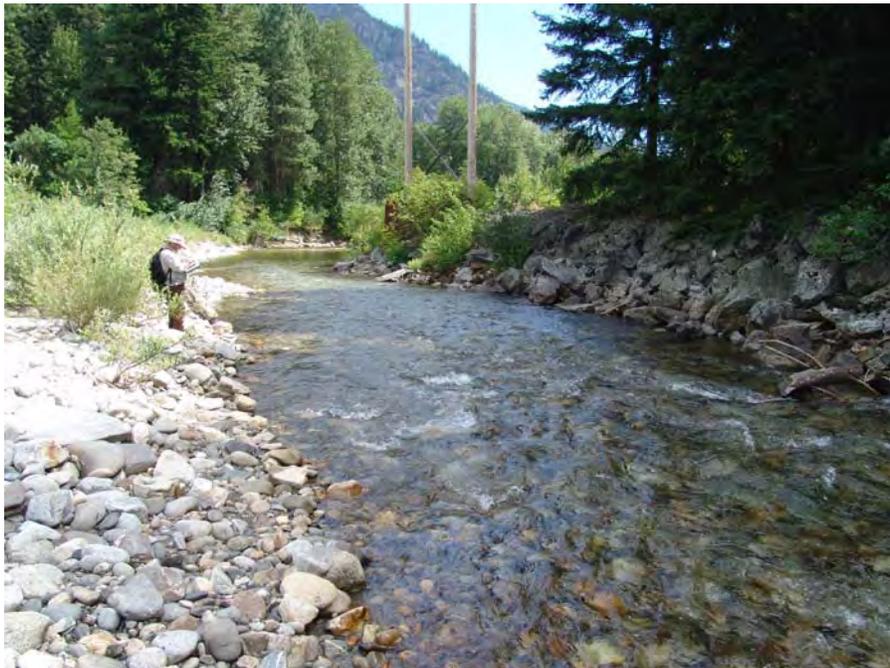
Photograph No. 3. View is to the east looking downstream at riprap and sheetpiling that protects the powerline along the right bank. Upper White Pine Reach; Subreach IZ-2, Nason Creek - Wenatchee Subbasin, Washington. Bureau of Reclamation Photograph by D. Bennett 8/7/07.

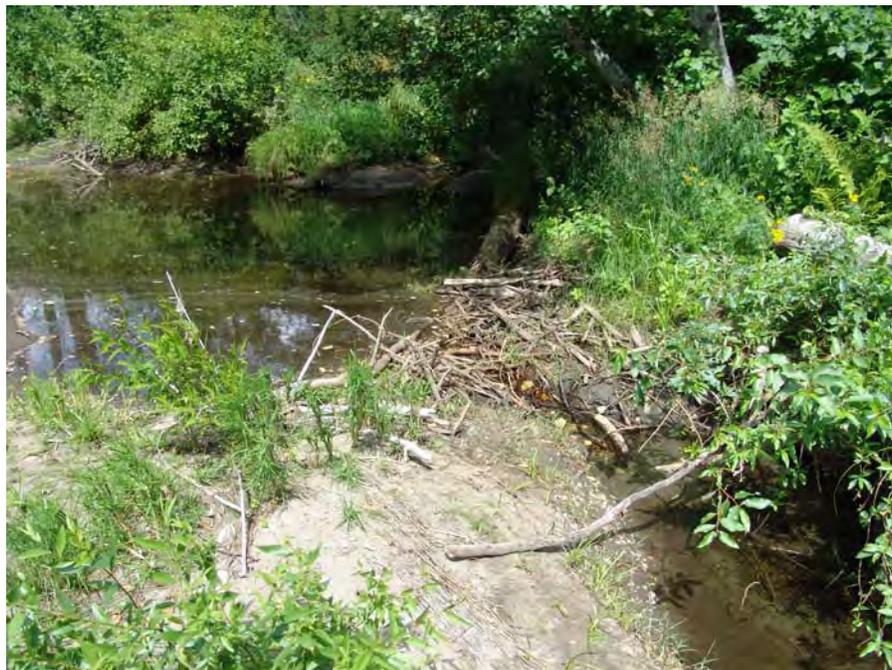
Photograph No. 5. View is to the north looking at a wetlands outfall with a beaver dam. Upper White Pine Reach; Subreach IZ-2, Nason Creek - Wenatchee Subbasin, Washington. Bureau of Reclamation Photograph by D. Bennett 8/7/07.

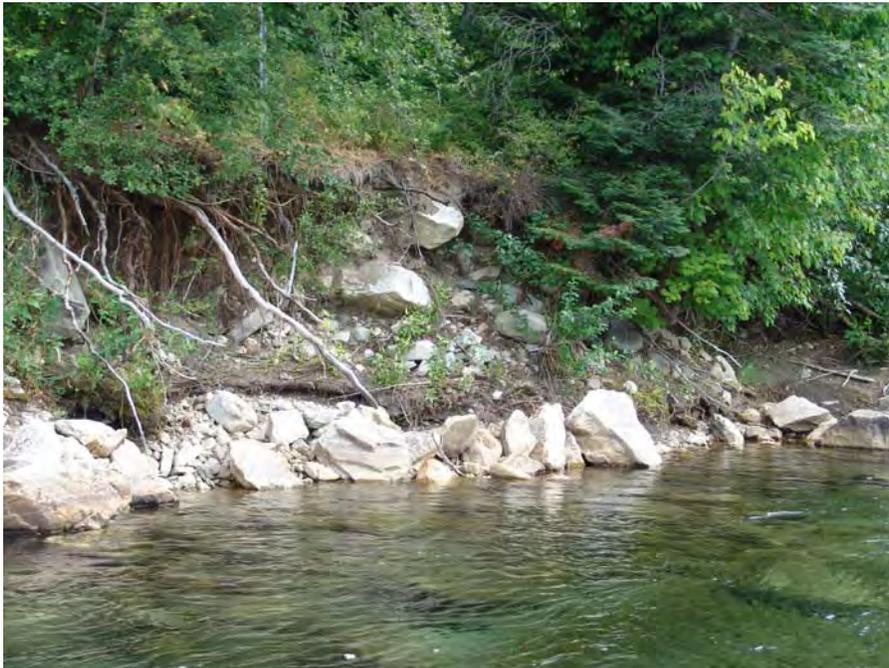
Photograph No. 7. View is to the north looking at subangular boulders along the toe of the left bank. Upper White Pine Reach; Subreach IZ-2, Nason Creek - Wenatchee Subbasin, Washington. Bureau of Reclamation Photograph by D. Bennett 8/7/07.

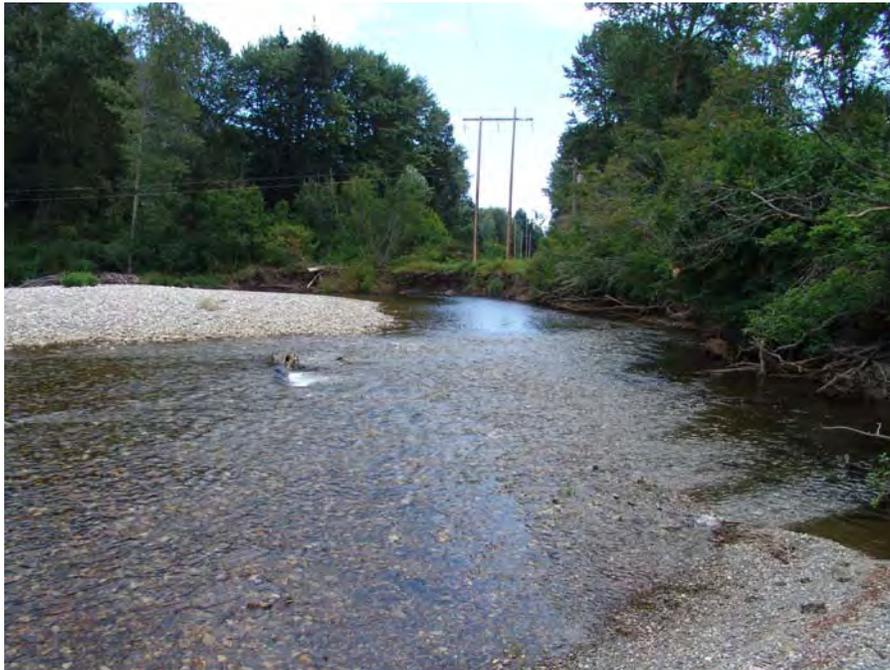
Photograph No. 9. View is to the southeast looking downstream at a channel unit sequence of run-riffle-pool, and removed vegetation along the right bank within the powerline right of way promoting local erosion. Upper White Pine Reach; Subreach IZ-2, Nason Creek - Wenatchee Subbasin, Washington. Bureau of Reclamation Photograph by D. Bennett 8/7/07.

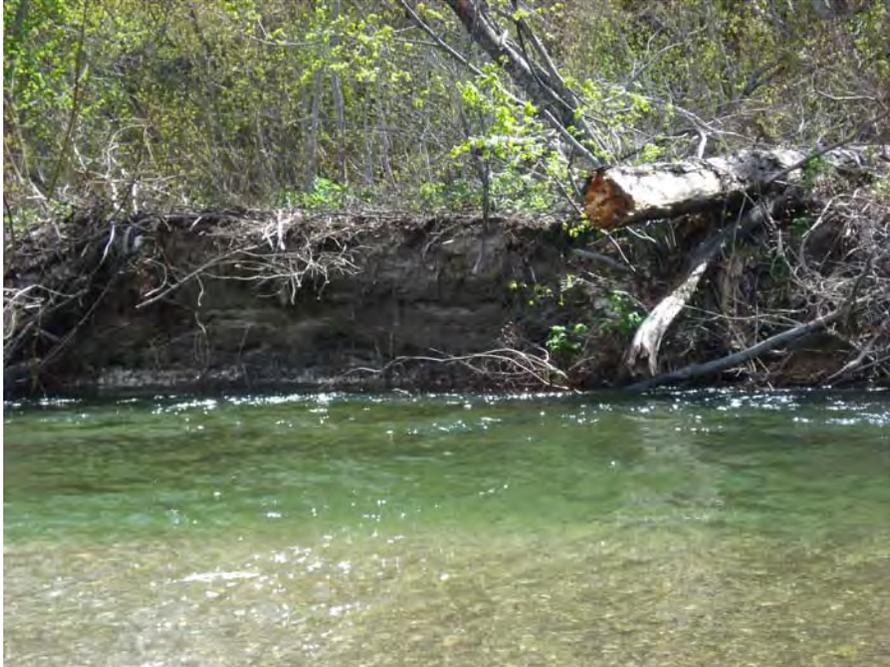
Photograph No. 14. View looking to the west, across the channel to the eroding right bank comprised of mostly silt and sand. Upper White Pine Reach; Subreach IZ-2, Nason Creek - Wenatchee Subbasin, Washington. Bureau of Reclamation Photograph by R. McAfee, May 3, 2007.

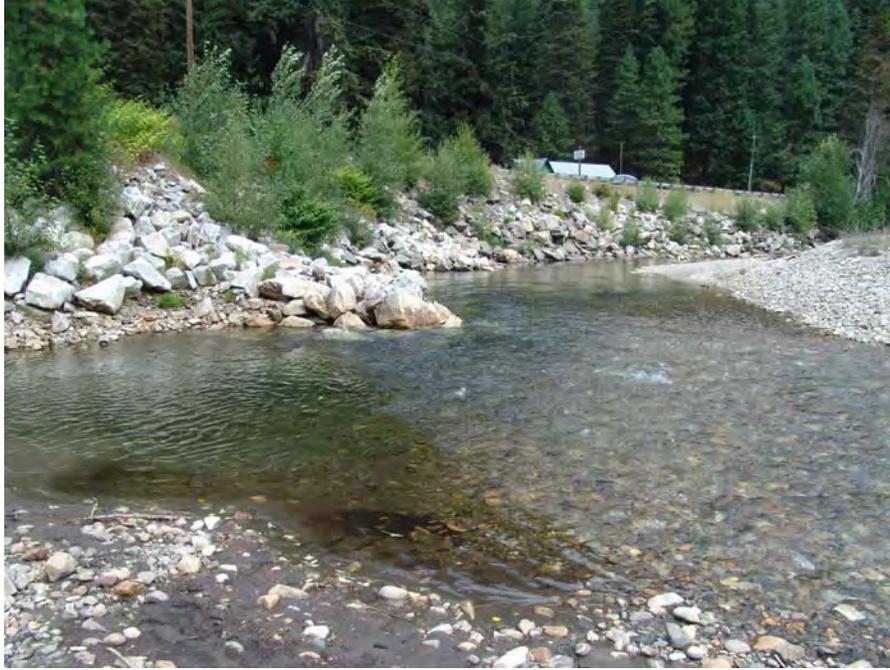
Photograph No. 16. View is to the northeast looking downstream showing riprap along the left bank with two rock spurs into channel. Upper White Pine Reach; Subreach IZ-2, Nason Creek - Wenatchee Subbasin, Washington. Bureau of Reclamation Photograph by D. Bennett 8/7/07.

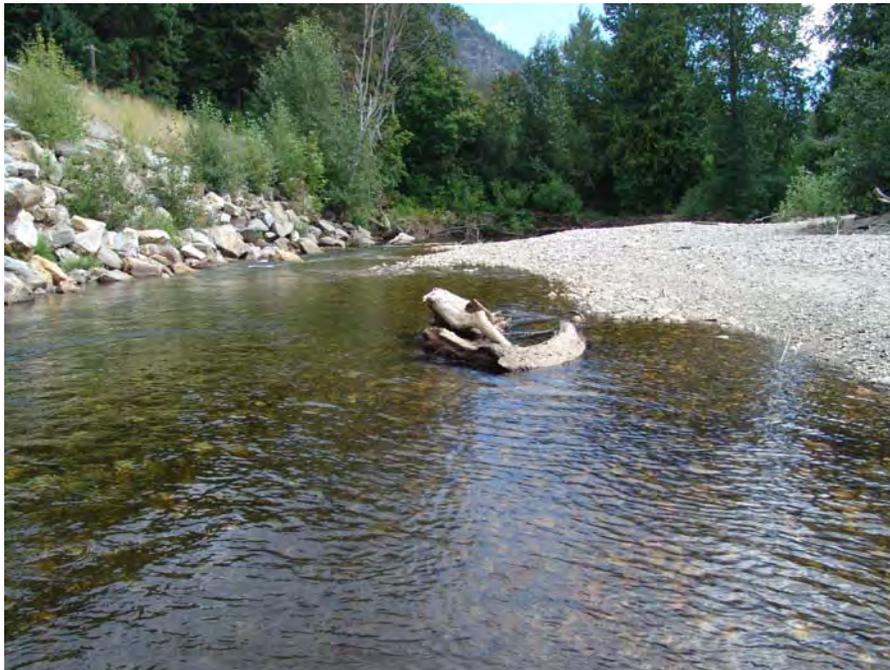
Photograph No. 17. View is to the east looking downstream at riprap that protects the highway along the left bank and a gravel point bar along the right bank. Upper White Pine Reach; Subreach IZ-2, Nason Creek - Wenatchee Subbasin, Washington. Bureau of Reclamation Photograph by D. Bennett 8/7/07.

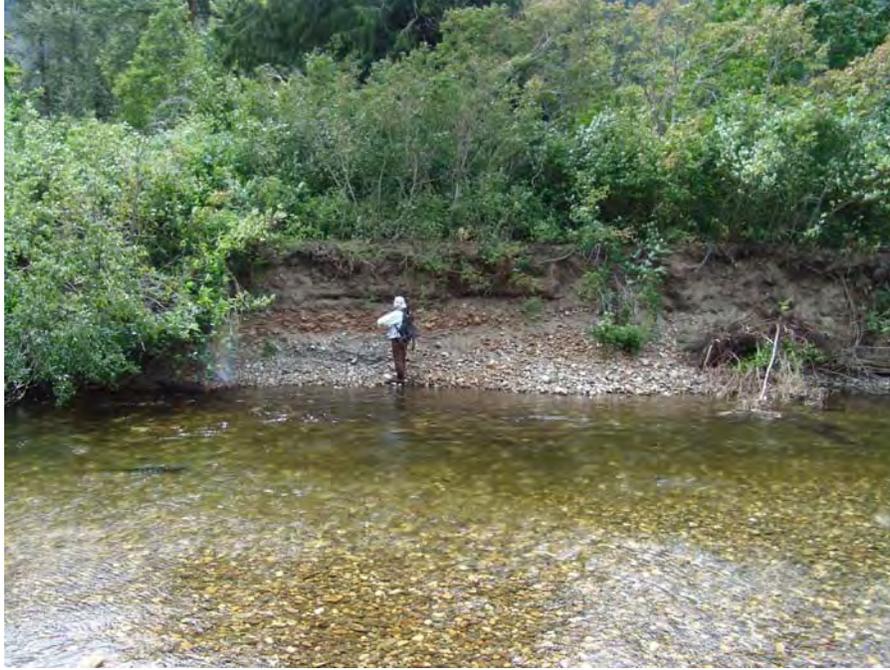
Photograph No. 20. View is to the south of local erosion along the right bank. Note the small diameter vegetation. Upper White Pine Reach; Subreach IZ-2, Nason Creek - Wenatchee Subbasin, Washington. Bureau of Reclamation Photograph by D. Bennett 8/7/07.

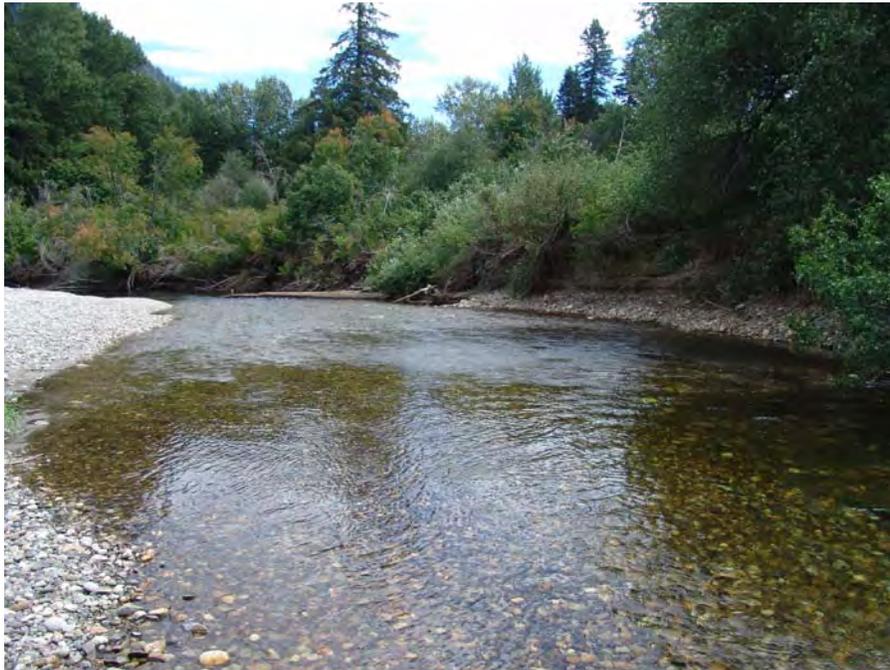
Photograph No. 21. View is to the east looking downstream at a gravel point bar along the left bank and local erosion along the right bank. The visible channel unit sequence is run-riffle-pool. Upper White Pine Reach; Subreach IZ-2, Nason Creek - Wenatchee Subbasin, Washington. Bureau of Reclamation Photograph by D. Bennett 8/7/07.

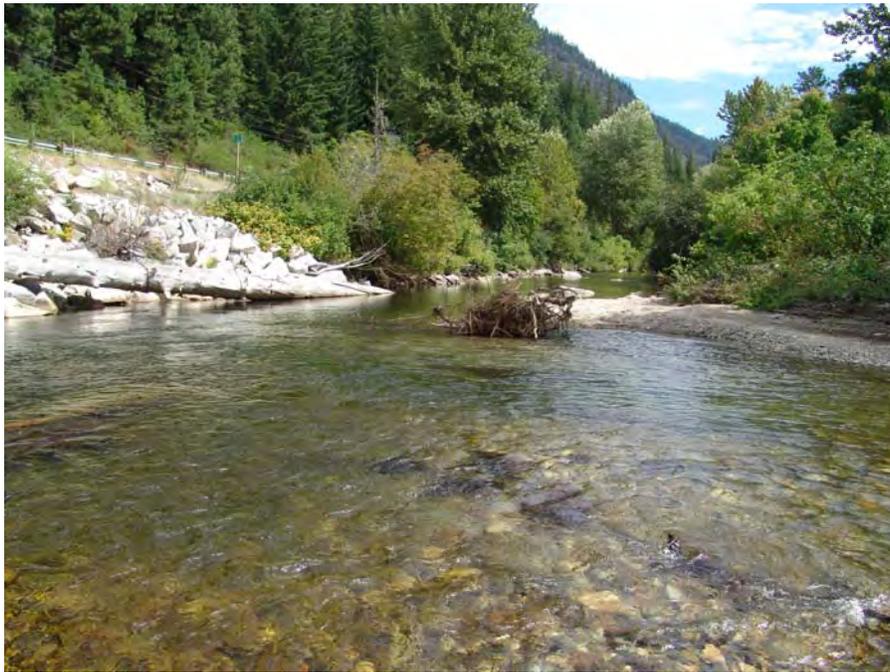
Photograph No. 23. View is to the east looking downstream at riprap that protects the highway and a cabled log along the left bank. The visible channel unit sequence is riffle to pool. Upper White Pine Reach; Subreach IZ-2, Nason Creek - Wenatchee Subbasin, Washington. Bureau of Reclamation Photograph by D. Bennett 8/7/07.

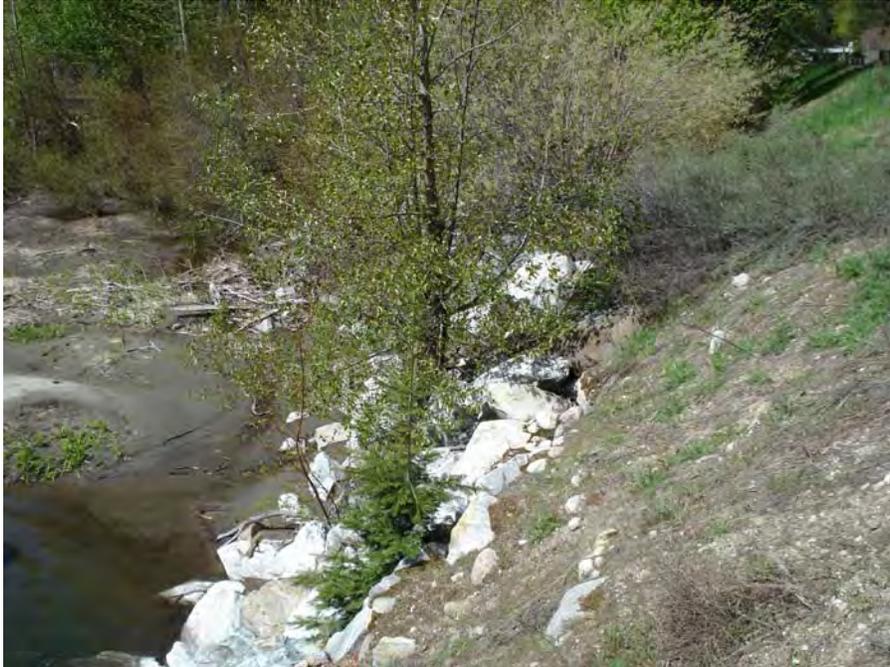
Photograph No.24. View to the west of riprap along the toe of the road embankment on the left bank of the river. Upper White Pine Reach; Subreach IZ-2, Nason Creek - Wenatchee Subbasin, Washington. Bureau of Reclamation Photograph by R. McAfee, May 3, 2007.

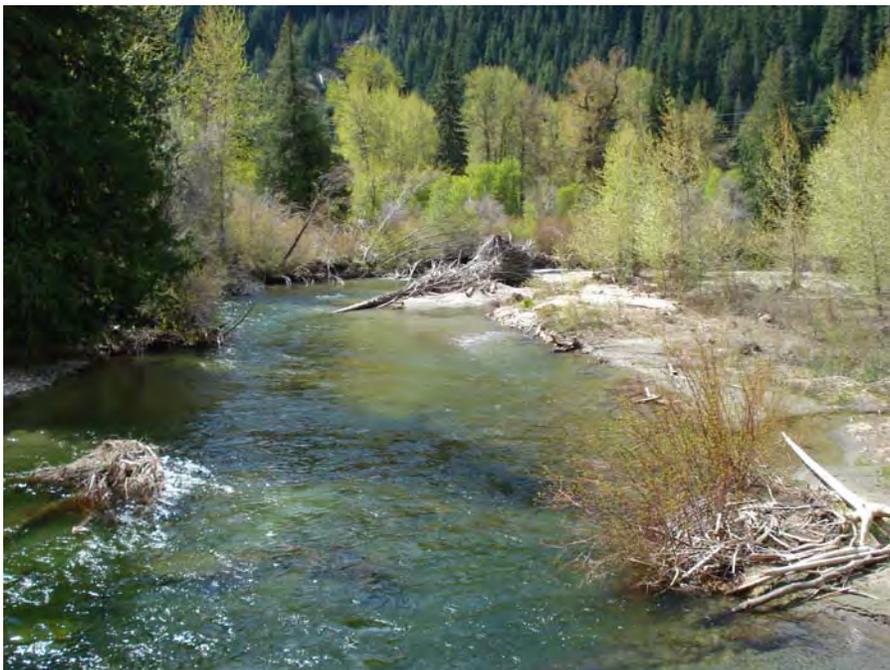
Photograph No.25. View to the south (upstream) of incorporated large wood and active erosion along the right bank. Upper White Pine Reach; Subreach IZ-2, Nason Creek - Wenatchee Subbasin, Washington. Bureau of Reclamation Photograph by R. McAfee, May 3, 2007.

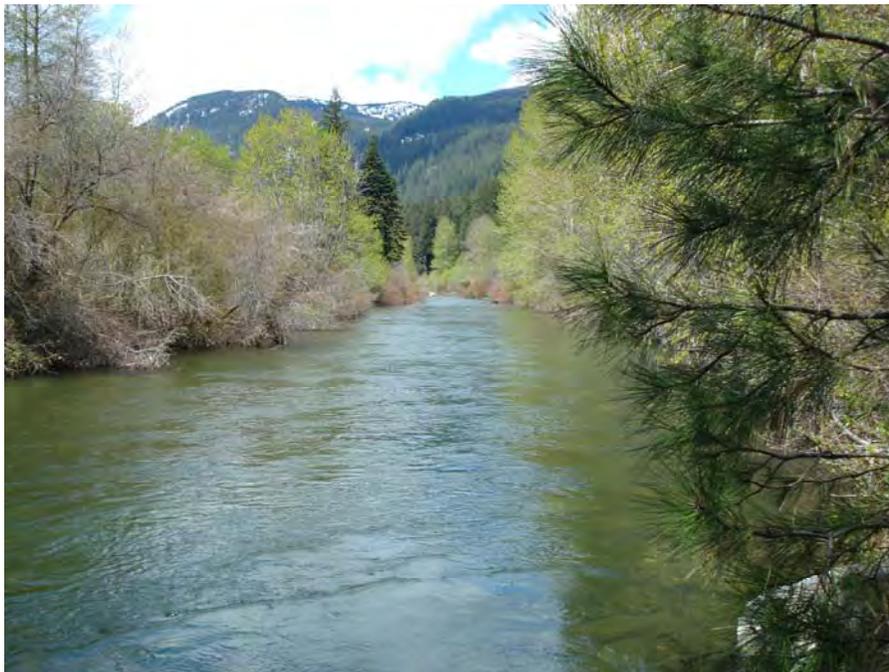
Photograph No.2. View to the southeast (downstream) of a cabled log and riprap on the left bank at the upstream end of subreach. Upper White Pine Reach; Subreach IZ-4 Nason Creek - Wenatchee Subbasin, Washington. Reclamation Photograph by R. McAfee, May 3, 2007.

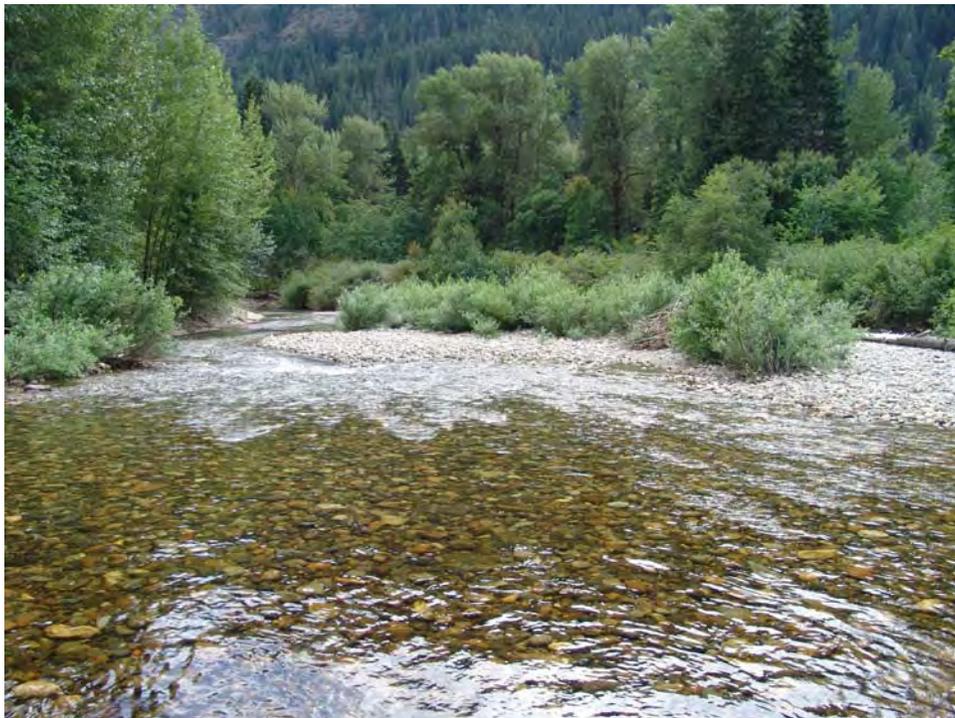
Photograph No. 6. View is to the south looking downstream at a cobble and gravel point bar on the left bank and an actively eroding right bank. Upper White Pine Reach; Subreach IZ-4 Nason Creek - Wenatchee Subbasin, Washington. Bureau of Reclamation Photograph by D. Bennett 8/7/07

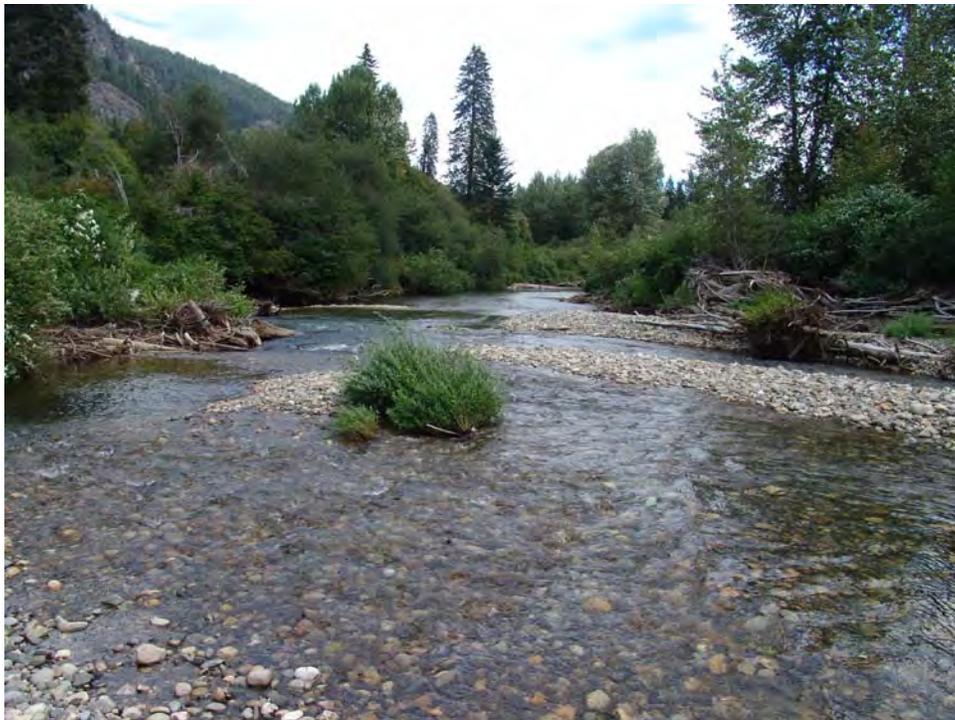
Photograph No. 8. View looking upstream to the northwest of gravel bar along the left bank and large woody debris being recruited from the right bank. Upper White Pine Reach; Subreach IZ-4 Nason Creek - Wenatchee Subbasin, Washington. Reclamation Photograph by R. McAfee, May 7, 2007.

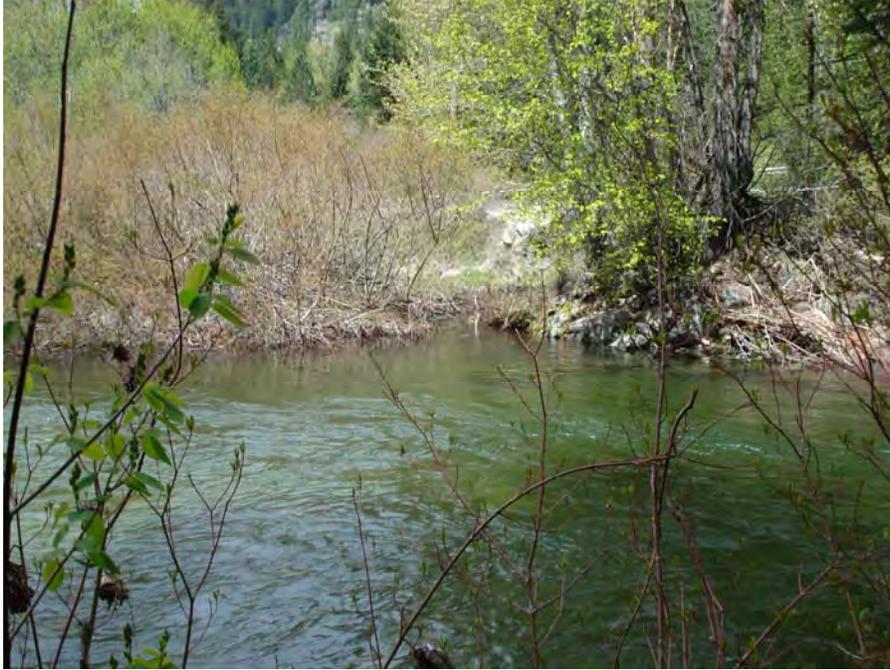
Photograph No. 2. View to the northwest of a wetlands outlet into the active channel. Upper White Pine Reach; Subreach OZ-3, Nason Creek - Wenatchee Subbasin, Washington. Bureau of Reclamation Photograph by R. McAfee, May 3, 2007.

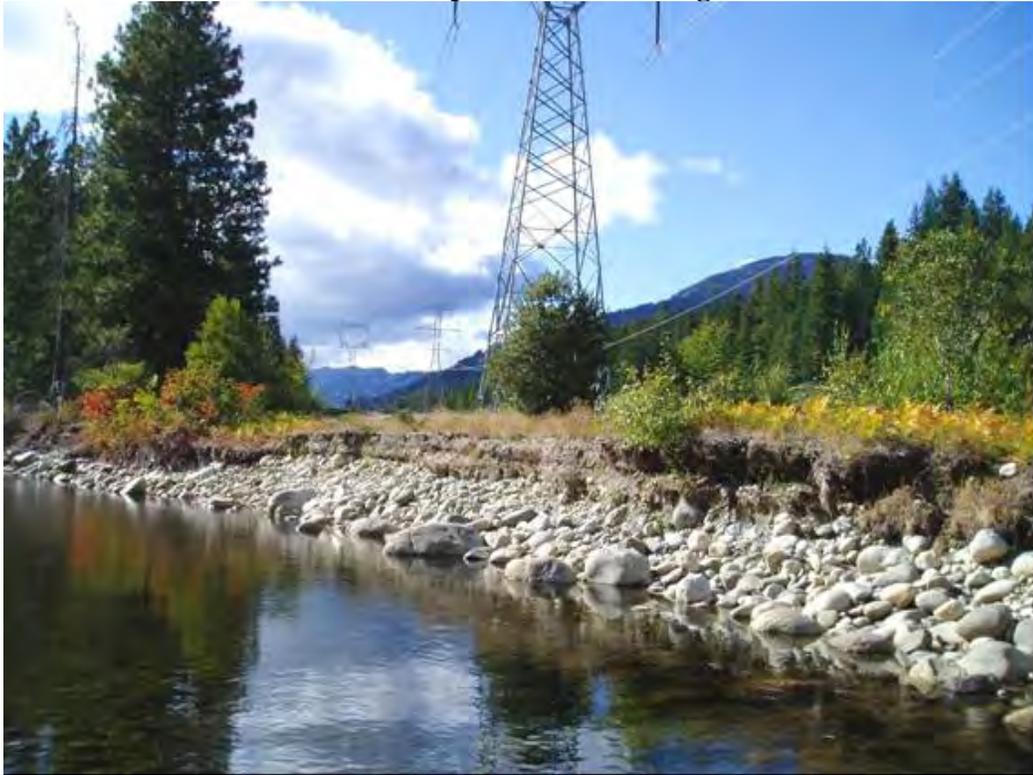
Pool habitat lacking complexity in Reach 1

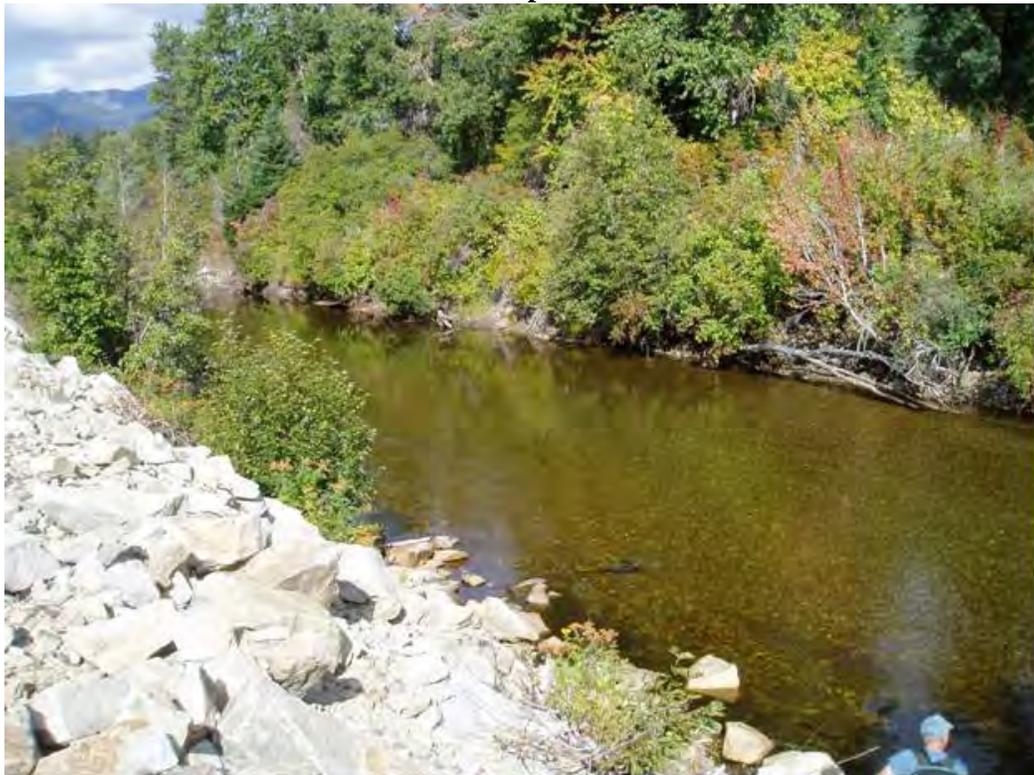
Cabled Logs in Pool at RM 10.3

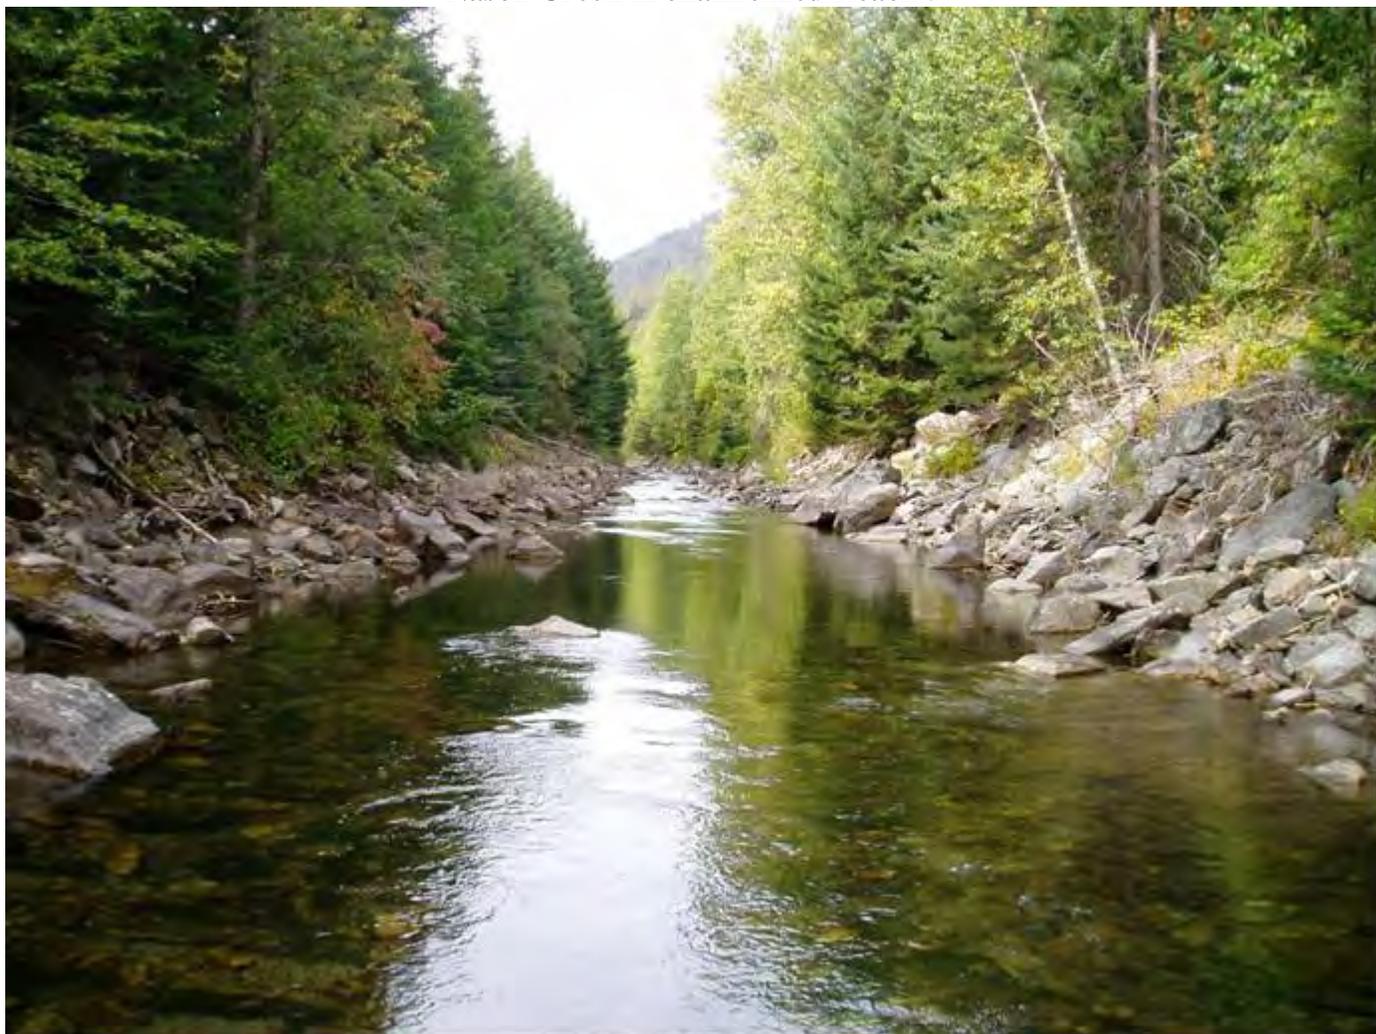
Nason Creek in channelized Reach 5
