## **APPENDIX C – GEOLOGY AND GEOMORPHOLOGY**

## GEOLOGY AND GEOMORPHOLOGY REPORT FOR THE CATHERINE CREEK TRIBUTARY ASSESSMENT – GRANDE RONDE RIVER BASIN Tributary Habitat Program, Oregon

February 2012

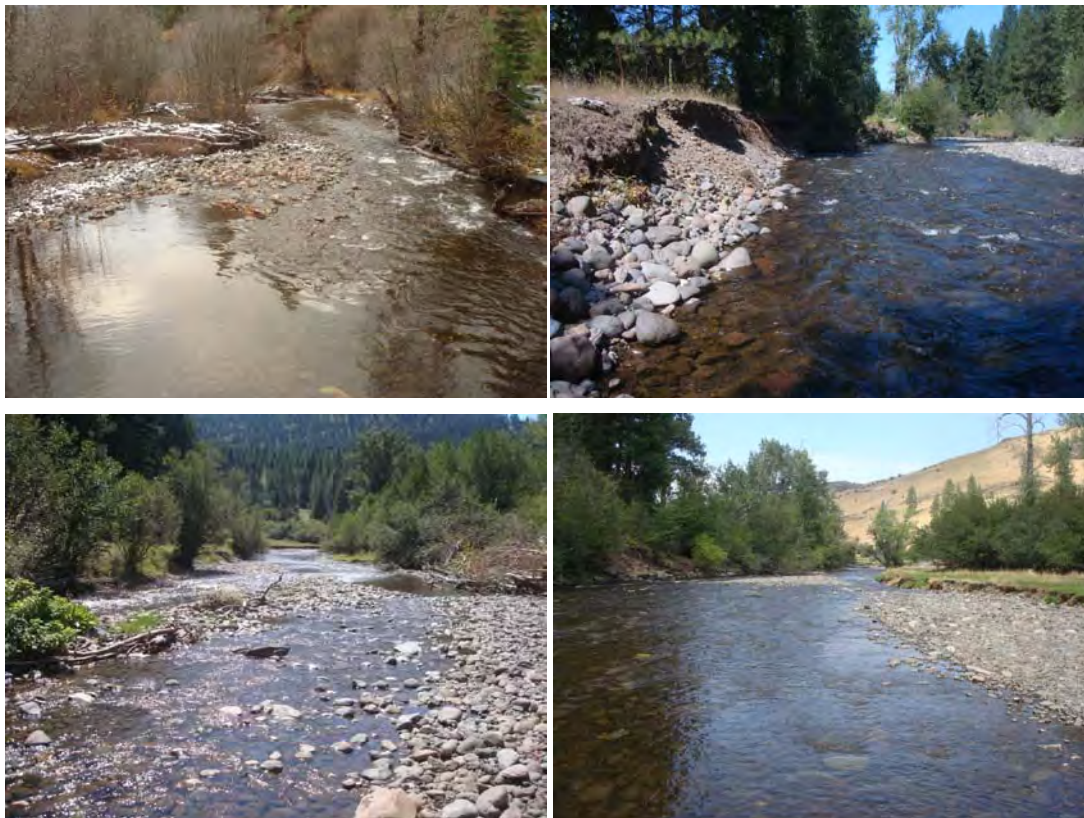
**Figure 25. Various bank conditions, vegetation, and substrate in the Upper Valley Group.**

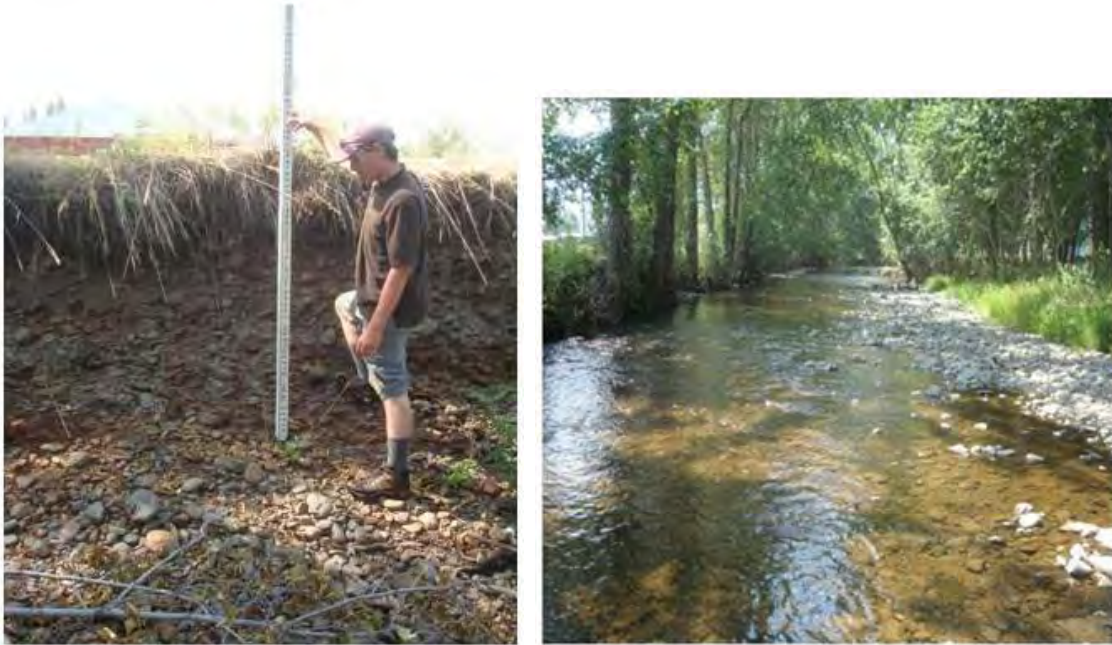
**Figure 27. Various bank conditions, vegetation, and substrate in reach 3.**

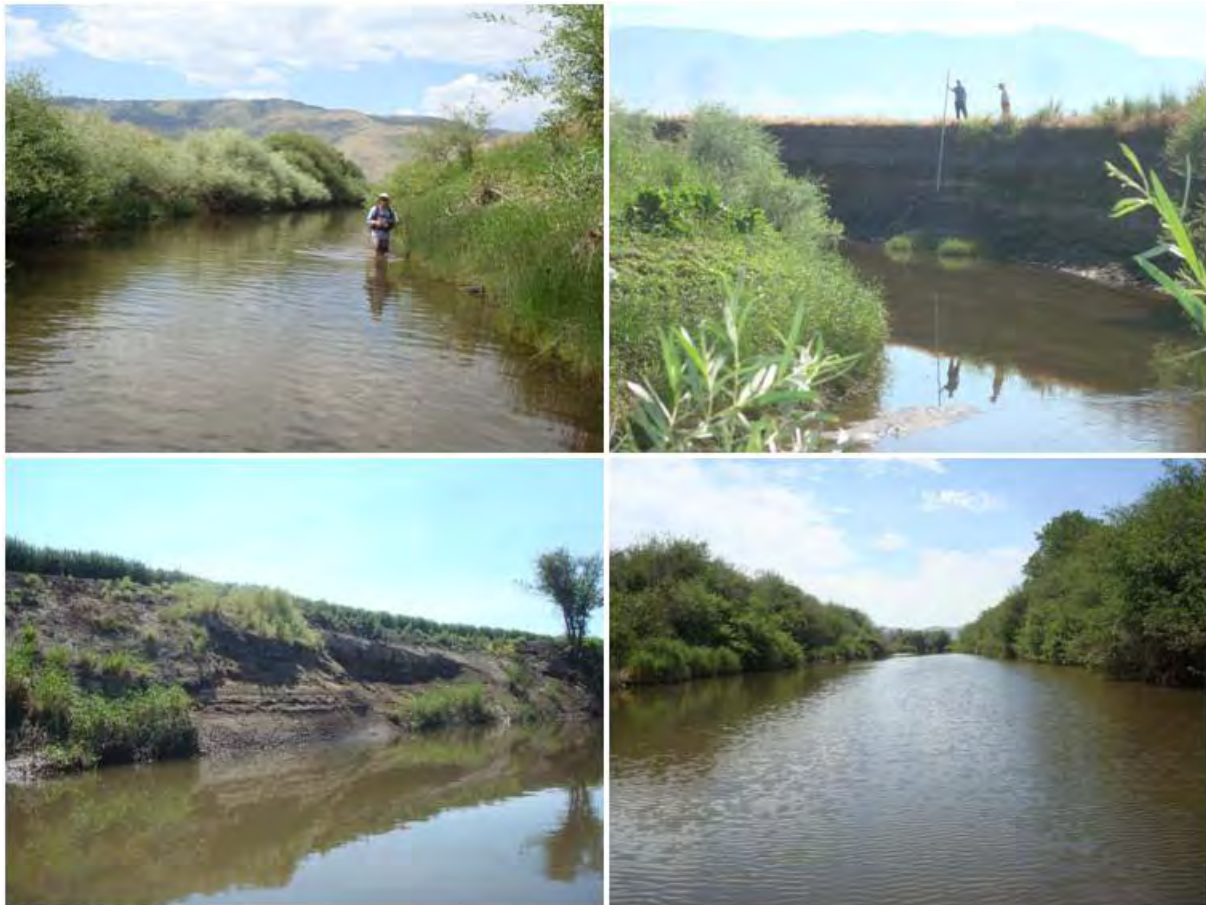
**Figure 29. Various bank conditions, vegetation, and substrate in the Valley Floor Group.**

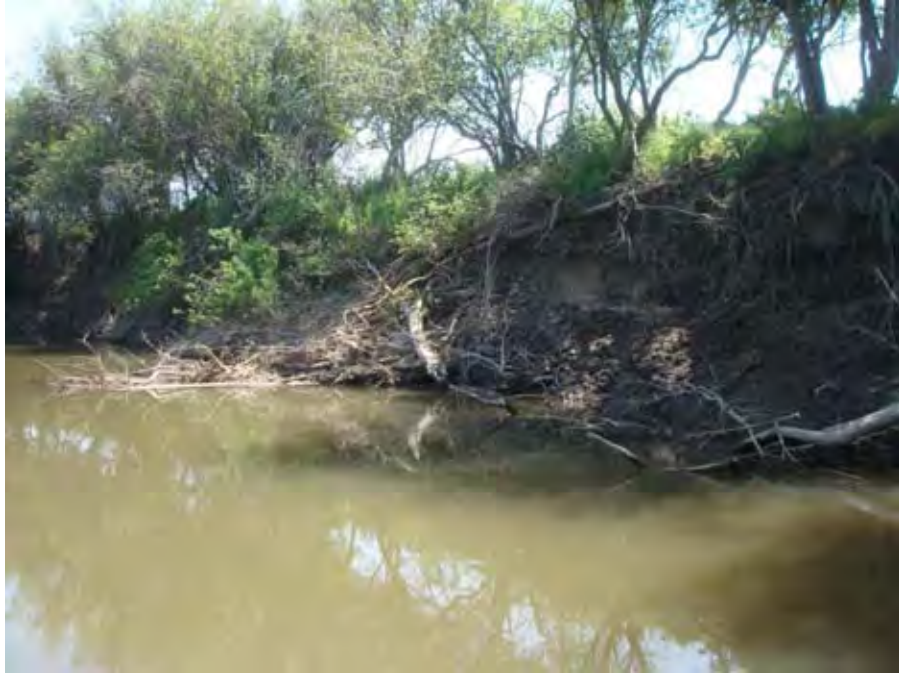
**Photograph 6. View of fine-grained alluvium, sloughing and tree debris on the right (east) bank of Catherine Creek near river mile 22.00. Reach 1 – Catherine Creek, Grande Ronde Subbasin, Oregon – Bureau of Reclamation Photograph by D. Stelma, July 11, 2010.**

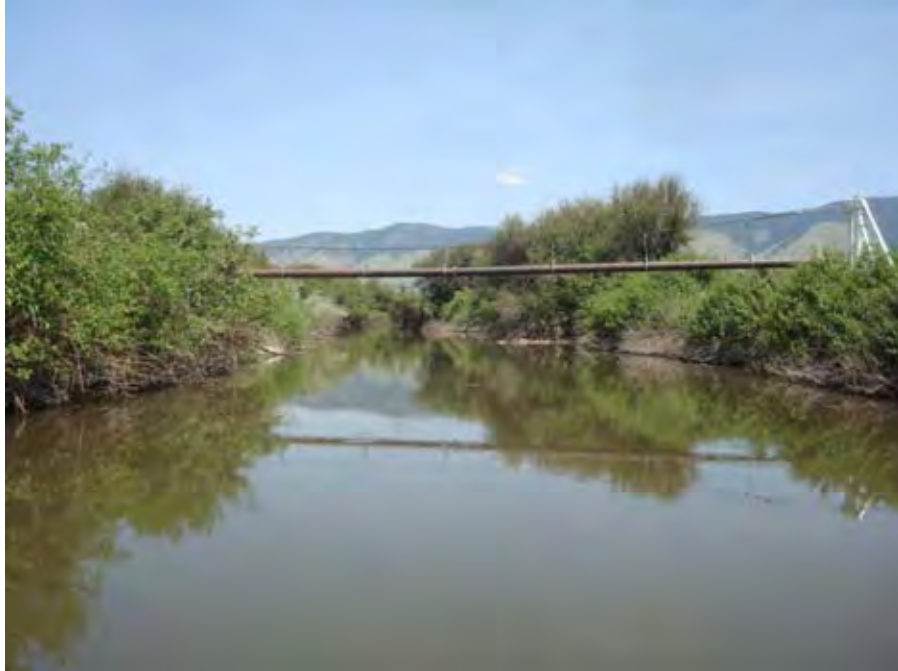
**Photograph 12. View looking downstream at irrigation pipe crossing Catherine Creek near river mile 20.81. Reach 1 – Catherine Creek, Grande Ronde Subbasin, Oregon – Bureau of Reclamation Photograph by D. Stelma, July 11, 2010.**

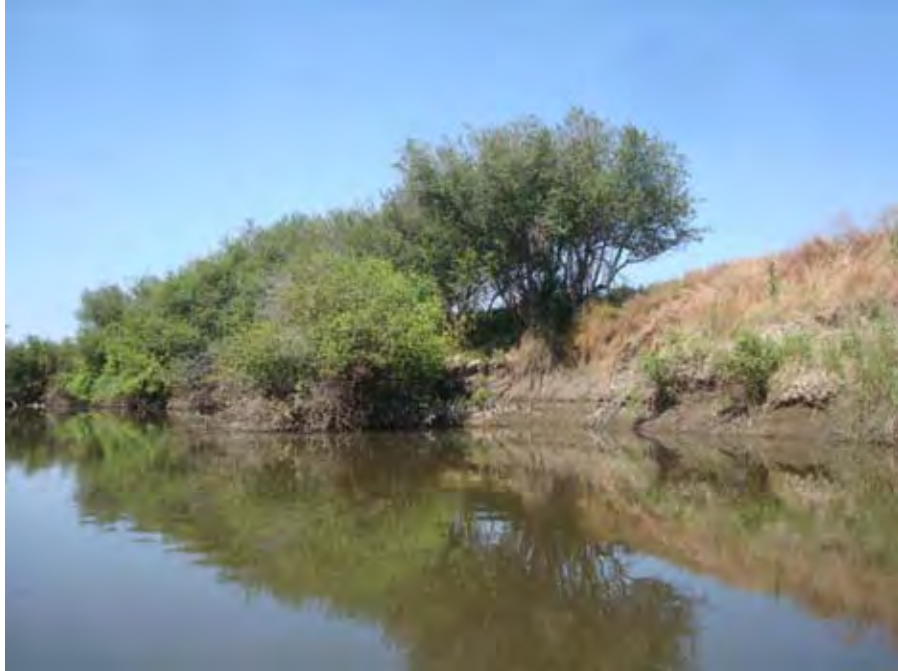
**Photograph 14. View looking upstream at left (west) bank of Catherine Creek, note erosion of bank materials downstream of shrubs near river mile 20.25. Reach 1 – Catherine Creek, Grande Ronde Subbasin, Oregon – Bureau of Reclamation Photograph by D. Stelma, July 11, 2010.**

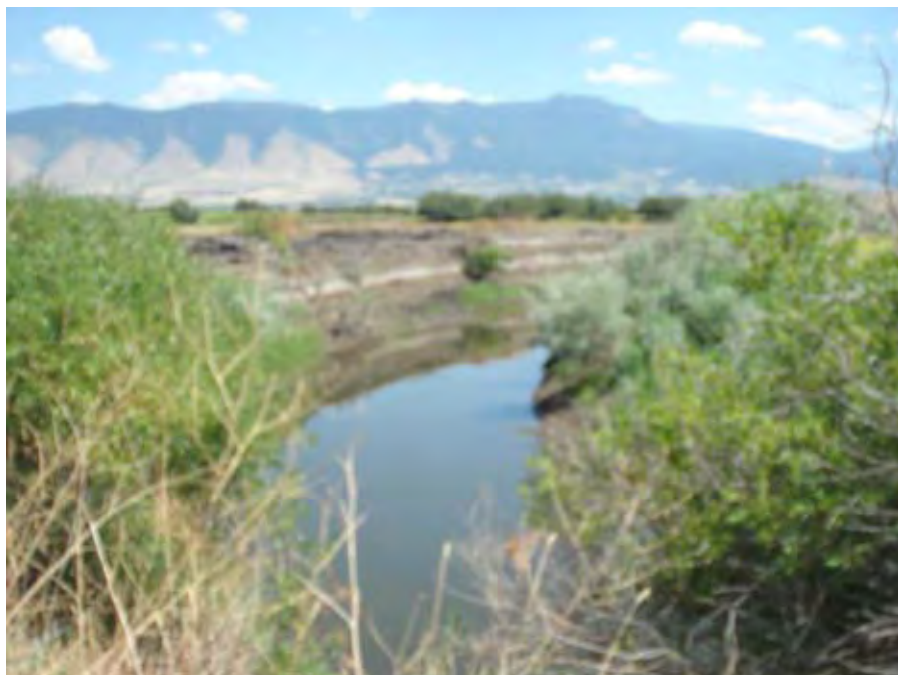
**Photograph 15. View from the left bank looking downstream at mostly bare banks near river mile 20.12. Reach 1 – Catherine Creek, Grande Ronde Subbasin, Oregon – Bureau of Reclamation Photograph by R. McAfee, July 29, 2010.**

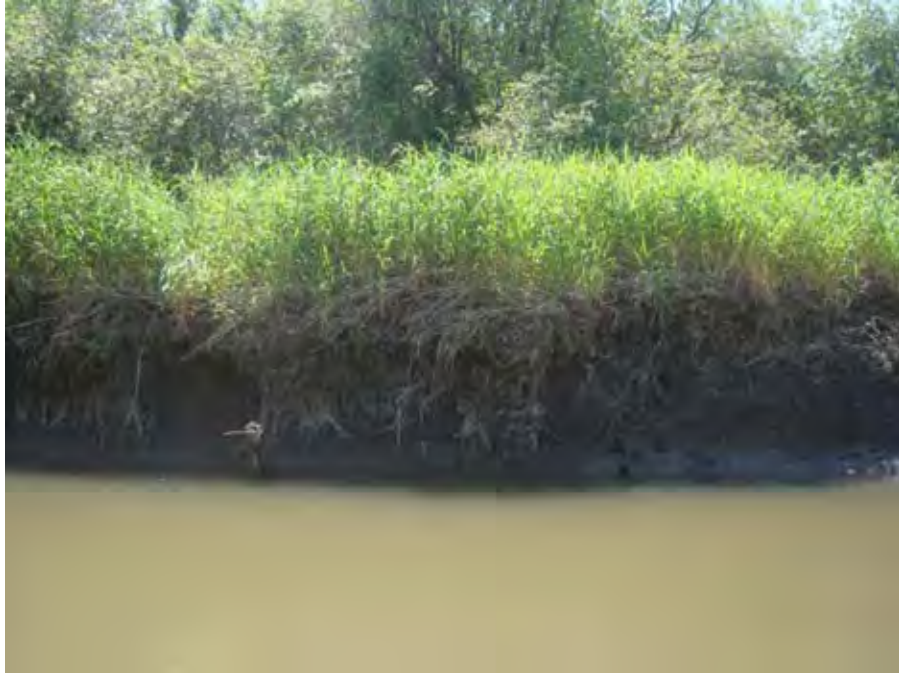
**Photograph 16. View looking at alfalfa grass and undercut right bank of Catherine Creek near river mile 20.10. Reach 1 – Catherine Creek, Grande Ronde Subbasin, Oregon – Bureau of Reclamation Photograph by D. Stelma, July 11, 2010.**

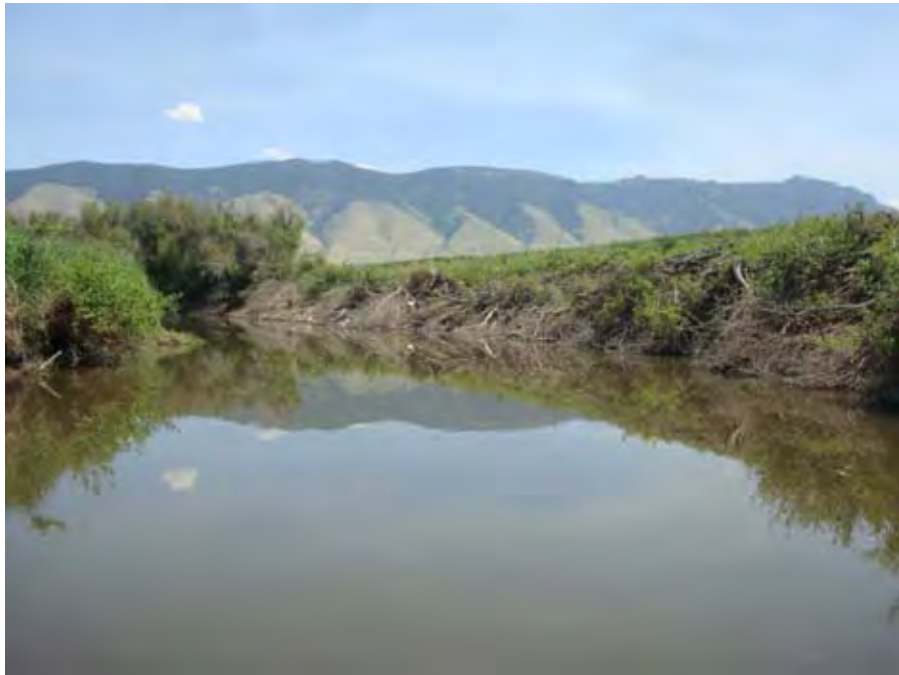
**Photograph 17. View looking downstream at tree branch erosion protection on right (east) bank of Catherine Creek adjacent to grain field near river mile 19.97. Reach 1 – Catherine Creek, Grande Ronde Subbasin, Oregon – Bureau of Reclamation Photograph by D. Stelma, July 11, 2010.**

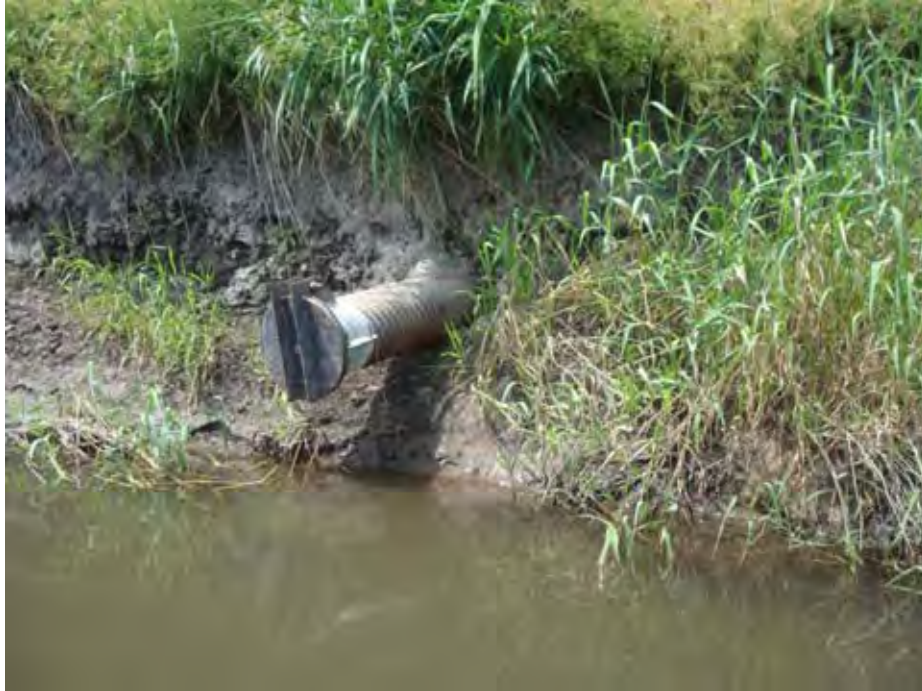
**Photograph 24. View looking downstream at discharge pipe with one-way flapper valve on left bank of Catherine Creek near river mile 17.33. Reach 1 – Catherine Creek, Grande Ronde Subbasin, Oregon – Bureau of Reclamation Photograph by D. Stelma, July 10, 2010.**

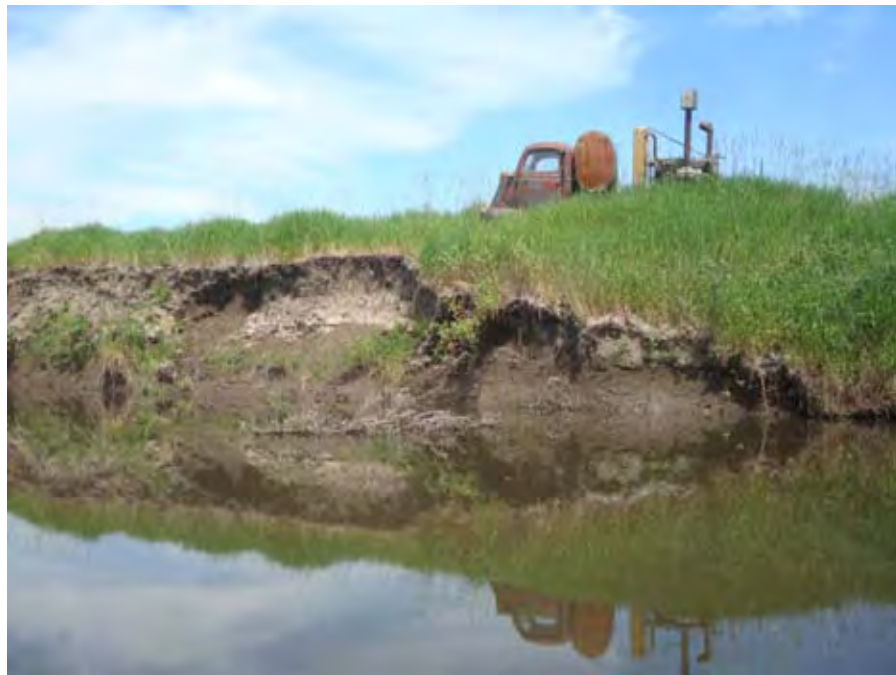
**Photograph 25. View looking at erosion and truck-mounted pump (abandoned?) on left (west) bank of Catherine Creek near river mile 17.10. Reach 1 – Catherine Creek, Grande Ronde Subbasin, Oregon – Bureau of Reclamation Photograph by D. Stelma, July 10, 2010.**

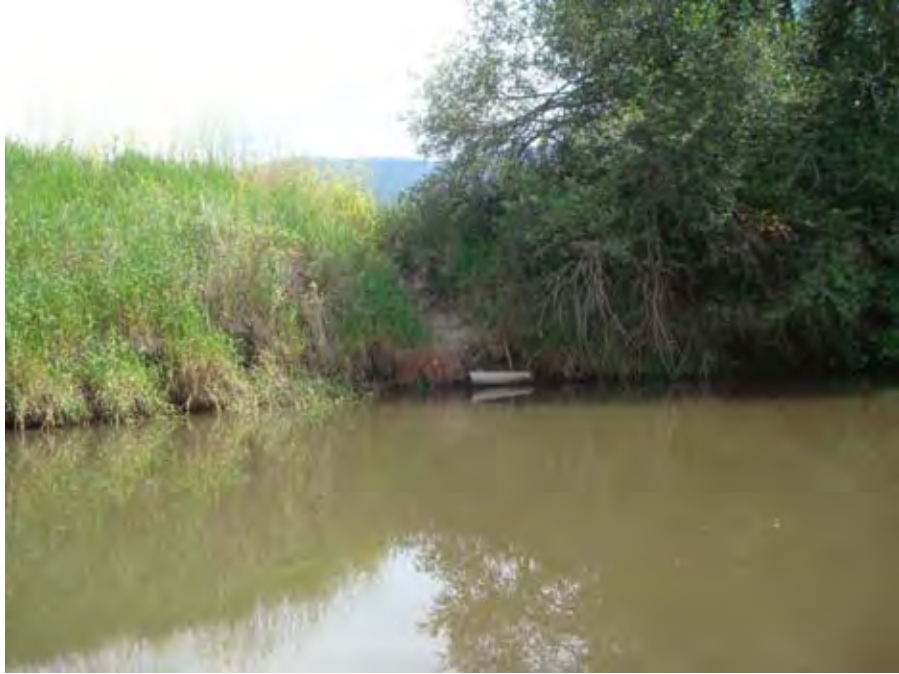
**Photograph 26. View looking downstream at discharge pipe with one-way flapper valve on right bank of Catherine Creek near river mile 16.93. Reach 1 – Catherine Creek, Grand Ronde Subbasin, Oregon – Bureau of Reclamation Photograph by D. Stelma, July 10, 2010.**

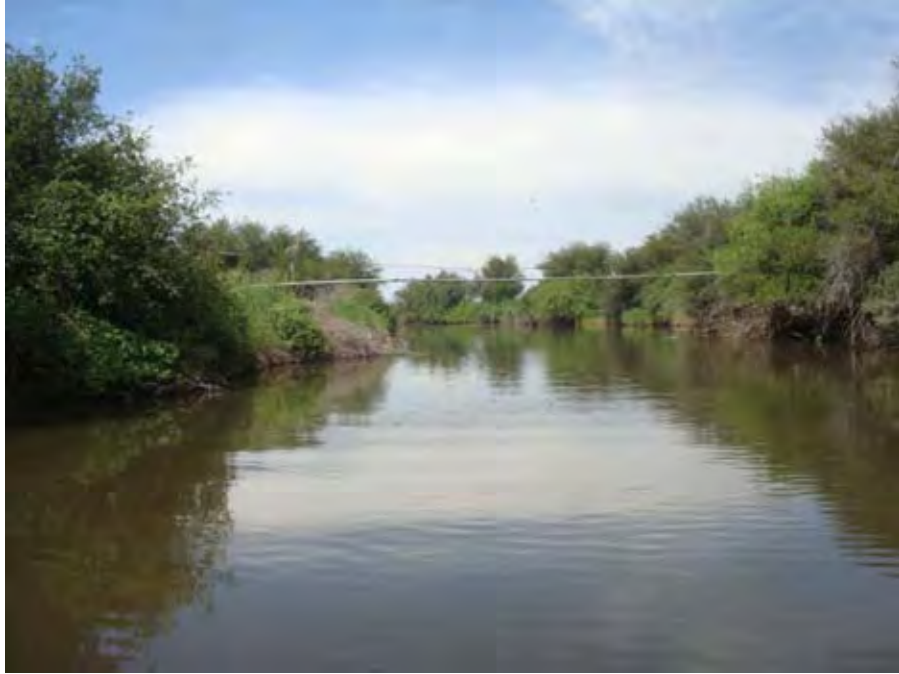
**Photograph 30. View looking upstream at small diameter pipe crossing Catherine Creek near river mile 16.06. Reach 1 – Catherine Creek, Grande Ronde Subbasin, Oregon – Bureau of Reclamation Photograph by D. Stelma, July 10, 2010.**

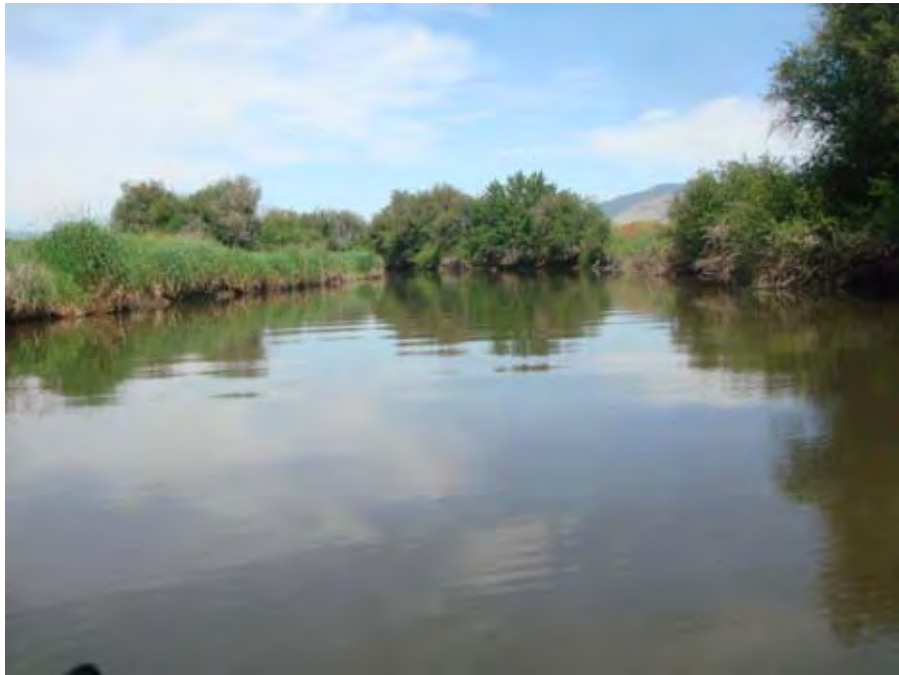
**Photograph 31. View looking upstream at Catherine Creek channel near river mile 15.90. Reach 1 – Catherine Creek, Grande Ronde Subbasin, Oregon – Bureau of Reclamation Photograph by D. Stelma, July 10, 2010.**

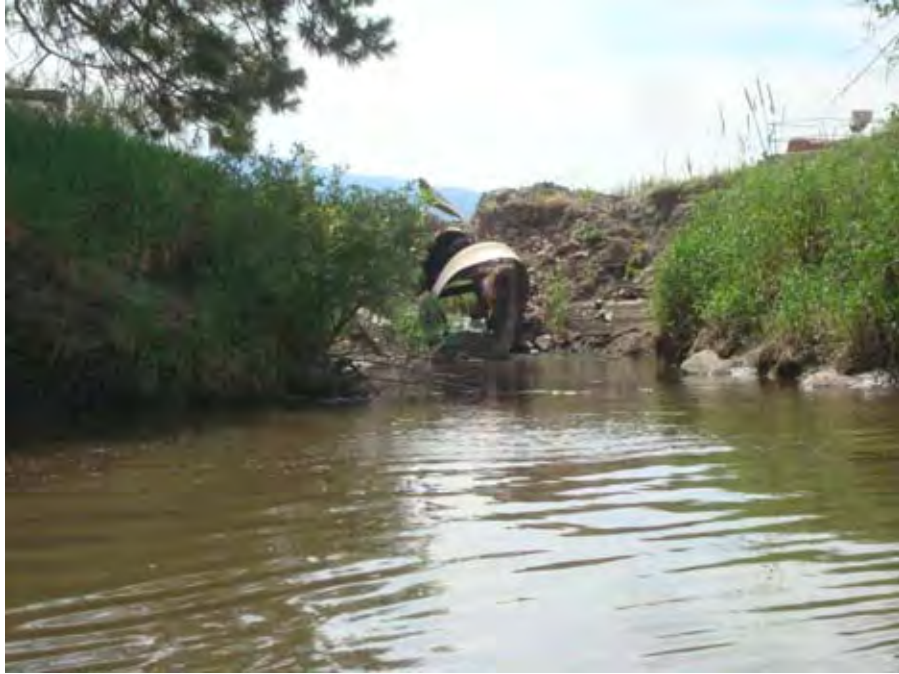
**Photograph 32. Crushed culvert at discharge of man-made drainage ditch, Catherine Creek in foreground near river mile 15.77. Reach 1 – Catherine Creek, Grande Ronde Subbasin, Oregon – Bureau of Reclamation Photograph by D. Stelma, July 10, 2010.**

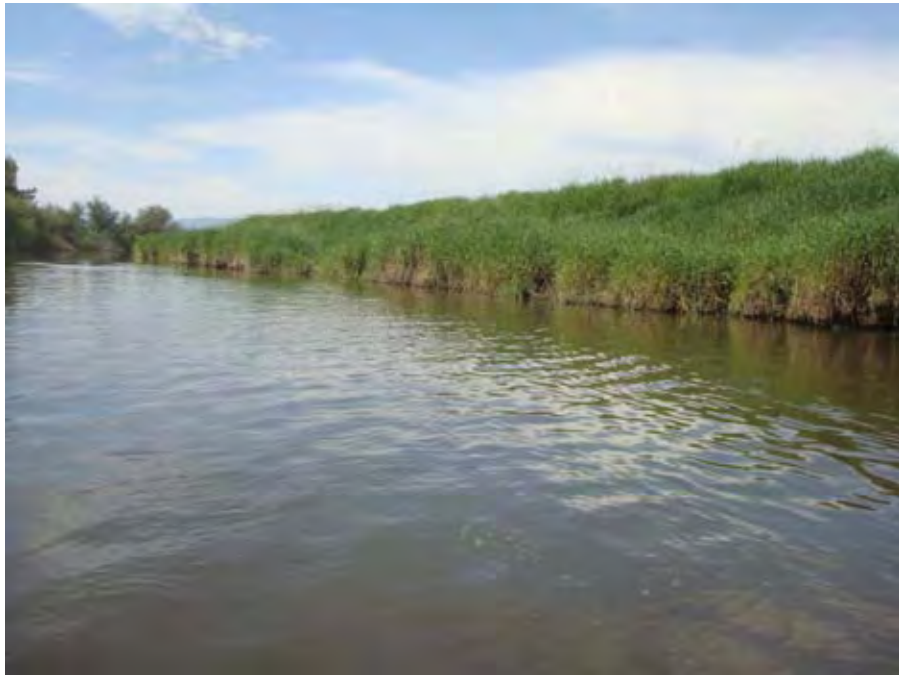
**Photograph 33. View looking upstream at Catherine Creek channel (alfalfa grass) near river mile 15.70. Reach 1 – Catherine Creek, Grande Ronde Subbasin, Oregon – Bureau of Reclamation Photograph by D. Stelma, July 10, 2010.**

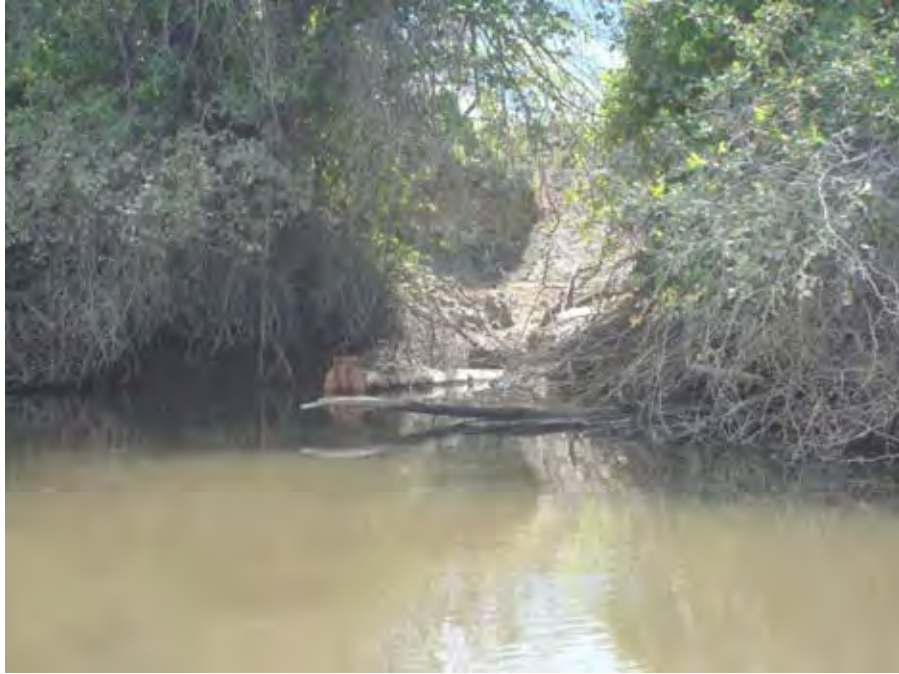
**Photograph 34. Oxbow lake discharge pipe with one-way flapper valve on right (east) bank of Catherine Creek near river mile 15.67. Reach 1 – Catherine Creek, Grande Ronde Subbasin, Oregon – Bureau of Reclamation Photograph by D. Stelma, July 10, 2010.**

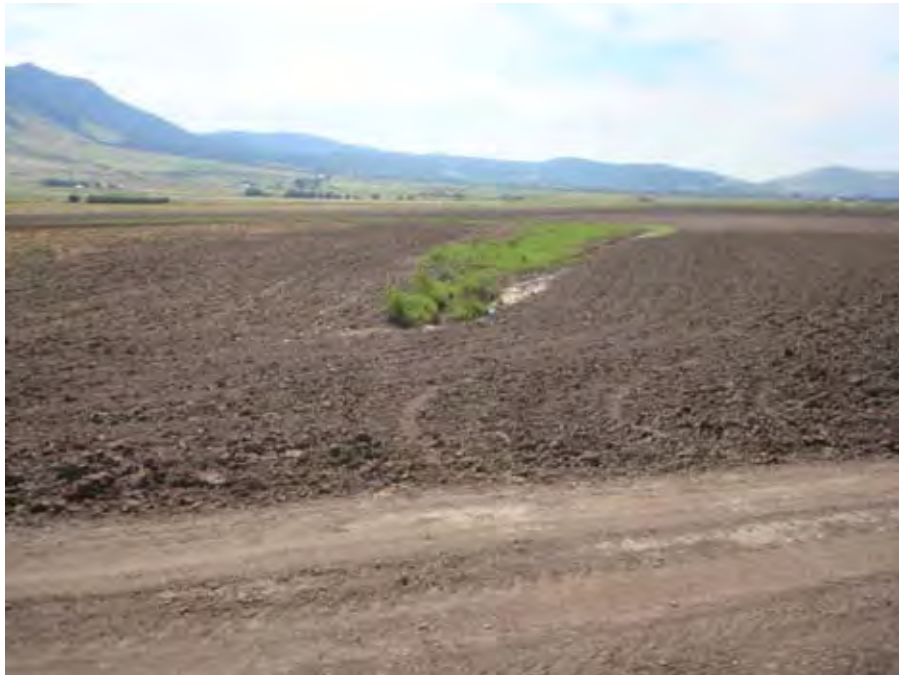
**Photograph 35. Small remnant of oxbow in field east of Catherine Creek near river mile 15.67. Reach 1 – Catherine Creek, Grande Ronde Subbasin, Oregon – Bureau of Reclamation Photograph by D. Stelma, July 10, 2010.**

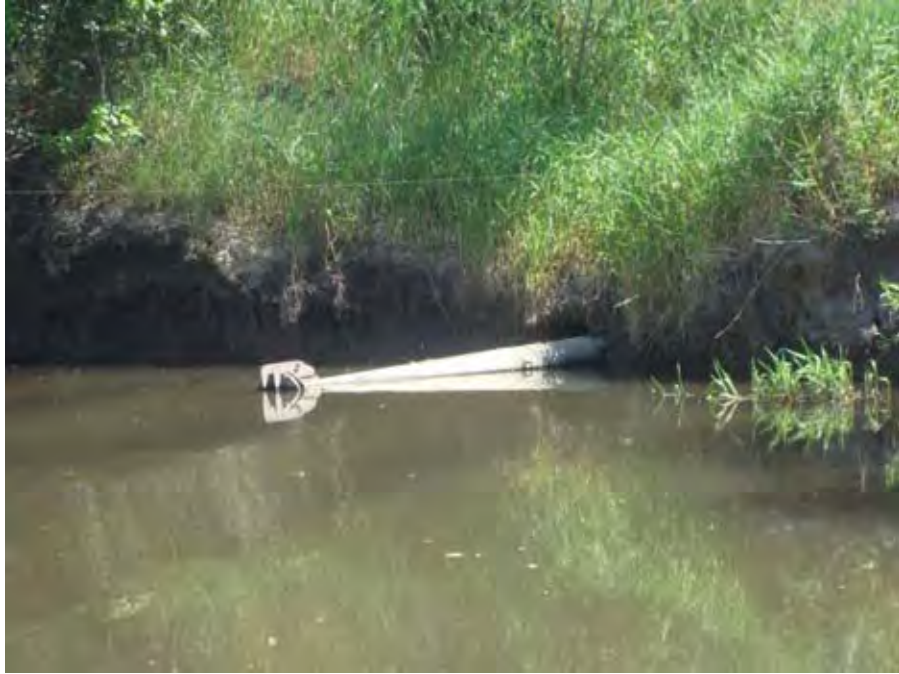
**Photograph 36. Oxbow lake discharge pipe with one-way flapper valve on right (east) bank of Catherine Creek near river mile 15.55. Reach 1 – Catherine Creek, Grande Ronde Subbasin, Oregon – Bureau of Reclamation Photograph by D. Stelma, July 10, 2010.**

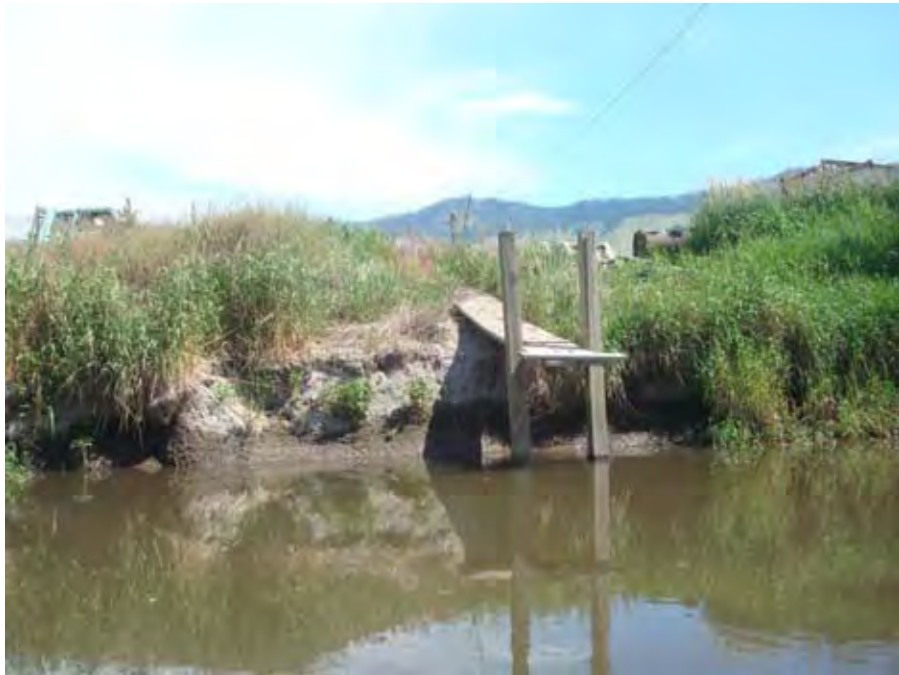
**Photograph 37. Dock on right (east) bank of Catherine Creek upstream of Booth Road bridge near river mile 15.45. Reach 1 – Catherine Creek, Grande Ronde Subbasin, Oregon – Bureau of Reclamation Photograph by D. Stelma, July 10, 2010.**

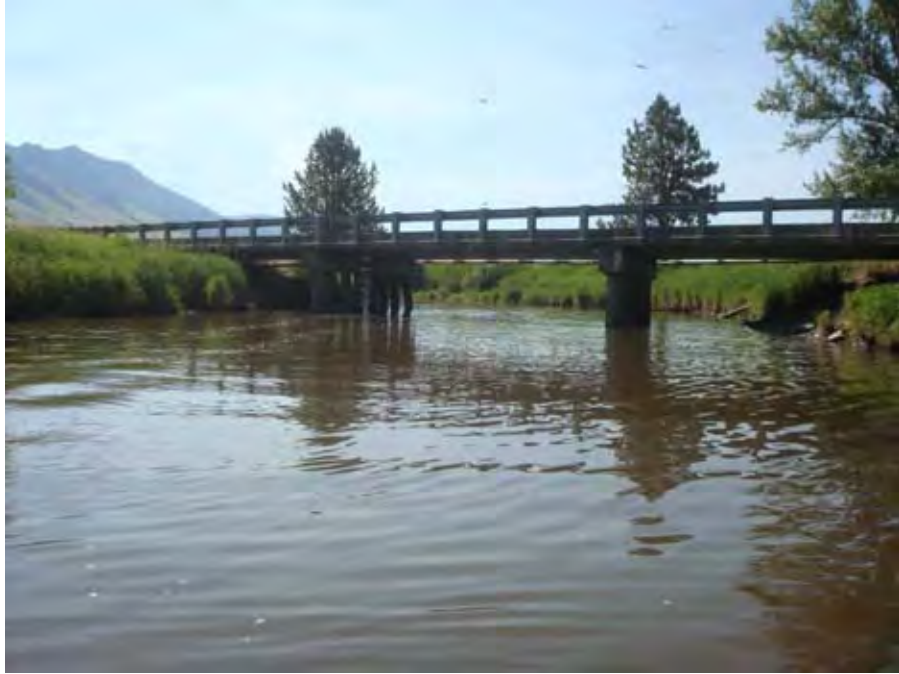
**Photograph 38. View looking upstream at Booth Road Bridge near river mile 15.30. Reach 1 – Catherine Creek, Grande Ronde Subbasin, Oregon – Bureau of Reclamation Photograph by D. Stelma, July 10, 2010.**

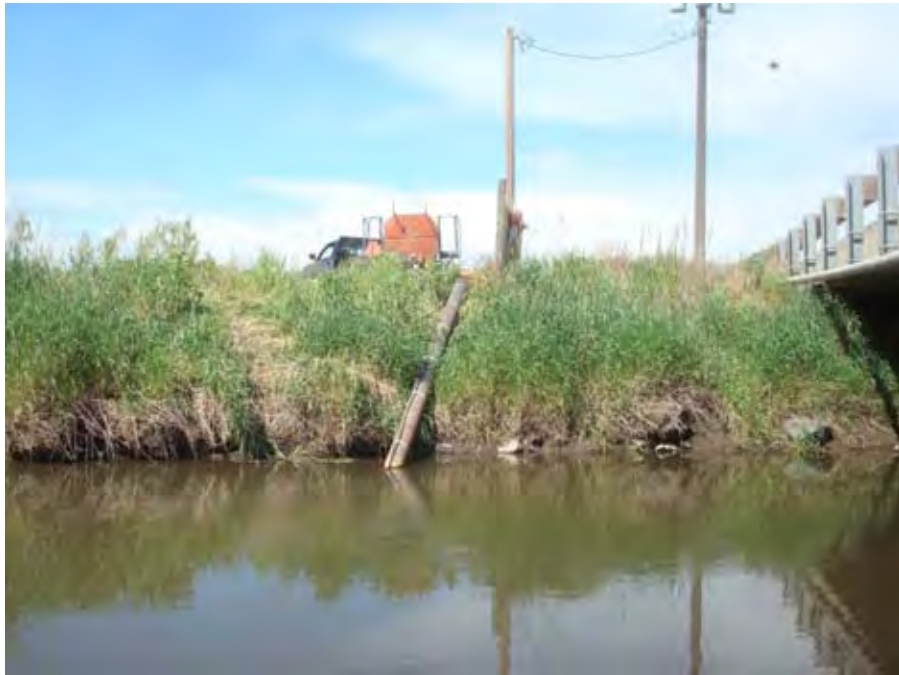
**Photograph 39. Pumping plant on left (west) bank of Catherine Creek upstream of Booth Road bridge near river mile 15.30. Reach 1 – Catherine Creek, Grande Ronde Subbasin, Oregon – Bureau of Reclamation Photograph by D. Stelma, July 10, 2010.**

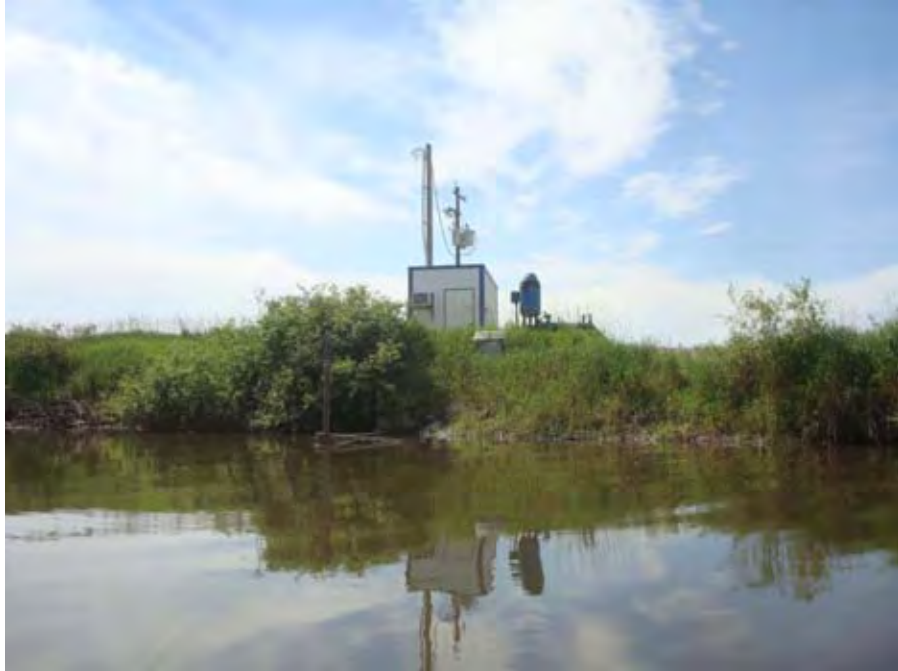
**Photograph 40. Pumping plant on left (west) bank of Catherine Creek, upstream of Elmer Dam near river mile 15.13. Reach 1 – Catherine Creek, Grande Ronde Subbasin, Oregon – Bureau of Reclamation Photograph by D. Stelma, July 10, 2010.**

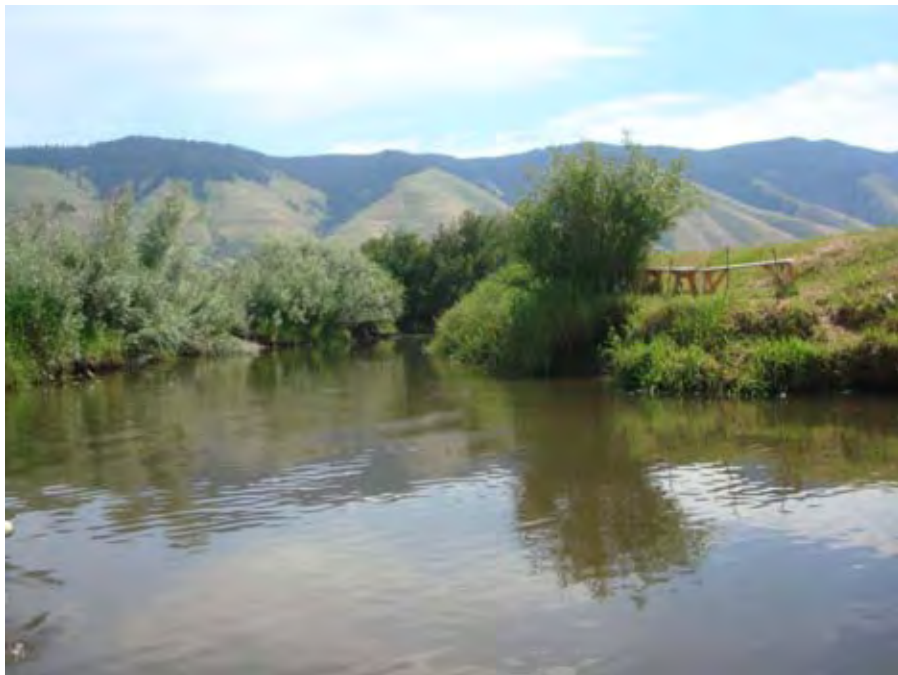
**Photograph 41. Bench at fishing hole on left (east) bank of Catherine Creek at partially opened inlet to an abandoned meander near river mile 14.84. Reach 1 – Catherine Creek, Grande Ronde Subbasin, Oregon – Bureau of Reclamation Photograph by D. Stelma, July 10, 2010.**

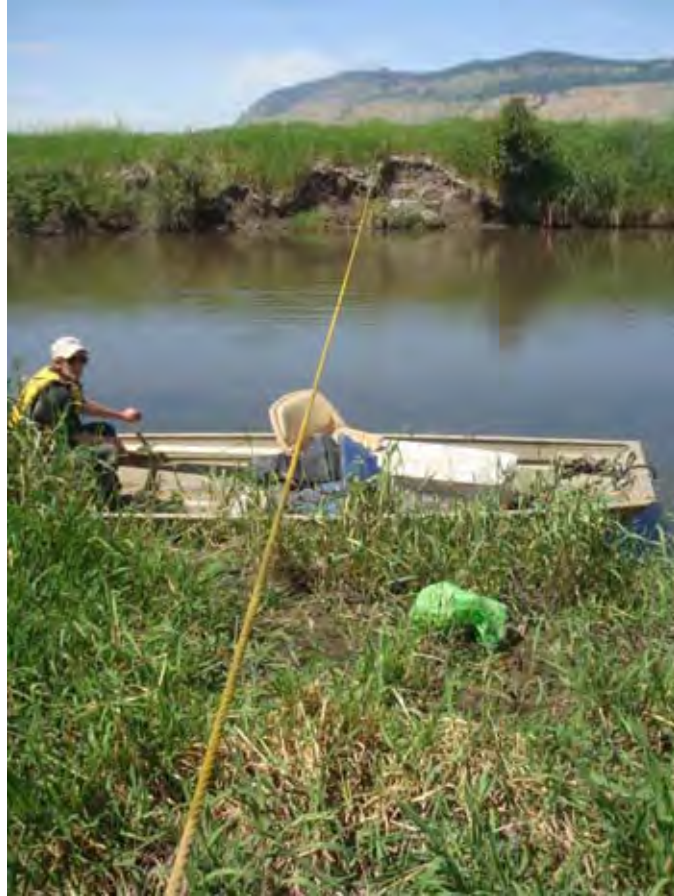
**Photograph 42. View looking from the left bank toward right of Catherine Creek at profile site near river mile 14.50. Reach 1 – Catherine Creek, Grande Ronde Subbasin, Oregon – Bureau of Reclamation Photograph by D. Stelma, July 10, 2010.**

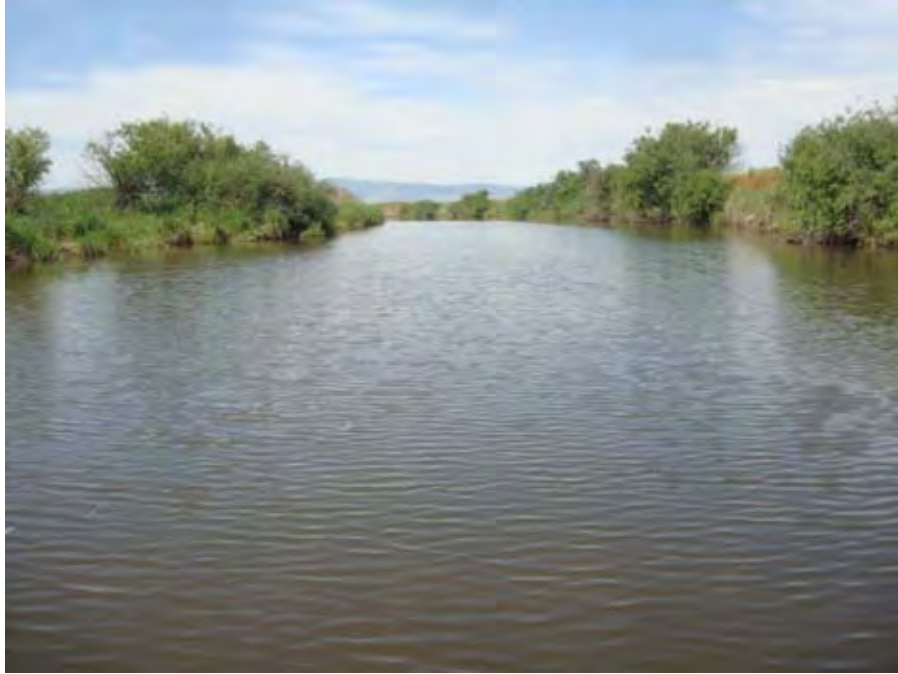
**Photograph 43. View looking upstream at Catherine Creek channel upstream of Elmer Dam near river mile 14.40. Reach 1 – Catherine Creek, Grande Ronde Subbasin, Oregon – Bureau of Reclamation Photograph by D. Stelma, July 10, 2010.**

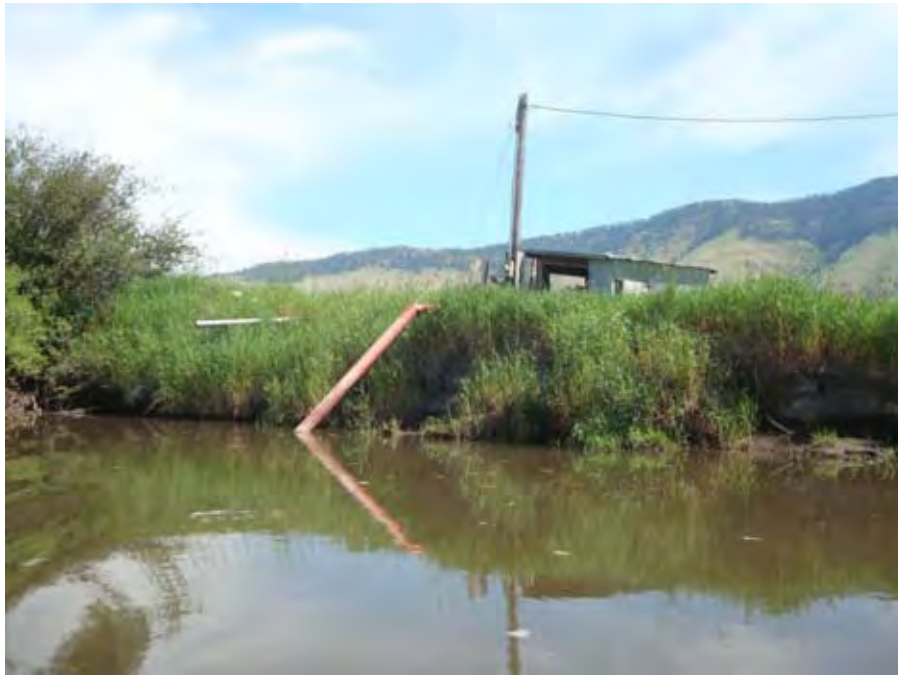
**Photograph 44. View of steel pump intake pipe, Elmer Reservoir, on right bank of Catherine Creek near river mile 14.30. Reach 1 – Catherine Creek, Grande Ronde Subbasin, Oregon – Bureau of Reclamation Photograph by D. Stelma, July 10, 2010.**

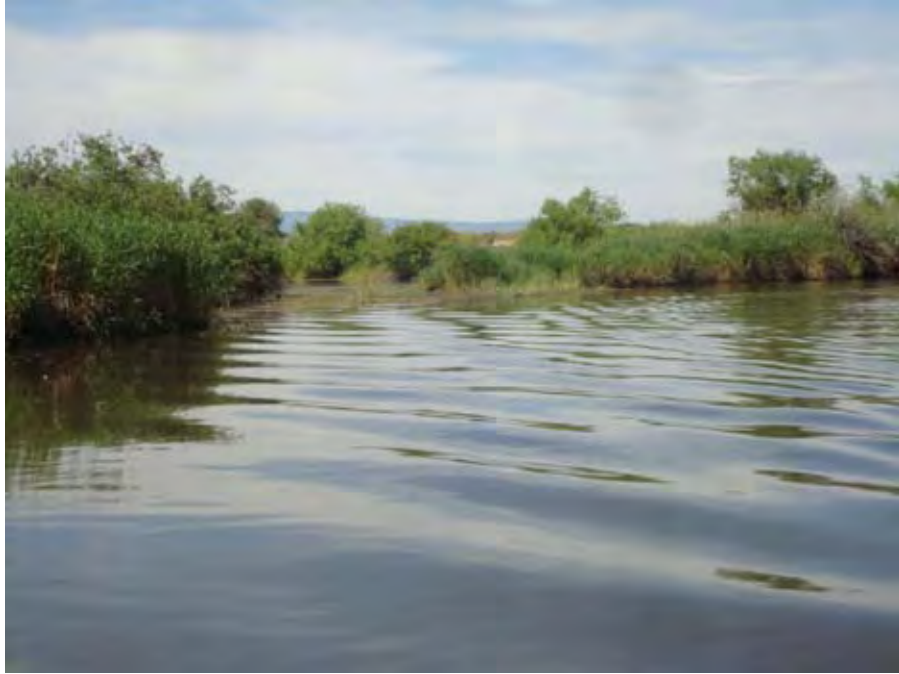
**Photograph 45. View looking west (left bank) at partially opened inlet to an abandoned meander near river mile 14.10. Reach 1 – Catherine Creek, Grande Ronde Subbasin, Oregon – Bureau of Reclamation Photograph by D. Stelma, July 10, 2010.**

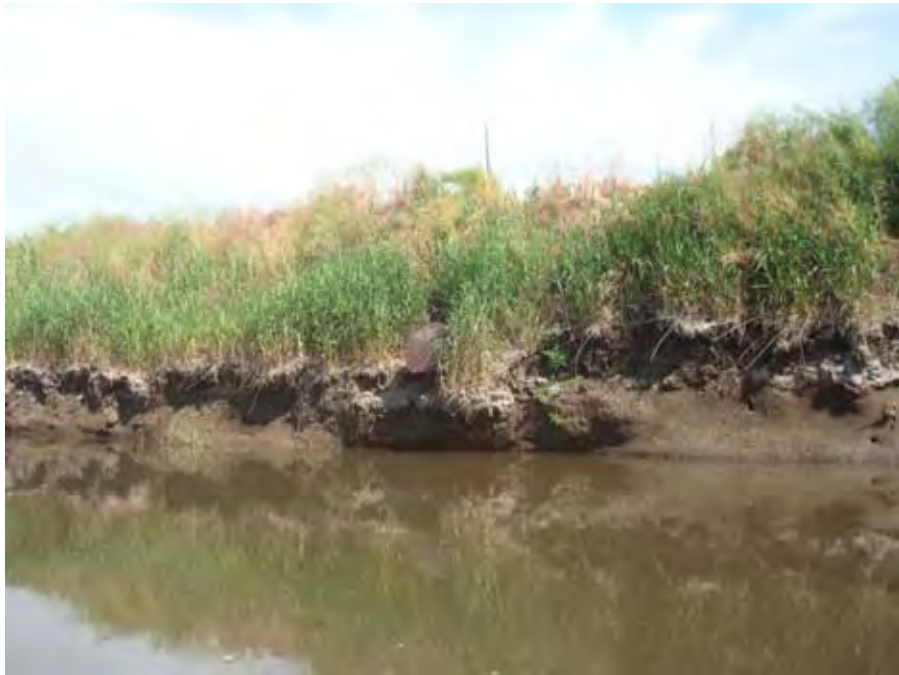
**Photograph 46. View of CMP drain pipe with one-way flapper-valve on the right bank of Catherine Creek near river mile 14.06. Reach 1 – Catherine Creek, Grande Ronde Subbasin, Oregon – Bureau of Reclamation Photograph by D. Stelma, July 10, 2010.**

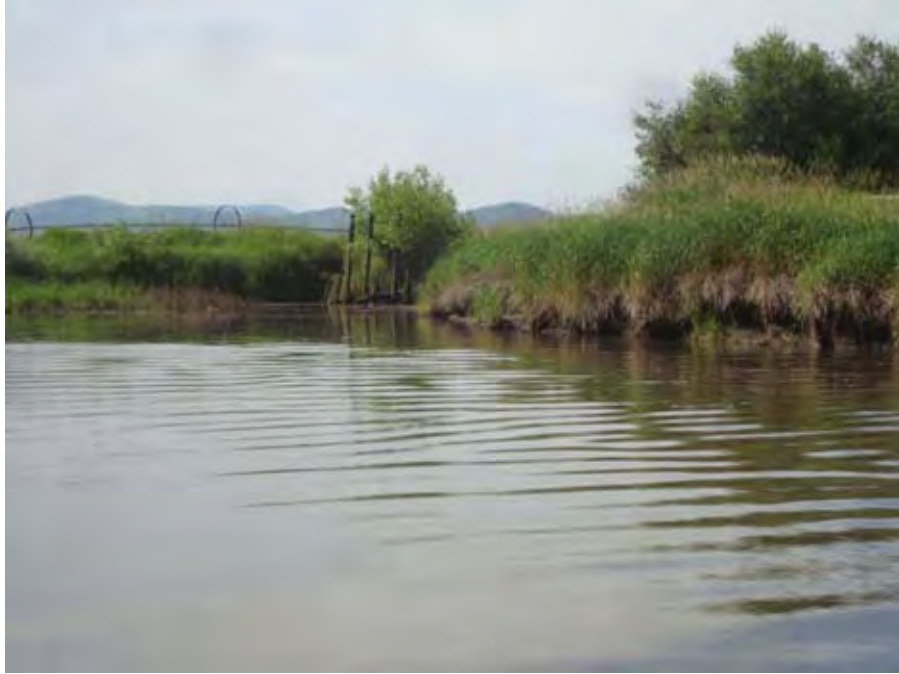
**Photograph 47. View looking west at wooden piers (pilings) exposed at oxbow lake and Catherine Creek intersection near river mile 13.90. Reach 1 – Catherine Creek, Grande Ronde Subbasin, Oregon – Bureau of Reclamation Photograph by D. Stelma, July 10, 2010.**

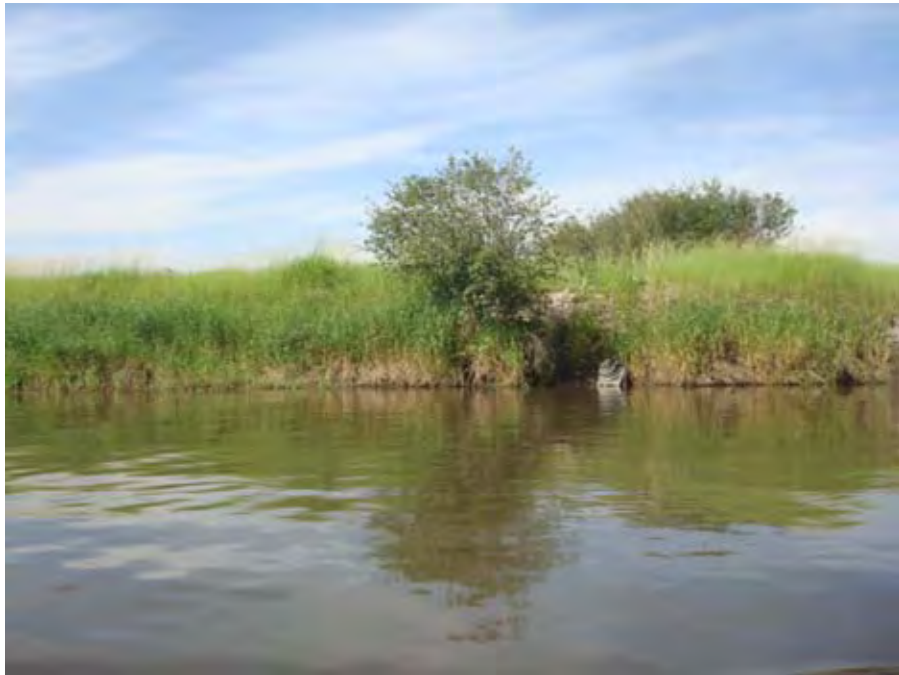
**Photograph 48. View looking west at discharge pipe from oxbow lake (cut-off meander), Catherine Creek in foreground near river mile 13.75. Reach 1 – Catherine Creek, Grande Ronde Subbasin, Oregon – Bureau of Reclamation Photograph by D. Stelma, July 10, 2010.**

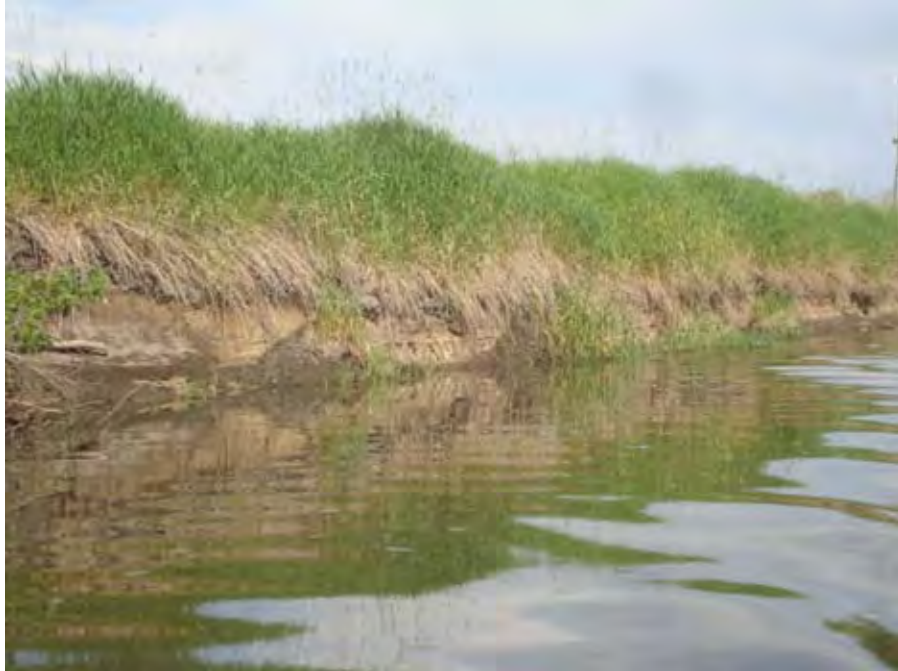
**Photograph 49. View looking downstream at fine-grained alluvium exposed along the left (west) bank of Catherine Creek (artificial cut) near river mile 13.68. Reach 1 – Catherine Creek, Grande Ronde Subbasin, Oregon – Bureau of Reclamation Photograph by D. Stelma, July 10, 2010.**

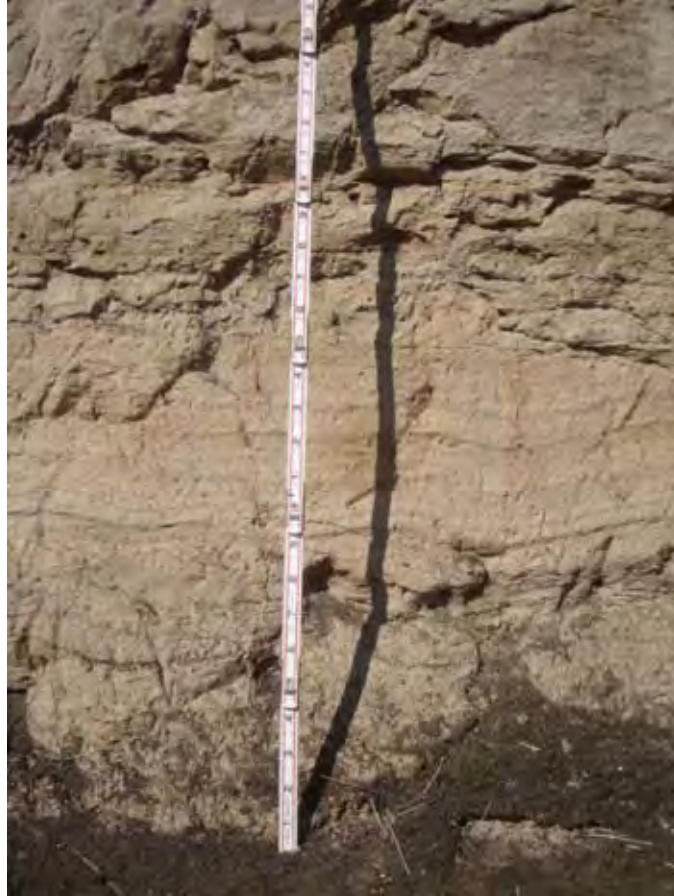
**Photograph 50. Close-up of fine-grained alluvium (firm to hard sandy silt) exposed along the left (west) bank of Catherine Creek (artificial cut) near river mile 13.68. Reach 1 – Catherine Creek, Grande Ronde Subbasin, Oregon – Bureau of Reclamation Photograph by D. Stelma, July 10, 2010.**
